# **INDOOR AIR QUALITY ASSESSMENT**

**Braintree Rehabilitation Hospital  
250 Pond Street  
Braintree, Massachusetts 02184**

Prepared by:  
Massachusetts Department of Public Health  
Bureau of Environmental Health  
Indoor Air Quality Program  
January 2009

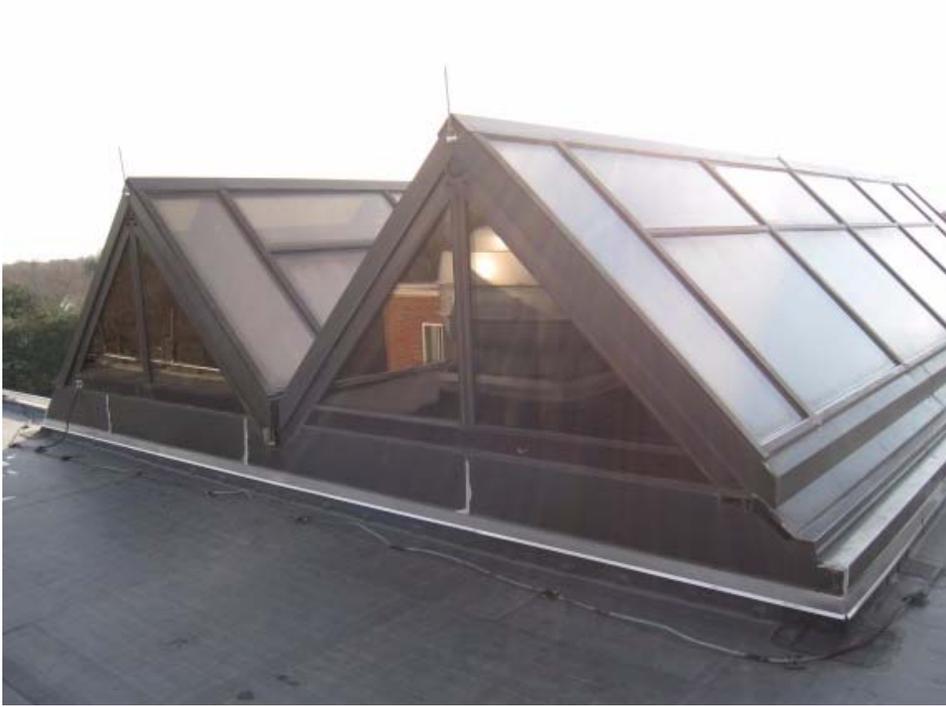
**Picture 1**

**Atrium Skylights**

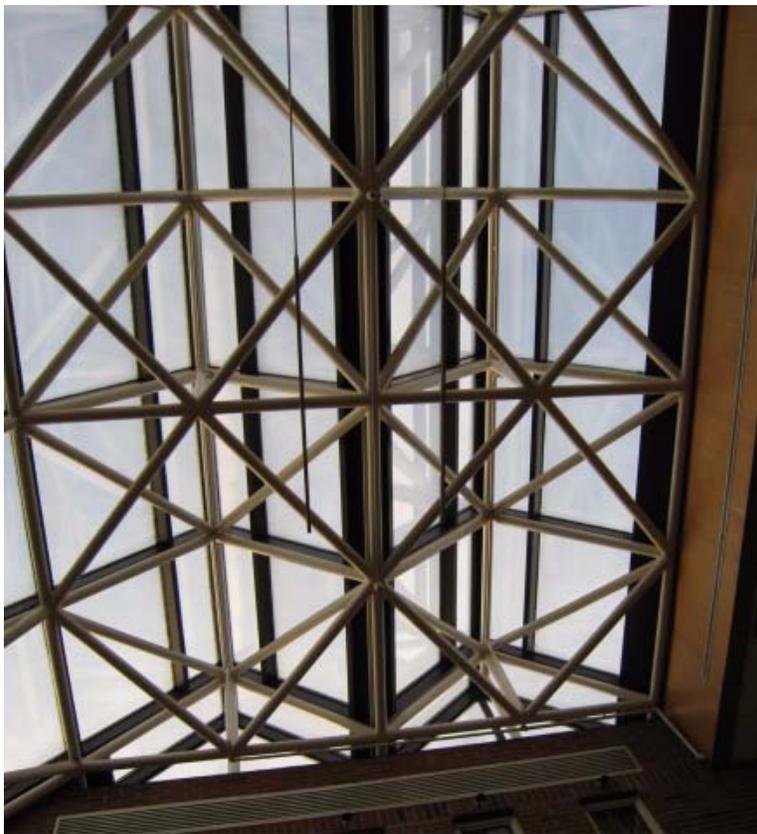
**Picture 2**

**Atrium Skylights (Interior View)**

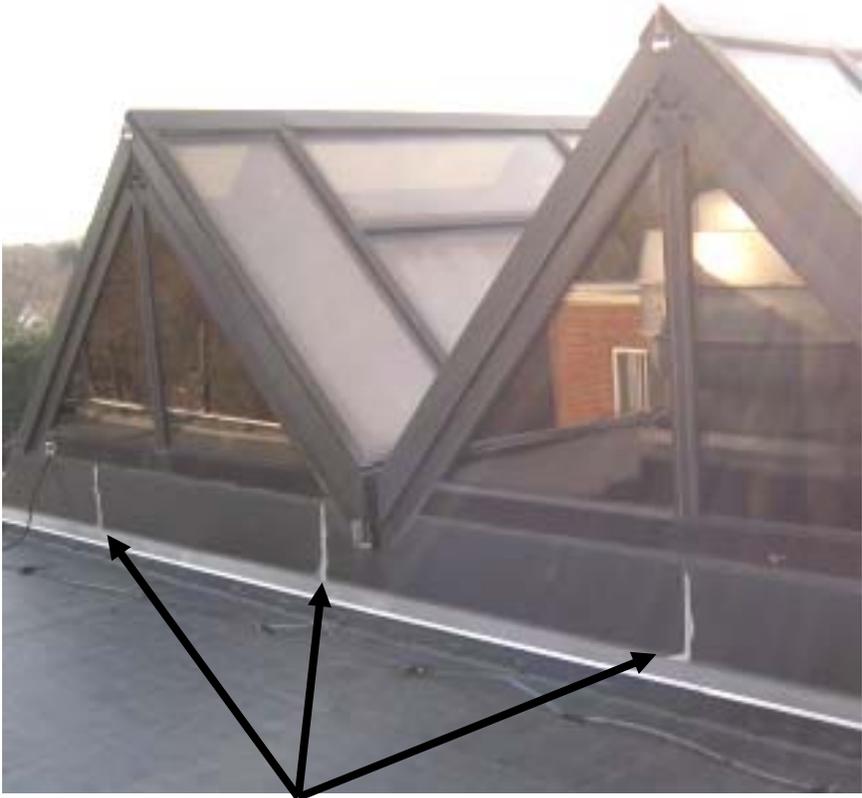
**Picture 3**

At the time of the assessment, BEH staff did not observe any evidence of water damage/staining of building materials (e.g., carpet, ceiling tiles, plaster) or mold growth in the main entrance, hallways or room 230-A. However, it was reported by BRH officials that skylights in the atrium/main entrance had leaked and were repaired one day prior to the BEH site visit (Pictures 1 and 2). BEH staff observed skylights on the roof of the atrium and observed areas of repair (Pictures 3 to 5).

**Areas of Skylight Repair/New Caulking (Arrows)**

2. Operate supply and exhaust units in patient rooms continuously during periods of occupancy. Patient rooms should be under slight positive pressure.
3. Monitor atrium skylights to ensure leaks have been repaired. Make additional repairs as needed.

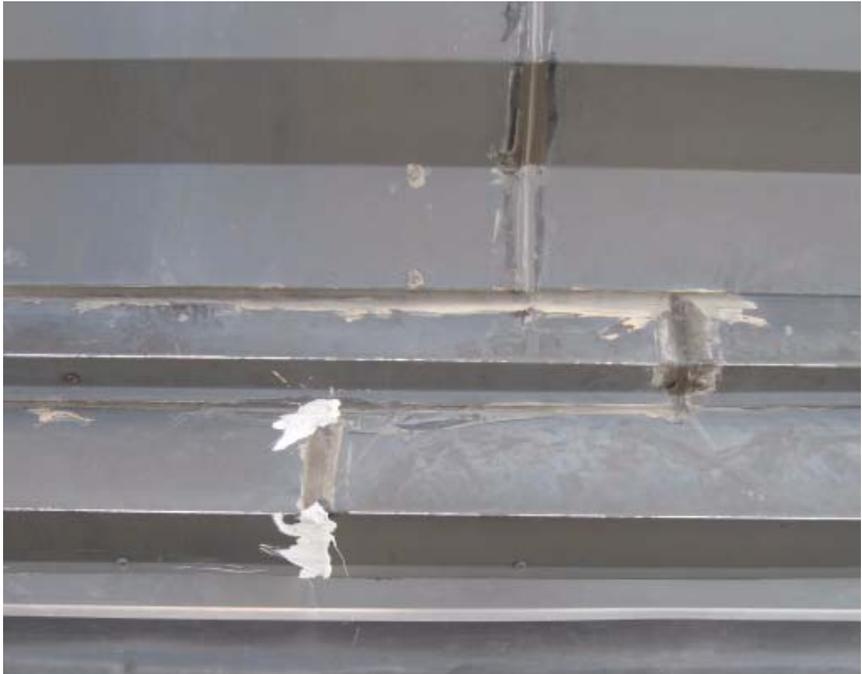
**Picture 4**

**Close-Up of Areas of Skylight Repair/New Caulking**

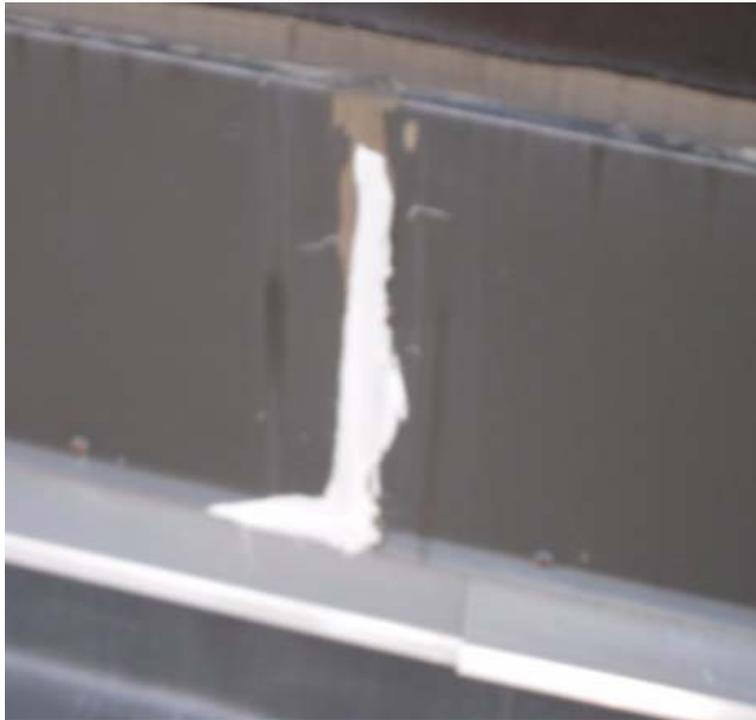
**Picture 5**

**Close-Up of Areas of Skylight Repair/New Caulking**

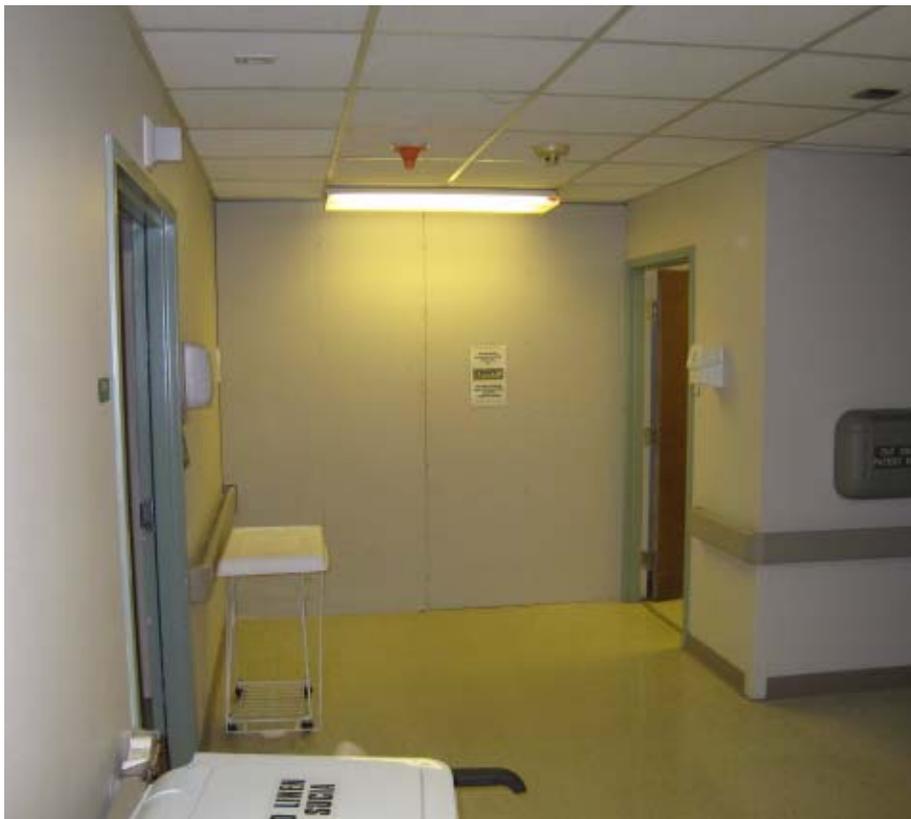
**Picture 6**

**Gypsum Wallboard Construction Barrier on 3<sup>rd</sup> Floor**

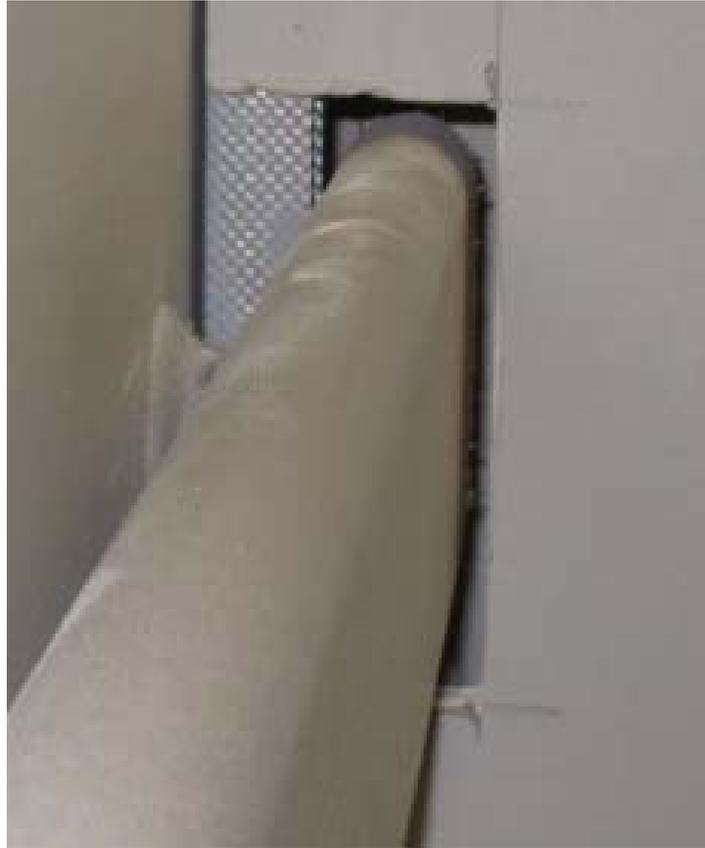
**Picture 7**

**Breach in Gypsum Wallboard Construction Barrier, Note Spaces around Hand Rail**

4. Seal remediation area(s) with a temporary impermeable barrier (e.g., plastic sheeting) as part of remediation activities. Ensure barrier is as airtight as possible by sealing edges and frames securely with duct tape. Inspect for drafts and/or light penetration to ensure that the barrier is airtight. Seal both the construction and occupied sides to create a dual barrier.

5. Inspect construction barriers for integrity *daily*. In addition, encourage staff to report any breaches in construction barriers immediately to the administration/construction personnel for prompt remediation.

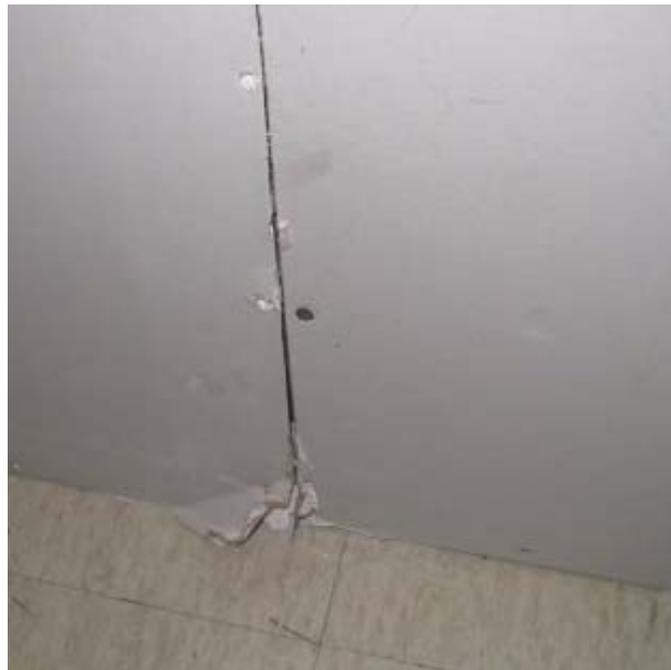
**Picture 8**

**Breach in Construction Barrier, Note Space between Sections of Gypsum Wallboard**

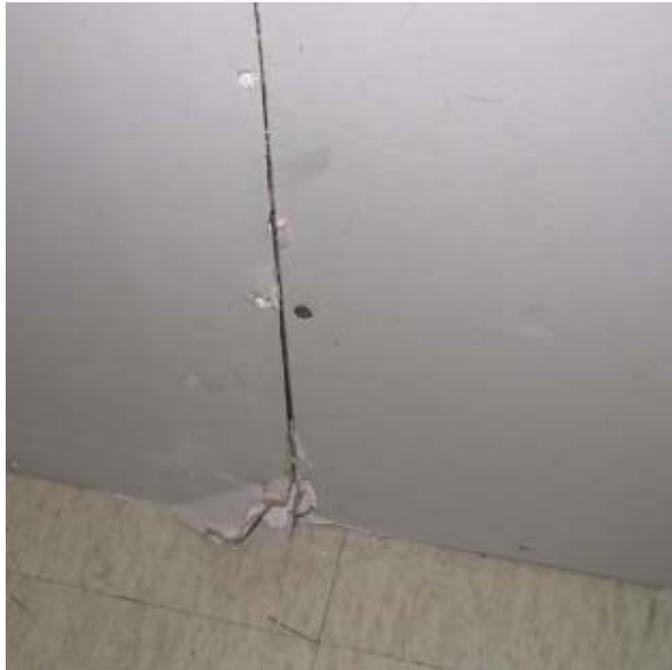
**Picture 9**

**Breach in Construction Barrier, Note Space between Sections of Gypsum Wallboard**

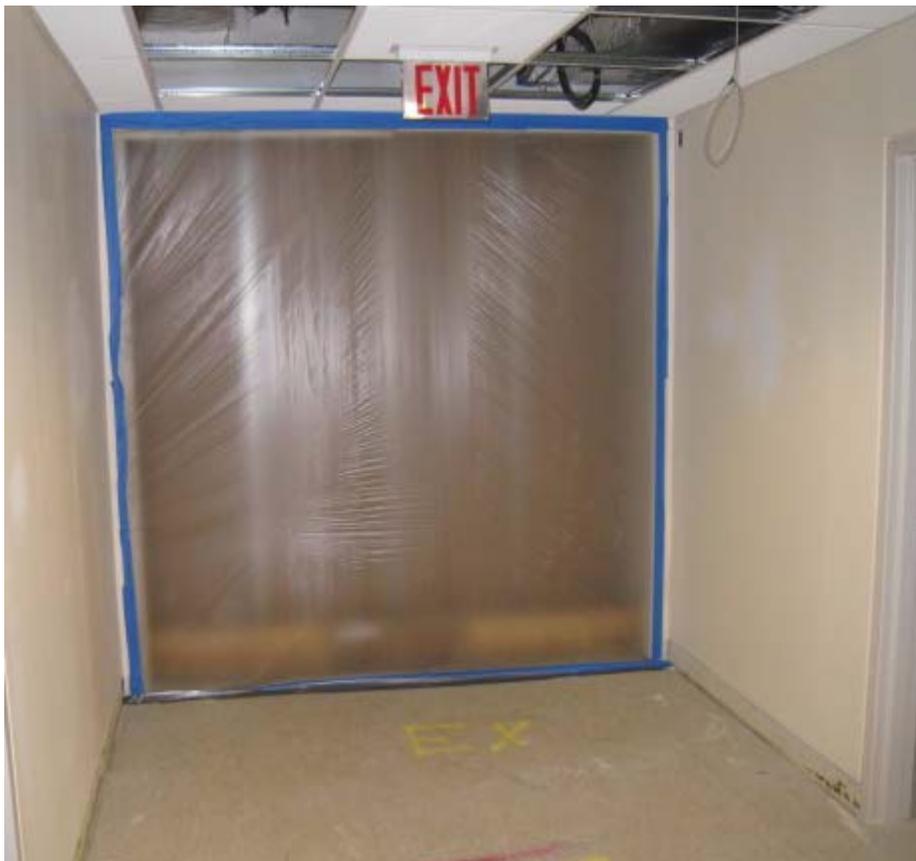
**Picture 10**

**Construction Barrier Resealed With Plastic and Tape**
