ODOR INVESTIGATION

**Alcoholic Beverages Control Commission
239 Causeway Street
Boston, Massachusetts 02114**

Prepared by:
Massachusetts Department of Public Health
Bureau of Environmental Health
Indoor Air Quality Program
March 2009

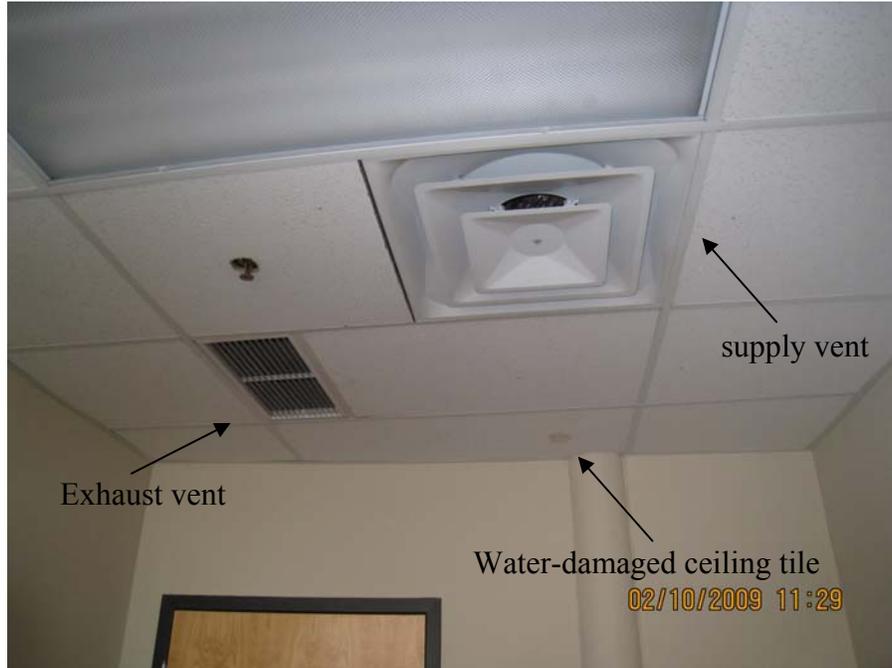
Picture 1

It can be seen from Table 1 that carbon dioxide levels were below 800 parts per million (ppm) in all areas surveyed. Ventilation is provided by a heating, ventilation and air conditioning (HVAC) system. Fresh air is introduced by air-handling units (AHUs). Heat pumps are located above ceiling tiles/in the ceiling plenum to facilitate airflow. Transfer air from the AHU is drawn into the heat pumps and delivered to work stations via ceiling-mounted air diffusers (Picture 1). Air drawn through metal/plastic grates into the ceiling plenum, which returns air to the AHUs where it is exhausted (Picture 1).

A water-damaged ceiling tile was observed in the CI's office (Picture 1). Water-damaged/missing ceiling tiles can indicate roof or plumbing leaks. Water-damaged ceiling tiles can provide a source for mold growth and should be replaced after a water leak is discovered and repaired.

Supply and exhaust ventilation

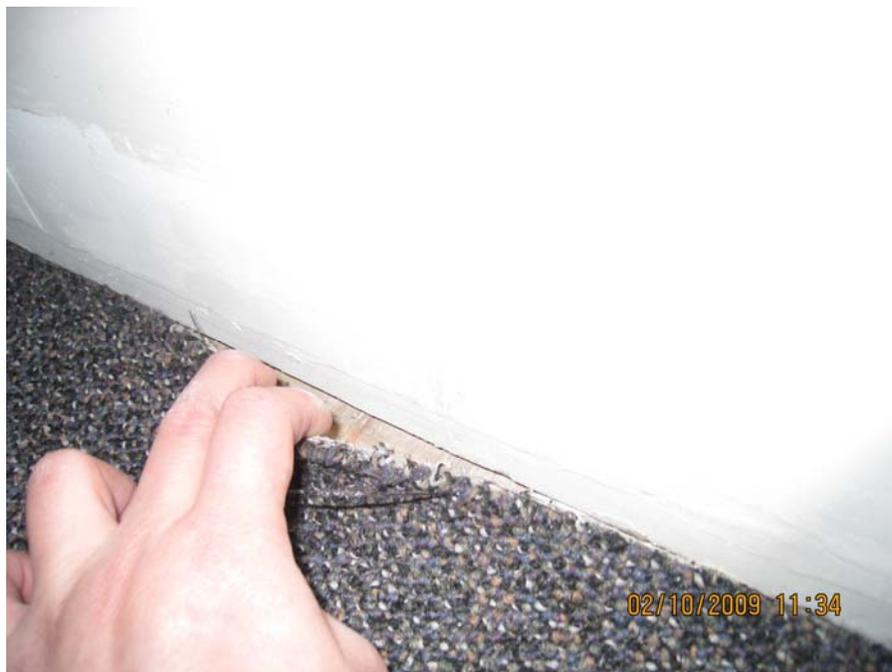
Picture 2

Space between floor and gypsum wallboard

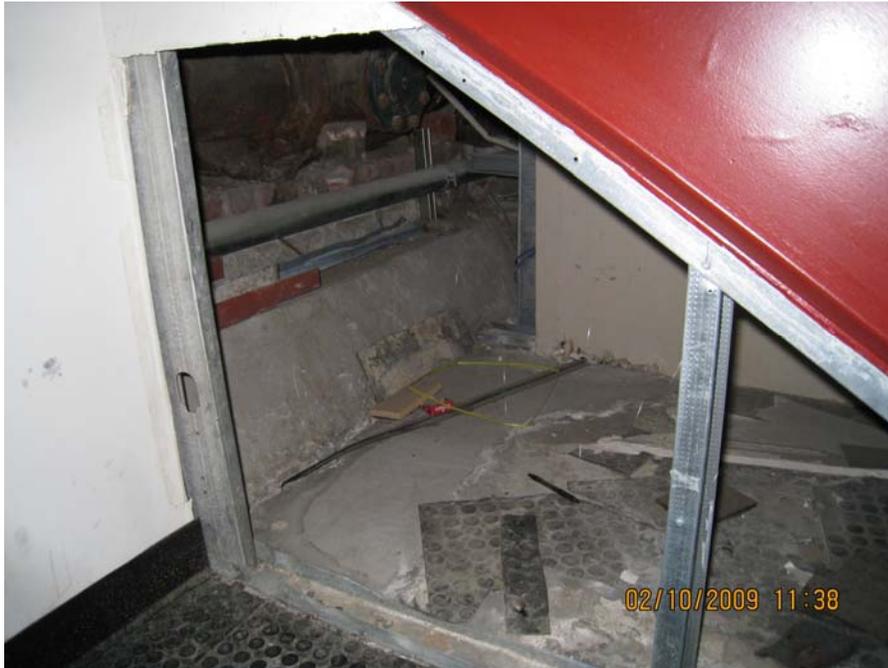
Picture 3

The CI office is adjacent to a stairwell, which leads to the exterior of the building. BEH staff located spaces around the exterior door. The lack of appropriate door sweep and weather stripping can allow air and moisture to penetrate the building. More importantly, BEH staff observed an opening under the bottom staircase, which provides access to a pipe chaseway

Opening under stairwell

1. Seal breaches in the building's exterior wall to prevent movement of outdoor air into the building.
2. Ensure breaches between the pipe chaseway and the first floor are sealed to prevent movement of air up through the wallspace.

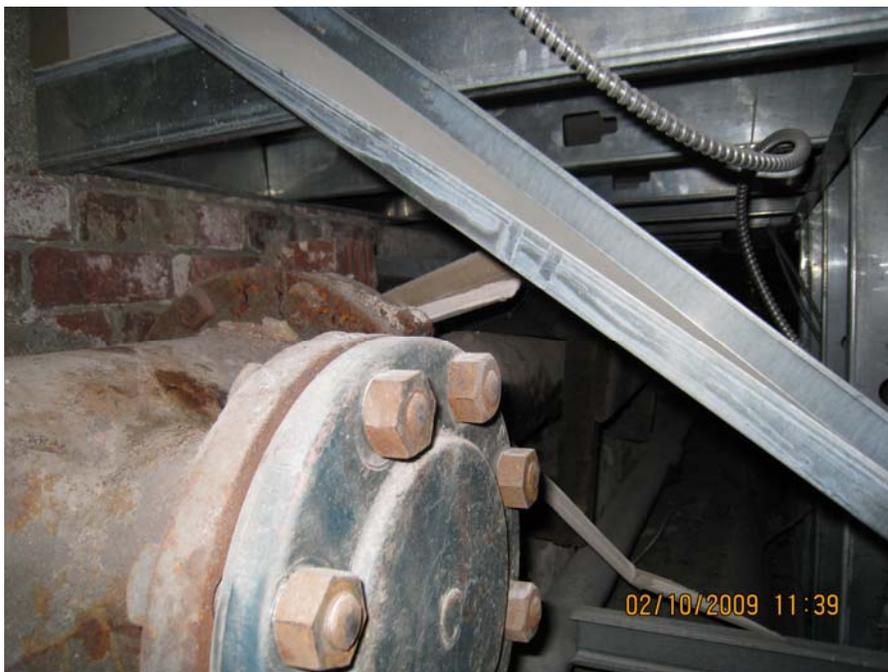
Picture 4

(Picture 3). This pipe chaseway runs below the CI office, conference room, Executive Director's office, as well as other offices along this exterior wall; it is also parallel to Causeway Street (Picture 4). Debris was observed on the floor of the chaseway, and signs of water penetration were noted (Picture 5). Repeated water penetration and increased humidity during the summer months can result in odors, as the dirt, dust and other debris in this space is repeatedly exposed to moisture. Air movement into this space from the outside of the building (i.e., through breaches in the exterior door system can result in pressurization of the chaseway, which can push the odors into the stairwell or up the office wall space. At the time of MDPH's visit on February 12, 2009, this opening had been sealed (Picture 6).

Pipe chaseway

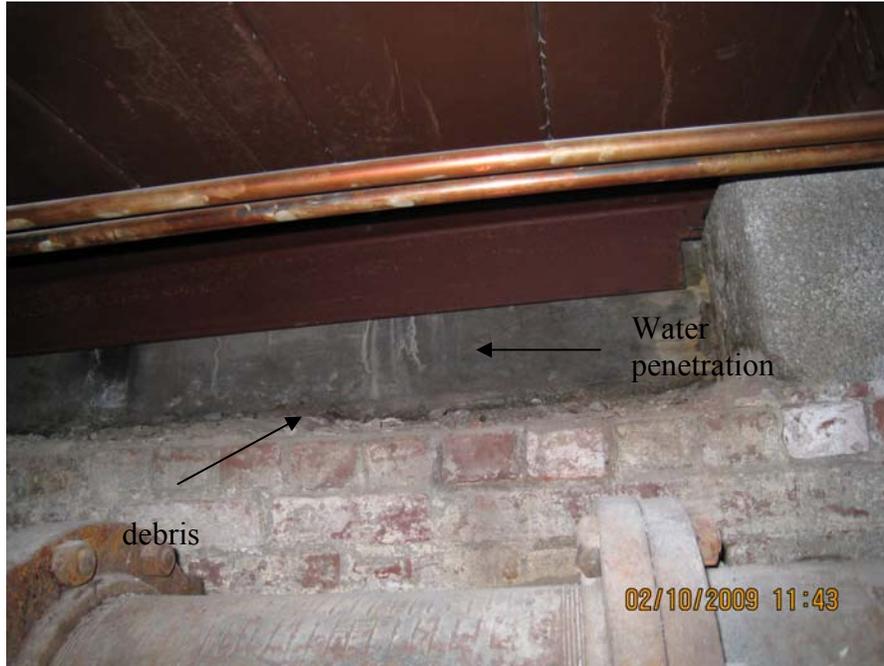
Picture 5

Brick wall of chaseway, note signs of water penetration against foundation wall

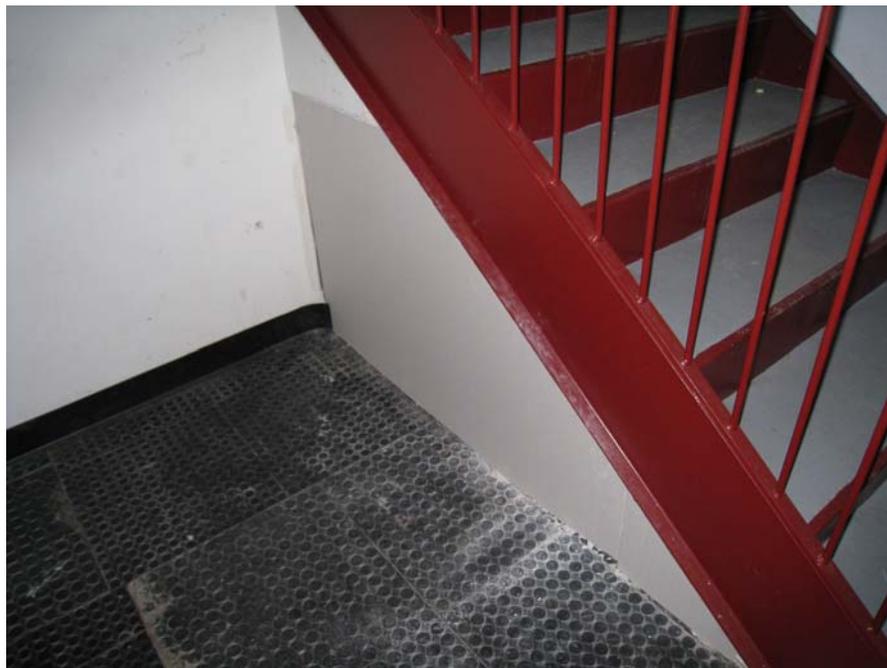
Picture 6

Opening under stairwell sealed

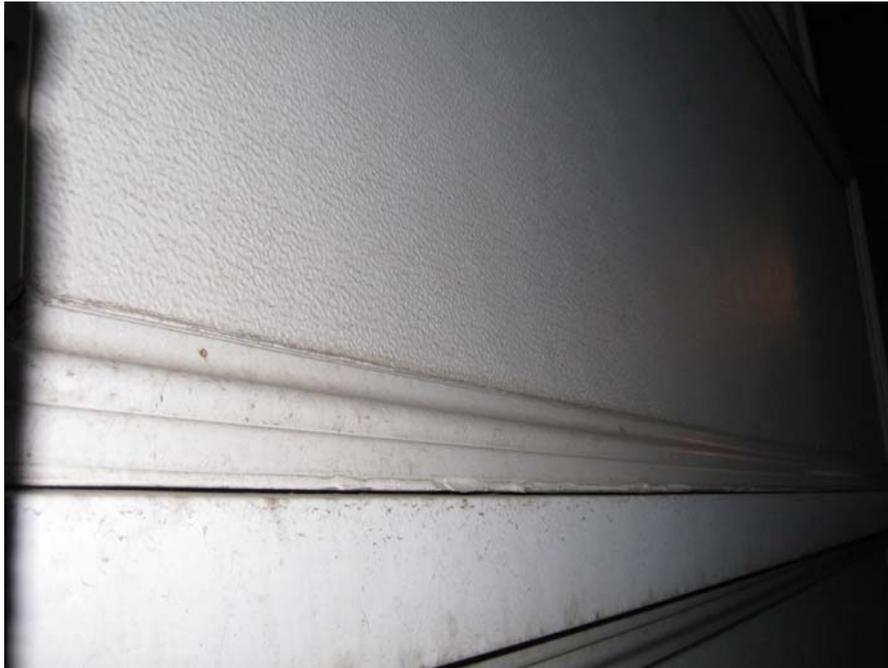
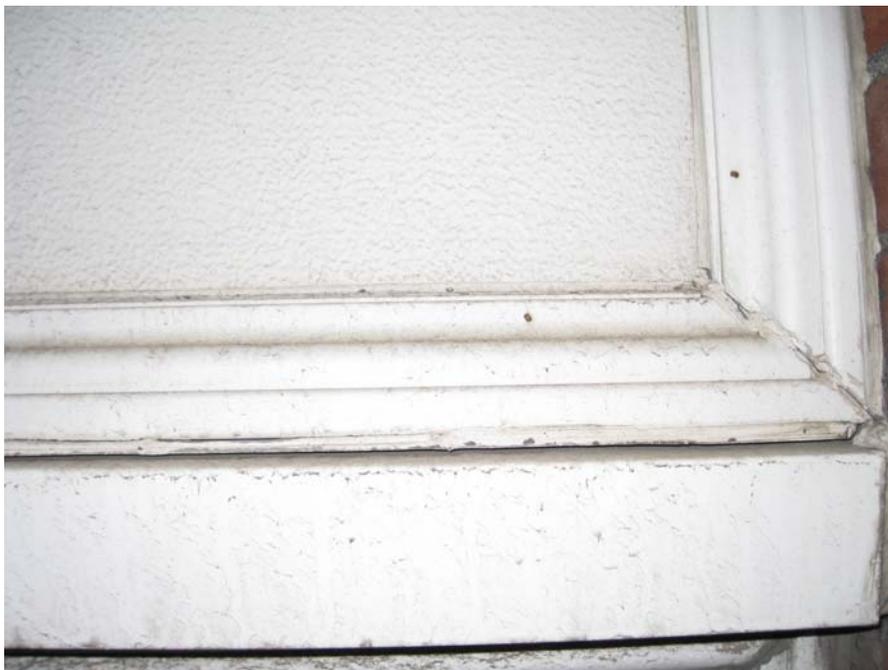
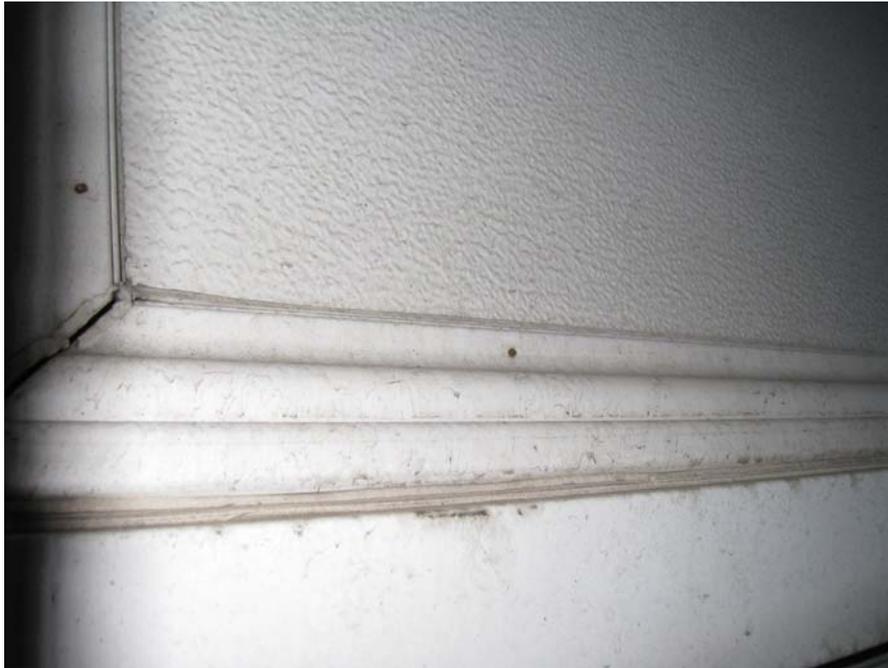
BEH staff also observed conditions around the building's exterior and noted breaches in window system panels (Pictures 7 to 9). These breaches can allow air and moisture to penetrate the wall space between the exterior wall and the interior wall. Air from these breaches aide the movement of air/odors from the chaseway into offices spaces.

Breach in exterior wall panel

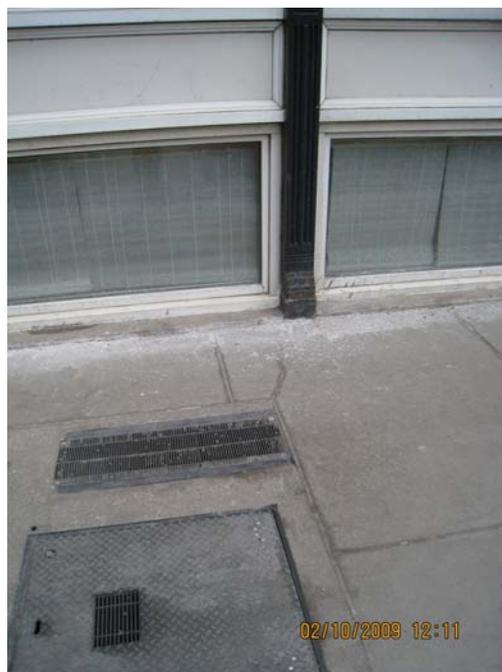
Picture 10

Furthermore, sidewalk grates were noted outside this area of the building (Picture 10). These grates allow heat and air to escape the subway system and pipes that run below the building. Odors can periodically be detected from air emanating from these grates, which can further contribute to odors within the ABCC occupied space.

Exhaust grates in sidewalk

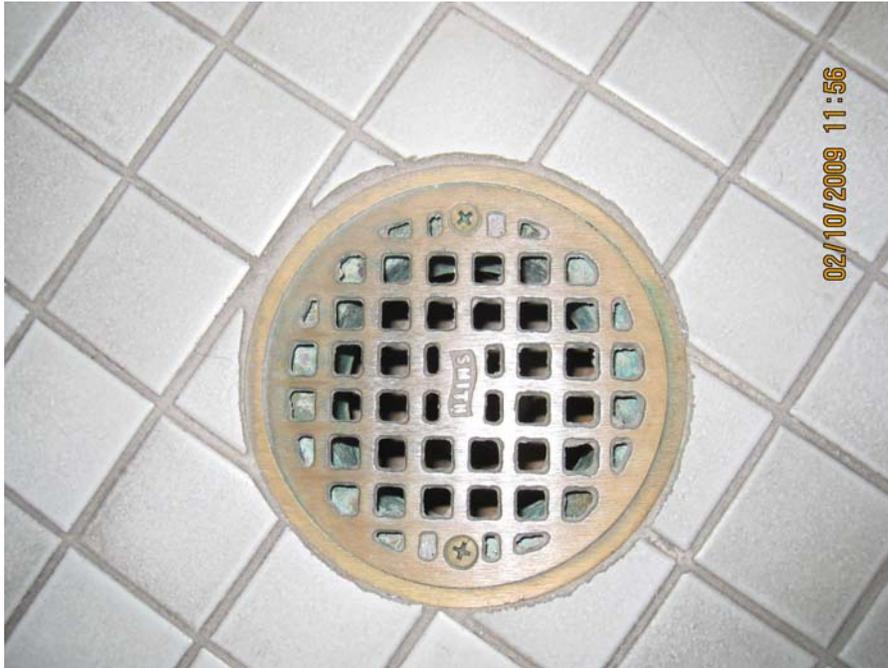
Picture 11

In addition, staff reported sewer-like odors in the women's restroom. As reported by ABCC staff, these odors occur periodically. BEH staff observed conditions in the women's restroom and noted a floor drain. The floor drain appeared dry at the time of the assessment (Picture 11); however, no odors were detected. The most likely source of odors in the restroom

is a dry drain trap in floor drain. The purpose of a drain trap is to prevent sewer system gases and odors from entering the occupied space. When water is poured into a trap, an air tight seal is created by the water in the U-bend section of the pipe. Water must be poured into the traps at least twice a week to maintain the integrity of the seal and prevent odors. Without water, the drain opens the room to the sewer system. If a mechanical device depressurizes the room, air, gas, and odors can be drawn from the sewer system into the room.

Floor drain in women's restroom

5. Weather-strip the exterior door in the adjacent hallway.
6. Pour water into floor traps at least twice a week to maintain the integrity of the seal and prevent odors.

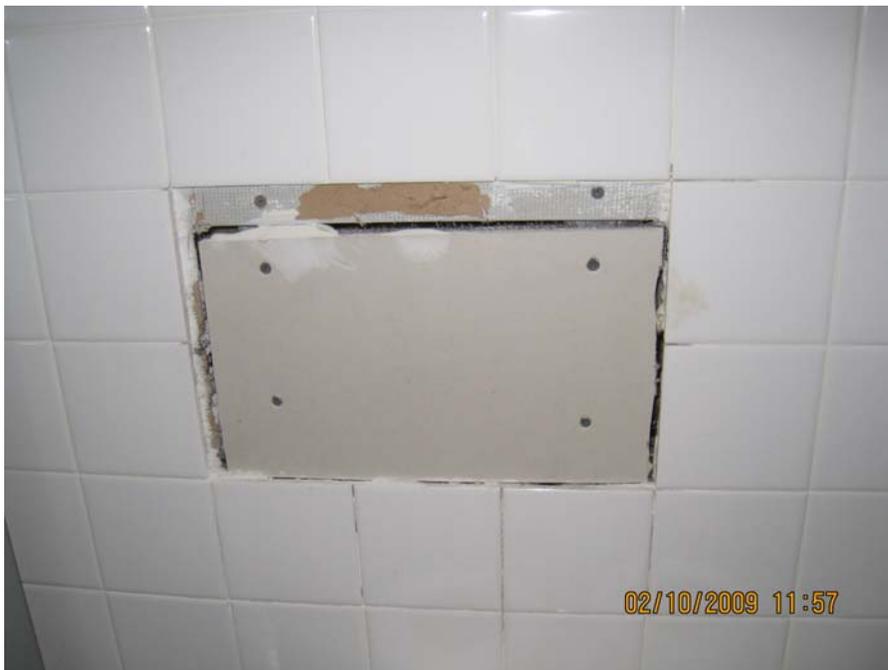
Picture 12

It appears that work to repair a pipe had been conducted in the women's restroom (Picture 12); however, the tiles that were removed for the repair had not been replaced. According to ABCC staff, these tiles have been missing for some time. These tiles should be replaced to prevent movement of particles from the chaseway through the breaches around the gypsum wallboard into the restroom.

Missing wall tiles in women's restroom

7. Replace missing tiles in women's restroom wall to prevent movement of particles.
8. Re-wrap insulation to prevent exposure.
9. Refer to resources and other related indoor air quality documents located on the MDPH's website for further building-wide evaluations and advice on maintaining public buildings. These documents are available at: <http://mass.gov/dph/iaq>.

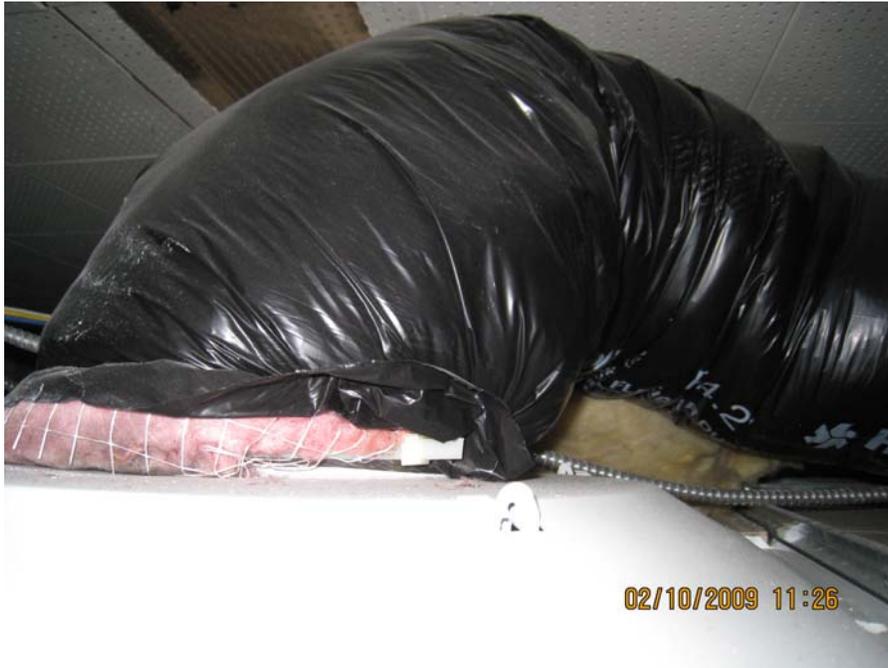
Picture 13

Lastly, exposed fiberglass insulation was observed in the ceiling plenum of the CI's office (Picture 13). Fiberglass insulation can provide a source of skin, eye and respiratory irritation. If drawn into the ceiling's HVAC system, fiberglass particles can be distributed throughout the office spaces.

Exposed fiberglass insulation in ceiling plenum of CI's office
