# **INDOOR AIR QUALITY ASSESSMENT**

**Alfred J. Gomes Elementary School  
286 South Second Street  
New Bedford, Massachusetts 02740**

Prepared by:  
Massachusetts Department of Public Health  
Bureau of Environmental Health  
Indoor Air Quality Program  
May 2009

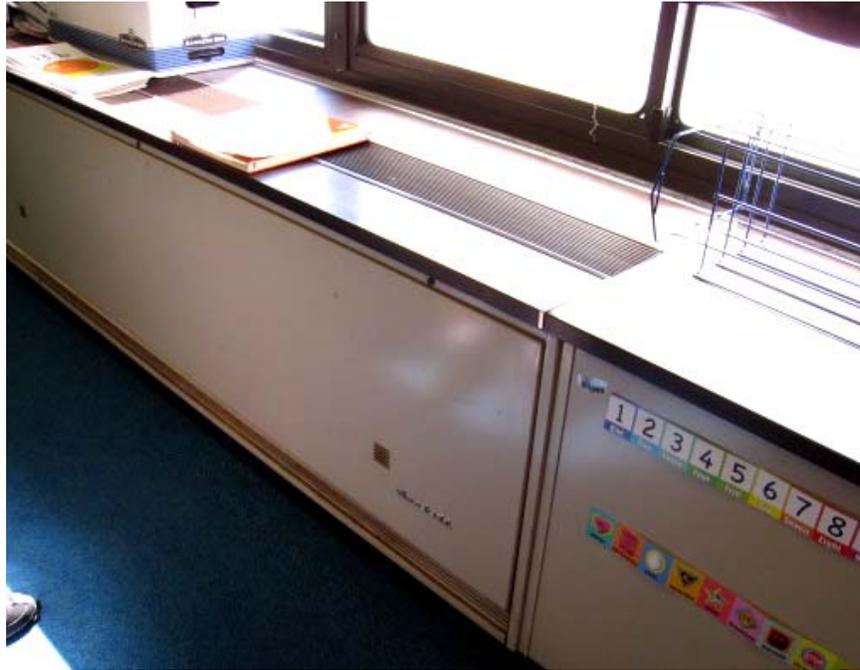
**Picture 1**

Fresh air for exterior classrooms is supplied by unit ventilator (univent) systems (Picture 1). A univent draws fresh, outdoor air through an air intake located on the exterior wall of the building (Picture 2), and return air from the room through an air intake located at the base of the unit (Figure 1). Fresh and return air are mixed, filtered, heated and provided through an air diffuser located in the top of the unit.

**Classroom Univent**

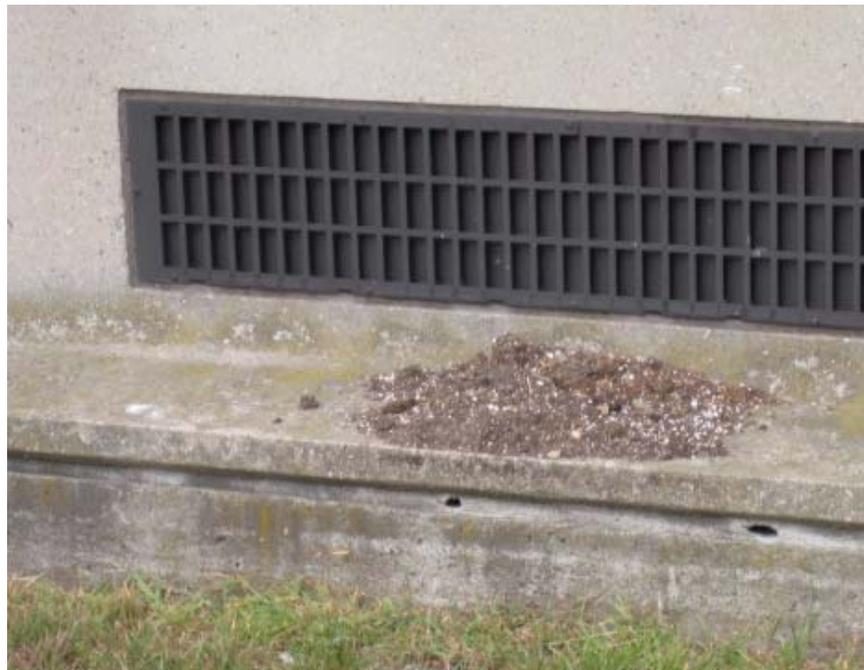
**Picture 2**

**Univent Fresh Air Intake**

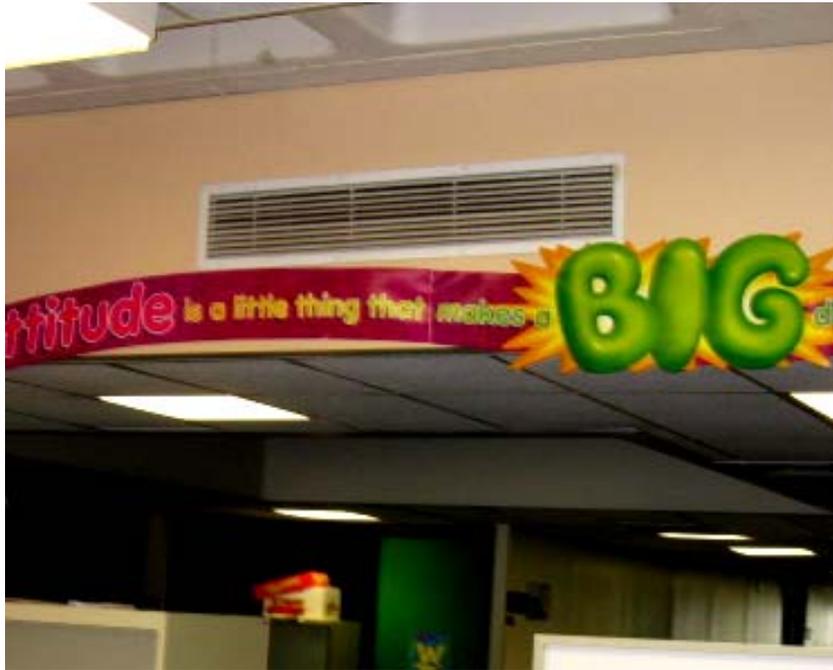
**Picture 3**

Exhaust ventilation in exterior classrooms is provided by wall or ceiling vents ducted to rooftop motors (Pictures 3 and 4). Exhaust ventilation systems continuously remove air that has

**Classroom Exhaust Vent**

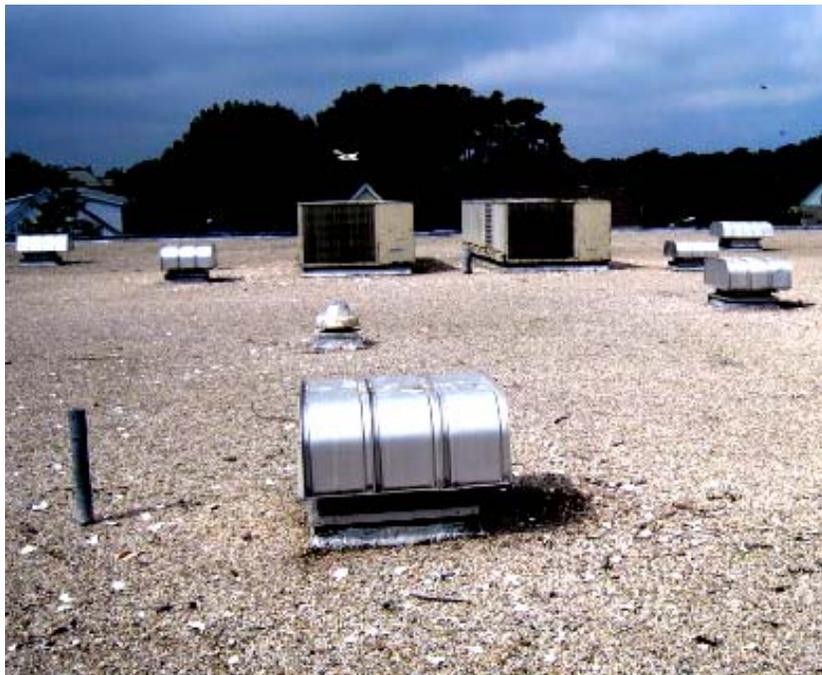
**Picture 4**

become stale from moisture, odors, and pollutants. As with the univents, exhaust vents were operating in the majority of areas surveyed during the assessment (Table 1). Mr. Pimentel reported that several of the rooftop exhaust motors needed to be serviced/repared and orders had been placed to obtain replacement parts. In classroom 250, the exhaust vent was covered with cardboard and sealed with tape to avoid backdrafting (Picture 5). Once the exhaust motor for this area is repaired, the blockage should be removed from the vent to allow air exchange.

**Rooftop Exhaust Motors**

4. Inspect all exhaust motors and belts periodically for proper function. Repair and replace as necessary.
5. Use openable windows in conjunction with mechanical ventilation to increase air exchange. Care should be taken to ensure windows are properly closed at night and weekends to avoid the freezing of pipes and potential flooding.

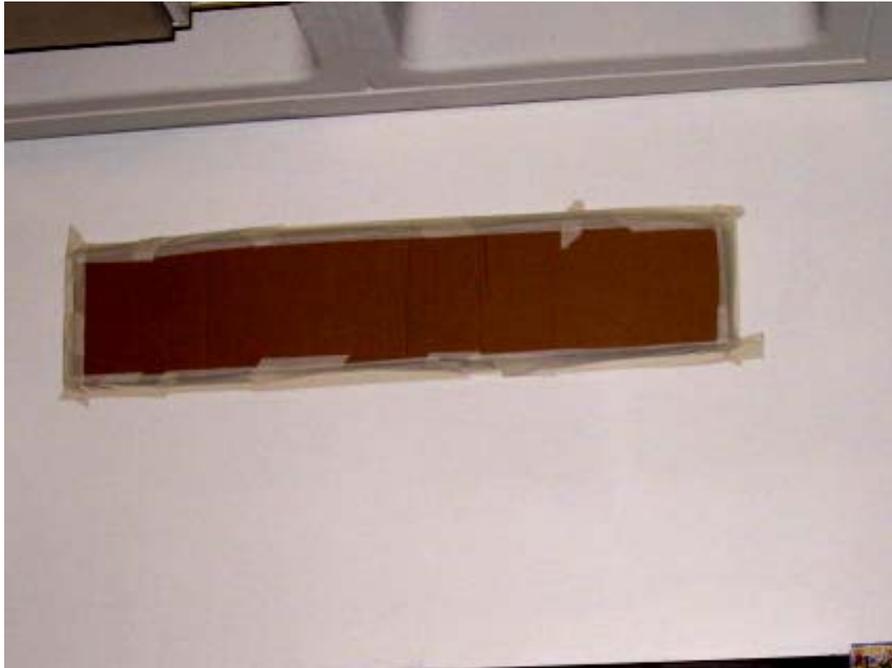
**Picture 5**

**Classroom 250 Exhaust Vent Covered with Cardboard to Prevent Backdrafting**

2. Inspect univents in classrooms 726 and 344 (noise); and 247 and 251 (excessive heat) for proper function. Make adjustments/repairs as needed.
3. Continue with repairs to restore exhaust ventilation. Once repaired, remove any blockages from exhaust vents to ensure adequate airflow.

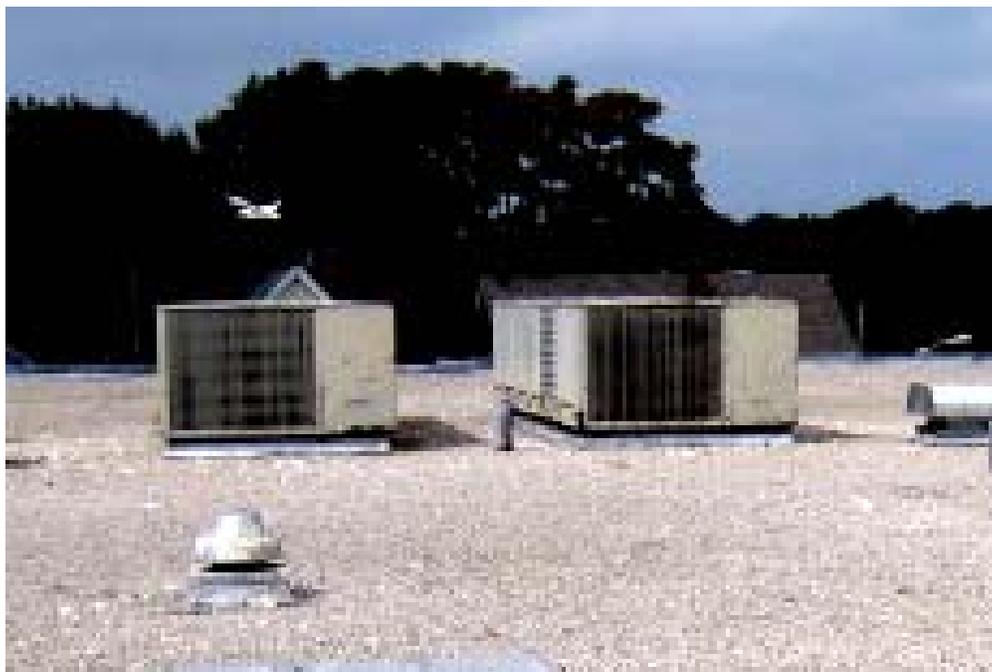
**Picture 6**

The HVAC system for interior/centralized areas consists of rooftop air-handling units (AHUs) (Picture 6). AHUs draw in fresh, outdoor air through air intakes; filter, heat and/or cool the air; then distribute it to occupied areas via ceiling-mounted air diffusers (Picture 7). Exhaust air is drawn through ceiling-mounted vents and ducted back to the AHUs. These systems were functioning at the time of the assessment.

**Rooftop AHUs**

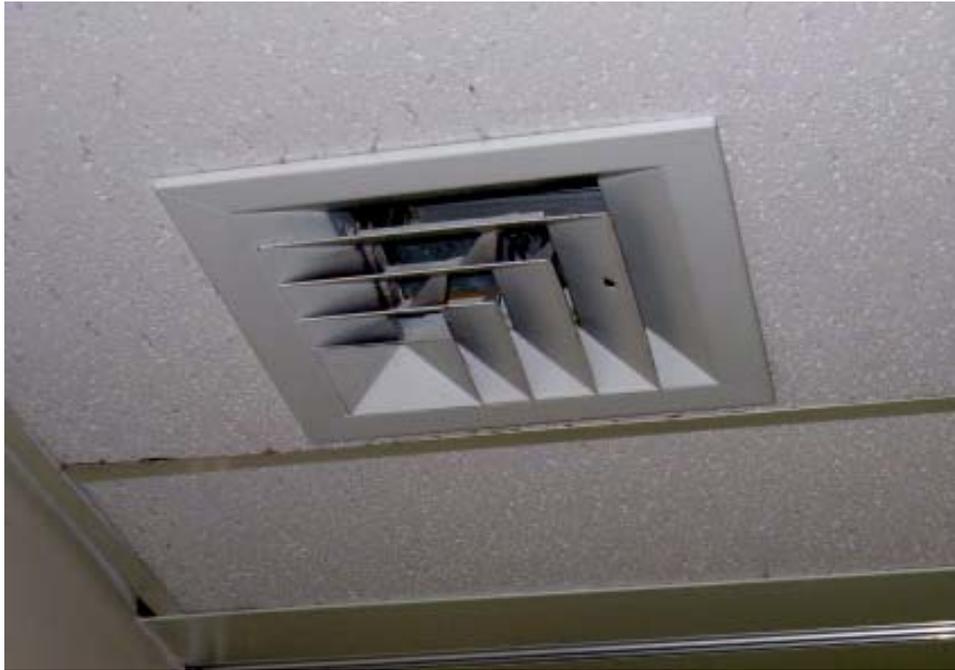
**Picture 7**

**Ceiling-Mounted Supply/Return Vent**

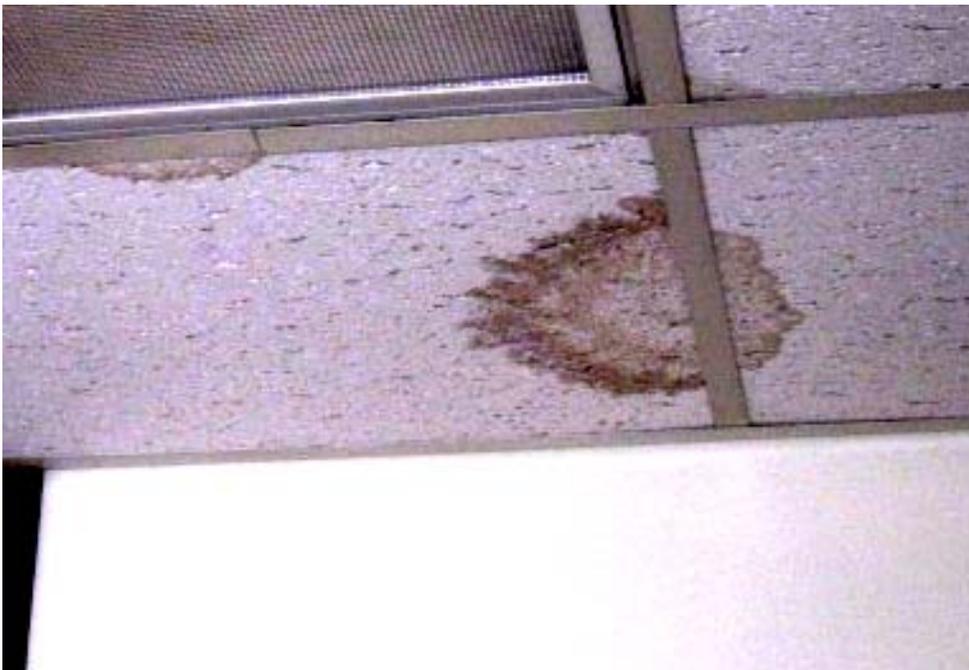
**Picture 8**

A number of areas (classrooms, common areas and hallways) had water-damaged ceiling tiles, which can indicate leaks from the roof or plumbing system (Pictures 8 through 11/Table 1). Water-damaged ceiling tiles can indicate sources of water penetration and provide a source of mold growth. In the music room, dark staining that appeared to be mold growth was visible on a ceiling tile near the wall-mounted air-conditioner (Picture 9). Water damage to ceiling tiles was particularly noted around ceiling vents, most likely due to condensation from the air conditioning system (Picture 10). Ceiling tiles should be replaced after a water leak is discovered and repaired. At the time of assessment, BEH staff recommended that this ceiling tile be removed and replaced.

**Water Damaged Ceiling Tiles**

8. Ensure building envelope/plumbing leaks are repaired. Remove/replace any water-damaged ceiling tiles, particularly in the music room.
9. Scrape/clean efflorescence from masonry walls and monitor for further water penetration. Clean, prepare, and re-paint concrete ceilings in water damaged areas once leaks are repaired.

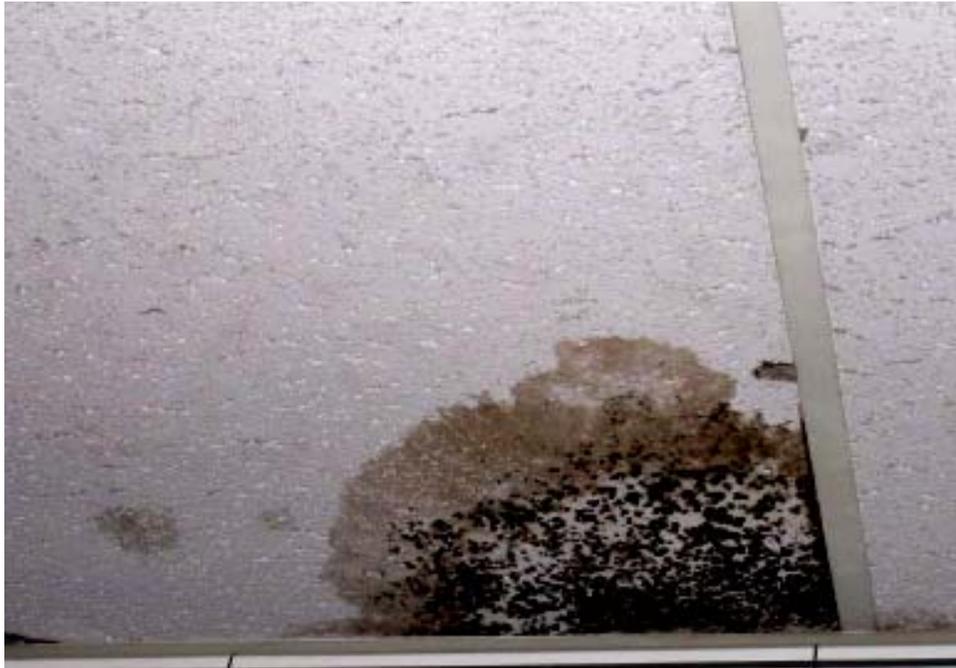
**Picture 9**

**Water Damaged Ceiling Tile in Music Room Colonized With Mold**

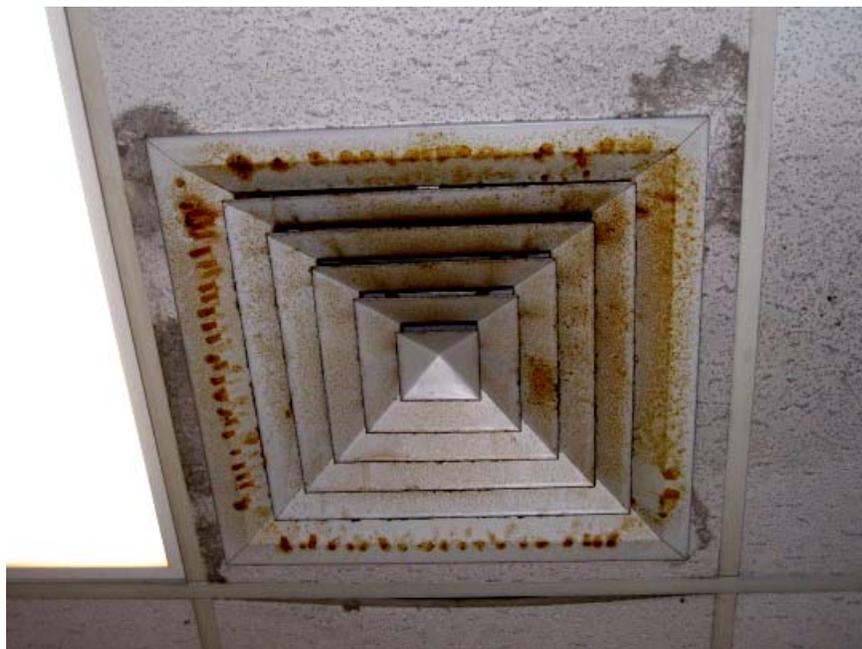
**Picture 10**

**Water Damaged Ceiling Tile in Music Room Note Rusted Metal Diffuser  
Due to Condensation from AC**

10. Encourage staff to monitor their classrooms for active leaks/water damage and report to school maintenance staff for prompt remediation.
11. Work with HVAC Engineer to examine best methods to avoid condensation around metal vents in air-conditioned music room(s).

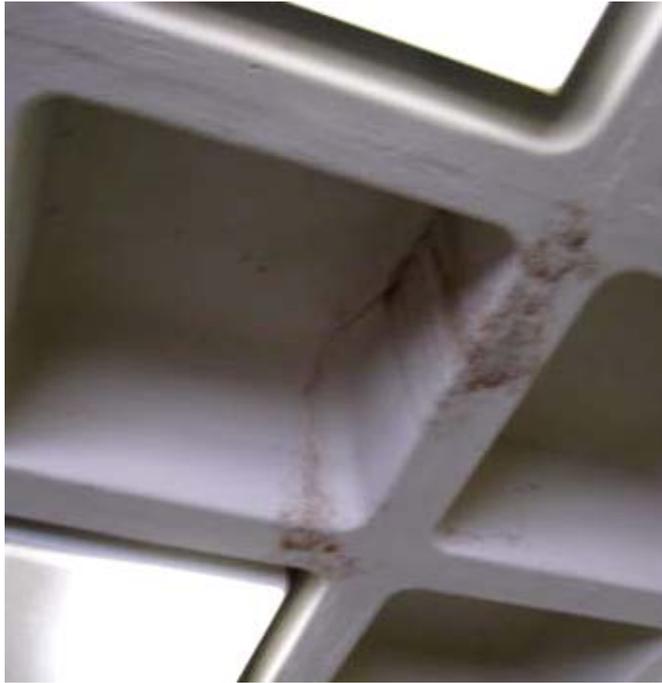
**Picture 11**

The building appears to have had water infiltration issues through the building envelope as evidenced by water stained concrete ceilings (Picture 11) and efflorescence on interior brick (Pictures 12 and 13). Efflorescence is a characteristic sign of water damage to building materials, but it is not mold growth. As moisture penetrates and works its way through building materials (e.g., masonry), water-soluble compounds dissolve, creating a solution. As this solution moves to the surface, the water evaporates, leaving behind white, powdery mineral deposits.

**Signs of Water Penetration/Staining on Concrete Honeycomb Ceiling**

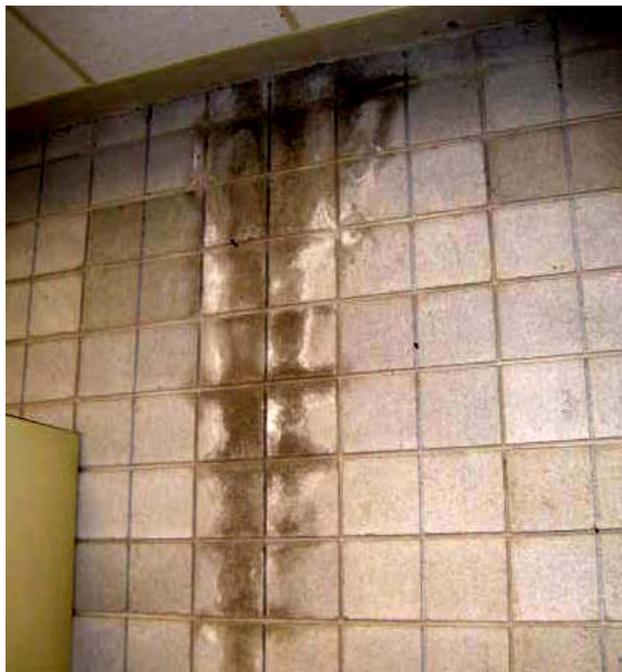
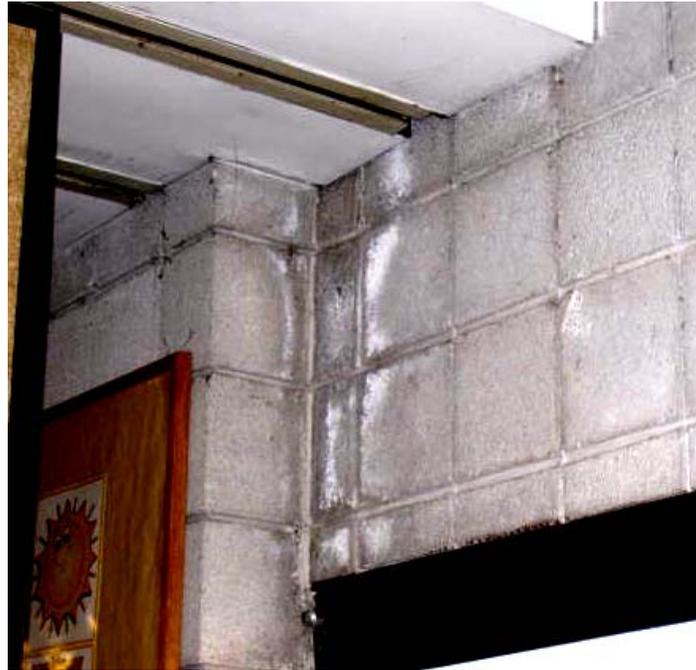
**Water Staining and Efflorescence on Interior Masonry Walls**

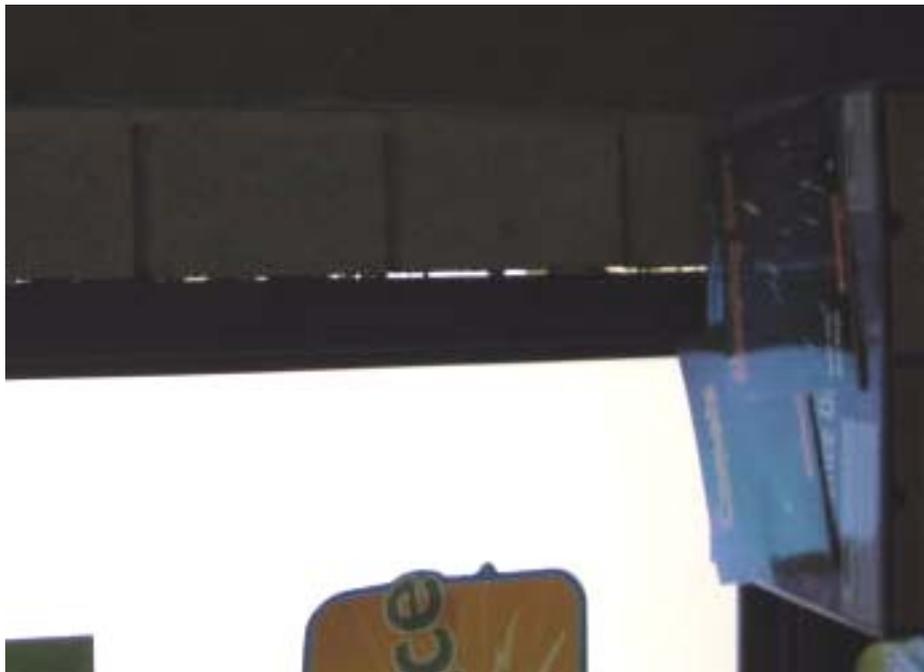
**Picture 14**

Air infiltration was noted around windows throughout the school. In classroom 729, BEH observed sizable gaps around the window frame (Picture 14). In this condition, moisture-laden air can move into the building and subsequently damage building materials, which can lead to musty odors and mold growth under certain conditions. In addition, air infiltration around the window systems can make temperature control difficult to maintain. Repairs to the window systems are necessary to prevent further air infiltration and water penetration.

**Light Penetrating around Window Frame in Classroom 729**

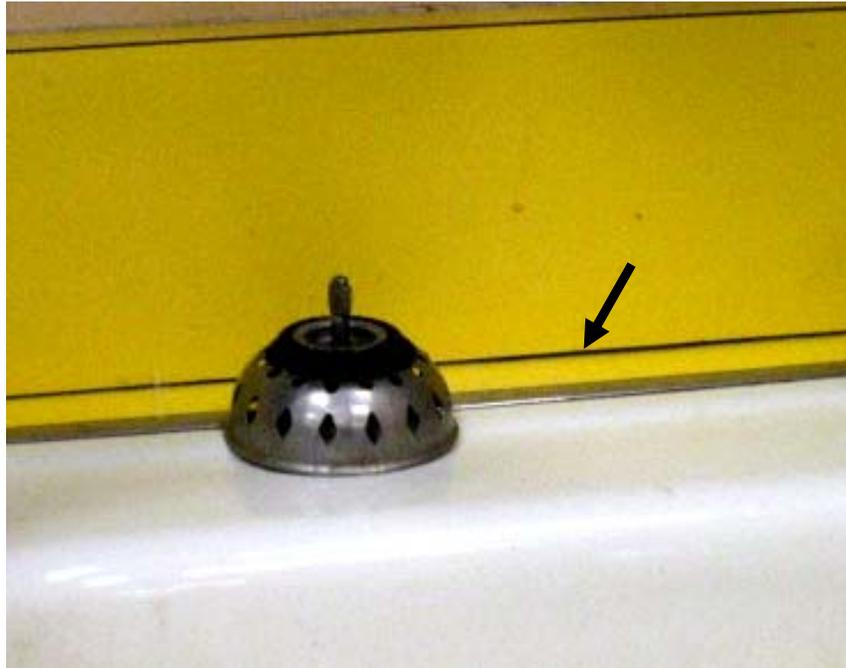
**Picture 15**

Open seams between sink countertops and walls were observed in several rooms (Picture 15/Table 1). Improper drainage or sink overflow can lead to water penetration into the countertop, cabinet interior and areas behind cabinets. If not watertight, moisture can penetrate through the seam, causing water damage and potential mold growth. Water penetration and chronic exposure of porous and wood-based materials can cause these materials to swell and show signs of water damage. Repeated moistening of porous materials can result in mold growth.

**Breach between Sink Backsplash and Countertop**

12. Seal areas around sinks to prevent water damage to the interior of cabinets and adjacent wallboard.
13. Ensure plants have drip pans. Examine drip pans periodically for mold growth and disinfect with an appropriate antimicrobial where necessary. Remove plants from the air stream of mechanical ventilation.

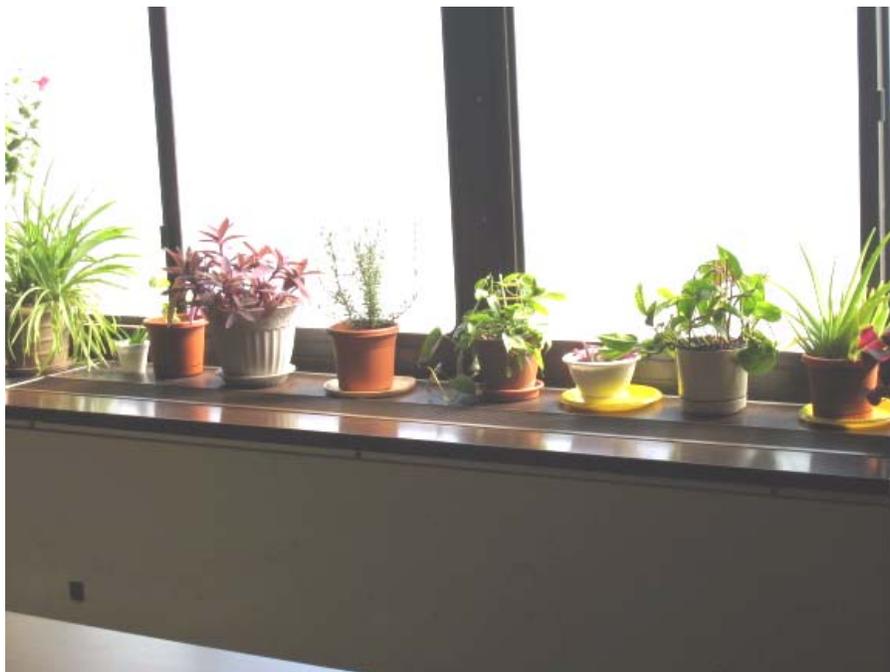
**Picture 16**

Several classrooms had a number of plants. Moistened plant soil and drip pans can be sources of mold growth. Plants should be equipped with drip pans; the lack of drip pans can lead to water pooling and mold growth on windowsills. Plants are also a source of pollen. Plants

should be located away from the air stream of ventilation sources to prevent the aerosolization of mold, pollen or particulate matter throughout the classroom (Picture 16).

**Plants on Univent**

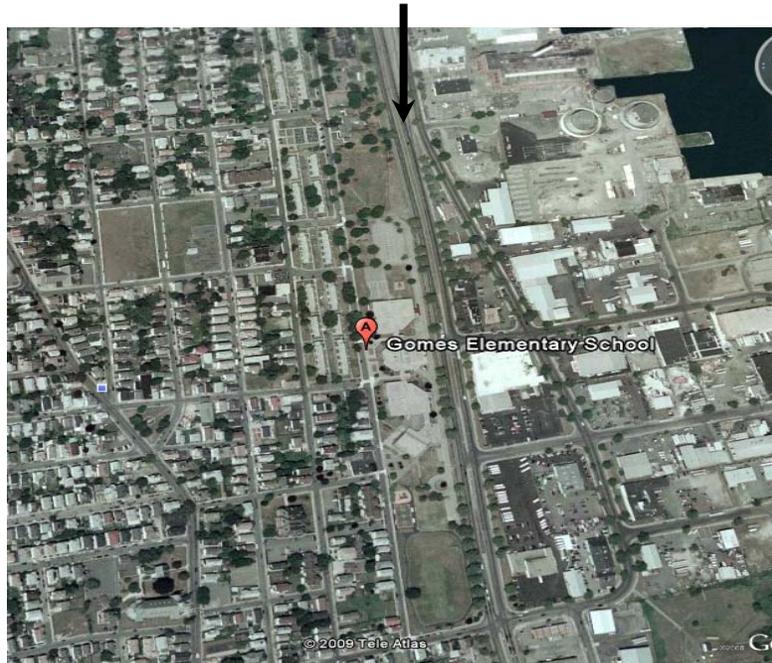
**Picture 17**

*Carbon monoxide should not be present in a typical, indoor environment.* If it is present, indoor carbon monoxide levels should be less than or equal to outdoor levels. On the day of assessment, outdoor carbon monoxide concentrations ranged from non-detect (ND) to 3.5 ppm (Table 1). Carbon monoxide levels measured in the school ranged from ND to 3.0 ppm, which were reflective of outside ambient conditions. The most likely source of measurable levels of carbon monoxide was vehicle exhaust. The GES is located in close proximity to Route 18 which serves as a major roadway traveling north/south through the city of New Bedford (Picture 17).

**Proximity of Gomes Elementary School to Route 18**

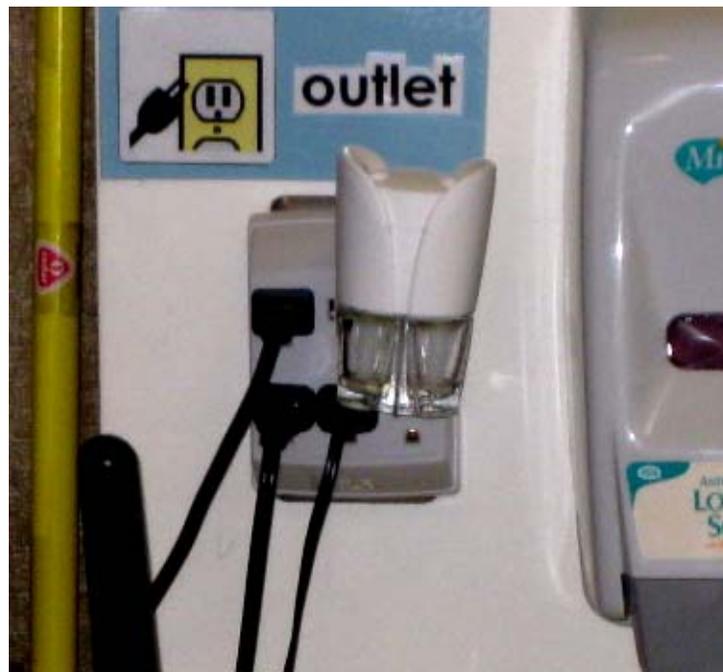
**Picture 18**

Plug-in air fresheners were in use in a few areas (Picture 18/Table 1). Many air fresheners contain 1,4-dichlorobenzene, a VOC which may cause reductions in lung function (NIH, 2006). Furthermore, deodorizing agents do not remove materials causing odors, but rather mask odors that may be present in the area. Air fresheners contain chemicals that can be irritating to the eyes, nose and throat of sensitive individuals. Further, air fresheners do not remove materials causing odors, but rather mask odors which may be present in the area.

**Plug-In Air Freshener in Classroom**

15. Refrain from using strongly scented materials (e.g., plug-in air fresheners).

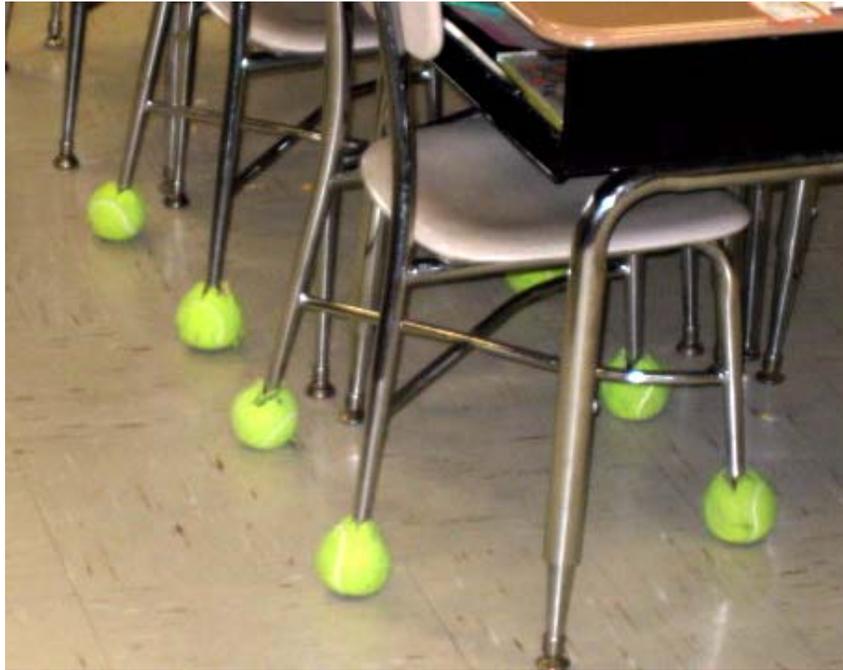
**Picture 19**

In an effort to reduce noise from sliding chairs, tennis balls had been sliced open and placed on chair legs (Picture 19). Tennis balls are made of a number of materials that are a source of respiratory irritants. Constant wearing of tennis balls can produce fibers and cause TVOCs to off-gas. Tennis balls are made with a natural rubber latex bladder, which becomes abraded when used as a chair leg pad. Use of tennis balls in this manner may introduce latex dust into the school environment. Some individuals are highly allergic to latex (e.g., spina bifida patients) (SBAA, 2001). It is recommended that the use of materials containing latex be limited in buildings to reduce the likelihood of symptoms in sensitive individuals (NIOSH, 1997). A question and answer sheet concerning latex allergy is attached as [Appendix B](#) (NIOSH, 1998).

**Tennis Balls on Chair Legs**

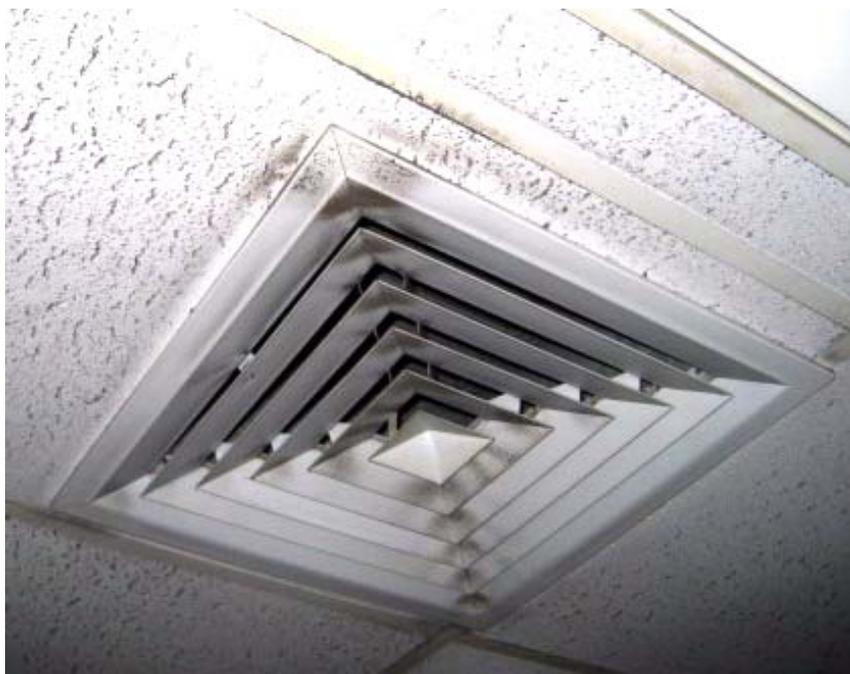
**Picture 20**

A number of supply diffusers (and surrounding ceiling tiles), exhaust vents and personal fans in classrooms were observed to have accumulated dust/debris (Picture 20). Re-activated supply vents/fans can aerosolize dust accumulated on fan blades/housing. If exhaust vents are not functioning, backdrafting can occur, which can re-aerosolize dust particles.

**Dust/Debris Accumulation on Supply Vent and Surrounding Ceiling Tiles**

17. Clean supply/exhaust vents, surrounding ceiling tiles and personal fans periodically of accumulated dust. If ceiling tiles cannot be cleaned, replace.

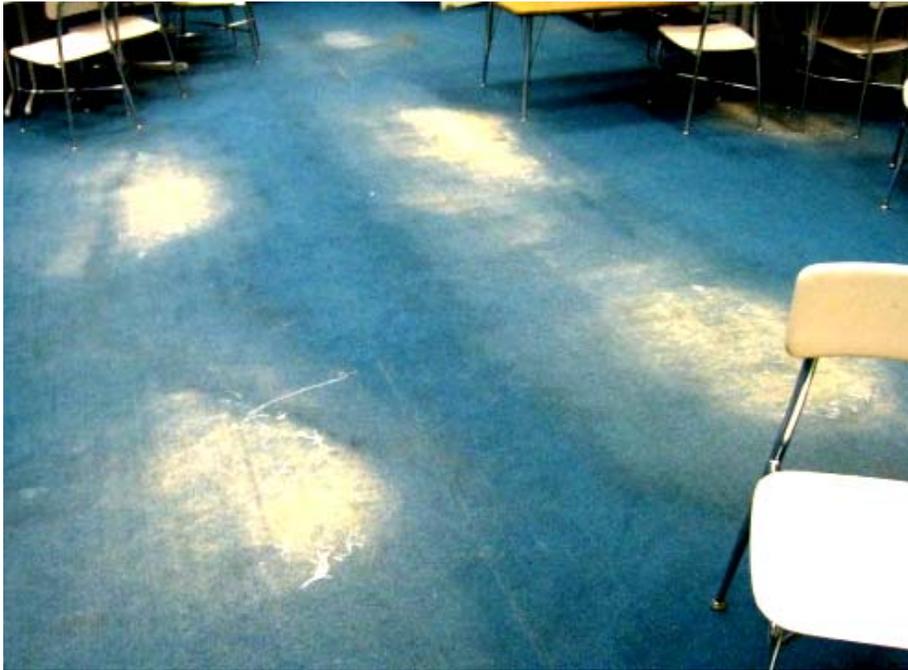
**Picture 21**

As previously mentioned, carpet in several areas is original to the building (approximately 25 to 30 years old) and was extremely worn and damaged (Pictures 21 and 22). Disintegrating textiles can be a source of airborne particulates, which can be irritating to the eyes, nose and throat.

**Vintage/Damaged Carpeting, Note Bare/Worn Spots as Indicated by Light Areas**

18. Clean carpeting annually (or semi-annually in soiled/high traffic areas) as per recommendations of The Institute of Inspection, Cleaning and Restoration Certification (IICRC). Copies of the IICRC fact sheet can be downloaded at:  
[http://www.cleancareseminars.com/carpet\\_cleaning\\_faq4.htm](http://www.cleancareseminars.com/carpet_cleaning_faq4.htm) (IICRC, 2005)

19. Continue with carpet replacement protocol throughout the building as funds become available.
20. Limit the amount of drinking and eating in the classroom. Make sure food and liquids are stored in tightly sealed containers, to prevent pests from multiplying.

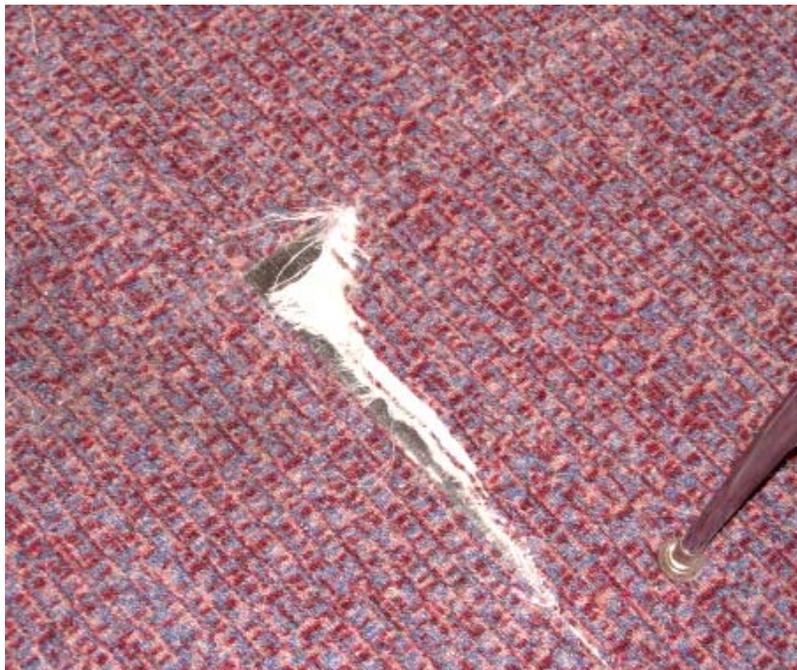
**Picture 22**

**Worn/Damaged Carpeting**

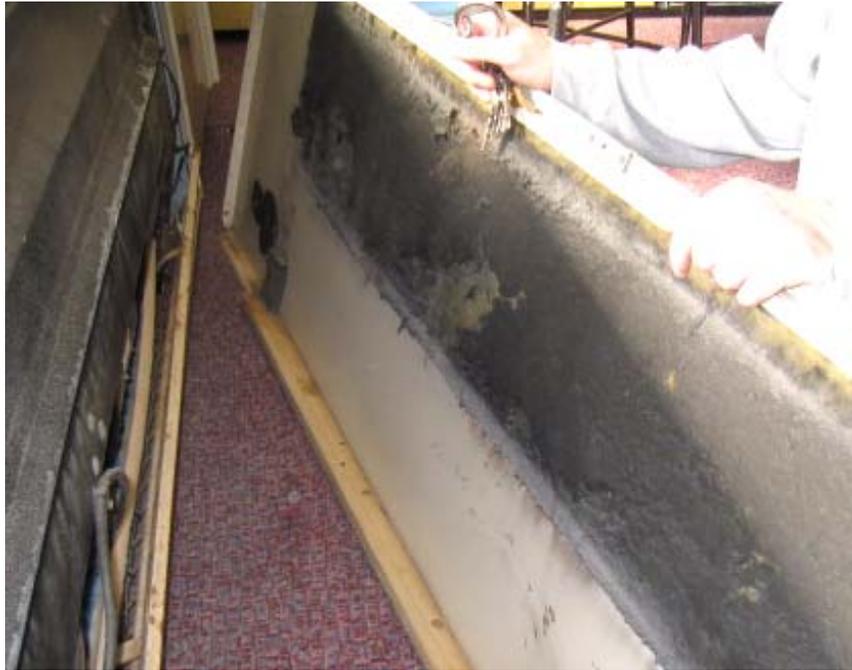
**Picture 23**

Finally, an occupant in classroom 318 reported that pieces of dark debris are sometimes observed originating from the univent. BEH staff opened the unit to examine the interior to find

the fiberglass insulation panel on the inner side of the cabinet soiled and damaged (Picture 23).

A tremendous amount of air flows through the univent; as it flows across the damaged insulation panel it appears likely that pieces of it slough off and can be distributed by the univent air diffuser.

**Soiled/Damaged Fiberglass Insulation Panel on Interior Cabinet of Univent**

21. Remove and replace damaged/soiled interior insulation panels in univents as necessary. Replace with an appropriate fire-rated material. Consider consulting the manufacturer for comparable replacement advice.
