INDOOR AIR QUALITY ASSESSMENT

**HCAC Building
9 Russell Road
Huntington, Massachusetts 01050**

Prepared by:
Massachusetts Department of Public Health
Bureau of Environmental Health
Indoor Air Quality Program
August 2009

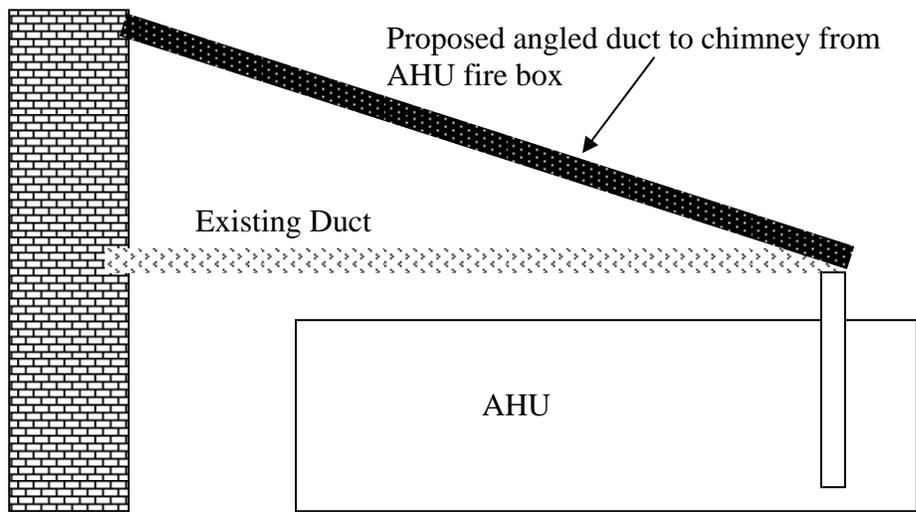
Figure 1
Reconfiguration of Combustion Product Vent to Chimney

Of note is the configuration of the exhaust ventilation for the attic AHU. The exhaust vent appears to be over 10 feet in length on the horizontal plane and has at least 270° in bends (Picture 18). In general, exhaust ducts should minimize the numbers of horizontal pipes and turns. Increasing length and turns in exhaust ductwork can decrease the efficiency of products of combustion to the chimney. If this occurs, products of combustion can pool in the ducts, which can then enter into the attic space through spaces in the ductwork. In this configuration, all seams in the flue pipe should be sealed.

1. In order to address the attic furnace vent, examine the feasibility to install the exhaust vent at a location several feet higher in the chimney to provide a means for upward movement of combustion products to the chimney (Figure 1) or install a power vent to draw combustion products to the chimney.
2. Have the building inspector examine the various support beams in the cellar to determine their structural integrity and adequacy to support the floor load.
3. Have the building inspector examine the second floor porch (Picture 20) for adequacy to support the floor load.
4. Consult a licensed asbestos abatement contractor to identify and remove potential asbestos insulation noted in the crawlspace, basement and under the cabinets of the east wing. Remediate damaged floor tiles in conformance with State and Federal asbestos remediation and hazardous waste disposal laws.

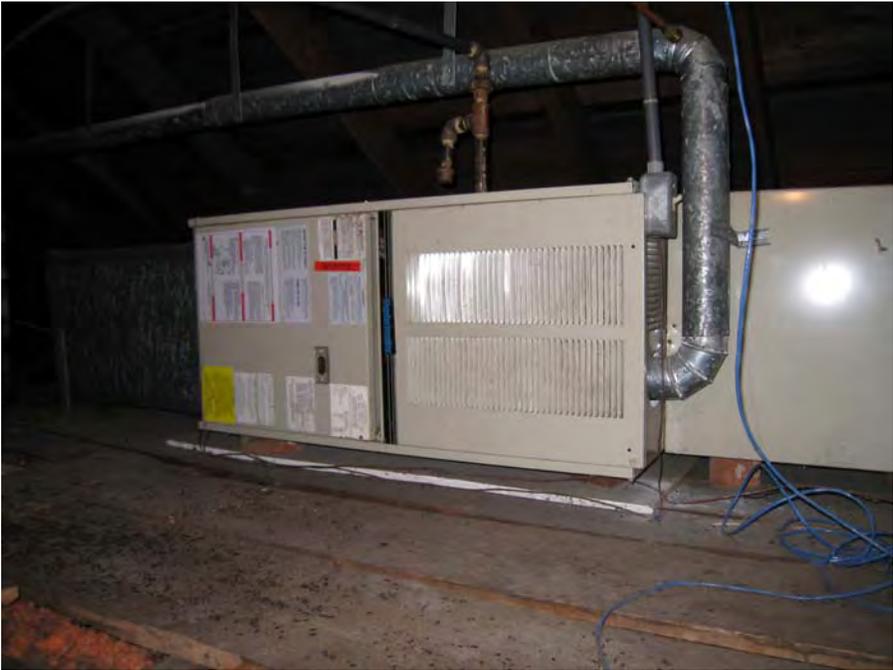
Picture 1

The heating, ventilating and air conditioning system consists of three air handling units (AHUs): one AHU in the attic serves the second floor (Picture 1); an AHU in the cellar serves the first floor (Picture 2); and the third AHU serves the day care center. Each AHU provides cooling and/or heating of air within the building to occupied areas through ceiling and wall-mounted air diffusers connected via ductwork. Air returns to the AHUs through ceiling or wall-mounted exhaust grilles via ductwork with the exception of the first floor, which has return vent in the floor (Picture 3). None of the AHUs at the HCAC have the ability to draw fresh air from outdoors or to exhaust stale air from the building.

Attic AHU

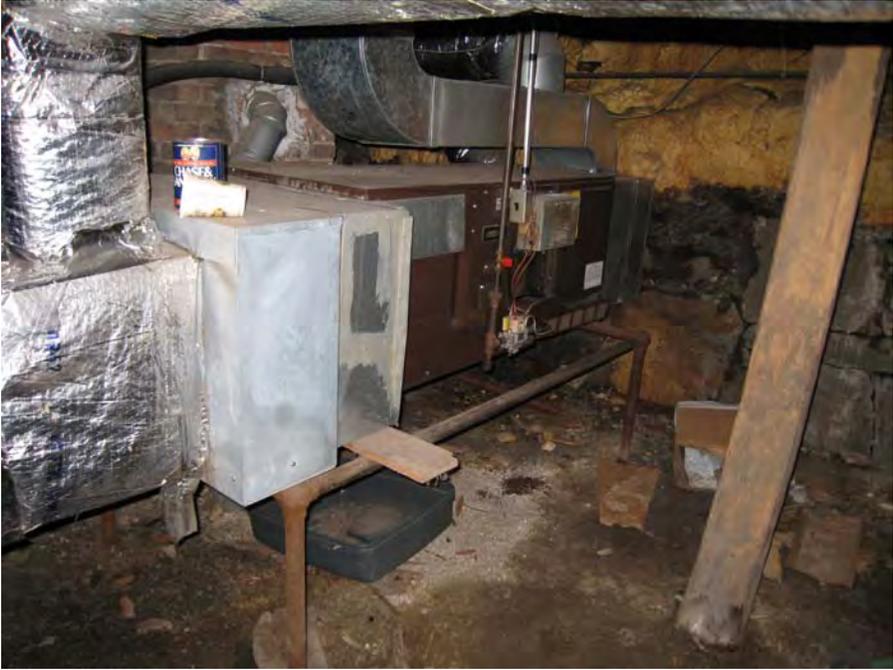
Picture 2

As discussed previously, the building has a cellar. The first floor AHU is located in the cellar that consists of a furnace/forced hot air air-handling unit (AHU) (Picture 2). Floor-mounted heating vents and ducted return vents provide tempered air to the main section of the

building. The location of the AHU in the cellar presents a number of water damage/mold concerns.

Cellar AHU

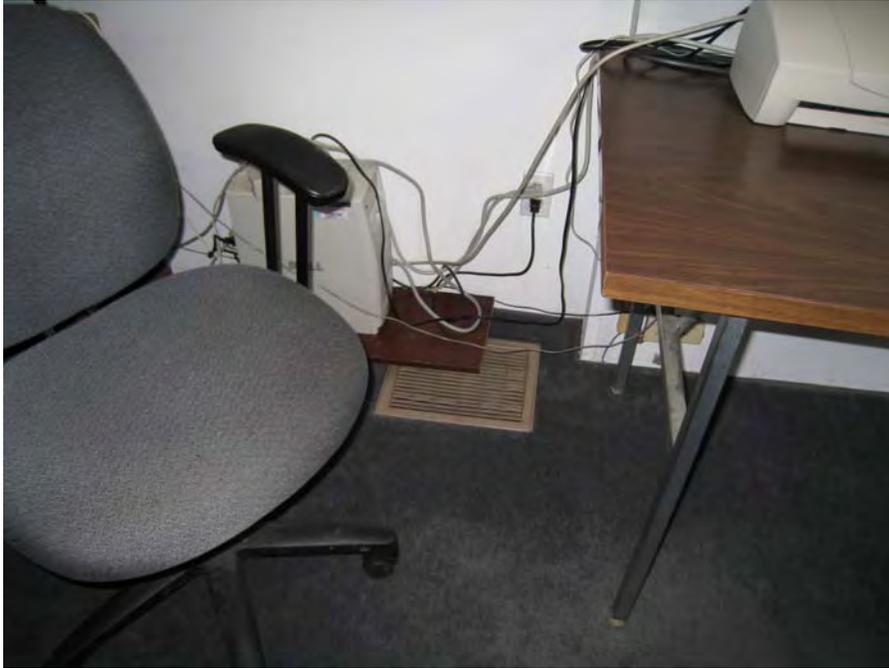
Picture 3

Three pathways exist for cellar air and its pollutants to migrate into the occupied first floor: (1) the HVAC system; (2) an open duct near the chimney; and (3) spaces and cracks that exist in the cellar ceiling/first floor boards created by damage to support timber. The AHU has a return vent that does not have its seams sealed. Since the return vent is depressurized as air is drawn from the first floor to the AHU, any seams that are not sealed can draw cellar air, water vapor and other pollutants into the duct, which may then be distributed to occupied areas.

Floor Return Vent

4. Seal all spaces in the return ductwork for the attic and cellar AHUs.
5. Remove rotten timber and other accumulated debris from the basement.
6. To prevent moisture penetration into the basement, the following actions should be considered:

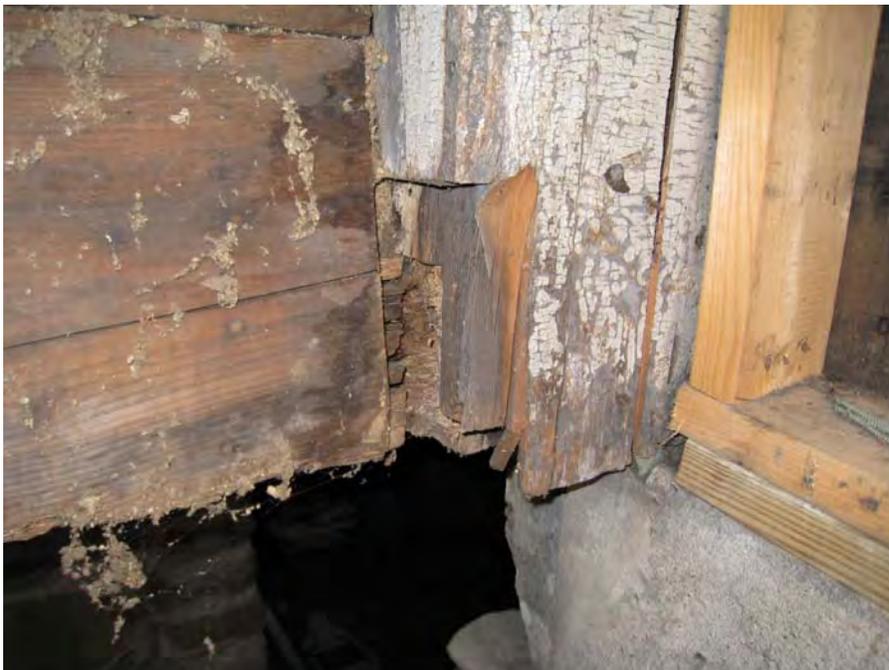
Picture 4

The cellar has a flagstone foundation with a dirt floor. The crawlspace appears to be subjected to significant water penetration as suggested by damp soil, water stains on wood support beams (Picture 4), wood rot around the bulkhead door (Picture 5), discoloration of a spray on insulation that was applied over the foundation wall (Picture 6) [and windows (Picture 7)] and water damaged cardboard (Picture 8). A significant amount of rotted wood and other discarded materials were observed in the crawlspace (Picture 9). If moistened for prolonged periods of times, these materials can serve as media for mold growth. Any water absorbent material (e.g., cardboard, paper, soil, cloth,) stored in the cellar, particularly in direct contact with the dirt floor, is likely chronically moistened and mold colonized. The US Environmental Protection Agency (US EPA) and the American Conference of Governmental Industrial Hygienists (ACGIH) recommend that porous materials be dried with fans and heating within 24 to 48 hours of becoming wet (US EPA, 2001; ACGIH, 1989). If not dried within this time frame, mold growth may occur. Once mold has colonized porous materials, they are difficult to clean and should be removed/discarded.

Rotted Wood near Bulkhead Door

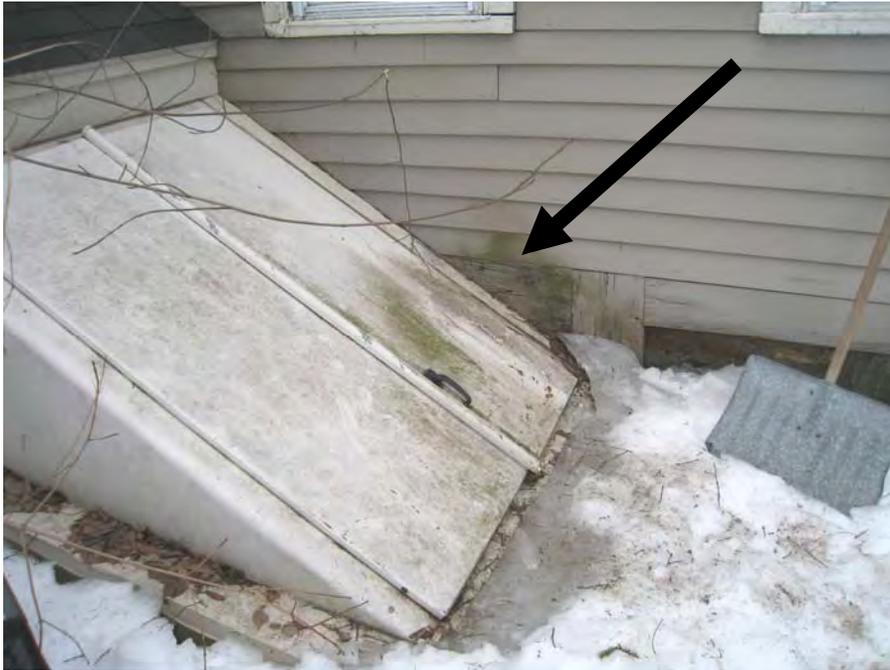
Picture 5

Bulkhead Door, Note Moss and Water Stain

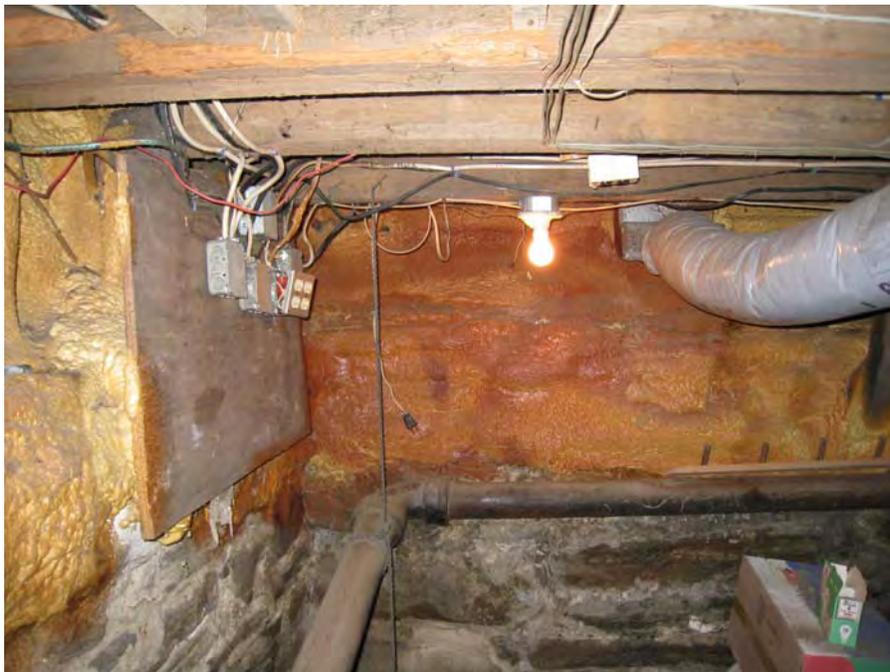
Picture 6

Discolored Spray on Insulation

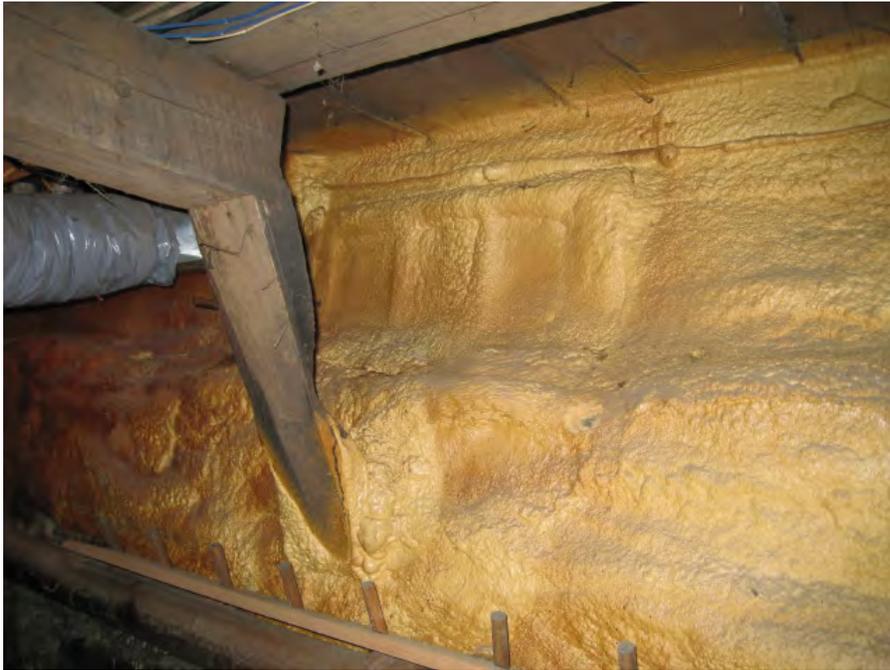
Picture 7

Cellar Window Sealed Over Using Spray-On Insulation

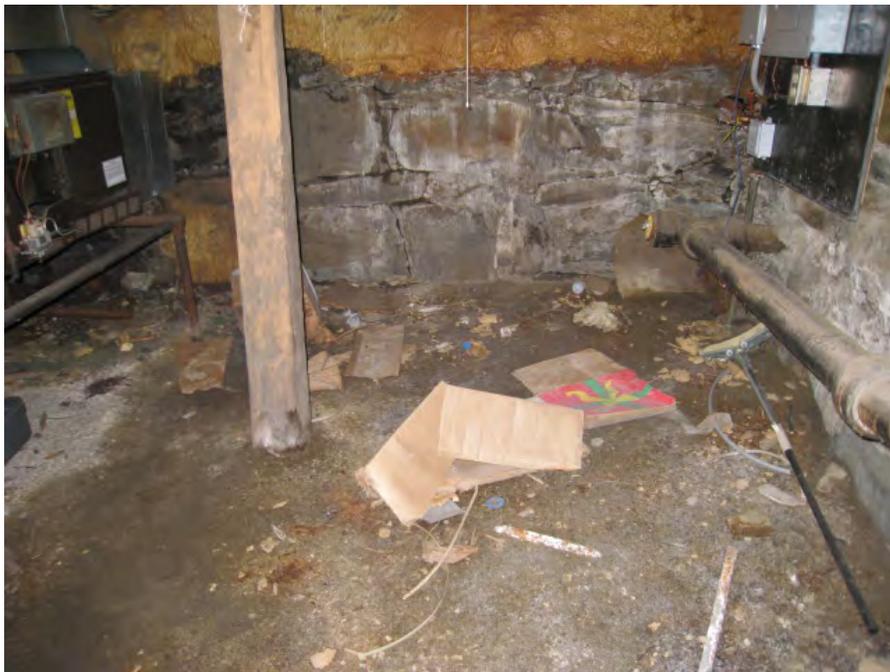
Picture 8

Water Damaged Cardboard

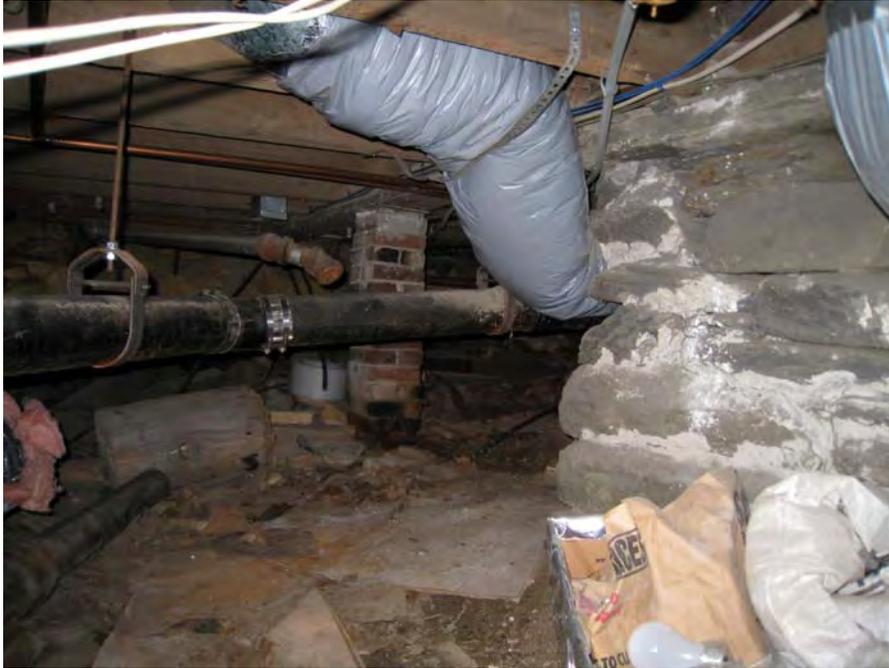
Picture 9

Various Debris on Cellar Floor

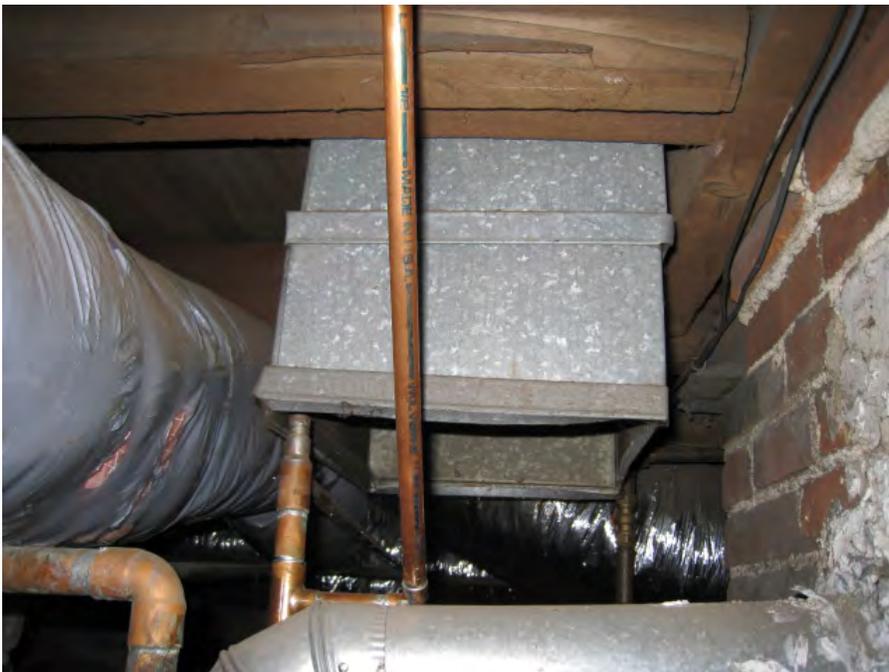
Picture 10

The second pathway is an open duct near the chimney in the basement (Picture 10). The purpose of the duct is unknown, but seems to be used as a pipe/electric wire chase. Since this appears to be abandoned ductwork, it is likely that it ends in wall cavities in the upper floors. This duct opening in the basement should be sealed to prevent cellar air movement into the upper levels of the building.

Open Duct in Cellar

8. Determine the purpose of the open duct in the cellar in Picture 10. If used as an electrical or pipe chase, seal the opening.
9. Repair cracks in drywall.

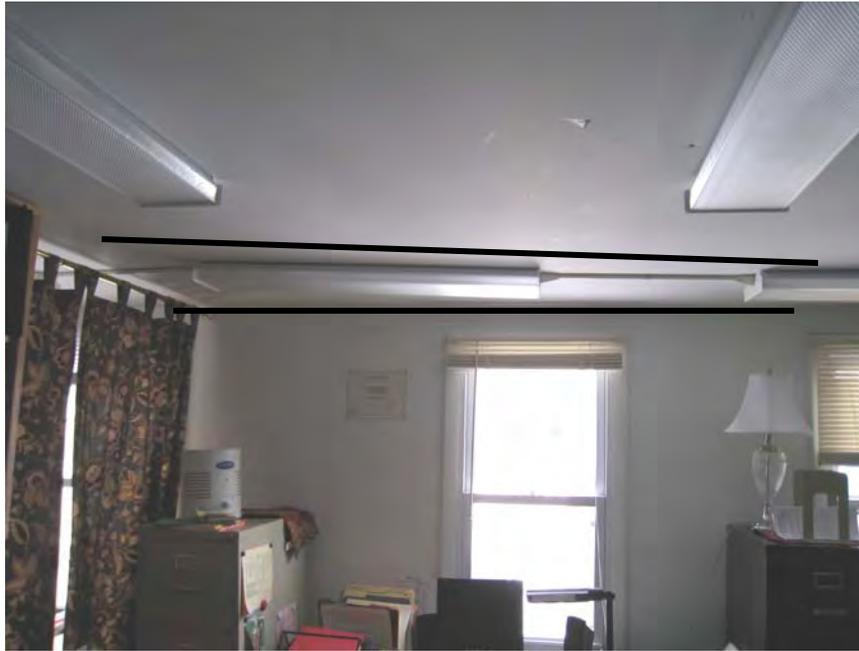
Picture 11

The third pathway for cellar air, moisture and other pollutants to migrate into occupied areas is through spaces that exist in the cellar ceiling that have been opened due to damage to the support timbers. The first floor had noticeably uneven areas in the floor and the ceiling (Picture 11). This unevenness may be attributable to cracked beams (Picture 12), water damage to the support beams (Picture 13), poorly supported beams (Picture 14), or free, unsupported beams that exist in the cellar. Damage to the timbers supporting the floor can lead to spaces in the floor which would then expose the wall-to-wall carpet on the first floor to moisture.

Uneven Ceiling
(The Light Fixture Bracketed By the Added Lines Should Be Parallel To the Rooms Wall/Ceiling, Not At an Angle)

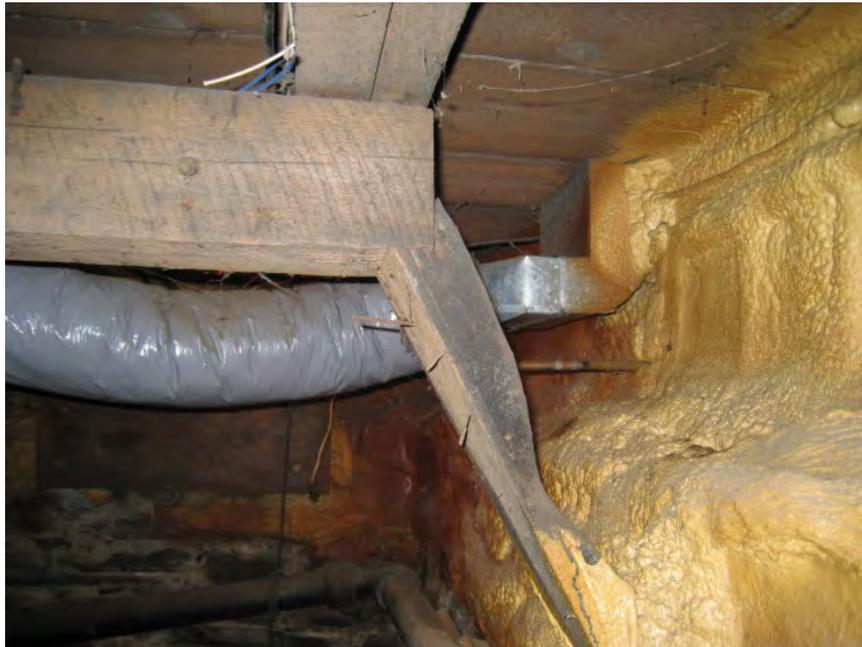
Picture 12

Cracked Cellar Beam

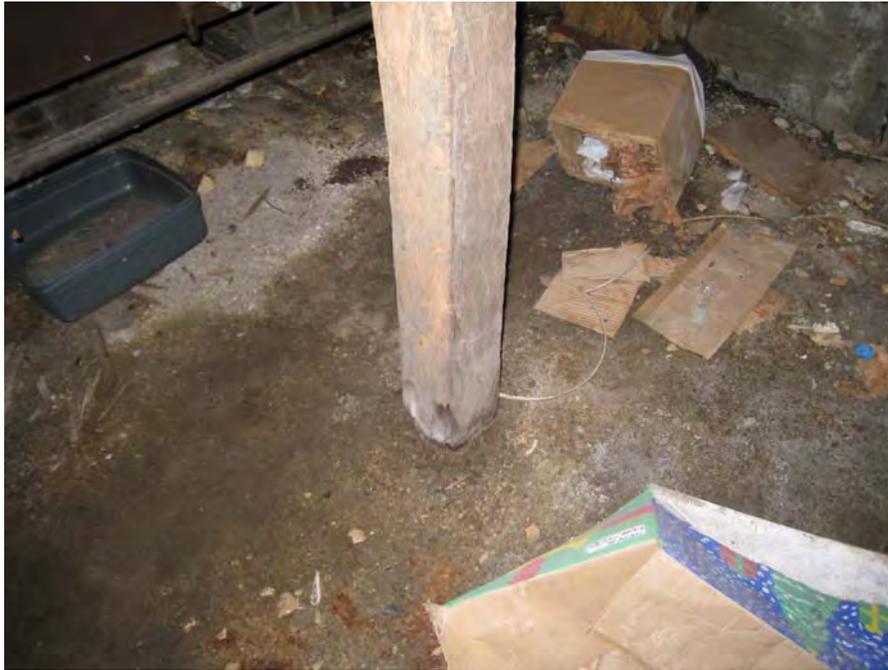
Picture 13

Water Damaged Cellar Beam

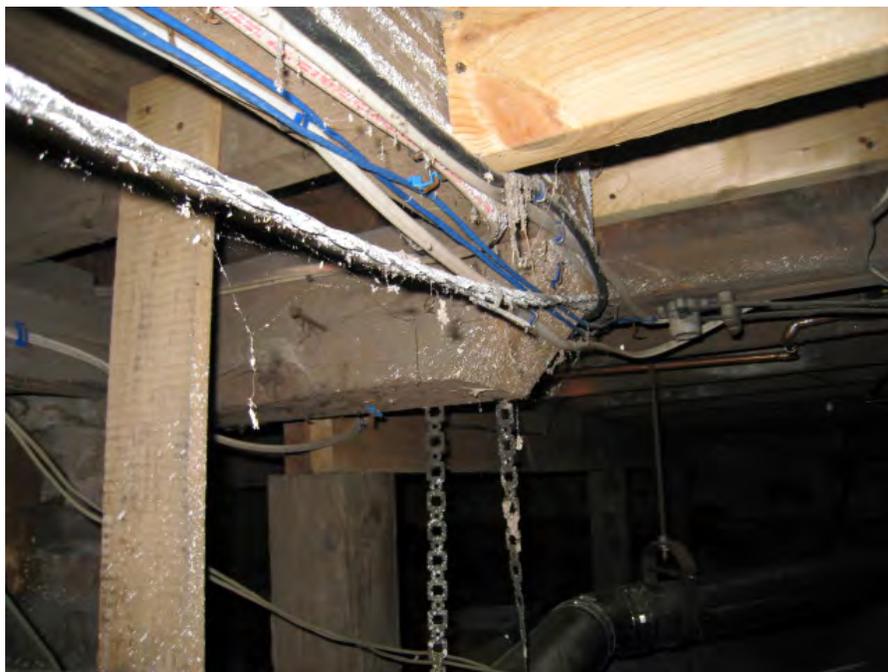
Picture 14

Poorly Supported Cellar Beam

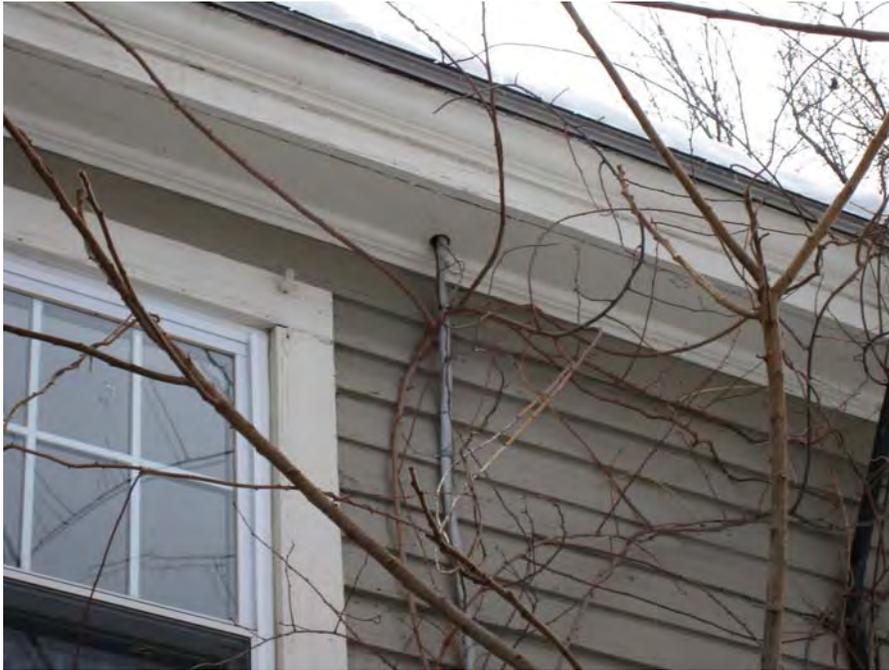
Picture 15

- The basement is subject to water penetration through its foundation, likely due to a lack of a gutter/downspout system for the roof edge at the front of the building (Picture 16) and the emptying of downspouts at the base of the foundation.

Roof Edge above Bulkhead without Gutter/Downspout

- a. Extend downspout to direct water away from the foundation wall.
 - b. Remove foliage to no less than five feet from the foundation.
 - c. Improve the grading of the ground away from the foundation at a rate of 6 inches per every 10 feet (Lstiburek, J. & Brennan, T.; 2001).

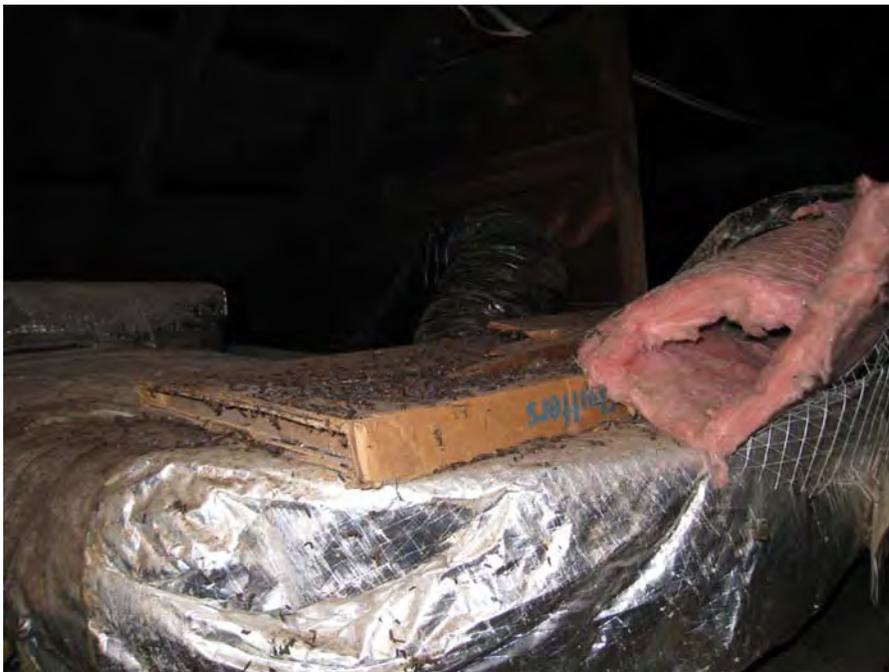
Picture 16

Bat waste was observed on the floor of the attic (Picture 16). Bats in a building raise concerns over diseases that may be caused by exposure to bat wastes. These conditions warrant clean up and appropriate disinfection. Certain molds (*Histoplasma capsulatum*) are associated with bat waste (CDC, 2001; NIOSH, 1997) and are of concern for immune compromised individuals. Diseases of the respiratory tract may also result from exposure to bat waste. While immune compromised individuals have an increased risk of health impacts following exposure to the materials in bat wastes, these impacts may also occur in healthy individuals exposed to these materials. Further, exposure to the saliva of a bat due to either a bite or a scratch poses a risk for rabies. Please see [Appendix B](#) for more information regarding the disease of rabies and rabies prevention methods. Although written for residential purposes, much of the information would nonetheless be helpful in addressing the situation in the building.

Bat Waste on AHU Duct in Attic

1. Remove carpet and padding from the first floor. Use a non-porous flooring material in the place of carpeting.
2. Consider removing as much wood/cardboard and other materials that can support mold growth from the floor of the crawlspace.
3. Contact a professional extermination firm to inspect the building for the presence of bats. Have the firm provide recommendations concerning the migration of bats into the

building. Particular attention should be made to seal pathways in the attic. Remediation of bat waste and elimination of entry pathways into the building should be conducted in accordance with MDPH and CDC guidelines ([Appendices B and C](#)).

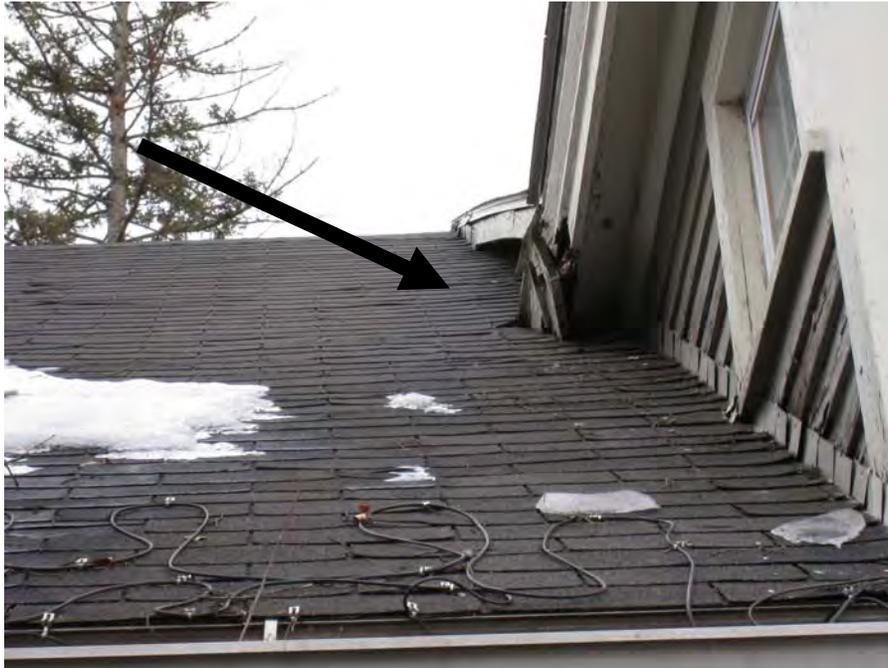
Picture 17

The rotted fascia on the exterior of the building provides more than enough space for the entry of bats, birds and/or squirrels (Picture 17). These pathways into the building must be eliminated in order to eliminate the problem within the building.

Hole In Roof That Is Likely Bat Access Point

10. Discontinue use of air fresheners.
11. Store cleaning products out of reach of children.
12. Obtain Material Safety Data Sheets (MSDS) for all cleaning products used within the HCAC and store in an area that is accessible to all individuals during periods of building occupancy.
13. Repair rotted fascia on the exterior of the building. Attempt to identify additional entry points into the building and eliminate those pathways into the building as well.

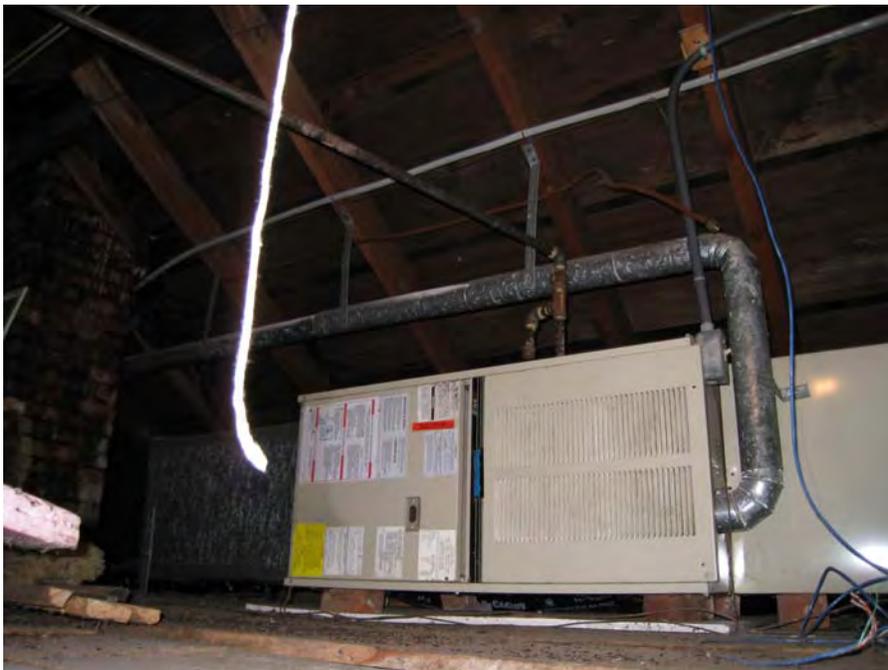
Picture 18

Exhaust Pipe of AHU Running Parallel To the Attic Floor

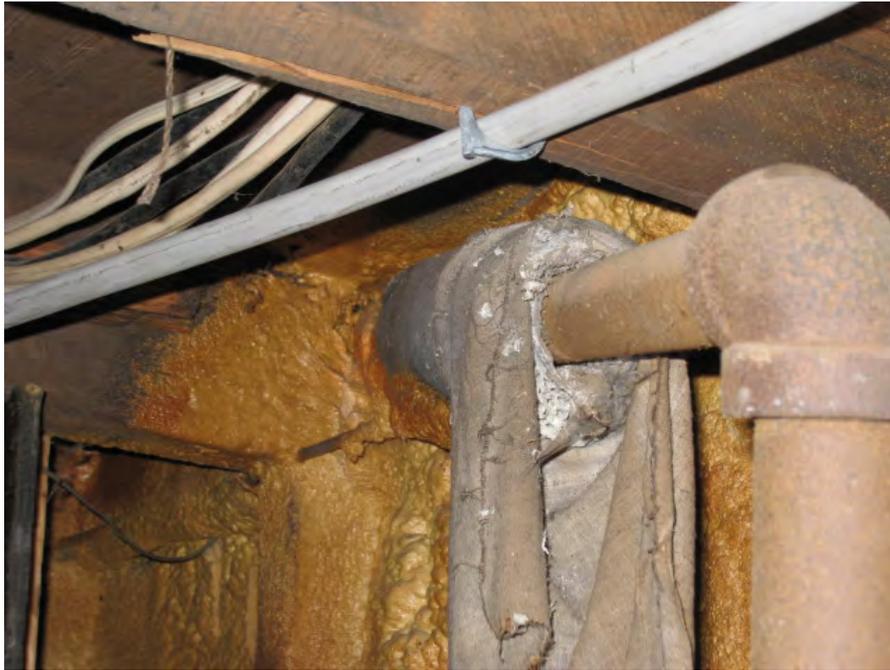
Picture 19

A pipe in the basement appears to have damaged insulation (Picture 19). This insulation may contain asbestos and, if so, should be remediated in conformance with all applicable State and Federal asbestos abatement and hazardous materials disposal laws.

Damaged Pipe Insulation

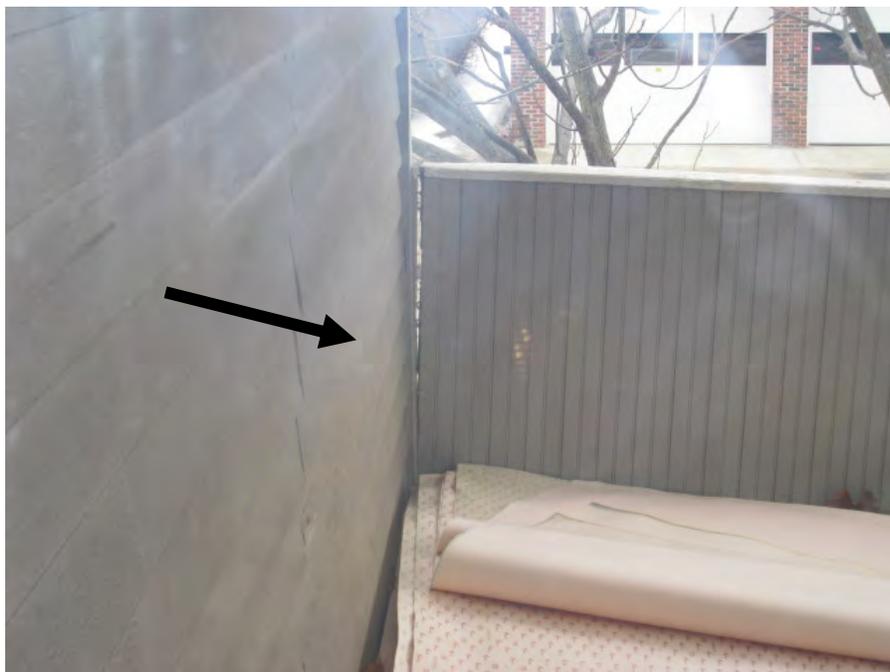
Picture 20

Second Floor Porch, Note Gap in Railing
