INDOOR AIR QUALITY ASSESSMENT

**Tewksbury Town Hall Annex
11 Town Hall Avenue
Tewksbury, Massachusetts 01876**

Prepared by:
Massachusetts Department of Public Health
Bureau of Environmental Health
Indoor Air Quality Program
September 2009

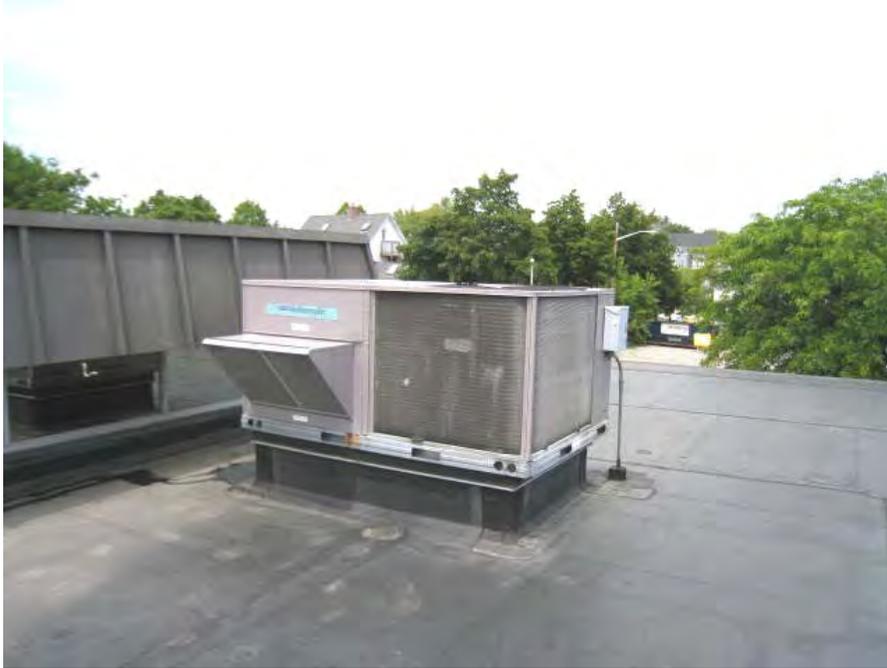
Picture 1

Mechanical ventilation is provided by rooftop air-handling units (AHUs) (Picture 1). Fresh air is drawn through AHU intakes on the roof and distributed via air diffusers in the suspended ceiling. Exhaust air is drawn into the ceiling plenum through vents installed in the suspended ceiling and exhausted via rooftop motors. Vents from the original construction also exist along the perimeter wall of the building, which appear to be connected to the rooftop AHUs by ductwork inside the cement slab. In some areas, dividing walls were erected over these ducts (Picture 2).

Rooftop AHU, Note Fresh Air Intake, No Exhaust Vent

1. Consideration should be given to abandoning at least two of the AHUs on the roof to provide for better temperature and relative humidity control. This activity would require connecting the ductwork for areas formerly serviced by abandoned AHUs to the remaining AHUs.
2. Consider installing ductwork to connect exhaust vent directly to each area serviced inside the ceiling plenum to improve removal of water vapor and other normally occurring pollutants.
3. Consideration should be given to replacing the roof membranes and replacing the existing skylight window systems.

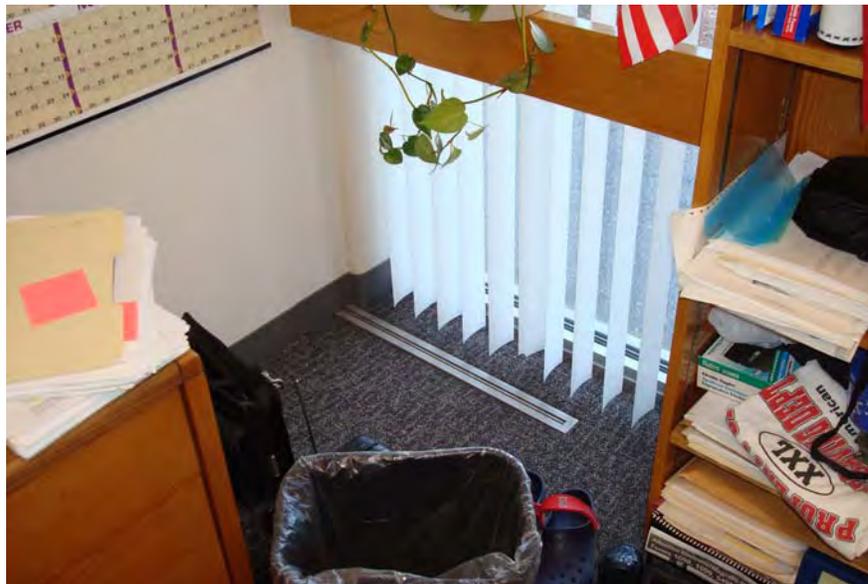
Picture 2

- Also of note is GW that was installed over these floor vents in a number of areas (Picture 2). This GW may also be repeatedly moistened. Repeated water damage to porous building materials (e.g., GW, carpeting) can result in microbial growth.
- The final moisture source identified is related to the HVAC system. The roof of the TTHA has four separate AHUs (Pictures 9 and 10). The blueprint for the building indicates that each AHU has the capacity to supply 3,000 cfm (Blueprint 1). Based on input from TTHA staff, it was indicated that the building has a usual maximum occupancy of 20 individuals, the HVAC equipment installed has 600% more capacity than what is needed to provide for fresh air and temperature comfort for building occupants (Figure 1). Over capacity of HVAC system equipment can lead to the following problems:

GW Installed over Floor Vent

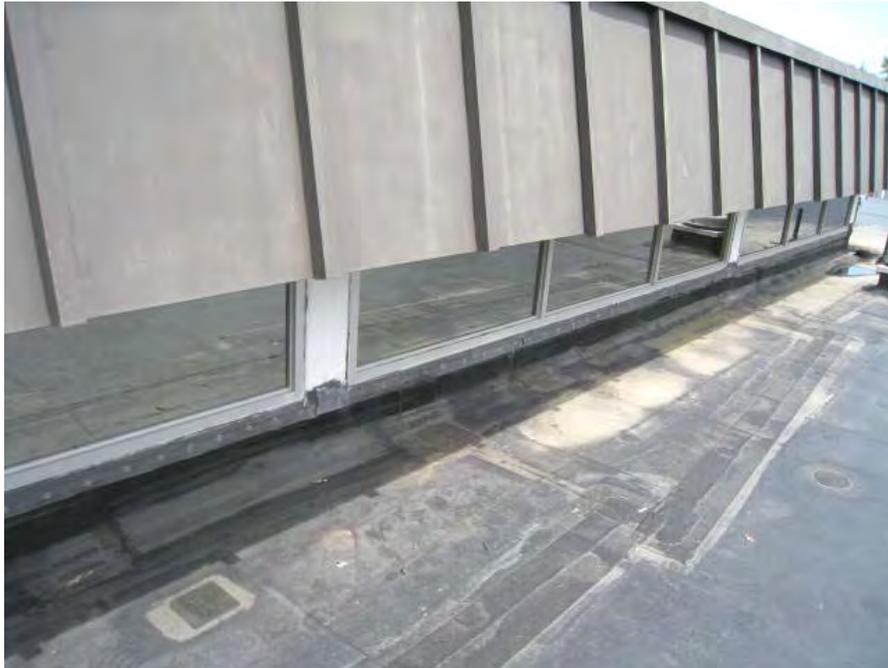
Picture 3

- metal framed window system (Picture 3), which requires flashing to transfer rain from the windows onto the roof for drainage. If the flashing is damaged or window gaskets are missing or ill fitting, rainwater can enter into the building to moisten ceiling tiles and GW. Caulking around windows appeared to be damaged. In addition, the membrane of the skylight roof appeared to be damaged (Picture 4).

Skylight Window System

6. Wall-to-wall carpeting in the foyer should be removed and replaced with a floor material that can readily dry and is mold resistant.
7. Water leaks through the roof and sky light window system must be repaired to prevent further water damage.

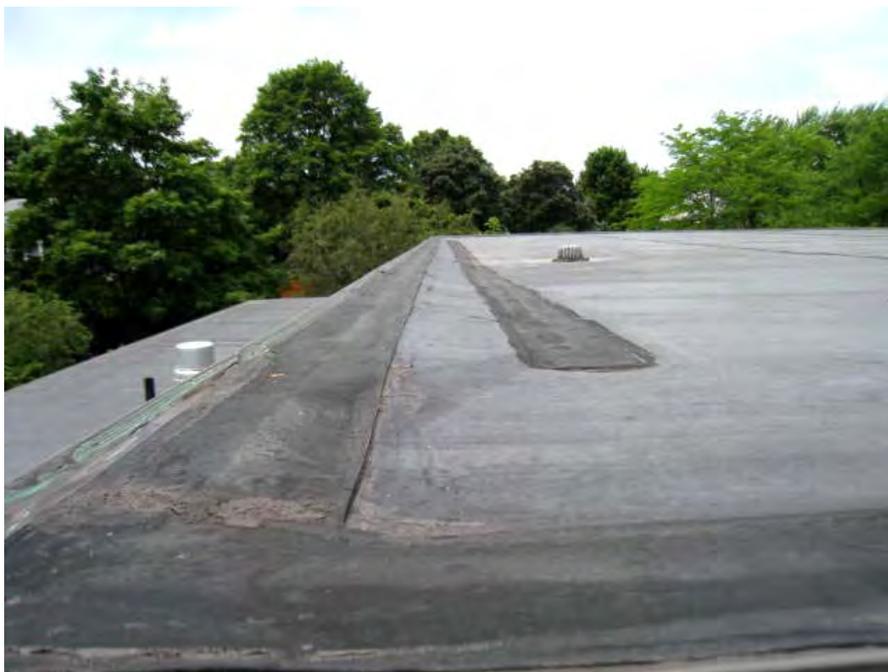
Picture 4

Seam in the Skylight Roof Section

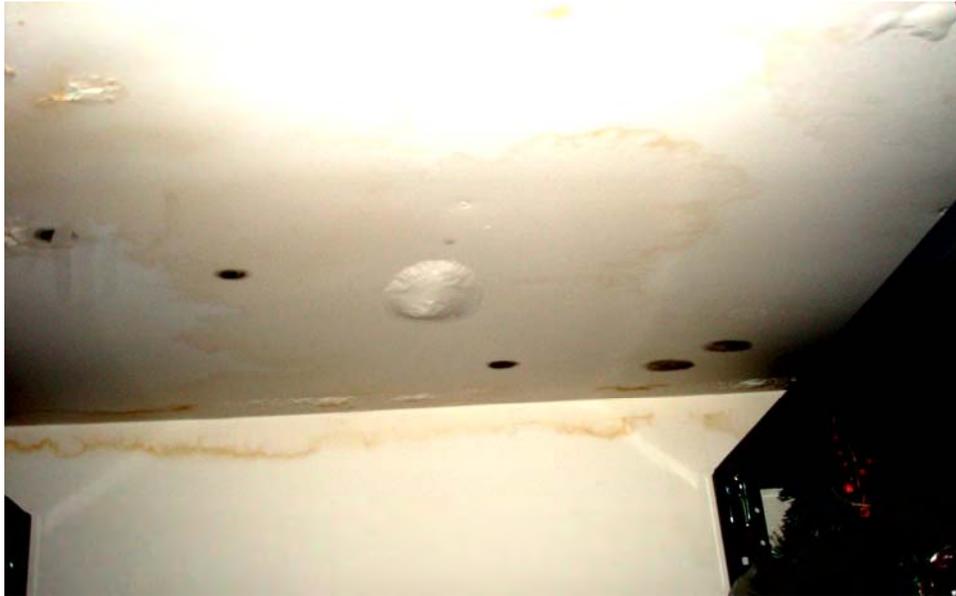
Picture 5

- GW in a storeroom in the treasurer's office directly below a rooftop AHU had saturated GW, which has resulted in mold colonization (Picture 5). The ceiling plenum side of this GW appeared to have plastic sheeting placed over the ceiling material, a likely effort to prevent further water damage (Picture 6). Beaded water on the surface of the plastic sheet facing the GW indicates that the plastic is preventing water evaporation, keeping the GW moistened and increasing the likelihood of mold growth.

**Storeroom in the Treasurer's Office Directly below Rooftop AHU
Dark Stains Indicate Mold Colonization of GW**

1. Remove all water damaged and mold colonized GW in a manner consistent with recommendations in "Mold Remediation in Schools and Commercial Buildings" published by the US Environmental Protection Agency (US EPA, 2001). This document is available from the US EPA website:
http://www.epa.gov/mold/mold_remediation.html.
2. Seal all floor vents with an appropriate material. The interior of all GW wall installed over these vent should be examined and removed if water damaged and/or mold colonized.
3. Seal one fresh air supply to the building lobby so that heat and air-conditioning is provided by one AHU instead of two. Disconnect the duct connected to the sealed vent from the main HVAC system. Seal both disconnected duct openings with an appropriate permanent material.

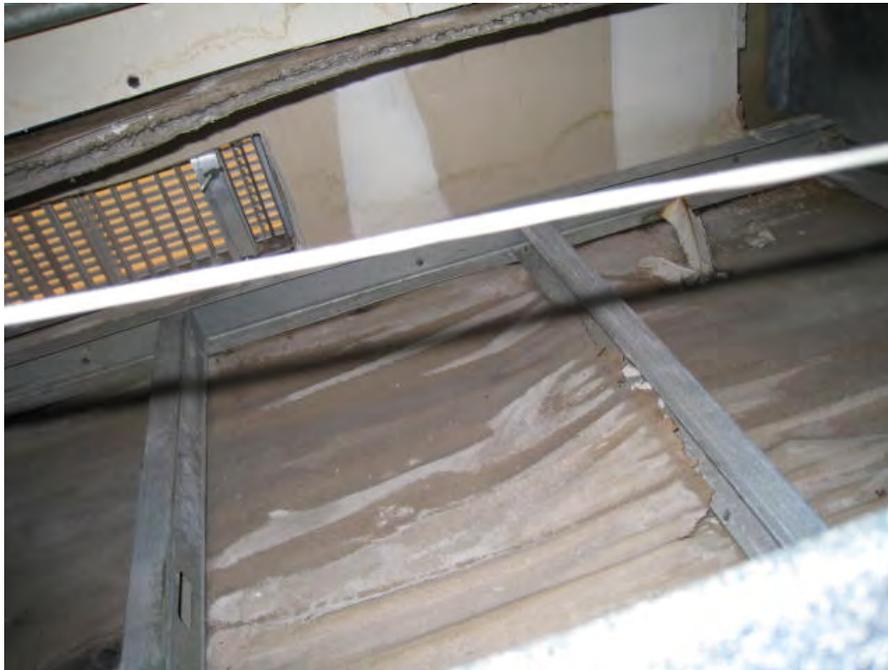
Picture 6

**Plastic Sheeting Placed over the Ceiling Material in an Effort to Prevent Further
Water Damage, Note Beading Water on the Underside of the Plastic**

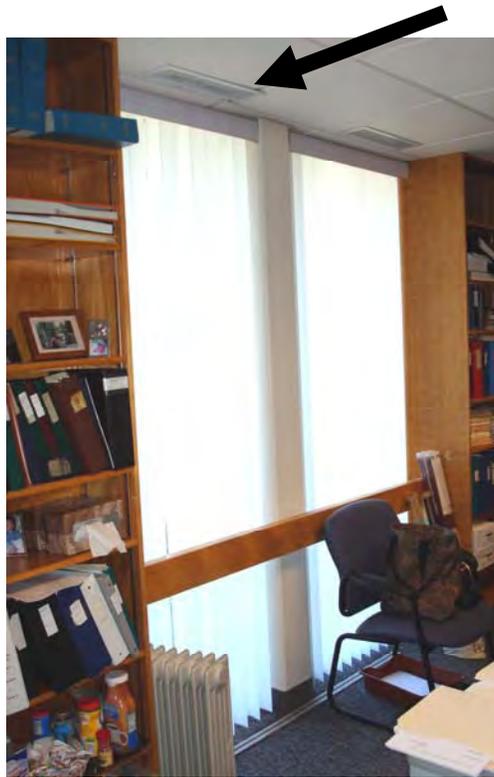
Picture 7

Fresh Air Supply Vent Installed in Suspended Ceiling, Note Floor Vent

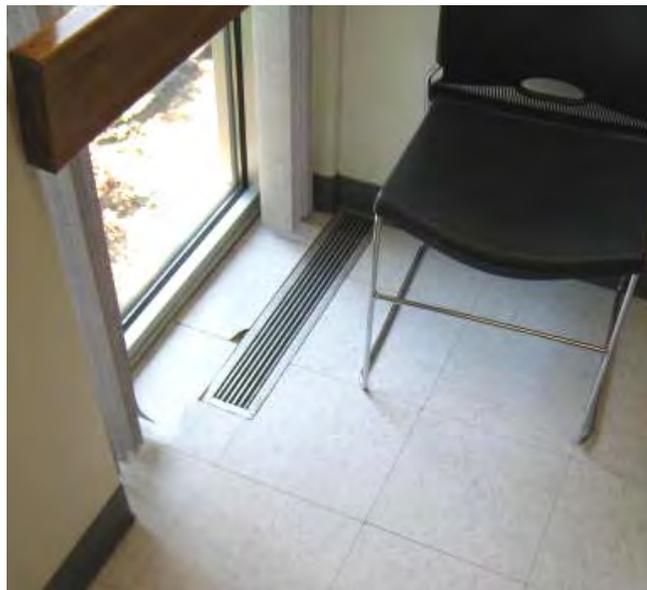
Picture 8

- Another possible water source may be from a non-functioning ductwork system that was part of the original construction of the TTHA. Along the floor of the building are a series of vents that are connected to ductwork that exists either within or beneath the slab of the building. When the building was renovated, a complete system of rooftop AHUs, fresh air supply and return ducts was installed, including ceiling mounted fresh air diffusers directly above windows (Picture 7). The installation of this system rendered the floor-mounted ducts superfluous for heating and cooling of the building. Unfortunately, these ducts do not appear to have been properly abandoned and may be a source of excess moisture in the building. Slab or subsurface ductwork can be prone to generating condensation, wetting carpet and damaging floor tile (Picture 8). When warm, moist air passes over a surface that is

Damaged Floor Tile around Vent

4. Seal the open vent in the ceiling to the Treasurer's storeroom with an appropriate permanent material.
5. Remove wall-to-wall carpeting in contact with vents and windows. Replace the carpeting with an appropriate flooring material.

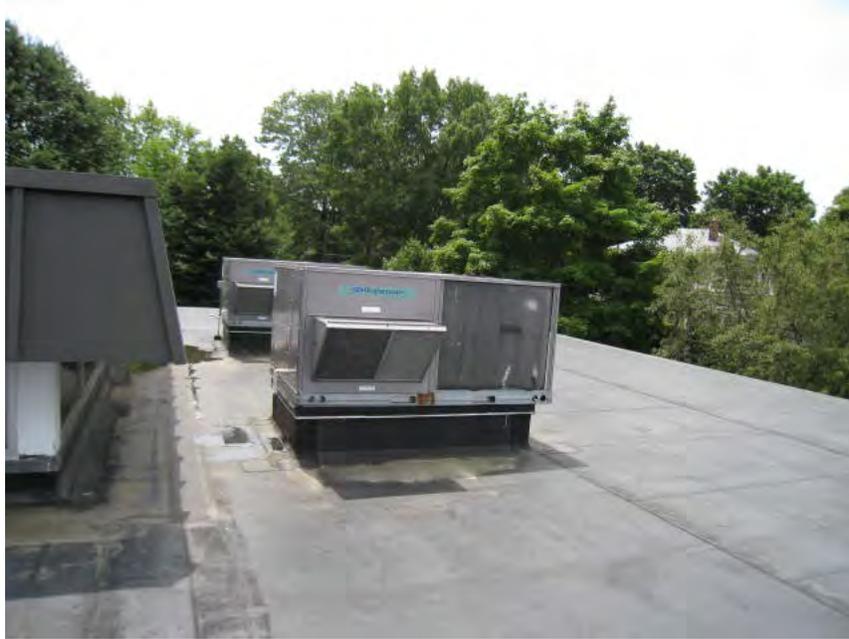
Picture 9

- The AHUs do not have the capacity to exhaust air. Each AHU has a fresh air intake with no corresponding exhaust vent (Picture 9). The TTHA has a ceiling plenum return system where the space between the roof decking and suspended ceiling is used in the place of ductwork to draw air through the plenum to be expelled from the building by two exhaust vent motors located at the rear of the roof (Picture 11). The ceiling plenum is small and is lined with fiberglass insulation (Picture 12). Since the ceiling plenum is narrow and its' surfaces rough, it would seem that air and water vapor from the Assessor's and Treasurer's offices (located in the front of f the TTHA) is limited. This is evidenced by higher relative humidity level for offices closest to the exhaust vent (e.g., the Auditor's Office (Table 1). Based on the design of the HVAC system, moist air can be introduced by all four AHUs while limited means for that moisture to exit the building exists.

Two AHUs on West Side of Roof, Note Standing Water on Roof

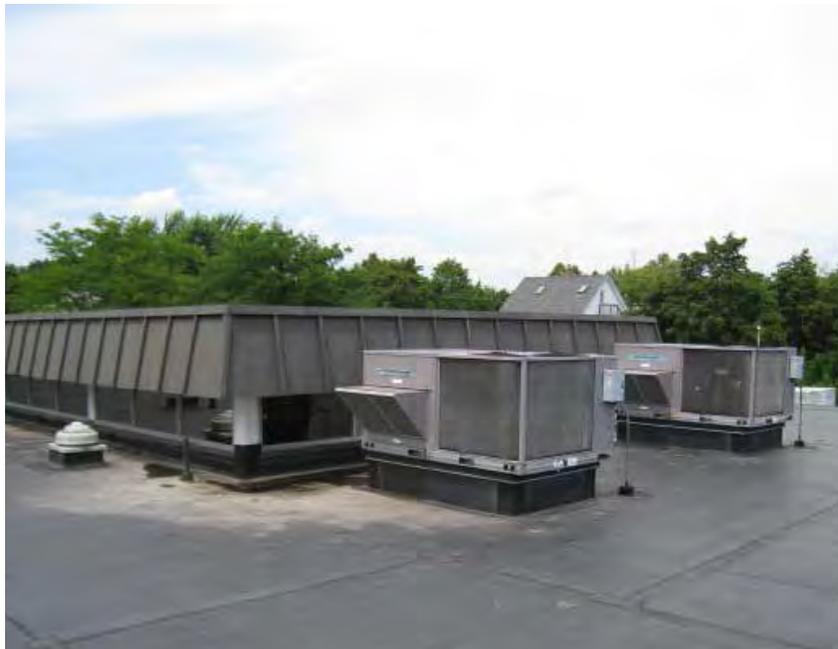
Picture 10

Two AHUs on East Side of Roof, Note Dirt on Roof Which Indicates Location of Likely Pooling Water

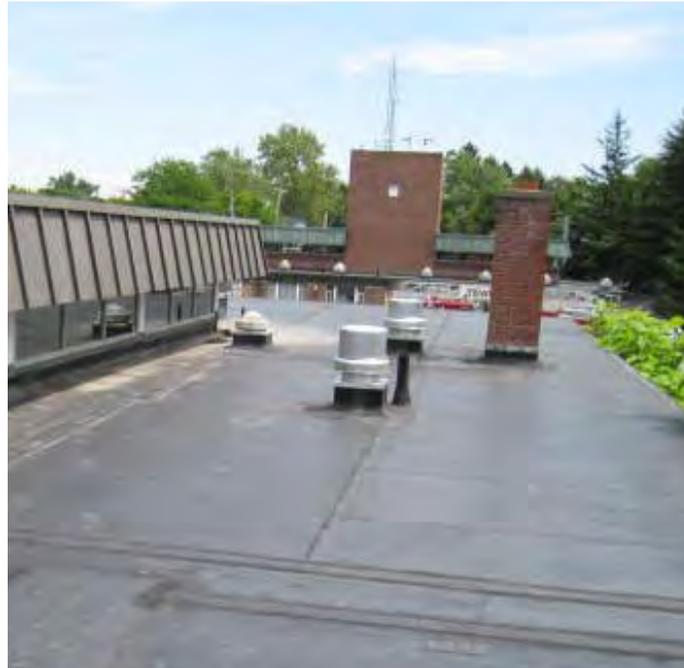
Picture 11

Exhaust Vents On Roof

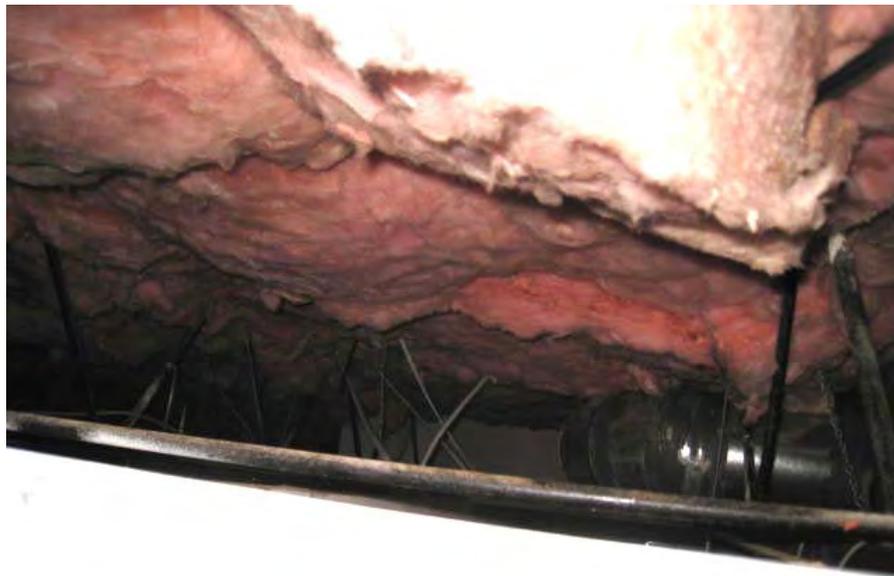
Picture 12

Ceiling Plenum, Note Insulation and Narrowness of the Plenum Space Which Restricts Free Air Movement

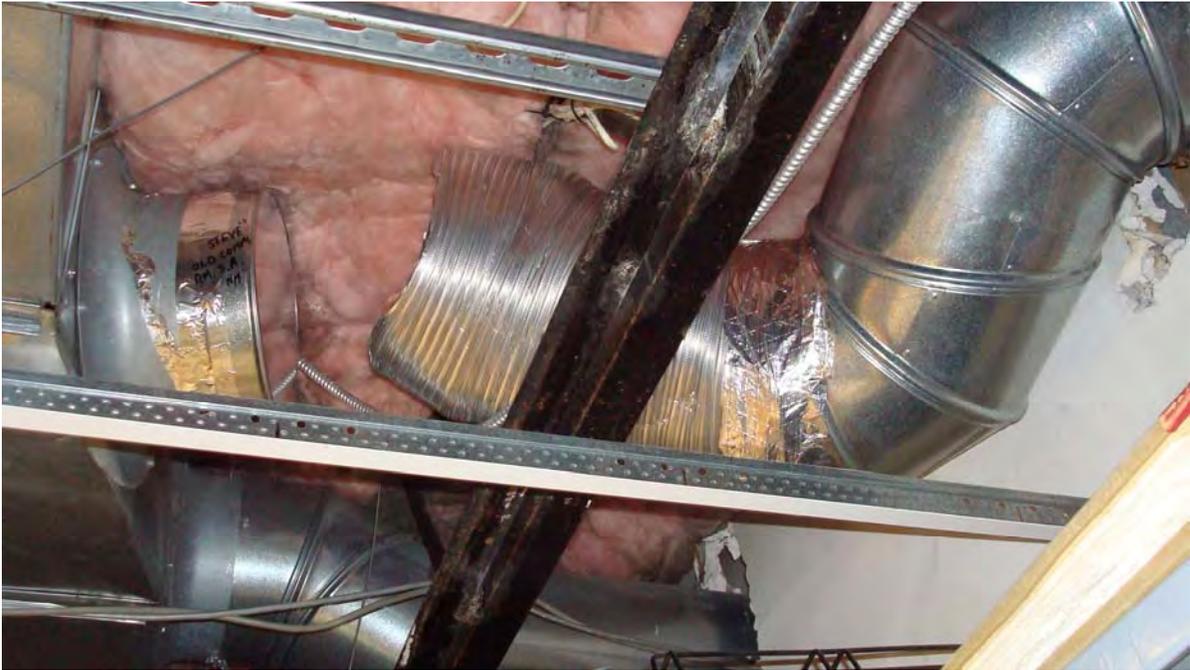
Picture 13

Disconnected ductwork was found in the Treasurer's storeroom (Picture 13). Open ductwork can be a pathway for odors to migrate from one area to another. Proper ductwork abandonment procedure would be to seal all open ends of unused ductwork if it is abandoned in place.

**Disconnected Ductwork Found above the Ceiling Plenum
in the Treasurer's Storeroom**
