INDOOR AIR QUALITY ASSESSMENT

**Massachusetts Department of Developmental Services
Charles River West Area Office
255 Elm Street, Suite 205
Somerville, MA 02144**

Prepared by:
Massachusetts Department of Public Health
Bureau of Environmental Health
Indoor Air Quality Program
October 2009

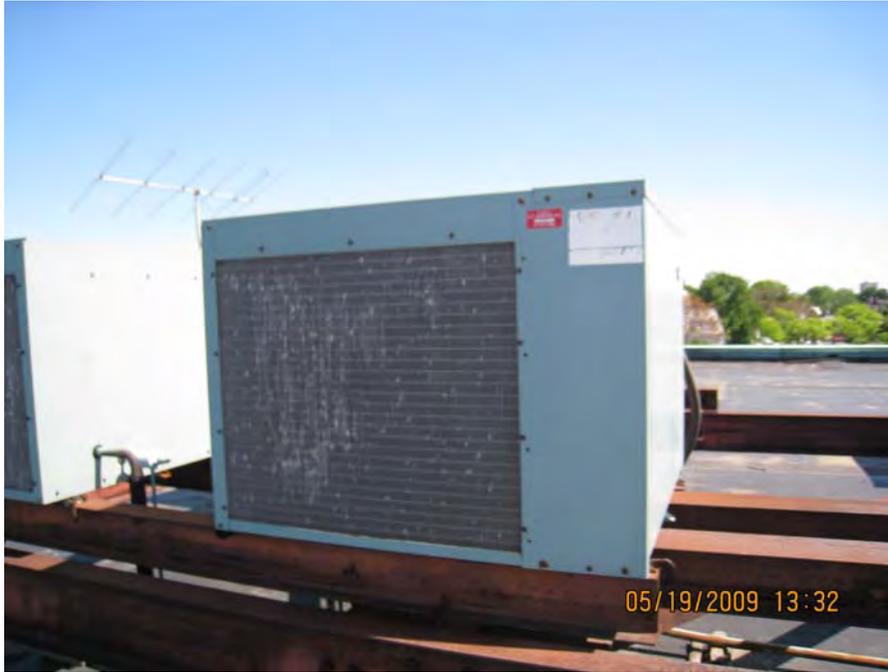
Picture 1

It can be seen from Table 1 that carbon dioxide levels were elevated above 800 parts per million (ppm) in all areas sampled, indicating less than adequate air exchange. Fresh air is introduced into the ceiling plenum (the space above the suspended ceiling tile system) by three air-handling units (AHUs) located on the building's rooftop (Pictures 1 to 3). Heat pumps located above the suspended ceiling tile system (Picture 4) draw air from the ceiling plenum and distribute filtered air to occupied areas via ceiling-mounted air diffusers (Picture 5). Filters are reportedly changed four times a year, or more frequently as needed. Filters were reportedly changed approximately 2 weeks prior to the BEH assessment. During the summer months, additional cooling is reportedly provided by a cooling unit located in the server room (Picture 6). Air supplied to offices is pressurized into the hallway, where exhaust vents return air to the AHUs (Picture 7).

Rooftop AHU #1

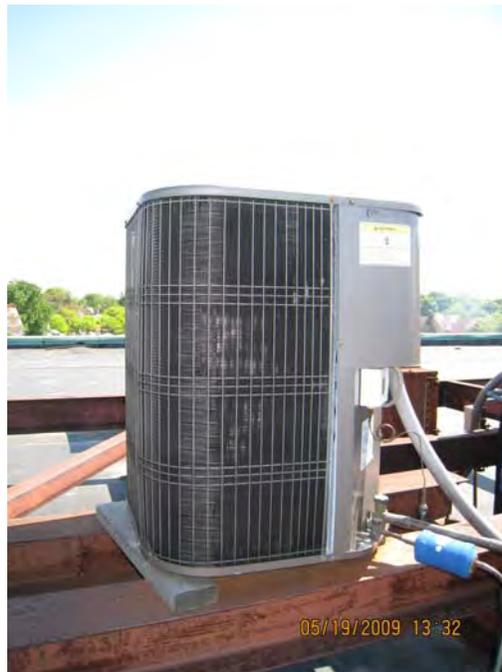
Picture 2

Rooftop AHU #2

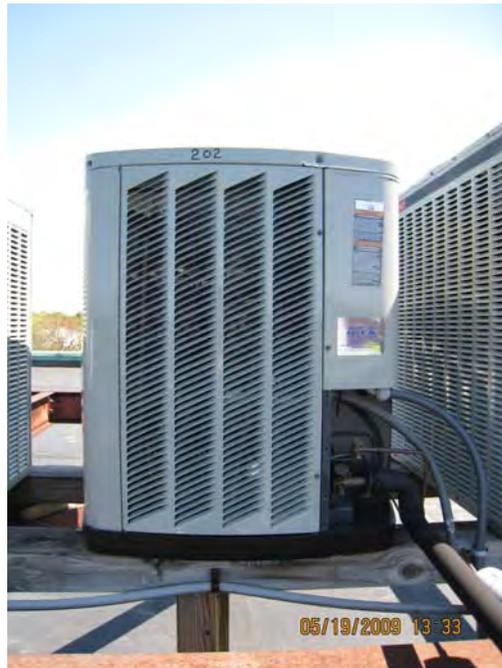
Picture 3

Rooftop AHU #3

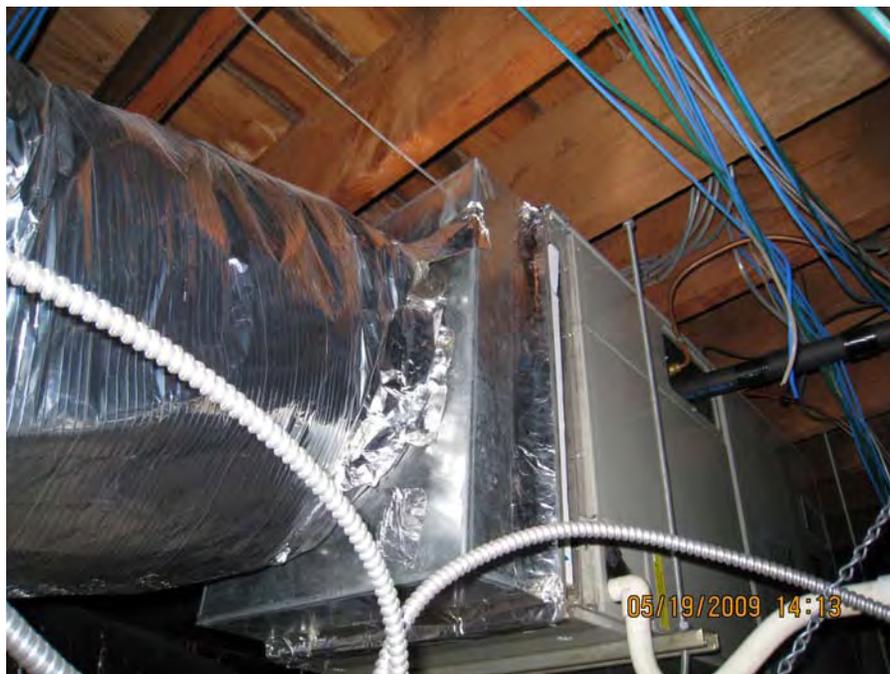
Picture 4

Heat pump in ceiling plenum

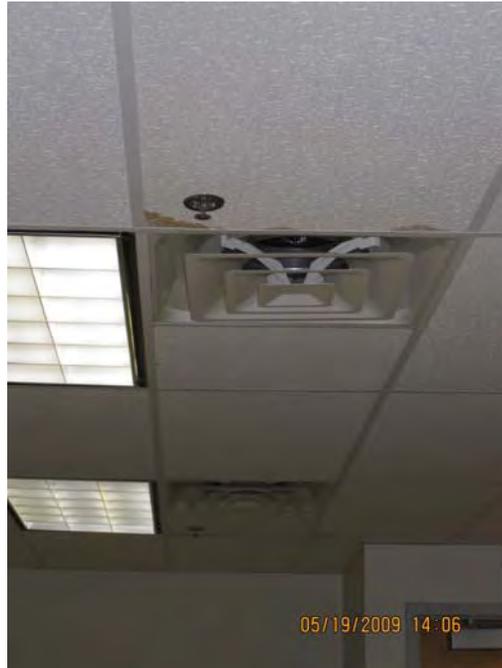
Picture 5

Ceiling-mounted supply vents

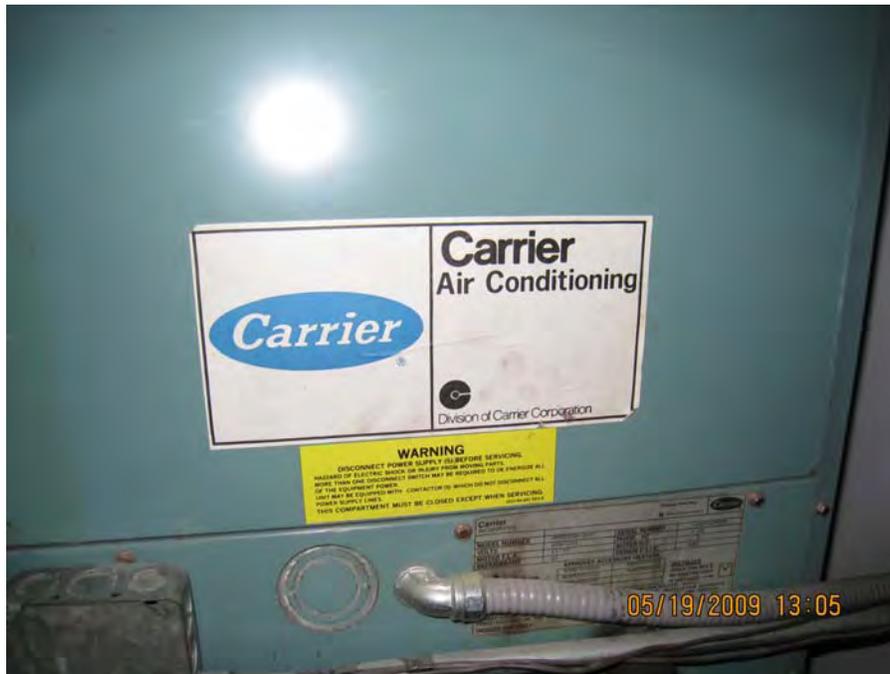
Picture 6

Cooling unit in server room

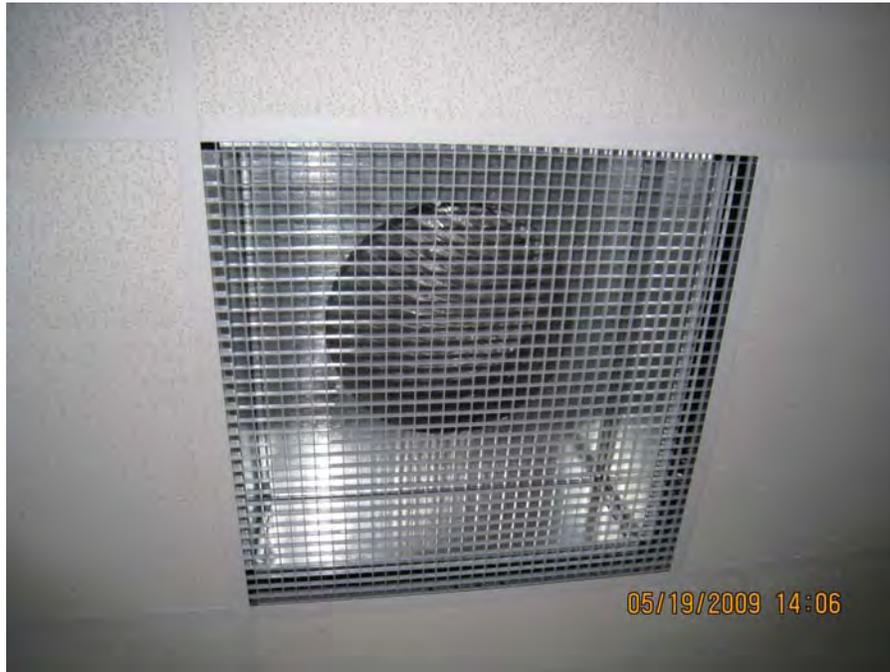
Picture 7

Ceiling-mounted exhaust vent

3. Balance the HVAC system to ensure appropriate delivery of fresh air, *after* the return vents are repositioned.
4. For buildings in New England, periods of low relative humidity during the winter are often unavoidable. Therefore, regular scrupulous cleaning practices should be adopted to minimize common indoor air contaminants whose irritant effects can be enhanced when the relative humidity is low. To control for dusts, a HEPA filter equipped vacuum cleaner in conjunction with wet wiping of all surfaces is recommended. Drinking water during the day can help ease some symptoms associated with a dry environment (throat and sinus irritations).

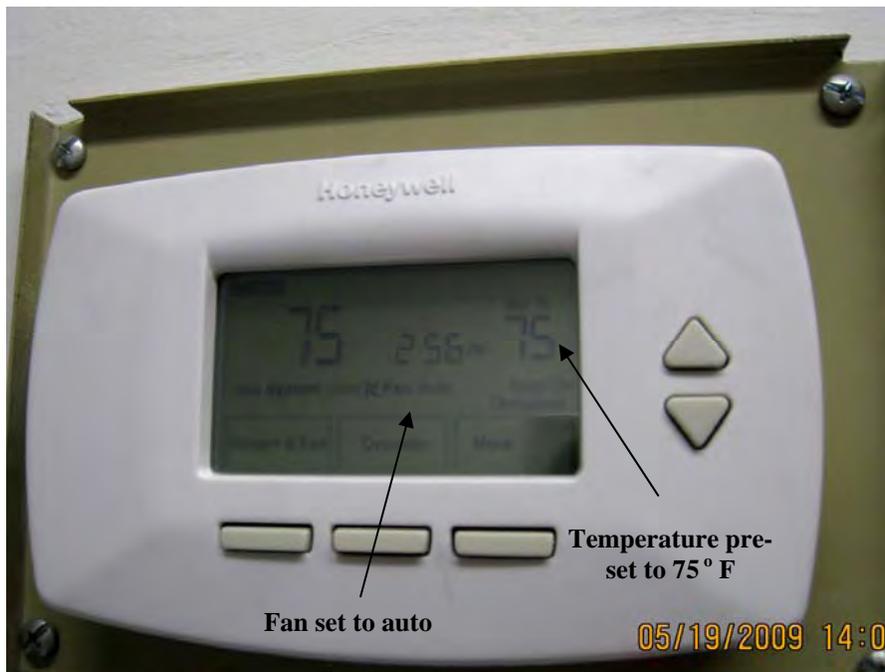
Picture 8

Each of the AHU units is controlled by a thermostat. At the time of assessment, BEH staff observed that all thermostats in the fan "auto" setting (Picture 8). In the auto setting, the thermostat activates the HVAC system at a preset temperature. Once the preset temperature is reached, the HVAC system is deactivated. Therefore, no mechanical ventilation is provided until the thermostat re-activates the system. For example, at the time of assessment, one of the

thermostats was set to 75 °F (Picture 8). Since the thermostat is set to 75°F, the HVAC would not be activated until that temperature is reached indoors. Since the temperature in the majority of areas assessed was below 75°F, the thermostat did not activate the AHU to provide conditioned fresh air (Table 1). Limiting the provision of fresh air can contribute to an increase in carbon dioxide levels and a decrease in the comfort of building individuals. Consideration should be given to operating the thermostat at a lower setpoint and with the fan in the on mode when the building is occupied.

Thermostat Fan set to auto, temperature pre-set to 75° F

1. Consider operating the thermostat fan setting in the 'on' mode while the building is occupied to provide adequate fresh air to the building.
2. Refrain from manual adjustments to the thermostat to prevent increases in comfort complaints and to allow for adequate air provision within the suite. Building

management should work with MDDS staff to determine an optimal thermostat setpoint to improve occupant comfort and prevent damage to AHUs.

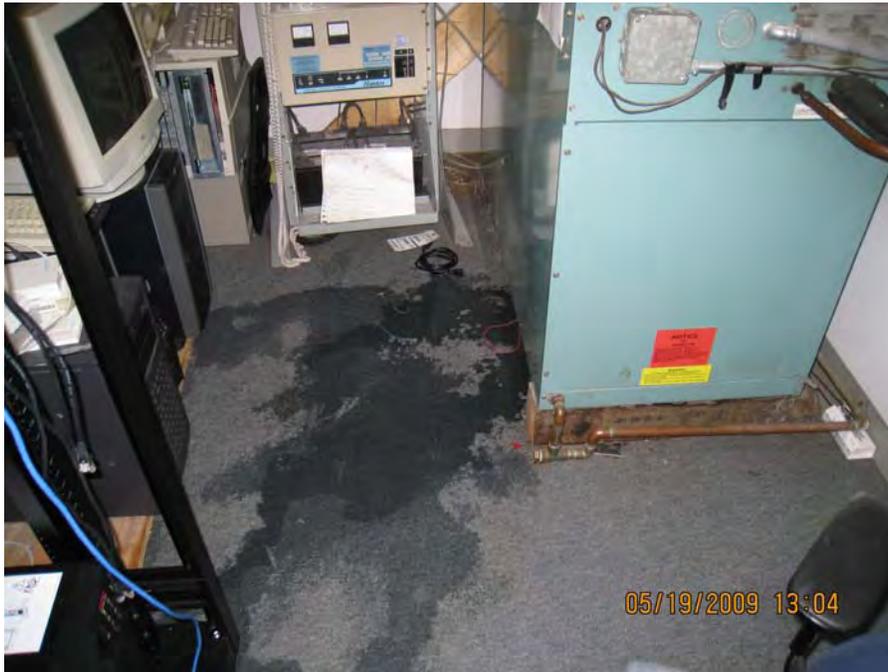
Picture 9

At the time of the assessment, BEH staff observed water leaking from the air-conditioning unit located in the computer server room. Carpeting was saturated from the leak (Picture 9). BEH staff immediately notified Mr. Wallach of the leak. Mr. Wallach contacted the building management; the building managers promptly assessed the server room, contacted the HVAC service technician regarding the unit, and brought industrial fans to dry carpeting. The

HVAC technician reportedly indicated that he would provide on-site response and asked that the system be turned off in the interim.

Wet carpet from leaking cooling unit

The US Environmental Protection Agency (US EPA) and the American Conference of Governmental Industrial Hygienists (ACGIH) recommend that porous materials be dried with fans and heating within 24 to 48 hours of becoming wet (US EPA, 2001; ACGIH, 1989). If not dried within this time frame, mold growth may occur. Once mold has colonized porous materials, they are difficult to clean and should be removed/discarded.

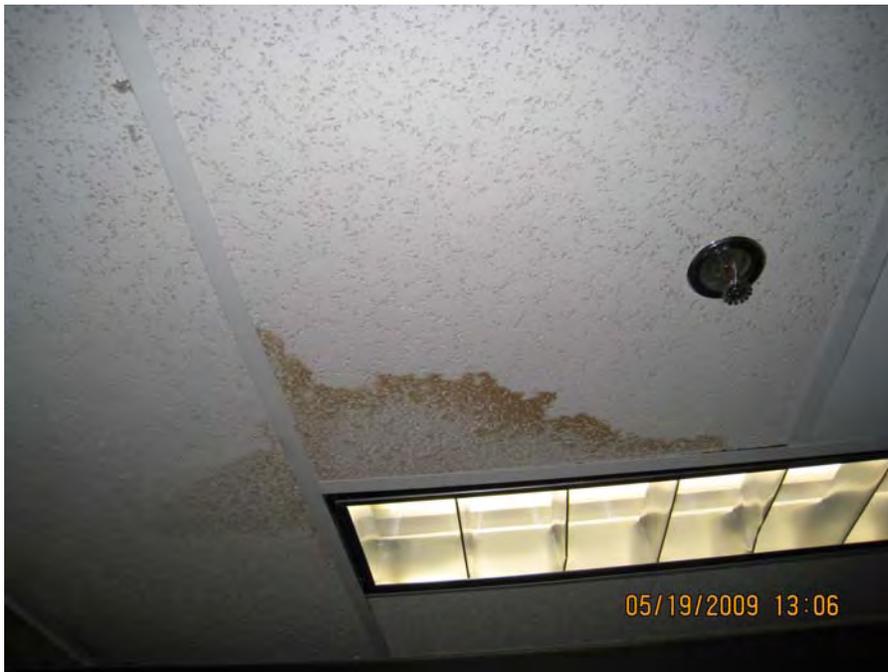
Picture 10

Water-damaged ceiling tiles were noted in several areas (Picture 10), likely from pipe leaks or condensation formed on pipes and subsequently dripping on tiles below. Ceiling tiles should be replaced after a water leak is discovered and repaired. Missing ceiling tiles observed in some areas can result in uneven heating and/or cooling conditions as well as movement of particles into occupied areas.

Water-damaged ceiling tile

5. Replace water-damaged ceiling tiles once leaks are repaired.
6. Seal breach between sink countertop and backsplash to prevent water infiltration.
7. Clean supply and exhaust vents and sprinklers to prevent accumulation of dust and debris.

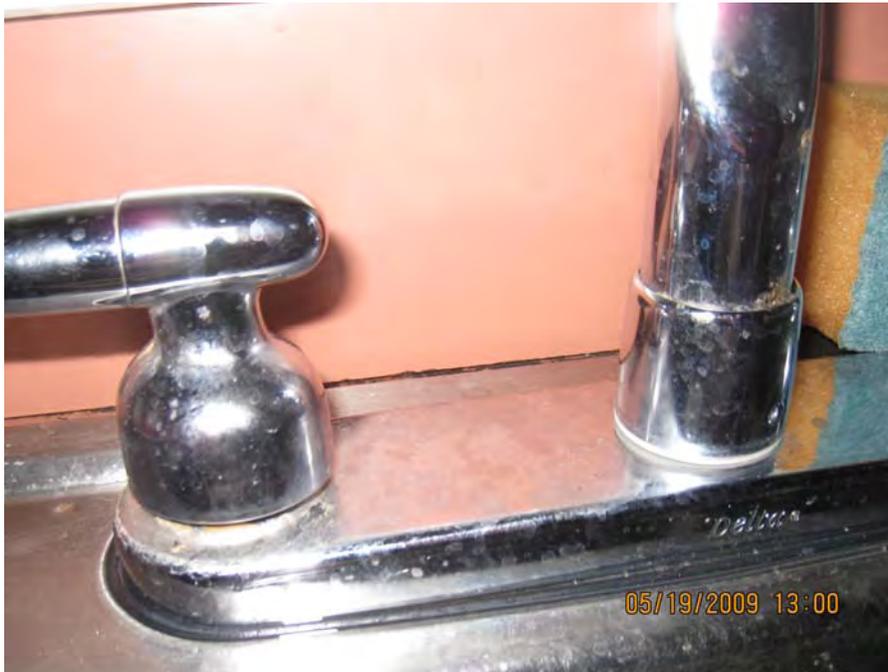
Picture 11

Open seams between sink countertops and walls were observed in several rooms (Picture 11). If not watertight, water can penetrate through the seam, causing water damage. Improper drainage or sink overflow can lead to water penetration into the countertop, cabinet interior and areas behind cabinets. Water penetration and chronic exposure of porous and wood-based materials can cause these materials to swell and show signs of water damage. Repeated moistening of porous materials can result in mold growth.

Breach between sink countertop and backsplash

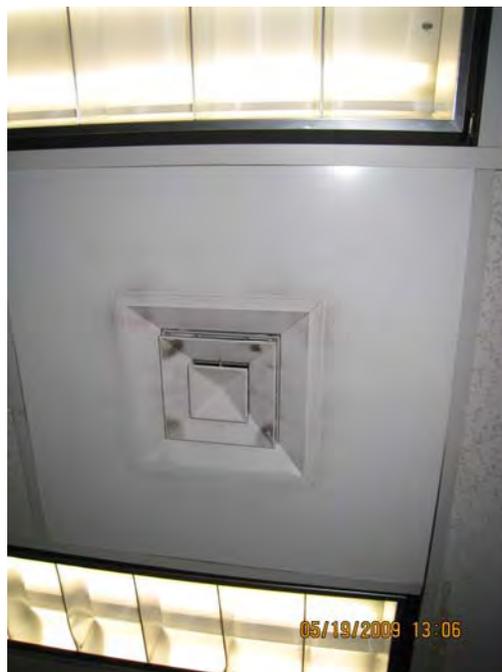
Picture 12

At the time of assessment, MDDS staff were concerned with dust accumulation on exhaust vents. Dust was reportedly cleaned from these vents recently. At the time of assessment, BEH staff did not observe dust on any exhaust vents. However, BEH staff did observe dust on supply vents, personal fans, and sprinklers. Dust/dirt was observed on the metal casings of supply vents (Picture 12), likely the result of air passing over the metal casing which creates a static charge that attracts dust particles. Occasional wet wiping/cleaning of supply and exhaust vents should be conducted to prevent dust accumulation and re-aerosolization. Similarly, personal fans should also be cleaned regularly to prevent aerosolization of dust accumulated on fan blades/housing when the unit is activated. Dust accumulated on sprinkler heads should be removed to prevent clogging of the head.

Dust on supply vent metal casing

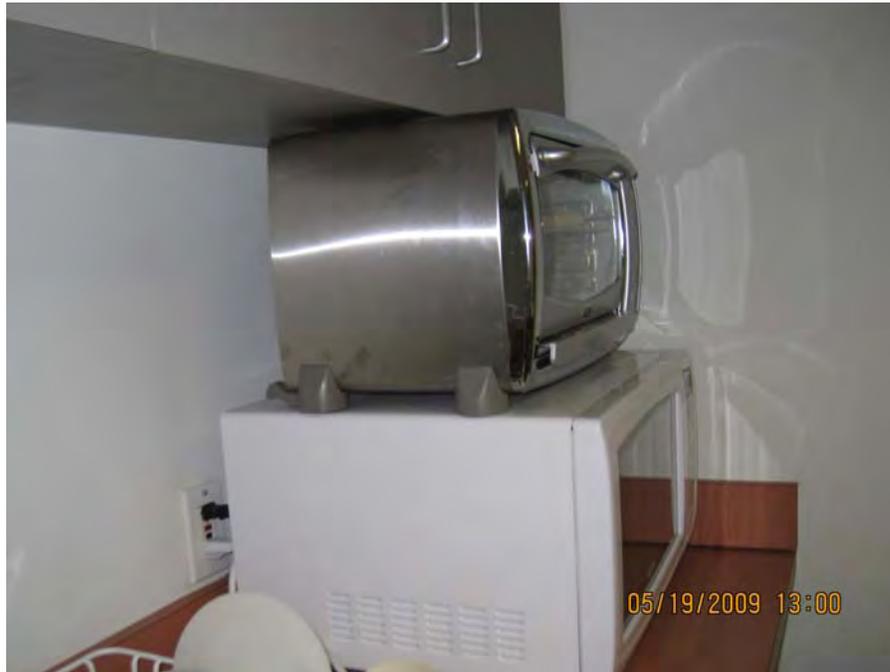
Picture 13

Additional sources that can contribute to odors/irritants in building include the configuration of food warming appliances and cleaning products/air deodorizers. BEH staff observed a toaster oven and microwave stacked under a cabinet in the kitchen (Picture 13). Of particular concern is the proximity of the toaster oven to the cabinet. The lack of open space around these appliances prevents heat and odors from dissipating. Overtime, heat generated by

the toaster oven can cause the cabinet to delaminate and off-gas volatile organic compounds (VOCs), which are irritating to the eyes, throat, and respiratory system. This configuration can also be a fire hazard.

Toaster oven and microwave placed below cabinet

8. Clean personal fans to prevent aerosolization of dusts.
9. Relocate the toaster oven and microwave away from cabinet and place in area that allows for odors and heat to dissipate the top, sides, and back of the appliances.
