# **INDOOR AIR QUALITY ASSESSMENT**

**Richard Sugden Library  
8 Pleasant Street  
Spencer, Massachusetts 01562**

Prepared by:  
Massachusetts Department of Public Health  
Bureau of Environmental Health  
Indoor Air Quality Program  
October 2009

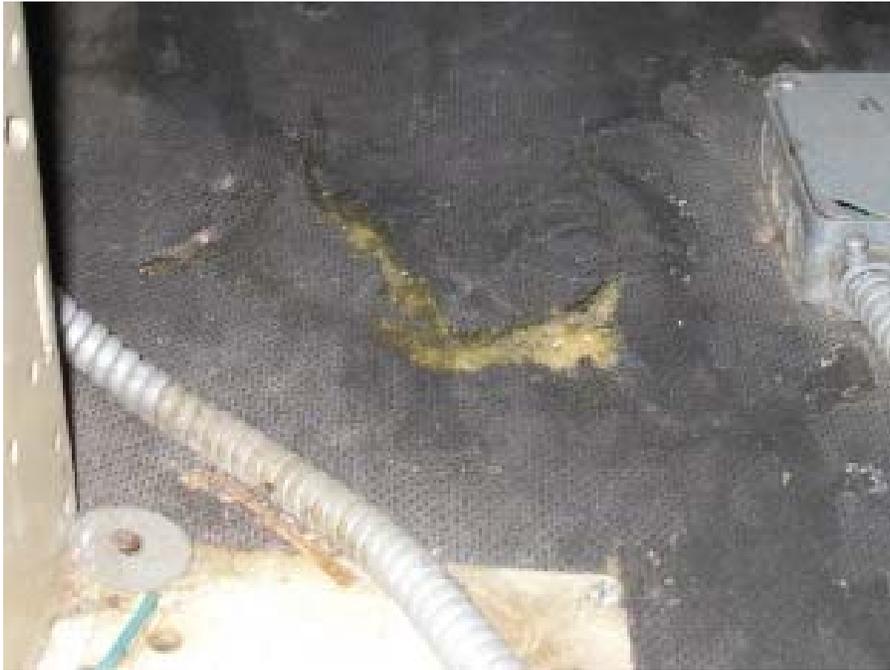
**Picture 1**

Ventilation is provided by means of six air handling units (AHUs) located throughout the interior of the building. Fresh air is supplied to rooms by ducted air supply diffusers. Stale air and contaminants are removed by means of ducted exhaust vents. The AHU located in the bell tower (Unit # SA6) has reportedly leaked over time, resulting in damage to the ceilings in the staff room the first floor and the children's library. Damage to the interior liner of this AHU was evident, as was the resulting exposed fiberglass insulation (Picture 1). A tear was observed in the exterior liner of the same unit. A breach was also evident where the liner attaches to the AHU (Pictures 2 and 3). Filters in this unit as well as others lacked spacers between them, creating a gap between the filters. The existence of these gaps allows for air to by-pass the

installed filters, resulting in aerosolization of dust and particulates. In addition to the AHUs, supplemental temperature/humidity control and filtration is provided in the staff room and archives by wall mounted air handling units.

**Damaged Liner in AHU**

1. Contact an HVAC engineering firm to survey AHUs to ensure equipment no longer leaks and to repair/replace damaged interior and exterior liners on AHUs as needed.

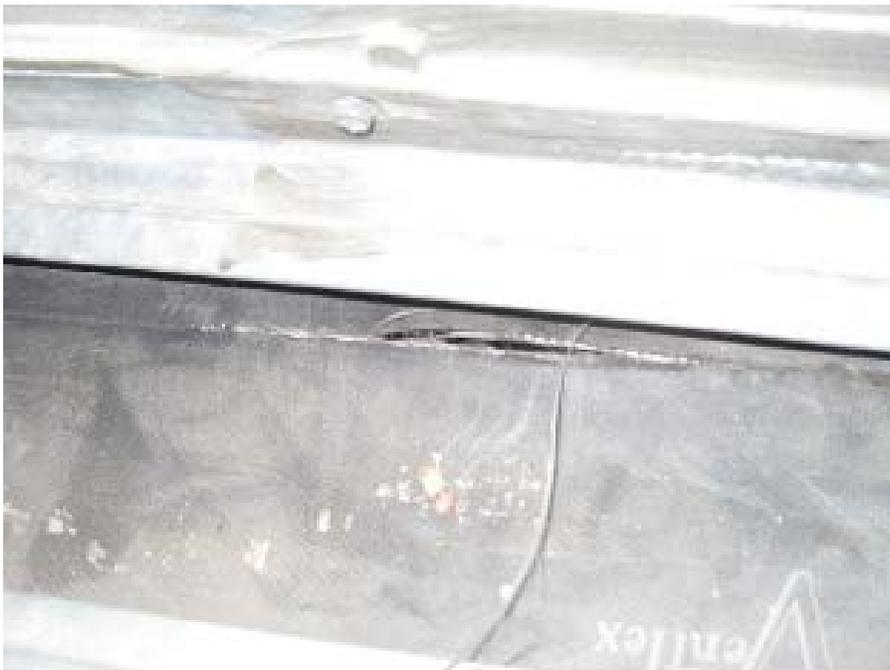
**Picture 2**

**Exterior Liner to AHU is Damaged**

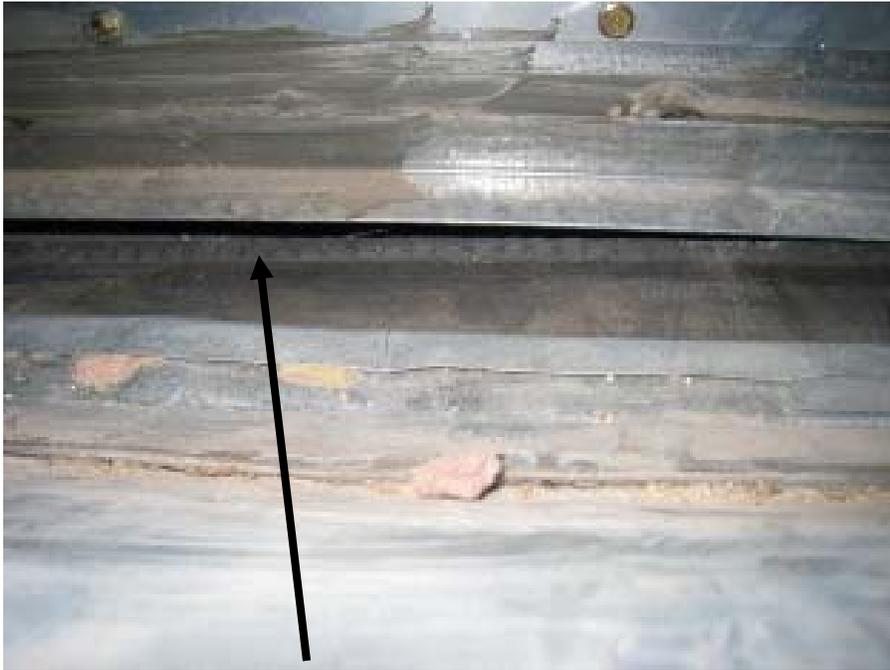
**Picture 3**

**Exterior Liner on AHU Has Also Separated from Unit**

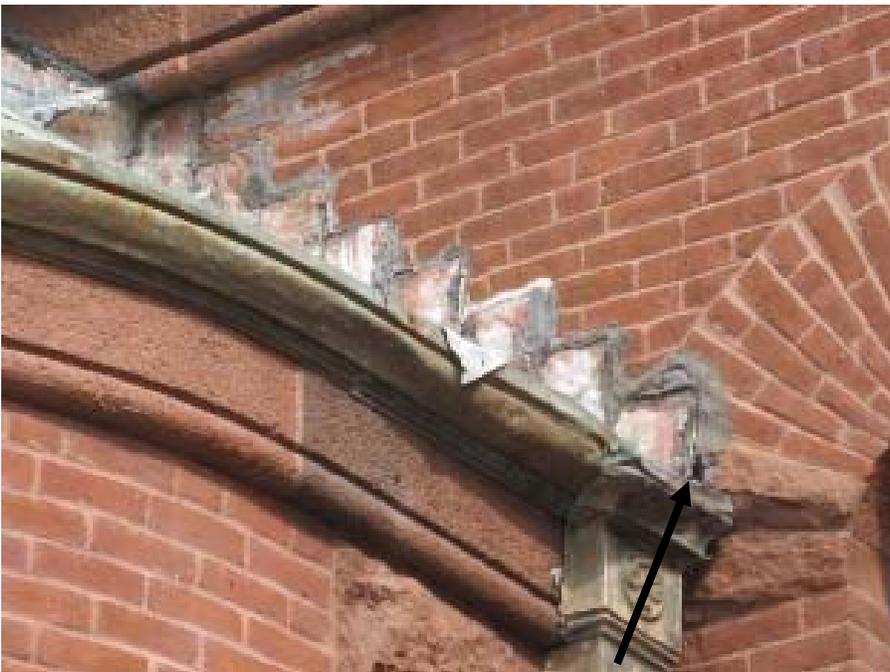
**Picture 4**

Several potential sources of water damage and/or mold growth were observed during the assessment. Sealant on the flashing of the slate roof appeared to be deteriorated in some areas (Pictures 4 and 5). Water damage to the ceiling adjacent to the fireplace in the seating area on

**Deteriorated Sealant on Flashing**

16. Repair deteriorated sealant on roof of original building.
17. Seal gaps around exterior doors.
18. Repoint masonry and ensure all gaps are appropriately sealed on the exterior of the building, with particular attention to areas where the addition is joined to the original building.

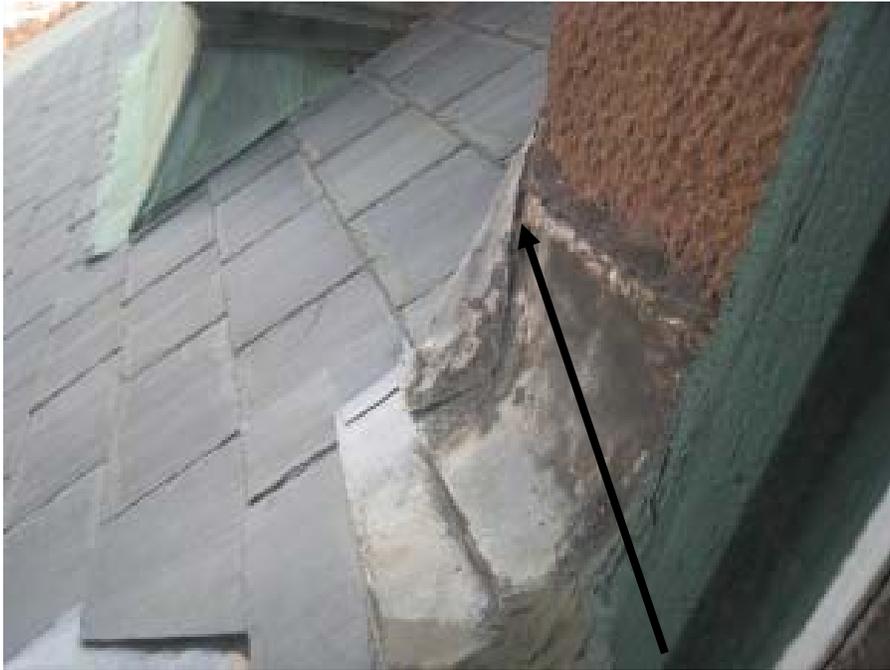
**Picture 5**

**Deteriorated Sealant**

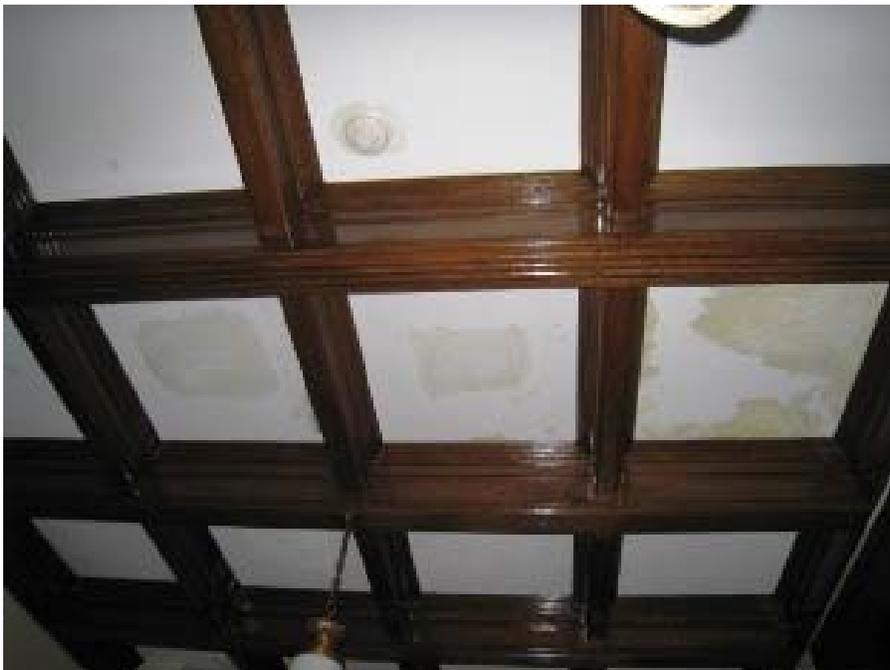
**Picture 6**

the first floor as well as to the ceiling in the stairway to the bell tower was observed. Water damaged ceiling and walls were also observed in the staff room (Picture 6). This damage was attributed by RSL staff to the repeated leaks from the AHU located above the ceiling. Water damaged ceiling was observed in the entry to the children's library as well. On the ground floor in the children's library, numerous areas exhibited water damage (Picture 7). Ceilings exhibited substantial water damage as did the base of cabinets in the children's work room (Picture 8). Evidence of water penetration was evident on painted brick surfaces on the ground floor. Mold colonization was observed on portions of the brick as well (Picture 9).

**Water Damaged Ceiling in Staff Room**

5. Determine whether peeling paint in basement contains lead. If so, remediate in compliance with state and federal regulations.
6. Repair/Replace water damaged materials within the RSL. Discard affected porous materials if they were not dried within 24 to 48 hours of becoming wet.

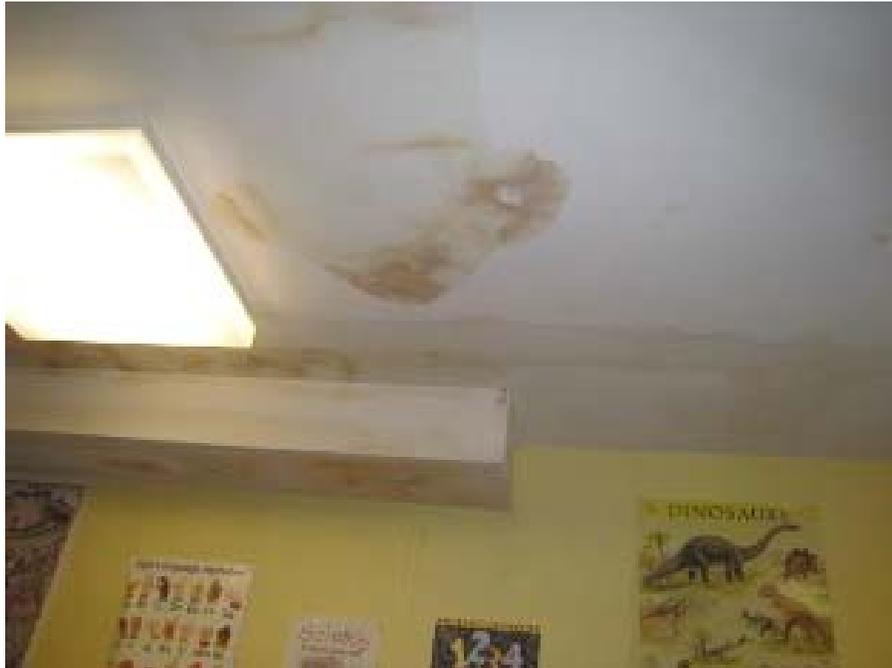
**Picture 7**

**Water Damaged Ceiling in Children's Library**

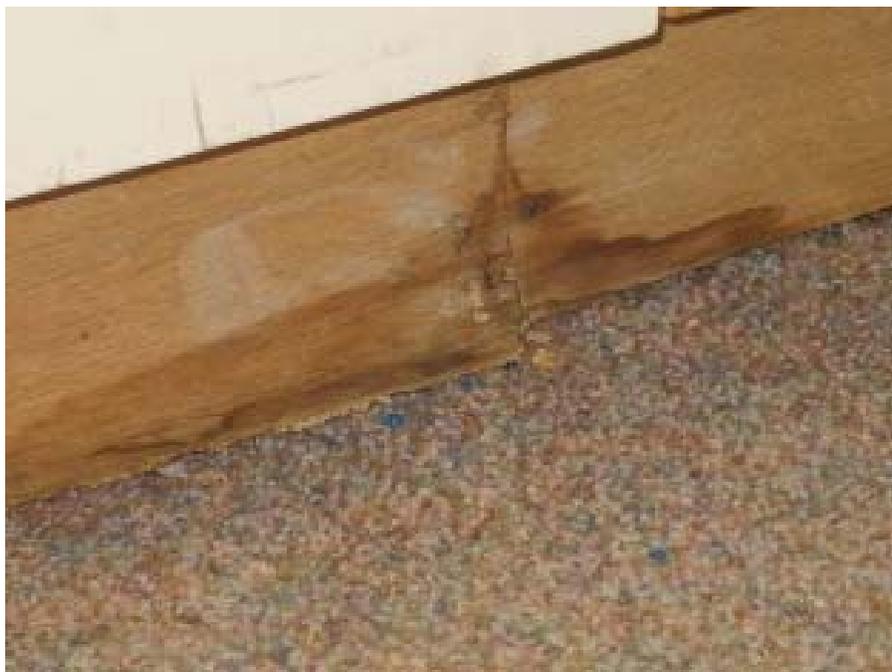
**Picture 8**

**Water Damage to Base of Cabinet**

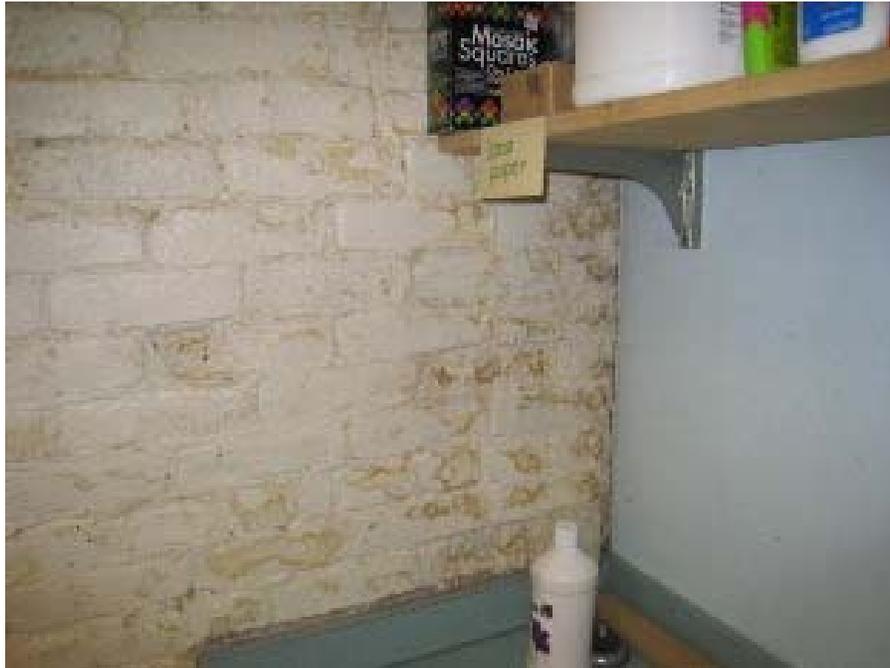
**Picture 9**

**Evidence of Water Penetration**

4. Clean mold colonized areas in accordance with EPA guidelines. For more information, please consult “Mold Remediation in Schools and Commercial Buildings,” which can be accessed at the following location: [http://www.epa.gov/mold/mold\\_remediation.html](http://www.epa.gov/mold/mold_remediation.html)

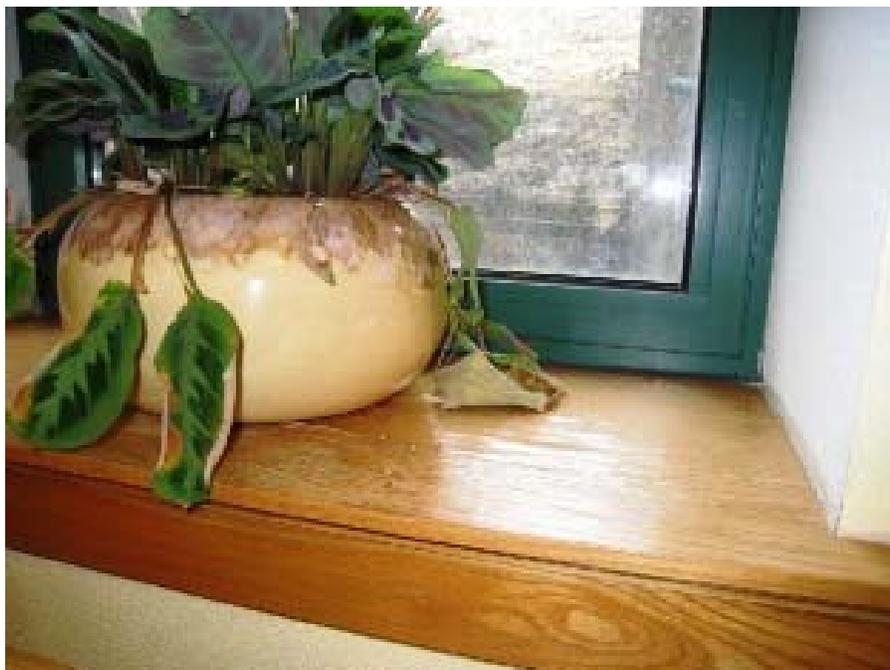
**Picture 10**

Some plants were observed lacking drip pans. Water damage was evident on the window sill beneath one plant, likely due to over-watering (Picture 10). Plant soil and drip pans can serve as a source of mold growth. Plants should be properly maintained and be equipped with drip pans. Plants should also be located away from the air stream of mechanical ventilation to prevent aerosolization of dirt, pollen or mold.

**Water Damage to Window Sill**

9. Consider providing plants with drip pans and avoid over-watering. Examine drip pans periodically for mold growth. Disinfect with an appropriate antimicrobial where necessary.

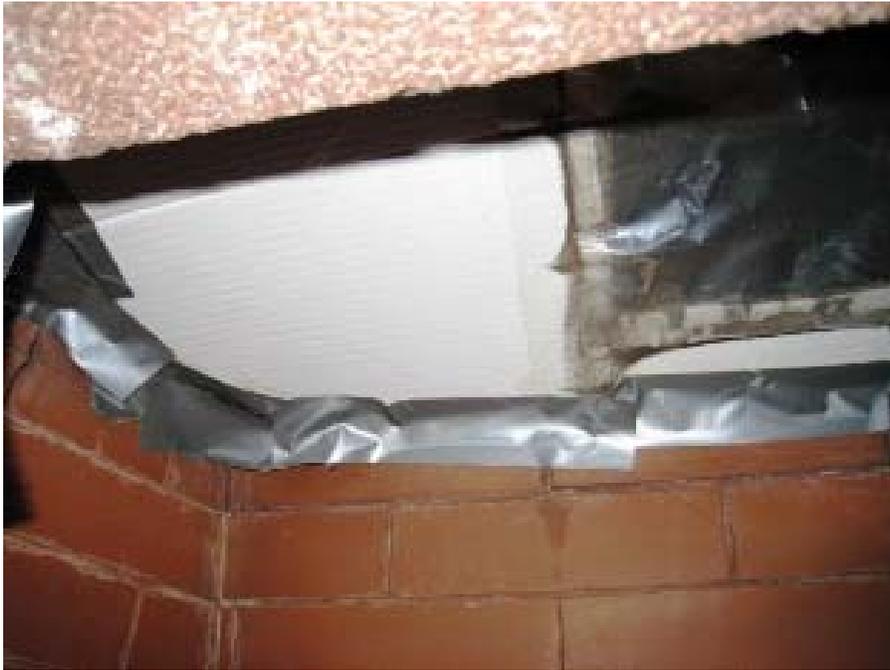
**Picture 11**

A chimney flue sealed with wood, cardboard and duct tape was observed in the fireplace in the main library (Picture 11). Signs of moisture accumulation were observed on the cardboard. Soot accumulation was noted on an area of clear plastic utilized in the fireplace as well. A similar condition was noted in the fireplace in the Director's office. The current conditions allow unconditioned air including moisture and particulates into the building as well.

**Seal on Interior of Chimney**

10. If fireplaces are not used, consider sealing both ends to prevent moisture and particulates from entering the occupied space.
11. Material Safety Data Sheets for all cleaning products utilized at the RSL should be made available at a central location within the building in the event of an emergency. Cleaning product should be stored out of reach of children in the children's library.

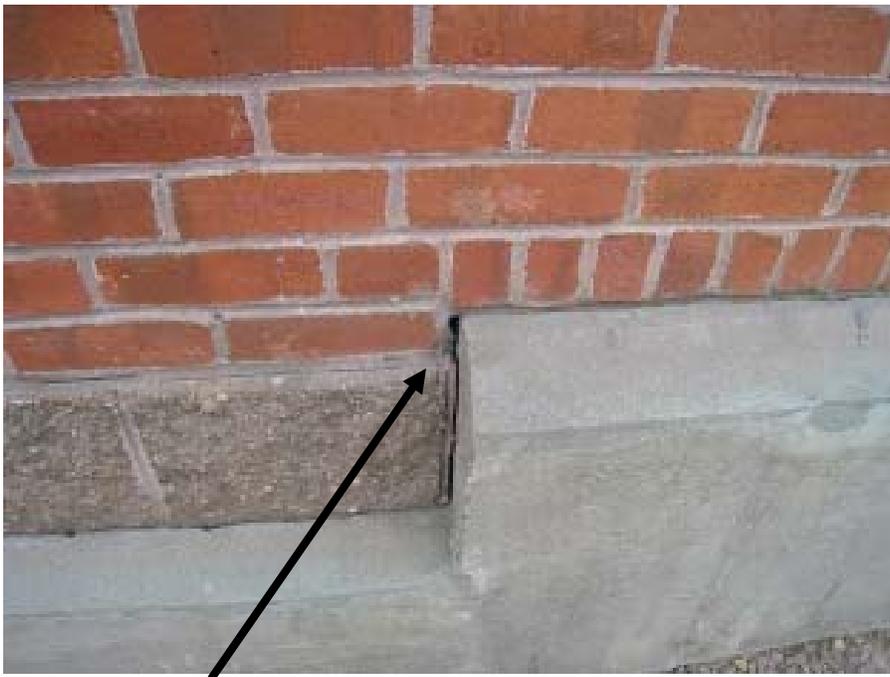
**Picture 12**

- Light fixture above entrance to children's library is detached, exposing an open penetration into the block wall.
- Large gaps were observed between the foundation and masonry in some areas (Picture 12).

**Gap Between Foundation and Masonry**

19. Seal gaps where foundation meets masonry. Replace deteriorating sealant on the exterior of the building.
20. Seal all open utility holes in the building, both on the interior of the building as well as the exterior.

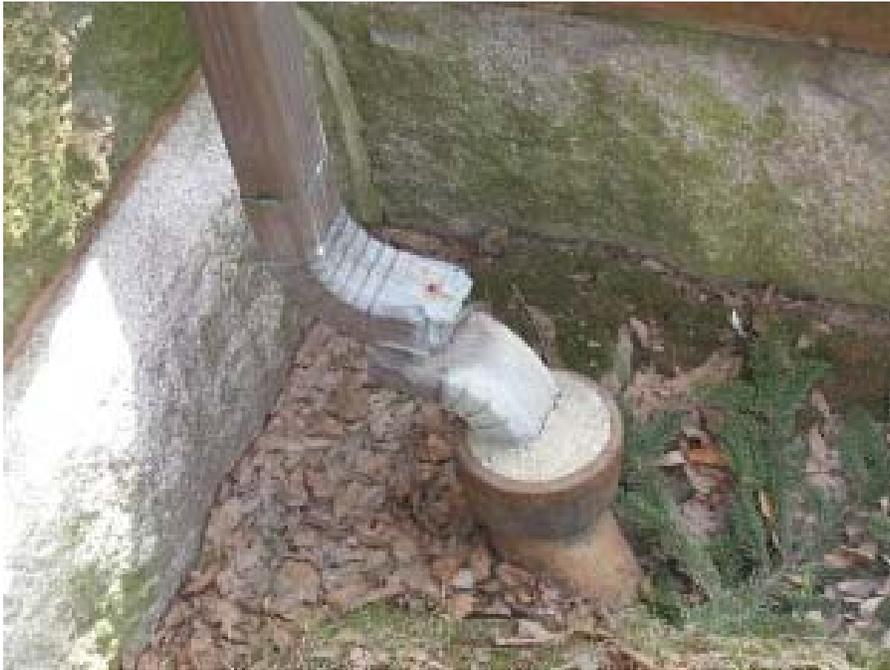
**Picture 13**

- Deteriorated sealant and decomposing wood frame was observed on the exterior of the original building.
- Downspouts do not enter piping to drainage system in some areas and therefore, deposit rainwater adjacent to the foundation. Moisture is visible at the base of the concrete foundation in one location. In addition, evidence of chronic moisture exposure was also observed in the form of heavy moss accumulation adjacent to a downspout (Pictures 13 and 14).

**Downspout Draining at Base of Building  
Note Moss Accumulation**

21. Repair gutters/downspouts to ensure rainwater is deposited away from the building foundation. Downspout that empties onto the patio should be redesigned to eliminate rainwater from being deposited in this area.

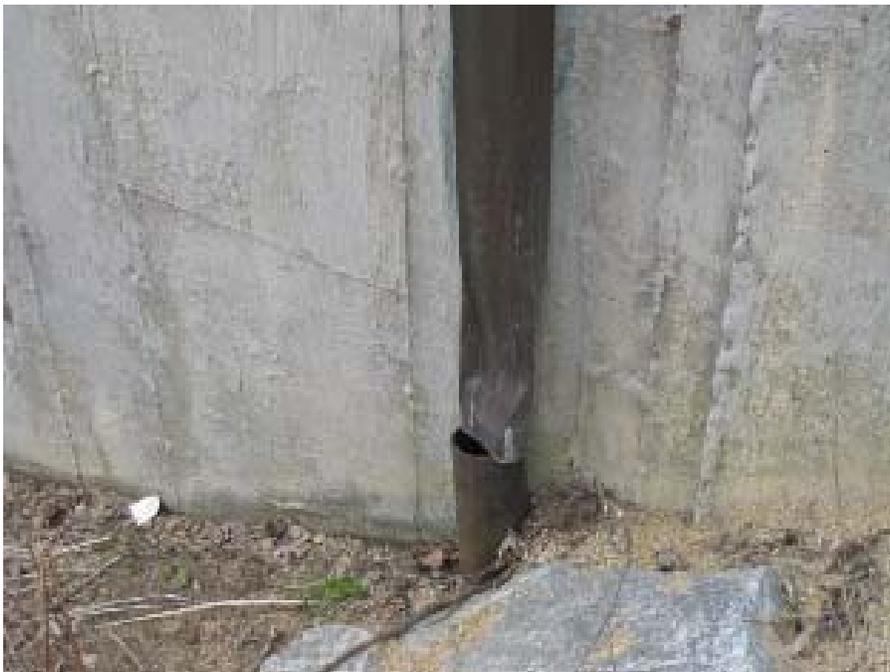
**Picture 14**

**Disconnected Downspout**

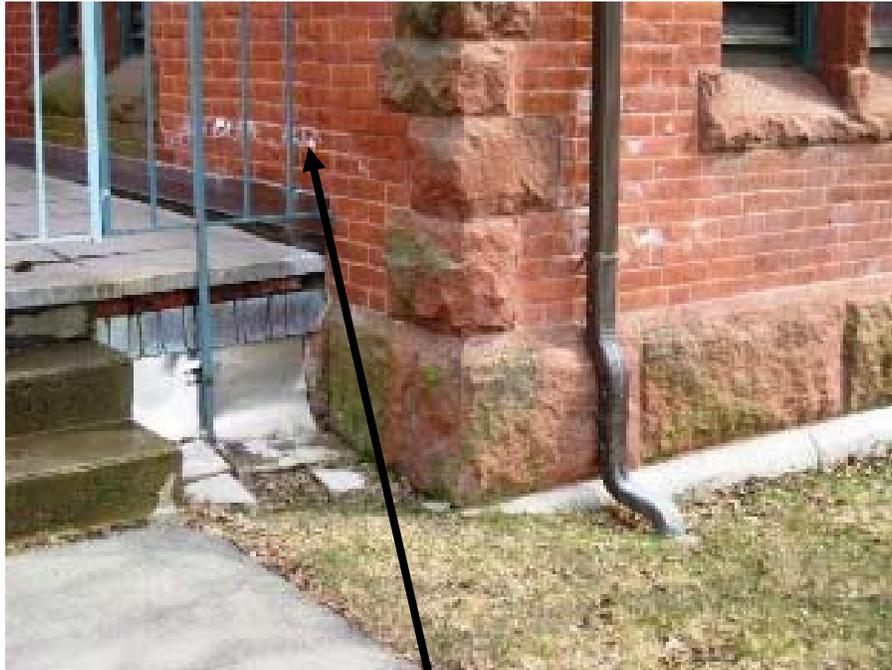
**Picture 15**

- A white, powdery material known as efflorescence was noted on several sections of the exterior masonry (Picture 15). Efflorescence is a characteristic sign of water intrusion, but it is not mold. As penetrating moisture works its way through mortar around brick, it leaves behind characteristic mineral deposits.

**Efflorescence on Masonry**

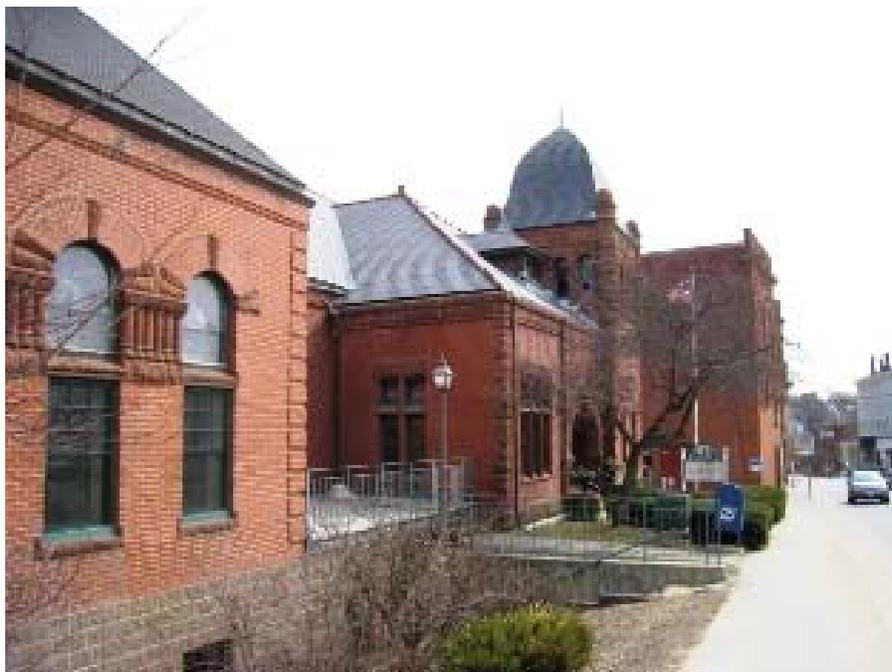
**Picture 16**

- Also of note was the block wall foundation which connects the original building to the 1997 addition. The construction of this component created an alcove (Picture 16). The conditions observed in this area may well contribute toward water penetration through the building envelope. A downspout drains rainwater directly onto a patio in close proximity to the original foundation of the building (Picture 17). Water penetrates between the patio stones, and can be seen with movement of water from a melting pile of snow on the patio (Picture 18). As the water penetrates the stones, much of it migrates beneath the stones and drains down the stairs and along the block wall foundation, despite efforts to prevent it that were made by placing pieces of sheet metal adjacent to the wall (Pictures 19 and 20). As Picture 20 depicts, the ground adjacent to the block wall is saturated. Additionally, since the patio area is in an alcove, the water received by it may not dry as quickly as it might in a more open area. The patio/alcove is also located on the west side of the building. This could be significant because moist weather tends to travel in a northeasterly track up the Atlantic Coast towards New England (Trewartha, G.T., 1943). Wet weather systems generally produce south/southwesterly winds, which will tend to deliver driving rain to the south/southwestern/western walls of the RSL. As a result, heavy moss accumulation was noted between the stones as well as at the juncture of the wall of the original building and the patio (Picture 21). The presence of moss in Picture 21 is indicative of repeated water exposure. And lastly, the sealant above the flashing on the original building has begun to deteriorate, which will allow moisture to potentially enter the building envelope (Picture 22).

**Block Wall Foundation Connecting Addition to Original Building**

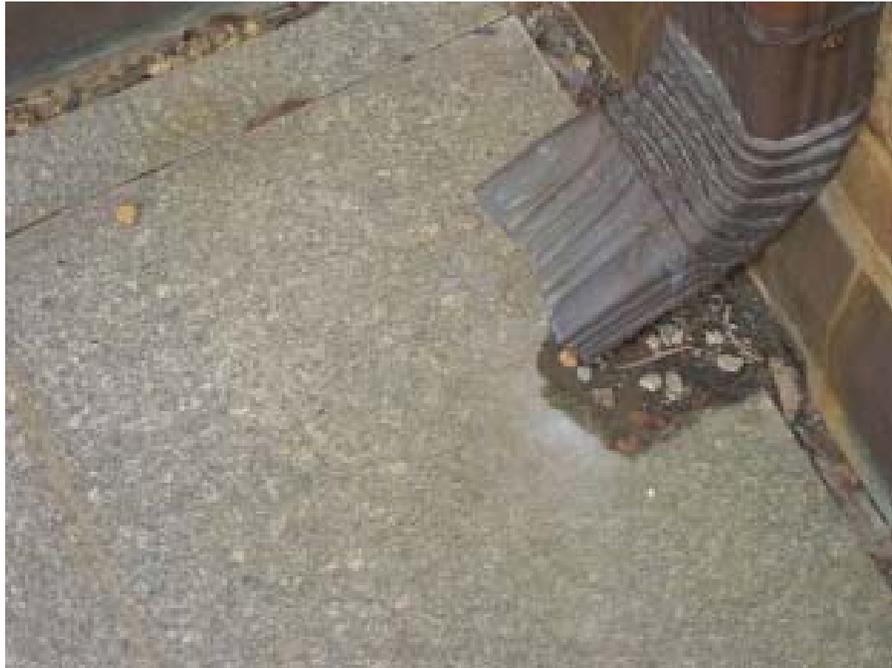
**Picture 17**

**Downspout in Alcove/Patio**

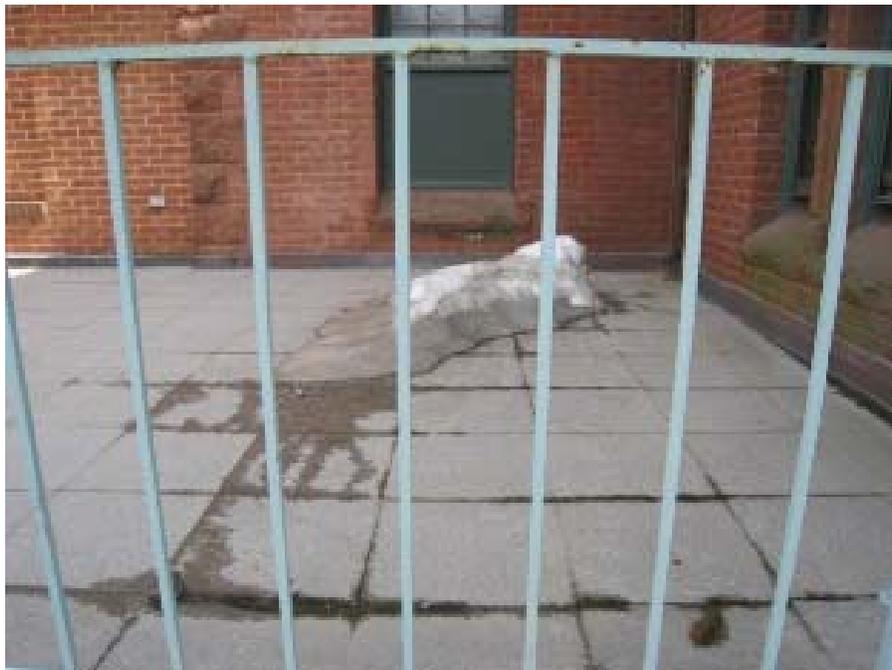
**Picture 18**

**Movement of Water on Patio  
Note Moss Growth Between Tiles**

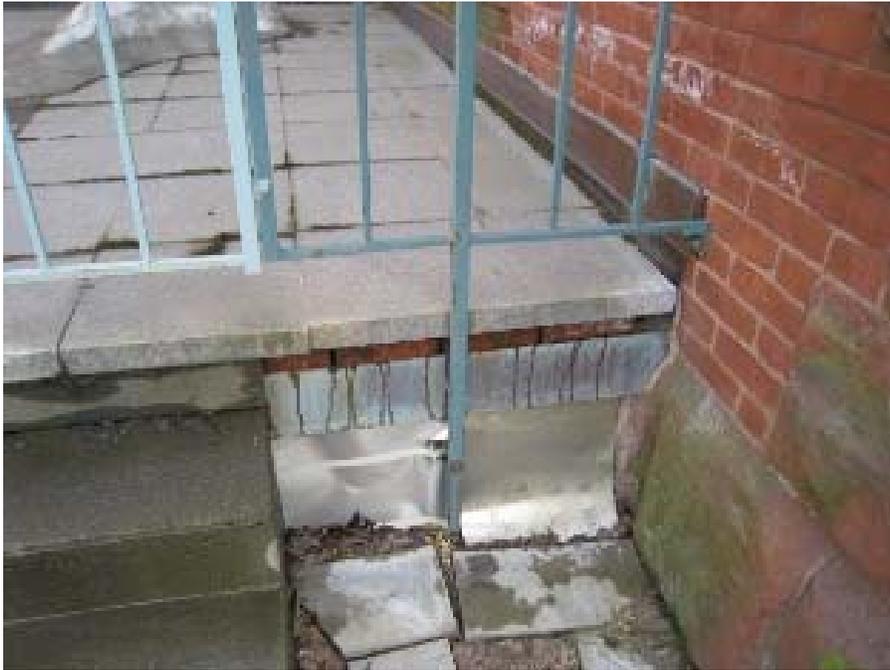
**Picture 19**

**Water Draining Against Foundation**

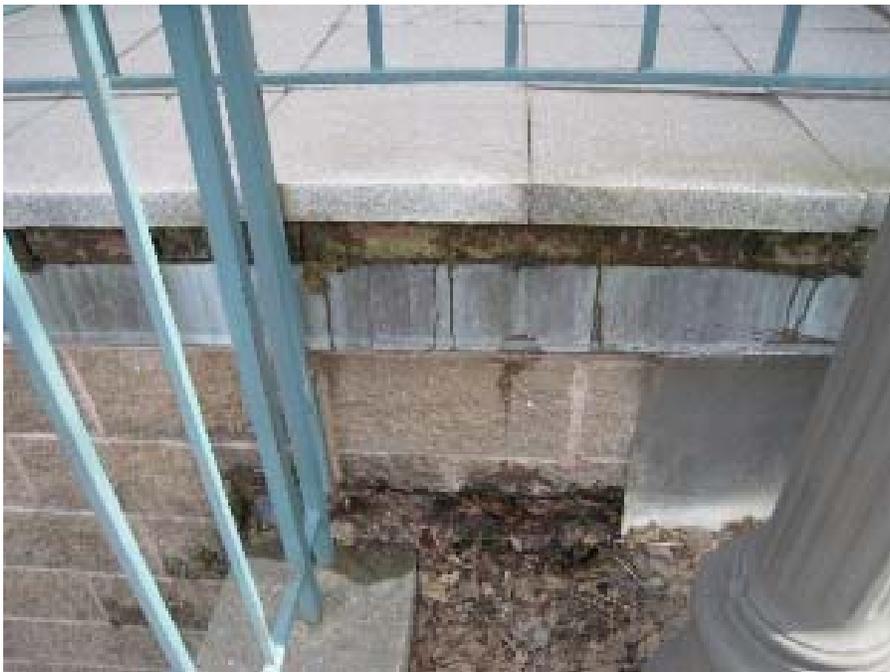
**Picture 20**

**Saturated Soil Adjacent to Block Wall  
Note Sheet Metal**

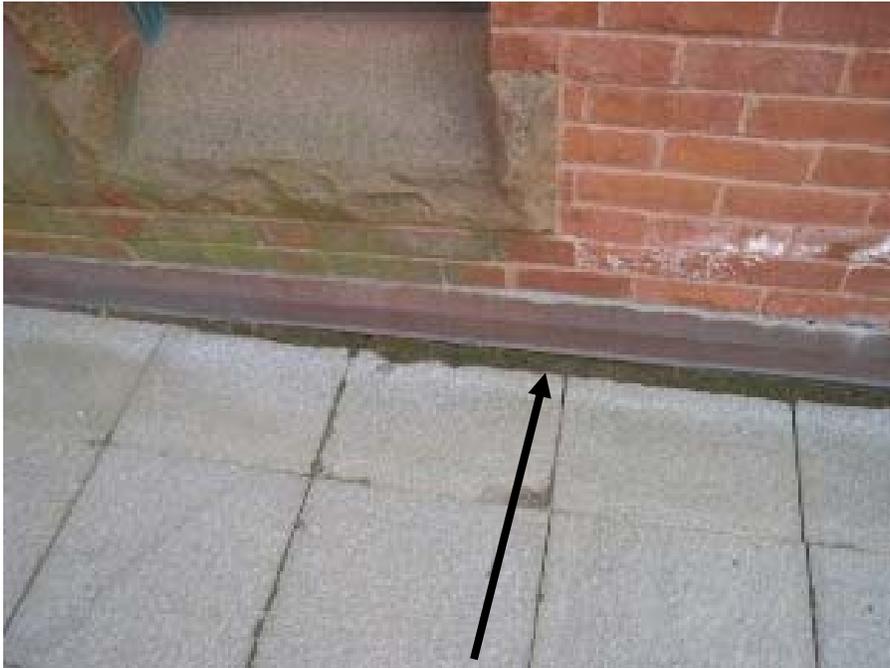
**Picture 21**

**Heavy Moss Growth**

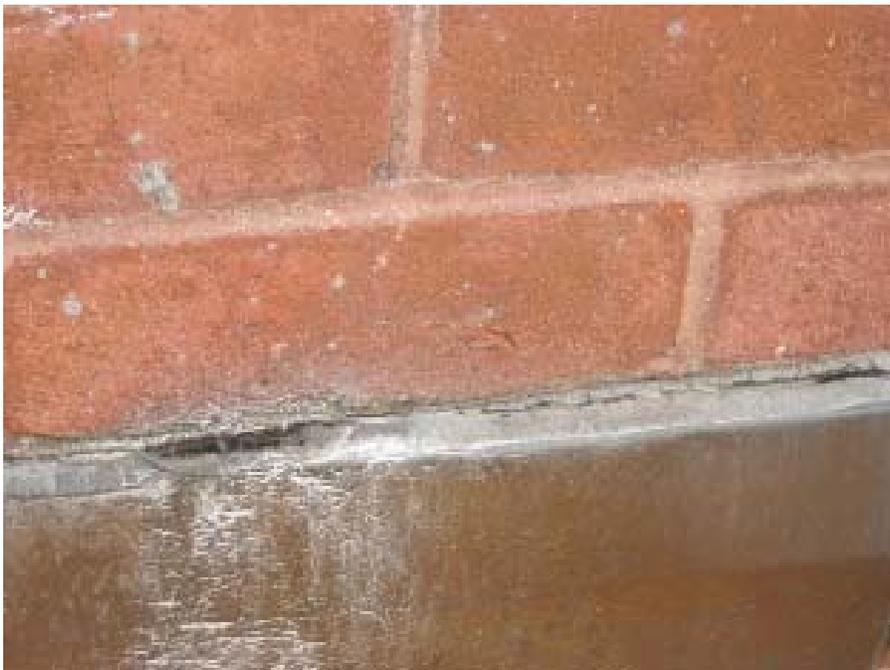
**Picture 22**

**Deteriorated Sealant**

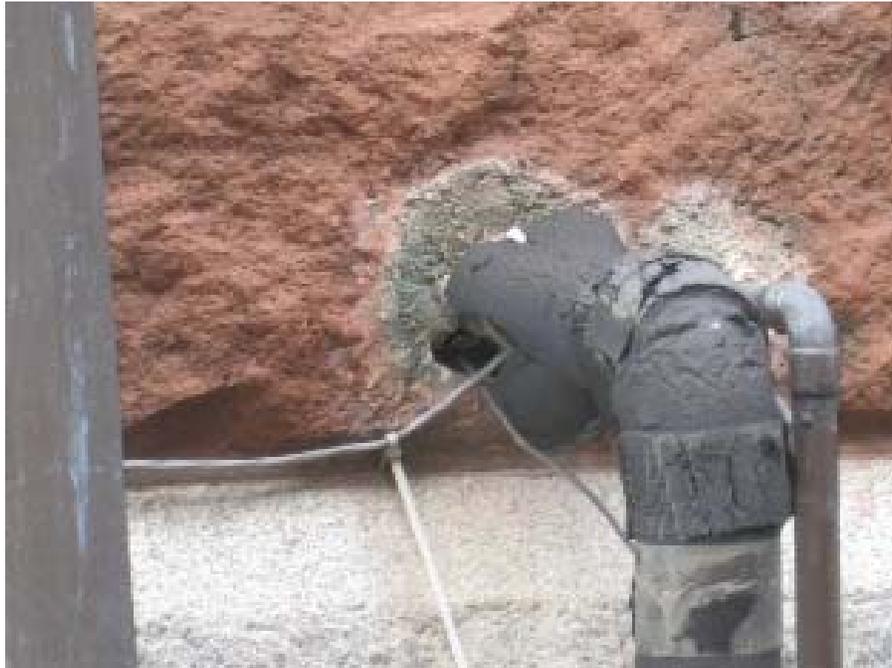
**Picture 23**

- Exterior utility holes were not adequately sealed (Picture 23).
- Plant growth was noted throughout stone walkway adjacent to children's library.

**Open Utility Hole**

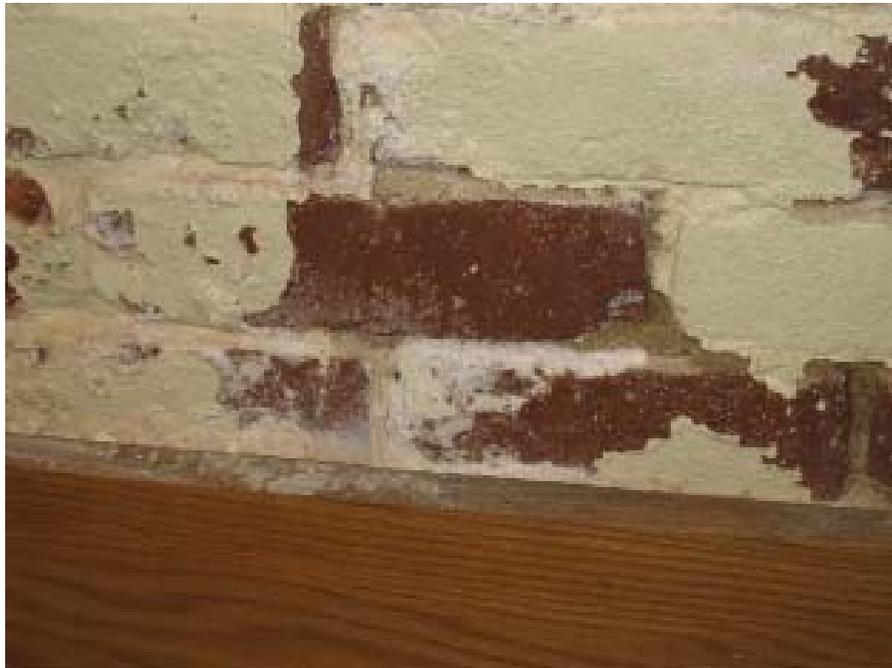
**Picture 24**

As previously mentioned, the painted brick areas on the ground floor exhibited evidence of water penetration (Picture 24). This has, in turn, resulted in some paint peeling/chipping off the brick. Prior to conducting any repainting of those surfaces, it would be prudent to determine if the paint is lead based.

**Peeling Paint on Bricks**
