# **INDOOR AIR QUALITY ASSESSMENT**

**Massachusetts Emergency Management Agency  
Region 3 and 4 Office  
1002 Suffield Street  
Agawam, Massachusetts**

Prepared by:  
Massachusetts Department of Public Health  
Bureau of Environmental Health  
Indoor Air Quality Program  
April 2010

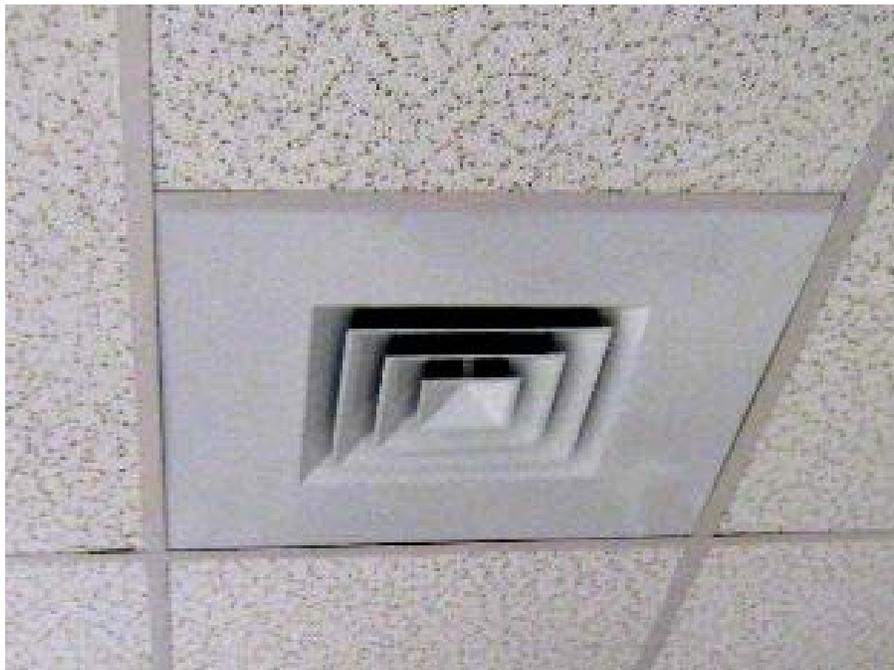
**Picture 2**

Fresh air is supplied to each room by means of ducted air diffusers. Fresh air is drawn by a duct on the roof to an air handling unit (AHU) located in a mechanical room, air is returned via ducted exhaust vents (Pictures 2 and 3). BEH staff were informed that the HVAC system is not always in operation while the MEMA offices are occupied. BEH staff could not confirm this fact as they did not have access to the roof during the assessment.

**Fresh Air Supply**

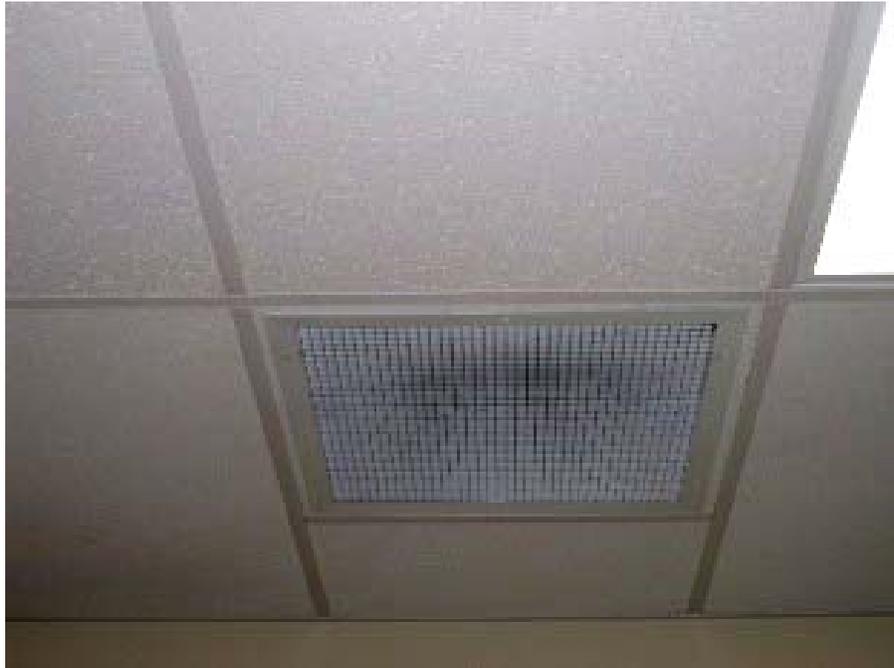
**Picture 3**

**Return Vent**

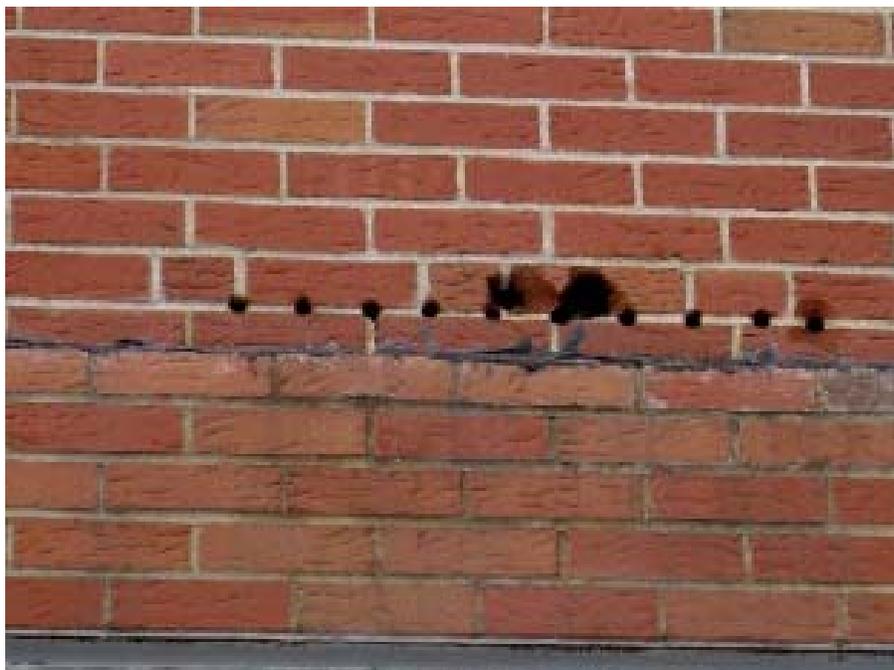
**Picture 4**

- A number of holes were observed in exterior brick (Picture 4).
- A cracked pane of glass was seen in a window (Picture 5).
- Downspouts terminate in close proximity to the building. In addition to causing erosion of soil along the foundation, moisture adjacent to the building can eventually penetrate

The aforementioned conditions represent potential water penetration sources. Over time, these conditions can undermine the integrity of the building envelope and provide a means of water entry into the building via capillary action through foundation concrete and masonry (Lstiburek & Brennan, 2001). In addition, these breaches may provide a means for pests/rodents to enter the building.

**Exterior Wall Holes**

8. Seal holes/breaches in exterior brickwork.
  9. Extend downspouts to drain water away from the foundation.
  10. Remove plants/vegetation from along the foundation.

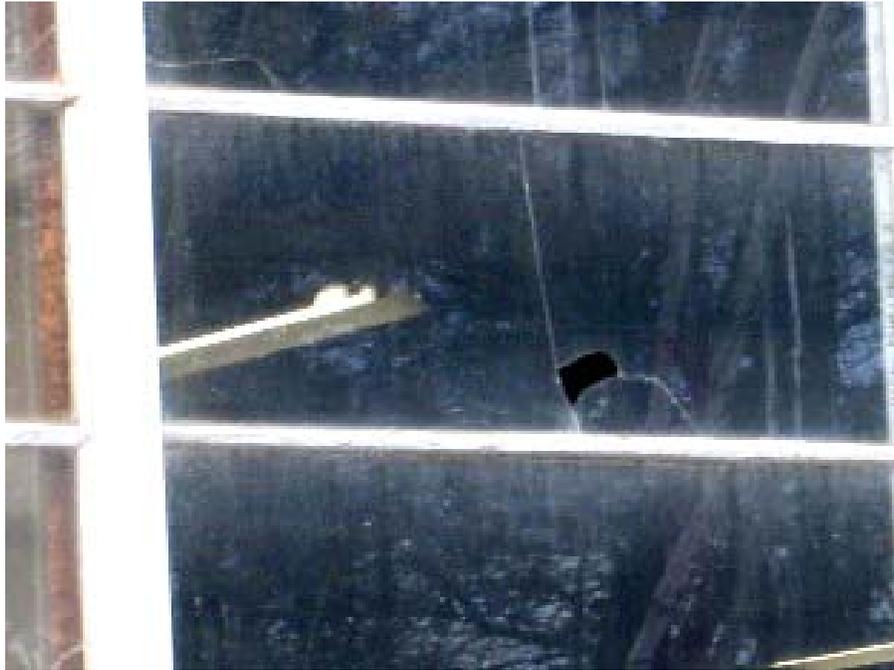
**Picture 5**

**Broken Window Panes**

6. Monitor areas of the building for roof/plumbing leaks, make repairs and change water damaged ceiling tiles as necessary.
  7. Repair/replace broken window panes.

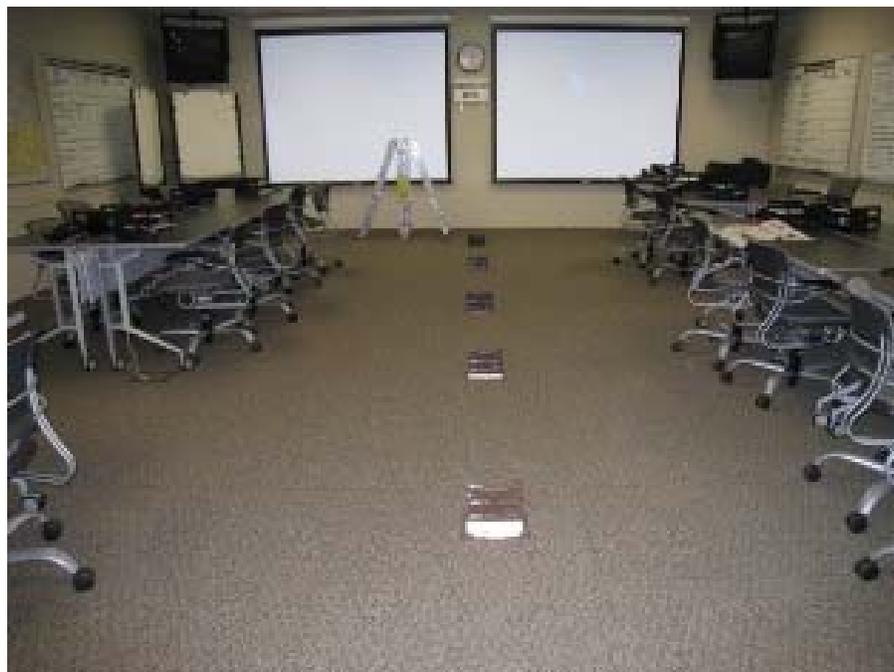
**Picture 6**

Outdoor ultrafine particulate concentrations were measured at 7,000 pt/cc. Ultrafine particulate levels measured inside the building ranged from 7,000 to 22,000 pt/cc at floor level. The highest reading was found in the EOC. The EOC contains a raised floor (called a plenum floor system) that is used typically in rooms with computers to aid in the installation of electrical outlets and other cables. The EOC has a number of electrical outlets installed in the floor (Picture 6). Each outlet housing has a number of holes which are open to the floor plenum (Picture 7). The highest ultrafine particle counts were obtained at the outlet openings, which indicates that the most likely source of vehicle exhaust odor is garage pollutants entering the floor plenum through breaches that exist in the shared wall between the EOC and garage. BEH staff also removed ceiling tiles in the EOC and detected a cold draft of air emanating from the ceiling plenum, which indicates that the ceiling plenum is pressurized. This is unusual since ceiling plenums are usually depressurized (if part of the HVAC system) or neutral pressure to occupied space. This draft indicates cold air penetration through the shared wall above the ceiling. This observation is supported by the finding of elevated ultrafine particle readings in the ceiling plenum (Table 1). Areas with higher ultrafine particle counts also had higher levels of carbon monoxide.

**Electrical Outlets in False Floor**

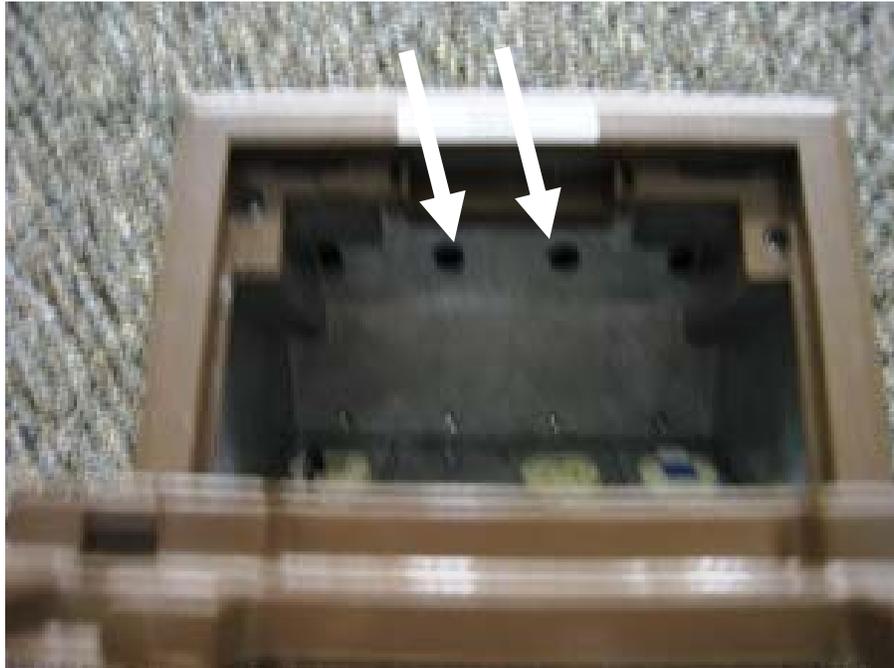
**Picture 7**

**Holes in Electrical Outlet Open to Floor Plenum**

- space, all breaches in the shared wall (e.g., utility holes, light switch holes, cracks, seams or crevices) must be identified and sealed on both sides to render the shared wall airtight.
