# **INDOOR AIR QUALITY ASSESSMENT**

**Department of Children and Families  
J.B. Blood Building  
20 Wheeler Street  
Lynn, Massachusetts**

Prepared by:  
Massachusetts Department of Public Health  
Bureau of Environmental Health  
Indoor Air Quality Program  
November 2010

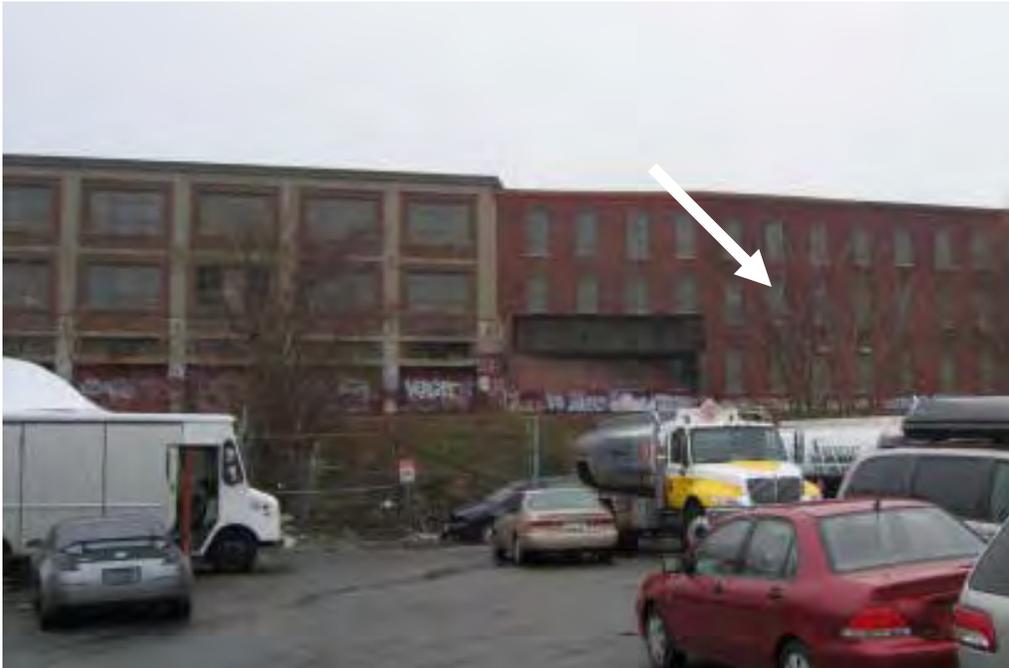
**Picture 1**

**Fresh Air Intake**

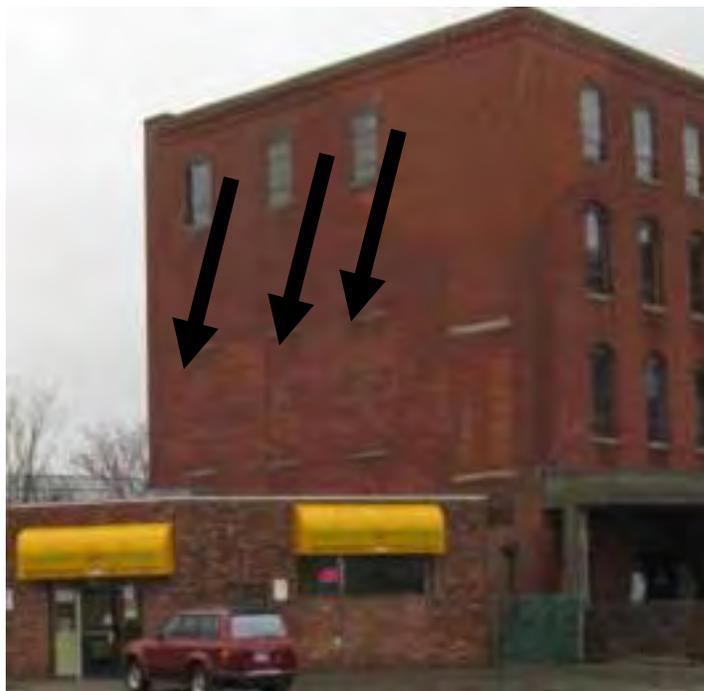
**Picture 2**

As with the previous MDPH assessment (MDPH, 2007), a distinct musty odor was detected in the hallway for rooms 1 to 14. The odors are attributed to water penetration through the exterior brick wall of rooms 1 and 2 (Picture 2). Water penetration through brick was identified in the area director's conference room and private office in the previous DPH IAQ assessment (MDPH, 2006). On April 9, 2010, the greater Lynn area was subjected to a wind driven rainstorm with 3 to 12 mile per hour (mph) wind speed (Weather Underground, 2010). At the time of the 2010 MDPH assessment, the walls in room 1 and 2 appeared to be moist (Pictures 3 and 4), and was confirmed by moisture sampling. It appears that moisture readily penetrates through the brick exterior wall and accumulates beneath the raised tile floor. This moisture accumulation wets building material and likely causes mold colonization of flooring materials. Odors are also drawn into the HVAC system into the hallway, resulting in odors migrating to other areas. BEH conducted moisture sampling in offices with exterior walls and found the plaster walls of Rooms 20 to 24 to have detectable moisture concentrations (Picture 5), whereas all other offices had no measurable moisture levels. The walls of rooms 1, 2 and 20 to 24 all appeared to be on the windward side of the building

**Brick-In Windows, Rooms 1 And 2**

1. Consider removing carpeting from areas 1 and 2 until water leakage through exterior walls is remedied.
2. Remove carpeting approximately 1 to 2 feet from exterior walls. Disinfect floor beneath carpet with an appropriate antimicrobial agent, clean and dry. Consider replacing carpet with tile or other non-porous floor material. Carpeting should be removed in a manner consistent with recommendations in “Mold Remediation in Schools and Commercial Buildings” published by the US EPA (2001), which is available from their website: [http://www.epa.gov/iaq/molds/mold\\_remediation.html](http://www.epa.gov/iaq/molds/mold_remediation.html).

8. Consult a building engineer concerning the best method for reducing water penetration through exterior walls, particularly in areas with bricked-in windows.

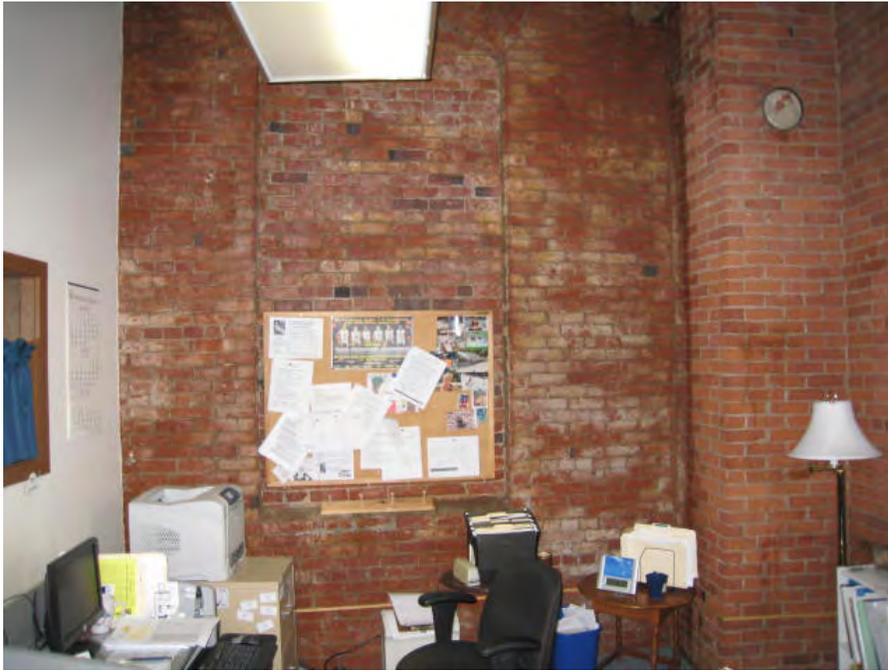
**Picture 3**

Missing/damaged mortar and efflorescence were also observed in Rooms 1 and 2 (Picture 6). Efflorescence is a characteristic sign of water damage to brick and mortar, but it is not mold growth. As moisture penetrates and works its way through mortar and brick, water-soluble compounds in mortar and brick dissolve, creating a solution. As the solution moves to the surface of the mortar or brick, the water evaporates, leaving behind white, powdery mineral deposits. Of note is a framed wall hanging with rippling paper, which is a telltale sign of moisture exposure (Picture 7). Water damage observed on a bulletin board hanging on a wall in room 1 is also likely the result of moisture exposure (Picture 3).

**Moist Wall, Room 1, Note Efflorescence, Bricked-In Windows and Bulletin Board**

3. Refrain from hanging pictures or placing materials capable of supporting mold growth (e.g., paper, cardboard, etc.) in contact with the exterior walls in all offices.

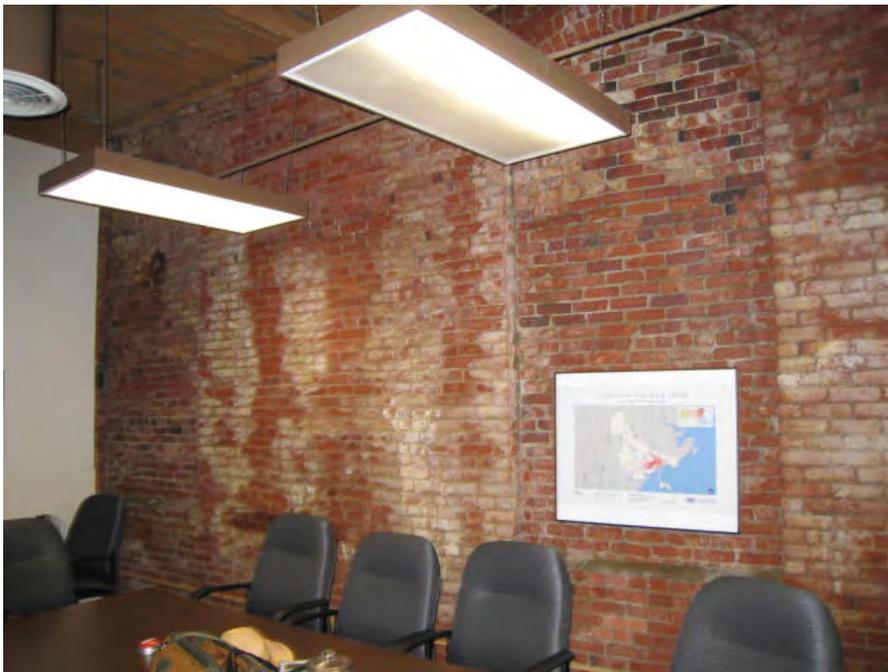
**Picture 4**

**Moist Wall, Room 2, Note Efflorescence and Bricked-In Windows**

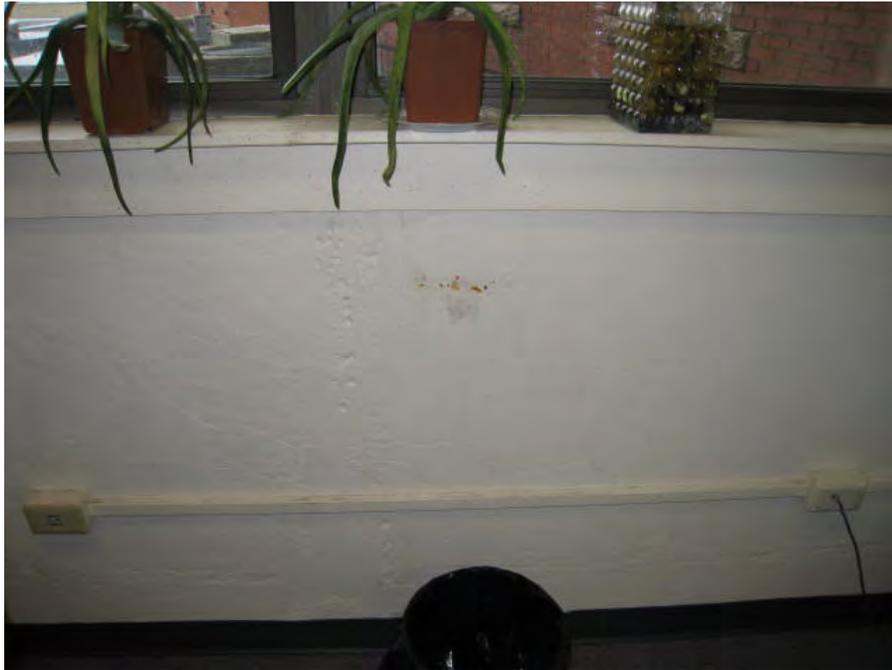
**Picture 5**

**Moist Low Wall, Room 20**

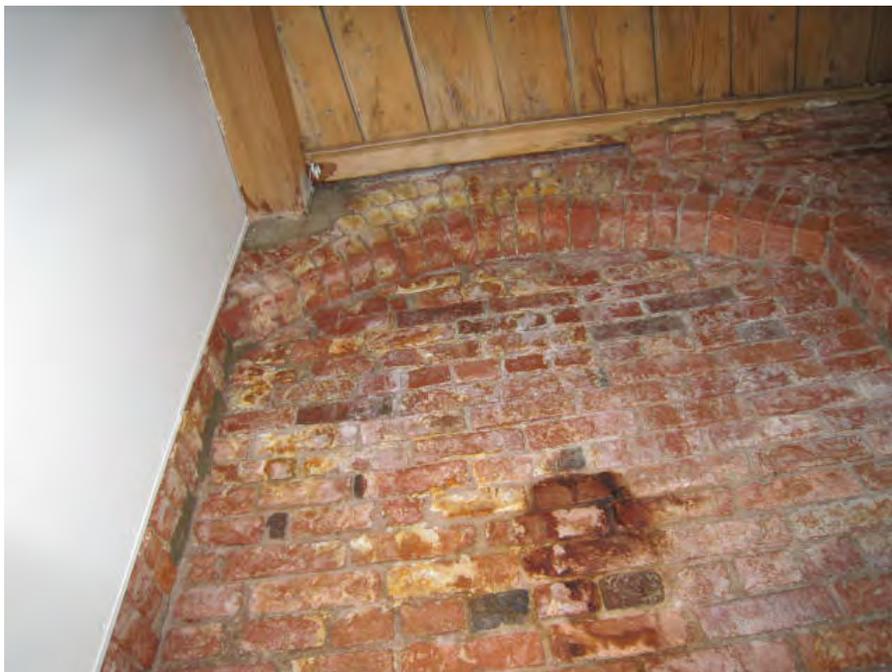
**Picture 6**

**Efflorescence and Wet Spot in Room 2**

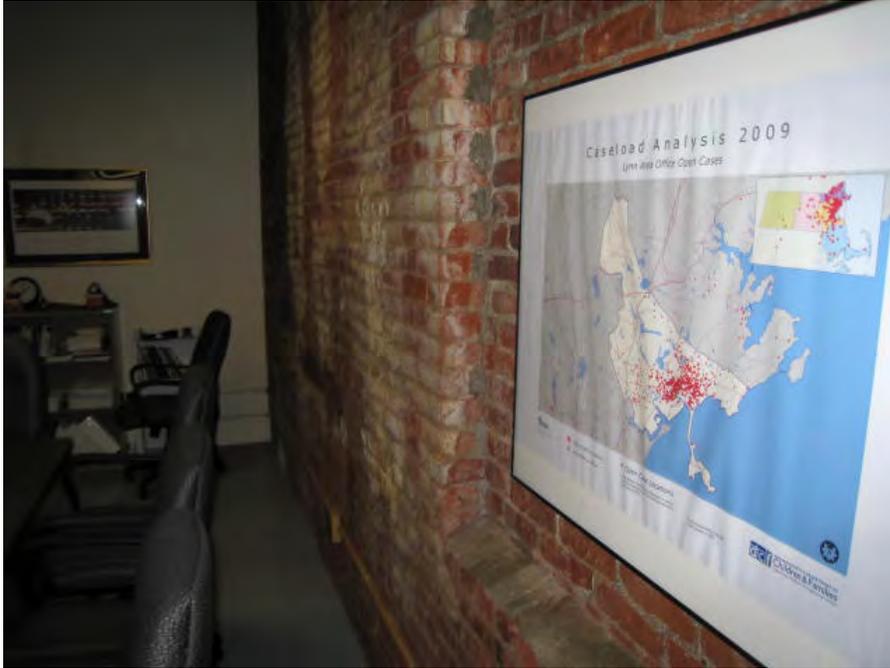
**Picture 7**

**Rippled Framed Materials, Indicative of Water Vapor Exposure**

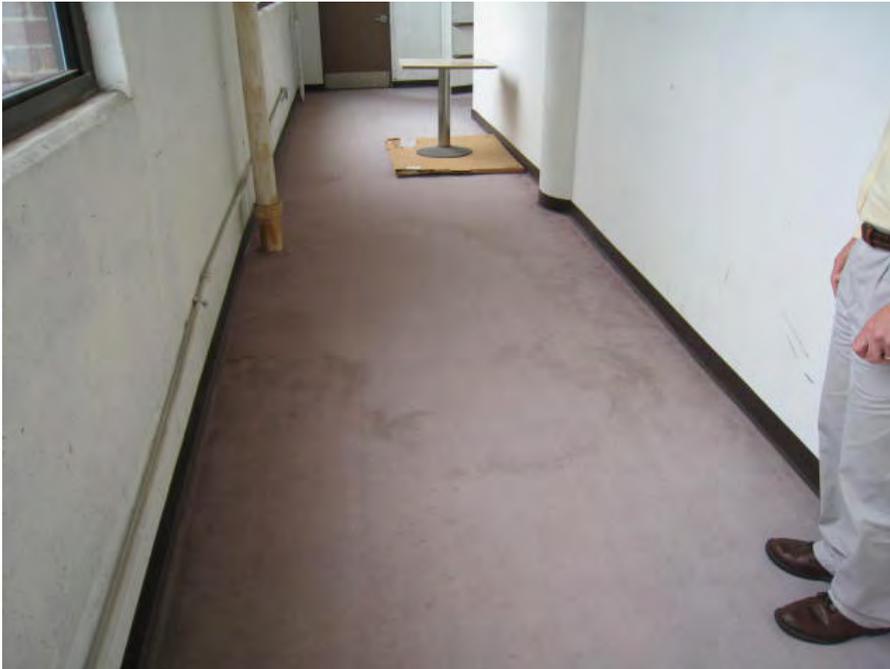
**Picture 8**

Water-damaged carpeting was noted in an unconditioned hallway adjacent to the DCF offices (Picture 8), this water damage is likely the result of leaks from roof drain pipes in the hallway. Water stained ceiling tiles were observed in some rooms, notably in the reception area. This building was constructed in a manner to have successively receding stories, creating a series of short roofs over occupied areas. Water damage in the reception is in line with a roof/wall junction that is above the reception area (Picture 9). Under certain wind conditions, it is likely that rain penetrates through the junction as well as exterior wall openings above room 26.

**Water Damaged Carpeting In A Hallway Adjacent To The DCF Offices**

4. Move furniture and book shelves away from exterior walls to allow airflow/drying.
5. Remove water-damaged carpet from hallway in Picture 9. Repair drainpipes.

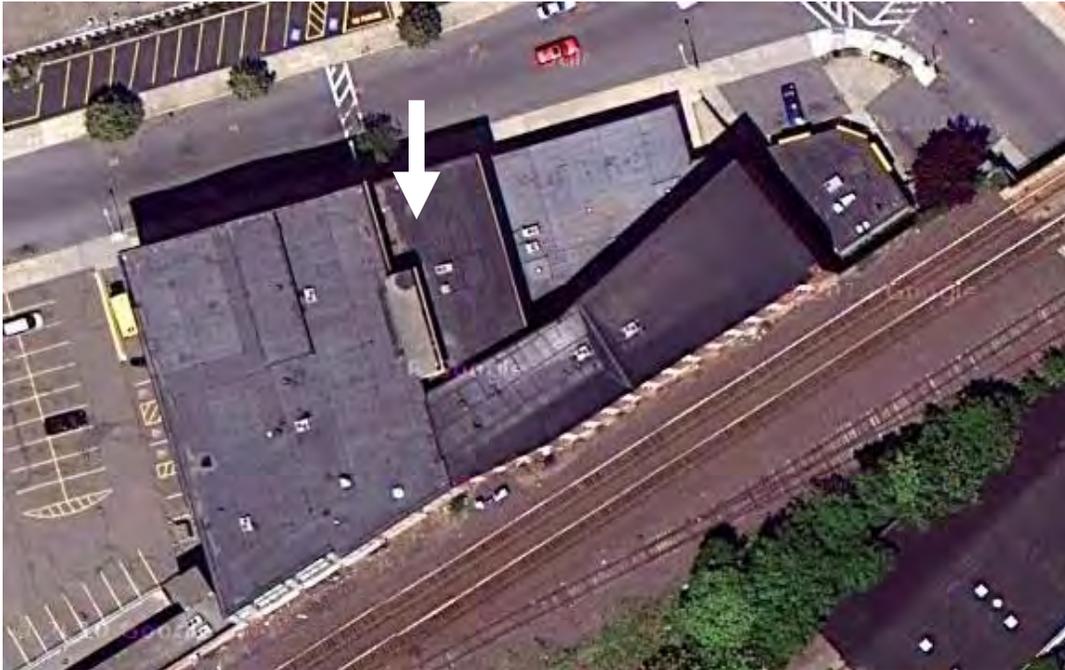
**Picture 9**

**Arrow Indicates Location of Roof above DCF Reception**

6. Examine the exterior wall/roof junction above the reception area and repair as needed.
7. Consult a building engineer concerning the best method for rendering window frames and windowsill water-tight to prevent moisture penetration.

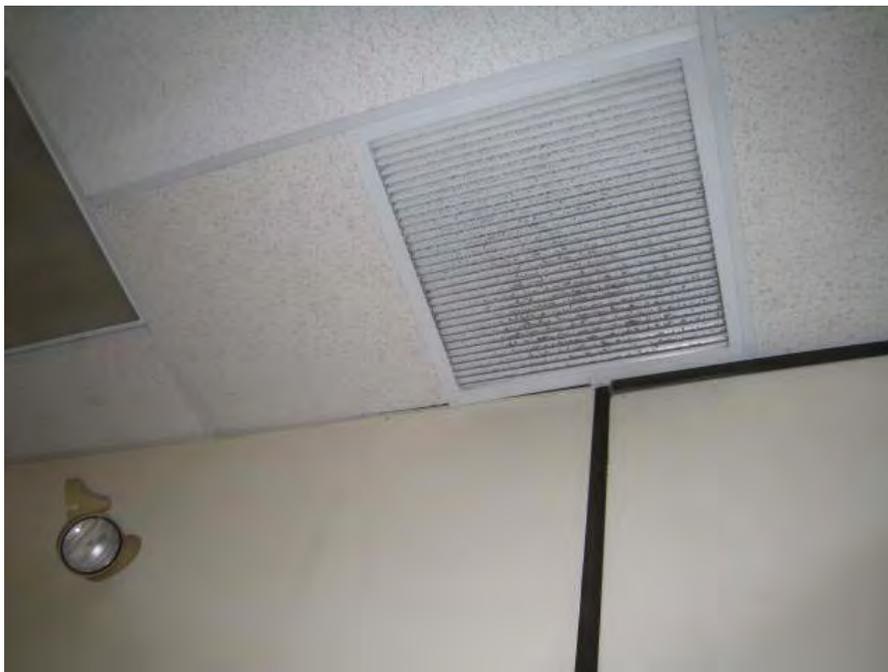
**Picture 10**

A number of supply and return/exhaust vents throughout the DCF office space were accumulated dust (Pictures 10 and 11). If exhaust vents are not functioning, backdrafting can occur, which can re-aerosolize dust particles. Dust can also become aerosolized from supply vents when HVAC units are activated.

**Supply Vent Occluded with Dust**

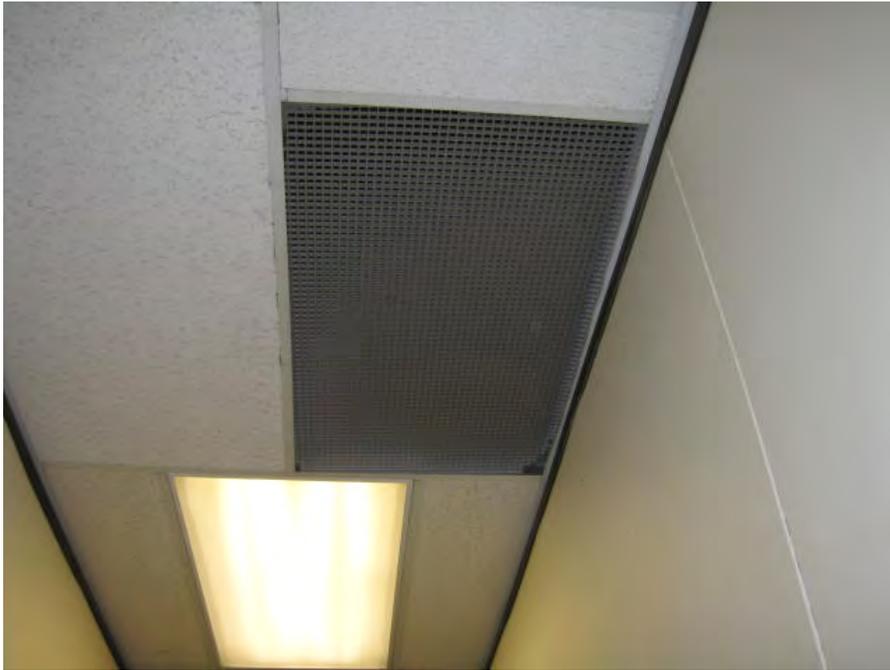
**Picture 11**

**Exhaust Vent Occluded with Dust**
