Mold/Water Damage Investigation

**Broad Meadows Middle School
50 Calvin Road
Quincy, Massachusetts**

Prepared by:
Massachusetts Department of Public Health
Bureau of Environmental Health
Indoor Air Quality Program
November 2010

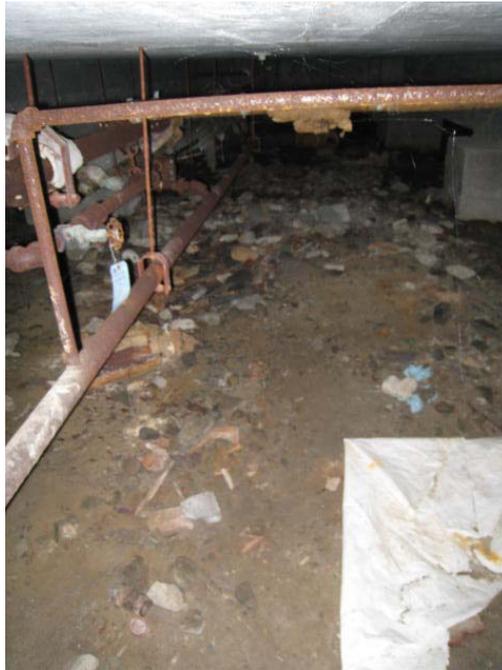
Picture 1

The ceiling of the band room office that reportedly had mold-colonization around its exhaust vent was examined by BEH staff. At the time of the visit, all ceiling paint had been removed down to the plaster surface and it was without viable signs of mold growth. Of note was a stale, musty odor in the area of the band room and adjacent hallway. After examining the hallway and exterior of the building around the band room, it was discovered that the school contains a dirt crawlspace that runs beneath the building (Picture 1). Designing a building with a dirt floor crawlspace in this area of Quincy presents a number of issues related to water

Dirt Floor Crawlspace beneath the Band Room Hallway

1. If no mechanical exhaust system for the crawlspace exists, consult with an HVAC engineering firm to examine the feasibility of a retrofit.
2. Examine the feasibility of enclosing the base of the elevator to prevent odor and water vapor migration into occupied space.
3. Consider installing an apron around the base of the band room wall to direct water away from the foundation.

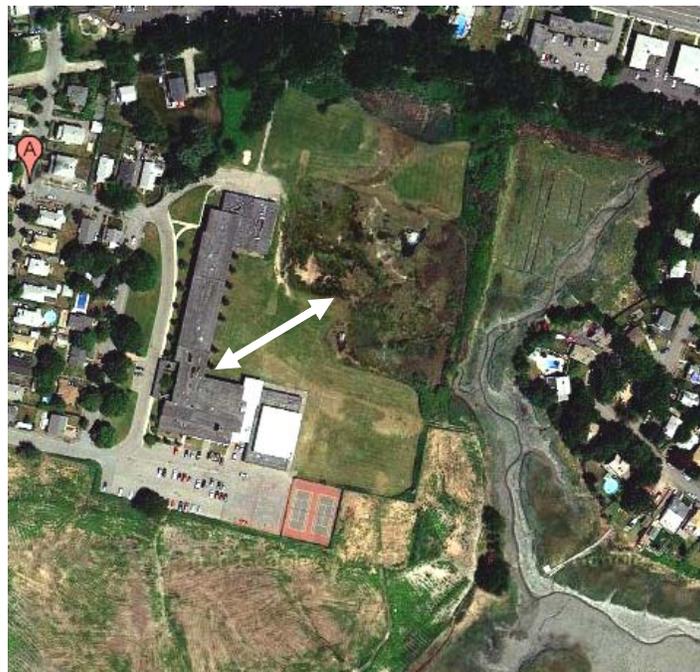
Picture 2

infiltration and associated odors. The band room is located roughly 200 feet from the edge of a salt marsh (Picture 2). At high tide, the depth of the crawlspace appears to be below the water level of the salt marsh; this likely results in the soil of the crawlspace becoming saturated due to tidal influence.

Broad Meadow Elementary School Located Within 200 Feet of Edge of Salt Marsh

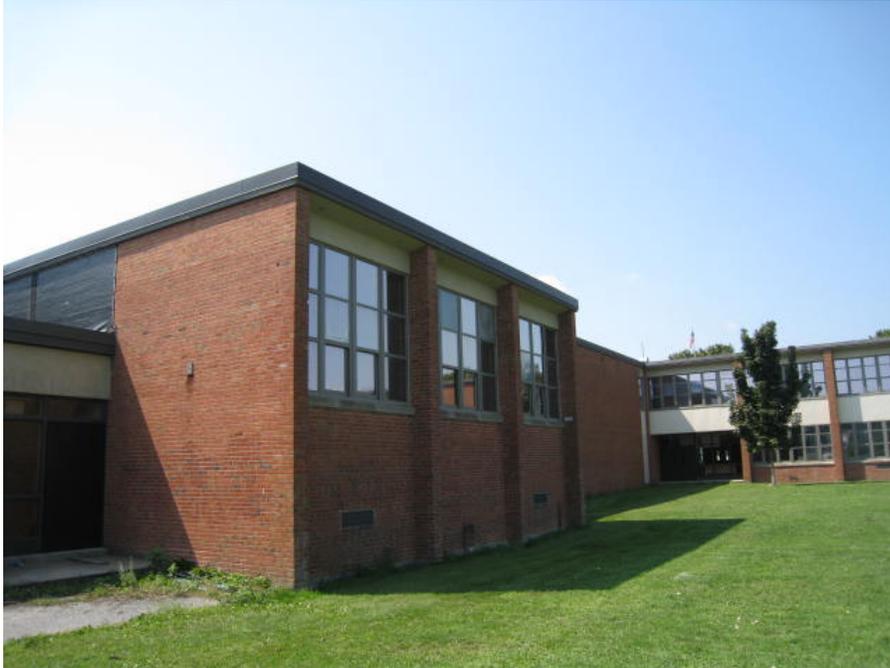
Picture 3

Other conditions also subject the crawlspace to water penetration (e.g. the design of exterior walls and surrounding landscape). The wall around the band room contains several inverted right angles (Picture 3), which would tend to direct rainwater *towards* the base of the exterior wall. No asphalt/cement apron exists at the base of the wall to direct rainwater *away* from its base. With meteorological condition involving southerly winds and driving rain, the wall of the band room would direct rainwater to the grass/soil adjacent to its foundation where it would readily be absorbed and penetrate into the crawlspace. The experience of BEH staff demonstrates that dirt floor crawlspaces are typically designed with a mechanical exhaust system to depressurize below grade areas to prevent odors from migrating into occupied areas above. No such system could be identified at the BMMS. Without a functional crawlspace exhaust system, mechanical ventilation systems in above spaces (e.g., band room office exhaust vent), can draw odors and water vapor from the dirt floor crawlspace.

Band Room Exterior Wall with Right Angles Facing Inward

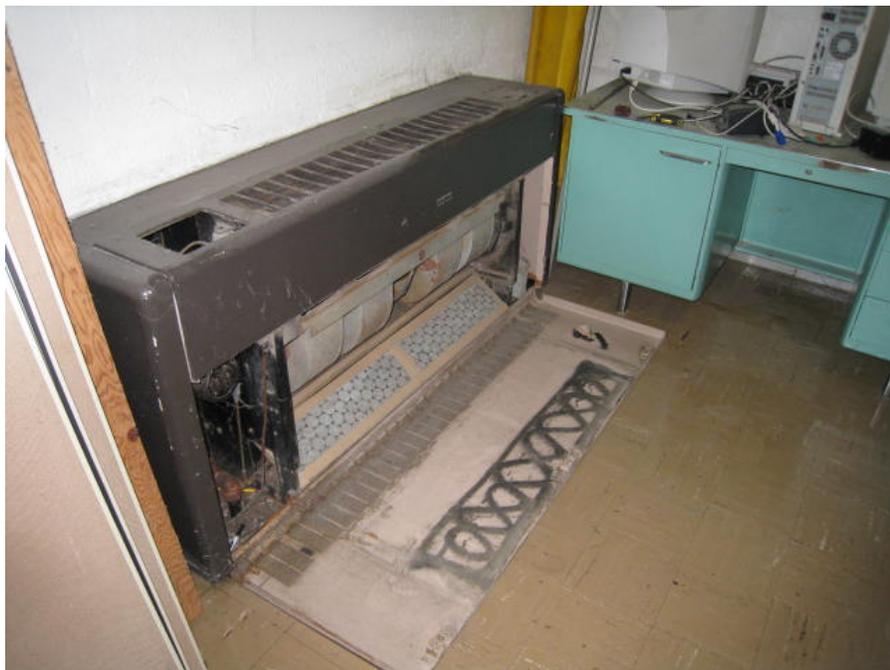
Picture 4

- The band room contains two unit ventilators (univents) (Picture 4). Within the cabinet floors of the univents were utility holes through which heating pipes pass (Picture 5).

Band Room Univent

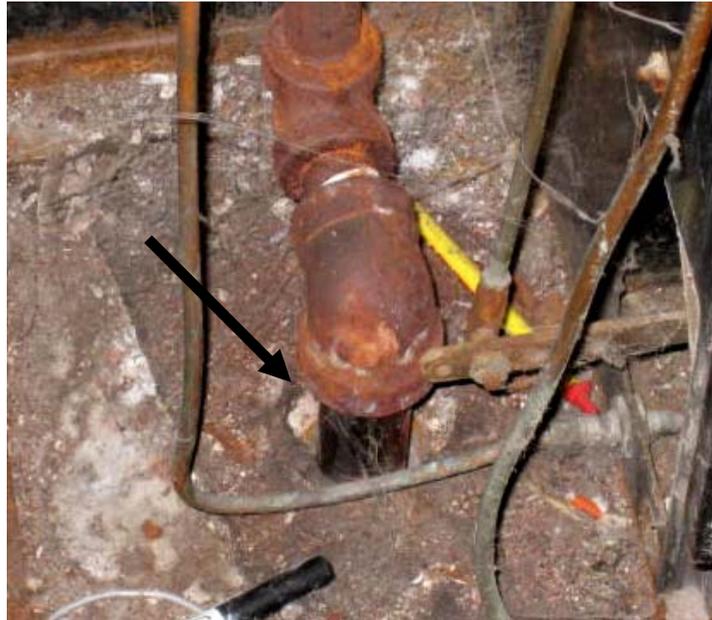
Picture 5

The diameter of the hole in the floor is larger than the diameter of the heating pipe, which

allows for odors and water vapor to be drawn from the crawlspace and distributed into the band room via the univent.

Utility Holes around Pipes in the Floor of Univent Cabinets Allowing Communication between First Floor and Dirt Crawlspace

2. Seal open utility holes around pipes in univent cabinets using a fire rated expandable foam.
3. Seal the holes and other penetrations in walls of the elevator mechanical room with a fire rated expandable foam.
4. Install weather-stripping around the frame and a door sweep at the bottom of the door of the elevator mechanical room to make door/frame as airtight as possible.
5. Ensure that the exhaust fan inside of the elevator mechanical room is operating during periods of school occupancy.
6. Repair/replace crawlspace access hatch to render as airtight as possible.
7. Identify whether a crawlspace exhaust system exists and operate as designed, make repairs as needed.
8. Ensure leaks are repaired and repair/replace water-damaged wooden box in elevator mechanical room.

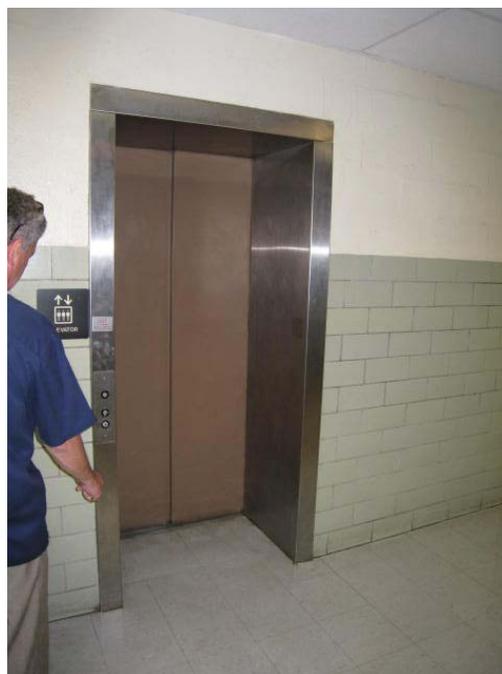
Picture 6

- Outside the band room is an elevator that appeared to have been installed after the initial construction of the building (Picture 6). When an elevator is retrofitted into a building, a base with solid walls (typically cement block) is customarily built to form the bottom of the elevator shaft. This provides fire protection and prevents debris from the area below the elevator entering occupied areas. No such structure appears to exist below the elevator (Picture 7). Without a walled elevator shaft in the crawlspace, odors, dirt/debris and water vapor can readily enter the elevator shaft and be distributed into the hallway, as well as the elevator mechanical room.

Retrofitted Elevator in Hallway

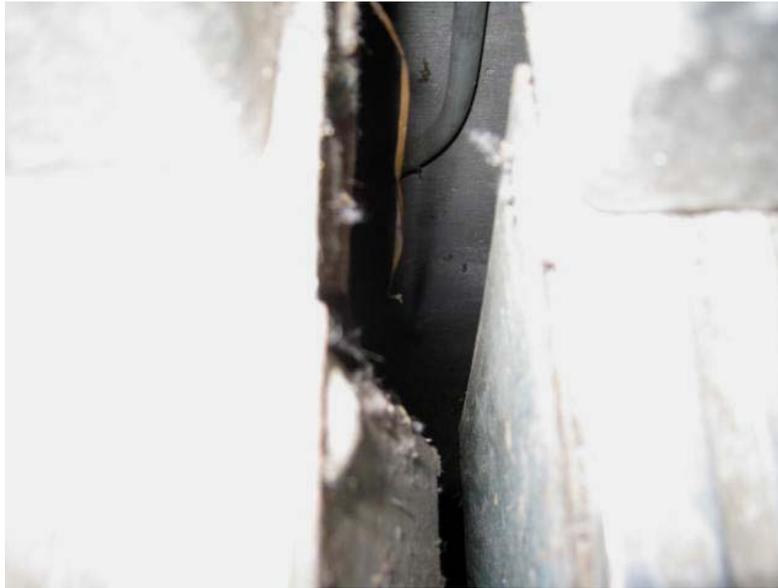
Picture 7

View between Elevator Car and Hallway Floor into Crawlspace

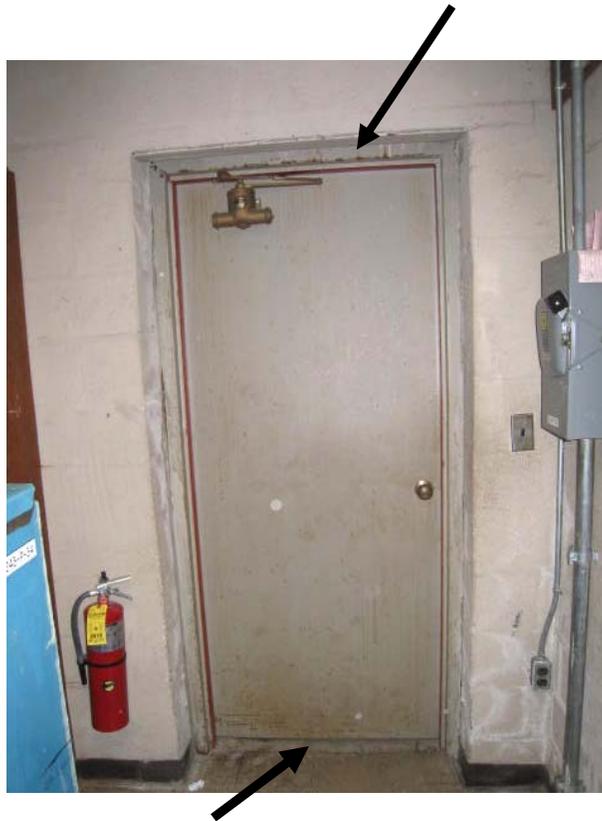
Picture 8

- The door to the mechanical room has a number of spaces around its frame (Picture 8). These spaces allow for odors and water vapor to be drawn into the band room by the exhaust vent in the office and operation of the univents.

Inside View of Elevator Mechanical Room Door in Band Room (Note Spaces around Door)

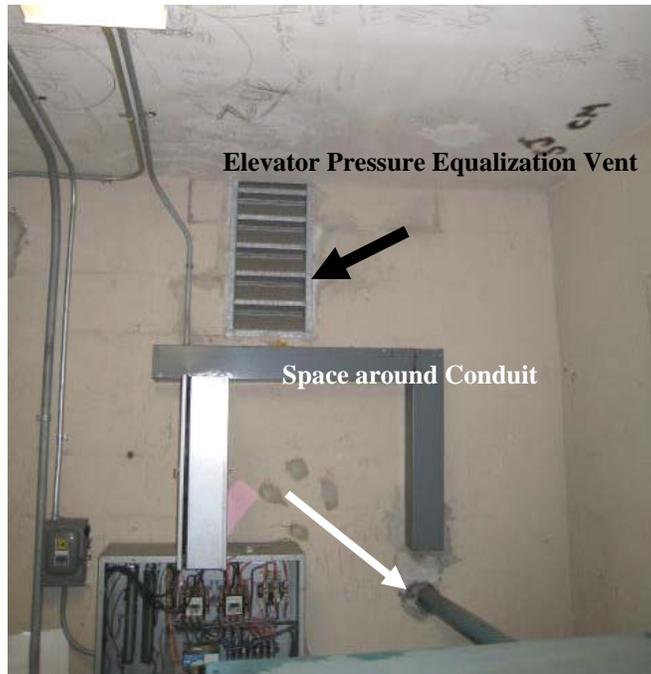
Picture 9

- The elevator mechanical room walls have a number of penetrations which open directly into the elevator shaft. As the elevator moves within its shaft, air can be drawn into the shaft and pushed out into the mechanical room through any breaches in the wall (Picture 9).

Openings in the Elevator Mechanical Room Wall Shared with Elevator Shaft

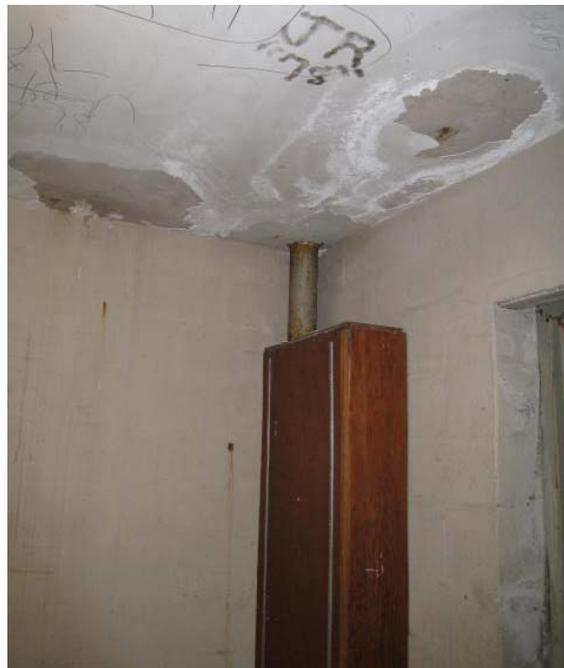
Picture10

It is also worthwhile to note that there is a roof drain pipe encased inside a wooden box in the elevator mechanical room (Picture 10). The wood around this drain pipe appears to be rotted from repeated water damage and can also provide a source of mold growth and odors.

Water-Damaged Wooden Box in the Elevator Mechanical Room
