MOLD/ODOR ASSESSMENT

**Monterey Library
452 Main Road
Monterey, Massachusetts**

Prepared by:
Massachusetts Department of Public Health
Bureau of Environmental Health
Indoor Air Quality Program
February 2011

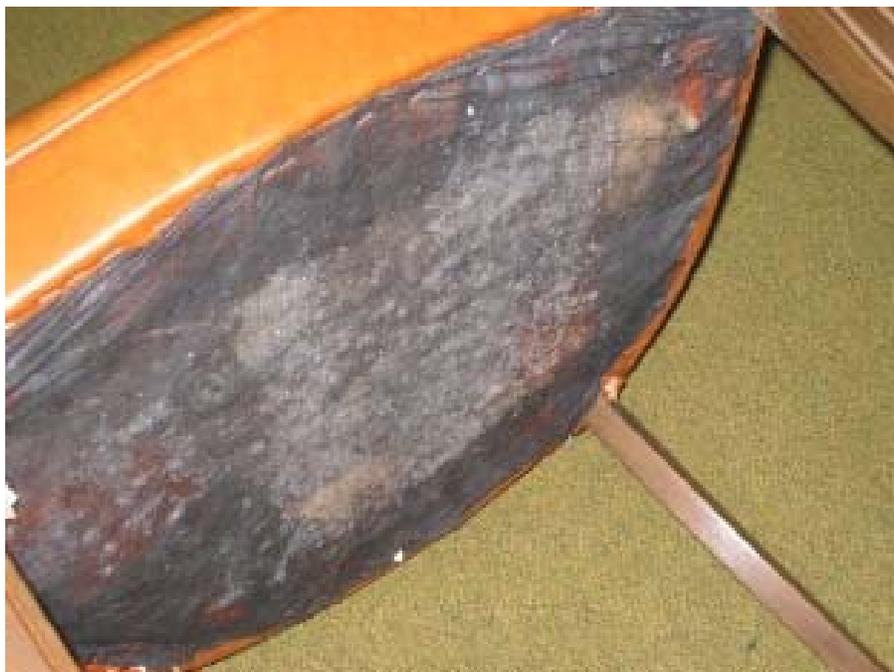
Picture 6

As previously stated, the primary concerns expressed were mold and odors associated with the Knox Wing (KW). In 1975, the wing was constructed for use by the local Historical Society as a museum (Picture 5). The museum was initially open to the public for approximately four hours a week. BEH was informed that over the years, it has remained closed for extended periods of up to two years. Upon entering the museum, a slight musty odor was detected. Mold colonization was observed on the underside of a chair stored in this area (Picture 6).

Mold Colonization on Underside of Chair

1. Remove and properly dispose of mold colonized chair from KW.
2. Examine stored materials in KW for evidence of mold colonization. If present, contact a document restoration firm to assess and/or remediate.

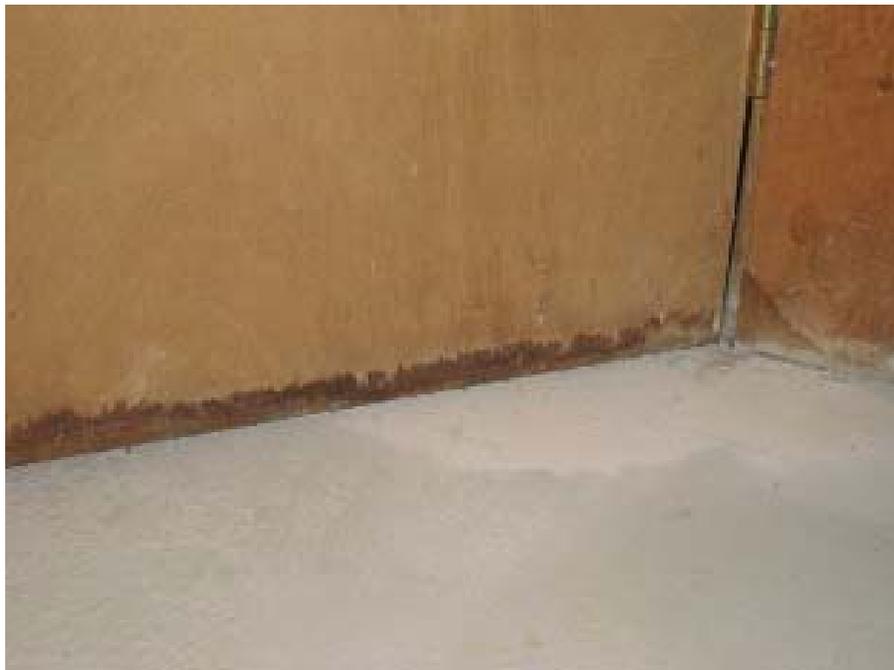
Picture 8

relative humidity coupled with condensation on dusty window panes could result in mold colonization. These windows should be thoroughly cleaned. Water damage was evident at the bottom of the entry door to the KW basement and to the adjacent door casing (Picture 8).

Evidence of Water Infiltration into Basement by Water Stains on Door and Door Casing

3. Consider removing carpeting in KW and installing a floor covering that is impervious to moisture.
4. Clean windows in KW.
5. Repair door to KW basement to eliminate water from entering the building.

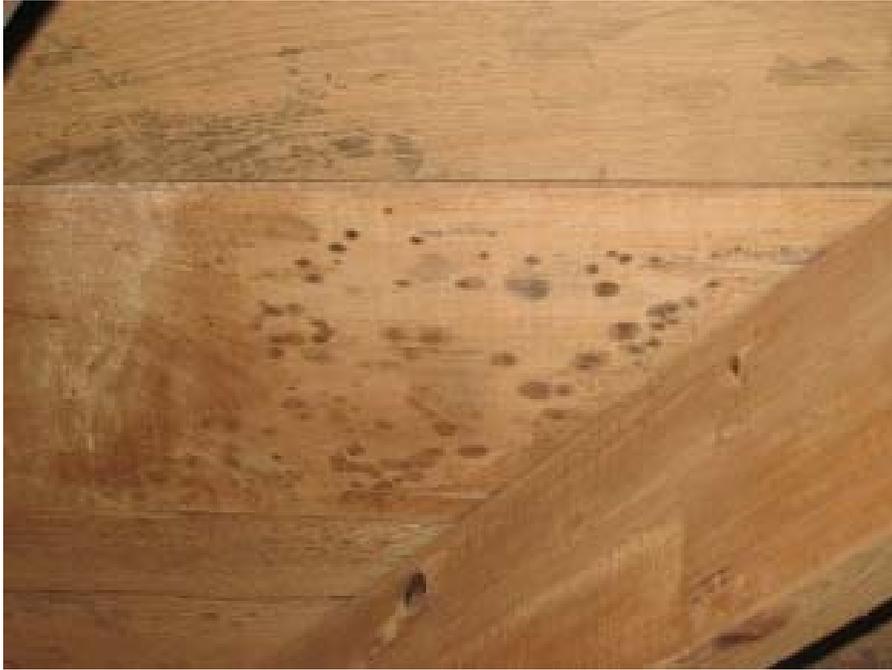
Picture 9

Dark staining, similar in appearance to mold colonization was observed on numerous floor joists and on the subfloor in the basement of the KW during the initial assessment (Picture 9). It was determined during the subsequent evaluation that the staining was likely due to the seepage of pitch from the wood itself rather than from mold colonization. Moisture content of selected basement floor joists and subfloors were measured with a Delmhorst Moisture Detector equipped with a Delmhorst Standard Probe. All areas tested were dry (Table 1).

Staining on Wood in KW Basement, Likely due to Seepage of Pitch

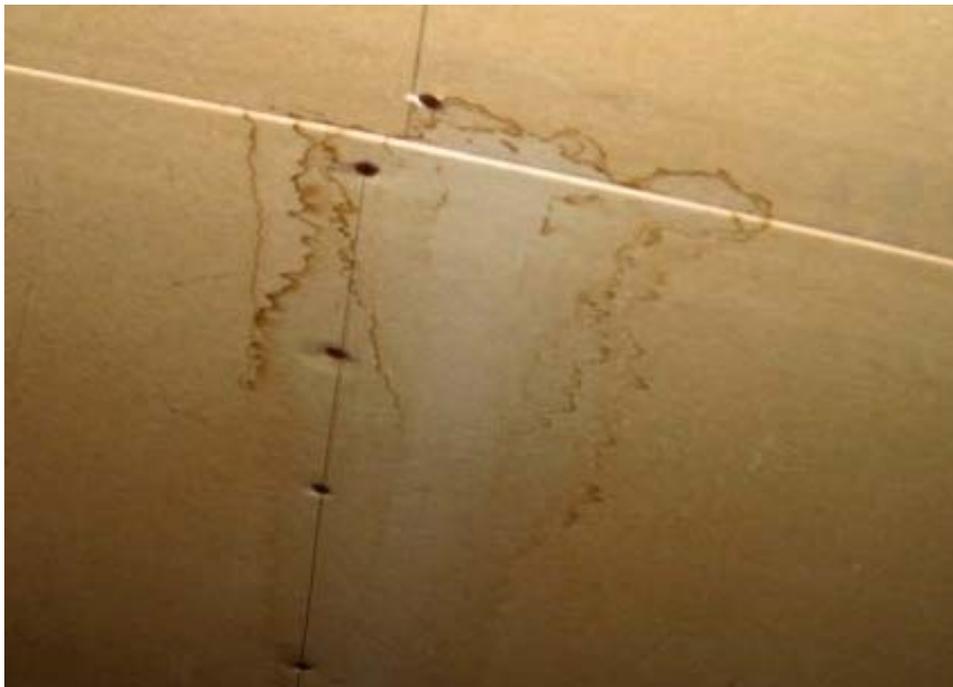
Picture 10

In the attic of the main library, water damage of gypsum wallboard (GW), a window frame, and the wood floor were observed (Pictures 10 and 11). On the first floor of the main library, gaps were observed on both sides of the fireplace flue. This can result in unconditioned air entering the library, potentially causing condensation to occur.

Water-Damaged GW in Attic

6. Repair any existing leaks and replace any remaining water-damaged gypsum wallboard (GW). Examine the area above GW for mold growth. Disinfect areas of water leaks with an appropriate antimicrobial, as needed.

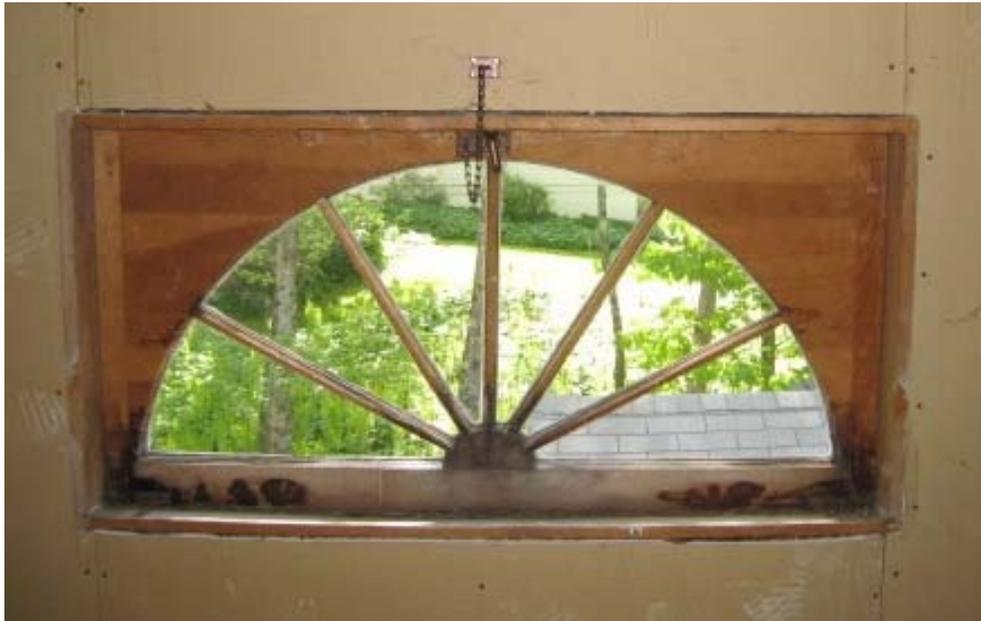
Picture 11

Water-Damaged Window

9. Repair/replace attic window as necessary to eliminate water infiltration.
10. Ensure chimney flue in fireplace of main library is properly closed/sealed.

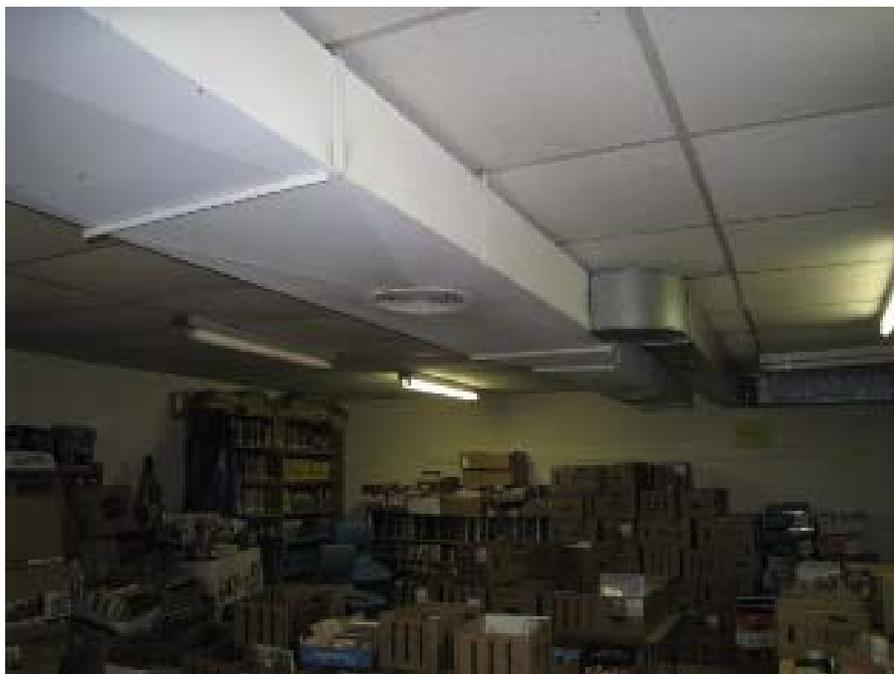
Picture 12

ML staff reported that seepage into the work room in the basement occurs on occasion. Stored boxes of books are placed on pallets to prevent damage from seepage (Picture 12). Despite this effort, water-damaged porous materials were observed in the area (e.g., magazines, cardboard boxes, Picture 13). Numerous porous materials were found stored in contact with the foundation wall, which may allow moisture to contact these materials.

Boxes of Books Stored in Workroom

7. Assess used books and all materials coming into the ML to ensure no water-damaged or mold colonized materials are brought into the building.
8. Ensure materials stored in workroom are not in contact with basement walls or floor.

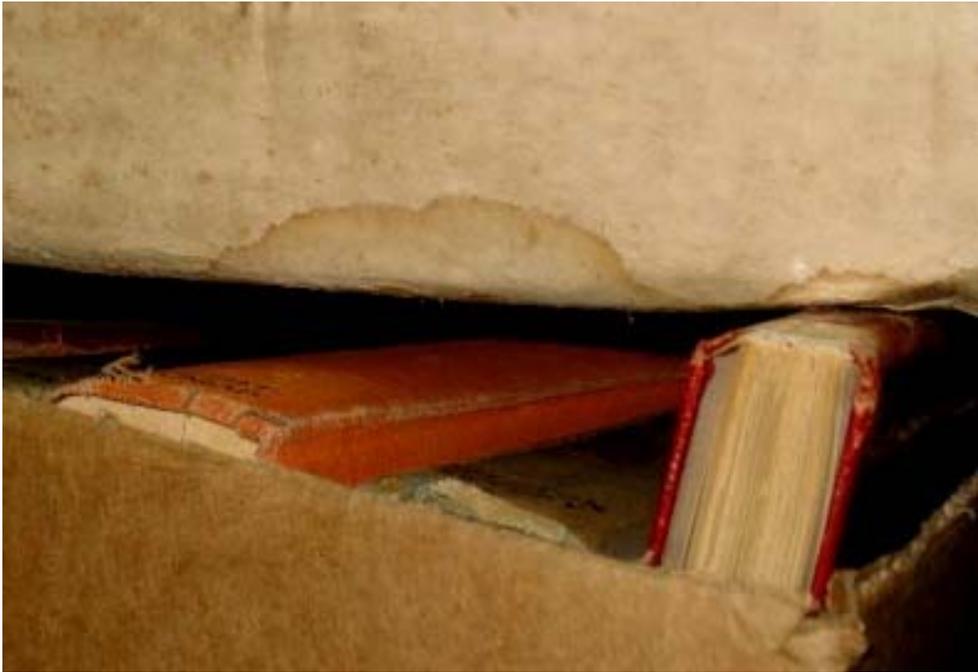
Picture 13

Water-Damaged Cardboard Box

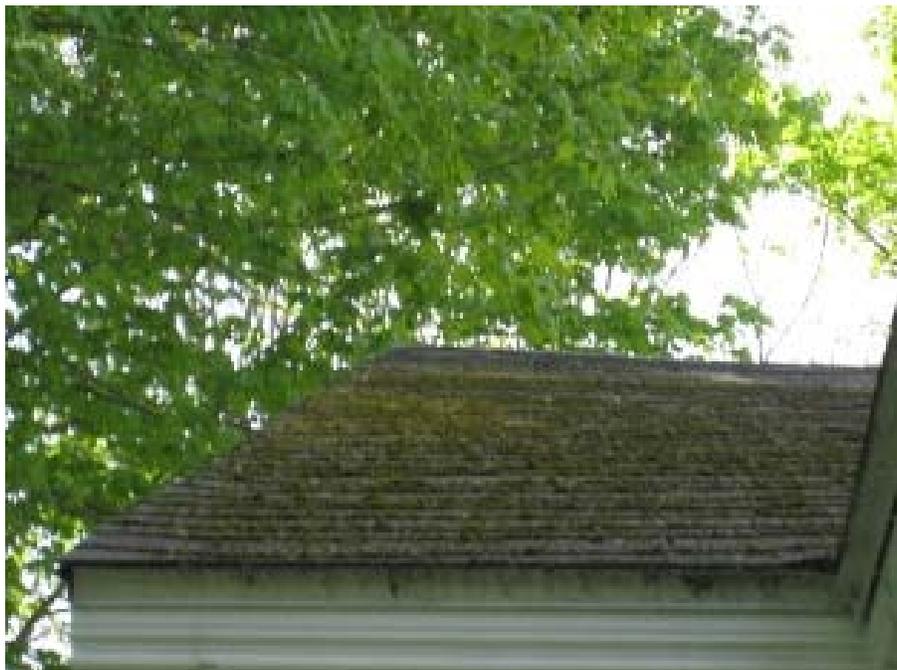
- Heavy moss growth was observed on the roof. The presence of moss shown in Picture 14 is indicative of repeated water exposure. In addition, moss hold moisture against the shingles which increases the potential for roof leaks;

- Plants, shrubs were located in close proximity to the building. Trees were observed providing shade over portions of the roof, likely contributing to the moss growth seen in Picture 14.

Heavy Moss Growth on Roof; Note Shade Provided by Tree

11. Repair/replace roof as necessary to eliminate leaks.
12. Design and install gutter and downspout system that will eliminate water from draining immediately adjacent to the foundation.

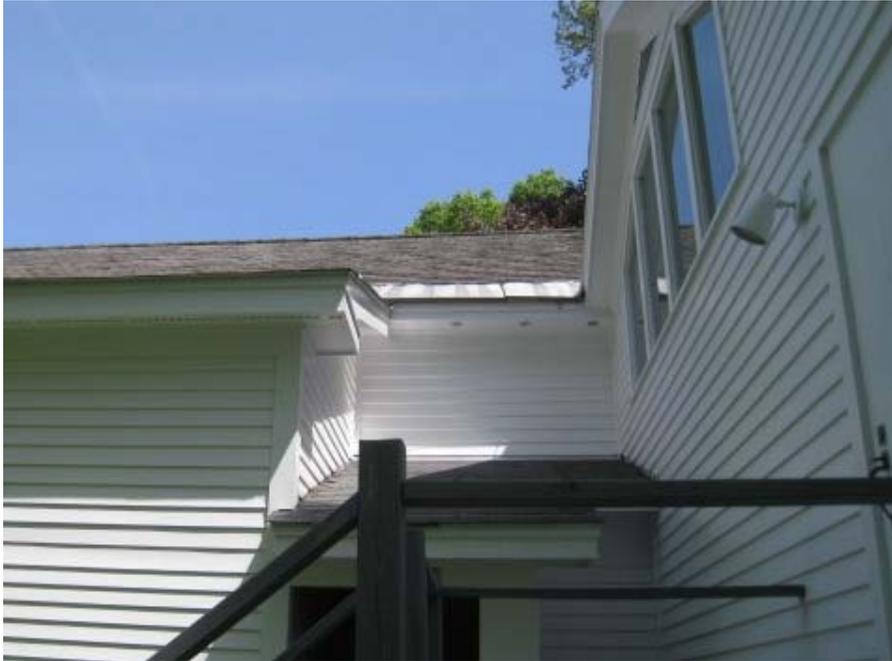
Picture 15

- Gutter and downspout system were missing from sections of the building. Several roof surfaces converge on the south side of the building and deposit water on the ground in close proximity to the foundation (Picture 15);

Lack of Gutters on Rear of ML
Results in Rain Deposition between ML and KW

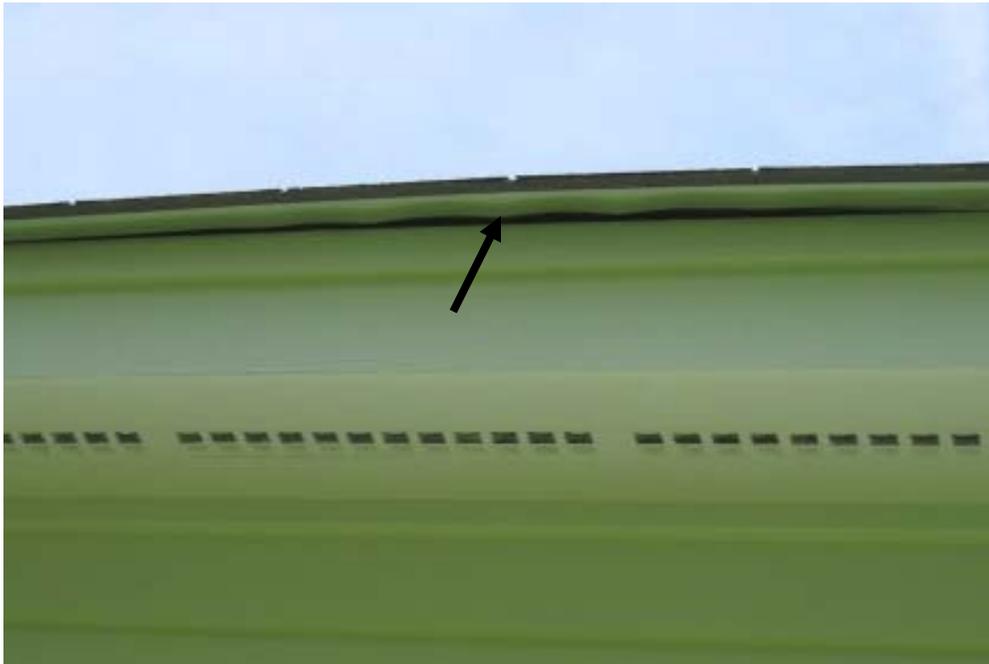
Picture 16

- A gap exists between the roof line and the soffit. In addition to moisture penetration, the gap is large enough to allow insects, bats or rodents access into the building (Picture 16);

Gap between Roof and Top of Soffit/Fascia Board (Arrow)

13. Repair sizable gap between roof line and soffit.
14. Repair cracked, broken mortar and loose flashing in chimney.

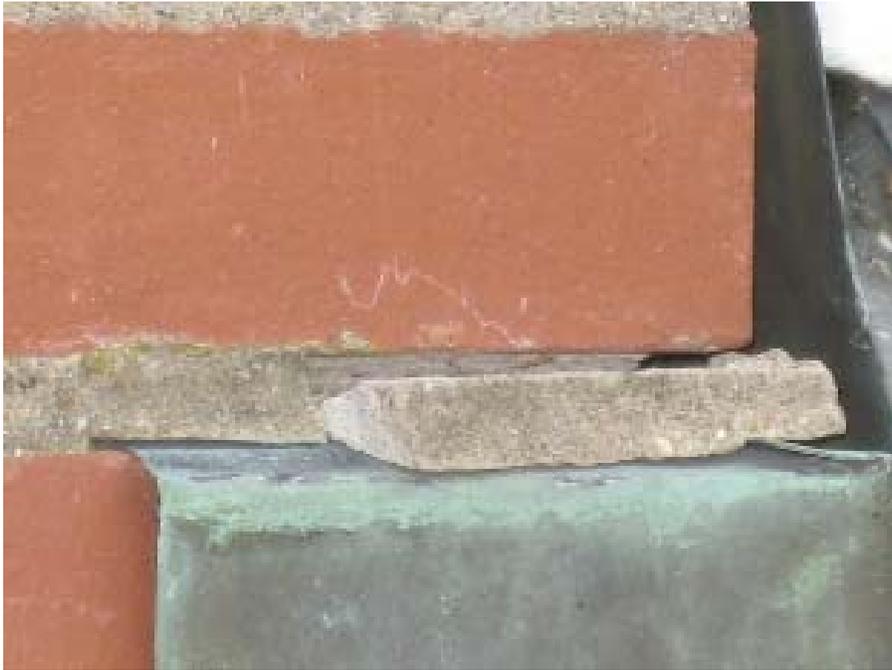
Picture 17

Cracked, Loose Mortar above Flashing

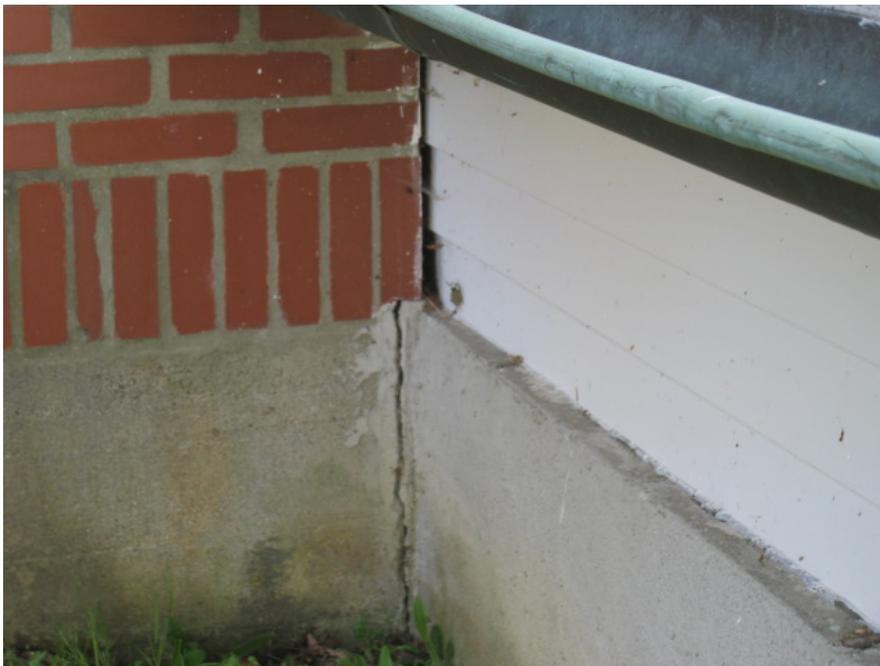
Picture 18

Crack in Foundation; Large Gap Between
Exterior Wall and Chimney

15. Seal cracks in foundation.
16. Seal open utility holes on exterior of building.
17. Ensure plants and shrubs are located at least five feet from the foundation. Consider trimming tree over KW roof.

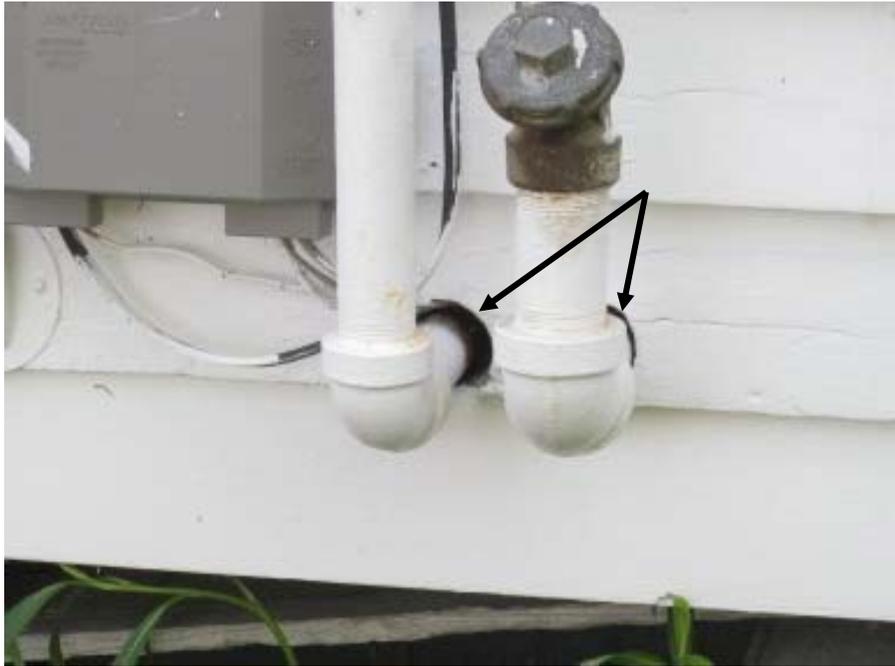
Picture 19

Open Utility Holes (Arrows)

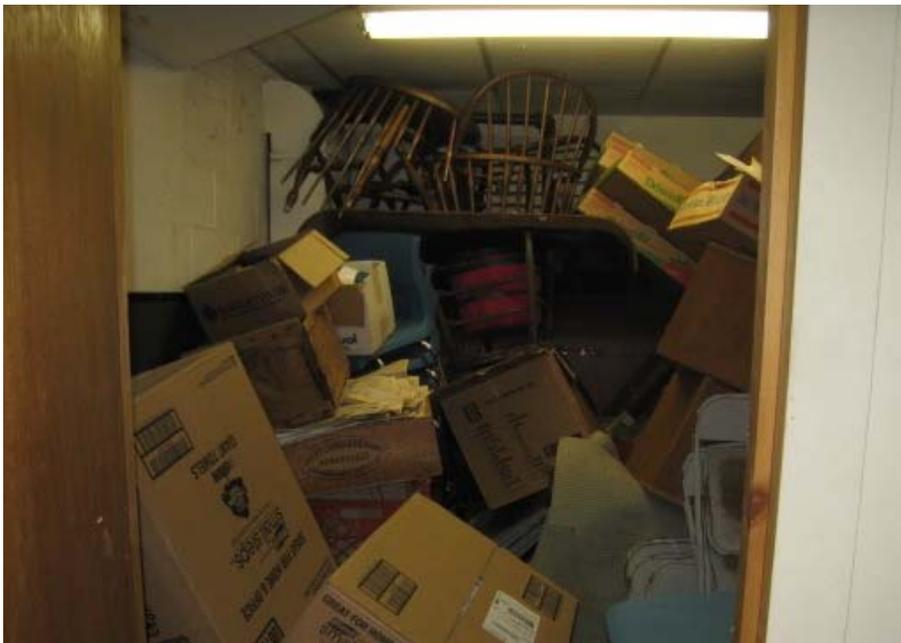
Picture 20

In the basement workroom and in the attic, items were observed on the floor, tabletops, book cases and in closets. The large number of items stored in these areas provides a source for dusts to accumulate (Picture 20). These items (e.g., magazines, books, boxes) make it difficult for staff to clean. Items should be relocated and/or be cleaned periodically to avoid excessive dust build up. In addition, these materials can accumulate on flat surfaces in occupied areas and subsequently be re-aerosolized causing further irritation.

Closet Off Basement Work Room Showing Clutter

19. Consider reducing the amount of materials stored in attic and basement to allow for more thorough cleaning of these areas. Remove items that are no longer in use. Clean items regularly with a wet cloth or sponge to prevent excessive dust build-up.
