INDOOR AIR QUALITY ASSESSMENT

**Norman E. Day School
75 East Prescott Street
Westford, Massachusetts**

Prepared by:
Massachusetts Department of Public Health
Bureau of Environmental Health
Indoor Air Quality Program
February 2011

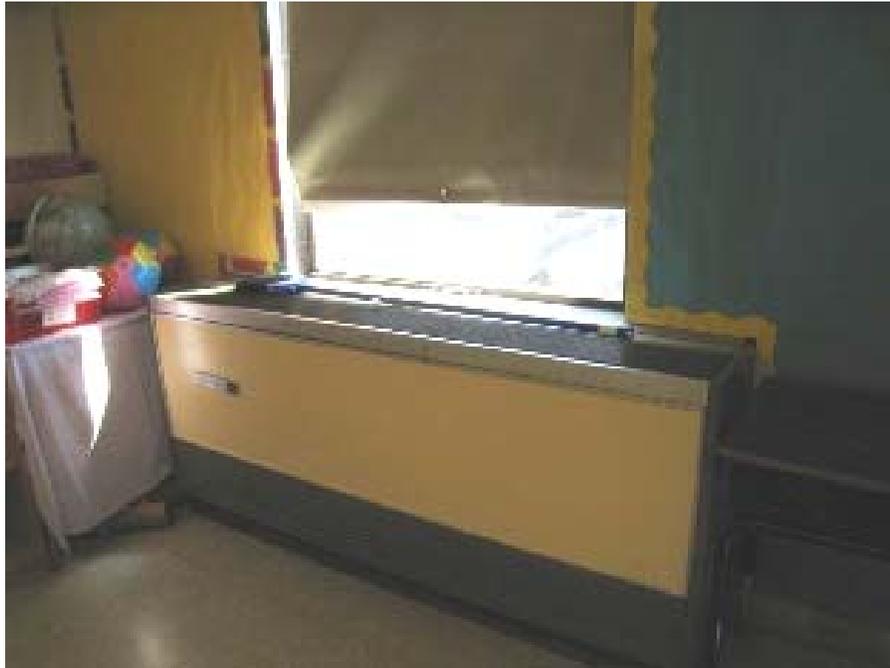
Picture 1

It can be seen from Table 1 that carbon dioxide levels were below 800 parts per million (ppm) in 37 of 46 areas indicating adequate air exchange in the majority of rooms surveyed (Table 1). Fresh air is introduced into classrooms by means of wall or ceiling-mounted unit ventilator (univent) systems ([Figure 1](#)). A univent draws air from the outdoors through a fresh air intake located on the exterior wall of the building and returns air through an air intake located at the base of the unit. Fresh and return air are mixed, filtered, heated and provided to classrooms through an air diffuser located in the top of the unit (Picture 1).

Unit Ventilator (Univent)

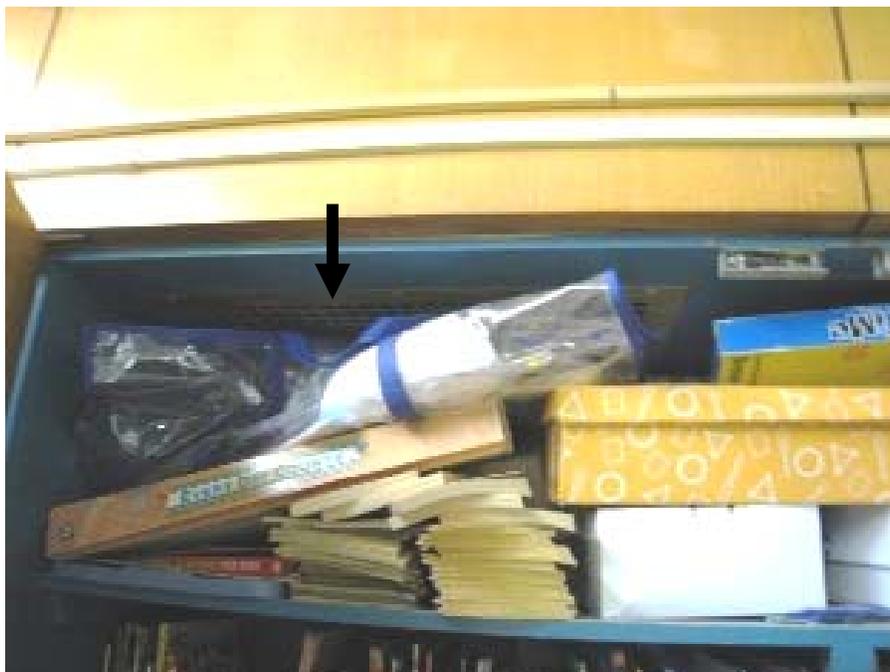
Picture 2

Stale air is removed from classrooms by either ducted ceiling mounted exhaust vents or vents that are located in coat closets (Pictures 2 and 3). Univents as well as exhaust vents were found to be obstructed and/or deactivated in a number of areas during the assessment. To function as designed, ventilation equipment must be free of obstructions (Picture 4). Importantly, these units must be activated and allowed to operate. If not activated, air can backdraft through exhaust vents into the building, depending on weather conditions. Drafts can also introduce any particulates that may have accumulated in the ducts into the building. Several closets were unable to be easily opened due to dry erase boards that had been mounted on their doors (Picture 5).

**Exhaust Vent in Closet (Arrow)
Note Exhaust is Obstructed with Stored Materials**

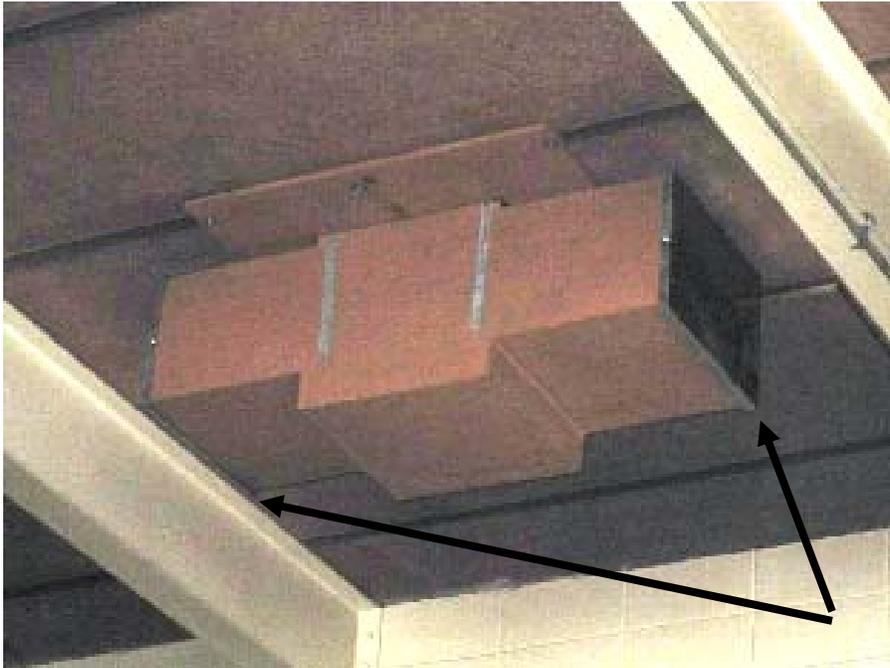
Picture 3

**Ceiling Mounted Exhaust Vent
Note Ends are Capped (Arrows)**

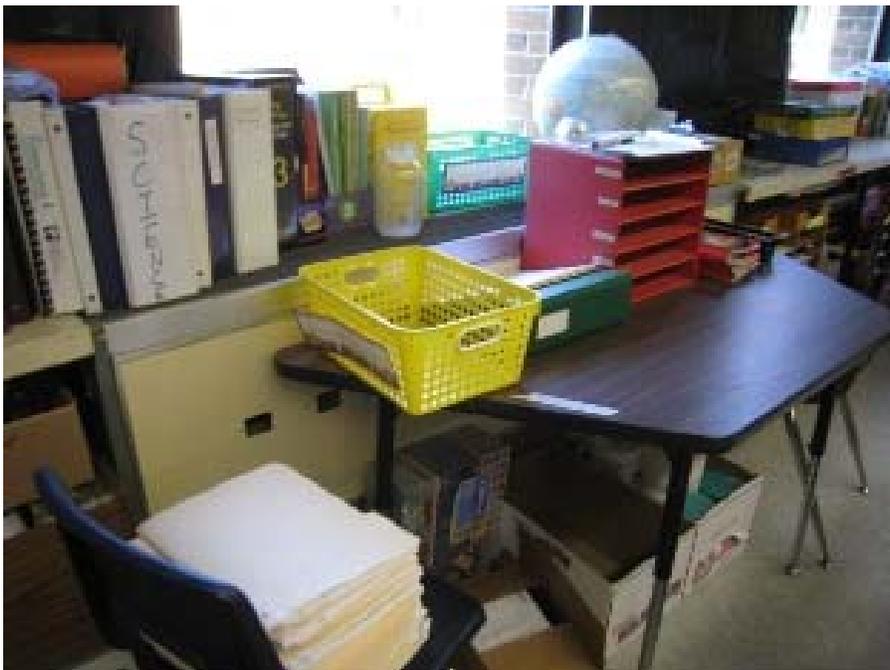
Picture 4

Univent Obstructed by Stored Materials

19. Discontinue use of spray enamel paints in the classroom.
20. Consider replacing tennis balls with latex-free tennis balls or glides.
21. Discontinue storage of school materials, brooms, plants, etc. on or in close proximity to univents.

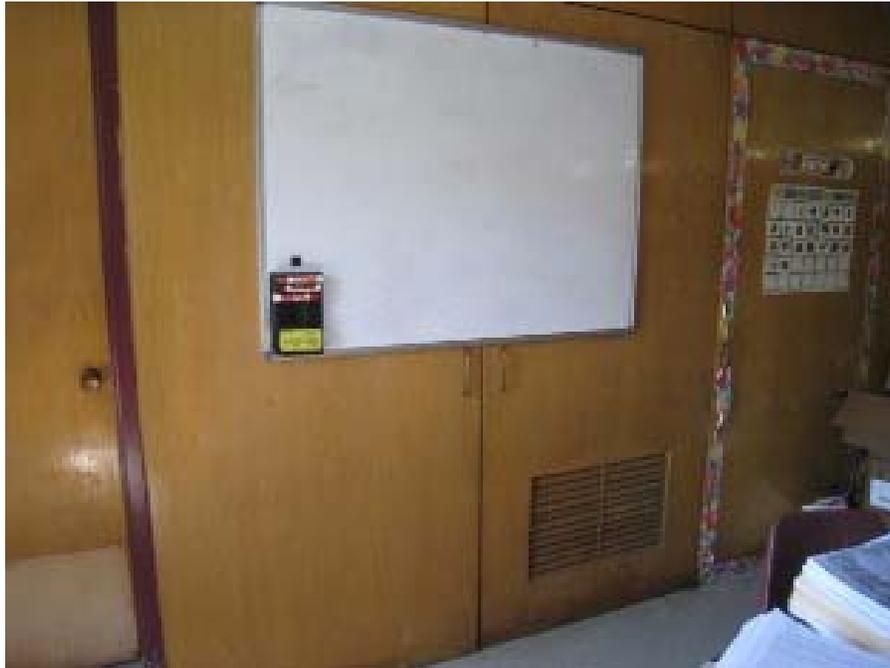
Picture 5

Dry Erase Board Covers Door to Exhaust Vent

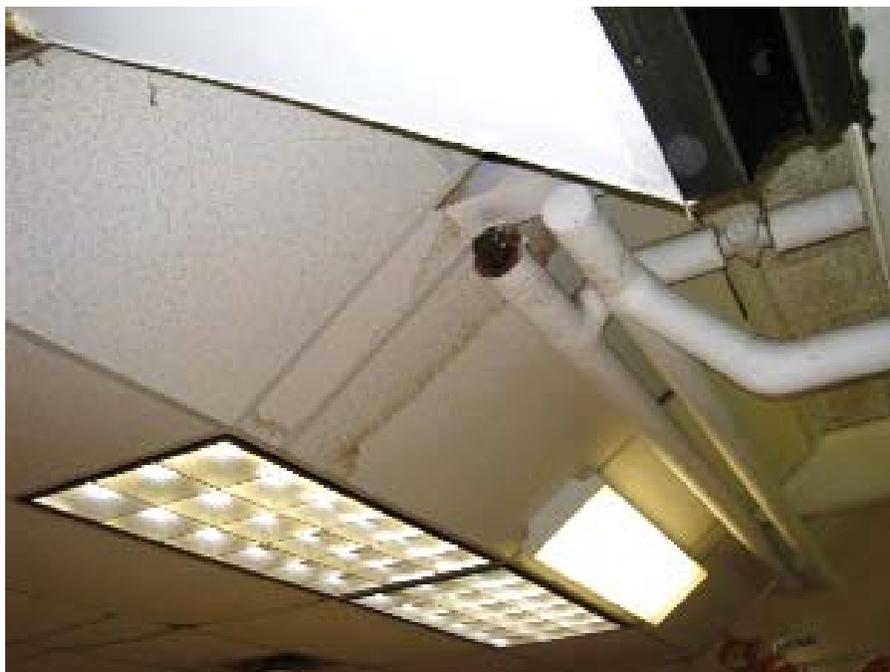
Picture 6

Several classrooms had water-damaged ceiling tiles, which can indicate sources of water penetration from either the building envelope or plumbing system (Picture 6; Table 1). Water-damaged ceiling tiles can provide a source of mold and should be replaced after a water leak is discovered and repaired. A cracked pane of glass was observed in the music room. Gaps (i.e. missing caulking and/or door sweeps) were observed on the bottom of several exterior doors at the DES. These conditions may allow unconditioned air to enter the DES, potentially causing condensation to occur on interior surfaces. If these surfaces are porous, mold colonization may result. Severely damaged/loose/missing interior caulking around windows was noted throughout the building. In addition to the potential of allowing unconditioned air into the DES, depending on its age, this sealant may contain regulated materials (e.g., asbestos, polychlorinated biphenyls or PCBs). If so, materials should be addressed in accordance with state and federal

Water-Damaged Ceiling Tiles

7. Repair any existing water leaks and replace any remaining water-damaged ceiling tiles. Examine the area above these tiles for mold growth. Disinfect areas of water leaks with an appropriate antimicrobial, as needed.

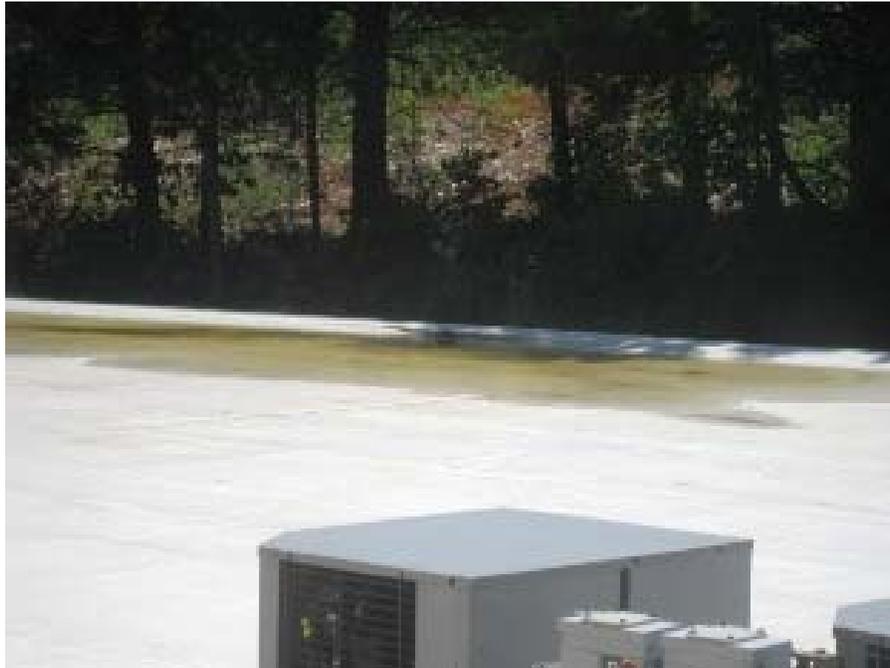
Picture 7

- Standing water was observed on several areas of the roof (Picture 7);
- Roof drains were obstructed by an accumulation of silt and debris (Picture 8);
- Severely deteriorated caulking was observed on the exterior of the DES (Picture 9).

Standing Water on Roof

10. Routinely examine and clear roof drains of materials and debris to eliminate standing water from accumulating on roof.
11. Seal spaces in masonry/expansion joints.

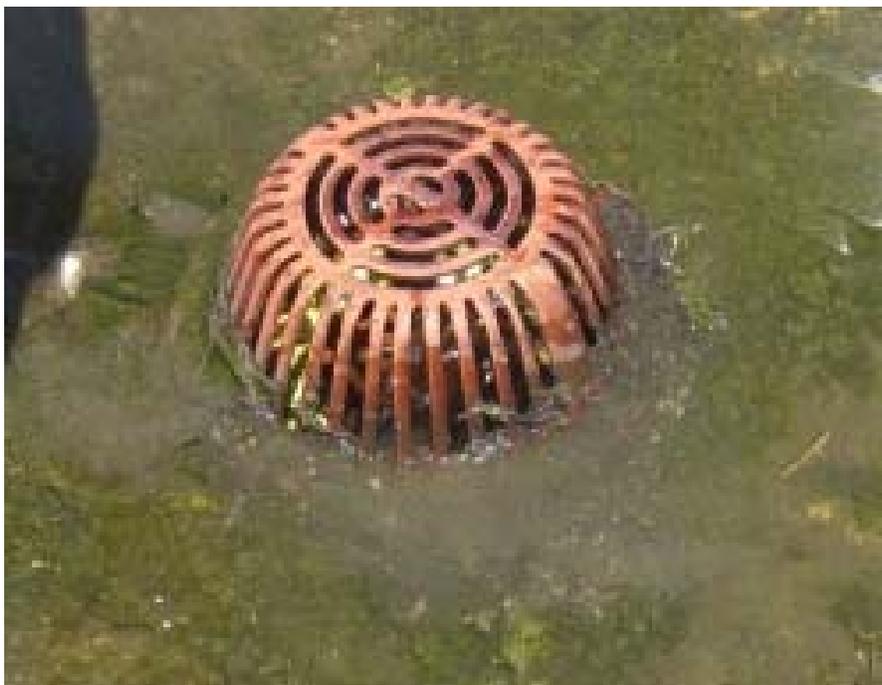
Picture 8

Accumulation of Debris around Perimeter of Roof Drain

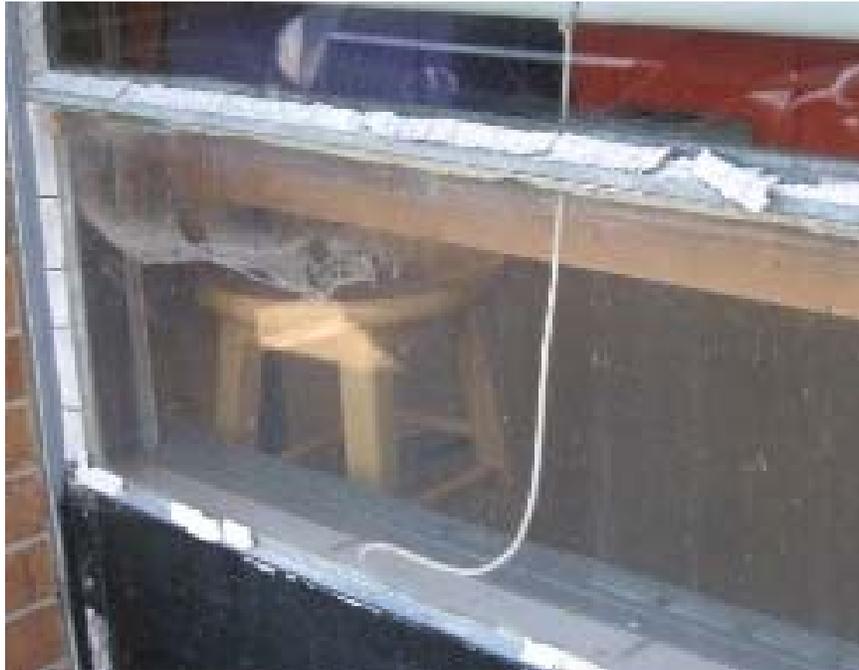
Picture 9

This material may also be composed of regulated materials;

Cracked, Deteriorated and Missing Window Glazing/Sealant

8. Repair cracked panes of glass.
9. Reseal window panes and frames to prevent water penetration drafts and pest entry. If caulking and expansion joint sealants contain regulated materials, these materials should be addressed in accordance with EPA regulations. For further information on addressing PCB-containing materials in schools, consult MDPH guidance (Appendix B).

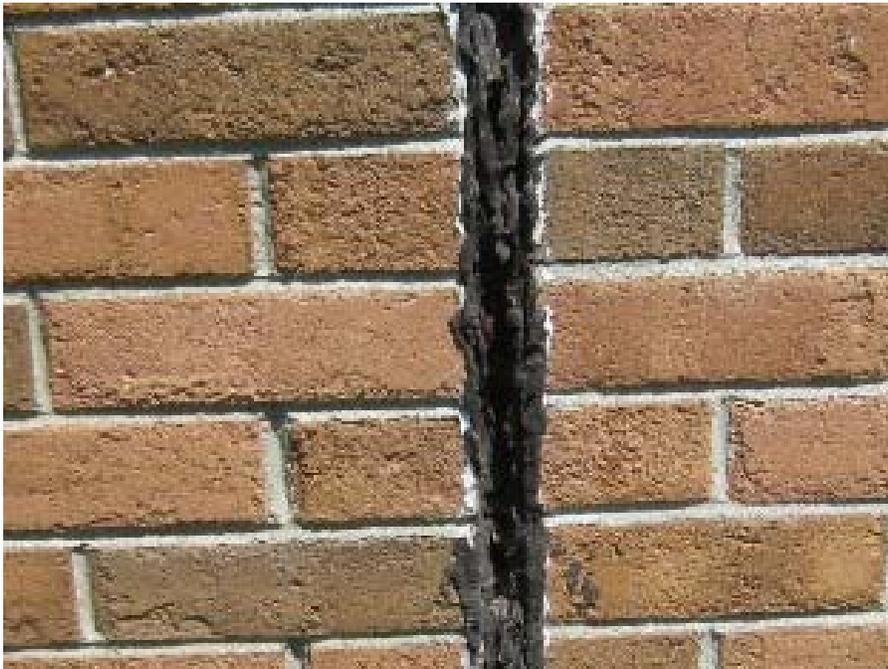
Picture 10

- Peeling paint was observed on several areas of plywood on the exterior of the building. Over time, this condition will cause deterioration of the plywood;
- Expansion joint sealant is dry, cracked and deteriorating. Expansion joints must be watertight and airtight, while at the same time must allow the joint to expand as necessary (Accommodating Expansion, 2006) (Picture 10).
- Gutter downspouts deposit water directly adjacent to foundation (Picture 11);
- Plants and shrubs were also observed growing in close proximity to the building. The growth of roots against exterior walls can bring moisture in contact with the foundation. Plant roots can eventually penetrate, leading to cracks and/or fissures in the sublevel foundation.

Deteriorated Expansion Joint Sealant

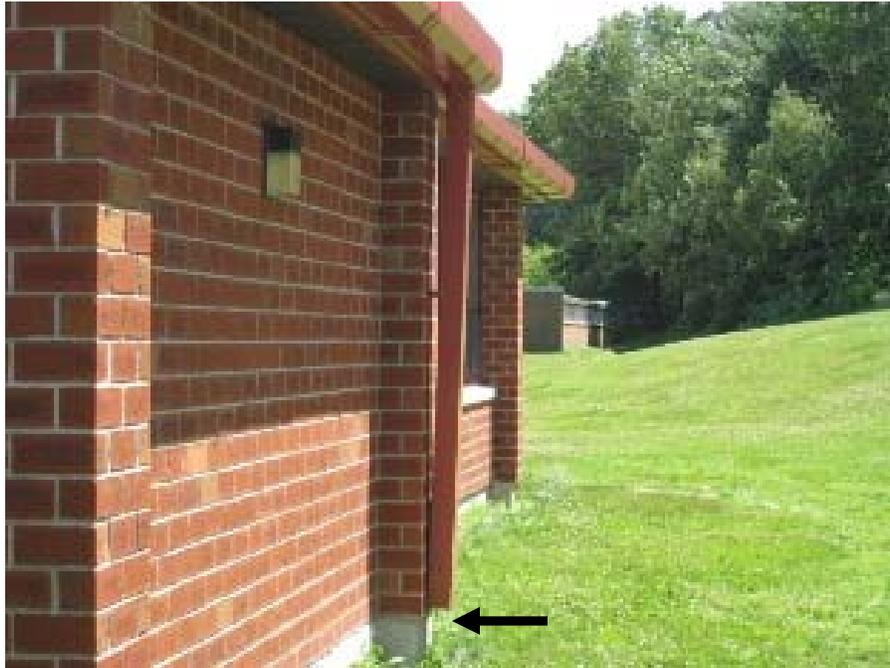
Picture 11

Downspout Deposits Water Directly onto Foundation (Arrow)

15. Ensure downspouts from gutter system deposit water several feet away from the building.
16. Ensure plants are equipped with drip pans. Examine drip pans periodically for mold growth and disinfect with an appropriate antimicrobial, as needed. Move plants away from fresh air supply sources.

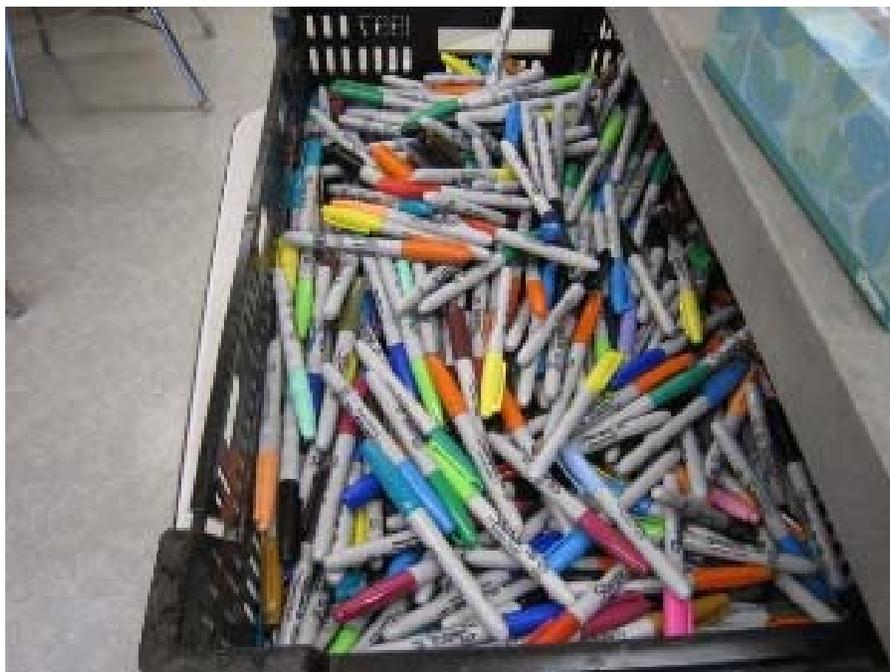
Picture 12

Several classrooms contained permanent markers, dry erase boards and dry erase board markers (Picture 12). Materials such as permanent markers, dry erase markers and dry erase board cleaners may contain VOCs, such as methyl isobutyl ketone, n-butyl acetate and butyl-cellusolve (Sanford, 1999), which can be irritating to the eyes, nose and throat.

Permanent Markers

17. Consider using low odor permanent and dry erase markers in order to reduce exposure to VOCs.
18. Store cleaning products properly and out of reach of students. All cleaning products used at the facility should be approved by the school department with MSDS' available at a central location.

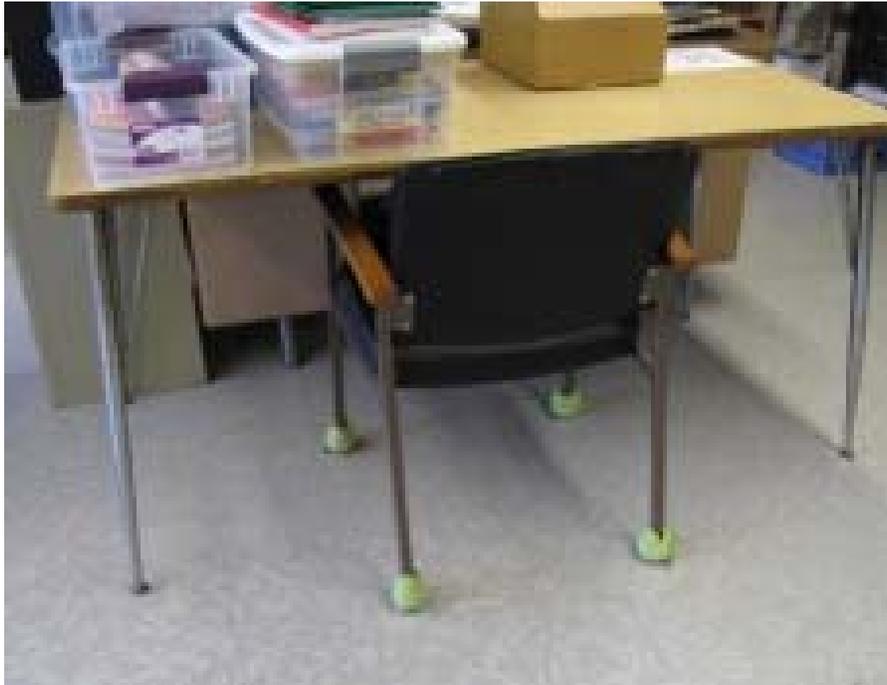
Picture 13

BEH staff observed tennis balls which had been sliced open and placed on chair and/or table legs (Picture 13). Tennis balls are made of a number of materials that are a source of respiratory irritants. Constant wearing of tennis balls can produce fibers and cause VOCs to off-gas. Tennis balls are made with a natural rubber latex bladder, which becomes abraded when used as a chair leg pad. Use of tennis balls in this manner may introduce latex dust into the

school environment. Some individuals are highly allergic to latex (e.g., spina bifida patients) (SBAA, 2001). It is recommended that the use of materials containing latex be limited in buildings to reduce the likelihood of symptoms in sensitive individuals (NIOSH, 1997).

Latex Tennis Balls in Use as Glides on Chair

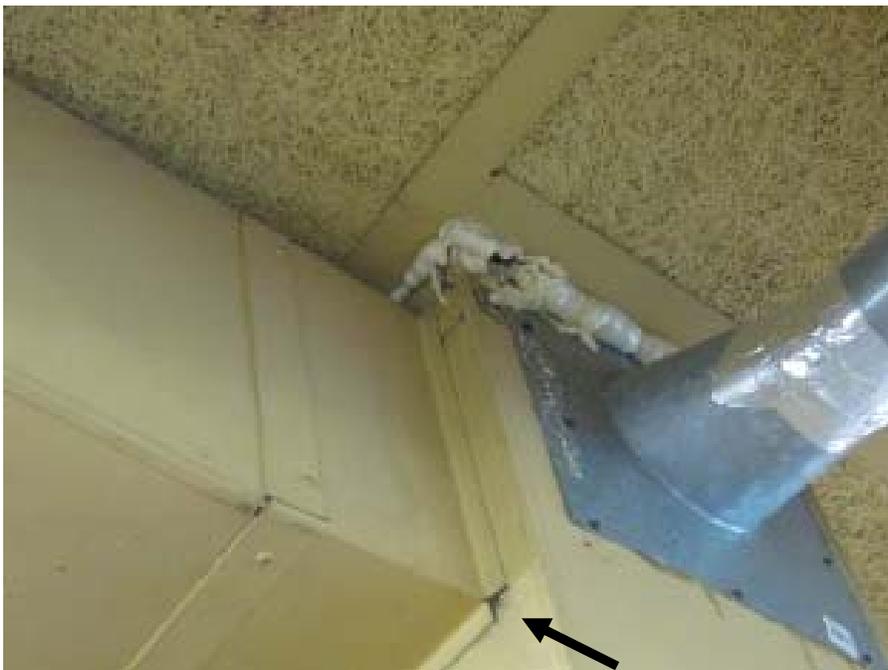
Picture 14

Other conditions that can affect indoor air quality were observed during the assessment. Breaches were observed in the exhaust duct for the art room kiln (Picture 14). To ensure products of combustion do not enter the classroom, breaches should be properly sealed.

Breaches in Exhaust Duct for Kiln (Arrow)

27. Inspect and seal all breaches in kiln exhaust system to ensure proper removal of pollutants and products of combustion.
28. Consider adopting the US EPA (2000) document, "Tools for Schools", as an instrument for maintaining a good indoor air quality environment in the building. This document is available at: <http://www.epa.gov/iaq/schools/index.html>.

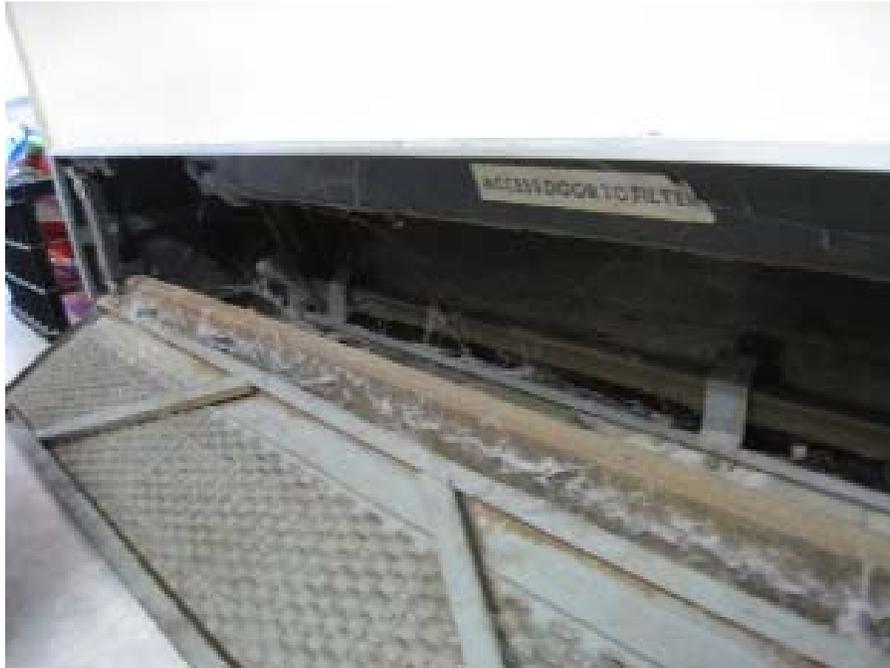
Picture 15

A number of univents, air diffusers, exhaust vents and personal fans were observed to have accumulated dust/debris (Picture 15). This equipment should be routinely cleaned in order to prevent dust/debris from being aerosolized and redistributed throughout the room.

Dust and Debris on Interior of Univent

23. Clean accumulated dust and debris periodically from the surface of air diffusers, exhaust vents and blades of personal and ceiling fans.
24. Consider professionally cleaning upholstered furniture annually.

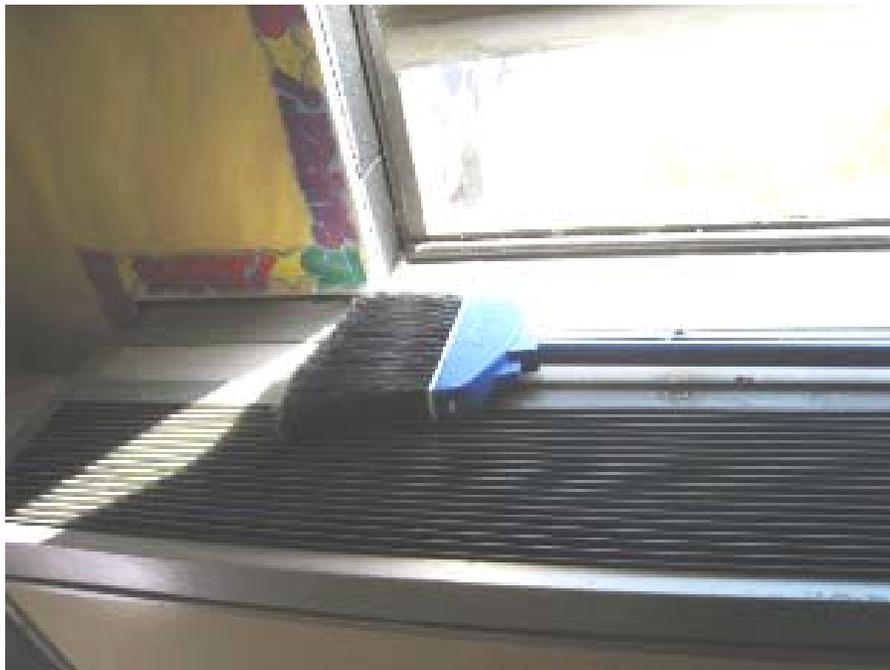
Picture 16

A broom was observed stored on top of a univent, which can aerosolize dust and particulates (Picture 16). The top of univents should remain clear of stored materials. Plants were observed in close proximity to univents (Picture 17). Plants should be located away from the air stream of ventilation sources to prevent aerosolization of mold, pollen and particulate matter.

Broom Stored on Top of Univent

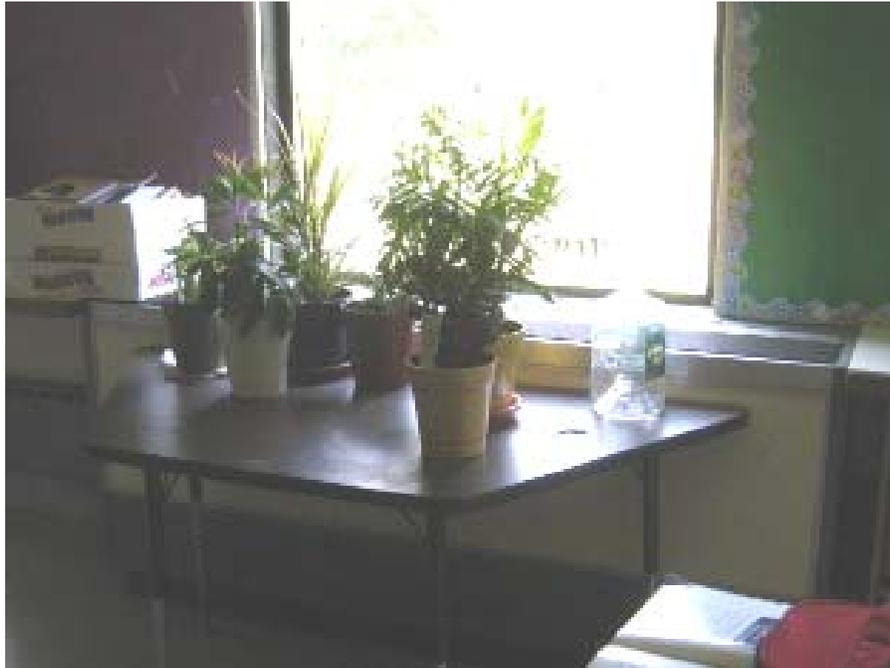
Picture 17

Plants Located in Front of Univent

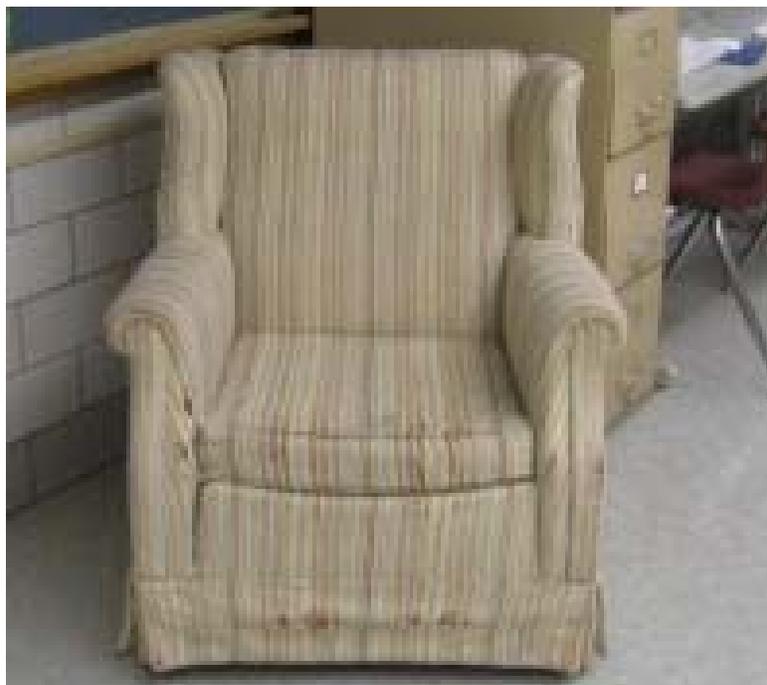
Picture 18

Upholstered furniture, cloth chairs and mats were noted in some classrooms (Picture 18). Close contact with such items can leave behind oils, perspiration, hair and skin cells. Dust mites

feed upon human skin cells and excrete waste products that contain allergens. As discussed, dust can be irritating to the eyes, nose and respiratory system.

Upholstered Chair in Classroom
