INDOOR AIR QUALITY ASSESSMENT

**Massachusetts Department of Transitional Assistance
Shetland Park Office Complex
35 Congress Street
Salem, Massachusetts**

Prepared by:
Massachusetts Department of Public Health
Bureau of Environmental Health
Indoor Air Quality Program
April 2011

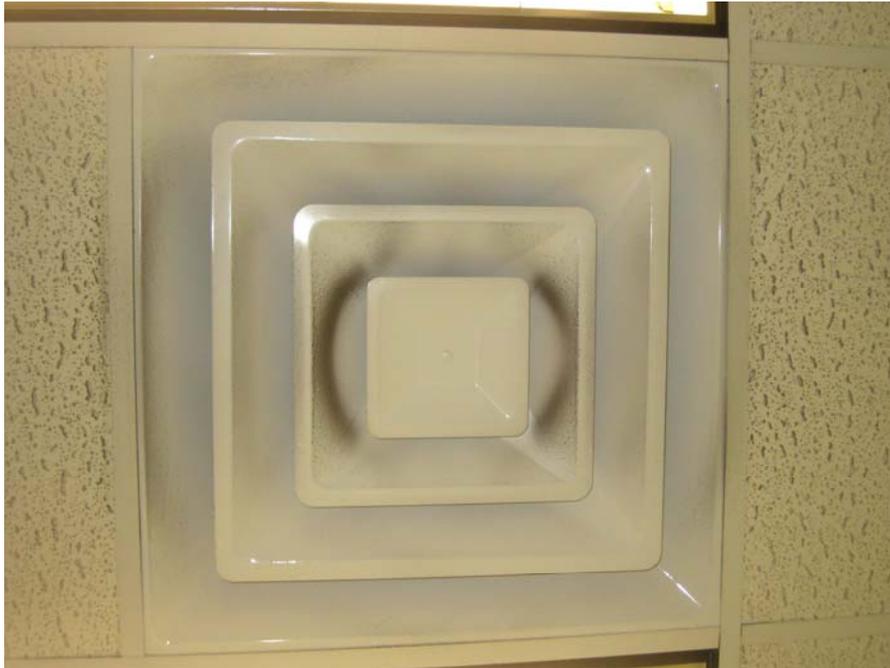
Picture 1

Other conditions that can affect indoor air quality were observed during the assessment. Dust/debris was observed accumulated on supply vents (Picture 1), as well as on the fan blades of personal fans. Vents and fans should be cleaned periodically to prevent dust/debris from being aerosolized and redistributed throughout the room.

Supply vent, note dust

12. Refrain from using air deodorizers to prevent exposure to VOCs.
13. Ensure personal fans and ceiling vents are cleaned periodically to prevent aerosolization of dusts collected on fan blades.

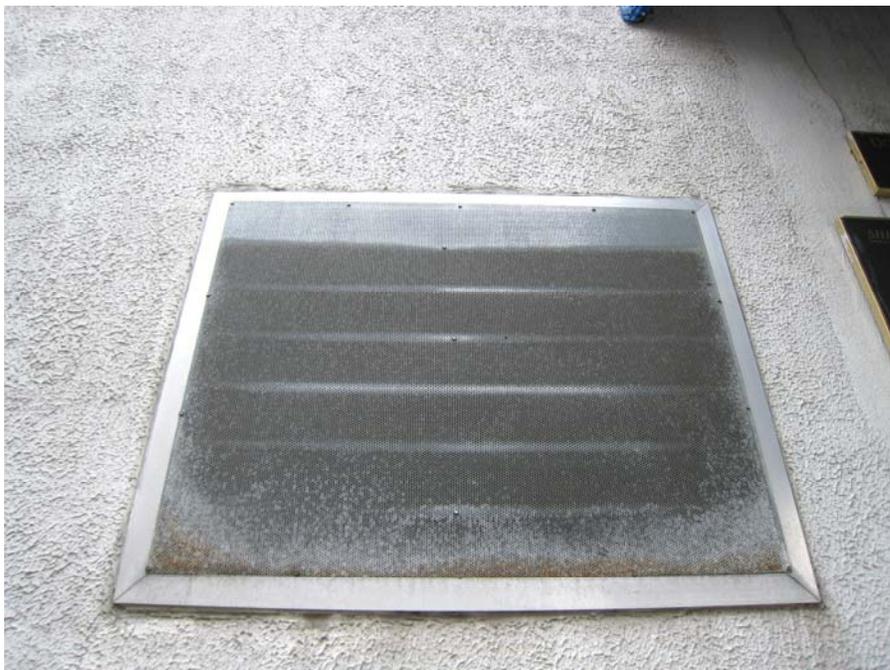
Picture 2

Furthermore, BEH staff observed a bug screen installed on a vent for the AHU servicing this space (Picture 2). This bug screen also collects dust and debris. During wind-driven rain or periods of high humidity, materials collected against the screen can become moistened and produce odors, which can be distributed to the DTA space when the mechanical ventilation system is in operation.

Bug screen on vent, note accumulated debris

1. Implement measures/recommendations to address water infiltration through the building envelope as outlined in previous reports if not already completed (MDPH, 2007; MDPH, 2008).
2. Remove bug screen currently installed over vent and replace with a bird screen. Clean vent and screen periodically to prevent accumulation of debris.
3. Examine masonry around the building's exterior, especially at southwest facing corners (i.e., corner formed by exterior wall and stairwell outside cubicles 144/147). Repoint masonry to prevent water penetration.
4. Remove carpeting in stairwell and replace with non-porous flooring (i.e., tiles).
5. Seal breaches the mechanical room.
6. Alert Shetland Park Management to presence of water-damaged ceiling tiles to identify source of leak. Once repaired change ceiling tiles and monitor for further leaks.

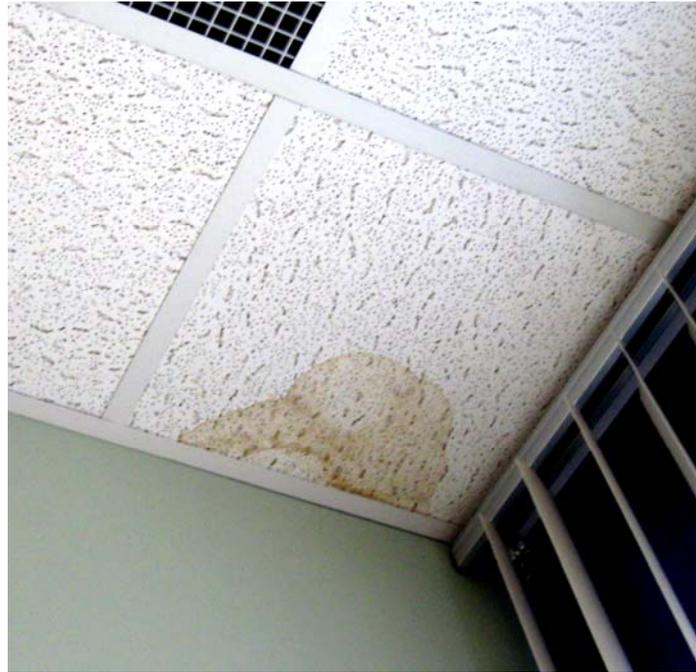
Picture 3

Water-damaged ceiling tiles were observed in some areas, primarily near exterior walls (Picture 3: Table 1). The location of these water-damaged tiles suggests that water is penetrating either through the building exterior or from roof drainage. Water-damaged ceiling tiles can provide a source of mold and should be replaced after a leak is discovered and repaired.

Water-damaged ceiling tile

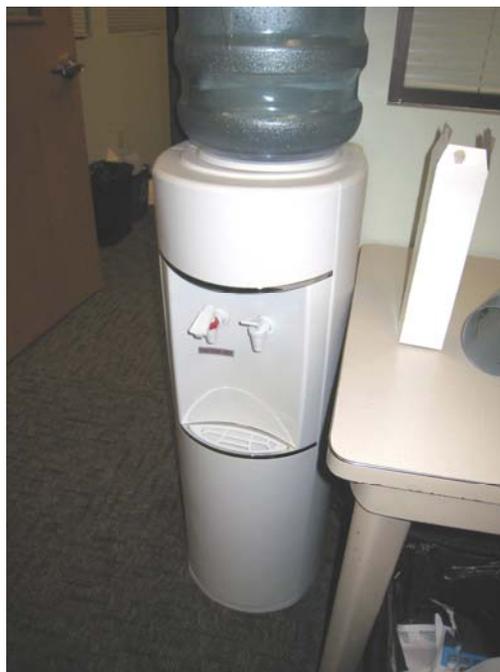
Picture 4

A water cooler was located over a carpeted area (Picture 4). Overflow of the water basin or spills that often occur can moisten carpeting, leading to mold growth. It is also important that catch basins of water coolers be cleaned regularly as stagnant water can be a source of odors. Further, materials (i.e., dust) collected in the water can provide a medium for mold growth.

Water cooler on carpet

10. Consider decreasing the number of plants in the office space. Relocate plants from the airstream of ventilation sources.
11. Install a water impervious mat (e.g., rubber, plastic) under water coolers to prevent water damage to carpeting.

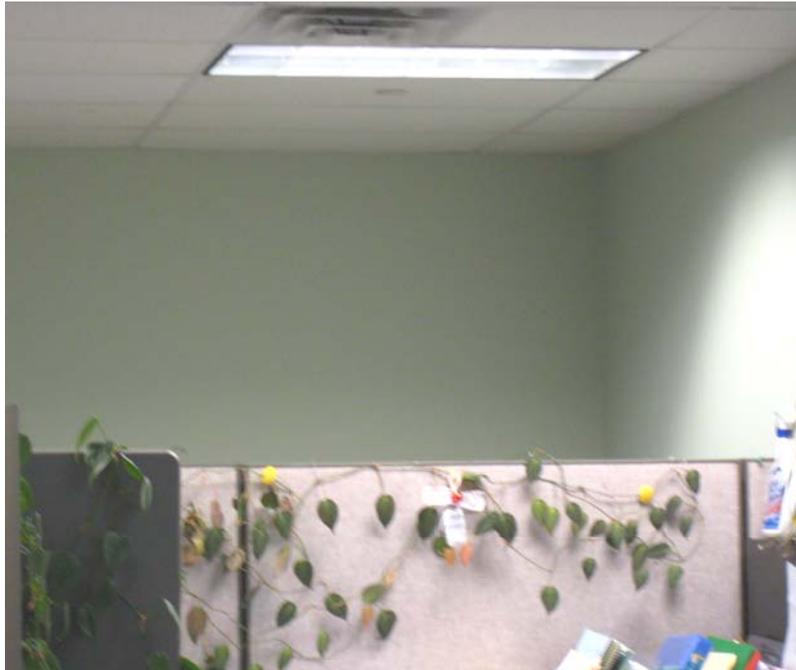
Picture 5

Plants were observed in several areas (Picture 5; Table 1). Plants should be properly maintained and equipped with drip pans. Plants should also be located away from ventilation sources to prevent aerosolization of dirt, pollen or mold. Finally, they should not be placed on porous materials, since water damage to porous materials may lead to microbial growth.

Plants in close proximity to supply vent

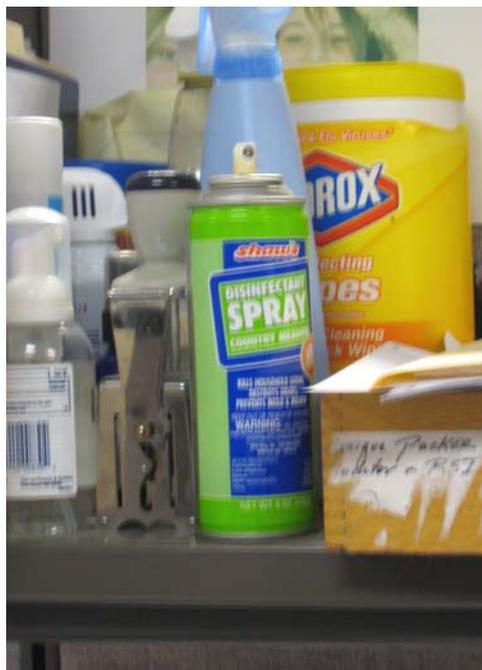
Picture 6

Cleaning products were observed in a number of areas (Picture 6). Cleaning products contain VOCs and other chemicals. These chemicals can be irritating to the eyes, nose and throat. Additionally, a Material Safety Data Sheet (MSDS) should be available at a central location for each product in the event of an emergency.

Various cleaning products

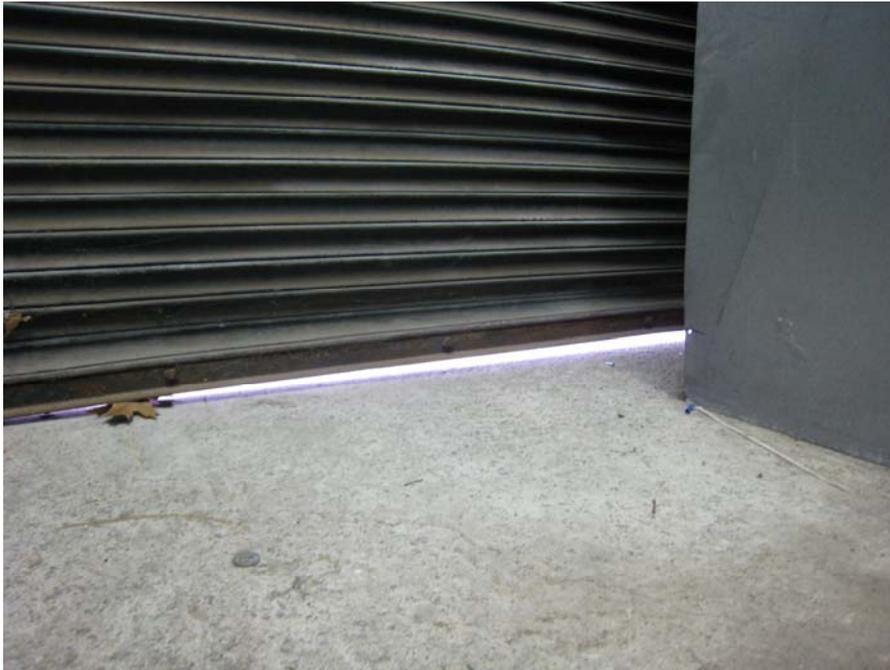
Picture 7

Light could be seen penetrating through breaches in the mechanical room doors (Pictures 7 and 8). These breaches can allow moisture and pests to enter the building. Moisture penetrating this area can result in dampening of materials, creating odors.

Light penetrating from garage door in mechanical room

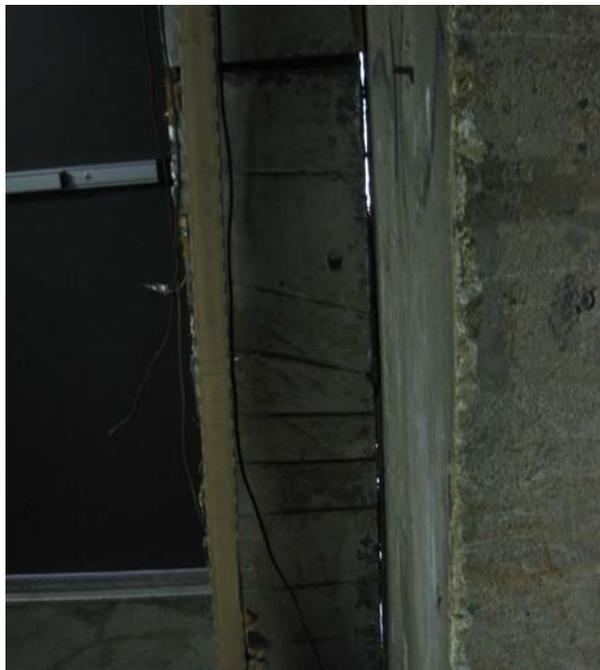
Picture 8

Light penetrating through wall door in mechanical room
