INDOOR AIR QUALITY REASSESSMENT

**South Elementary School
178 Bourne Road
Plymouth, Massachusetts**

Prepared by:
Massachusetts Department of Public Health
Bureau of Environmental Health
Indoor Air Quality Program
June 2011

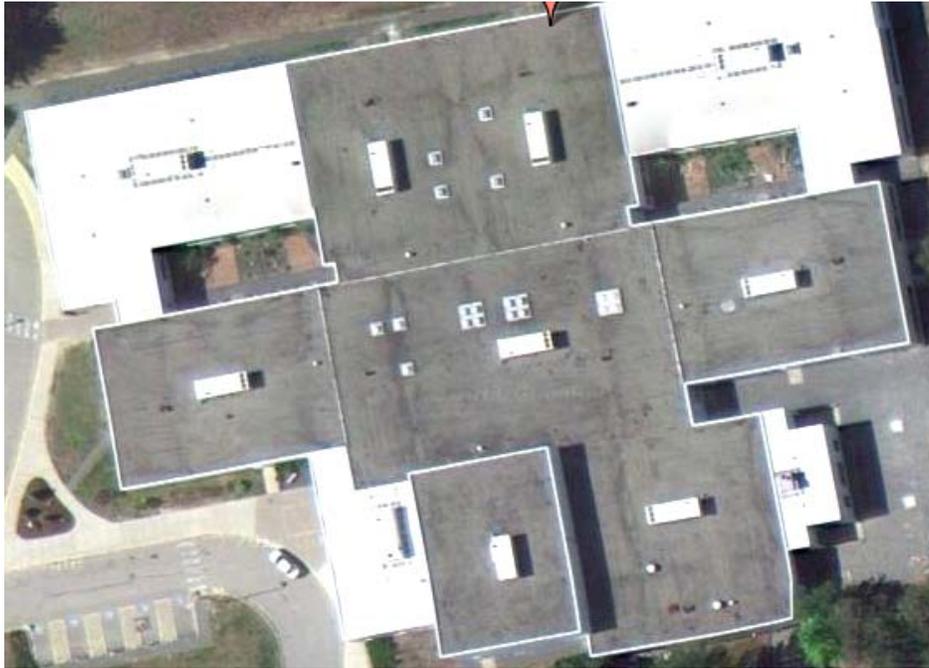
Picture 1

Rooftop Air Handling Units

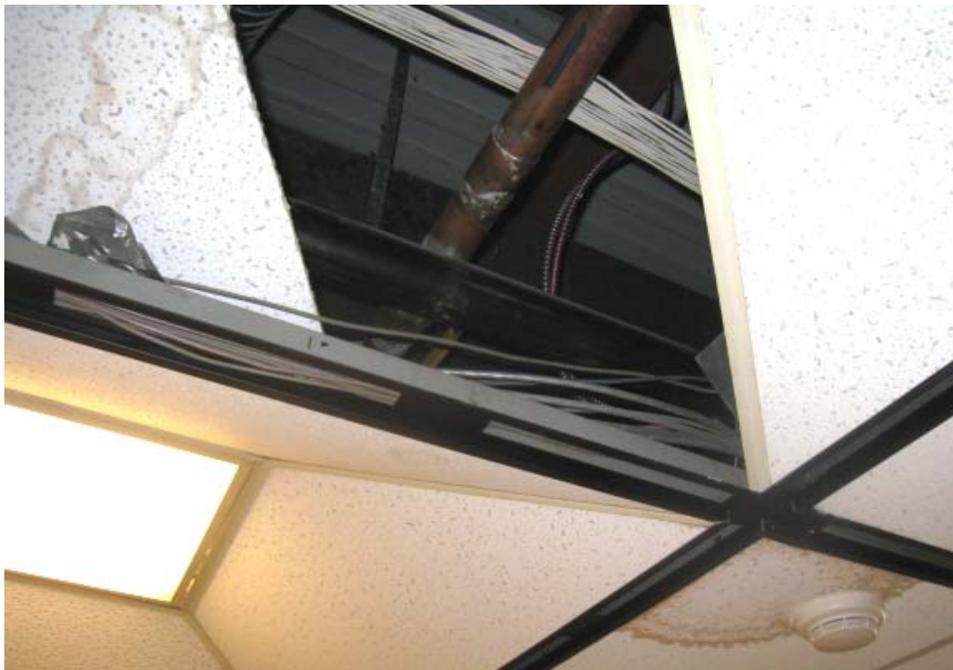
Picture 2

Water-Damaged Ceiling Tiles in Guidance Hallway below Uninsulated Metal Pipes

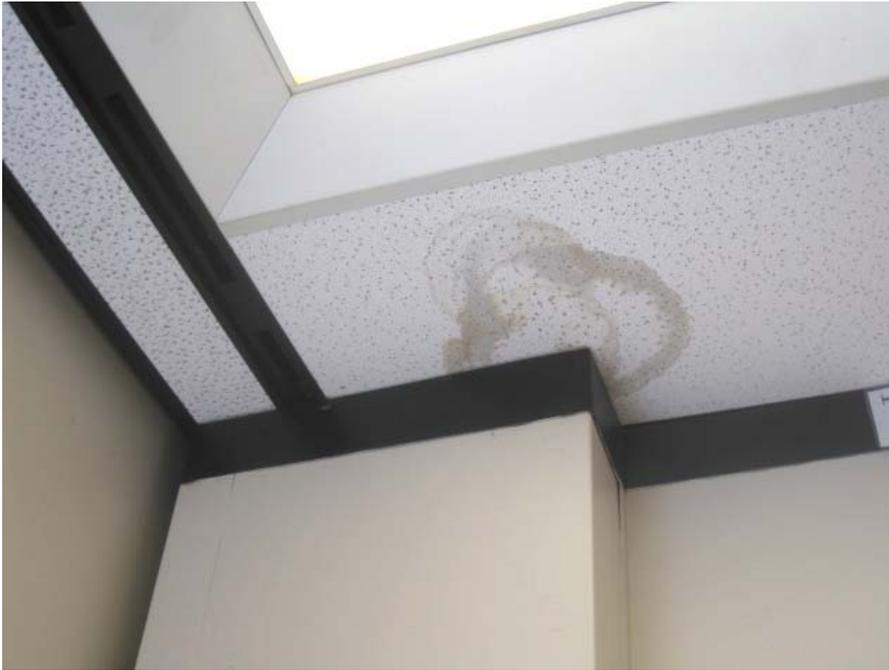
Picture 3

Water-Damaged Ceiling Tile Rear Corner of Room 1 below Roof Drain

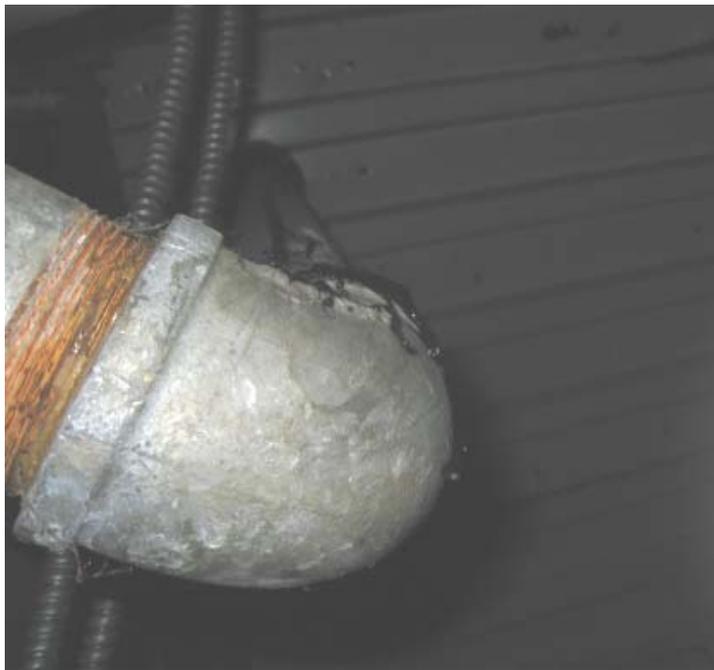
Picture 4

Roof Drain above Water-Damaged Ceiling Tile Rear Corner of Room 1

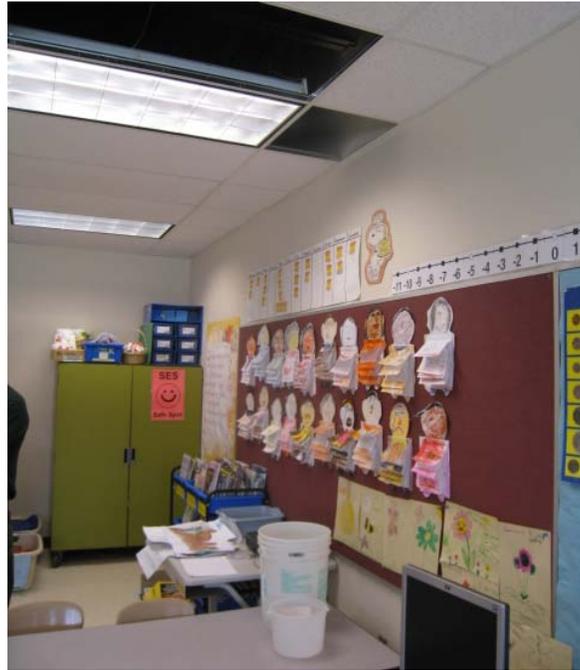
Picture 5

In order for building materials to support mold growth, a source of water exposure is necessary. Identification and elimination of the source of water moistening building materials is necessary to control mold growth. As indicated previously, the assessment was prompted by concerns of the presence of mold related to water-damaged ceiling tiles. Signs of plumbing/roof leaks were observed in several areas throughout the school (Table 1). Water-damaged ceiling tiles can provide a source of moisture/microbial growth and should be replaced after a water leak is discovered and repaired. In most cases the cause of water-damaged ceiling tiles appeared to be leaks from the plumbing system and/or roof drains that have been repaired (Pictures 2 through 4). An active leak was reported in room 7 beneath a roof drain, where ceiling tiles had been removed and buckets were stationed to catch water (Pictures 5 and 6).

Buckets Stationed under Leaking Roof Drain in Room 7

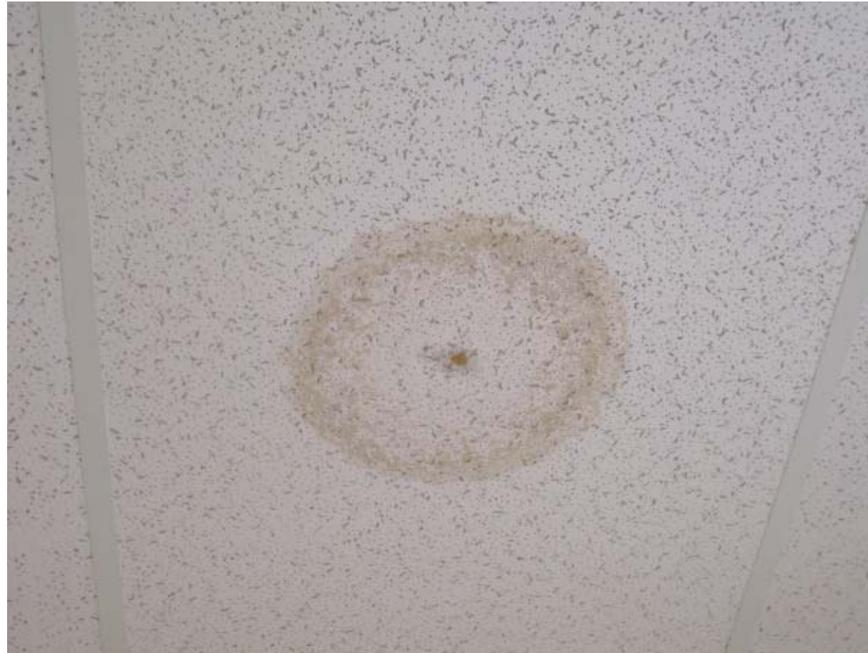
Picture 7

Water-Damaged Ceiling Tile in Hallway outside Room 3, Staining at Center Indicates Light Mold Growth

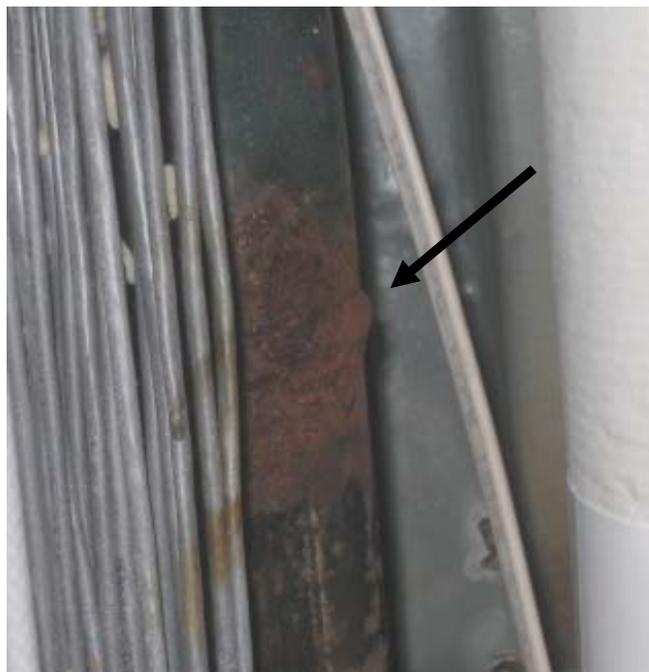
Picture 8

Rusted/Leaking Pipe above Ceiling Tile in Hallway outside Room 3

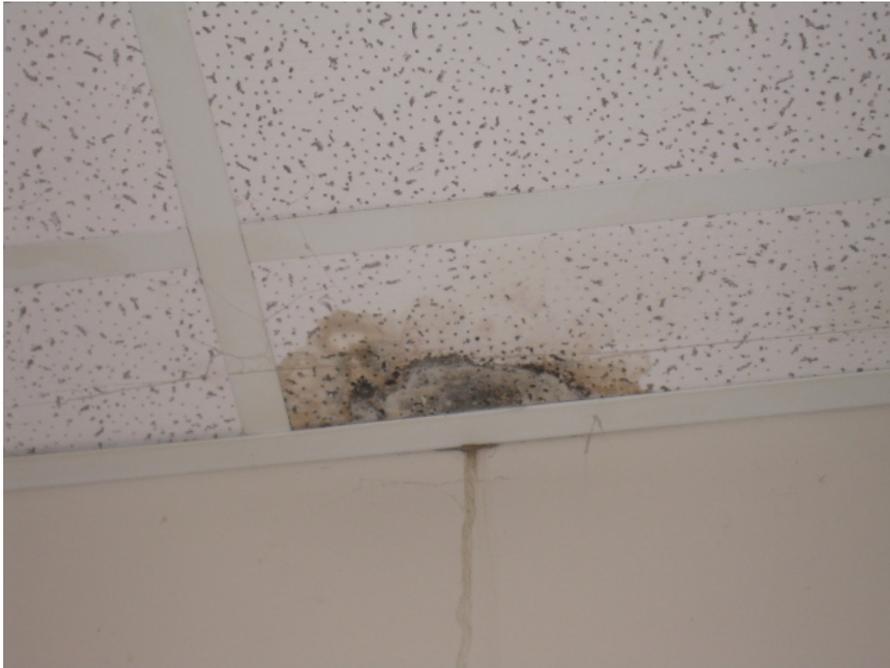
Picture 9

Water-Damaged/Mold-Colonized Ceiling Tile in Room 25

4. Remove small portion of water-damaged/mold colonized drywall above ceiling tiles shown in Pictures 9 and 10.
5. Examine if fresh air supply can be increased/intake adjusted in areas that measured over 800 ppm carbon dioxide (Table 1).

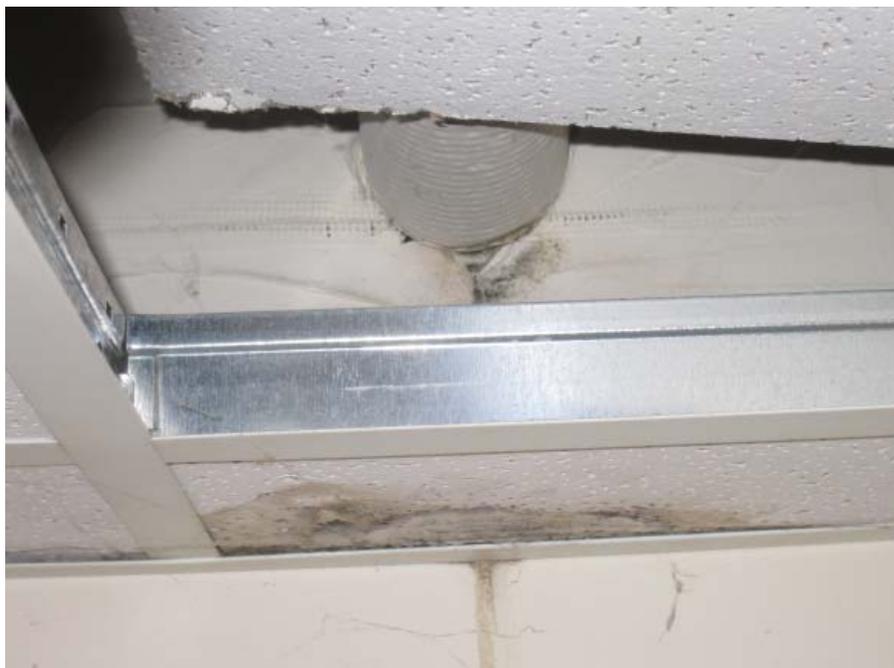
Picture 10

Water-Damaged/Mold-Colonized Ceiling Tile and Drywall (above Ceiling Tile System/below Pipe) in Room 25

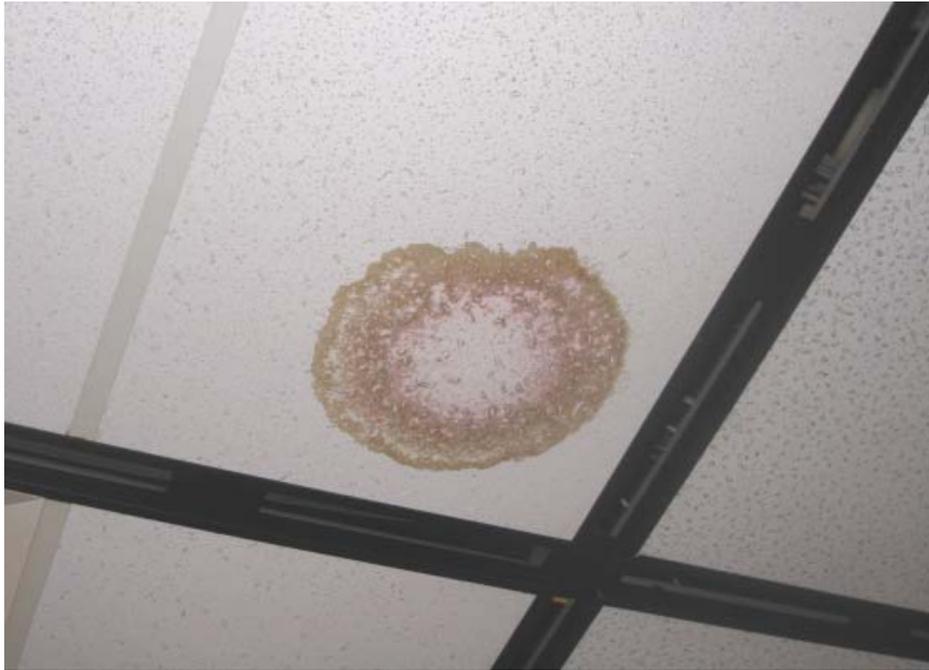
Picture 11

Water-Damaged Ceiling Tile with Pink Staining in Hallway outside Rooms 1 and 2

2. Ensure plumbing leaks and roof drains are repaired.
3. Remove/discard any water-damaged/mold-colonized ceiling tiles and pipe insulation (e.g., hallway outside cafeteria and rooms 1 & 2) (Table 1). Any mold-colonized building materials should be sealed in plastic bags for transport. Examine the area above these tiles for mold growth. Disinfect areas of water leaks with a mild detergent or an appropriate antimicrobial, as needed.

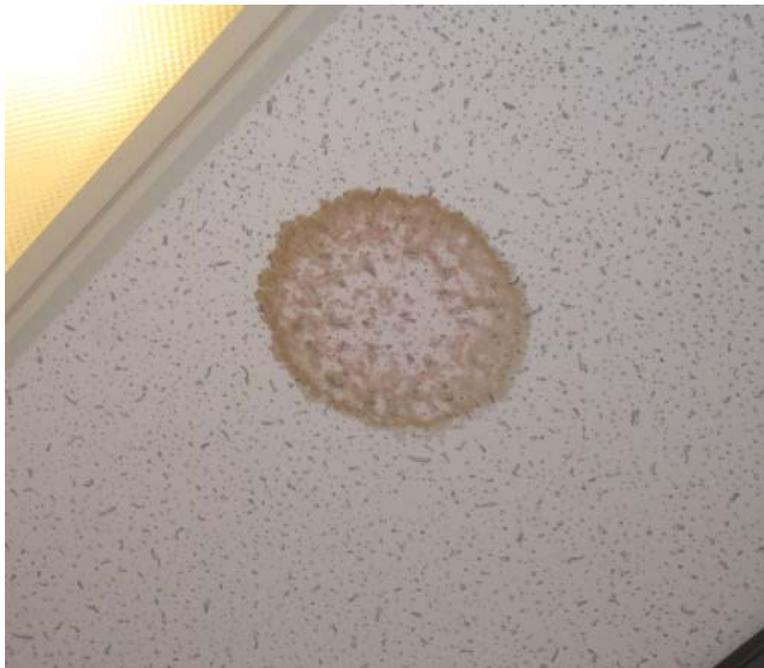
Picture 12

Water-Damaged Ceiling Tile with Pink Staining in Hallway outside Cafeteria

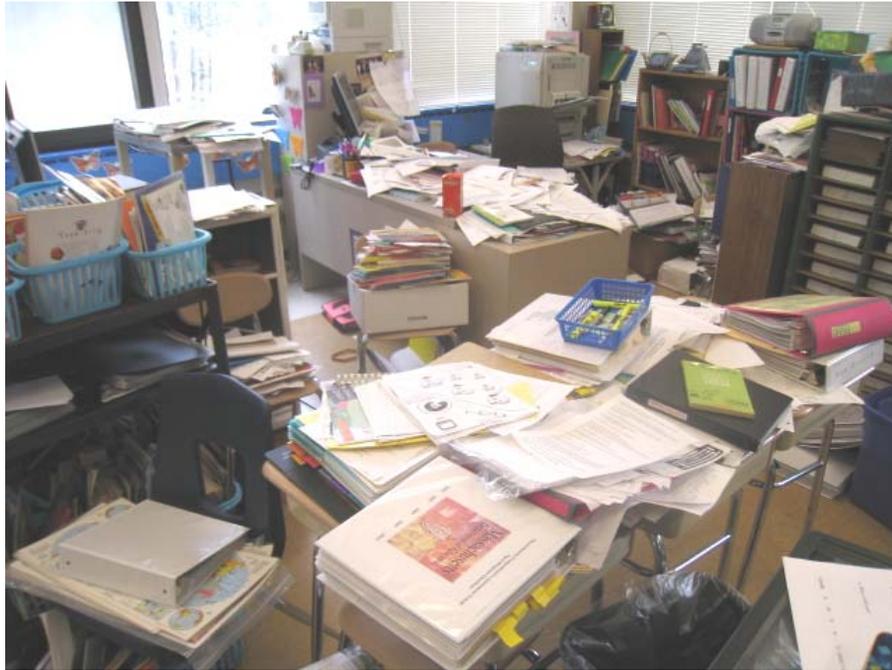
Picture 13

Other conditions that can affect indoor air quality were observed during the assessment. In several classrooms, items were observed on the floor, windowsills, tabletops, counters, bookcases and desks (Picture 13). The large number of items stored in classrooms provides a source for dusts to accumulate. These items (e.g., papers, folders, boxes) make it difficult for custodial staff to clean. Items should be relocated and/or be cleaned periodically to avoid excessive dust build up. In addition, these materials can accumulate on flat surfaces (e.g., desktops, shelving and carpets) in occupied areas and subsequently be re-aerosolized causing further irritation.

Accumulated Items in Classroom

7. Relocate or consider reducing the amount of materials stored in classrooms to allow for more thorough cleaning of classrooms. Clean items regularly with a wet cloth or sponge to prevent excessive dust build-up.
