INDOOR AIR QUALITY ASSESSMENT

**C.D. Hunking Middle School
98 Winchester Street
Haverhill, MA**

Prepared by:
Massachusetts Department of Public Health
Bureau of Environmental Health
Indoor Air Quality Program
April 2012

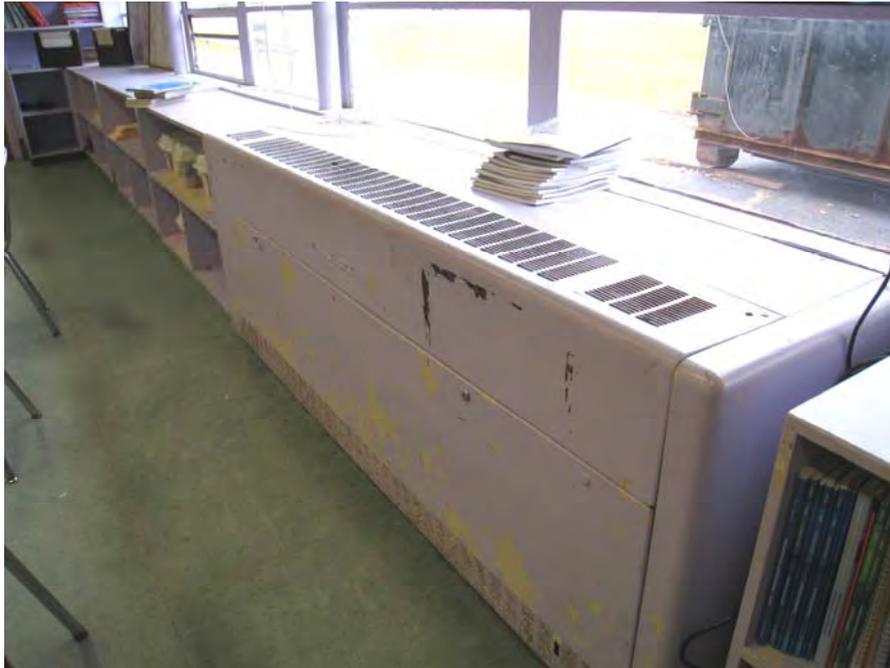
Picture 1

Fresh air in classrooms is supplied by unit ventilator (univent) systems (Picture 1). A univent draws air from outdoors through a fresh air intake located on the exterior wall (Picture 2) of the building and returns air through an intake located at the base of the unit ([Figure 2](#)). Fresh and return air are mixed, filtered, heated and provided to classrooms through an air diffuser located in the top of the unit. Univents were found obstructed by papers, books, furniture and other stored materials (Picture 3; Table 1). A heavy buildup of dust and debris was also observed on the air diffusers of several univents. In order for univents to provide fresh air as

Classroom univent

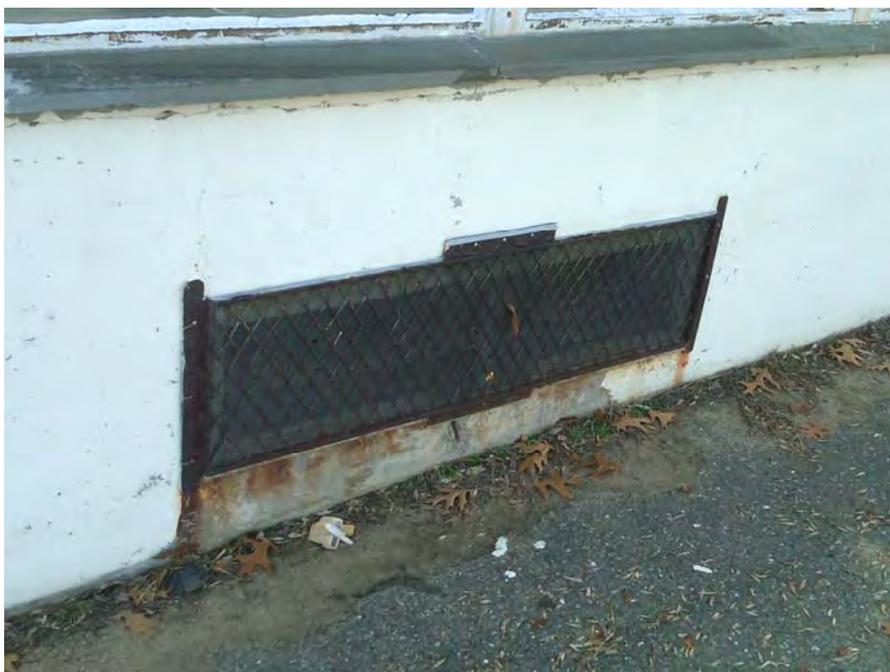
Picture 2

Univent fresh air intake on exterior wall of building

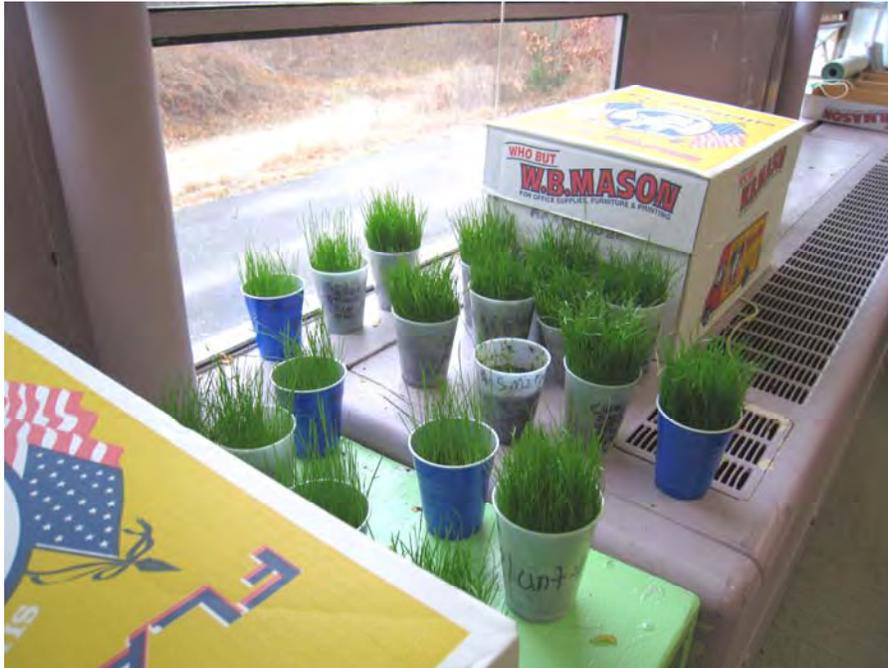
Picture 3

Plants were observed in a number of classrooms (Picture 3). Plants, soil and drip pans can serve as sources of mold growth and should be properly maintained. Over-watering of plants should be avoided and drip pans should be inspected periodically for mold growth. In addition, flowering plants can be a source of pollen. Therefore, plants should be located away from the air stream of univents to prevent aerosolization of mold, pollen and particulate matter.

Plants and other items placed on univent

15. Make adjustments/repairs to crawlspace accesses to render airtight (as possible) to prevent odor/moisture infiltration into occupied areas.
16. Ensure plants have drip pans and avoid over-watering. Examine drip pans periodically for mold growth. Disinfect with an appropriate antimicrobial where necessary. Remove plants from univent air diffusers.

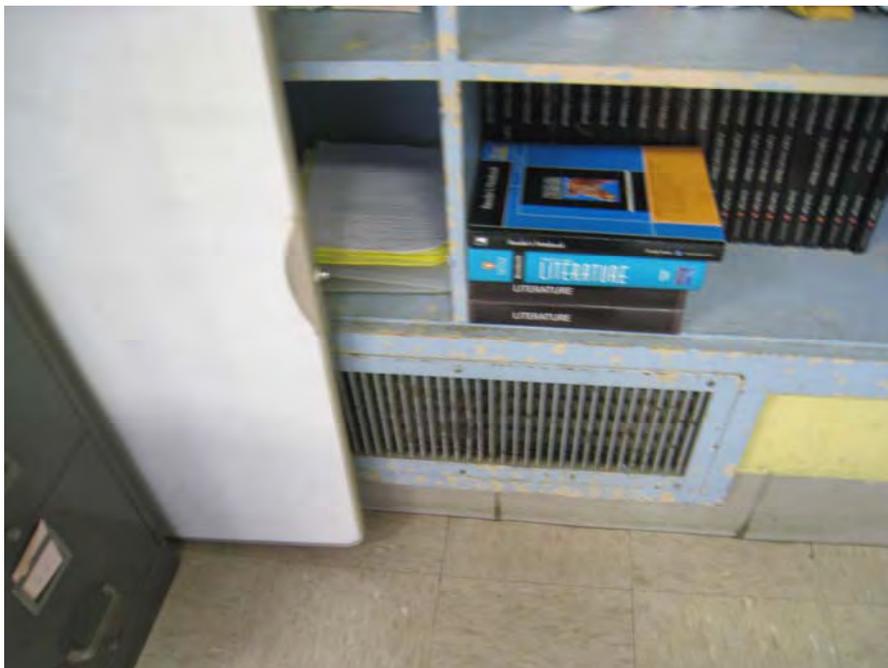
Picture 4

Exhaust ventilation in classrooms is provided by wall-mounted vents (Picture 4) that are connected to ductwork and exhaust fans located inside the crawlspace. At the time of assessment, BEH staff could not detect any draw of air by the mechanical exhaust systems. As reported by AECOM (2011), “structural deficiencies [in the crawlspace] have caused collapse of many of the heating, ventilation and drainage systems.” Corrosion and physical deterioration have rendered the exhaust system inoperable. Without adequate supply and exhaust ventilation, excess heat and normally occurring environmental pollutants can build up, leading to indoor air/comfort complaints.

Classroom exhaust vent

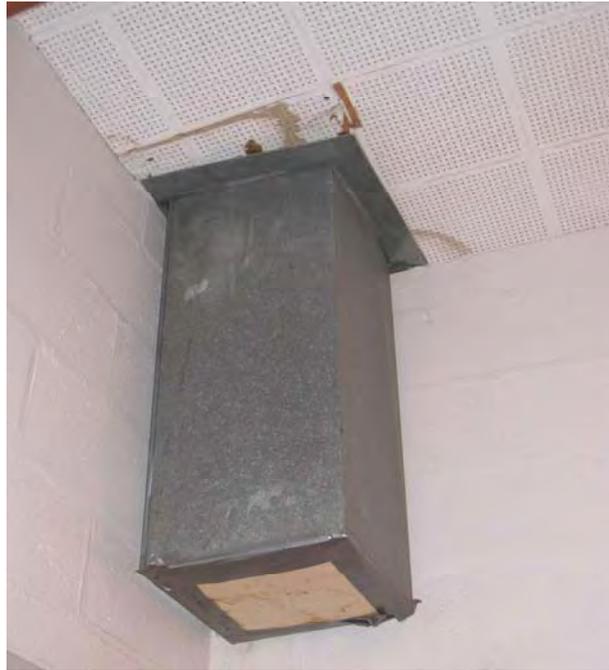
Picture 5

Please note, a ducted vent observed in an office (room 158) was sealed with duct tape and cardstock (Picture 5). The purpose of this vent was unknown. Measures should be taken to determine whether this vent can be made operable to create air movement in this office. This office currently lacks any sources for ventilation, relying on air movement from doors opening

Cardstock-sealed vent, note water-damaged interlocking ceiling tiles

into adjacent offices. If a means of ventilation can be restored through this vent, a source of fresh air could be established. If the vent is no longer functional, it should be sealed in a manner that does not allow odors, dust/debris and moisture that may be within the vent to penetrate the occupant area.

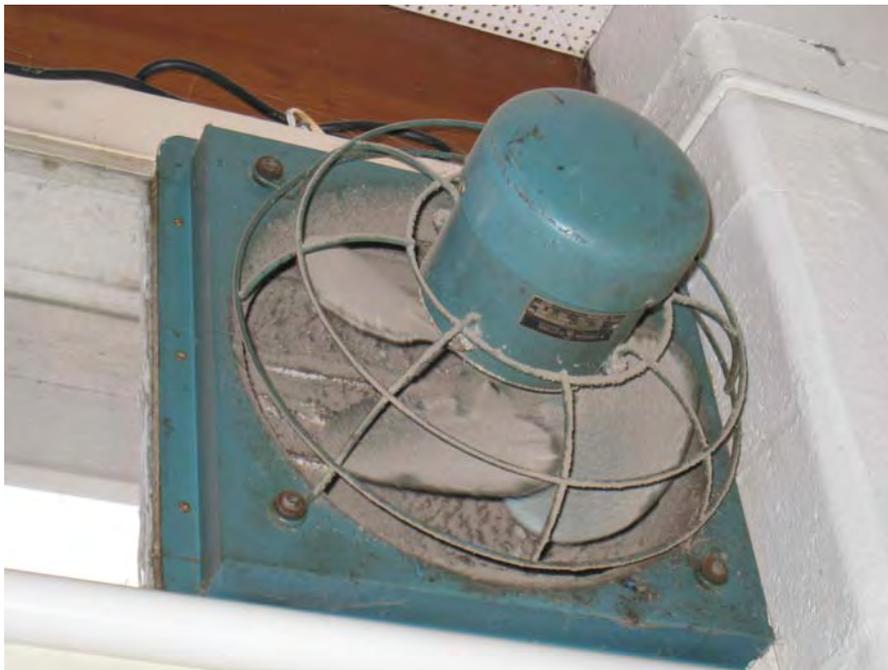
Picture 6

A number of fans/blades (Picture 25), exhaust vents (Picture 6) and air-conditioners (Picture 26) had accumulated dust/debris. Fans should be cleaned periodically in order to prevent them from serving as a source of aerosolized particulates. Exhaust vents should also be cleaned to prevent re-aerosolization of dust due to back drafting. Air-conditioners and their filters should be cleaned periodically to prevent distribution of materials.

Switch-activated exhaust fan, note occlusion with dust

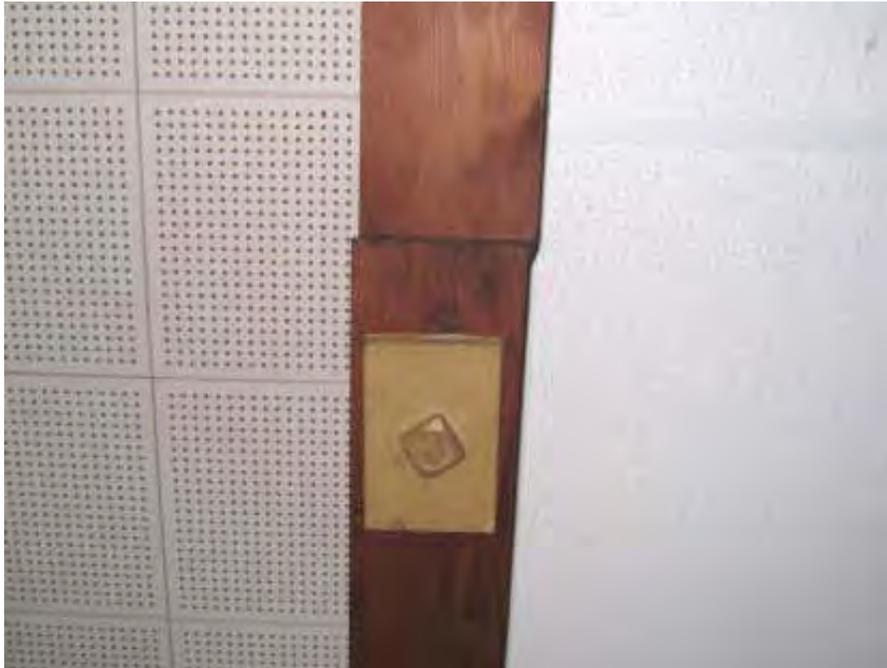
Picture 7

Horizontal movement of load-supporting beam

7. Monitor all beams and walls for any changes in size of gaps on a monthly basis and after any appreciable snowstorm.
8. For buildings in New England, periods of low relative humidity during the winter are often unavoidable. Therefore, scrupulous cleaning practices should be adopted to minimize common indoor air contaminants whose irritant effects can be enhanced when the relative humidity is low. To control for dusts, a high efficiency particulate arrestance

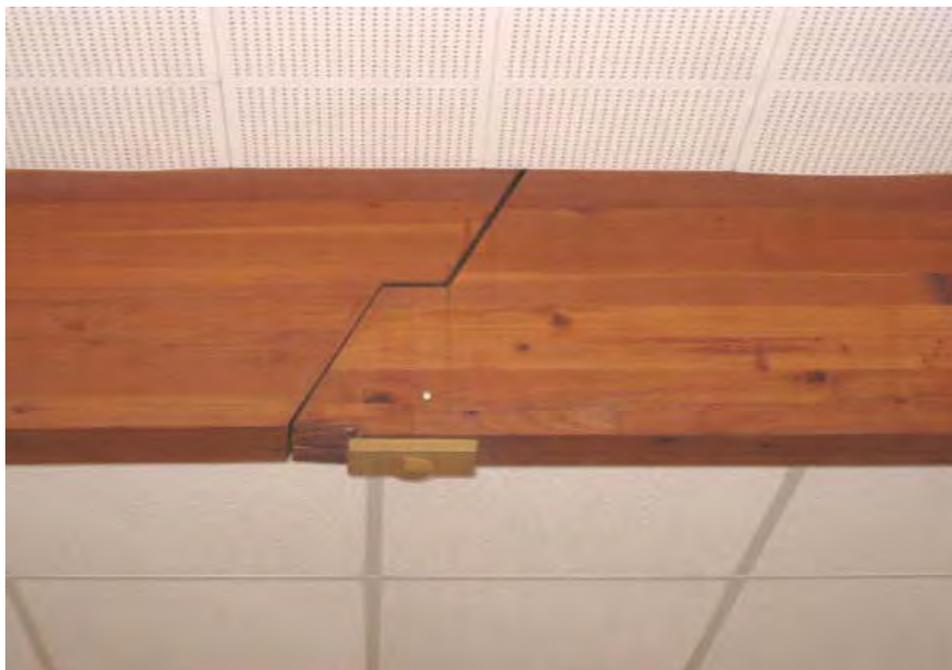
Picture 8

Vertical movement of load-supporting beam

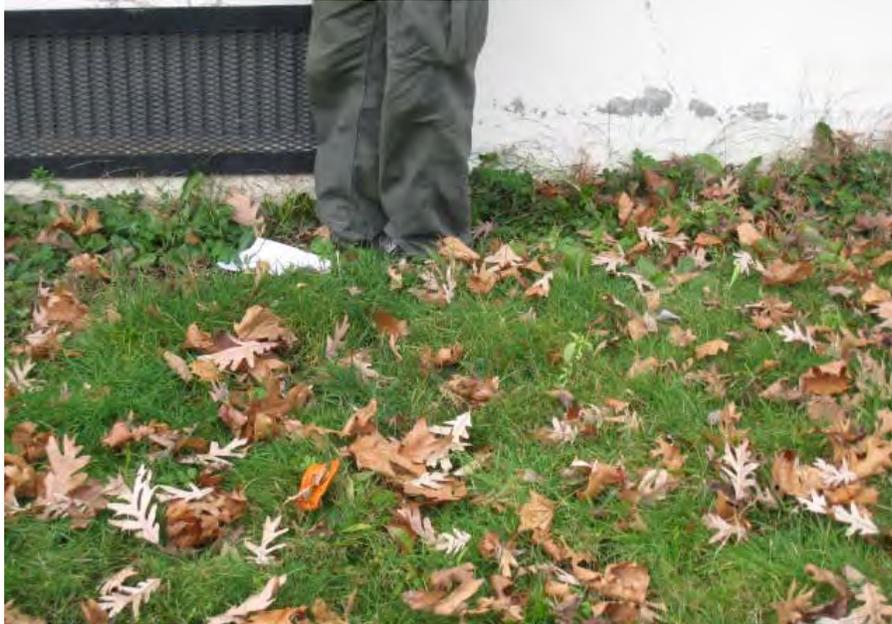
Picture 9

roof drain pipes. BEH staff examined the building and noted an additional source of water penetration. Based on observations of the exterior of the building, it is likely that water is also penetrating through the foundation. Compressed soil, forming up to 4-inch depressions, was observed on both sides of the unoccupied wing. These depressions can allow pooling water to come into extended contact with the foundation (Picture 9). Based on these observations as well as documented reports, the crawlspace beneath the unoccupied wing has been chronically exposed to moisture, which in turn has caused significant structural and mechanical damage.

**Depression in soil near footing to building
(note level of grass in foreground and lack of visibility of feet in background)**

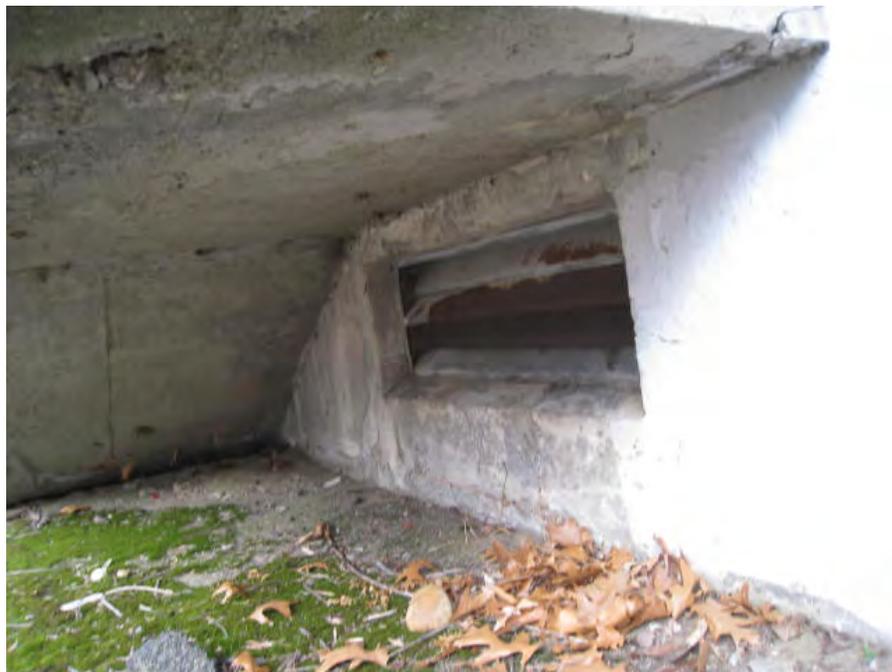
Picture 10

Passive vents are typically installed to allow water vapor and other materials in a crawlspace to be removed or diluted. Such vents were observed beneath classroom exterior doors on the western side of the occupied wing (Picture 10). These vents were installed in a manner to create cross-ventilation in the crawlspace. Of note is the orientation of the exterior doors and their stairs/landings, which likely takes advantage of New England's prevailing westerly wind direction. The stairs at position 1 face northwest, while the stairs at positions 2 and 3 face southwest (Figure 3; Picture 11). Depending on the orientation of the wind, the cement stairs/landings either form an air scoop to direct air into the passive vents (windward side) or provide a sheltered location for air to escape from the crawlspace (leeward side). For example, a southwest wind can force air to enter the space formed by the stairs and landing in Positions 2 and 3, creating pressurization that forces air in the crawlspace to escape via the passive vent in Position 1. This airflow created through passive ventilation allows water vapor to escape the crawlspace.

Crawlspace exhaust vent below staircase

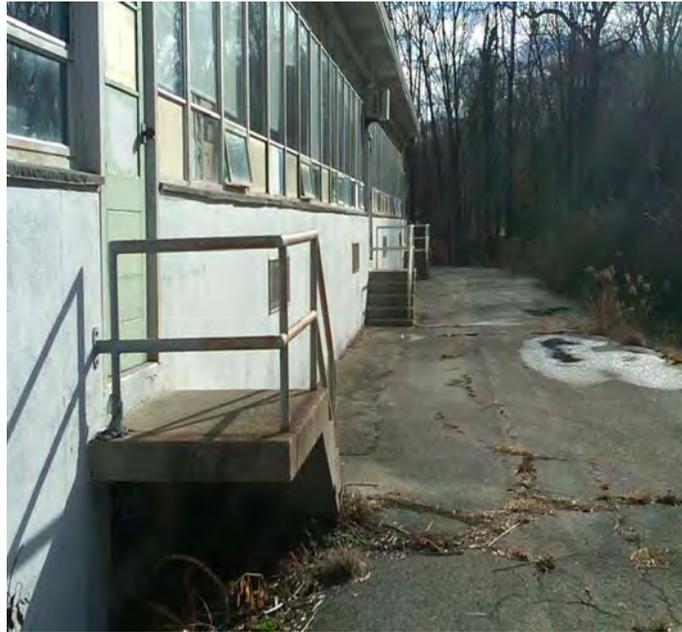
Picture 11

Crawlspace exhaust vents below staircases, note orientation of staircase 1 (foreground) and staircases 2 and 3 (background)

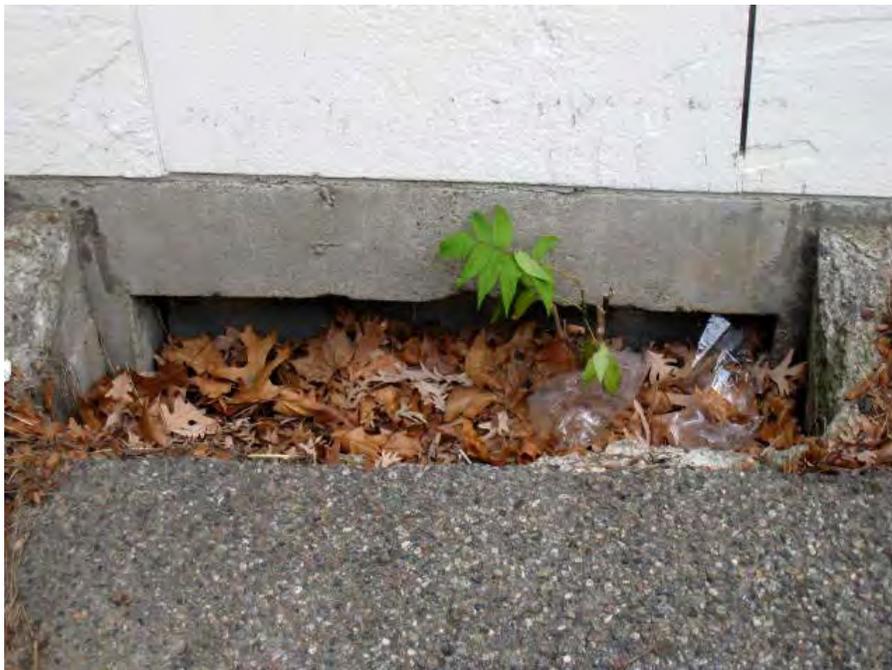
Picture 12

Sealed crawlspace vent near gymnasium

- a. Installation of a series of mechanical exhaust vents to remove water vapor; or
 - b. Excavation of the crawlspace/foundation walls to cut in sufficient passive air vents similar to those found in the occupied wings crawlspace/foundation walls.

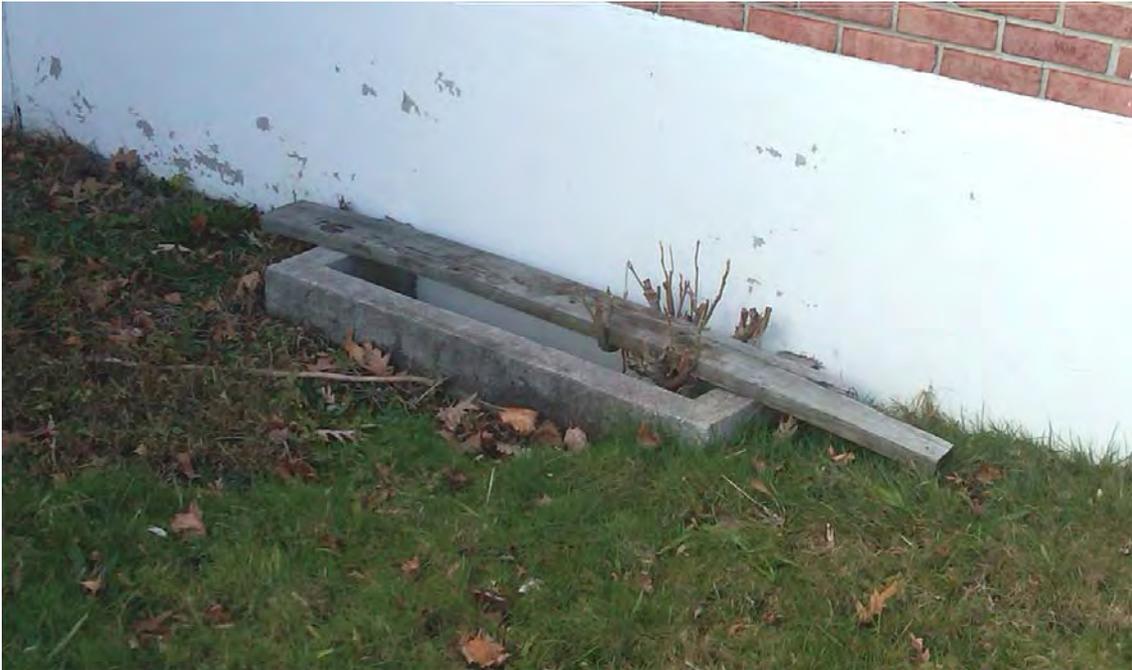
Picture 13

Sealed crawlspace vent near building entrance

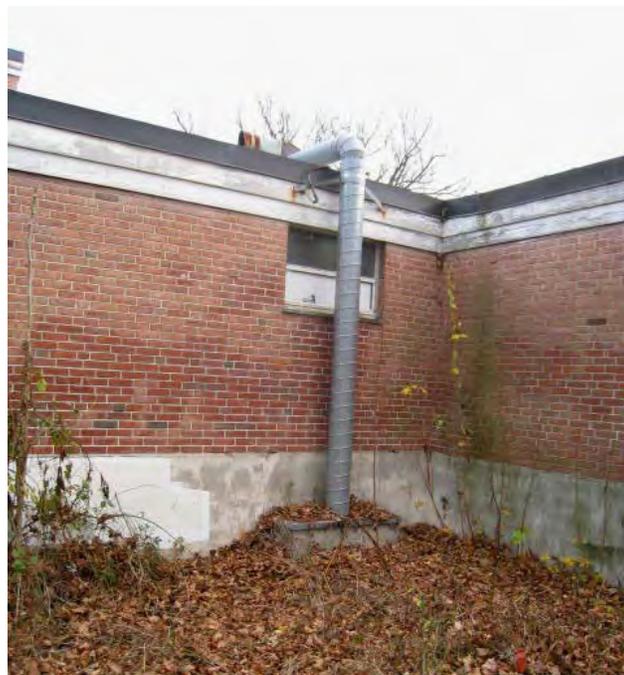
Picture 14

Ductwork connecting exhaust fan to passive vent

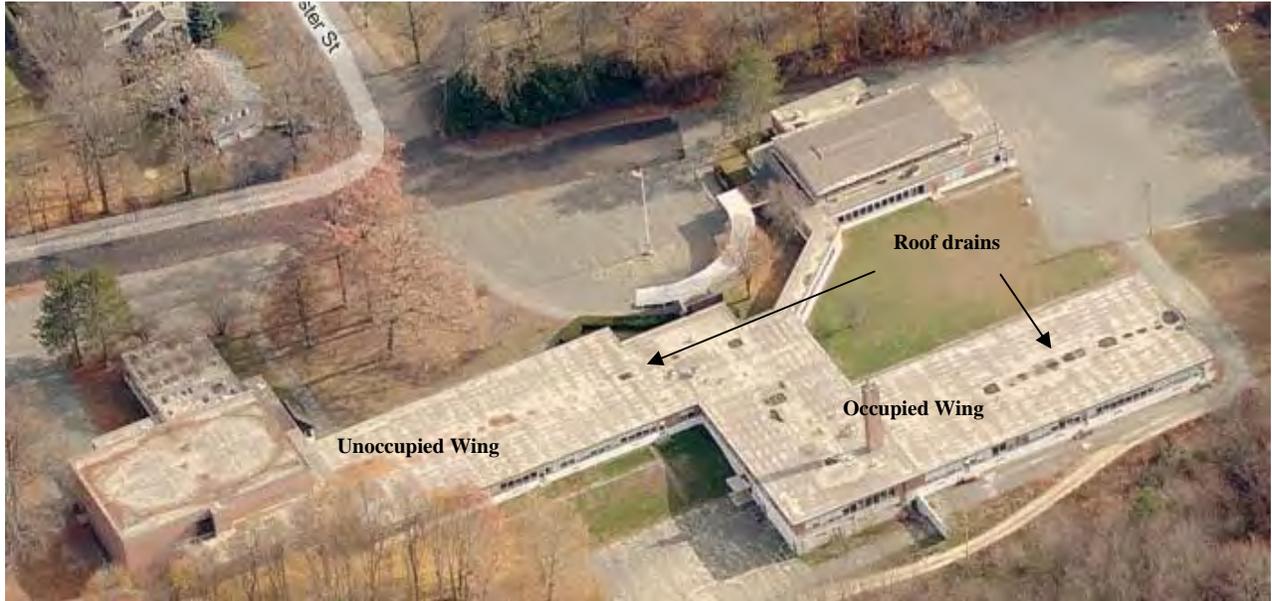
Picture 15

Roof drains located at the center of roof (i.e., along hallway) of each wing. A roof is typically pitched to move water towards the drain, indicating that the roof is convex. (Image source: Bing.com/Maps)

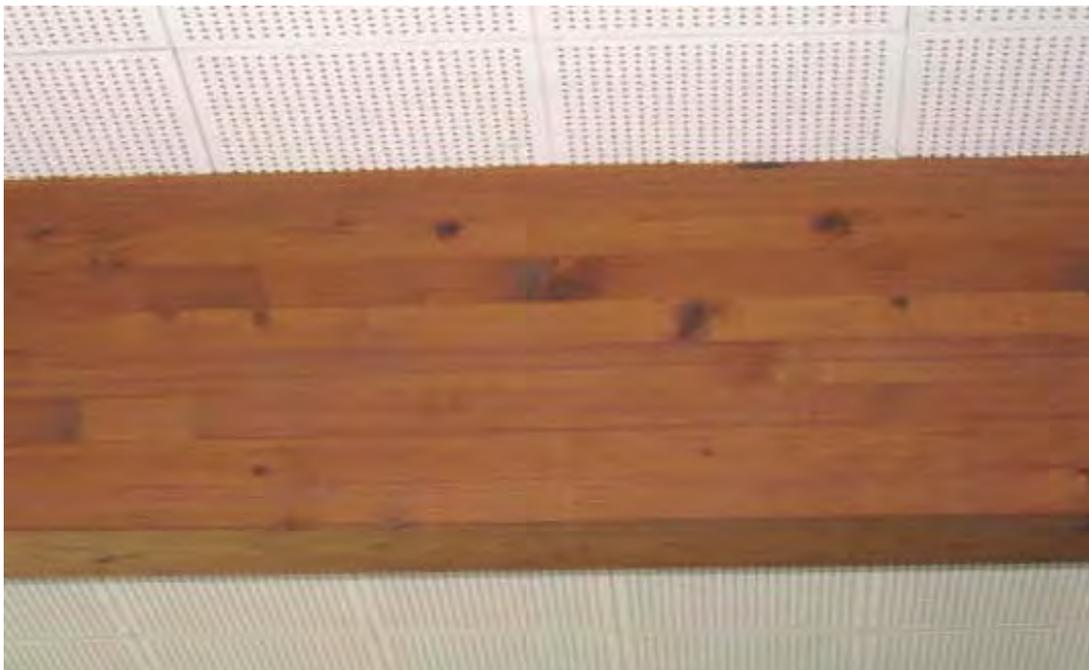
Picture 16

Eight layers of engineered wood glued together to form a laminated beam

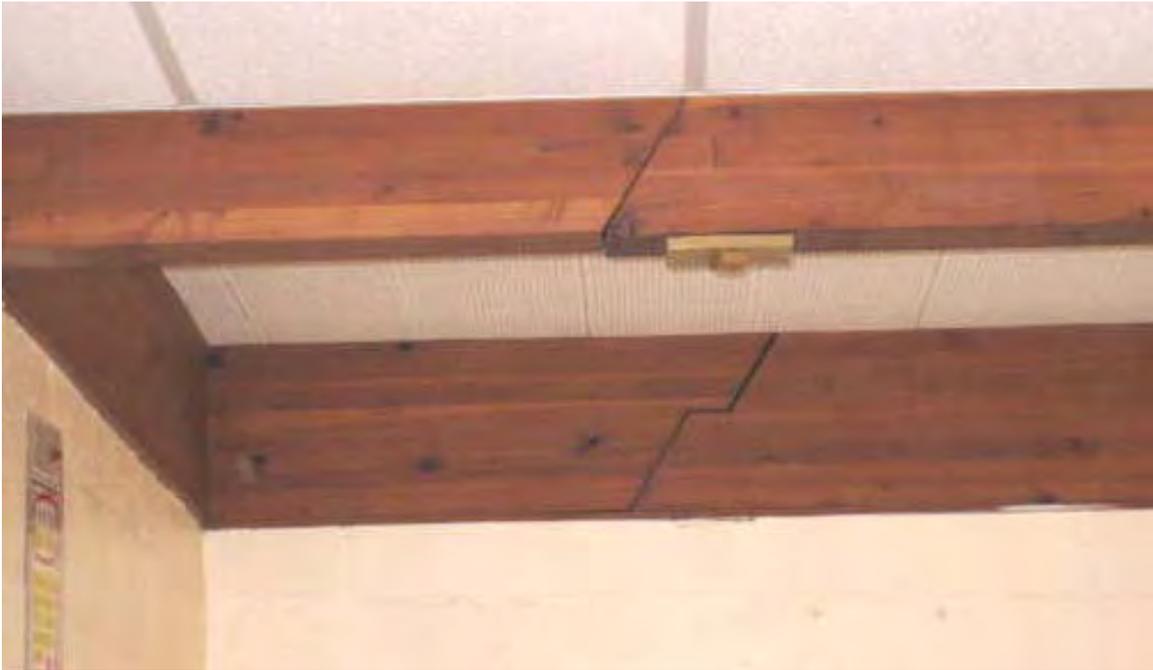
Picture 17

Wooden bolt joining hallway beam (left) to classroom beam (right)

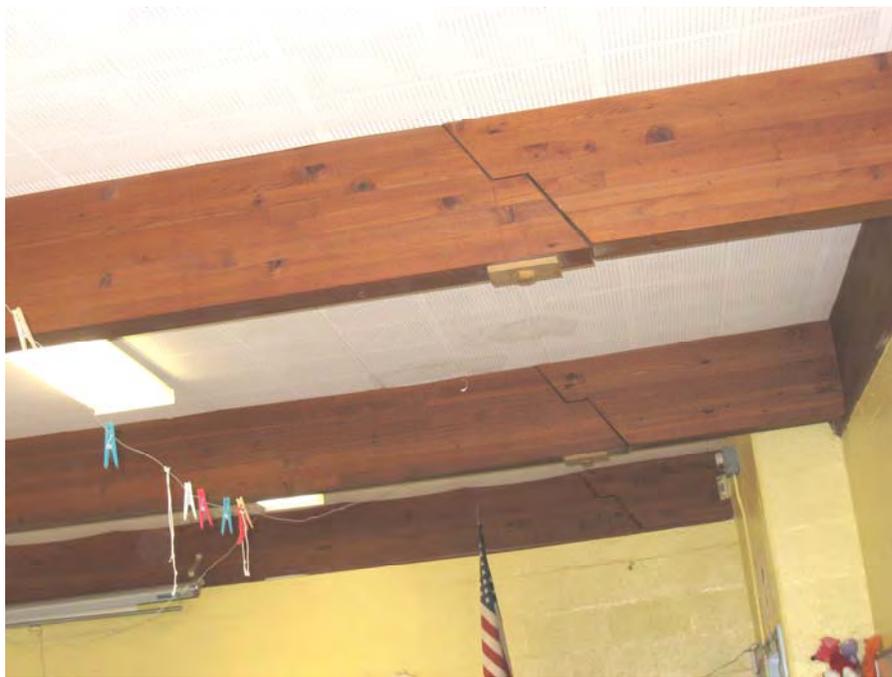
Picture 18

Vertical shift (downwards movement) creating space between two roof beams

4. Repair work to the roof would likely require a means to support the underside of each joint for each beam (not beneath a load bearing interior wall), in addition to the bolt connected the end to the roof. In each of these remedies, an engineering firm should be retained in order to examine the feasibility and cost of rendering the unoccupied wing safe for occupancy. The possible options may include, but are not limited to the following possibilities:

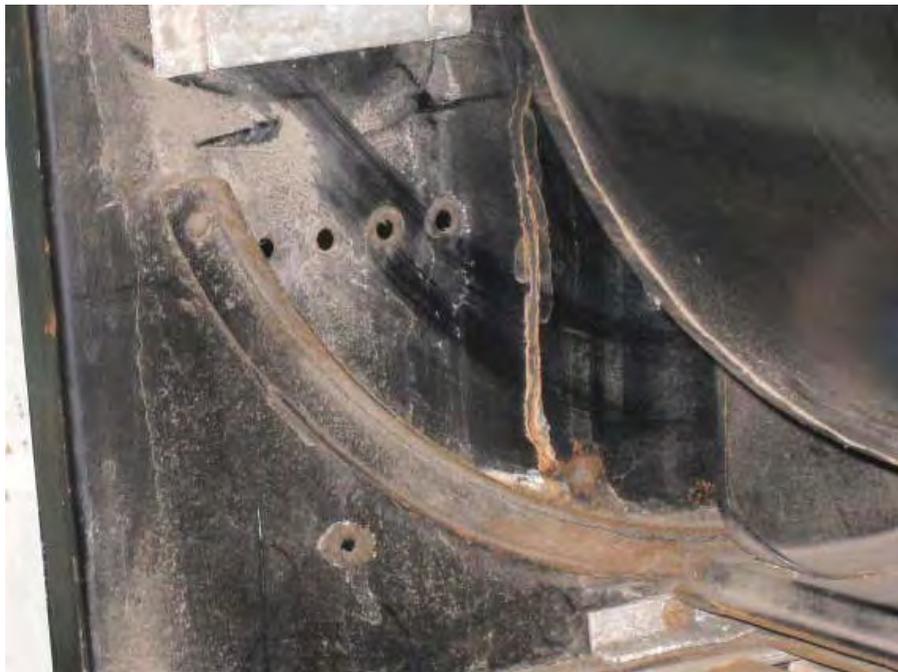
Picture 20

The interiors of some univents were examined. Spaces and holes in the wall, floor, around pipes, and within the air-handling cabinet were observed (Pictures 20 and 21). These breaches can serve as pathways for air, odors and particulates to be drawn from the crawlspace into classrooms. Breaches in cabinet walls allow draw of air, post-filtration.

Holes in univent cabinet wall

12. Repair cracks in the exterior cement walls and brick work
13. Seal open utility holes around plumbing fixtures beneath sinks.
14. Seal holes in univent cabinets.

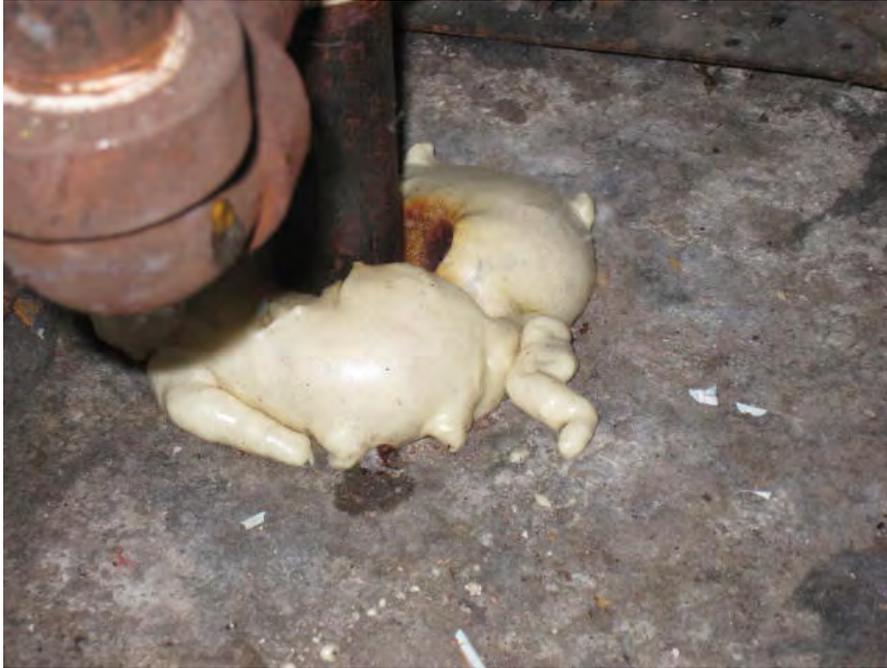
Picture 21

Space around pipe (with deteriorating old spray foam)

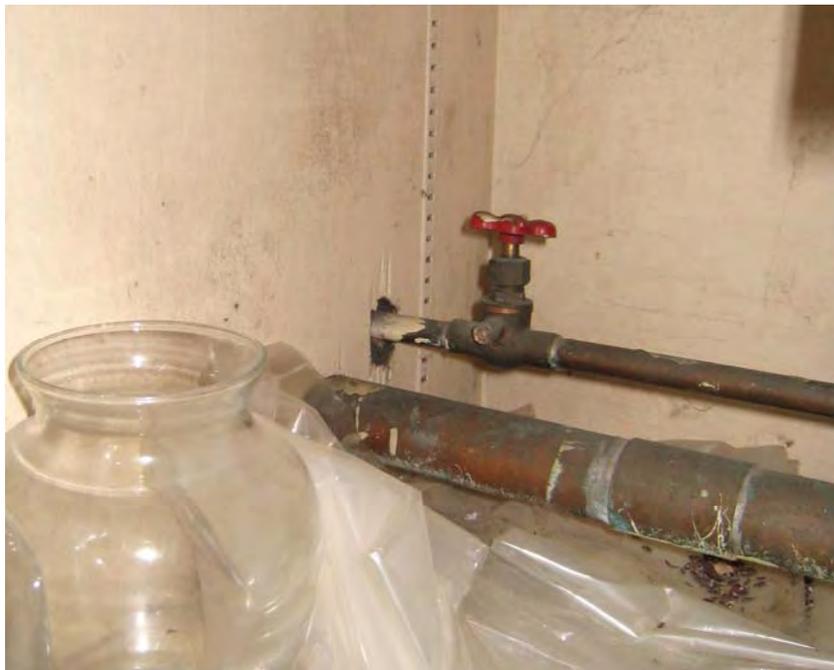
Picture 22

Similar breaches were observed around water utility pipes for sinks (Picture 22). Breaches around these water pipes can allow for air from the crawlspace to enter classrooms. Air penetration is magnified when the exhaust ventilation is operating, since exhaust vents are adjacent to the sinks in some classrooms.

Space around sink pipe

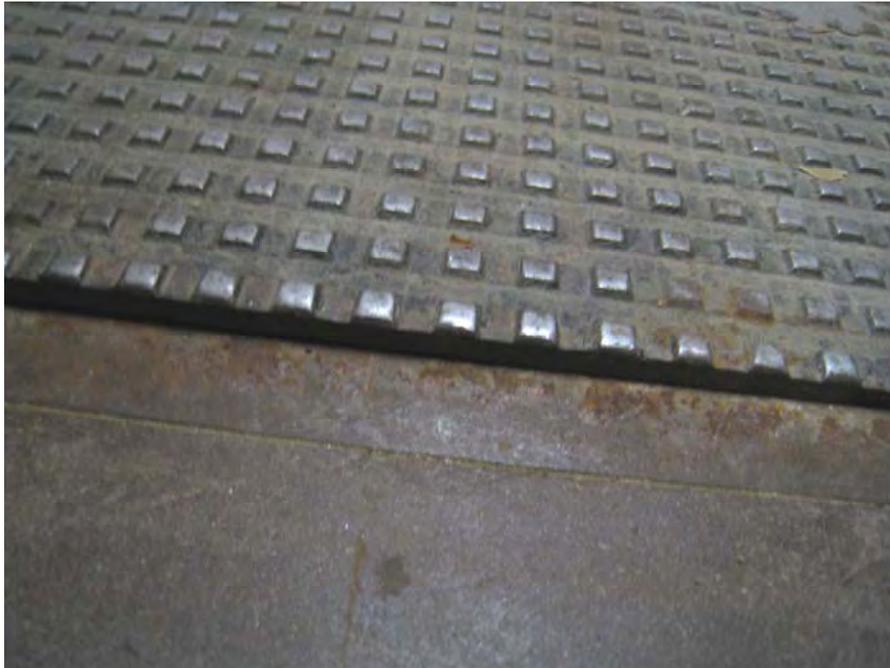
Picture 23

Musty odors were detected in the AV storage room, where a crawlspace access door was observed. The door to the crawlspace access was not flush to the floor (Picture 23), which can allow materials/odors from the crawlspace to migrate into occupant areas. Measures should be taken to render the access door airtight to prevent penetration of odors into the AV storage room.

Crawlspace access not flush

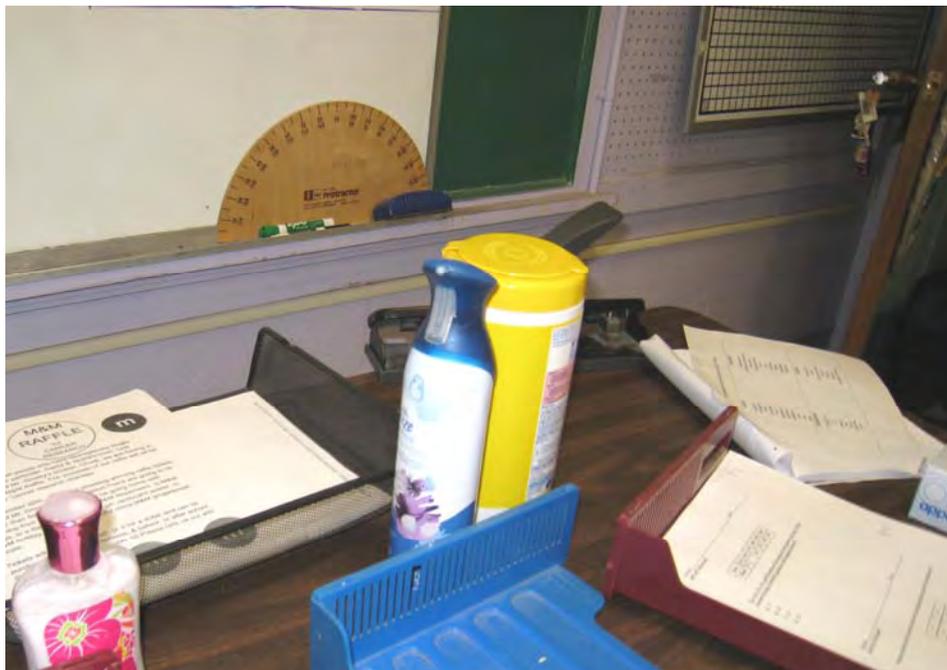
Picture 24

Household cleaning products, air fresheners and deodorizing materials were found in several areas (Picture 24, Table 1). Cleaning products and air deodorizers contain chemicals that can be irritating to the eyes, nose and throat of sensitive individuals. Many air fresheners contain 1,4-dichlorobenzene, a VOC which may cause reductions in lung function (NIH, 2006). Furthermore, deodorizing agents do not remove materials causing odors, but rather mask odors that may be present in the area. Additionally, a Material Safety Data Sheet (MSDS) should be available at a central location for all school chemicals in the event of an emergency such as an adverse chemical interaction between residues left from cleaners used by the facilities staff and those left by cleaners brought in by others.

Cleaning products and air deodorizers

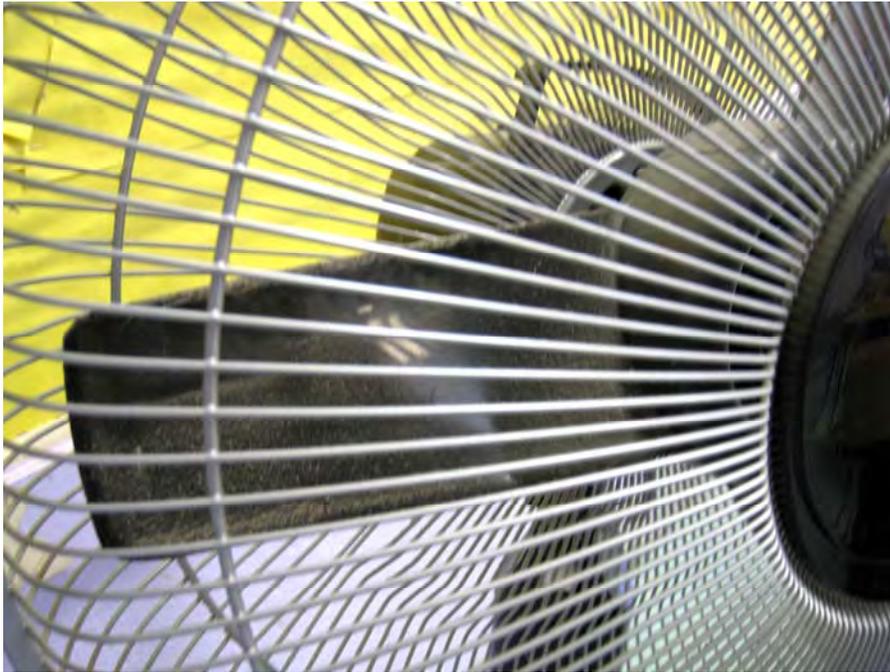
Picture 25

Dust on fan blade

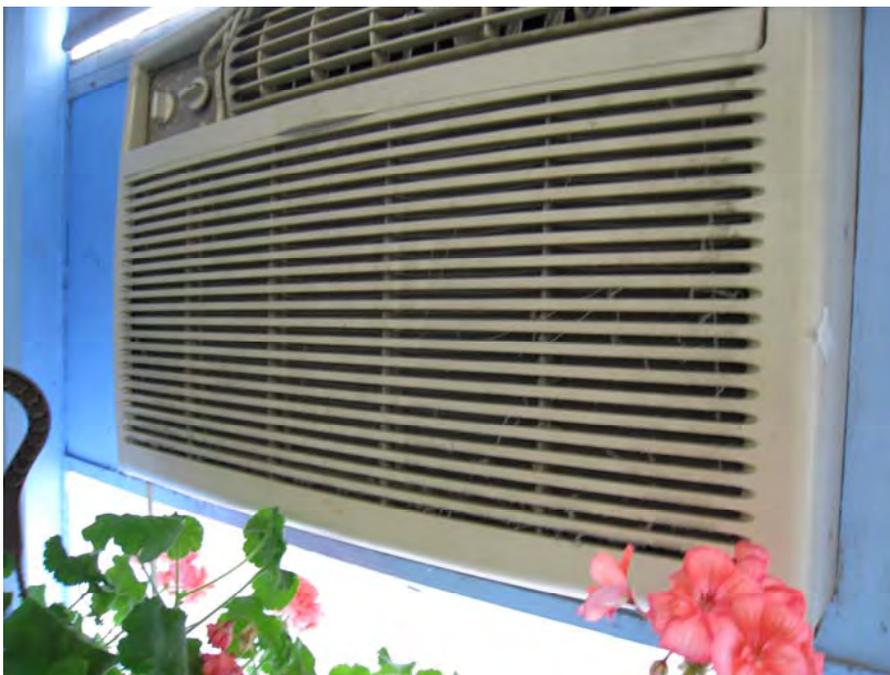
Picture 26

Air-conditioner occluded with dust

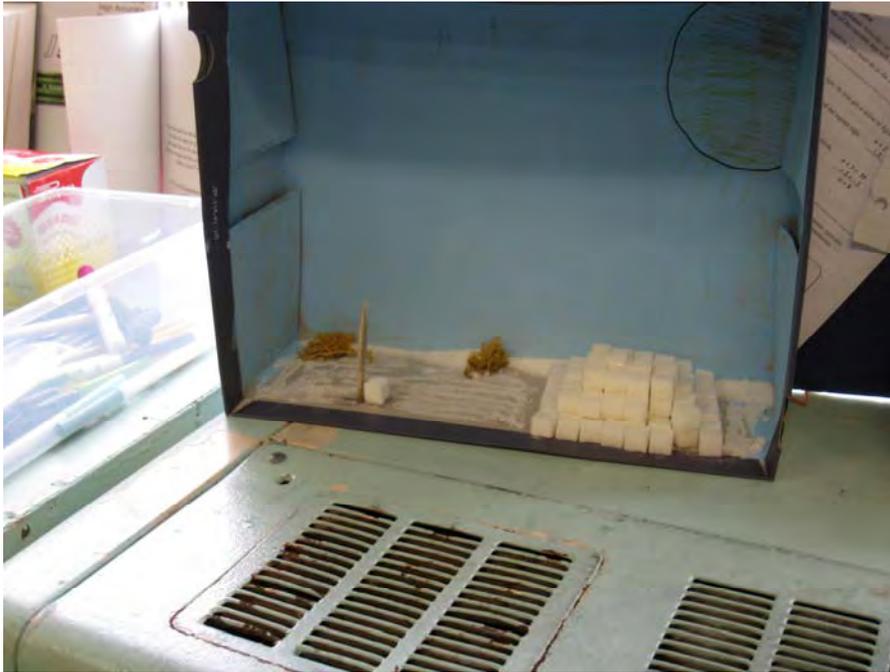
Picture 27

Open food items were seen in classrooms, including being used as art materials (Picture 27). Food is an attractant to pests and rodents. Proper food storage is an integral component in maintaining IAQ. Food should be properly stored and clearly labeled. Where food products are used in art, the artwork should be stored/displayed in a container or the food components should be treated in a manner that does not attract pests (i.e., non-toxic white glue sealant or other clear coat product). Reuse of food containers is not recommended, since food residue adhering to the surface may serve as an attractant to pests.

Food as art; note placement on univent, which can distribute dried food particles throughout room
