INDOOR AIR QUALITY ASSESSMENT

**Drewicz Elementary School
34 Hood Street
Lynn, Massachusetts**

Prepared by:
Massachusetts Department of Public Health
Bureau of Environmental Health
Indoor Air Quality Program
March 2012

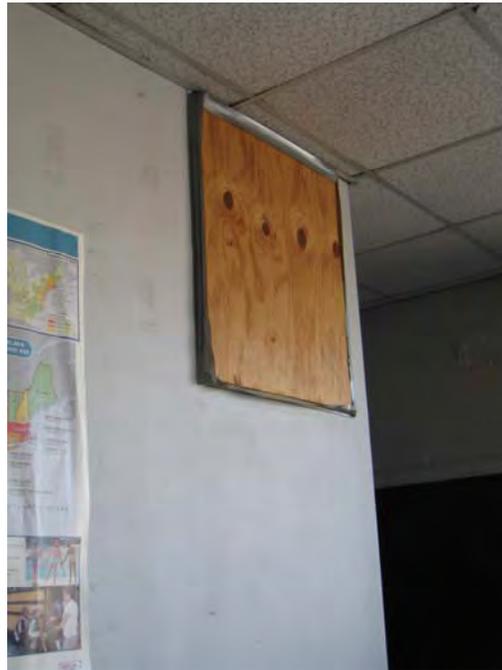
Picture 1

Classrooms are constructed around these shafts to provide exhaust ventilation. The draw of air into these exhaust vents is typically controlled by a draw chain pulley system, which is designed to set the flue in the ventilation shaft at a desired angle to adjust airflow. In this type of system, air movement is provided by the stack effect. Heating elements located in the base of the ventilation shaft warm the air, which rises up the ventilation shaft. As the heated air rises, negative pressure is created, which draws cold air from the enclosed air-mixing room in the basement into the heating elements/ventilation shaft. This system was designed to draw in outside air from windows in the air-mixing room (Pictures 2 and 6). Due to age, condition of the terra cotta structures that form the system, and general disrepair, this system appears to have been abandoned for some time. Plywood has been used to seal vents located in each of the classrooms.

Sealed ventilation grate in classroom

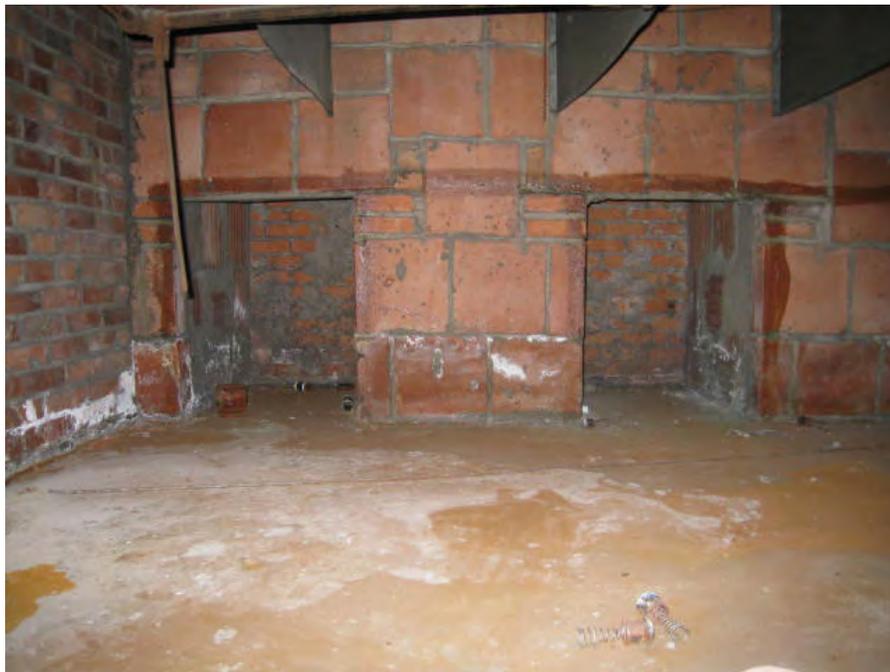
Picture 2

Air-mixing room in the basement

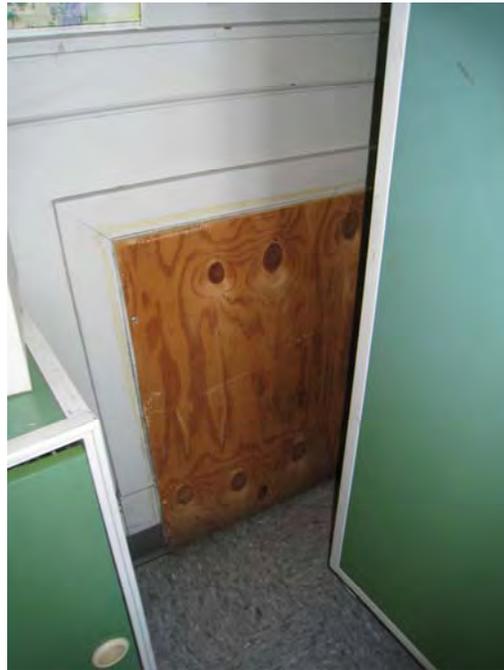
Picture 3

Sealed floor-level exhaust vent

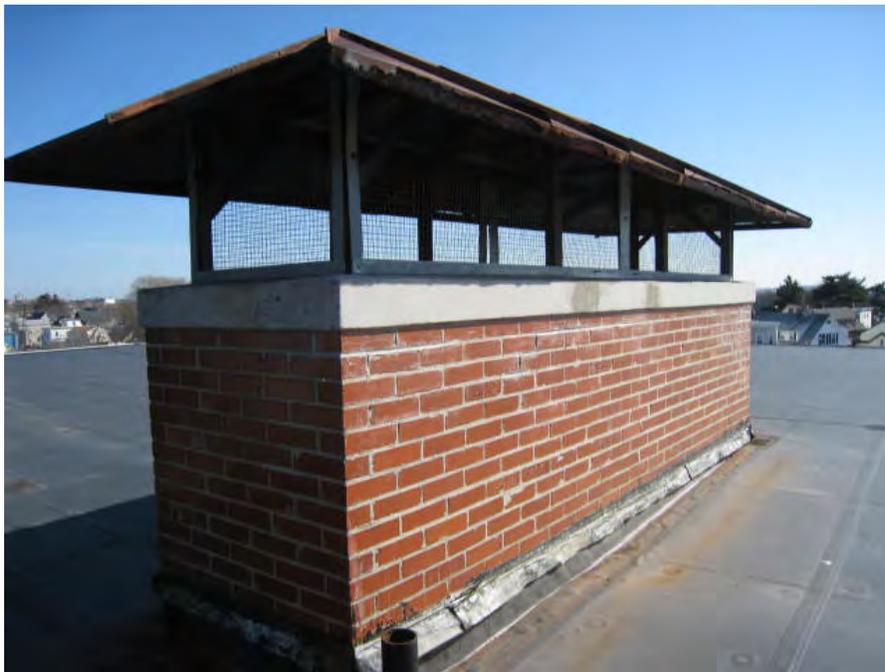
Picture 4

Exhaust ventilation shaft terminus on roof

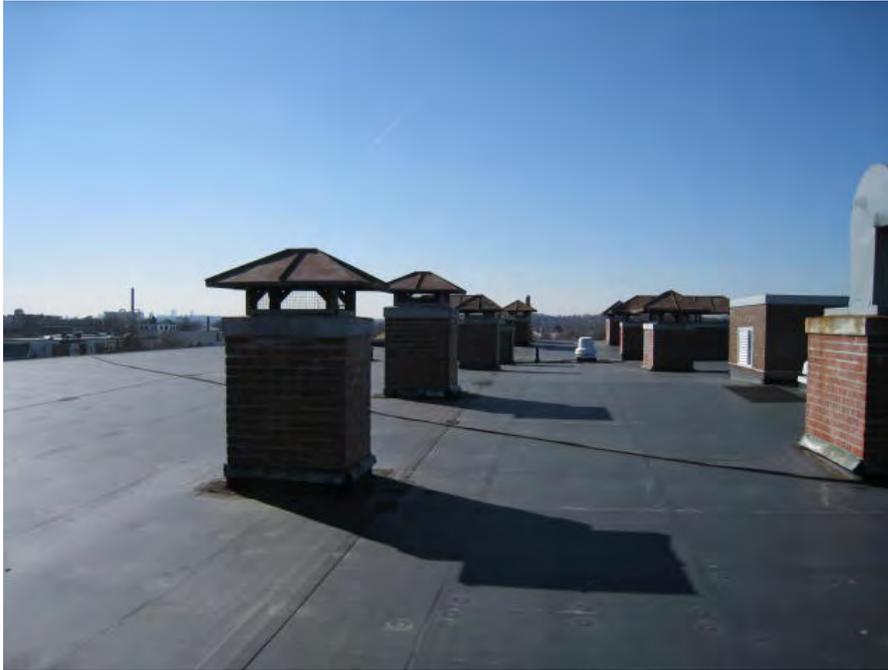
Picture 5

Exhaust ventilation shafts

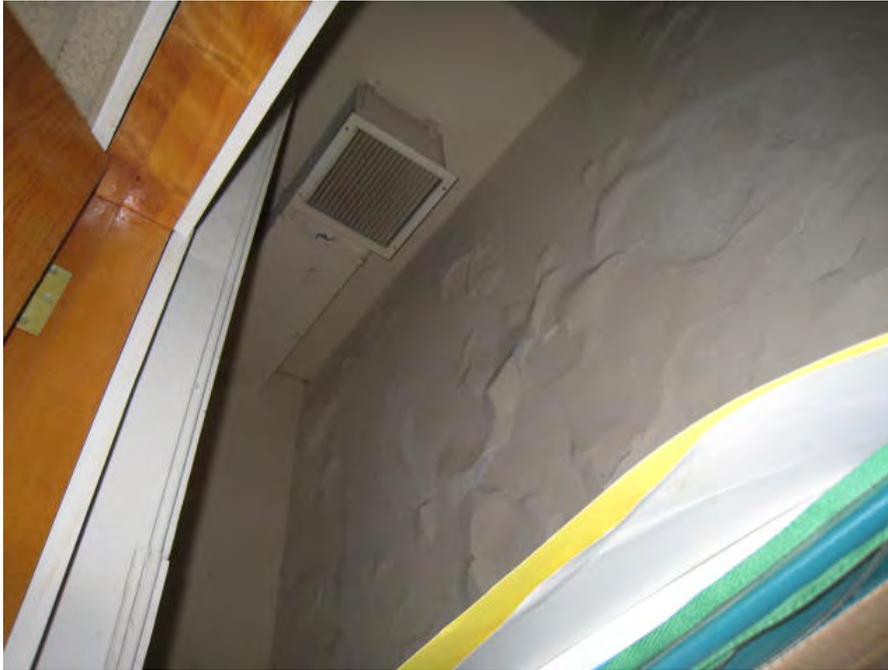
Picture 7

A second exhaust vent located in the coat closet of each classroom (Picture 7) is also ducted to an air vent that exhaust to the roof. Please note, in some cases, vents were blocked by materials stacked in the closet. This closet exhaust functions in a manner similar to the original system, relying on heated air generated by radiators to remove air from classrooms through shafts in the rooftop via the stack effect. These vents were not sealed at the time of assessment. The stack effect likely results in some air movement up these ducts, allowing air to exit via the bird-screened vent. However, when indoor temperatures are cooler than outdoor temperatures backdrafting can occur, allowing accumulated debris within the ductwork to become aerosolized in the indoor environment. Exposure to irritants/debris from the closet exhaust is limited since most closet doors are generally closed. Installation of an exhaust fan at the roof terminus of these vents would create active exhaust capabilities to remove waste heat/normally occurring indoor air pollutants from the classroom and prevent any backdrafting from occurring.

Exhaust vent in classroom closet (also note peeling paint on walls)

1. Consider installing rooftop motors on ductwork currently connected to the closet exhaust vents. If this cannot be achieved, consider temporarily sealing closet vents until such equipment can be installed. Sealing of these vents would prevent movement of materials when backdrafting occurs.
2. Contact an HVAC engineering firm for a building-wide ventilation systems assessment. Based on issues with air exchange/IAQ complaints, age, physical deterioration and availability of parts for ventilation components, such an evaluation is necessary to determine the operability and feasibility of repairing/replacing HVAC equipment or

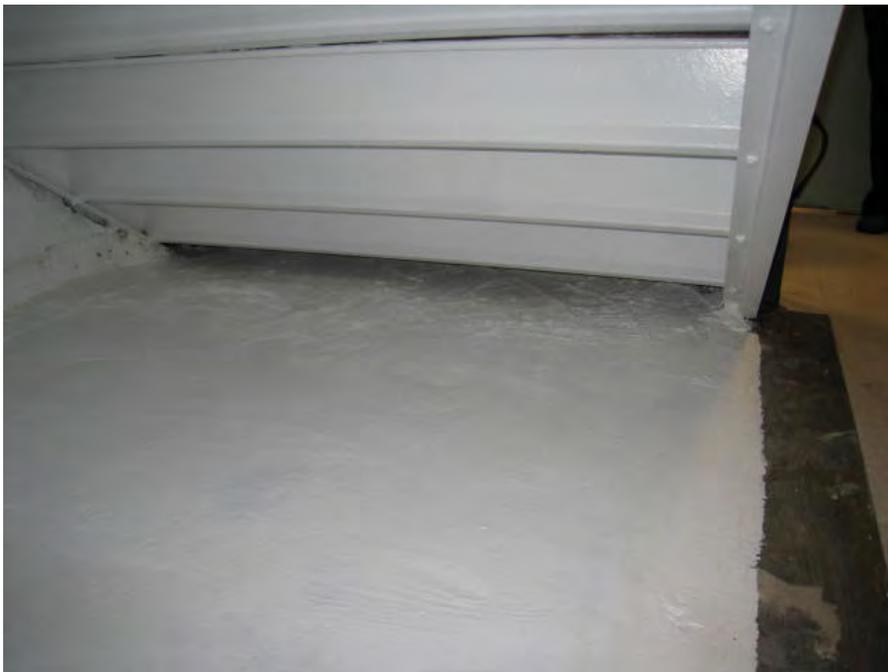
Picture 8

As mentioned, the DES has experienced several water-related events that have resulted in damage in the school. Most recently, a leaking pipe under a stairwell on the lower level resulted in mold growth. This leak reportedly occurred in late January 2012. Once the leak was reported, DES staff reportedly contacted the City Maintenance Department for assistance regarding removal/abatement and disinfection of this area. At the time damage occurred, the gypsum wallboard that formed walls, including the wall enclosing the space was damaged. When the space was examined, the floor was reportedly only partially cement finished, with a portion still consisting of dirt/soil. DES staff indicated a noticeable odor was observed in the area at the time the leak occurred and during remediation of this space. At the time of the MDPH assessment, City and School Department staff reported that the leak had been repaired; gypsum wallboard had been removed, cleaned and repainted; and cement was poured to form a solid floor in the area below the staircase (Picture 8). No staining or musty odors were noted at the time of the MPDH visit. It was reported that the plan was to limit access to this space by enclosing it with screen or lattice to allow airflow and for the detection of any subsequent leaks.

Under-stair area, site of recent leak, now repaired

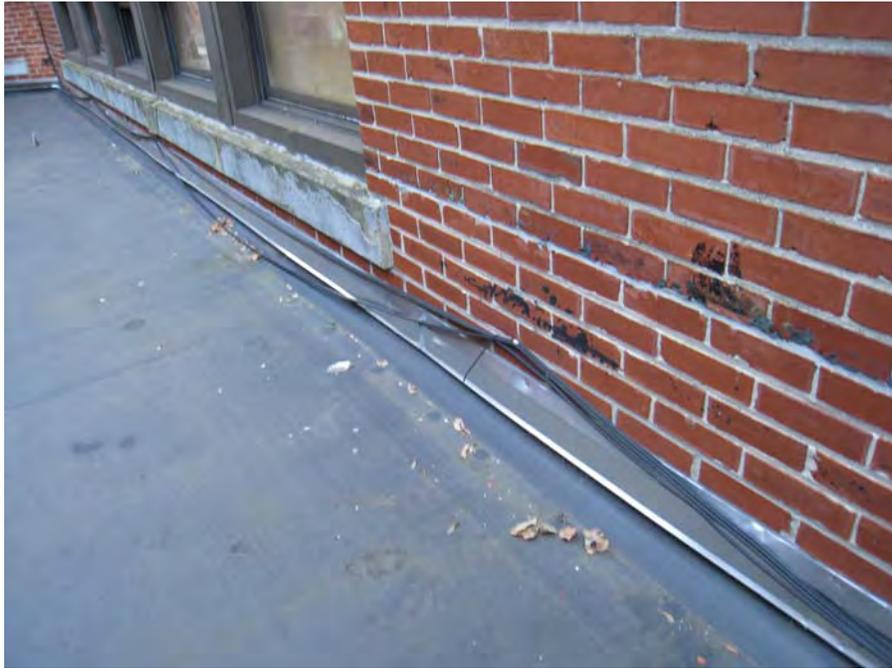
Picture 9

MDPH staff also examined the roof area accessible to the Conference Room/Nurse's Office. This roof was reportedly replaced within the last 10 years. MDPH staff observed damage to the exterior wall of this room (Picture 9), especially along where the metal roof flashing is

Nurse's office exterior wall damage

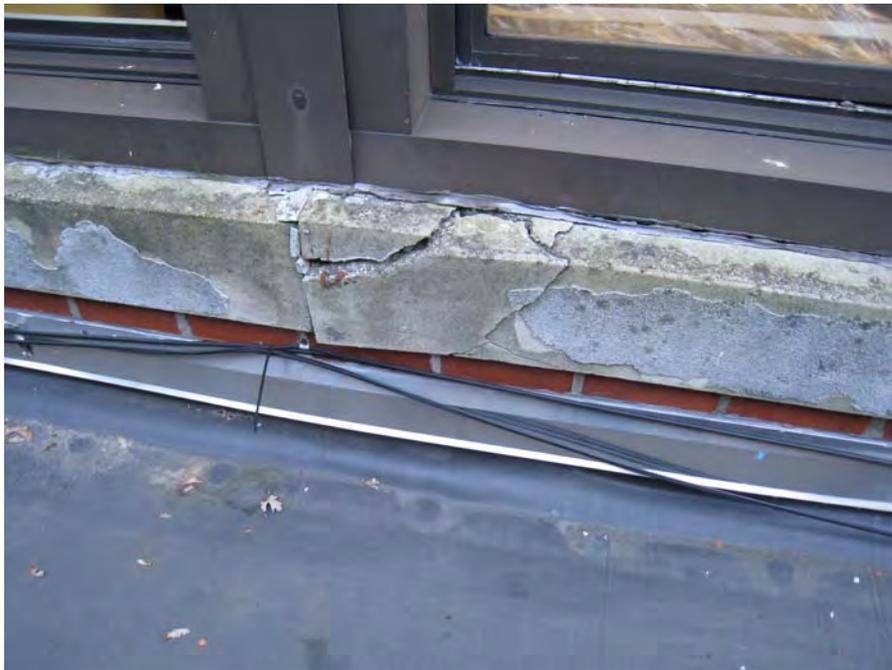
Picture 10

flashing is inserted into the exterior wall. Damaged window ledges were also observed (Picture 10). The condition of these ledges indicates that water is likely penetrating into the wall space behind brickwork and exiting via metal roof flashing. The movement of water out of the building likely resulted in damage to brickwork. Moisture remaining in the wall space may also contribute to prolonged moisture exposure of walls and flooring materials in this room.

Damaged window ledge outside nurse's office

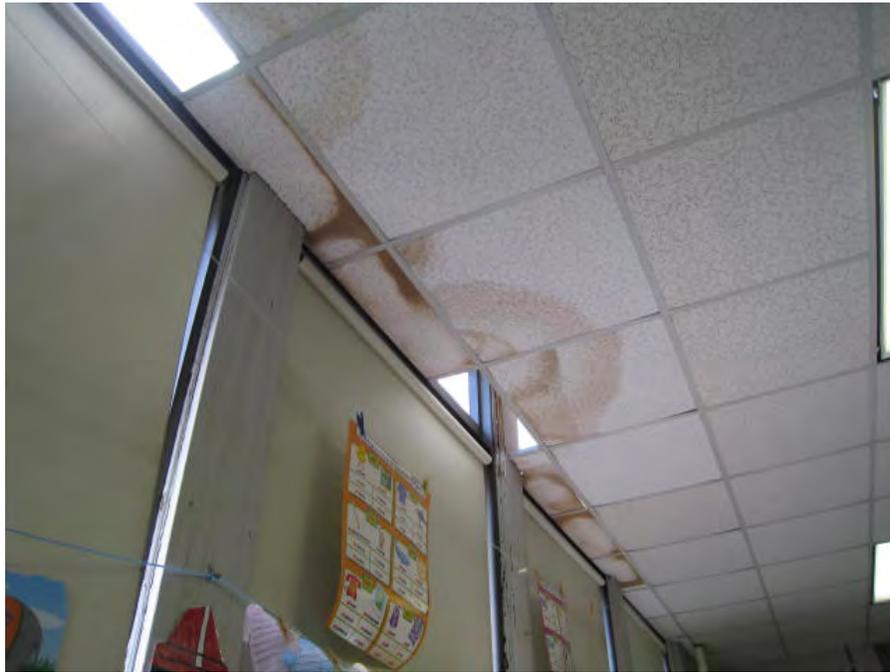
Picture 11

Water-damaged ceiling tiles were observed in many classrooms (Picture 11, Table 1). These were noted mostly along the area near the windows, suggesting that wind-driven rain or rainwater flowing down the building may be infiltrating into the brickwork. Water-damaged ceiling tiles can provide a source for mold growth and should be replaced after a water leak is discovered and repaired.

Water-damaged ceiling tiles near windows in classroom

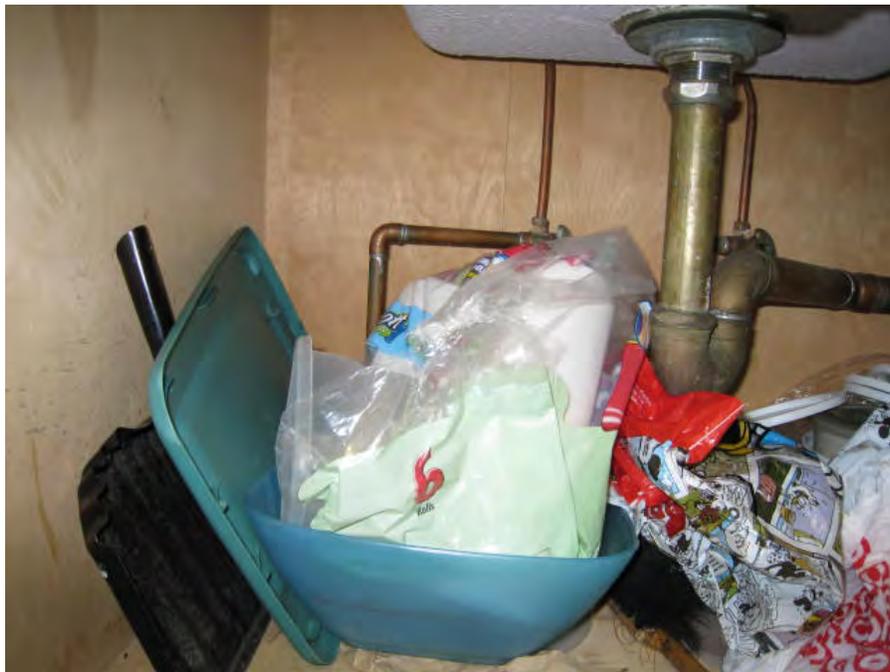
Picture 12

The sinks present in some classrooms were examined for water tightness between the backsplashes and countertops, and there were spaces observed in some of them (Table 1). If these seams are not watertight, water can penetrate through the seam, causing water damage. Improper drainage or sink overflow can lead to water penetration into the countertop, cabinet interior and areas behind cabinets. Water penetration and chronic exposure of porous and wood-based materials can cause these materials to swell and show signs of water damage. Classroom sinks were also found to have porous materials (e.g., cardboard, paper, cloth; Picture 12) stored beneath them where they may be subject to moisture. Repeated moistening of porous materials can result

Items stored under sink in classroom

5. Scrape and clean loose/bubbling paint from ceilings and walls. Refinish as needed.
6. Seal breaches between sink countertops and backsplashes to prevent water damage. Avoid storage of porous materials under sinks.

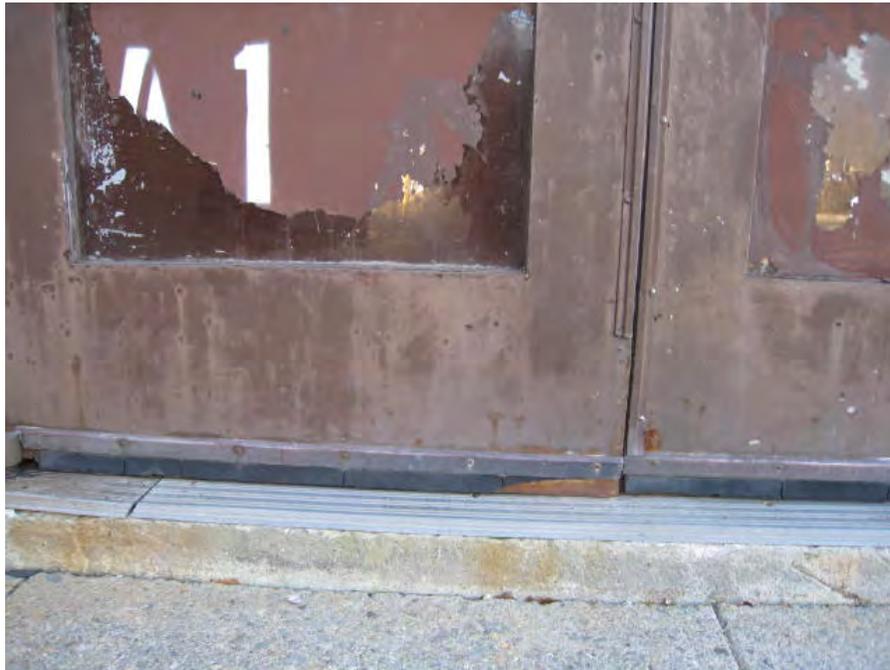
Picture 13

BEH staff examined the outside perimeter of the building to identify breaches in the building envelope and/or other conditions that could provide a source of water penetration. One of the doors along the side of the building had visible gaps beneath it (Picture 13), which can allow moisture to enter the building. In addition, these breaches can allow insects and rodents access to the building. A ¼-inch breach is enough space for rodents to enter a building.

Damaged sweep/gaps under exterior door

10. Ensure doors are tight to prevent entry of moisture and pests.
11. Where food products are used in art, the artwork should be stored/displayed in a container or the food components should be treated in a manner that does not attract pests (i.e., non-toxic white glue sealant or other clear coat product).

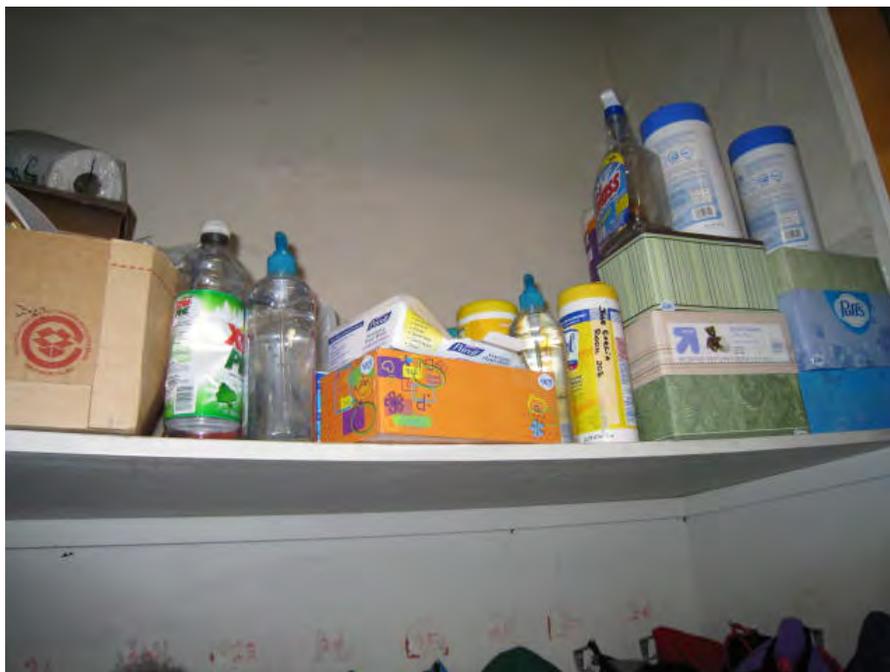
Picture 14

Household cleaning products, air fresheners and deodorizing materials were found in several areas (Picture 14, Table 1). Cleaning products and air deodorizers contain chemicals that can be irritating to the eyes, nose and throat of sensitive individuals. Many air fresheners contain 1,4-dichlorobenzene, a VOC which may cause reductions in lung function (NIH, 2006). Furthermore, deodorizing agents do not remove materials causing odors, but rather mask odors that may be present in the area. Additionally, a Material Safety Data Sheet (MSDS) should be available at a central location for all school chemicals in the event of an emergency such as an

Cleaning products in classroom closet

8. Ensure staff are provided with the school-sanctioned cleaning products with appropriate MSDSs and keep them out of reach of students. Remove/discard any household cleaners and air deodorizing materials.

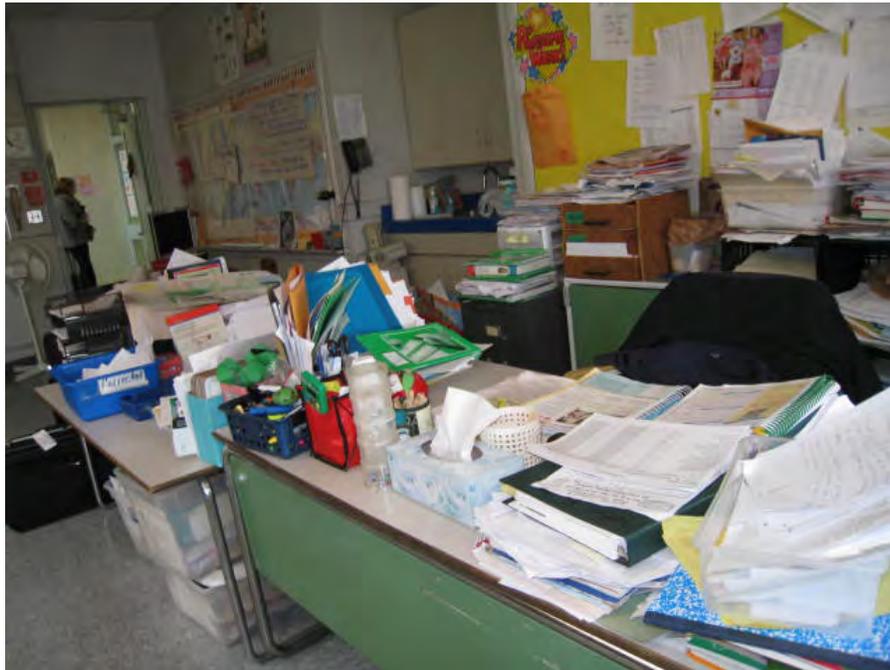
Picture 15

In several classrooms, items were observed on the floors, windowsills, tabletops, counters, bookcases and desks (Picture 15). The large number of items stored in classrooms provides a source for dusts to accumulate. These items (e.g., papers, folders, boxes) make it difficult for custodial staff to clean. Items should be relocated and/or be cleaned periodically to avoid excessive dust build up. In addition, these materials can accumulate on flat surfaces (e.g., desktops, shelving and carpets) in occupied areas and subsequently be re-aerosolized causing

Items/clutter in classroom

13. Relocate or consider reducing the amount of materials stored in classrooms to allow for more thorough cleaning of classrooms. Clean items regularly with a wet cloth or sponge to prevent excessive dust build-up. Use of plastic totes for storage of items not in use will allow for more thorough cleaning.
14. Professionally clean upholstered furniture on an annual basis, if not feasible consider removing.
15. Consider adopting the US EPA (2000) document, “Tools for Schools”, to maintain a good indoor air quality environment in the building. This document can be downloaded from the Internet at <http://www.epa.gov/iaq/schools/index.html>.
16. Refer to resource manuals and other related indoor air quality documents for further building-wide evaluations and advice on maintaining public buildings. Copies of these materials are located on the MDPH’s website: <http://mass.gov/dph/iaq>.

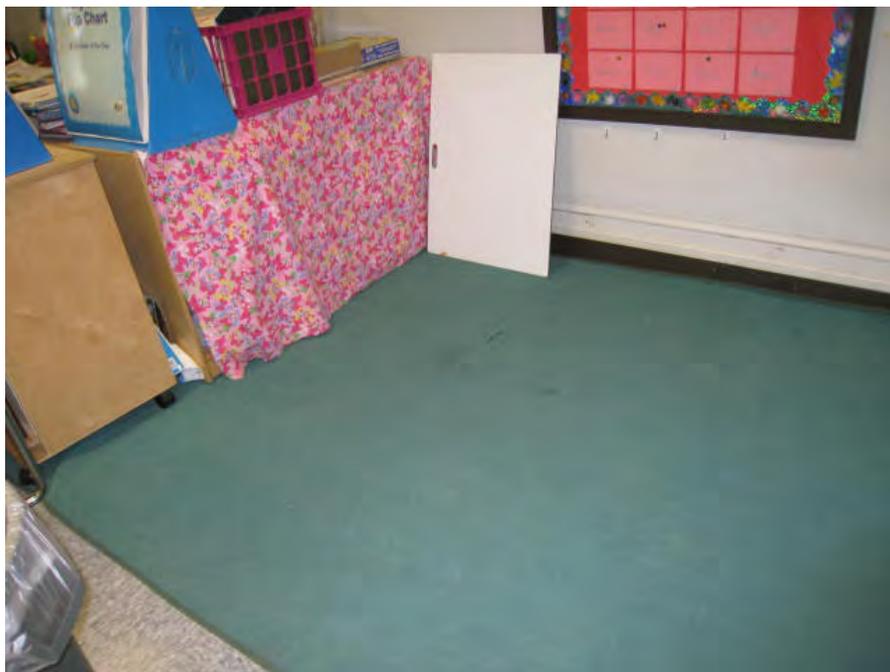
Picture 16

Upholstered furniture, plush toys and area carpets were observed in several classrooms (Picture 16; Table 1). In addition, upholstered furniture is covered with fabrics that are exposed to human skin. This type of contact can leave oils, perspiration, hair and skin cells. Dust mites feed upon human skin cells and excrete waste products that contain allergens. In addition, if relative humidity levels increase above 60 percent, dust mites tend to proliferate (US EPA, 1992). In order to remove dust mites and other pollutants, frequent vacuuming of upholstered furniture is recommended (Berry, 1994). It is also recommended that upholstered furniture (if present in schools), be professionally cleaned on an annual basis. Where an excessively dusty environment exists due to outdoor conditions or indoor activities (e.g., renovations), cleaning frequency should be increased (every six months) (IICRC, 2000).

Area rug in classroom

12. Clean carpeting annually or semi-annually in soiled high traffic areas as per the recommendations of the Institute of Inspection, Cleaning and Restoration Certification (IICRC). Copies of the IICRC fact sheet can be downloaded at:
<http://www.certifiedcleaners.org/faq.shtml> (IICRC, 2005).

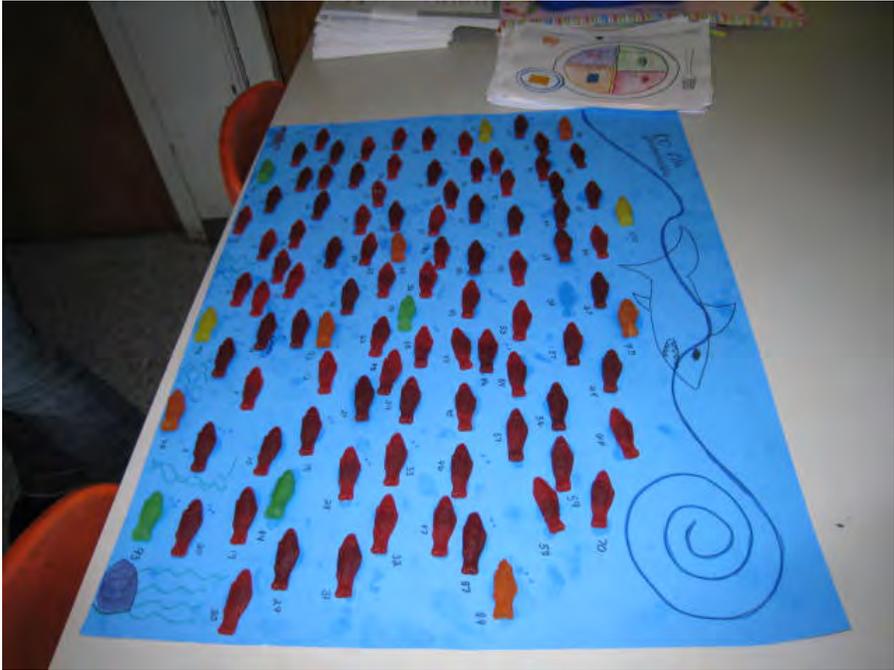
Picture 17

Open food items were seen in classrooms, including being used as art materials (Picture 17). Food is an attractant to pests and rodents. Proper food storage is an integral component in maintaining IAQ. Food should be properly stored and clearly labeled. Where food products are used in art, the artwork should be stored/displayed in a container or the food components should be treated in a manner that does not attract pests (i.e., non-toxic white glue sealant or other clear coat product). Reuse of food containers is not recommended, since food residue adhering to the surface may serve as an attractant to pests.

Food used as art material
