MOLD ASSESSMENT

**North Elementary School
580 Whetstone Hill Road
Somerset, Massachusetts**

Prepared by:
Massachusetts Department of Public Health
Bureau of Environmental Health
Indoor Air Quality Program
August 2012

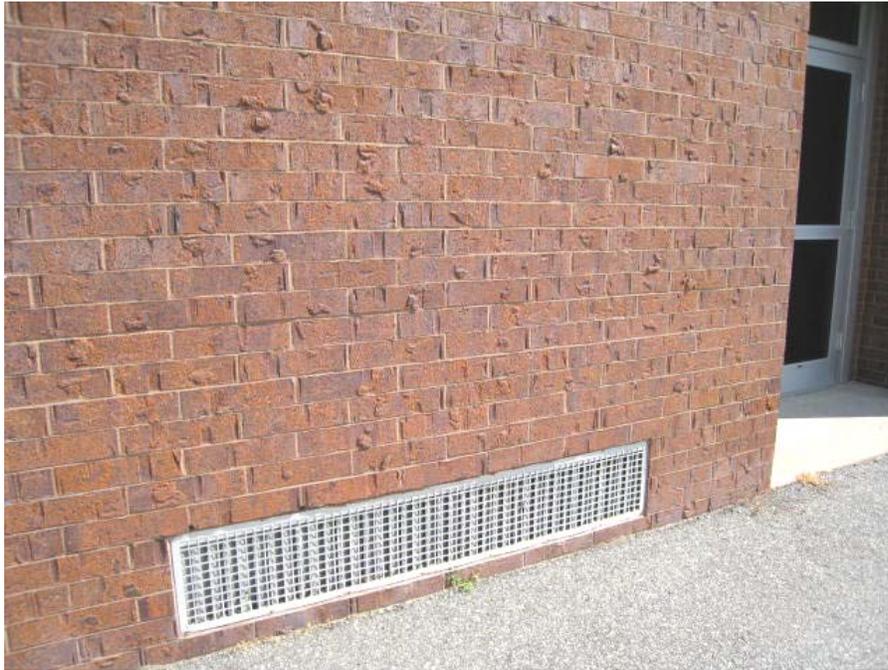
Picture 1

Univent air intake at ground level

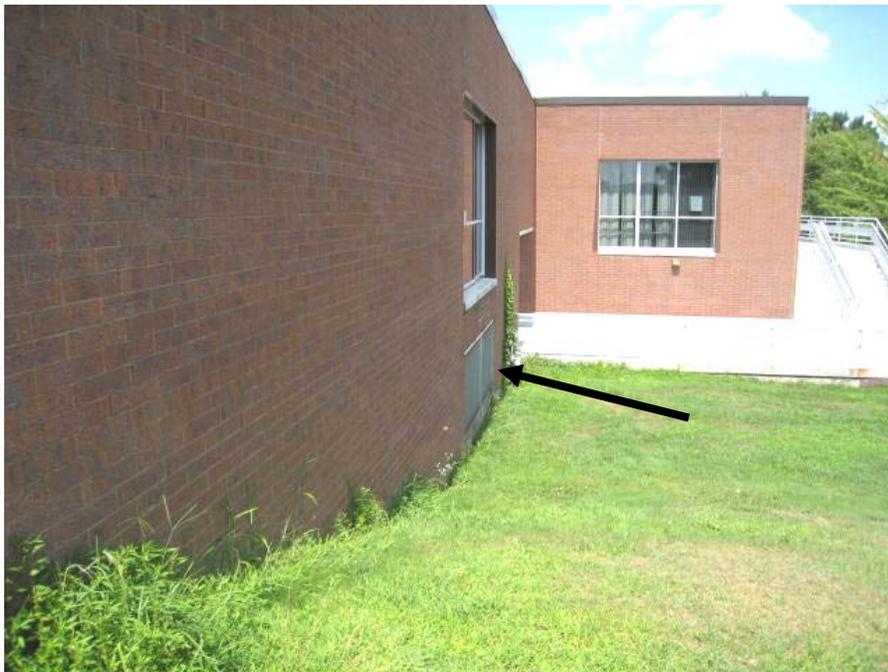
Picture 2

Univent air intake at ground level (arrow)

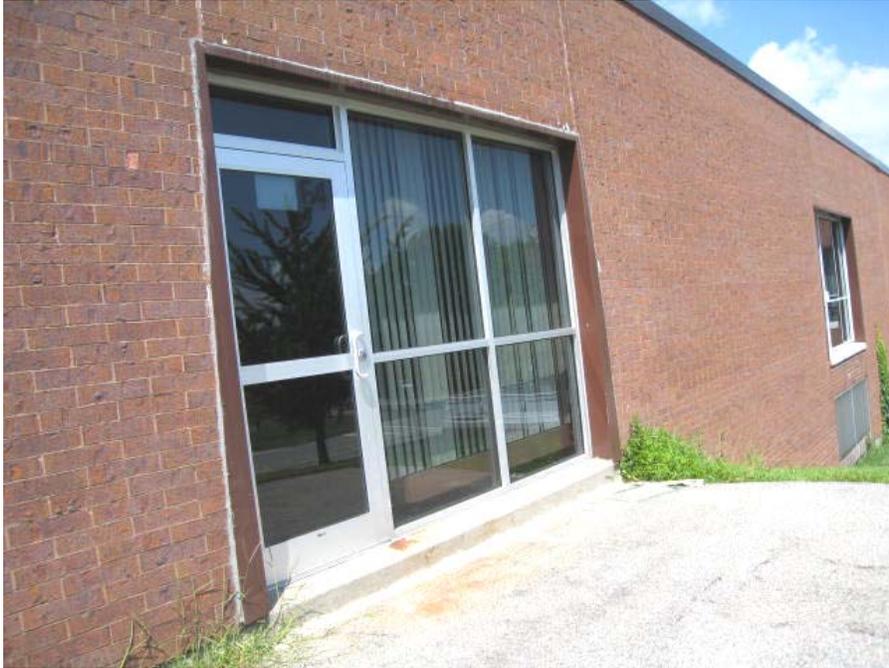
Picture 3

Exterior door with minimal rain protection

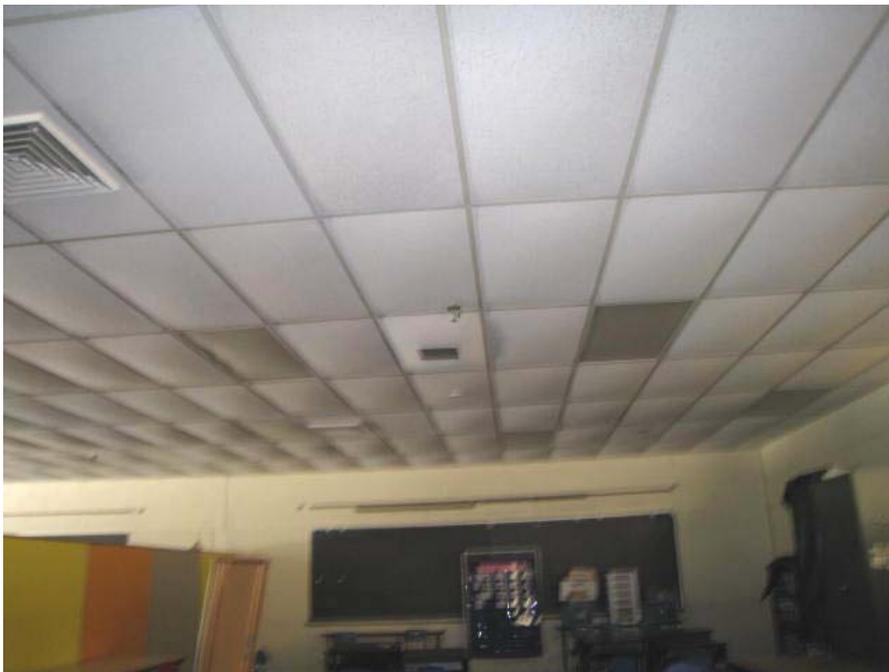
Picture 4

BEH staff conducted a visual inspection of the building and found no evidence of water damage attributable to roof or window leaks (such as stained ceiling tiles or damaged wall plaster). However, the ceiling tile system throughout the main floor was found to have significantly bowing tiles (Pictures 4 and 5). While this condition does not represent mold contamination, it suggests that there are chronic levels of water vapor/high relative humidity in the building. On the day of the assessment, the outdoor relative humidity was measured at 68 percent (Table 1). Thirty-four of the forty-one locations tested had relative humidity higher than the outdoor relative humidity (by one to eleven percent). In addition, thirty-two of these areas had a relative humidity of 70% or greater (Table 1). According to the American Society of

Heating Refrigeration and Air-Conditioning Engineers (ASHARE), sustained relative humidity indoors of 70 percent or greater can wet building components, which will then result in fungal growth (ASHRAE, 1989). The indoor relative humidity measurements indicate that a significant source of water vapor exists within the NES.

Ceiling in 5th grade area (old science area) showing bowed tiles

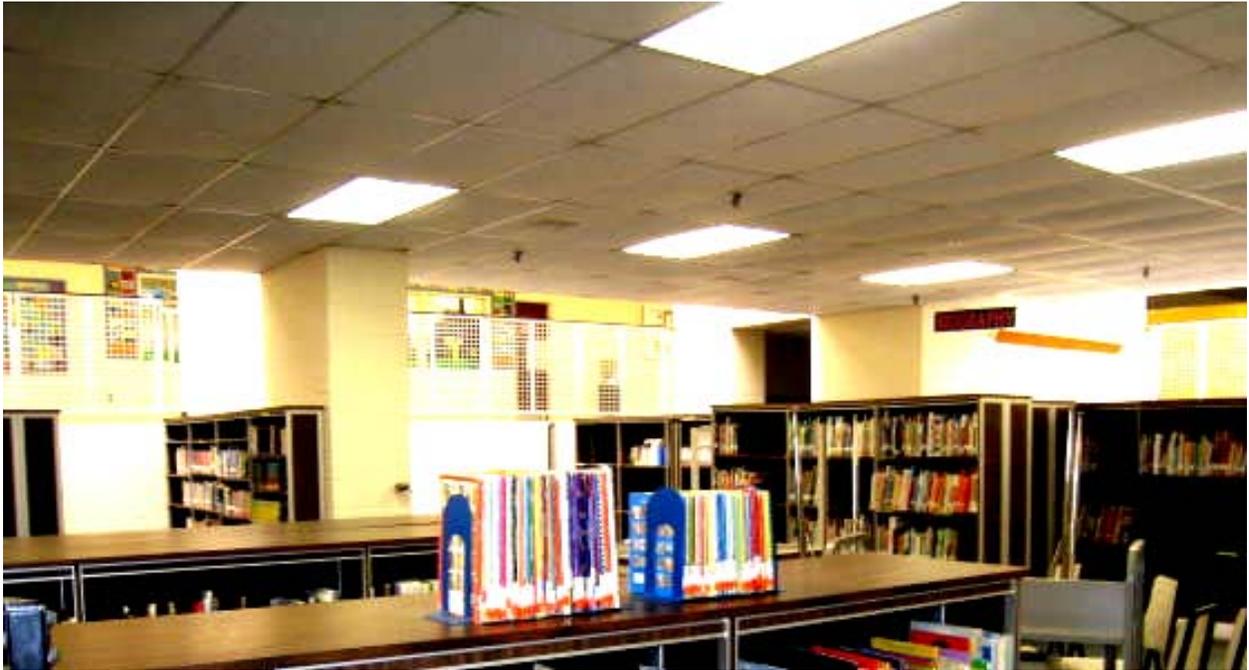
Picture 5

Bowed ceiling tiles in the library

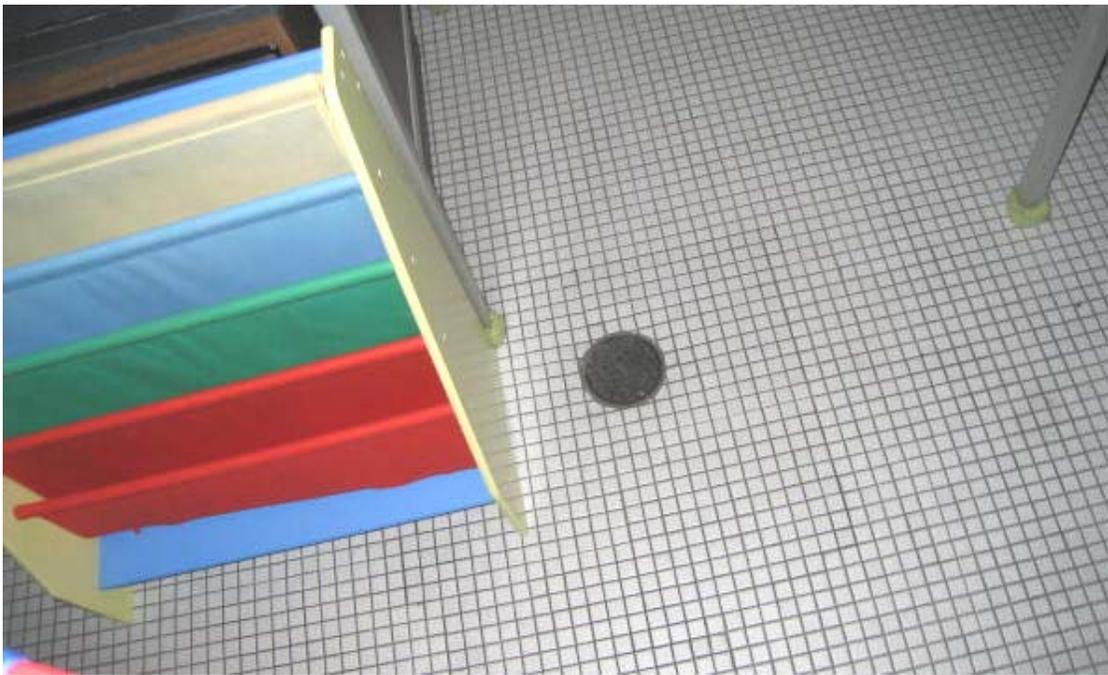
Picture 6

The most likely source of the high relative humidity noted in the building is in the center of the main floor bounded by Corridors A, B, C and D (Figure 1). This area originally served as a science area, and it contains multiple floor drains (Picture 6) and sinks (Picture 7), which are no longer in use since the conversion of the NES from a middle to an elementary school. All of the drains in these areas will have traps to prevent the backflow of gases (including methane) and water vapor from the sewer system back into the building; these traps rely on the regular introduction of water into the drain to maintain a seal. If the sinks are not in use, the traps will dry out and water vapor and gases from the drainage system can be drawn into the building and become a source of water vapor to the interior. Since the ceiling tiles in areas immediately adjacent to the former science area are significantly bowed, the drainage system appears to be a significant water vapor source.

Floor drain in the 5th Grade area (old science area)

1. Continue with plans to replace the carpeting in the kindergarten hallway and classrooms since it is likely moistened by condensation and past its service life.
2. Seal all sink and floor drains in the area bounded by corridors A, B, C and D. Disconnect water service to the science sinks to prevent accidental flooding.
3. Relocate the pottery kiln to the former shop area where existing exhaust ventilation systems could be used to vent pollutants to the outdoors.
4. Keep exterior doors closed to prevent hot, moist air penetration into the building. Ensure tightness of doors by monitoring for light penetration and drafts around doorframes.
5. Replace tennis balls with latex-free tennis balls or glides.

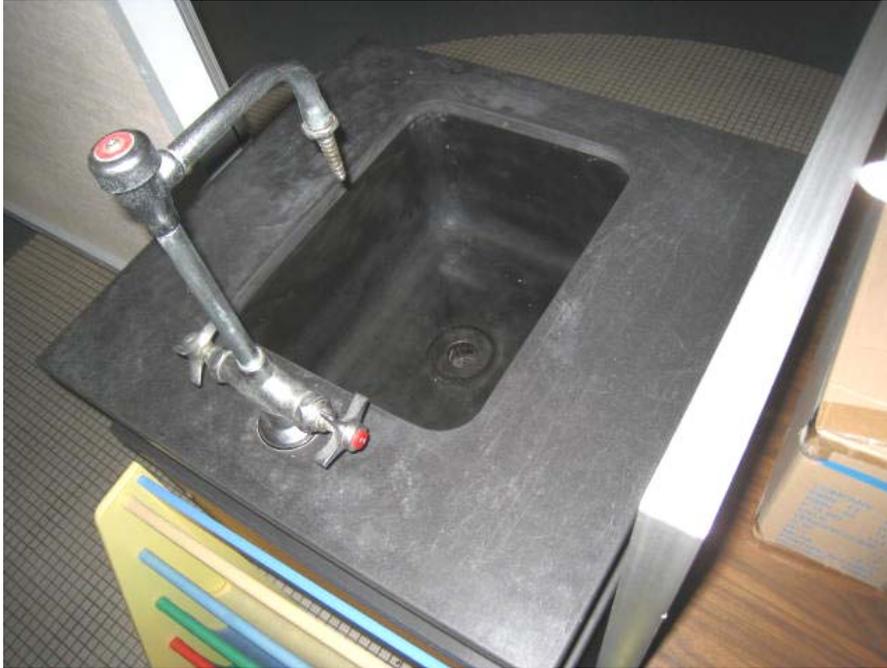
Picture 7

Unused sink in 5th grade area (old science area)

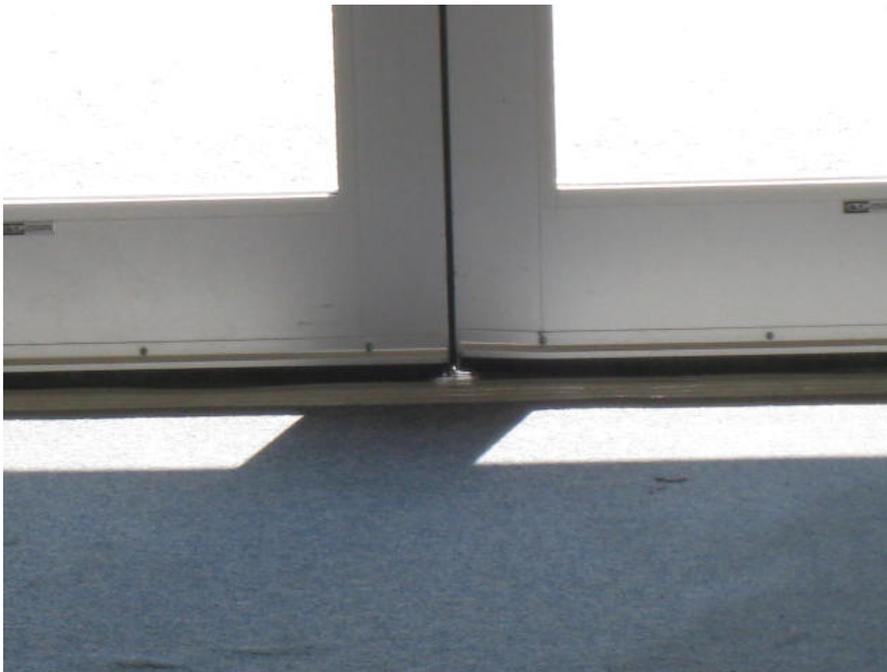
Picture 8

Of note was the condition of flooring in the hallway of the kindergarten classrooms as well as around exterior doors of classrooms. As noted previously, the exterior doors in these areas are not sheltered and appear to have had water penetration through/around the door thresholds (Picture 8). The carpeting in the hallway is water-stained, likely via rain penetration through the door. As reported by school officials, the carpeting was installed in 1997. The

It is also likely that the exterior doors are not energy efficient and can serve as a thermal bridge¹. Where a thermal bridge exists, condensation² is likely to form on the warm air side of the cold object which can moisten materials, such as floors. In hot humid weather, the lowering of temperature of the slab/exterior brickwork would likely lead to the accumulation of condensation along the interior side at the base of the exterior wall.

Door threshold at the end of the kindergarten wing with water-damaged carpeting

Institute of Inspection, Cleaning and Restoration Certification (IICRC), recommends that carpeting be cleaned annually (or semi-annually in soiled high traffic areas) (IICRC, 2005). Since the average service time of carpeting in a school environment is approximately eleven years (Bishop, 2002), consideration should be given to planning for the installation of new flooring as funds become available.

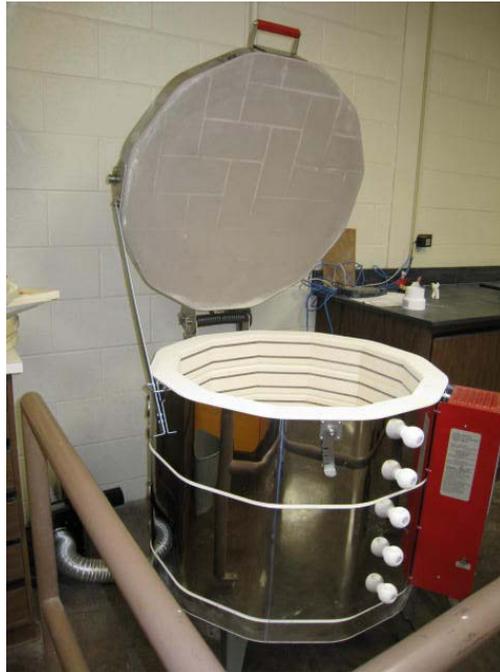
Picture 9

BEH staff observed two other potential sources of respiratory irritants. In the art area is an unvented pottery kiln (Picture 9). Pottery kilns can be a significant source of water vapor, particulate and other related pollutants when operating. In addition, a pottery kiln is a source of waste heat that can present a safety/fire hazard. This type of equipment should be vented directly outdoors and kept away from students.

Pottery kiln in art area

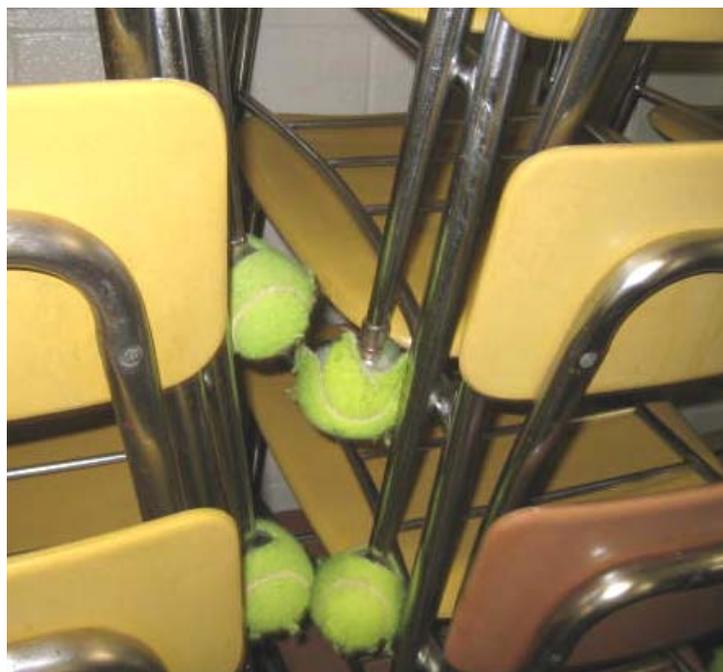
Picture 10

BEH staff observed tennis balls which had been sliced open and placed on chair legs, presumably to reduce noise (Picture 10). Tennis balls are made of a number of materials that are a source of respiratory irritants. Constant wearing of tennis balls can emit fibers and cause

VOCs to off-gas. Tennis balls are made with a natural rubber latex bladder, which becomes abraded when used as a chair leg pad. Use of tennis balls in this manner may introduce latex dust into the school environment. Some individuals are highly allergic to latex (e.g., spina bifida patients) (SBAA, 2001). It is recommended that the use of materials containing latex be limited in buildings to reduce the likelihood of symptoms in sensitive individuals (NIOSH, 1997).

Tennis balls on chair legs
