INDOOR AIR QUALITY ASSESSMENT

**Westfield High School
Career Center
177 Montgomery Road
Westfield, Massachusetts**

Prepared by:
Massachusetts Department of Public Health
Bureau for Environmental Health
Indoor Air Quality Program
October 2012

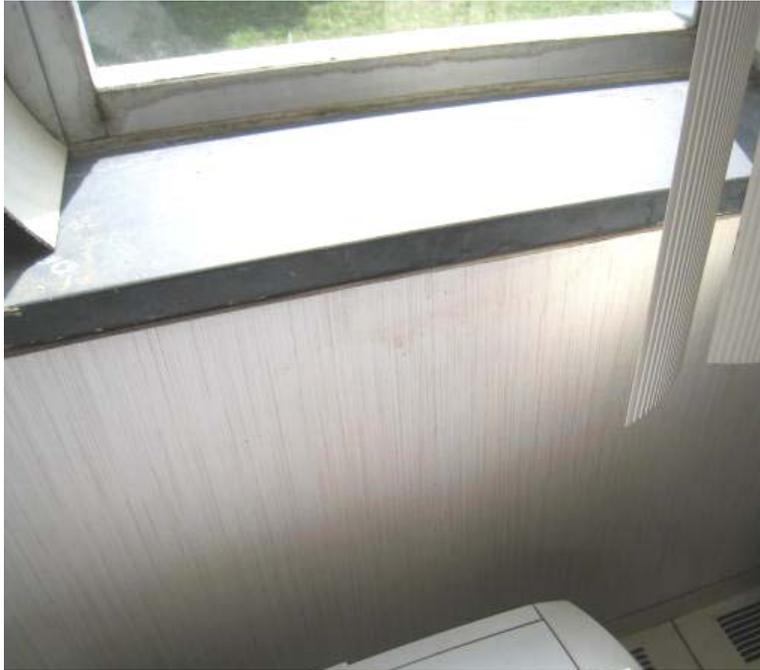
Picture 1

The WHS interior walls were constructed using finished cement blocks. The exterior walls of the rooms around the CC were designed to have wall-mounted radiators heat the surface of the cement block wall. During the renovation, the interior walls of the CC were covered with gypsum wallboard (GW) which was then covered with vinyl wallpaper. In this configuration, the surface of the cement block wall is not heated as designed during the colder months, allowing for the creation of a thermal bridge¹. Where a thermal bridge exists, condensation² is likely to form on the warm side of the cold object (i.e., the inside of the room in the winter); this can moisten materials, such as the space between the original cement block wall and the GW. The vinyl wallpaper is a water-impermeable material, which can trap water in the GW and cause water damage.

Vinyl wallpaper in the CC installed over the original walls

1. Remove the GW that is installed over the exterior wall and window wells in a manner consistent with the US EPA recommendation contained in the document “Mold Remediation in Schools and Commercial Buildings.” Examine GW adjacent to the CC exterior wall and remove as needed if water-damaged. Restore the cement block wall to its original condition and function.

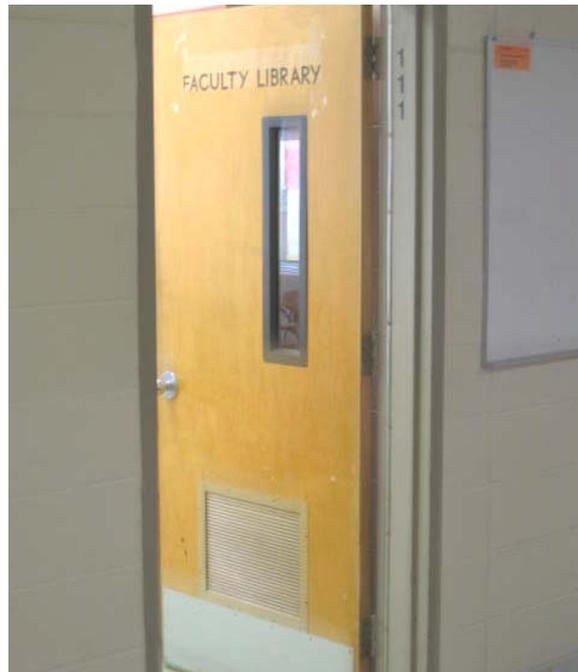
Picture 2

Nearby door with vent; it is likely the original door for CC had this design

4. Undercut the hallway doors to provide transfer air for the exhaust vent in this room to operate when the hallway doors are closed. Operate the exhaust vent when the CC is occupied and repair the fan as needed.

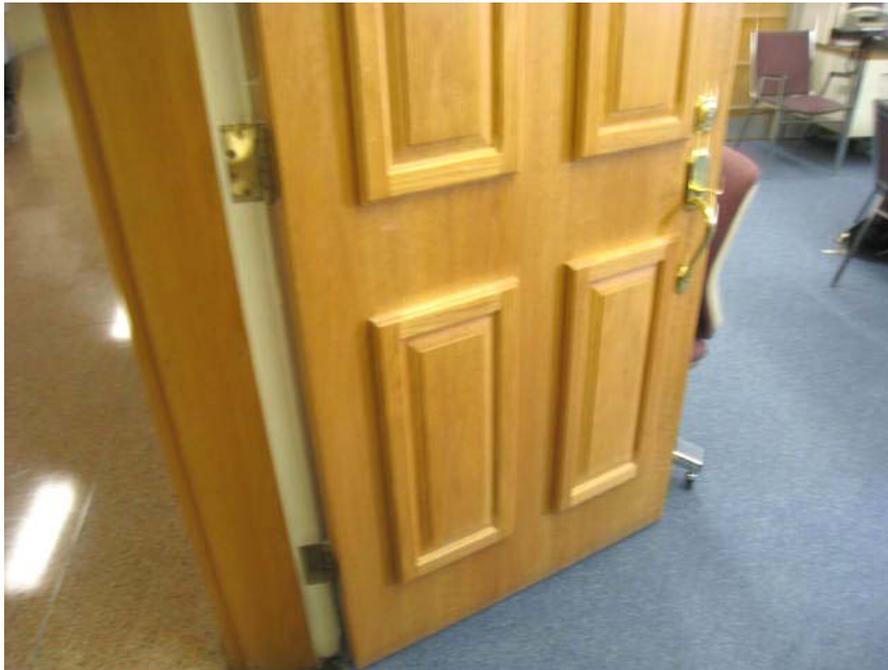
Picture 3

The WHS is a multi-wing brick building constructed in 1973. The CC is located on the first floor of a three-story wing located along the south exterior wall of the building. The interior of the CC was renovated after the building's original construction. During this renovation, a wall system covered with vinyl wallpaper was installed over the original painted cement block walls and window wells (Picture 1). The original doors, that likely had passive door vents (Picture 2), were replaced with a set of solid oak doors lacking passive door vents (Picture 3). Windows in this office are metal frame with a single glass pane and are openable.

Oak hallway door of CC without transfer air vent

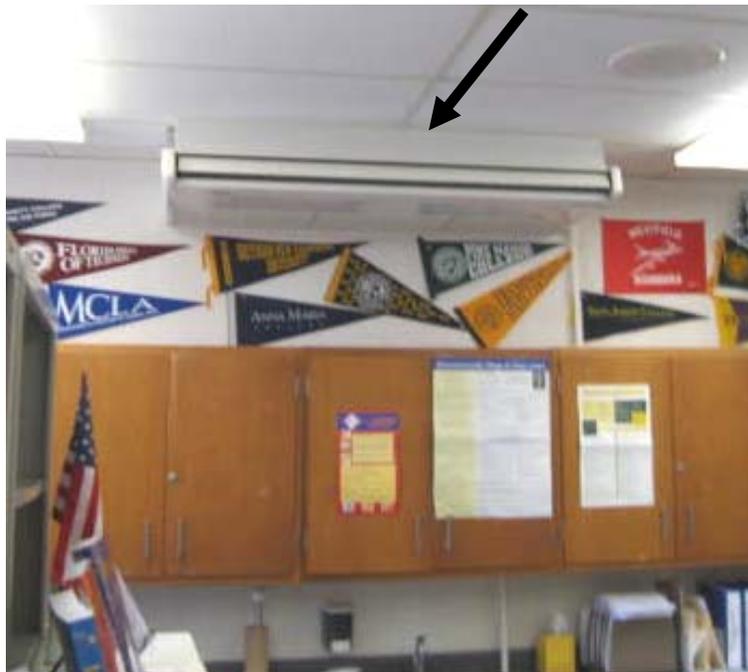
Picture 4

It can be seen from Table 1 that carbon dioxide levels were above 800 parts per million (ppm) in the CC indicating the lack of adequate fresh air supply at the time of assessment. The CC does not have a mechanical fresh air supply. An exhaust vent exists in the room, indicating that this room was originally designed to use a passive door vent (transfer air vent) to draw air from the main hallway, in a manner consistent with an adjacent room (Picture 2). As described previously, hallway doors to the CC were replaced with solid oak doors, preventing air movement into the CC when the doors are closed. It is also likely that the exhaust vent for this area was not operating at the time of the MDPH visit, which would result in decreased airflow and higher carbon dioxide levels. While the CC contains a wall-mounted air conditioner (Picture 4), the unit does not have a fresh air supply and serves only to cool recirculated air.

Wall-mounted air conditioner (arrow)

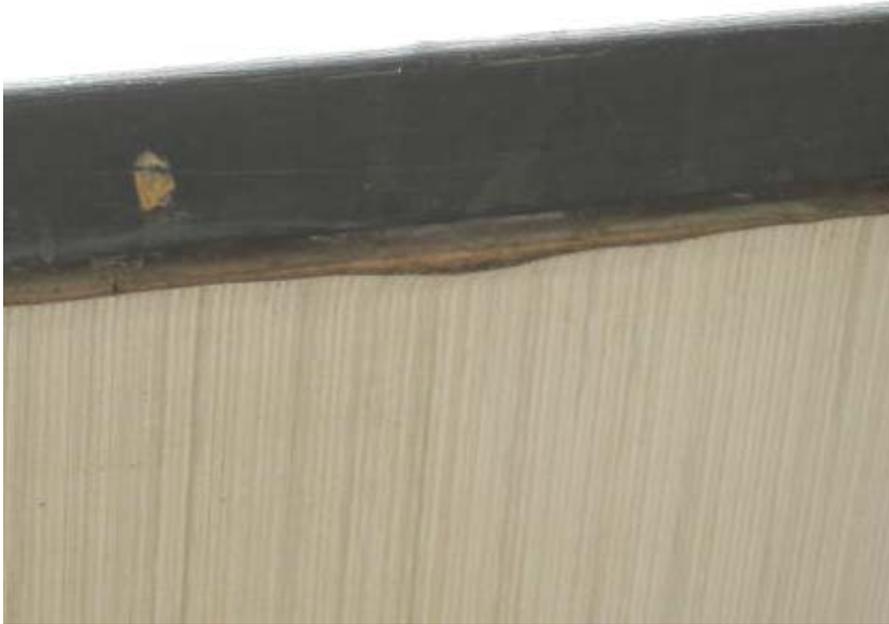
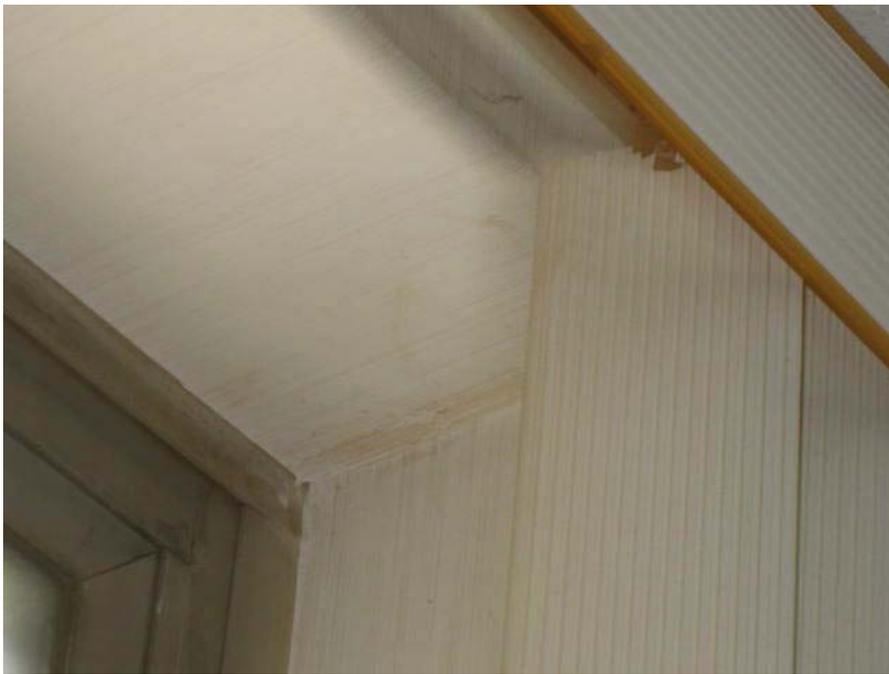
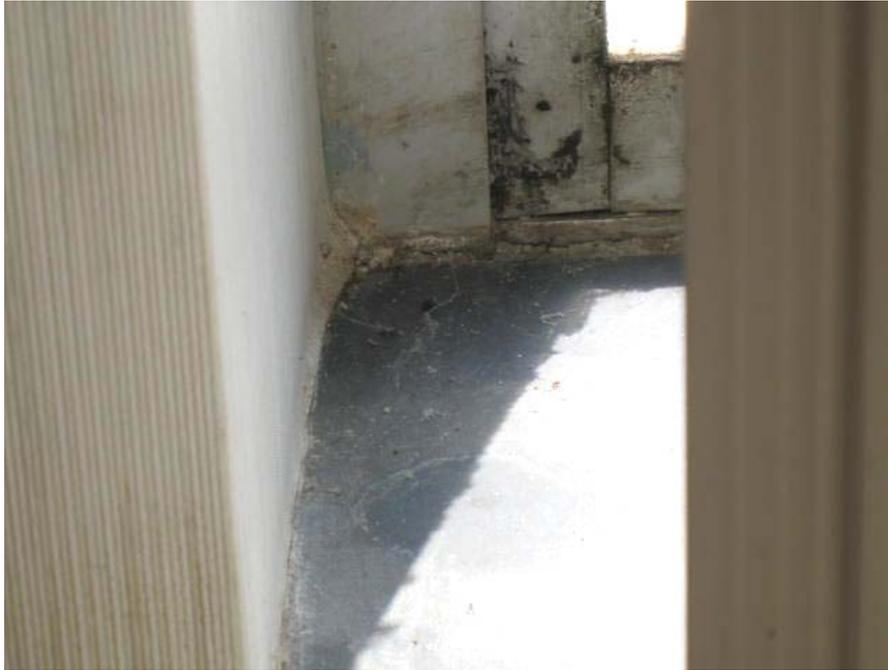
which were in direct sunlight on the day of the assessment. The window frame temperature was measured at 113°F while the outdoor temperature was 81°F (Table 2). The difference in temperature indicates that the windows, sill and wall are not energy efficient and can serve as thermal bridges. Because of the lack of insulating properties of the window system, the window components would be expected to be colder than the inside air temperature of the room during the heating season, leading to condensation, resulting in repeated exposure to moisture and potential mold growth in the GW. Water damage to this GW and peeling vinyl wallpaper were noted in the CC (Pictures 5 through 7).

Water damage and peeling vinyl wallpaper

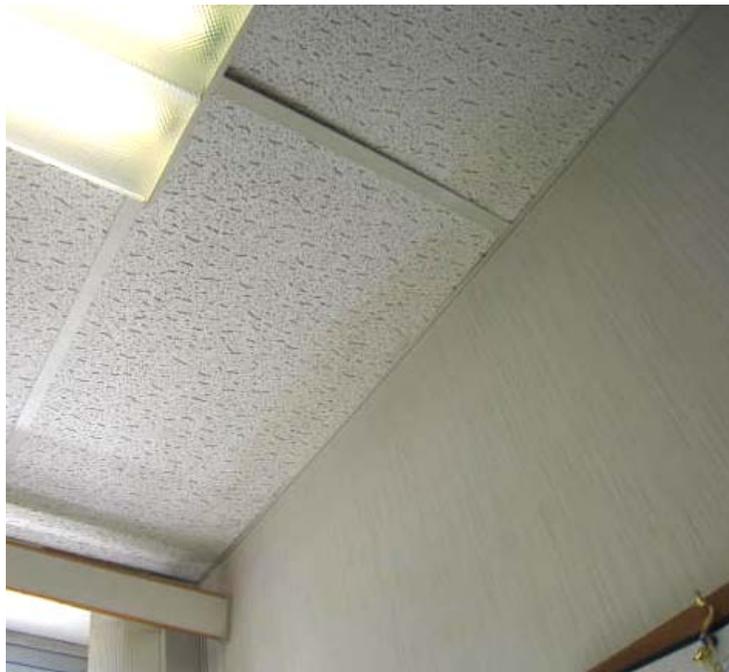
Picture 8

Water-stained ceiling tiles were also observed (Picture 8); the likely source of moisture appears to be condensation generated by a pipe that supplies coolant to the wall-mounted air conditioner in the CC from the chiller. Condensation occurs in coolant supply pipes if spaces in the insulation exist or the R-value³ of the insulation is not sufficient or compromised. Spaces between insulation sections can allow moist air to be exposed to the metal of the chilled water pipes, resulting in condensation. If an air conditioning system has coolant pipes with an insufficient R-value, temperature could be transferred to the surface of the insulation, leading to condensation. Once water wets insulation, a thermal bridge is created, which results in further wetting of insulation and enhancing mold growth. The R-value of insulation is decreased by compression of the material. Wires used to suspend the coolant supply pipe were observed to tightly pinch the insulation, which would result in reduced insulating properties, which would likely lead to condensation (Picture 9).

Water-stained ceiling tiles

2. Have the wall-mounted air conditioner condensation drain reconfigured to empty into the sink instead of the sink drain pipe.
3. Re-insulate the coolant pipe for the wall-mounted air conditioner with insulation with an appropriate R-value for the temperature of the coolant. Install the insulation so it is not pinched by the pipe hangers. Once the insulation is repaired, remove and replace the water-damaged ceiling tiles.

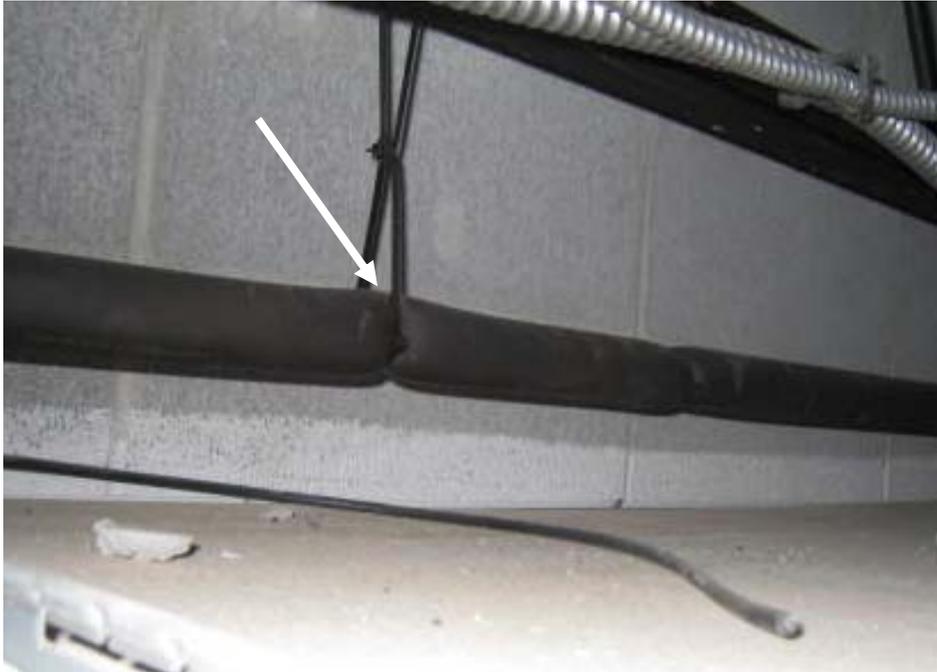
Picture 9

Wires used to suspend the coolant supply pipe pinching the insulation (arrow)

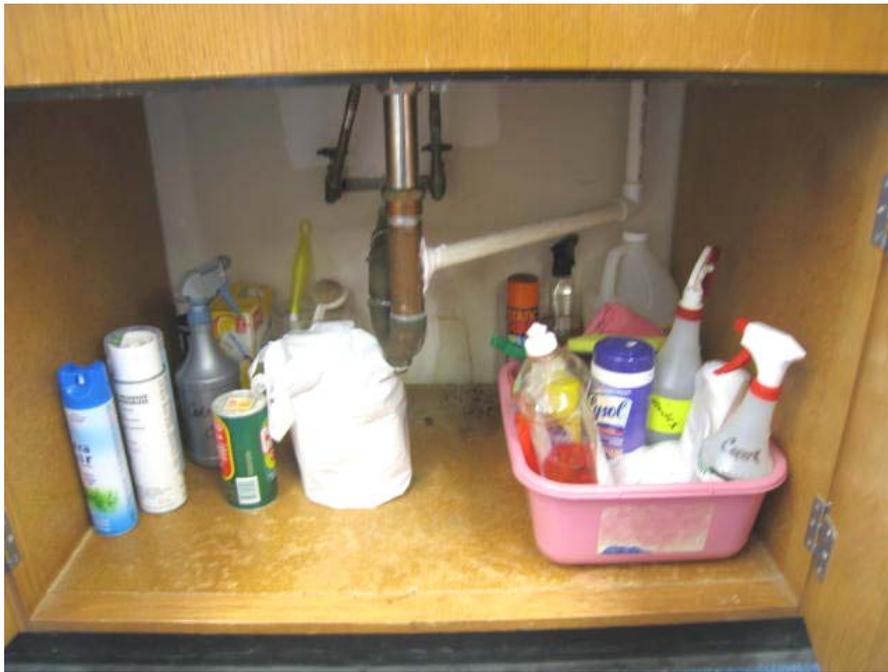
Picture 10

The condensation drain for the wall-mounted air conditioner is directly plumbed into the sink drain (Picture 10). In this configuration, if the sink trap is dry, air, moisture and associated odors may be drawn from the drain system by operation of the wall-mounted air conditioner.

Cleaning products were found under the sink (Picture 10). Cleaning products contain chemicals that can be irritating to the eyes, nose and throat of sensitive individuals. These products should be properly labeled and stored in an area inaccessible to children. Additionally, a Materials Safety Data Sheet (MSDS) should be available at a central location for each product in the event of an emergency. Consideration should be given to providing teaching staff with school-issued cleaning products and supplies to ensure that MSDS information is available for all products used at the school.

Condensation drain plumbed into the sink drain pipe (also note cleaning products)

5. Reduce or eliminate plants in the CC. Use non-porous drip pans and keep them clean.
6. Store cleaning products properly and out of reach of students. Ensure spray bottles are properly labeled. All cleaning products used at the facility should be approved by the school department with MSDSs available at a central location.
