# **INDOOR AIR QUALITY ASSESSMENT**

**Hadley Elementary School  
24 Redington Street  
Swampscott, MA**

Prepared by:  
The Massachusetts Department of Public Health  
Bureau of Environmental Health  
Indoor Air Quality Program  
January 2013

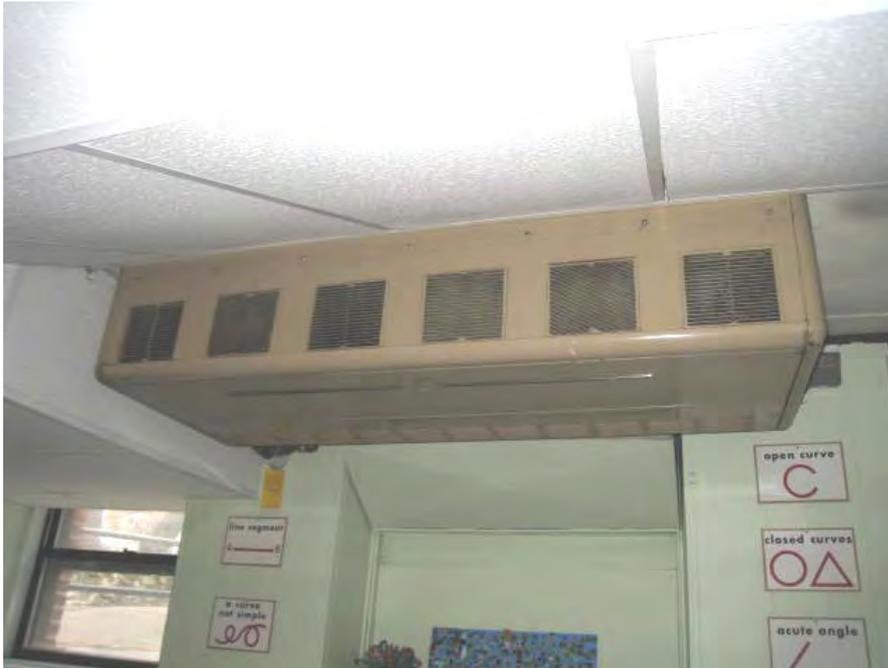
**Picture 1**

Note that some of the univents appear to be vintage equipment (i.e., over 20 years old). Function of equipment of this age is difficult to maintain, since compatible replacement parts are often unavailable. According to the American Society of Heating, Refrigeration and Air-Conditioning Engineers (ASHRAE), the service life<sup>1</sup> for a unit heater, hot water or steam is 20 years, assuming routine maintenance of the equipment (ASHRAE, 1991). Despite attempts to maintain these units, the operational lifespan of the equipment has been exceeded. Maintaining the balance of fresh air to exhaust air will become more difficult as the equipment ages and as replacement parts become increasingly difficult to obtain.

**Vintage ceiling-mounted univent**

1. Based on the age, physical deterioration and availability of parts, the BEH recommends that an HVAC engineering firm evaluate options for providing adequate ventilation building-wide. Such an evaluation is necessary to determine the operability and feasibility of repairing/replacing the equipment.

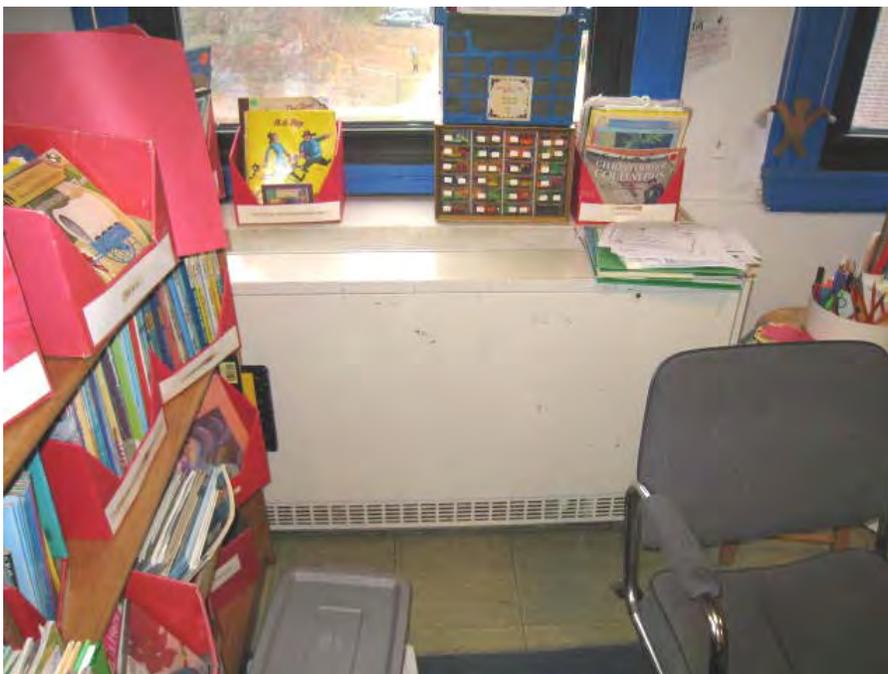
**Picture 2**

**Typical classroom univent**

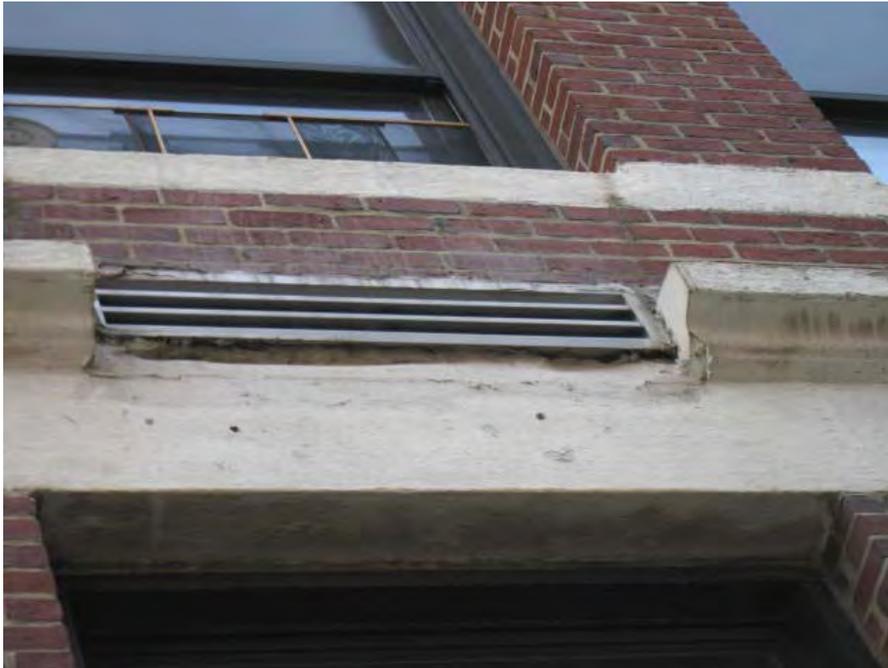
**Picture 3**

**Univent fresh air intake**

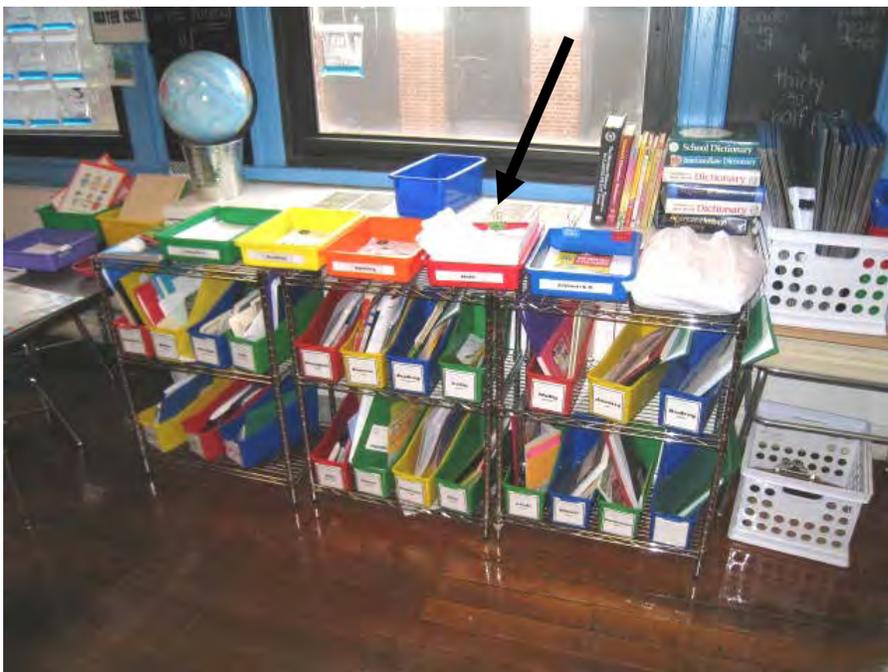
**Picture 4**

also obstructed by items such as boxes, papers and books in some areas (Picture 4). In order to function as designed, univents must be activated and allowed to operate free of obstructions.

**Univent (arrow) obstructed by classroom materials**

4. Remove all blockages from univents and exhaust vents to ensure adequate airflow.
5. Use openable windows in conjunction with classroom univents and exhaust vents to facilitate air exchange until repairs that are more permanent can be made. Care should be taken to ensure windows are properly closed at night and weekends to avoid the freezing of pipes and potential flooding.

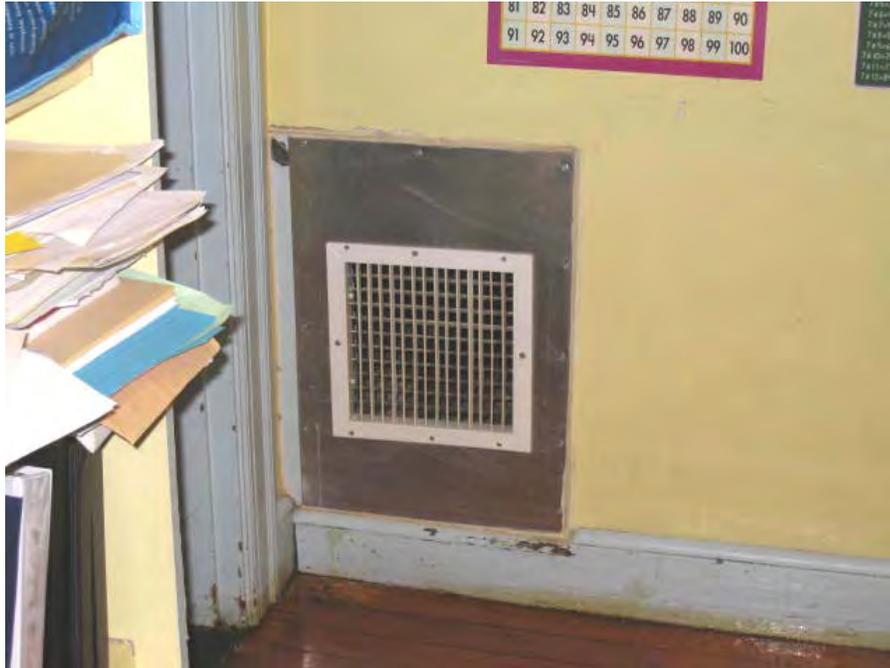
**Picture 5**

Exhaust ventilation is provided by wall-mounted exhaust vents powered by rooftop motors (Pictures 5 and 6). A number of exhaust vents were not operating and some were found to be backdrafting (air was flowing out of them) during the assessment, indicating that they had either been deactivated or had mechanical problems. In addition, some exhaust vents were obstructed by furniture and other items (Pictures 7 and 8), which can impede airflow and reduce the effectiveness of the vent to exchange air. As with the univents, exhaust vents need to be activated to function as designed. Exhaust vents should also be free of debris to prevent re-aerosolization of these materials, particularly if backdrafting occurs when exhaust vents are not functioning as designed. Without adequate supply and exhaust ventilation, excess heat and environmental pollutants can build up and lead to indoor air/comfort complaints.

**Wall-mounted exhaust vent**

2. Consult with HVAC vendor to examine methods of providing mechanical ventilation to the basement cafeteria.
3. Reactivate exhaust system. Ensure classroom exhaust vents are turned on at the start of school and are allowed to operate during occupancy.

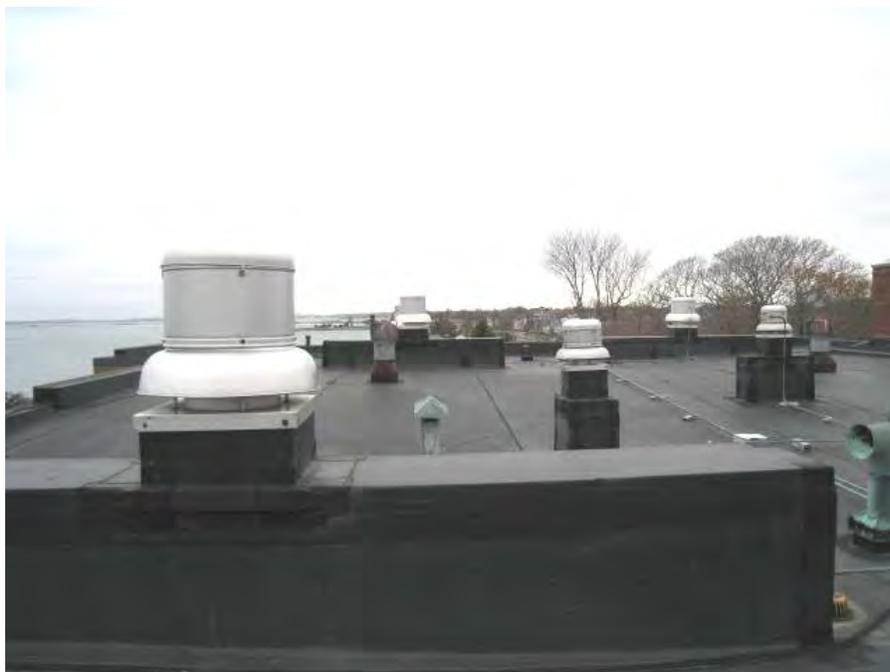
**Picture 6**

**Rooftop exhaust motors**

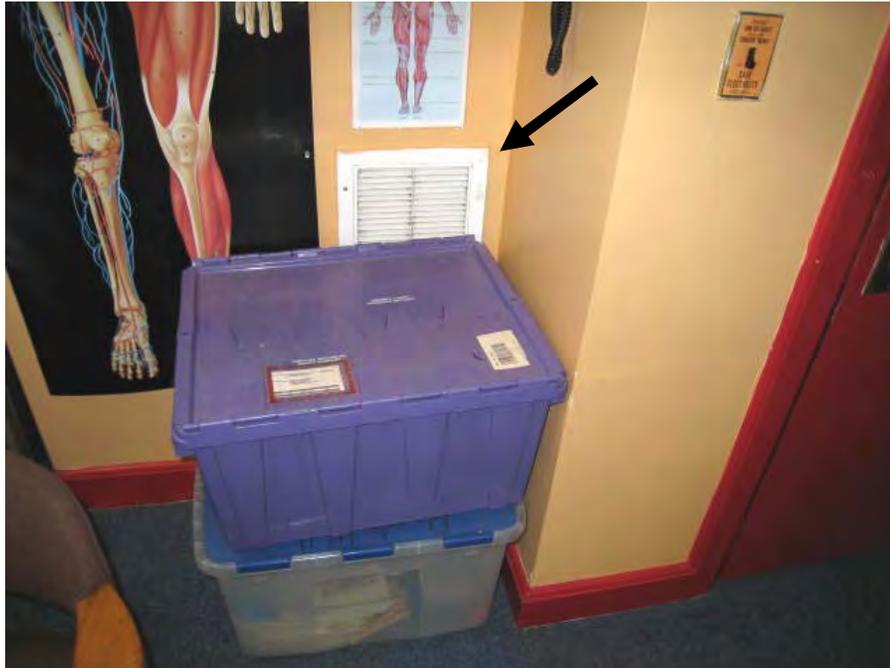
**Picture 7**

**Wall-mounted exhaust vent (arrow) partially obstructed**

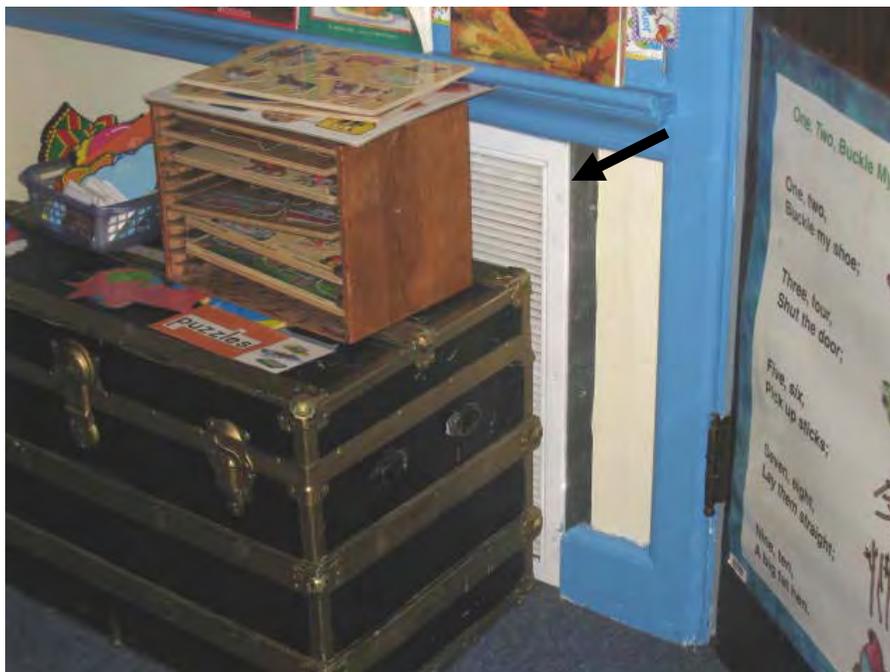
**Picture 8**

**Wall-mounted exhaust vent (arrow) partially obstructed**

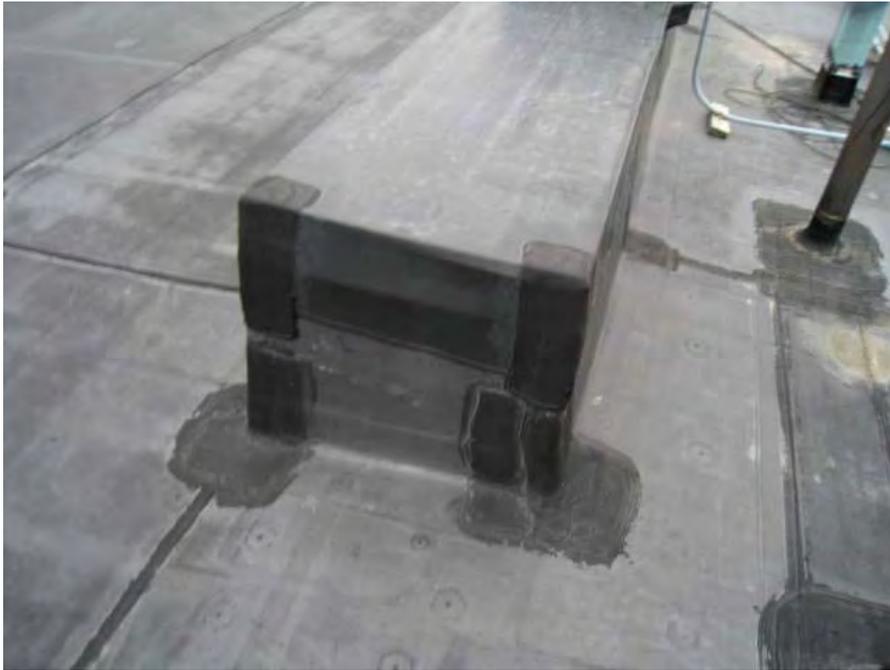
**Picture 9**

In order for building materials to support mold growth, a source of water exposure is necessary. Identification and elimination of the source of water moistening building materials is necessary to control mold growth. Water-damaged ceiling and wall plaster was observed in a number of areas, indicating roof leaks and/or water penetration through the building envelope. Mr. Baker reported that numerous attempts have been made over the past several years to repoint/reseal breaches to prevent further water penetration; evidence of this was evident along the exterior of the building and roof (Pictures 9 through 12).

**Roof patches**

7. Continue to repoint damaged mortar and seal any breaches/cracks along the building exterior to prevent water intrusion.
8. Continue to make roof repairs as needed. Remove/replace any water-damaged ceiling tiles.

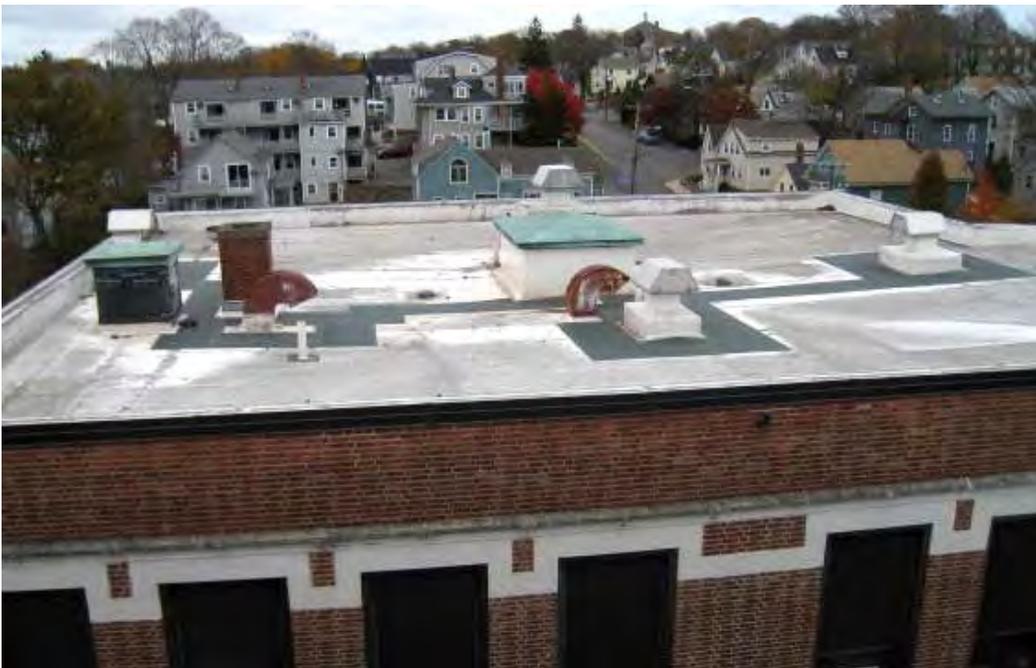
**Picture 10**

**Patched roof areas (dark portions)**

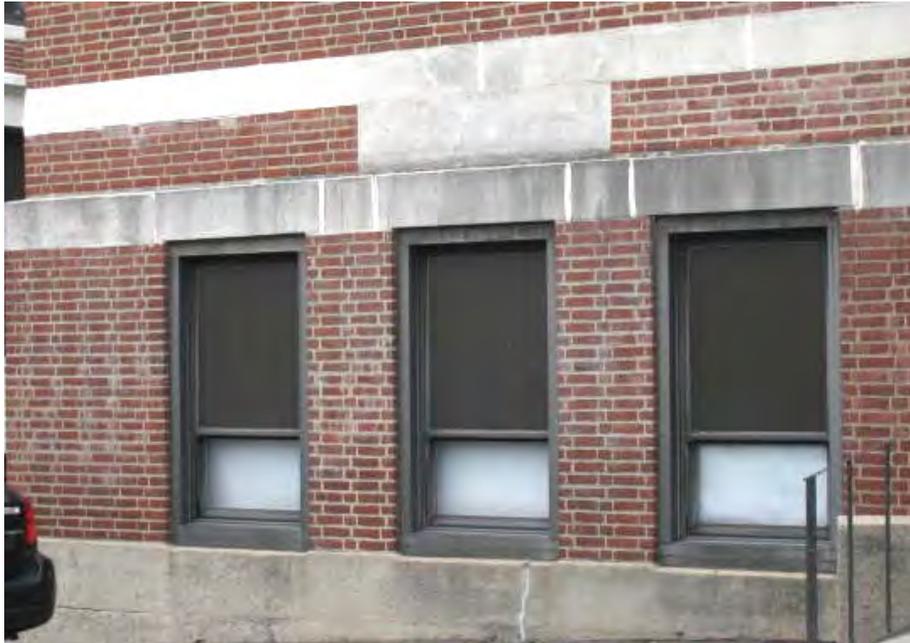
**Picture 11**

**Exterior areas repointed/resealed to prevent water penetration  
(indicated by light coloring)**

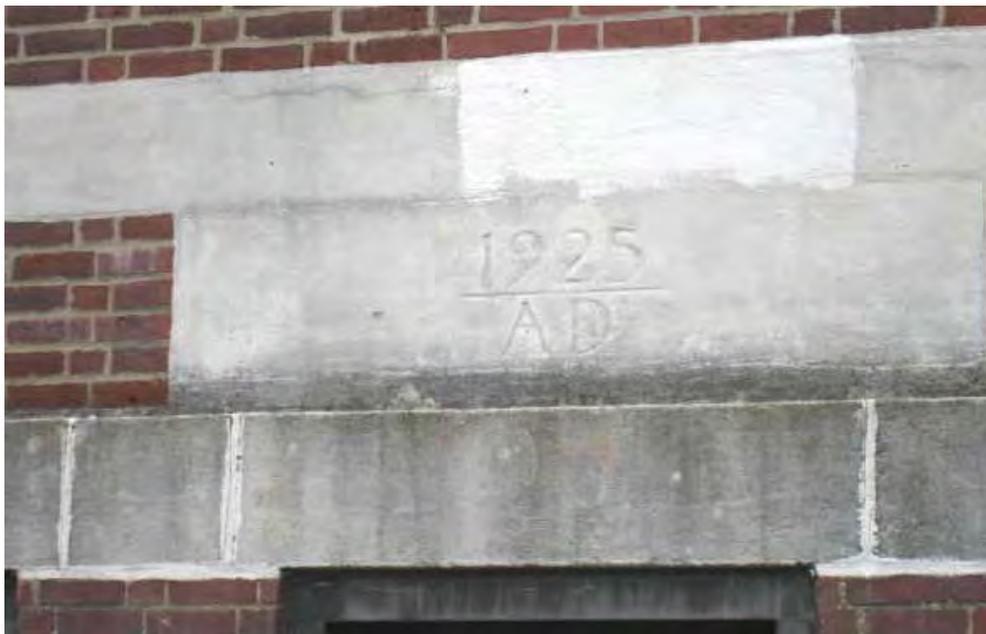
**Picture 12**

**Exterior areas repointed/resealed to prevent water penetration  
(indicated by light coloring)**

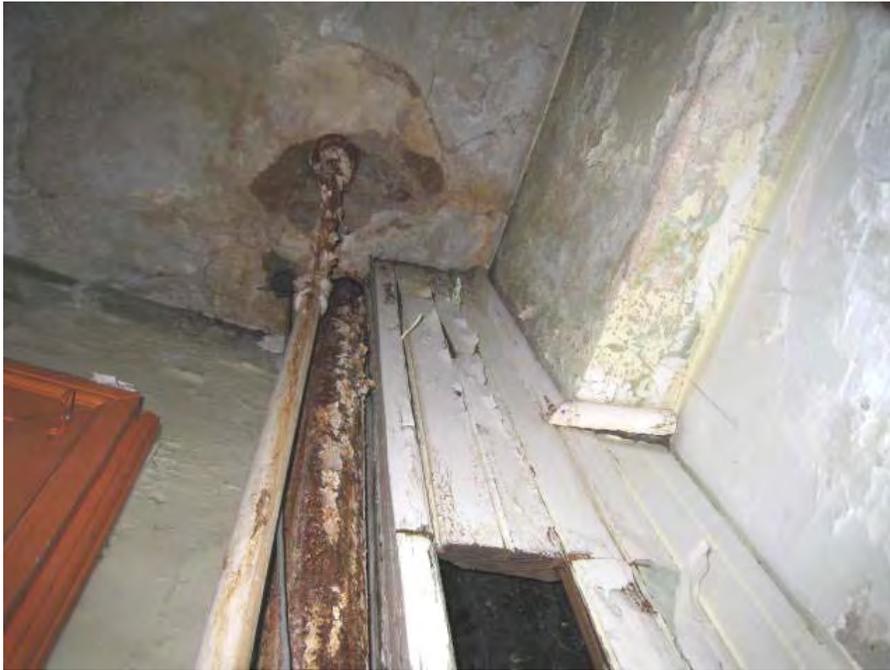
**Picture 13**

Despite these attempts, chronic water penetration has resulted in staining and efflorescence on both interior and exterior walls, ceilings, and around window frames in a number of areas throughout the building (Pictures 13 through 15). Efflorescence is a characteristic sign of water damage but it is not mold growth. As moisture penetrates and works its way through mortar, brick or plaster, water-soluble compounds dissolve, creating a solution.

**Water-damaged ceiling, walls, and wood in classroom 201 closet**

9. Scrape and clean efflorescence and loose paint from ceiling/wall plaster and brick, particularly in the top floor hallway of the annex building (Pictures 16 and 17). Remove water-damaged wood in closet of classroom 201.

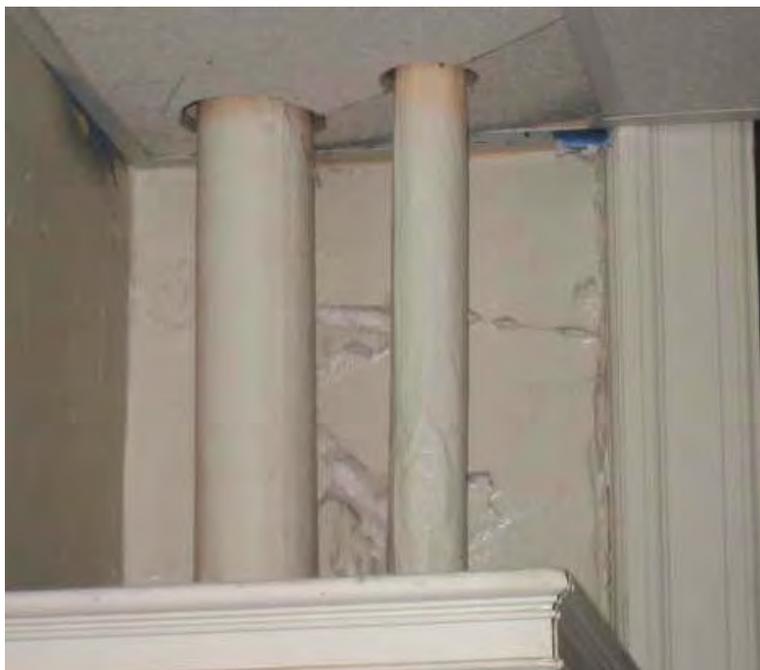
**Picture 14**

As the solution moves to the surface of the material, the water evaporates, leaving behind white, powdery mineral deposits.

**Efflorescence and peeling paint**

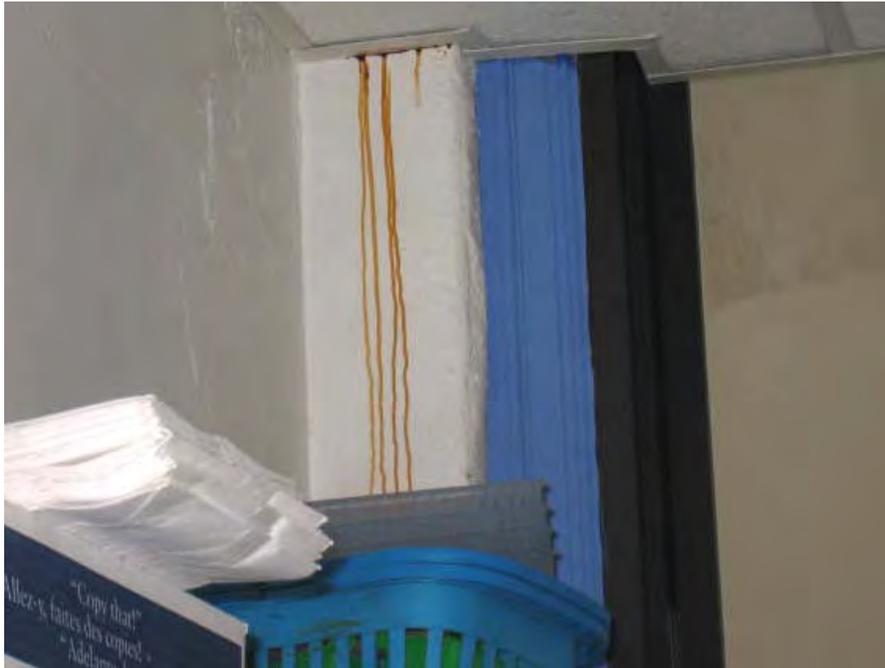
**Picture 15**

**Staining of walls, evidence of water penetration**

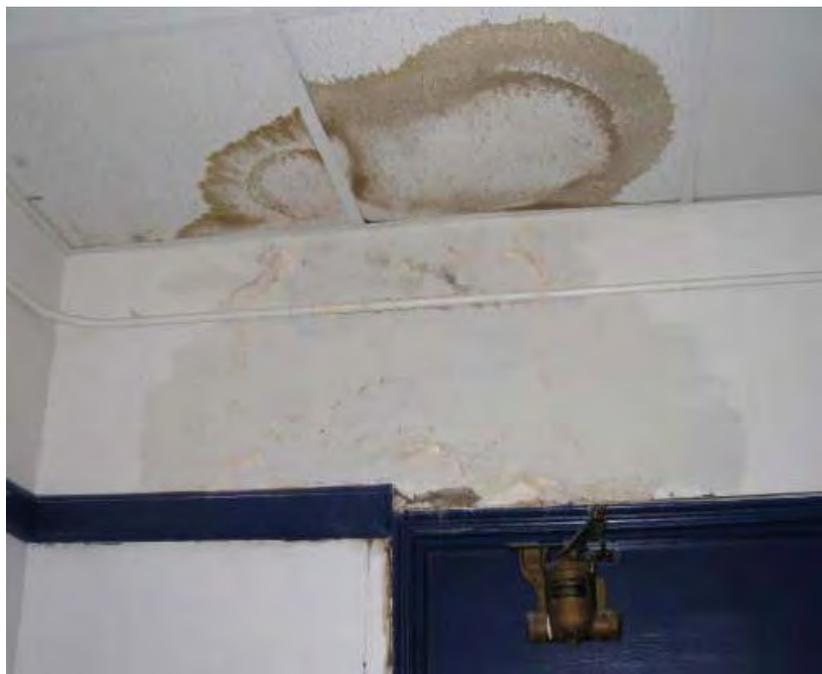
**Picture 16**

**Water-damaged building materials on top floor of annex building**

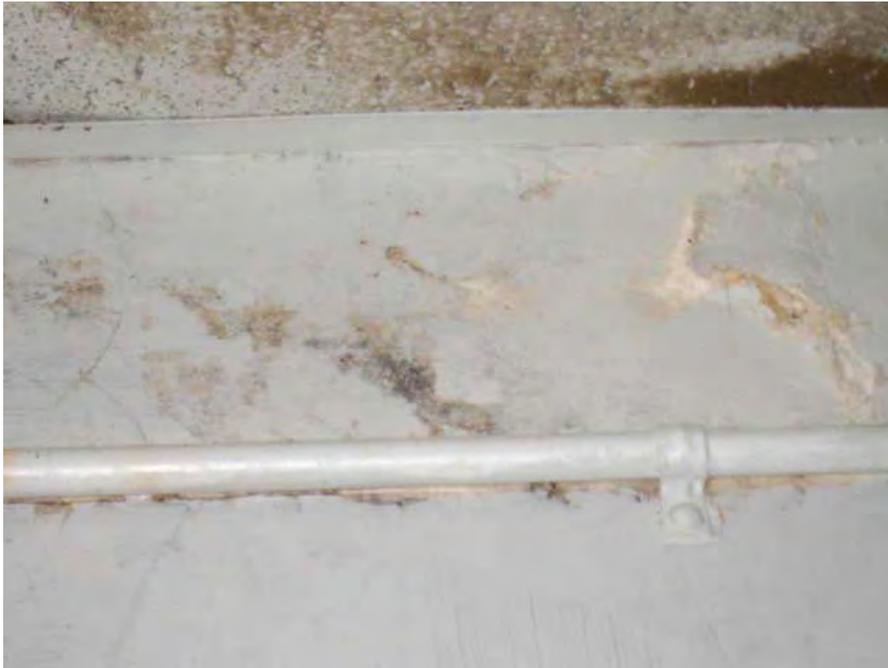
**Picture 17**

**Close-up of visible mold growth (dark staining) from preceding picture on the surface of water-damaged paint in top floor of annex building**

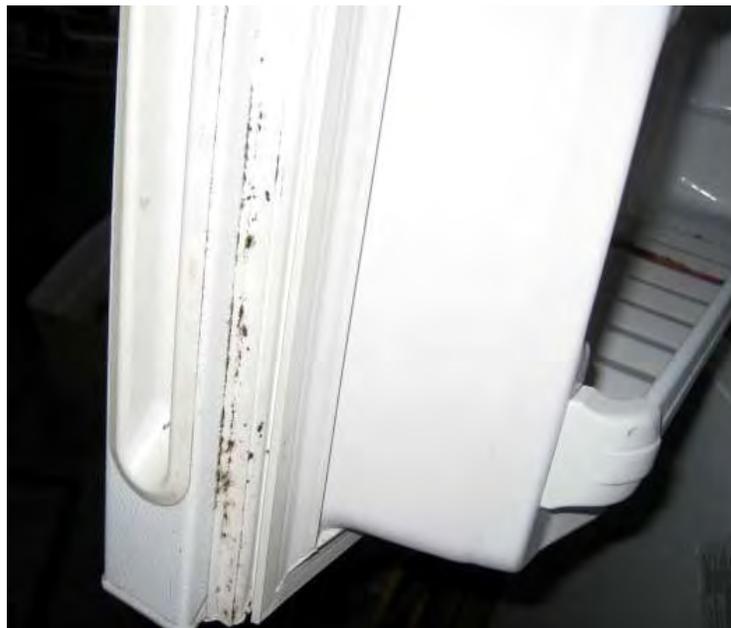
**Picture 18**

The US Environmental Protection Agency (US EPA) and the American Conference of Governmental Industrial Hygienists (ACGIH) recommend that porous materials be dried with fans and heating within 24 to 48 hours of becoming wet (US EPA, 2001; ACGIH, 1989). If not dried within this time frame, mold growth may occur. Once mold has colonized porous materials, they are difficult to clean and should be removed/discarded. Visible mold growth was observed on the surface of water-damaged paint on the top floor of the annex building (Pictures 16 and 17) and on the gasket of the refrigerator/freezer in the OT/PT room (Pictures 18 and 19).

**Mold growth on gasket of freezer in OT/PT room**

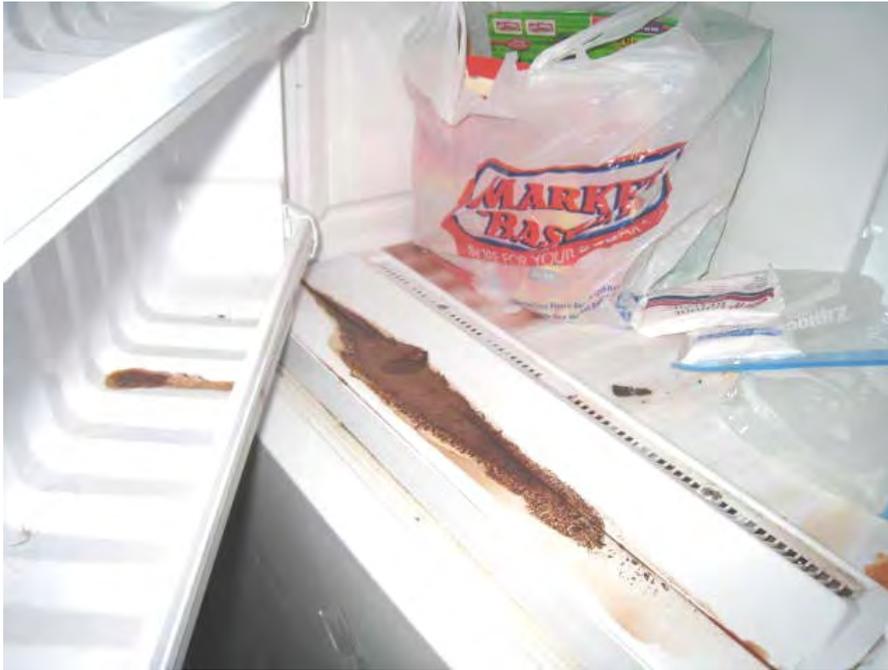
**Picture 19**

**Mold growth and spilled food/residue in freezer in OT/PT room**

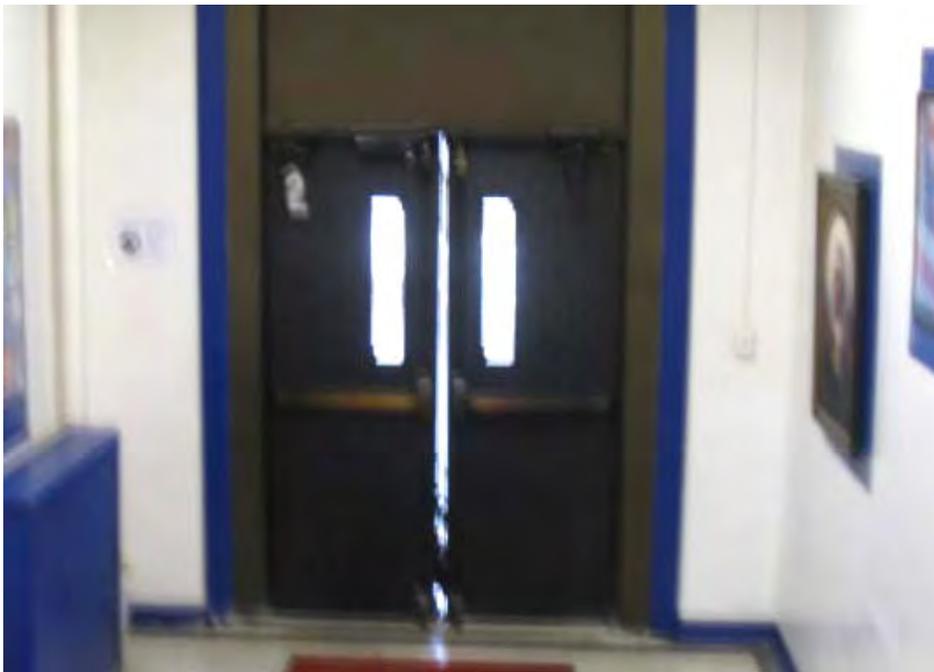
**Picture 20**

Several exterior doors had damaged weather stripping and light could be seen penetrating through the spaces underneath the door from the outdoors (Picture 20). Spaces around exterior doors can serve as a source of water entry into the building, causing water damage and potentially leading to mold growth. In addition, these spaces can serve as pathways for insects, rodents and other pests into the building.

**Light penetrating around exterior door**

10. Install weather-stripping around exterior doors to prevent drafts, water penetration and pest entry. Ensure tightness by monitoring for light.
11. Clean accumulated dust and debris periodically from the interior of univents, exhaust vents and blades of personal fans.

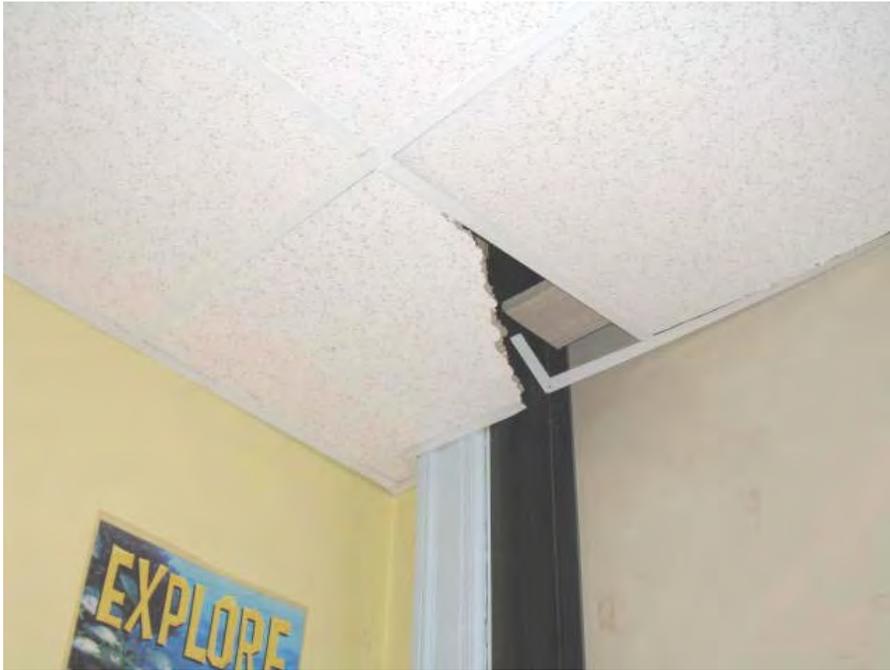
**Picture 21**

In several areas of the building, BEH/IAQ staff observed missing/broken ceiling tiles and holes/breaches in walls (Pictures 21 and 22). These breaches (if opened into wall cavities) can provide pathways for drafts, dust, odors and particulates to migrate into occupied areas. In one

**Broken ceiling tile**

12. Replace missing/broken ceiling tiles and seal any open holes/breaches in interior walls to prevent the migration of drafts, odors, particulates from the ceiling plenum/wall cavities into occupied areas.

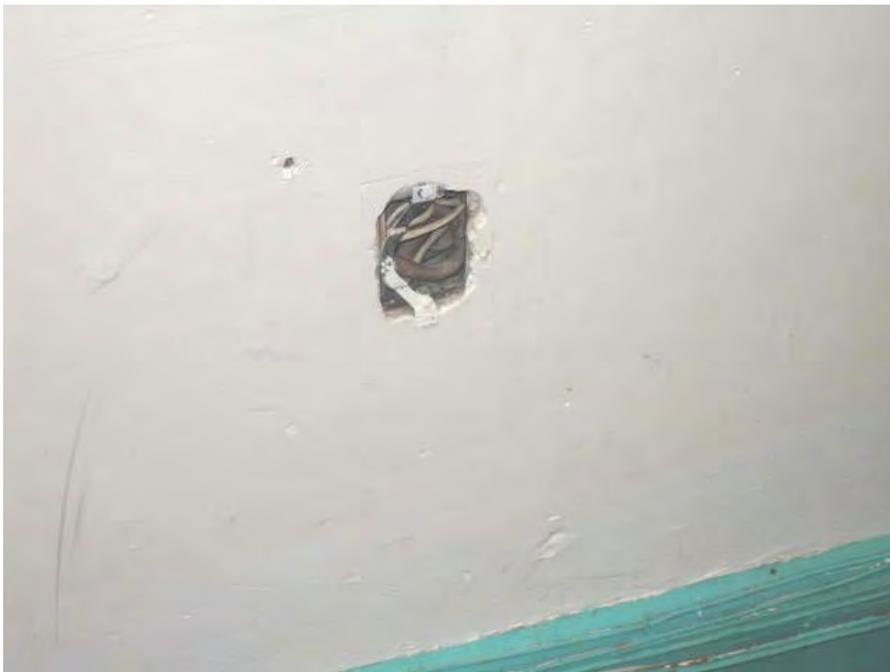
**Picture 22**

**Missing outlet cover/hole in wall**

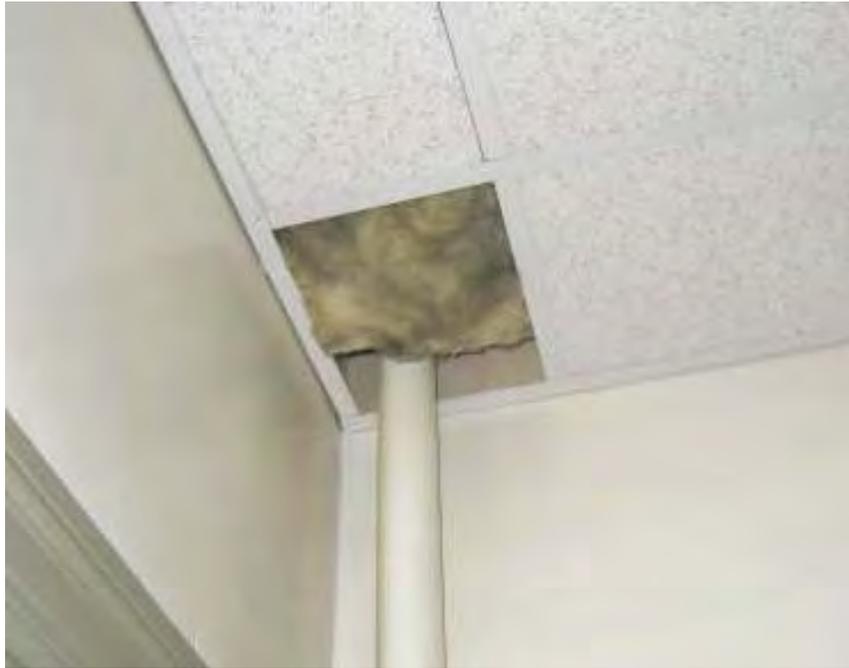
**Picture 23**

case a ceiling tile was missing exposing fiberglass insulation, which can be a source of skin, eye and respiratory irritation (Picture 23).

**Missing ceiling tile exposing fiberglass insulation**

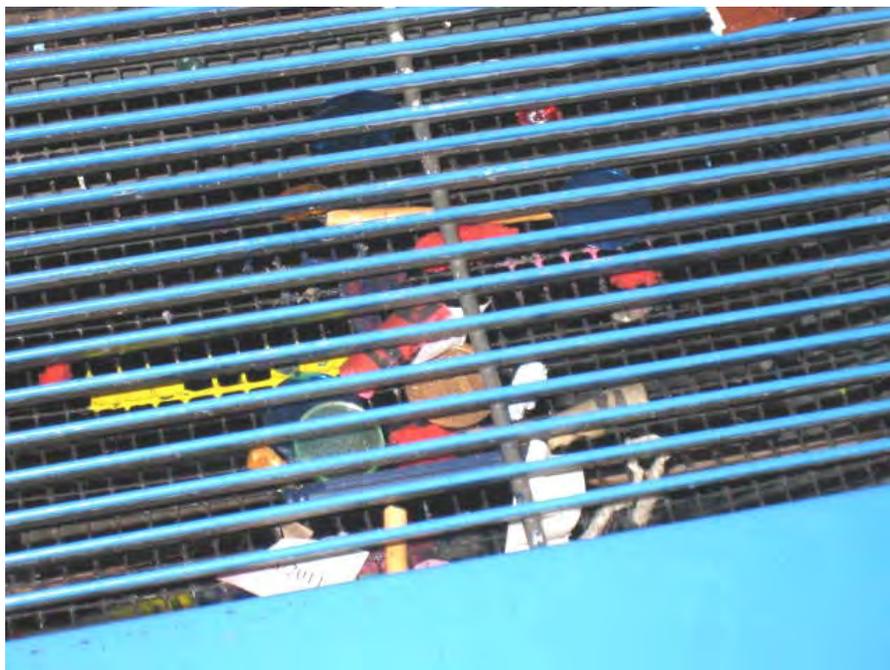
**Picture 24**

Finally, accumulated dust/debris and materials were observed in univents, on exhaust vents and on personal fans in classrooms (Pictures 24). This equipment should be cleaned periodically in order to prevent dust/debris from being aerosolized and distributed throughout the room.

**Various materials in univent air diffuser**
