INDOOR AIR QUALITY ASSESSMENT

**Westfield Athenaeum
6 Elm Street
Westfield, Massachusetts**

Prepared by:
Massachusetts Department of Public Health
Bureau of Environmental Health
Indoor Air Quality Program
February 2013

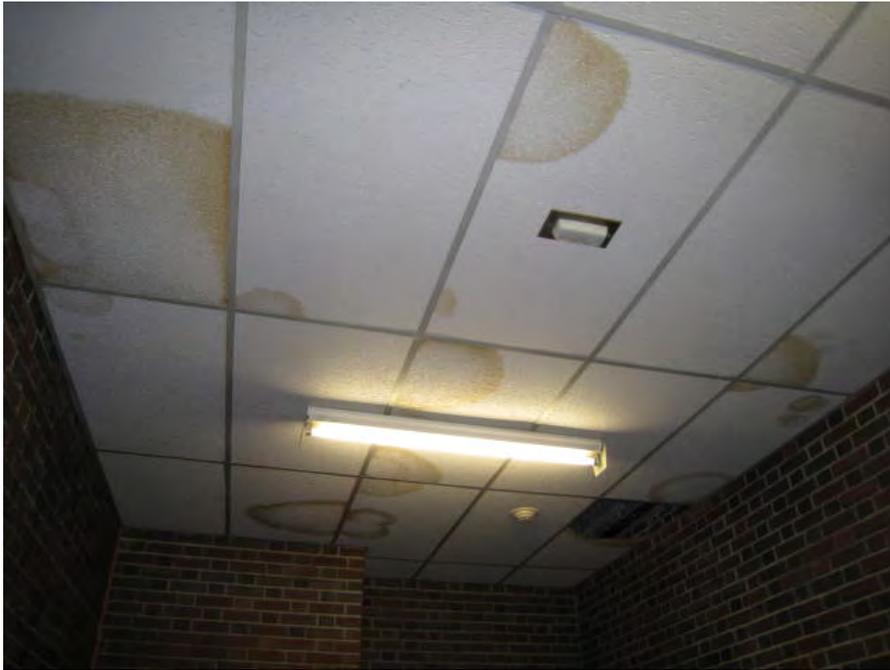
Picture 1

In response to the September 2011 MDPH visit, the remediation efforts (as detailed in Appendix A) included removal of water-damaged and mold-contaminated materials from the basement and replacement of ceiling tiles. During the November 20, 2012 visit, a section of water-damaged ceiling tiles was observed in the entrance hallway to the children's library and the basement hallway (Picture 1), indicating that there may still be roof leaks, plumbing leaks and/or leaks related to condensation from air conditioning components. Stained ceiling tiles can provide a source of mold and should be removed and replaced once the leak has been fixed. The sump area in the basement, which had been open at the time of the September 2011 visit had been covered (Picture 2) but the cover is not air-tight. Sealing the edges of the holes in the cover with a water-resistant material such as sealant foam or plumbing putty will decrease the

Water-damaged Ceiling Tiles

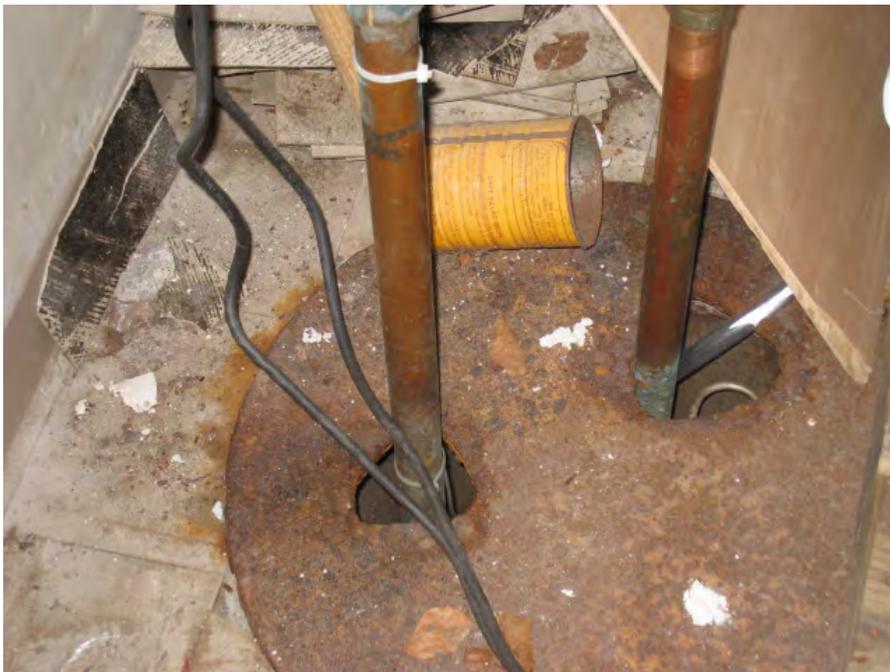
Picture 2

infiltration of odors from the sump into the occupied area. If possible, this sump should also be cleaned periodically to remove debris that may decompose and produce odors.

Sump Cover with Holes

The sump pump had been outfitted with a cover. This cover should still be further sealed to reduce evaporation of moisture and transfer of odors.

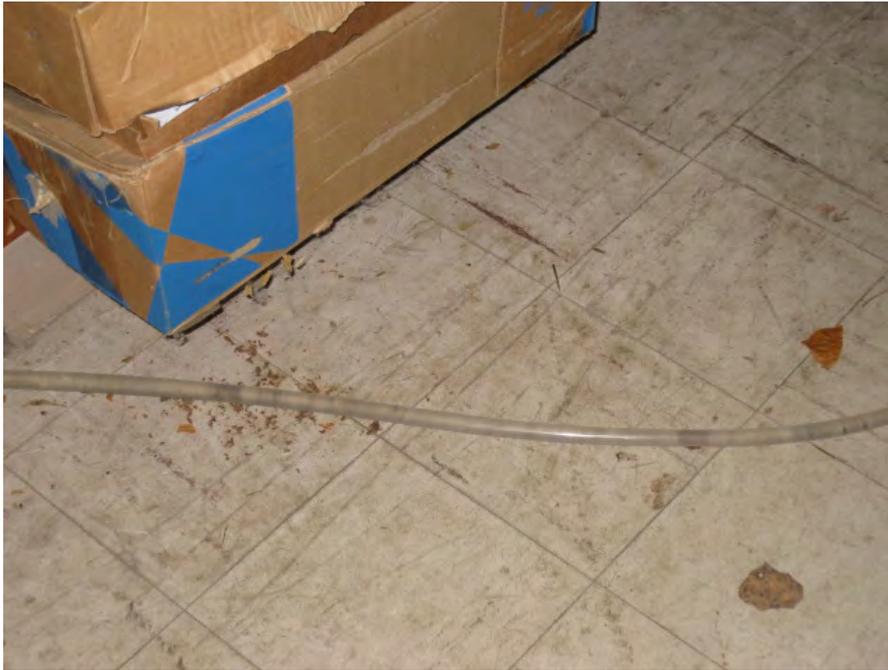
Picture 3

The dehumidifier in the basement had a hose which drained the condensate into the sump; however the hose did not have a sufficient slope to drain completely (Picture 3). If this hose is cut or disconnected, for example during maintenance of the dehumidifier, stagnant water can leak out. It should be drained before the unit is serviced and protected from accidental disconnection by placing the unit closer to the sump to which it drains.

Long Drain Hose from Dehumidifier Containing Stagnant Water

8. Continue to use dehumidifiers in below grade areas during humid or damp weather to reduce relative humidity. Ensure the dehumidifiers are cleaned and maintained as per the manufacture’s instruction to prevent microbial growth. The tube connection from the hose to the sump should be drained and cleaned periodically.

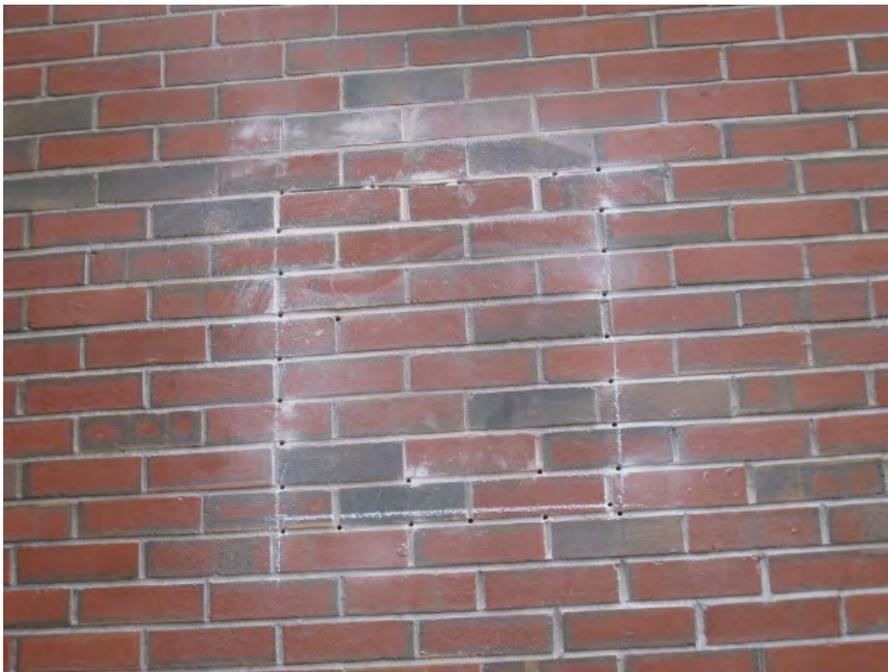
Picture 4

One of the recommendations from the September 2011 visit was to install an exhaust vent in the garage to remove combustion emissions and odors before they penetrate the inside of the basement workroom. Modifications to the garage to meet this recommendation were in process at the time of the visit: a hole was being cut into the masonry at the back of the garage which would reportedly be outfitted with an active exhaust fan (Picture 4). Once this measure is

complete, use of the exhaust fan should reduce or eliminate any penetration of exhaust fumes, including carbon monoxide, into the basement areas.

Location in Back of Garage Wall where Exhaust Vent is being Installed

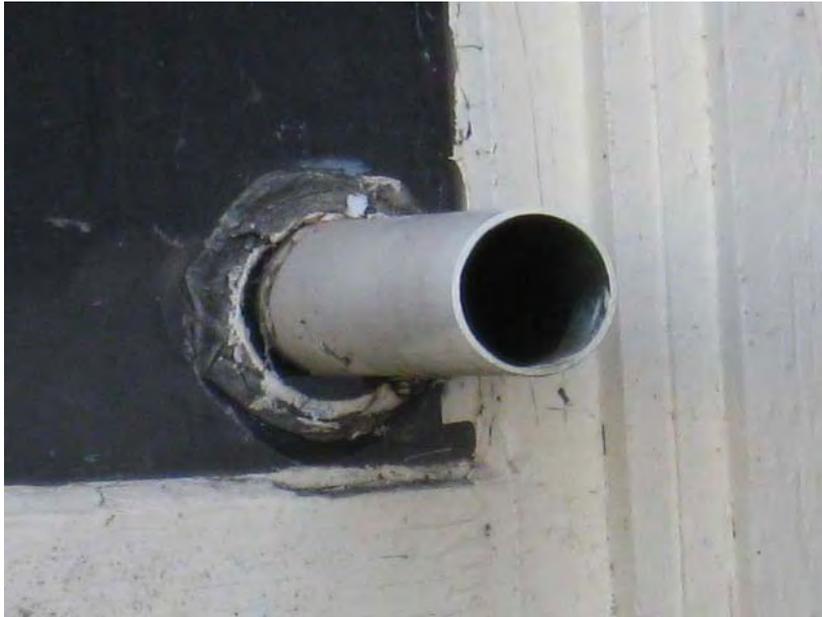
Picture 5

Of note, a PVC pipe was observed extending from a basement window (Picture 5) on the wall adjacent to the back of the garage where the exhaust vent is being outfitted. Once the installation of the exhaust vent is complete, the PVC pipe should be sealed in order to prevent the migration of exhaust fumes into the basement.

PVC Pipe Extending from Basement Window

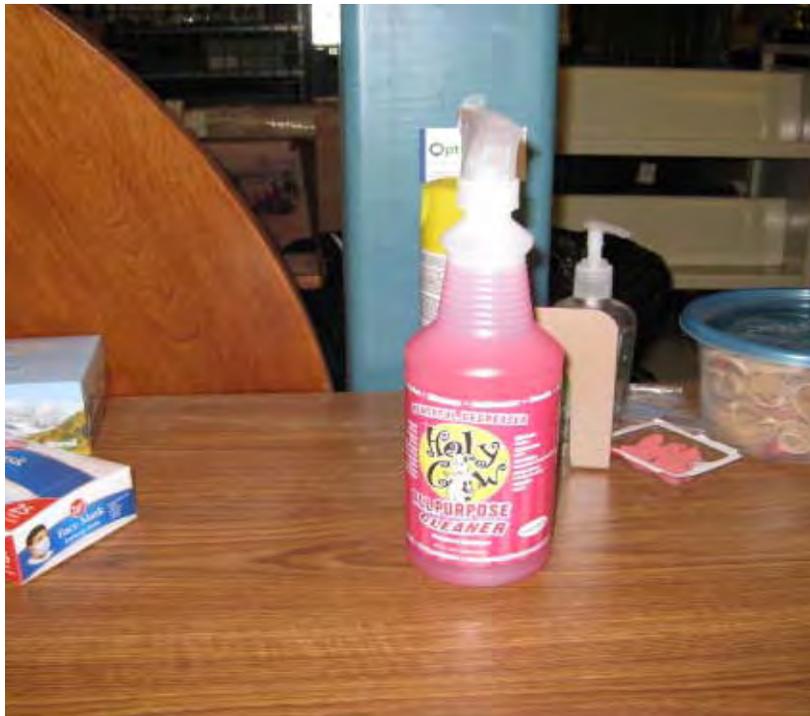
Picture 6

Cleaning products were found in a number of rooms throughout the building including in the basement work area (Picture 6). Cleaning products contain chemicals that can be irritating to the eyes, nose and throat of sensitive individuals. These products should be properly labeled and stored in an area inaccessible to children. In addition, a Material Safety Data Sheets (MSDS) should be available at a central location for each product in the event of an emergency.

Cleaner in the Basement Work Area of the Athenaeum

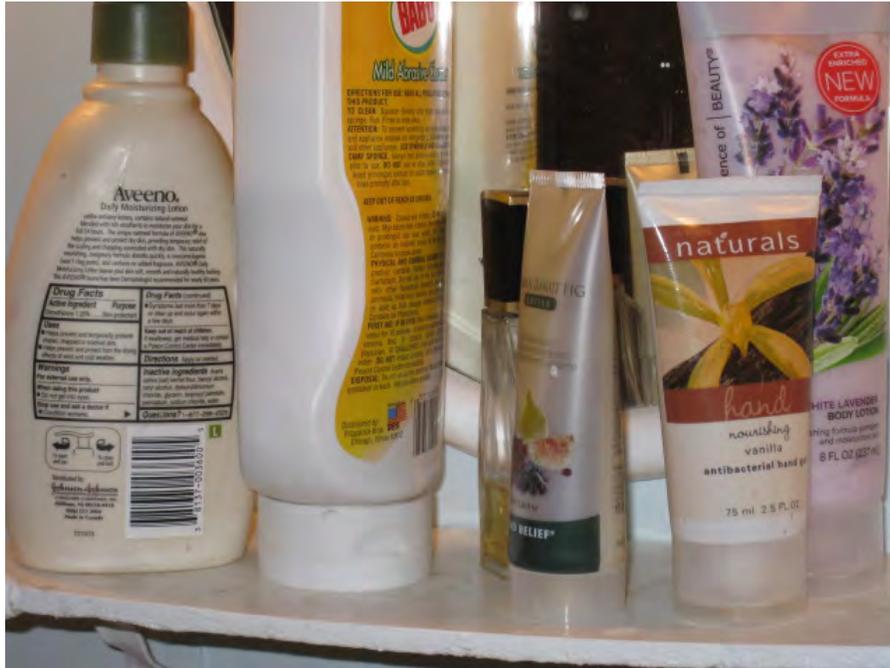
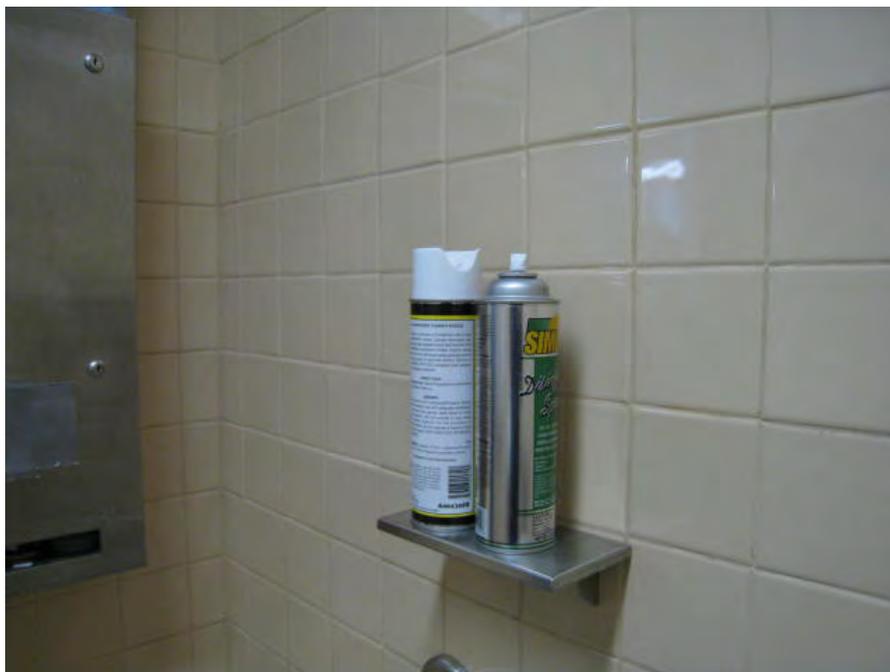
Air fresheners and deodorizing materials were observed in a couple of areas (Pictures 7 and 8). Air deodorizers contain chemicals that can be irritating to the eyes, nose and throat of sensitive individuals. Many air fresheners contain 1,4-dichlorobenzene, a VOC which may cause reductions in lung function (NIH, 2006). Furthermore, deodorizing agents do not remove materials causing odors, but rather mask odors that may be present in the area.

Air Fresheners and Scented Products

Deodorizing Spray in Restroom

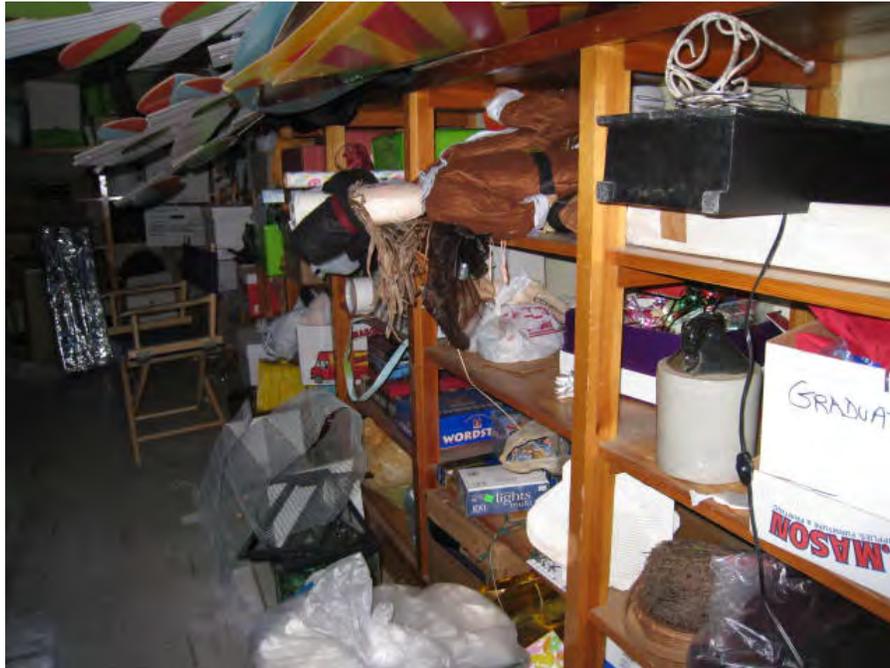
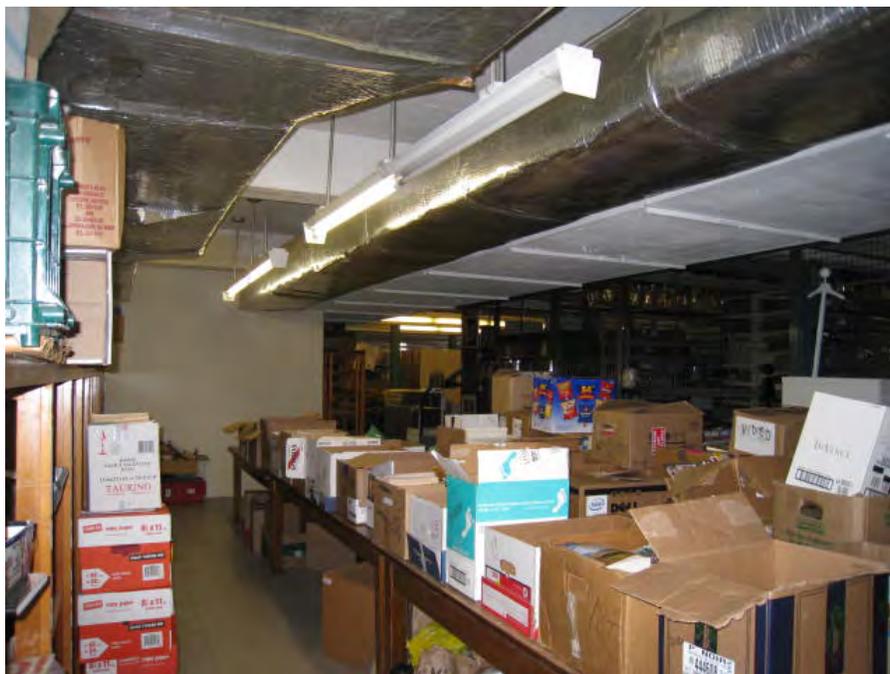
The area of concern that prompted this assessment was the basement work area. Although a significant amount of water-damaged materials were removed from this area since the September 2011 MDPH visit, there is still a large amount of materials stored in the room, including old materials which may be dusty and donated materials which may contain dust, pollen, pet hair and other allergens (Pictures 9 and 10). If a reduction in the amount of materials is not possible, the items should be cleaned as well as possible and stored in a manner that will allow access without disturbing other piles.

Stored Items in the Basement Work Area

Boxes of Items, including Donations, in the Basement Work Area

6. Remove any additional mold-contaminated materials in the basement. Store items away from exterior walls to prevent moistening.
7. Remove and replace any water-damaged/mold-colonized building materials (e.g., floor tiles). This measure will remove actively growing mold colonies that may be present. Remove mold contaminated materials in a manner consistent with recommendations found in “Mold Remediation in Schools and Commercial Buildings” published by the US Environmental Protection Agency, Office of Air and Radiation, Indoor Environments Division, Washington, DC. This document can be downloaded from the US EPA website at: http://www.epa.gov/mold/mold_remediation.html.

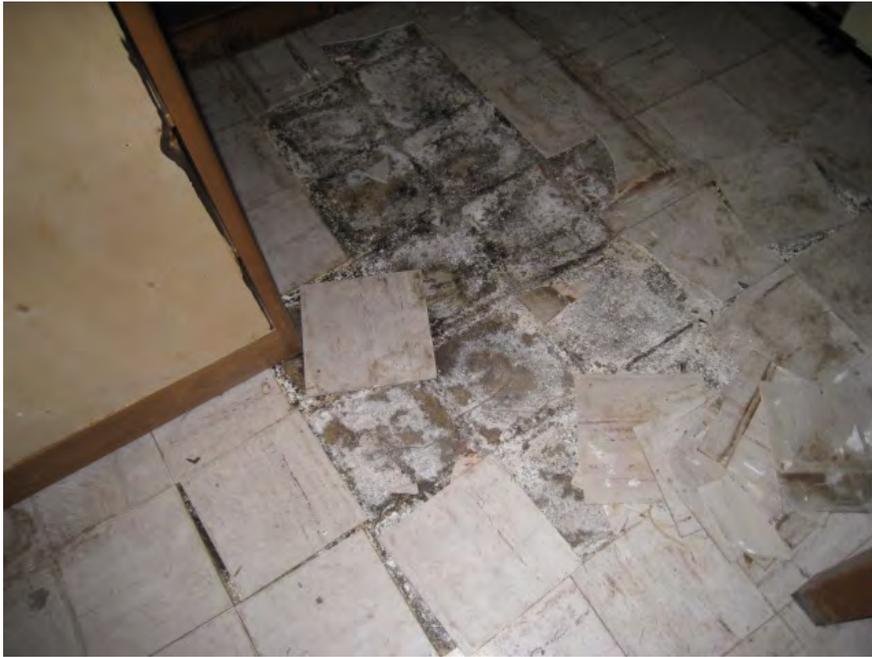
Picture 11

In addition, the floors in the basement work area were soiled and portions of the tiles were broken or peeling, increasing the potential for these materials to become aerosolized thus making the floors impossible to clean (Picture 11). As noted following the September 2011 visit, these tiles may also contain asbestos; therefore a determination of whether asbestos is present should be conducted by a licensed contractor. If asbestos is present, it should be remediated in conformance with all applicable Massachusetts asbestos abatement and hazardous materials disposal laws. If no asbestos is present, the tiles may be removed and replaced or the floor

covered with a matting material to reduce the potential for dust aerosolizing during use of the room.

Damaged Floor Tiles in Basement Work Area

14. Consult with a licensed asbestos inspector to ascertain whether pipe insulation and floor tiles contain asbestos and encapsulate or remove in conformance with Massachusetts law. Do not remove/replace water-damaged ceiling tiles until this issue is resolved.

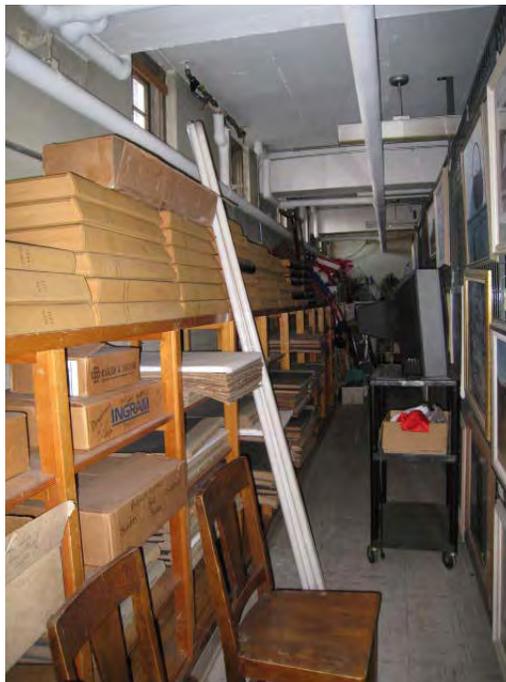
Picture 12

A set of fluorescent light tubes were found leaning against a shelf in the basement workroom (Picture 12). These tubes can be easily broken if they fall or are dropped and can emit mercury when they break.

**Stored Items on Shelves near Basement Walls
(Note Fluorescent Tubes Propped against Shelf)**

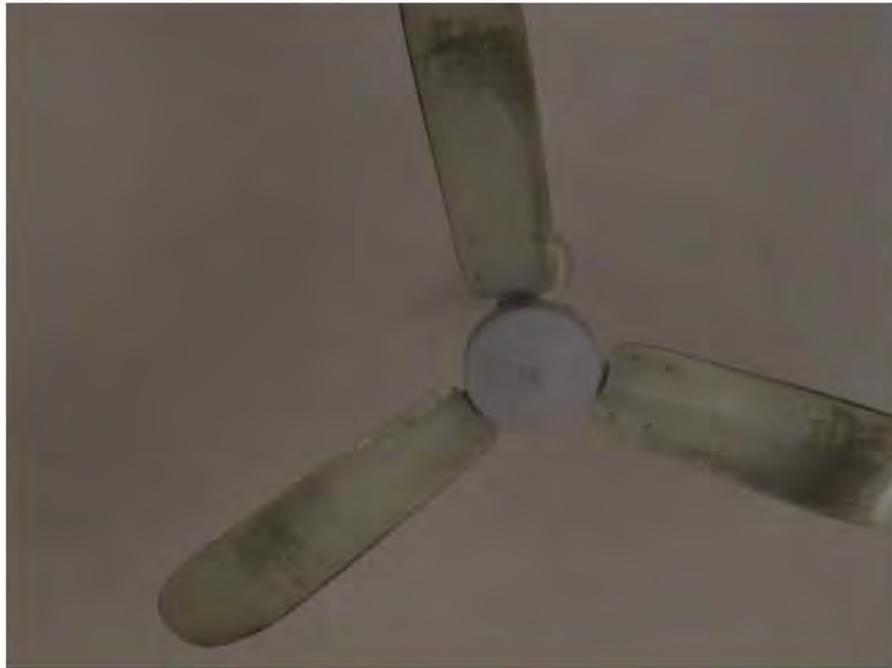
Picture 13

Ceiling fans (Picture 13) and personal fans were found dusty. These items should be periodically cleaned of dust so that they don't re-aerosolize the material when used.

Dusty Ceiling Fan

16. Routinely clean accumulated dust and debris periodically from the surface of supply and exhaust vents, radiators and blades of personal fans.
17. Clean carpeting annually or semi-annually in soiled high traffic areas as per the recommendations of the Institute of Inspection, Cleaning and Restoration Certification (IICRC). Copies of the IICRC fact sheet can be downloaded at:
<http://iicrc.org/consumers/care/commercial-carpet-cleaning/>.

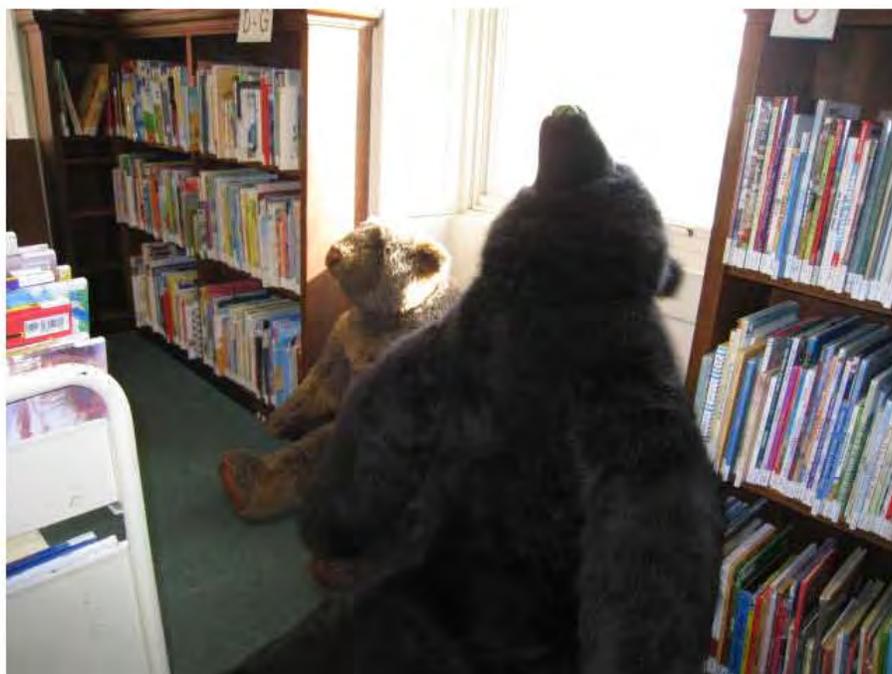
Picture 14

Plush toys were found in several areas of the children's section (Picture 14). These toys may be exposed to human skin. This type of contact can leave oils, perspiration, hair and skin cells. Dust mites feed upon human skin cells and excrete waste products that contain allergens. In addition, if relative humidity levels increase above 60 percent, dust mites tend to proliferate (US EPA, 1992). In order to remove dust mites and other pollutants, frequent vacuuming of toys is recommended (Berry, 1994).

Plush Toys in Children's Area

18. Clean plush toys frequently to remove dust and dust mites.
19. Refer to resource manual and other related indoor air quality documents located on the MDPH's website for further building-wide evaluations and advice on maintaining public buildings. These documents are available at: <http://mass.gov/dph/iaq>.

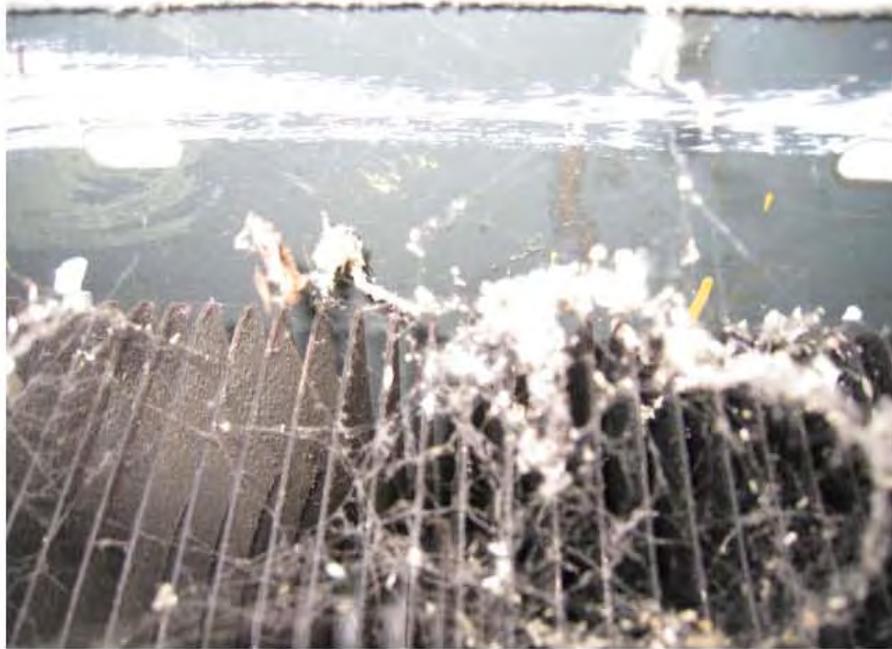
Picture 15

There were specific complaints of odors near the reference librarian's desk. This location is adjacent to a photocopier, which may emit odors. The fins inside the nearby heating registers were also occluded with dust (Picture 15). When the heating system starts operating early in the heating season, accumulations of dust in contact with heated metal may start to offgas odors. These fins may be cleaned using a wand attachment on a vacuum cleaner or with a damp cloth before the beginning of the heating season to reduce these odors.

Dusty Radiator Fins in Reference Librarian Area
