# **INDOOR AIR QUALITY REASSESSMENT**

**Dighton Public Library  
395 Main Street  
Dighton, MA**

Prepared by:  
The Massachusetts Department of Public Health  
Bureau of Environmental Health  
Indoor Air Quality Program  
April 2013

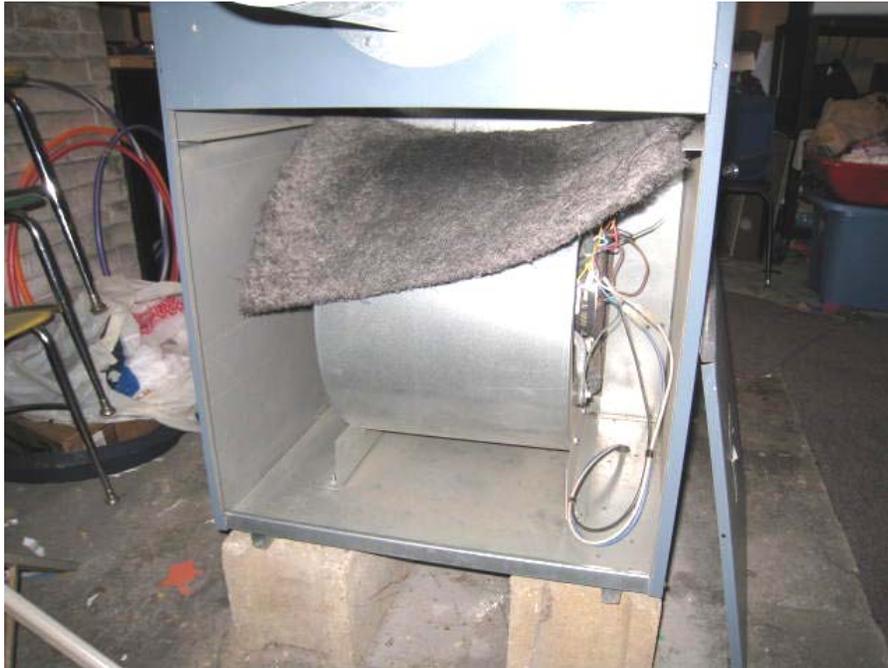
**Picture 1**

Other conditions that can affect indoor air quality were observed during the assessment. AHUs are typically equipped with air filters that should be cleaned or changed per the manufacturer's instructions to avoid the reaerosolization of dusts and particulates. DPL staff had no information on the frequency of filter changes for the AHU. The AHU was opened to observe the conditions of filters. The unit was outfitted with one filter that was found to be ill-fitting, saturated with dust/debris and appeared not to have been changed/cleaned in some time (Picture 1).

**Air handling unit located in basement, note ill-fitting filter saturated with dust/debris**

In order to decrease aerosolized particulates, disposable filters with an appropriate dust spot efficiency should be installed. The dust spot efficiency is the ability of a filter to remove particulates of a certain diameter from air passing through the filter. Filters that have been determined by ASHRAE to meet its standard for a dust spot efficiency of a minimum of 40

percent would be sufficient to reduce many airborne particulates (Thornburg, D., 2000; MEHRC, 1997; ASHRAE, 1992). Pleated filters with a Minimum Efficiency Reporting Value (MERV) dust-spot efficiency of 9 or higher are recommended. Note that increasing filtration can reduce airflow (called pressure drop), which can subsequently reduce the efficiency of the unit due to increased resistance. Prior to any increase of filtration, the AHU should be evaluated by an HVAC engineer to ascertain whether it can maintain function with more efficient filters.

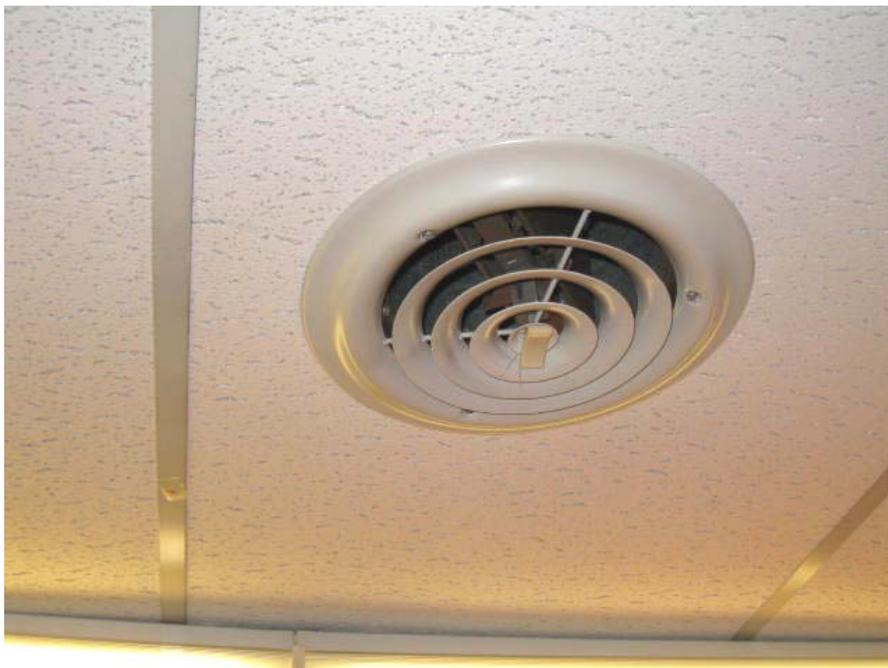
**Picture 2**

**Ceiling-mounted supply vent**

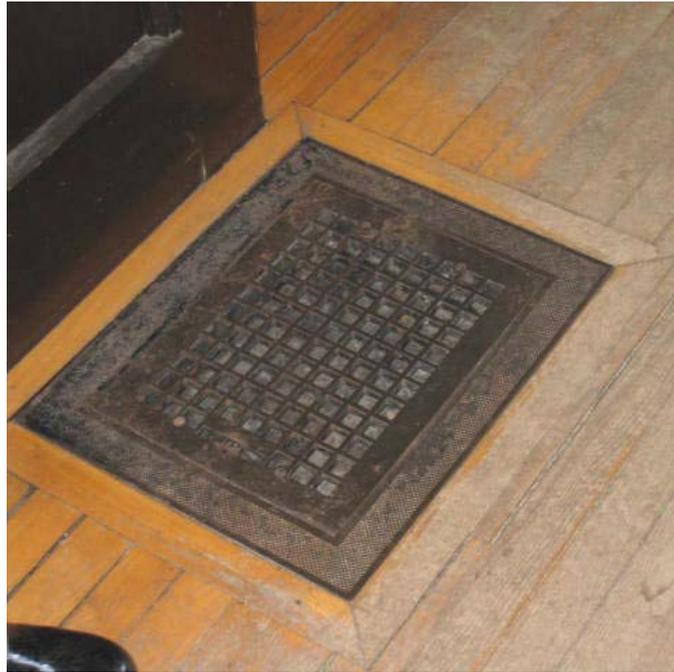
**Picture 3**

**Floor-mounted supply vent**

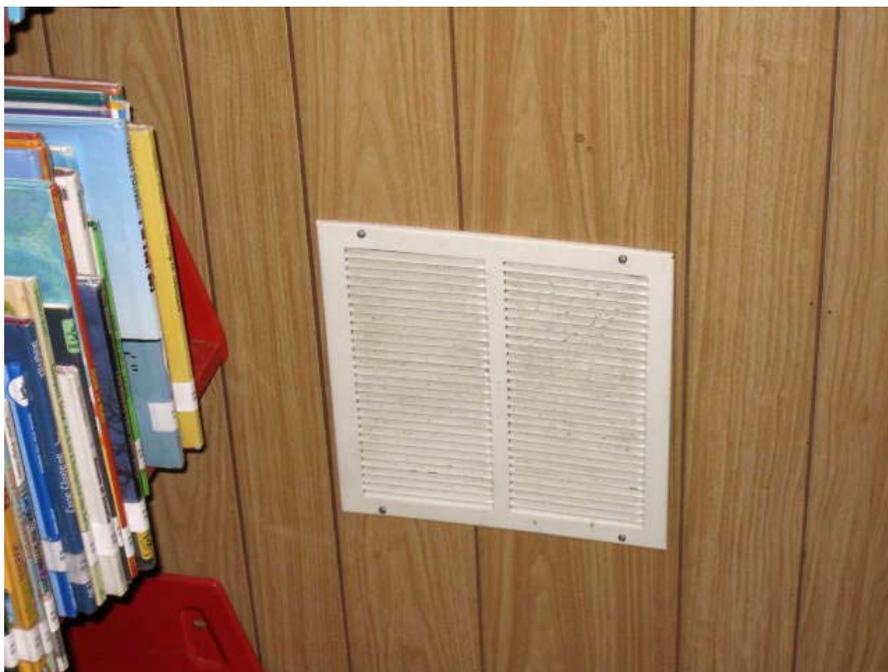
**Picture 4**

**Return vent**

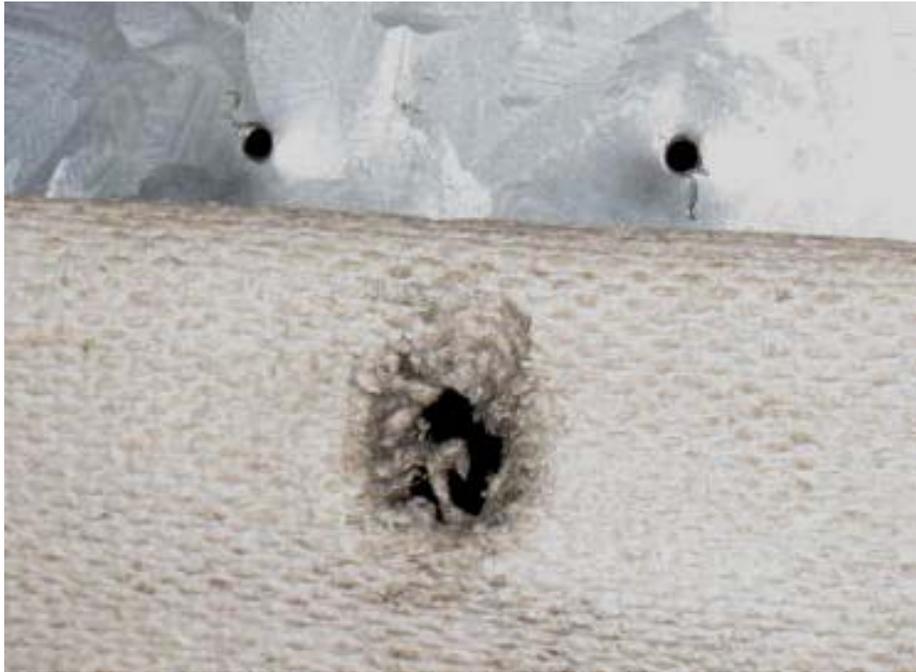
**Picture 5**

**Holes/breaches in ductwork**

- **Seal holes/breaches in HVAC ductwork, shown in Pictures 5 and 6, inspect remaining ductwork for similar breaches and repair as needed.**
  - **Have an HVAC firm evaluate the AHU for filter upgrade options. Ensure filters fit flush in their racks to prevent filter bypass. Change filters per manufacturer's instructions or more frequently if needed.**

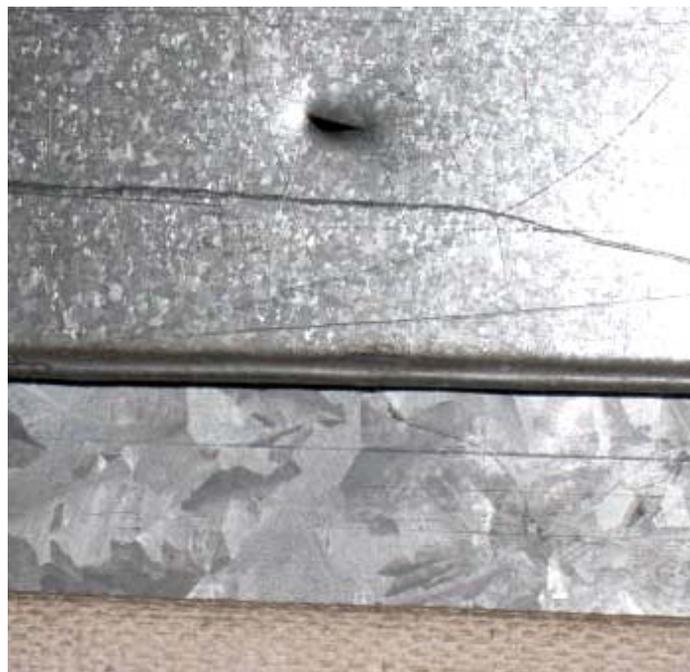
**Picture 6**

**Hole/breach in ductwork**

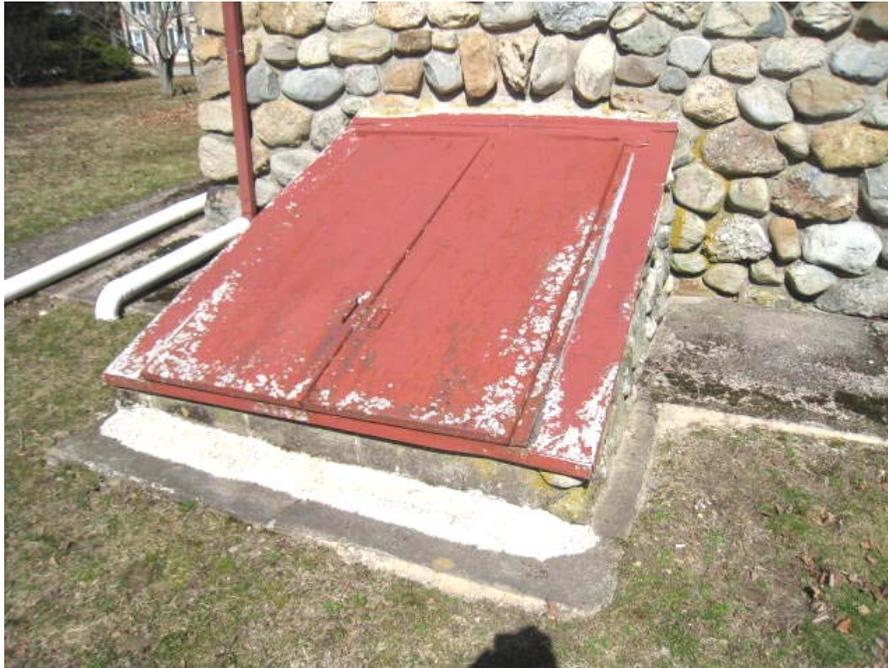
**Picture 7**

In order for building materials to support mold growth, a source of water exposure is necessary. Identification and elimination of the source of water moistening porous materials is necessary to control mold growth. Although no visible water damage or mold growth was observed, including the basement carpeting which prompted this assessment, a potential source of water infiltration was observed in the form of spaces around the metal bulkhead door (Pictures 7 and 8). These spaces can serve as a source for drafts and/or water penetration into the building,

causing water damage and potentially leading to mold growth. In addition, these spaces can serve as pathways for insects, rodents and other pests to enter into the building.

**Exterior view of metal bulkhead**

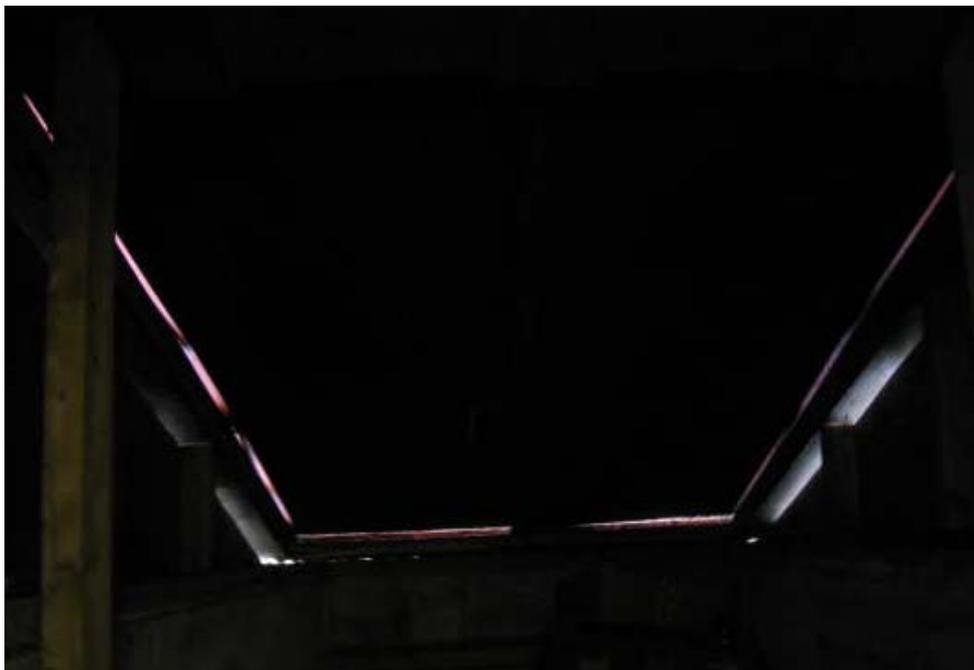
**Picture 8**

**Interior view of metal bulkhead, note light penetration through breaches**
