INDOOR AIR QUALITY ASSESSMENT

**Needham Town Hall
1471 Highland Avenue
Needham, MA**

Prepared by:
Massachusetts Department of Public Health
Bureau of Environmental Health
Indoor Air Quality Program
May 2013

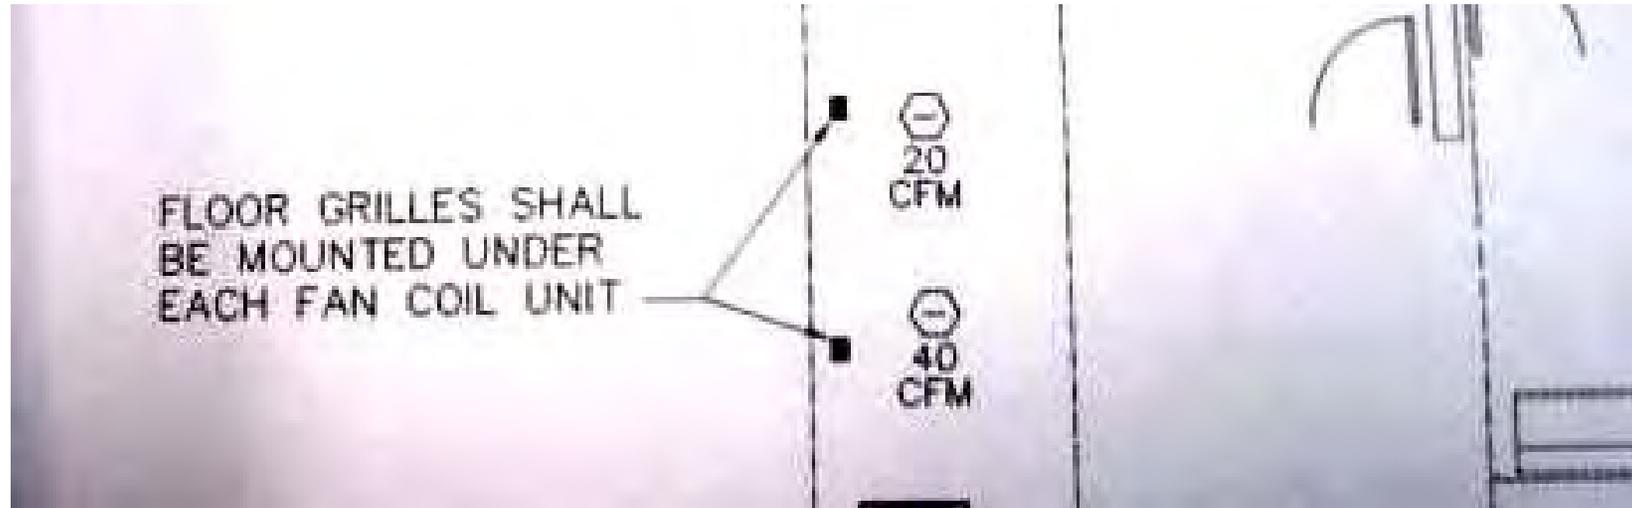
Figure 3

BEH/IAQ staff examined blueprints related to the NTH renovation specifically related to the NPHD offices. Of note was the duct and piping system plans, which indicated the interior rooms were to be heated/cooled using *both* ceiling-mounted air diffusers and FCUs (Figures 4 and 5). This configuration is unusual; interior areas typically use only ceiling-mounted air diffusers for heating, cooling and fresh air. All other spaces in the building have either FCUs located under windows or are configured to have the ceiling-mounted diffusers as the sole source of fresh air as noted in Figure 3. Excessive airflow from the ceiling-mounted fresh air diffusers

Detail of Design for Floor-Mounted Fresh Air Supplies beneath FCUs

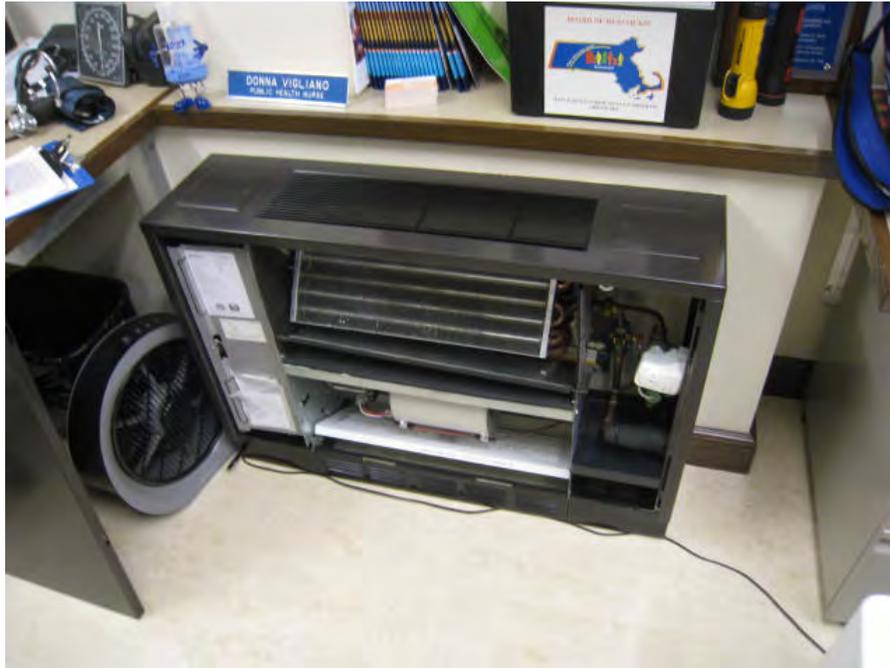
Picture 1

Example of an FCU installation

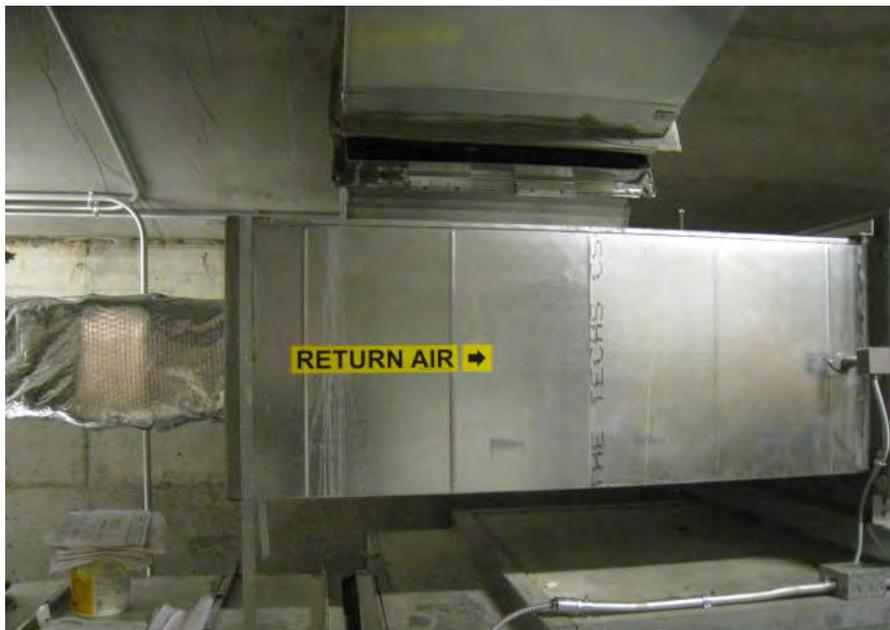
Picture 2

Fresh air AHU located in the underground chamber beneath the front stairs of the original building

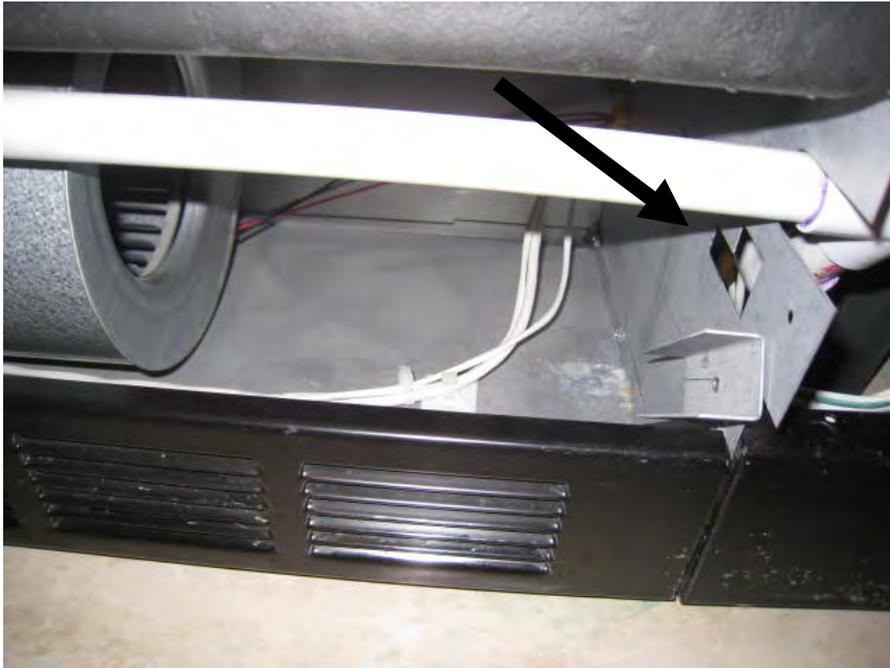
Picture 3

BEH/IAQ staff examined the interior conditions of FCUs in selected areas of the building. It appeared that the FCUs have two different designs: some FCUs have racks to install filters on a slant (Picture 3), while the FCUs in the NPHD interior offices have tabs to install the filters parallel to the floor (Picture 4). The NPHD FCUs in interior offices had components (the fans and electrical service) installed in a manner that prohibits the proper installation of filters (Picture 5). In this condition, unfiltered air would be circulated with dust and other debris that may become readily aerosolized. Properly fitting filters are needed to remove particulates from the air before it is circulated.

FCU with slanted filter rack, arrow notes hole in cabinet

1. Discontinue the use of FCUs in the NPHD interior offices. Shut off the coolant supply to these units to prevent condensation generation in hot, humid weather and seal the drip pan.
2. Ensure that FCU filters are installed properly. This may require reconfiguring the wiring of some FCUs or retrofitting filter racks so that filters can be installed in a manner to prevent drawn air by-passing filters.

3. Seal all holes in the walls of the FCU cabinets to limit filter bypass. Double sided, foil-faced insulation with adhesive or aluminum insulation tape can be applied in a manner to create an airtight seal.

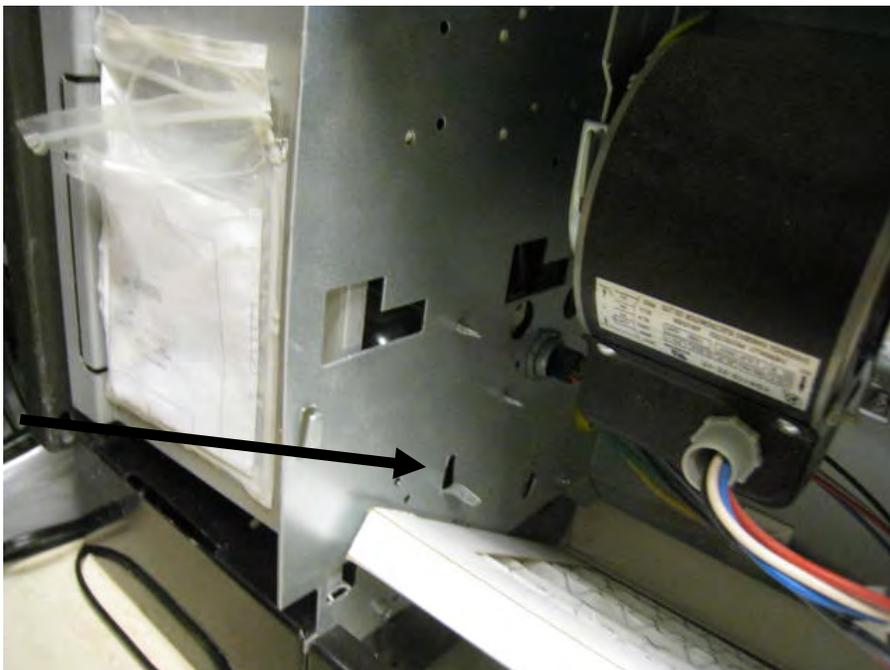
Picture 4

FCU with metal tab (arrow) to install filter parallel to floor

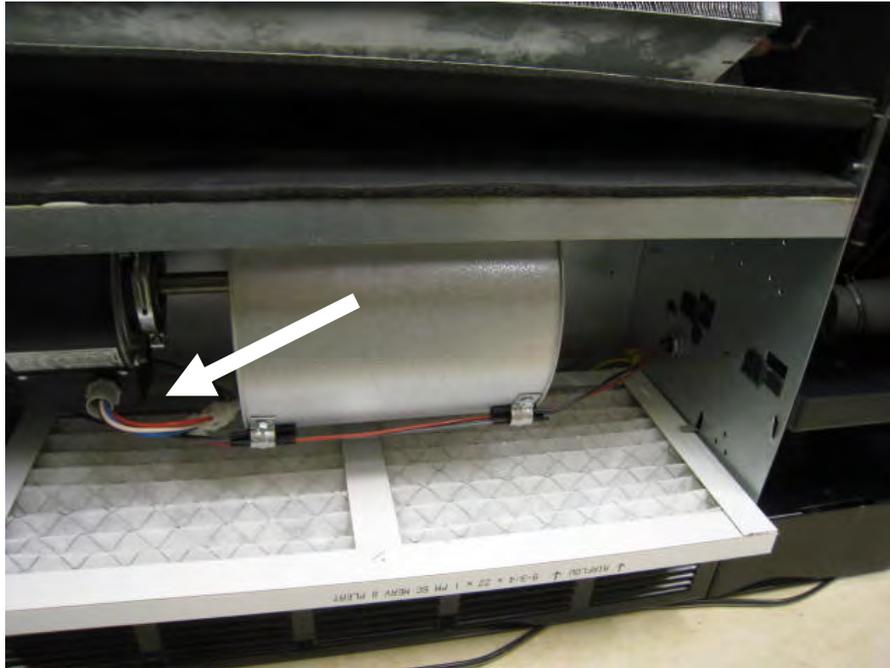
Picture 5

FCUs with interior components that prohibit the proper installation of filters

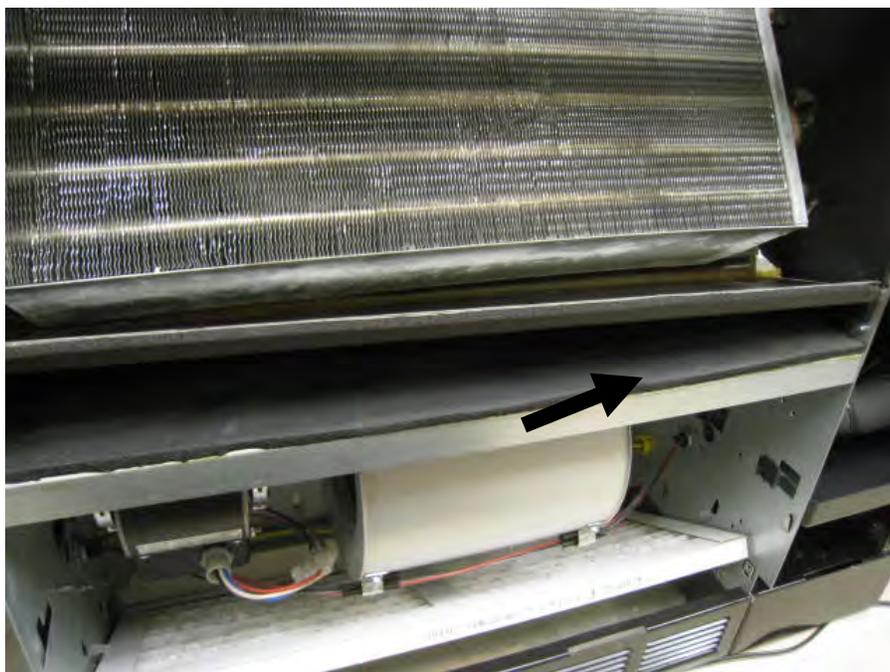
Picture 6

Spaces were also observed in the interior cabinet of FCUs above the filters (Picture 6). These gaps should be sealed with an appropriate fire-rated material to prevent the draw of odors and materials from other areas of the building into the FCUs. Please note, some FCUs are difficult to access due to partition walls that prevent access to the main compartment.

Example of space (arrow) in the interior cabinet of FCU above the filters

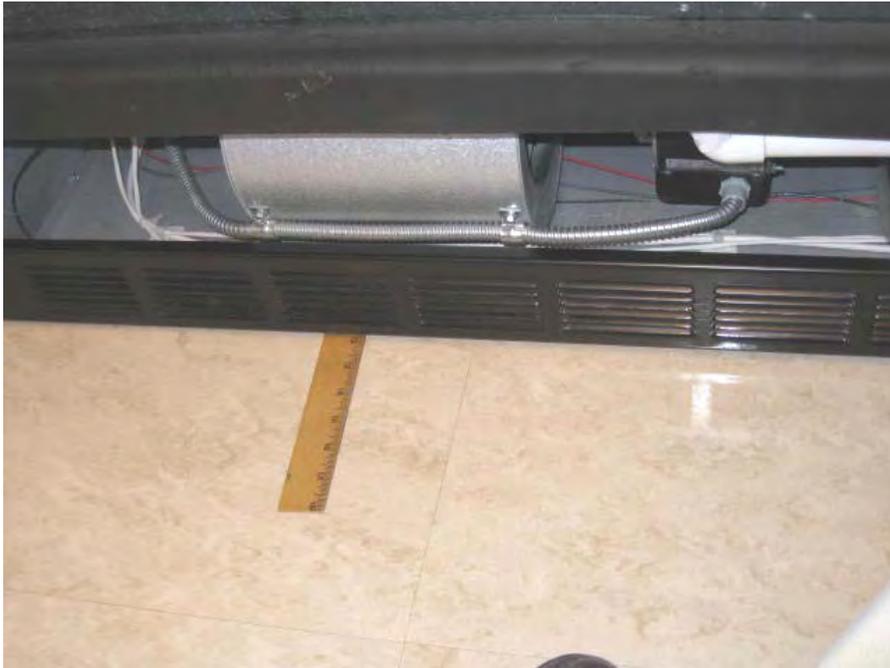
Picture 7

Space beneath FCU as indicated by ruler

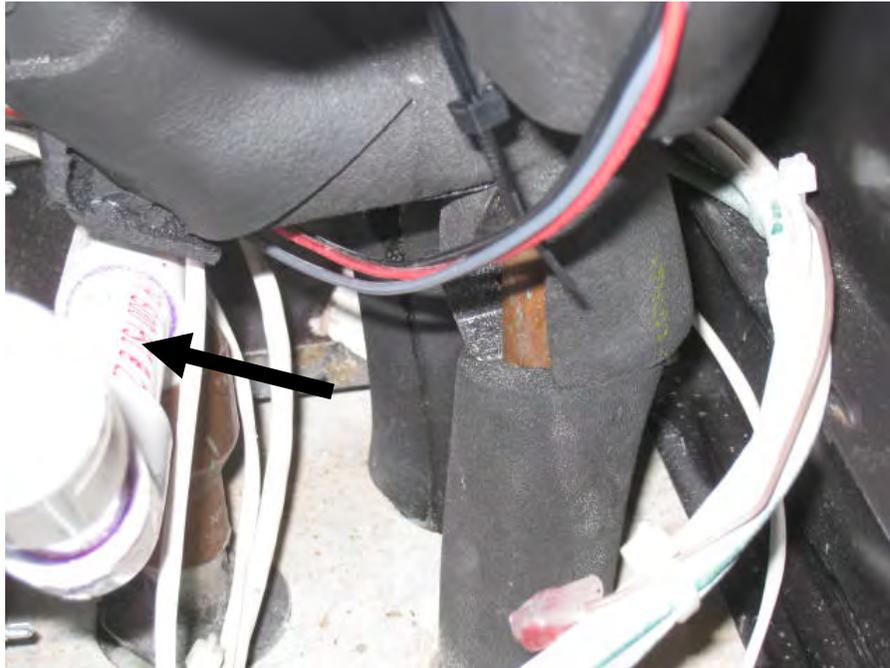
Picture 9

Of note is the drain system connected to drip pans. Typically FCUs have a trap installed inside the cabinet. The drains in the FCUs appear to not have traps (Picture 9). The lack of a trap may result in odors and other pollutants from the drain system being drawn and distributed into the room by FCU fans.

Drains in FCU appear to have no trap

10. Consult with HVAC engineer/plumber to determine:
 - if traps can be retrofitted into FCU condensate drains; and
 - if FCU components can/should be insulated to prevent/reduce condensation.

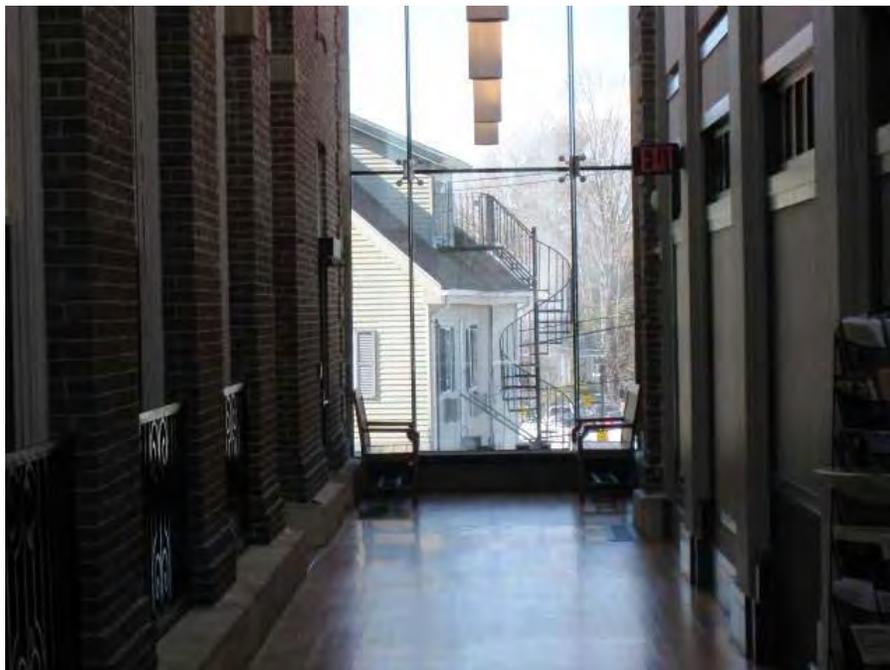
Picture 10

The wood flooring on the second floor of the addition appears to consist of manufactured wood installed over a cement floor decking (Picture 10). Spaces could be observed along seams formed where the flooring meets the hallway wall (Pictures 11 and 12). Spaces and gaps in the wood flooring can allow moisture and materials to accumulate under the flooring, particularly if the floor is routinely wet mopped. The decking beneath the wood flooring would hold moisture against the underside of the wood, preventing proper drying and potentially allowing mold to grow.

Atrium hallway floor of manufactured wood installed over a cement floor decking

14. Properly seal the edge of flooring in the atrium's second floor hallway to prevent mop water from moistening the space between the wood and cement decking. Consider other means of cleaning this floor in lieu of wet mopping.

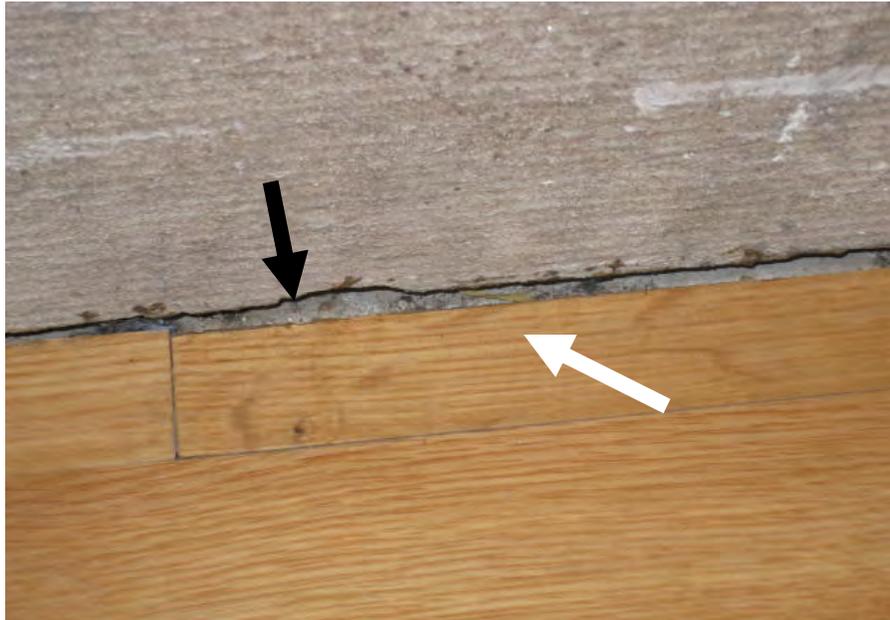
Picture 11

**Space (black arrow) along seams where flooring meets hallway wall
(white arrow shows warping floorboard)**

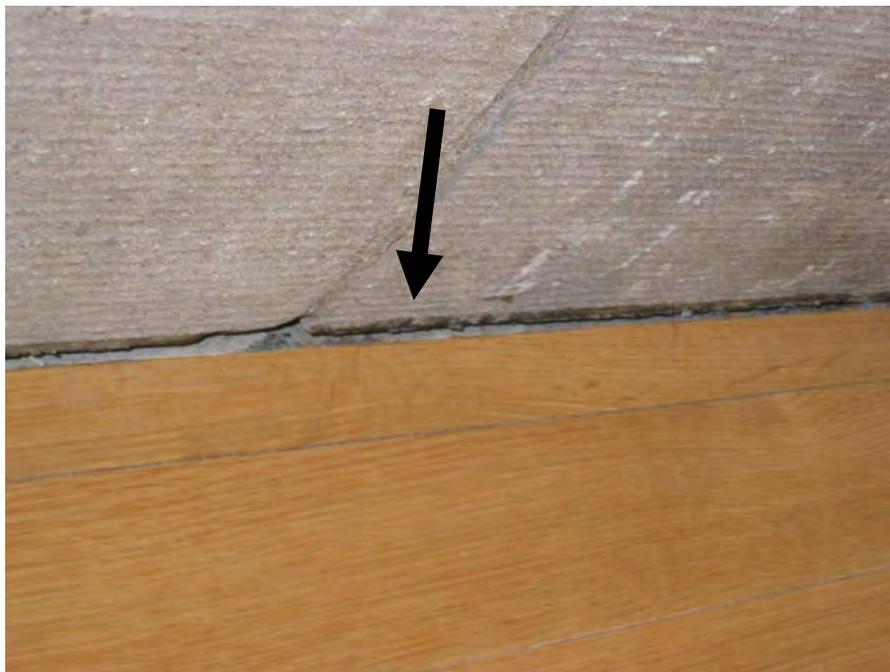
Picture 12

Spaces (black arrow) along seams where flooring meets hallway wall

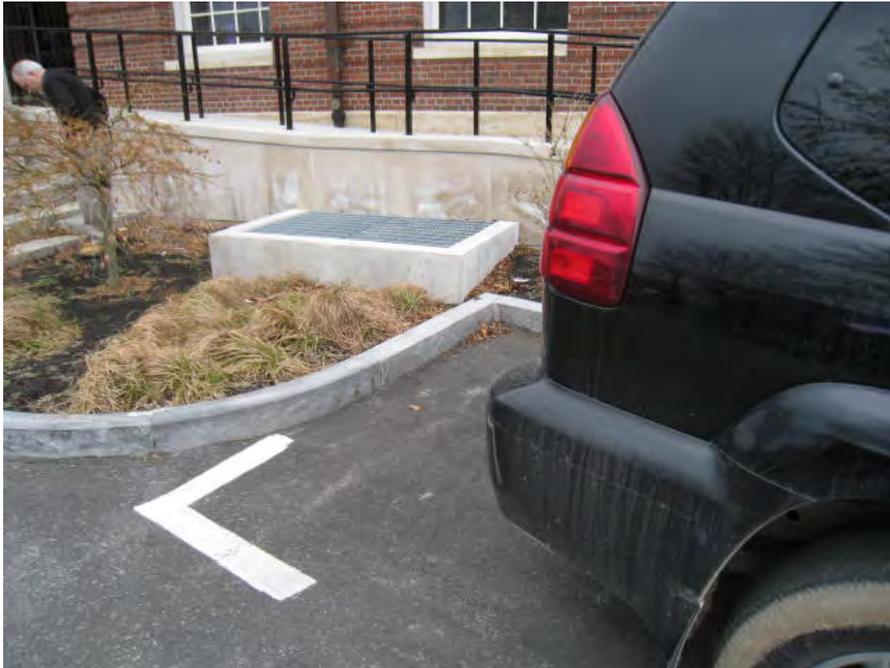
Carbon monoxide should not be present in a typical, indoor environment. If it is present, indoor carbon monoxide levels should be less than or equal to outdoor levels. Outdoor carbon monoxide concentrations were non-detect (ND) at the time of the January 11, 2013 assessment (Table 1). Carbon monoxide levels measured inside the building ranged from ND to 1.5 ppm (Table 1). These low levels of carbon monoxide may be due to fresh air being drawn from the subterranean cement-lined pit located next to a parking space at the front of the building (Picture 13). Under certain wind/weather conditions exhaust from idling vehicles in this location can be entrained by the HVAC system and distributed throughout the original building and the first floor of the addition. Serious consideration should be given to relocating this parking space.

The fresh air intake (in cement lined pit) next to a parking space

16. Consider relocating the parking space shown in Picture 13 to prevent products of combustion from being entrained into the HVAC system.
17. Render airtight all sewer ejector pumps. If possible, install mechanical exhaust ventilation in mechanical rooms with such equipment.

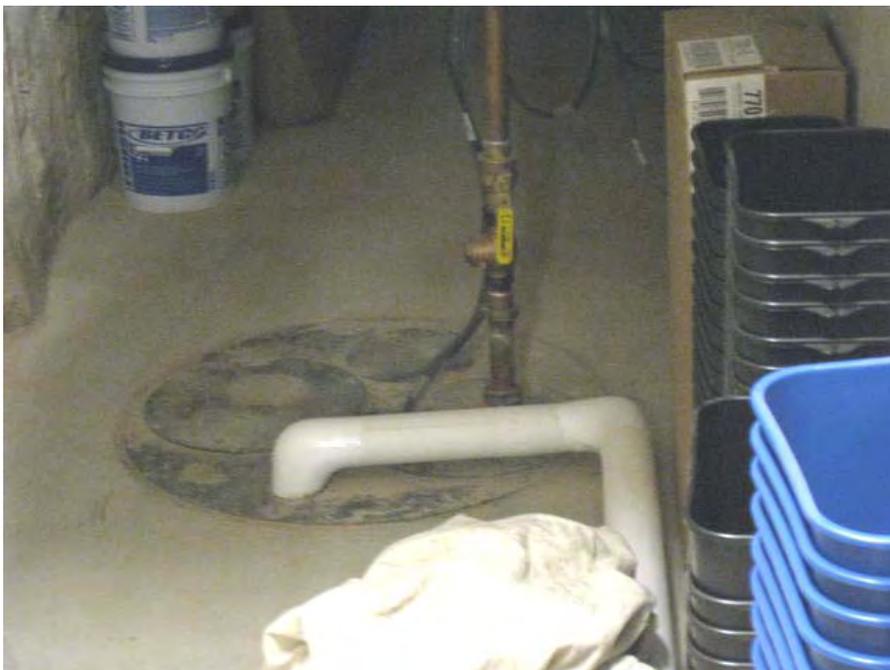
Picture 14

There were reports of sewer odors that periodically occur in the south stairwell and elevator area of the addition. At the base of the south stairwell is a sewage ejector pump (Picture 14). In the experience of the IAQ Program, this type of sewage system component may not be airtight, resulting in sewer odors and water vapor escaping from the pump. Odors and water vapor can enter the stairwell and elevator shaft. It is also important to note that other sewage ejector pumps are located in the underground chamber containing the building's main HVAC system, which could also provide a source of odors.

Example of sewage ejector sump pump area
