# **INDOOR AIR QUALITY ASSESSMENT**

**Massachusetts Department of Children and Families  
121 Providence Street  
Worcester, Massachusetts**

Prepared by:  
Massachusetts Department of Public Health  
Bureau of Environmental Health  
Indoor Air Quality Program  
July 2013

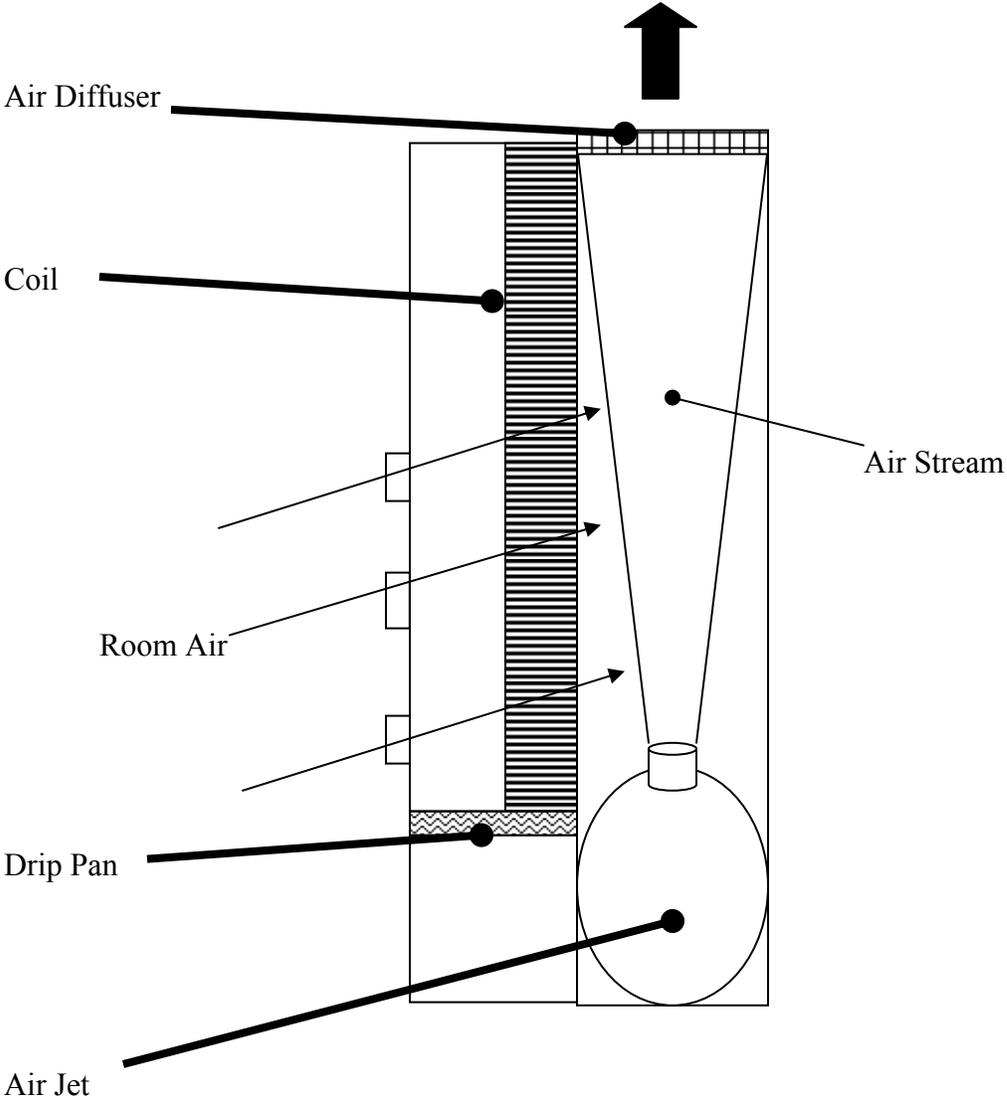
**Figure 1**  
**Induction Unit Configuration**

The IUs (Figure 1), located along the base of walls, provide heating and/or cooling to perimeter areas beneath windows. In a number of areas, IUs were blocked/obstructed by several items including cardboard boxes, books and other stored materials. In order for IUs to facilitate airflow as designed, air diffusers and return vents must remain free of obstructions. IUs appear to be original to the building, which would make them approximately 50-60 years old. Ventilation equipment of this age is difficult to maintain because replacement parts are often unavailable.

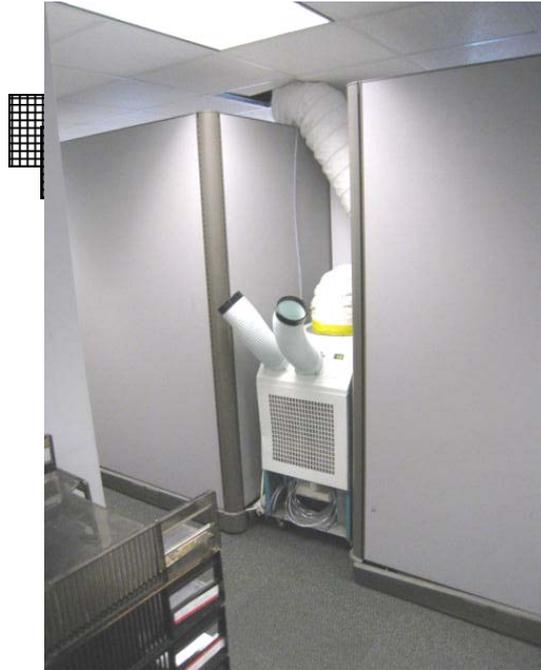
**Picture 1**

The portable AC units are equipped with flexible ducts. In their current configuration, the portable AC unit draws and directs air into the hallways instead of into employee-occupied cubicles. In addition, one portable unit is located direct below an exhaust vent, which would draw chilled air into the general HVAC system instead of into occupied space. The portable AC unit located in the waiting room was deactivated during this assessment. Airflow of these portable AC units should be redirected to provide chilled air for building occupants.

**Portable AC unit on opposite side of divider from staff cubicles**

3. Reconfigure portable AC units to provide heat relief to staff in low cubicles. Increasing the number of portable AC units on the second floor may be necessary.
4. Remove coving and carpet tiles around IU #48 (Picture 2) and replace after repairing source of water infiltration.
5. Reduce the amount of cardboard in the occupied space.
6. Relocate or consider reducing the amount of materials stored in offices and common areas to allow for more thorough cleaning.
7. Remove newspapers and other items from IUs.

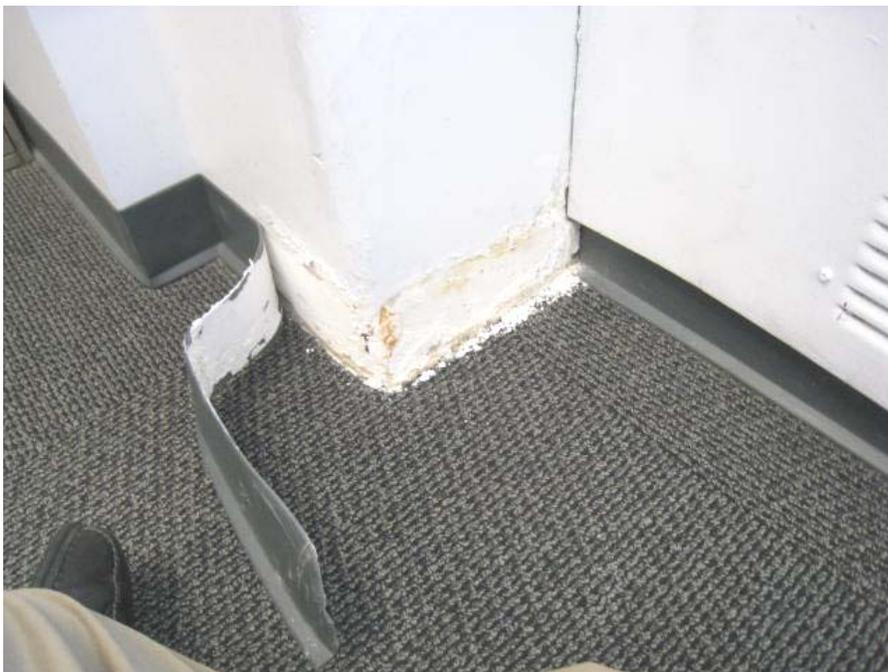
**Picture 2**

BEH/IAQ staff noted water damage around IU #48 on the third floor (Picture 2). It is possible that water has moistened the adjacent carpet tile. An odor was noted in the law library; newspapers were observed to be on top of the IU diffuser in direct sunlight (Picture 3). Newsprint, if moistened and/overheated, can be a source of irritating odors.

**Water damage around IU #48**

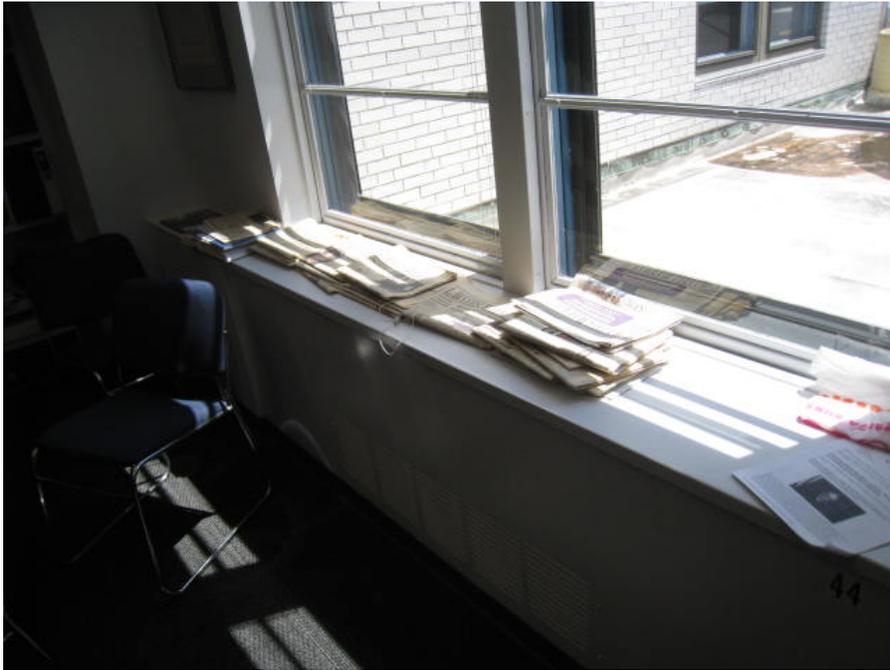
**Picture 3**

**Newspapers on IU in sunlight**

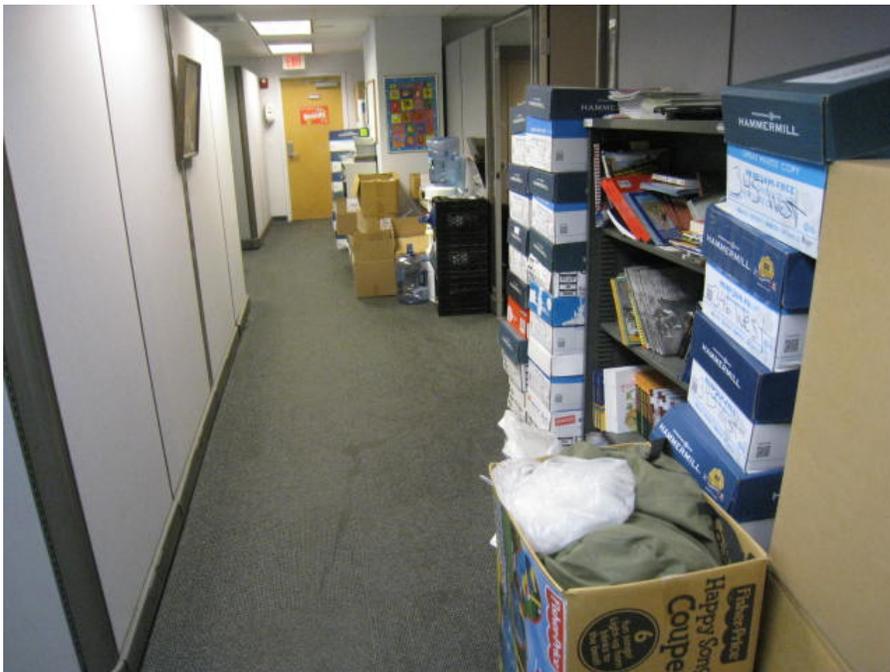
**Picture 4**

Other conditions that can affect indoor air quality were observed during the assessment. Of note is the number of locations that contain significant amounts of cardboard (Pictures 4 through 6). Cardboard is manufactured from a variety of chemicals which can off-gas and be a source of odors and irritation to the eyes, nose and respiratory system. Having a large amount of cardboard stored/shelved in occupied space can result in respiratory irritation to occupants.

**Cardboard in occupied space**

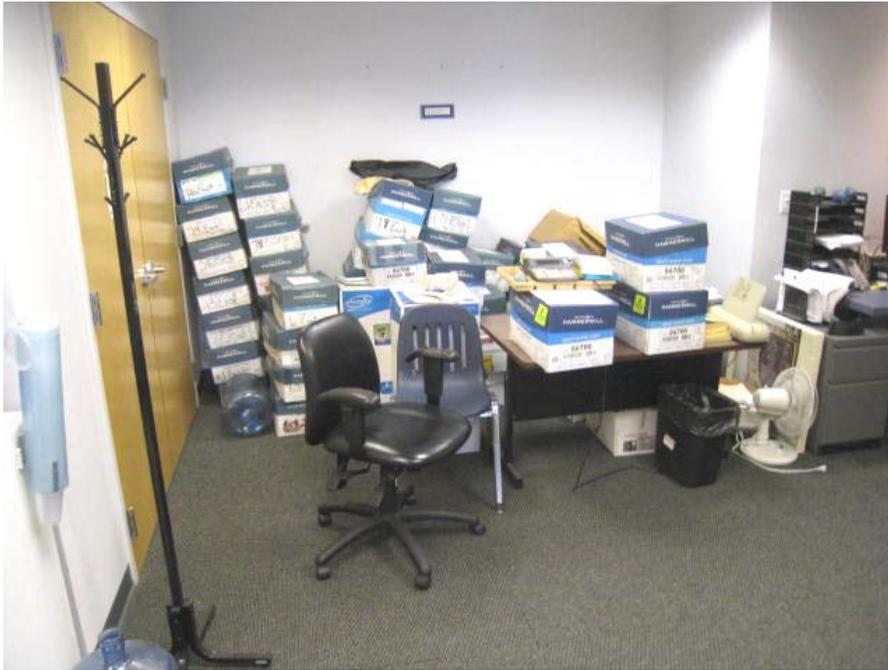
**Picture 5**

**Cardboard in occupied space**

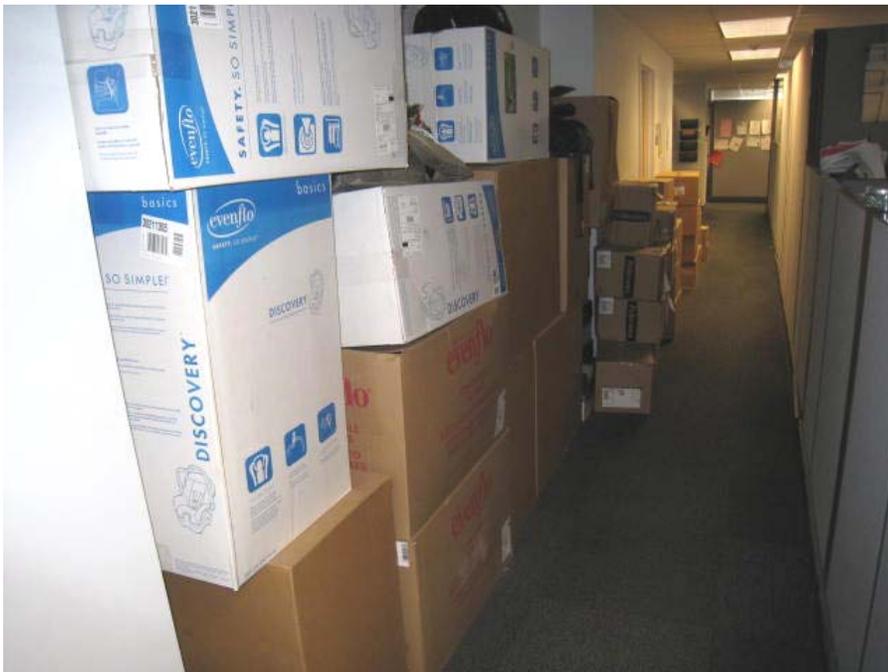
**Picture 6**

**Cardboard in occupied space**

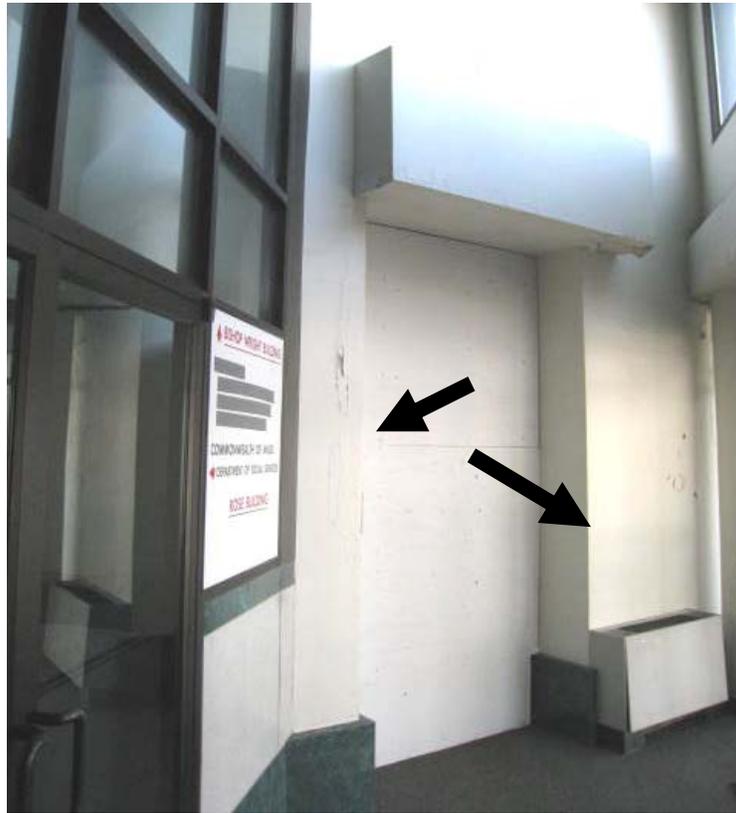
**Picture 1**

In order for building materials to support mold growth, a source of water exposure is necessary. It was reported to BEH/IAQ staff that water infiltration occurred in this area after a severe weather event on June 12, 2013. At the time of the BEH/IAQ assessment, the gypsum wallboard (GW) and carpeting remained wet. BEH/IAQ staff removed chipping paint and noted visible mold growth behind the paint layer (Pictures 1 through 3); paint acts as a water impermeable barrier that prevents drying. At the time of the assessment, the GW walls were saturated with moisture. DCF staff reported that these areas were not dried using fans and/or other means subsequent to the weather event previously mentioned.

**Water-damaged GW and wet carpeting in foyer**

1. Remove water-damaged/mold-colonized GW and carpeting as well as any wet insulation in wall cavities in the foyer and lobby.
2. Remediation efforts would best be conducted after work hours.

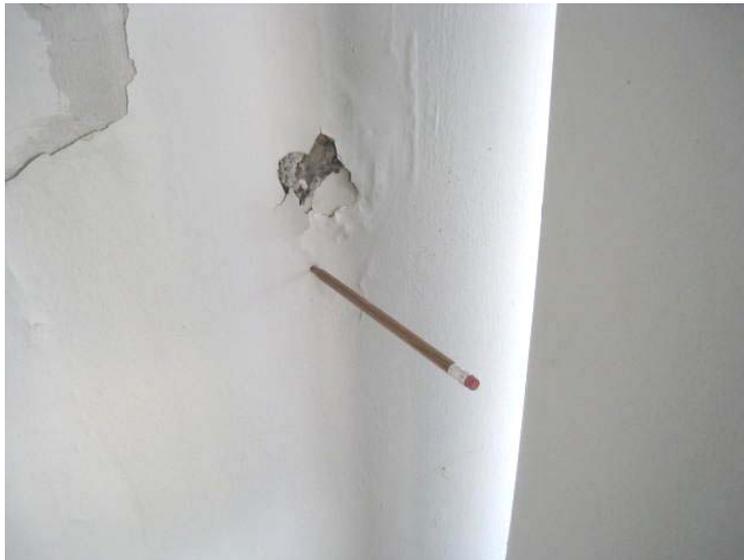
**Picture 2**

**Close-up of water damage in Picture 1  
(Note chipped paint reveals mold colonization behind paint layer, and the saturated GW allows a pencil to be easily inserted)**

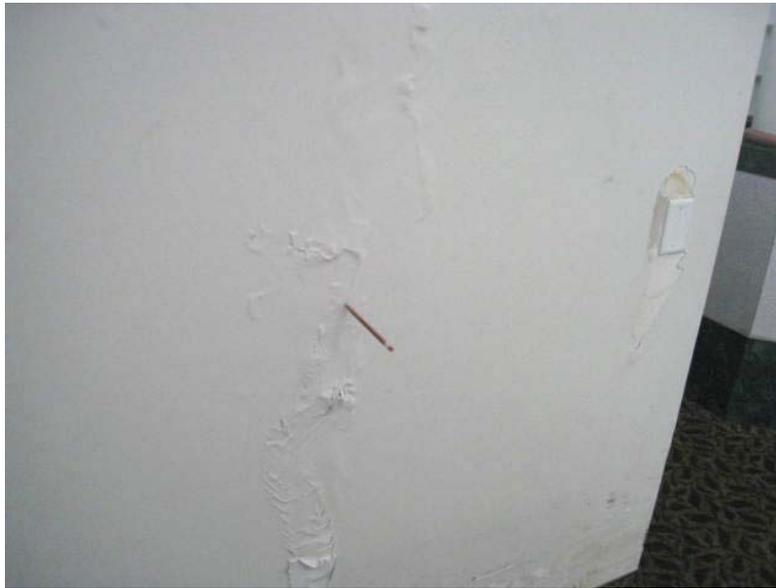
**Picture 3**

**Water-damaged/mold-colonized gypsum wallboard in the lobby above wet wall-to-wall carpeting**
