MOLD ASSESSMENT

**Old Mill Pond Elementary School
4107 Main Street
Palmer, Massachusetts**

Prepared by:
Massachusetts Department of Public Health
Bureau of Environmental Health
Indoor Air Quality Program
August 2013

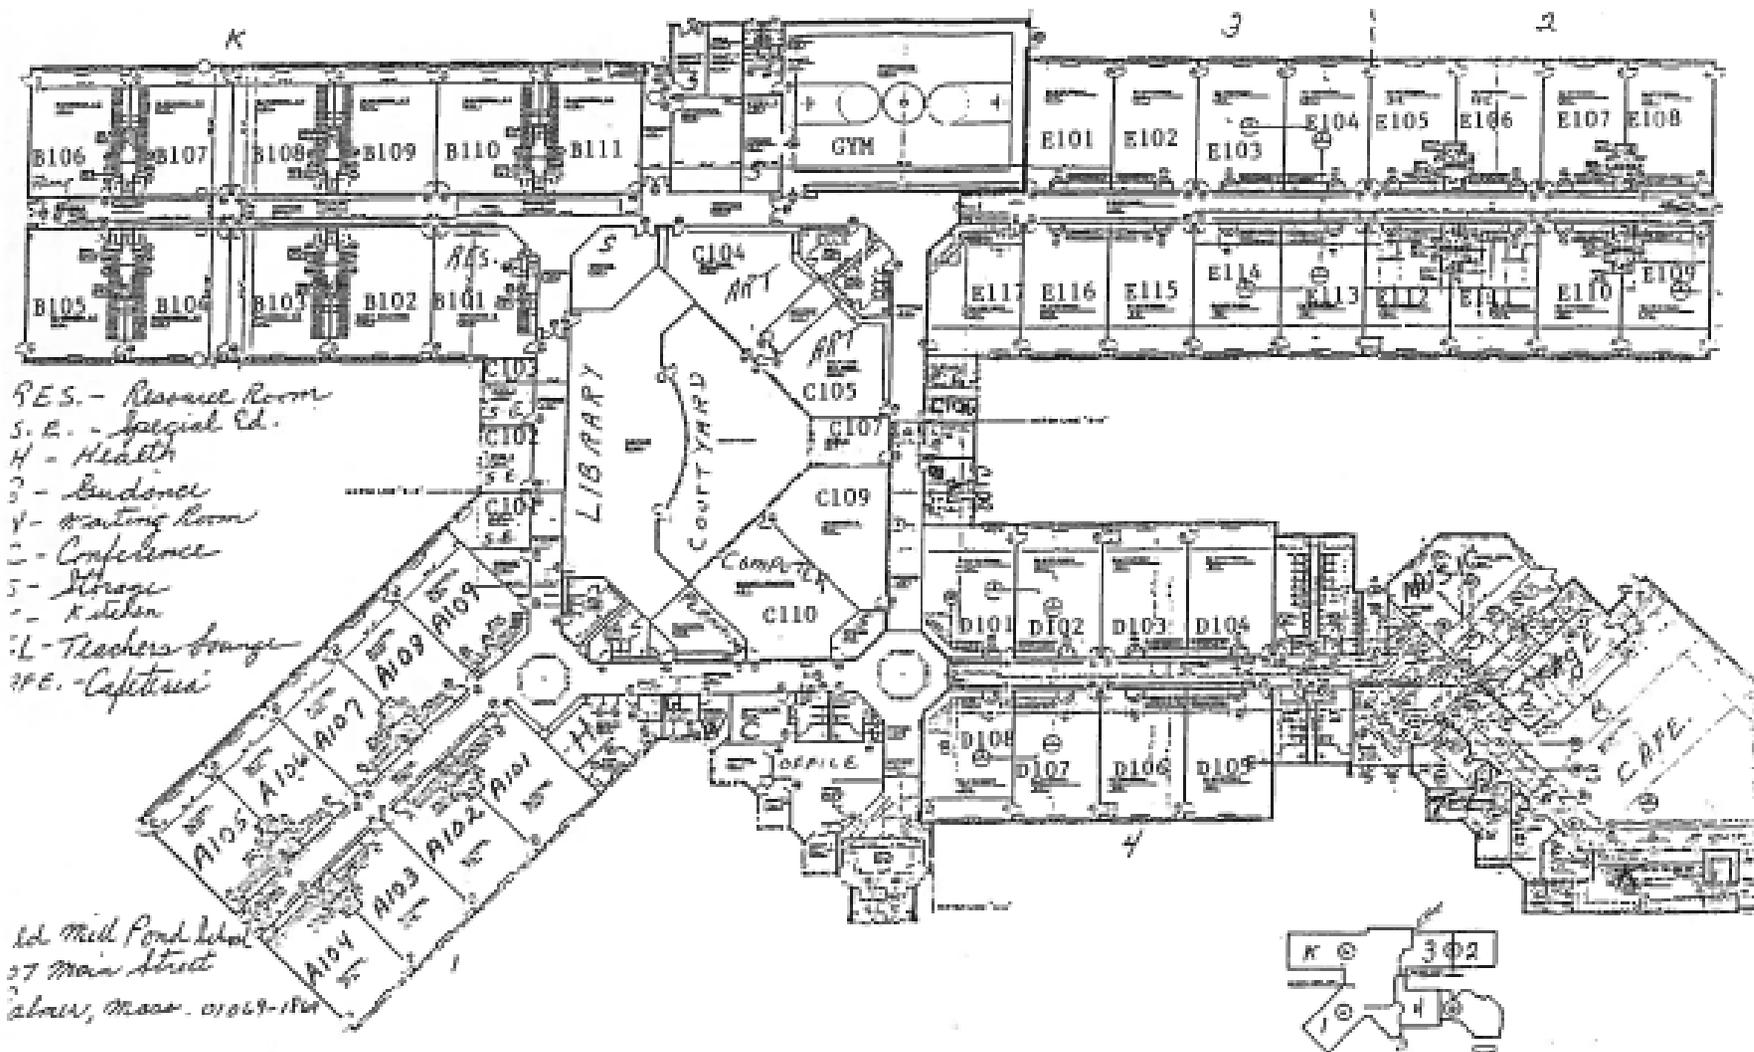
Figure 1
Old Mill Pond Elementary School

The OMPES is a single-level building, which had been originally constructed as a middle school in 1991 (Figure 1). The OMPES is not air-conditioned apart from a few locations with window-mounted air conditioners. Windows are openable throughout the building.
