WATER DAMAGE/MOLD INVESTIGATION

**Massachusetts Department of Developmental Services
68 North Main Street
Carver, Massachusetts**

Prepared by:
Massachusetts Department of Public Health
Bureau of Environmental Health
Indoor Air Quality Program
November 2013

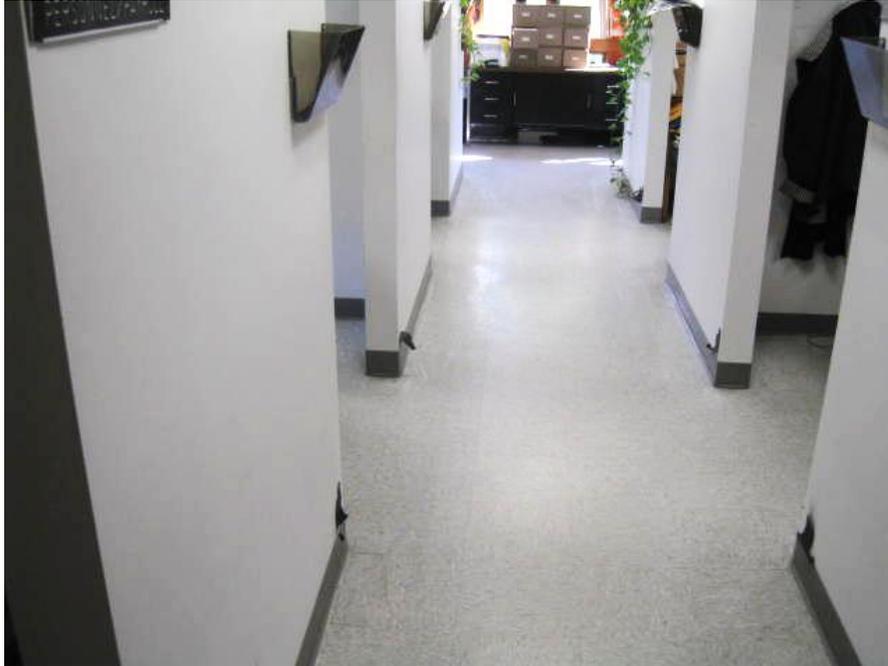
Picture 1

The flooding occurred after hours in a first floor restroom, reportedly the result of a water backup from blocked drainage. Ms. Slaiding reported that approximately two inches of standing water had accumulated in the adjacent work area (Picture 1). Water also seeped out in to the main foyer, moistening the wall-to-wall carpeting (Picture 2). Upon discovering the flood, building management contacted Kennedy Carpet Restoration/Cleaners to conduct remediation work (e.g., water extraction, drying the area with fans, cleaning, and disinfection of surfaces with an antimicrobial agent).

Work area outside of previously flooded restroom

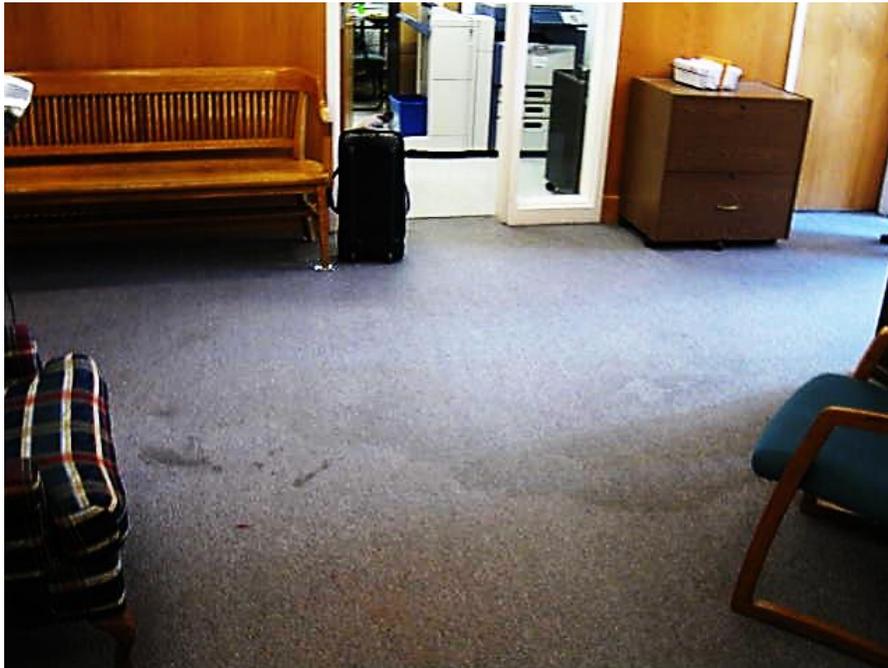
Picture 2

Water-damaged carpeting in main foyer

4. Consider replacing carpeting in main foyer with a non-porous surface (e.g., tile, rubber matting).
5. Consider using a water/mold-resistant material such as green board instead of GW in areas of chronic water leaks (e.g., mechanical rooms).

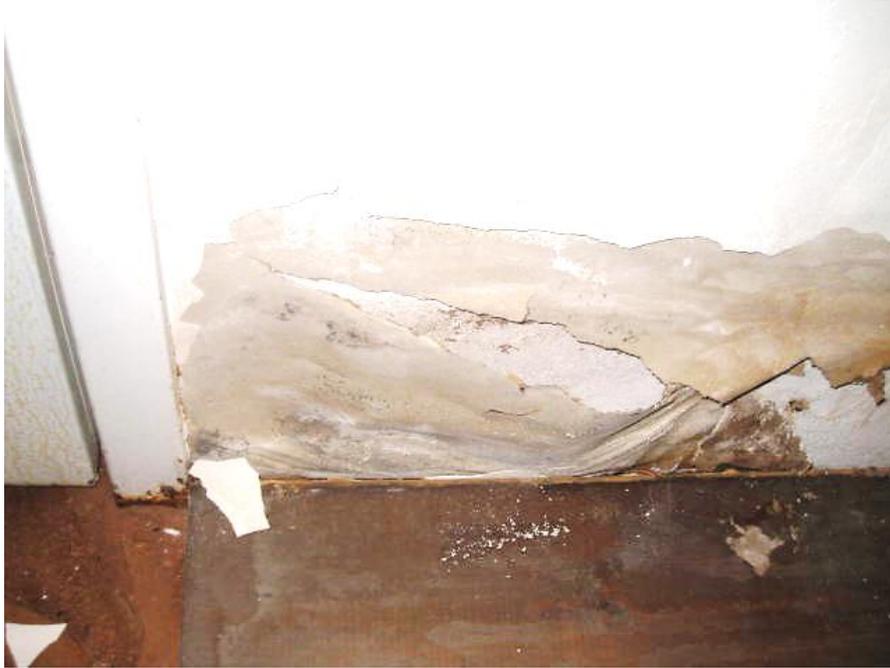
Picture 3

At the time of assessment, BEH/IAQ staff were asked to examine several other areas unrelated to the recent flooding event. Water-damaged/mold-colonized GW was found in two first floor mechanical rooms, one adjacent to the elevator known as the “water room” (Pictures 3

Water-damaged/mold-colonized GW in water/mechanical room

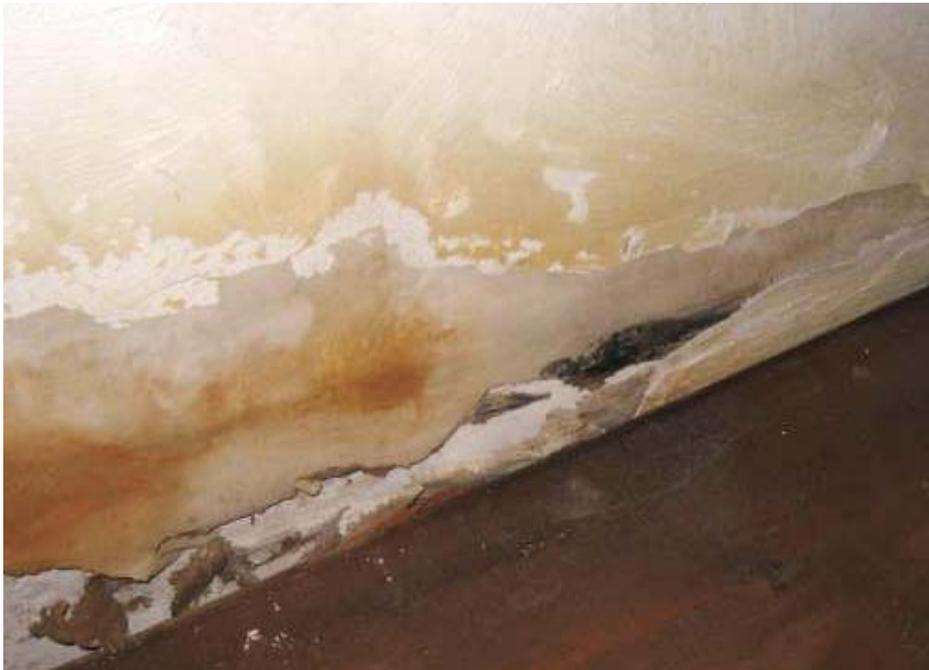
Picture 4

Water-damaged/mold-colonized GW in water/mechanical room

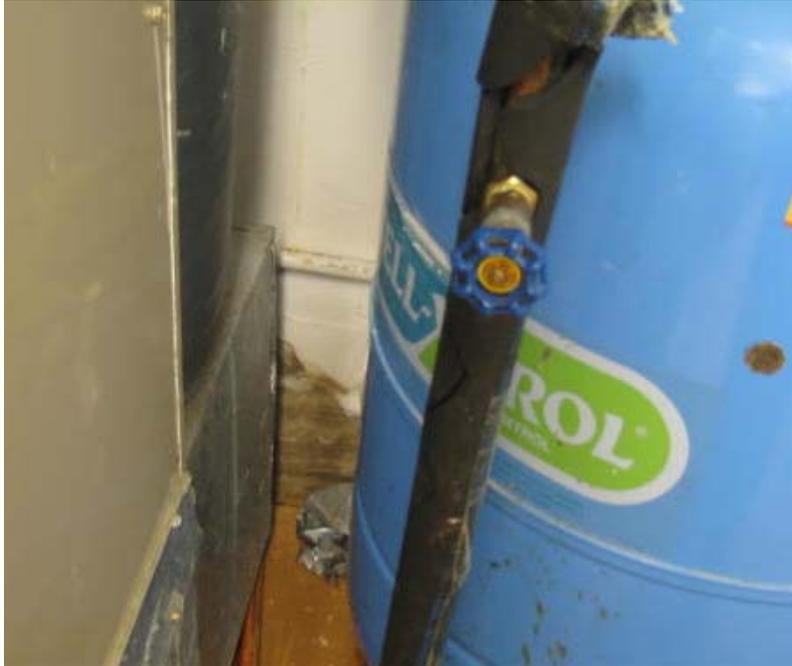
Picture 5

Water-damaged/mold-colonized GW in water/mechanical room

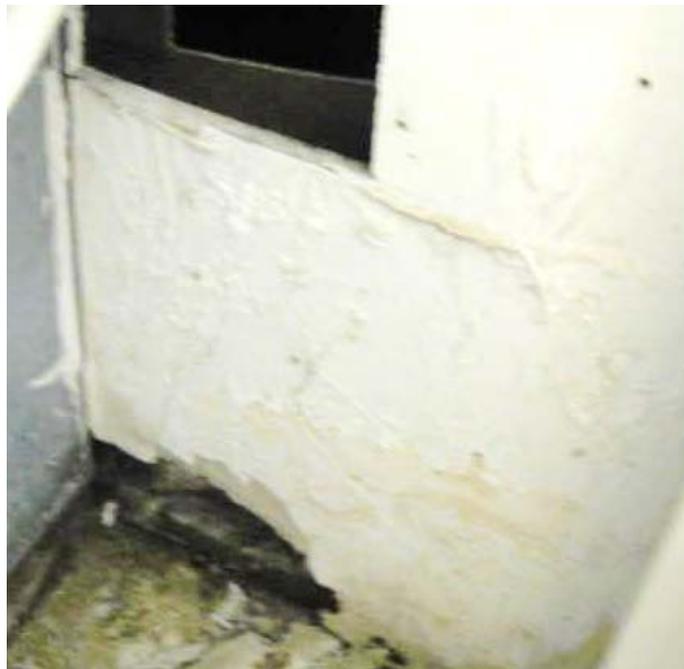
Picture 6

through 5) and another off the Personnel File Room (Pictures 6 and 7). Moldy/stained rolled-up carpeting was also observed in the water room (Picture 8).

Water-damaged/mold-colonized GW in mechanical room off Personnel File room

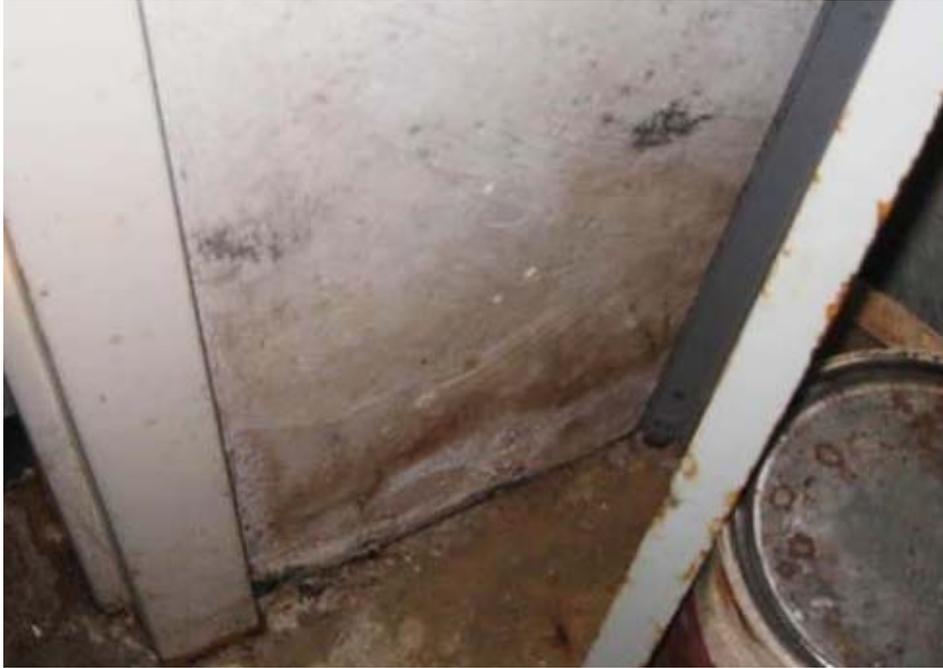
Picture 7

Water-damaged/mold-colonized GW in mechanical room off Personnel File room

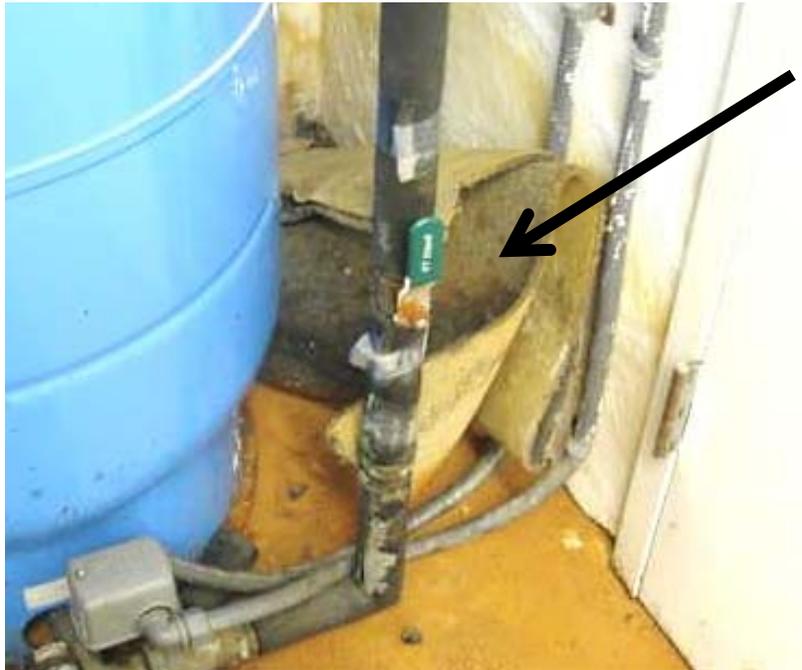
Picture 8

Stained/moldy carpeting in water/mechanical room (arrow)

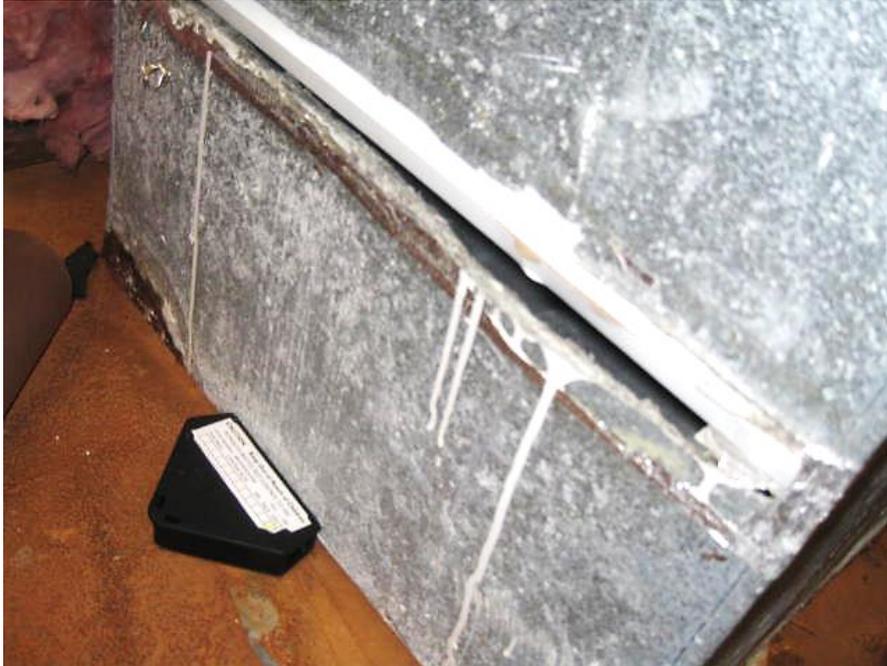
Picture 9

The air-handling unit (AHU) in the water room was missing a filter panel (Picture 9). Missing access panels will render the AHU casing non-airtight, allowing the draw of air from the mechanical room into the unit. As air bypasses filters, the opportunity exists for airborne dirt, dust, odors, and particulates and, in this case, fiberglass insulation (Picture 10) to be drawn into the HVAC system and distributed to occupied areas. Aerosolized dust, particulates, and odors can provide a source of eye, skin, and respiratory irritation to certain individuals. In addition, these materials can accumulate on flat surfaces in occupied areas and subsequently be re-aerosolized causing further irritation. A hole was observed in ductwork for the AHU in the mechanical room by the Personnel File room (Picture 11); breaches can allow infiltration of odors/particulates and also result in the loss of heated/cooled air.

Missing filter access panel, note spaces around filter

9. Install/replace missing filter panels on AHU(s). In the interim, seal with foil/duct tape to prevent entrainment of unwanted particulates and odors.

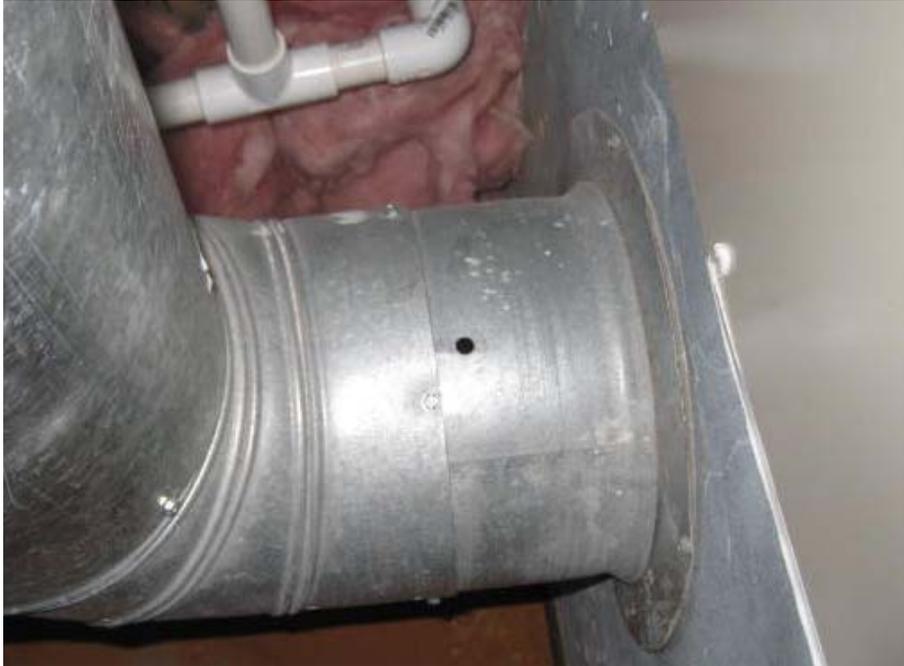
Picture 11

Hole in ductwork, note proximity to exposed fiberglass insulation

10. Seal hole in ductwork, shown in Picture 11. Inspect remaining ductwork for additional breaches and repair as needed.
11. Seal/cover fiberglass insulation in mechanical rooms (e.g., with plastic sheeting, green board).

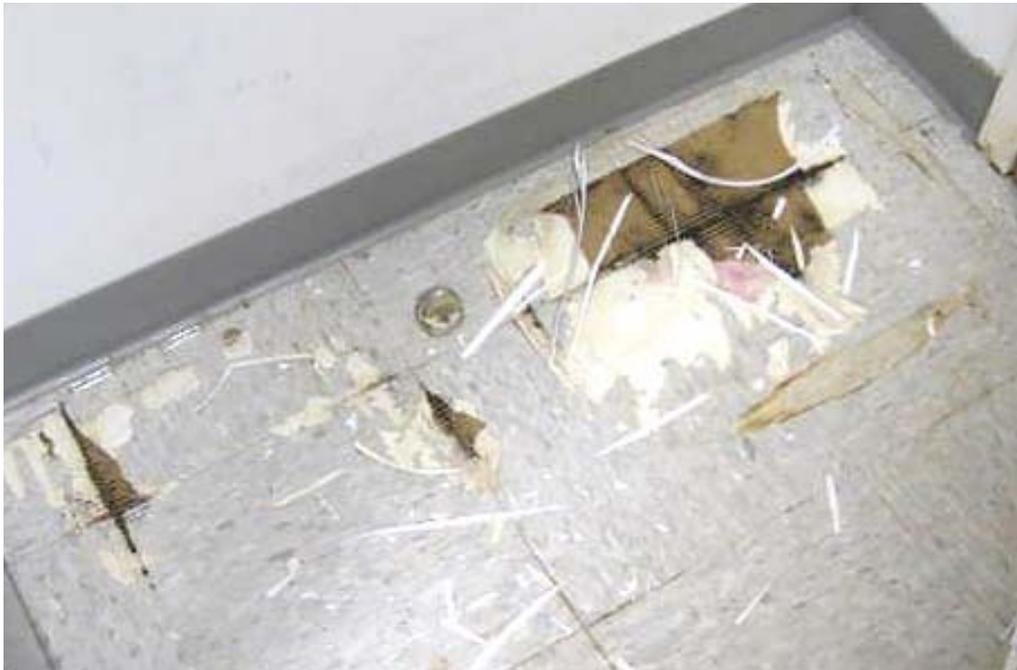
Picture 12

Remnants of mold-colonized boxes were present on the floor of the Personnel File room (Picture 12). Other cardboard boxes were observed on the floor (Picture 13). Cardboard boxes or other porous materials should not be stored directly on floors in areas where condensation can accumulate or other water exposure can occur. During summer months, the cool surface of floors can generate condensation due to elevated humidity. Condensation can moisten cardboard, which provide a medium for mold growth.

Remnants of water-damaged/mold-colonized boxes on Personnel File Room floor

12. Avoid storage of porous materials, such as cardboard boxes, directly on floors in areas subject to condensation or water infiltration. Use shelving or pallets to raise stored items up from the floor and allow air to circulate beneath.

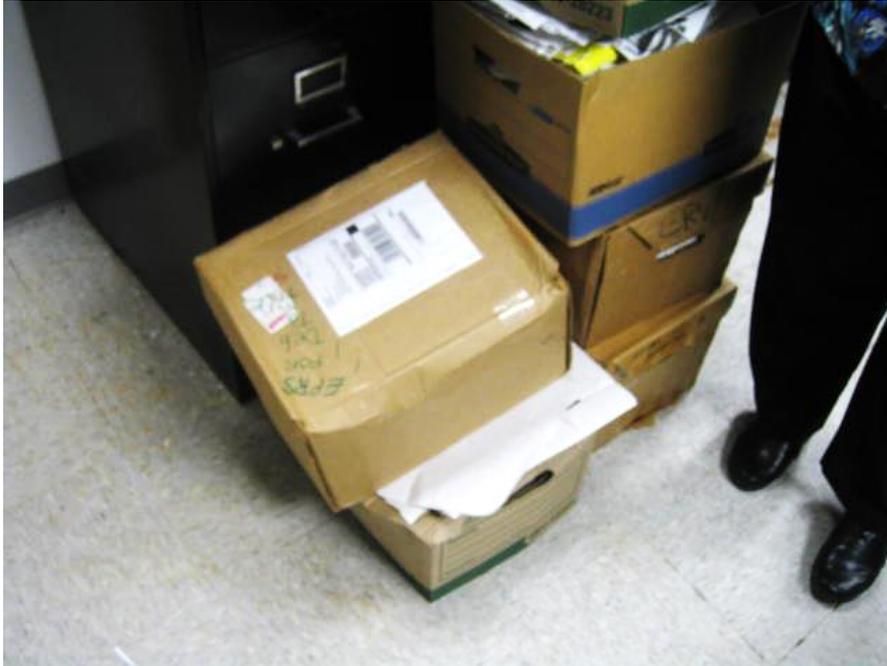
Picture 13

Cardboard boxes stored directly on Personnel File Room floor

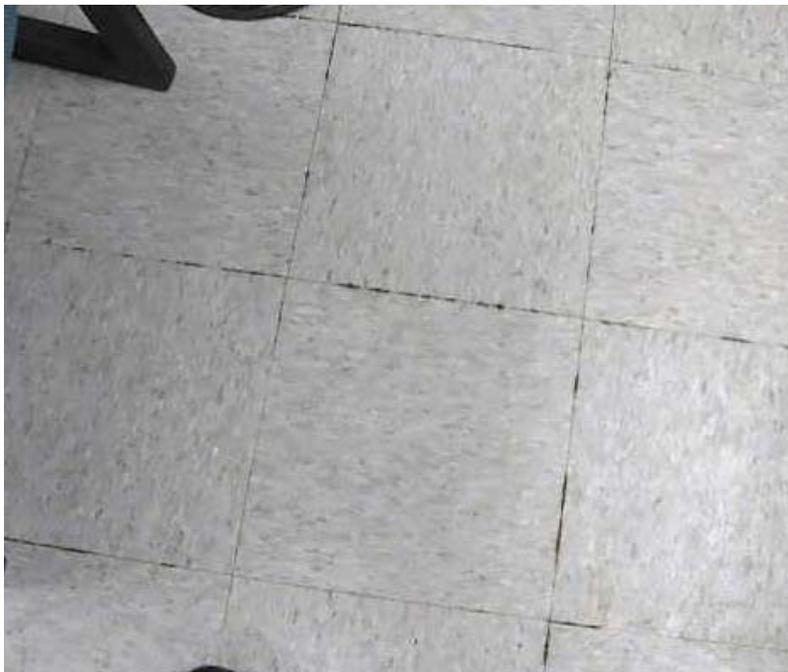
Picture 14

DDS staff reported concerns regarding the floor of the Personnel File Room, where deposits/stains were attributed to possible mold growth (Picture 14). In the experience of BEH/IAQ staff, the deposited material is most likely the mastic/glue from beneath the tiles that had softened due to condensation/moistening and is being pushed up between the tiles.

Glue/mastic between floor tiles in Personnel File Room

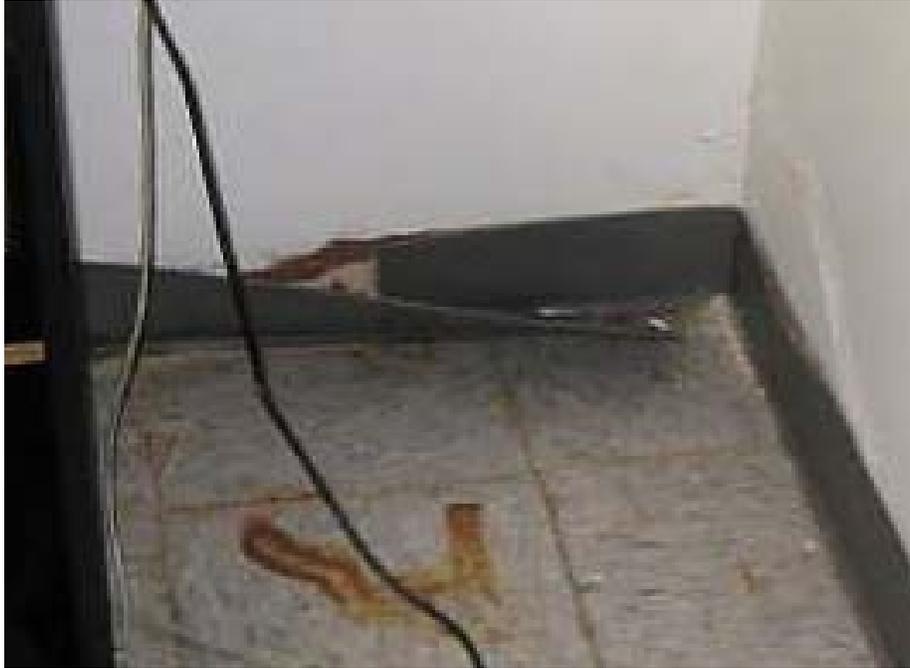
Picture 15

BEH/IAQ staff also examined failing base coving and water-damaged GW in Ms. Baker's office (Pictures 15 and 16), which is directly inside the main entrance. GW in this area was moist at the time of assessment (Table 1). This area appears to experience chronic water infiltration due to poor drainage. The exterior corner directly outside this portion of the building is not properly graded (Picture 17).

Water-damaged GW, failing base coving and efflorescence (corner/walls) in Ms. Baker's office

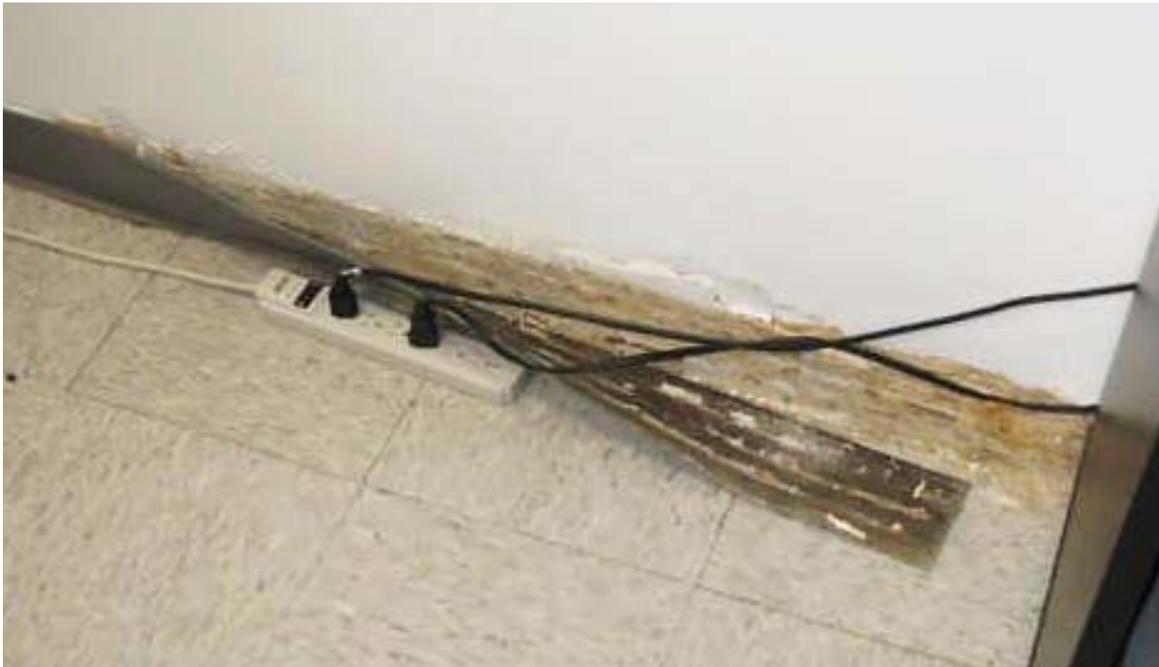
Picture 16

Water-damaged GW and failing base coving in Ms. Baker's office

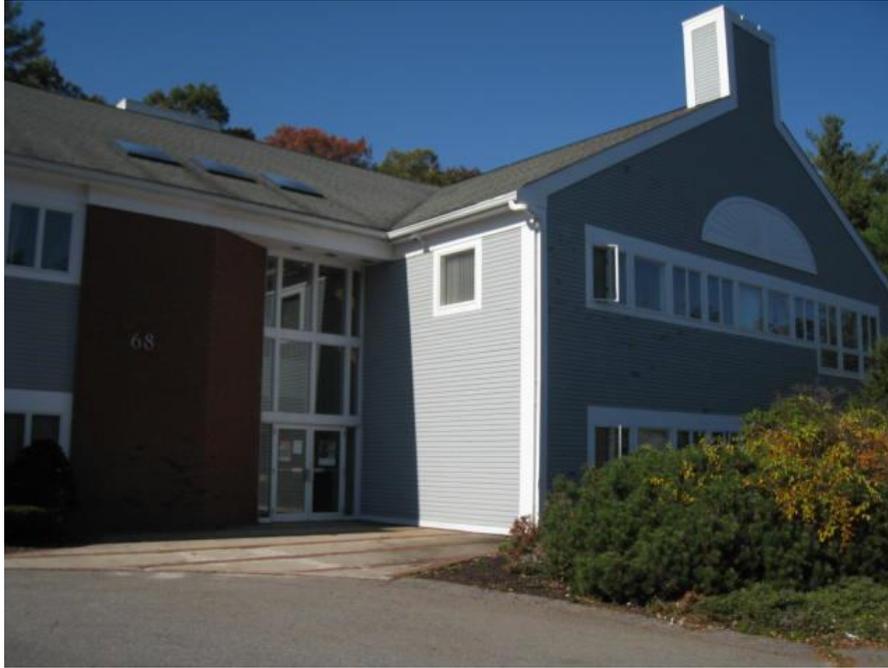
Picture 17

Exterior corner of building/main entrance outside of Ms. Baker's office

13. Consult with building engineer/drainage specialist to improve drainage outside of main entrance to prevent further water infiltration.
14. Reinstall window trim in Investigation area; continue to monitor to ensure water penetration does not reoccur.
