INDOOR AIR QUALITY ASSESSMENT

**Hopkinton Town Hall
18 Main Street
Hopkinton, Massachusetts**

Prepared by:
Massachusetts Department of Public Health
Bureau of Environmental Health
Indoor Air Quality Program
January 2014

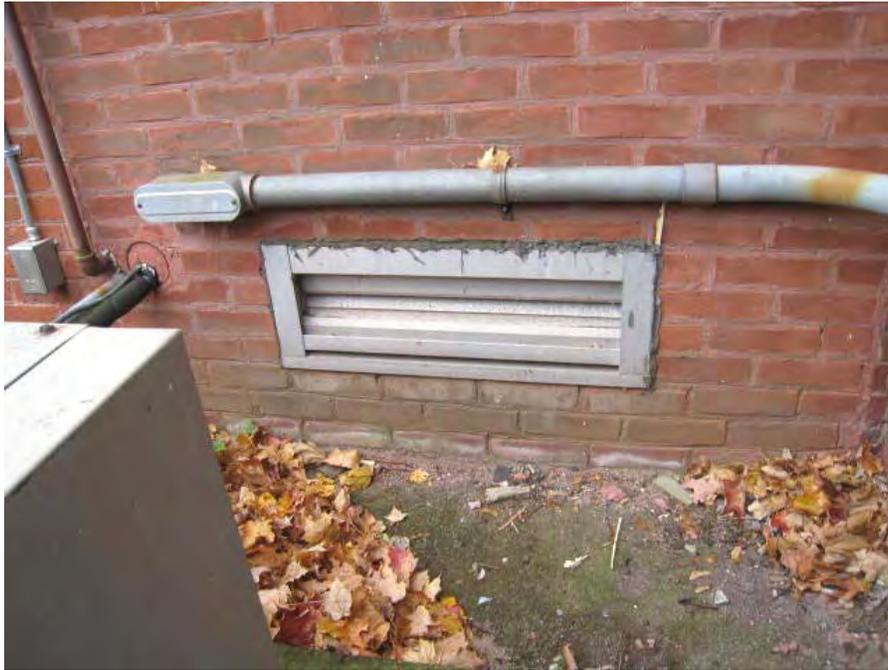
Picture 1

Fresh air vent for basement AHU

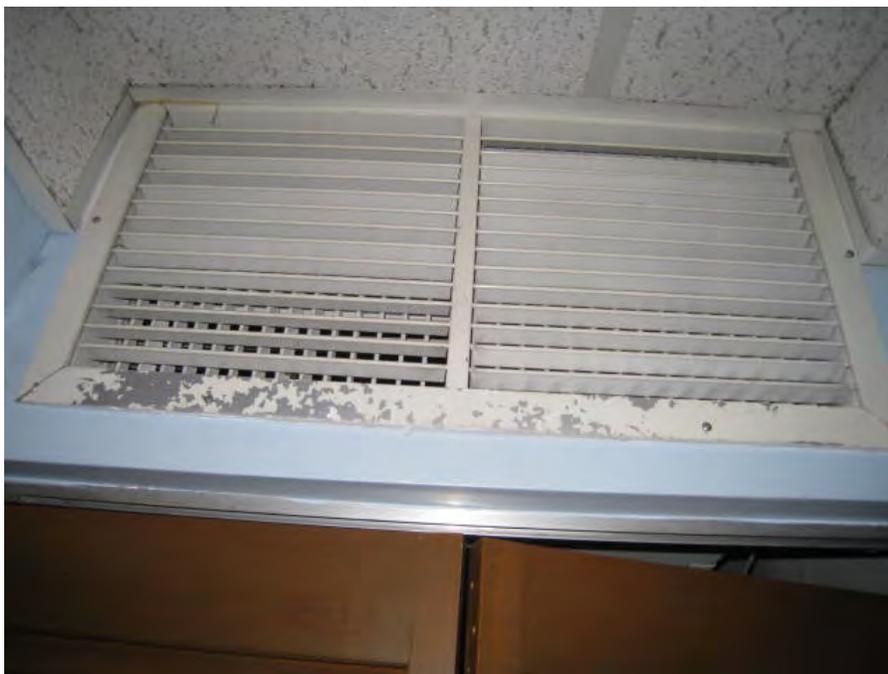
Picture 2

Supply vent in the basement

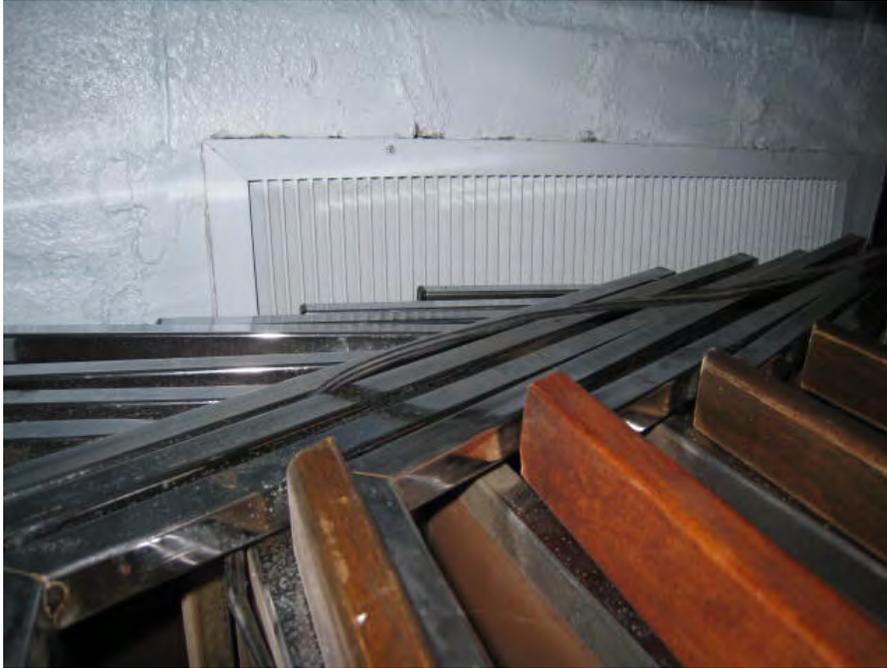
Picture 3

It can be seen from Table 1 that carbon dioxide levels were above 800 parts per million (ppm) in four of twenty-four areas surveyed, indicating adequate air exchange in most areas at the time of assessment (Table 1). There are a variety of heating, ventilation and air conditioning (HVAC) systems in the building, which reportedly have been retrofitted at various times. The basement is equipped with air handling units (AHUs) located in a mechanical space along one side of the basement. Fresh air for these units is brought in through an outside vent (Picture 1), and is heated/cooled and distributed to the basement via ducts and diffusers (Picture 2). Exhaust air is drawn into wall vents (Picture 3) and returned to the AHUs.

Exhaust vent for the basement; note partial blockage with stored items

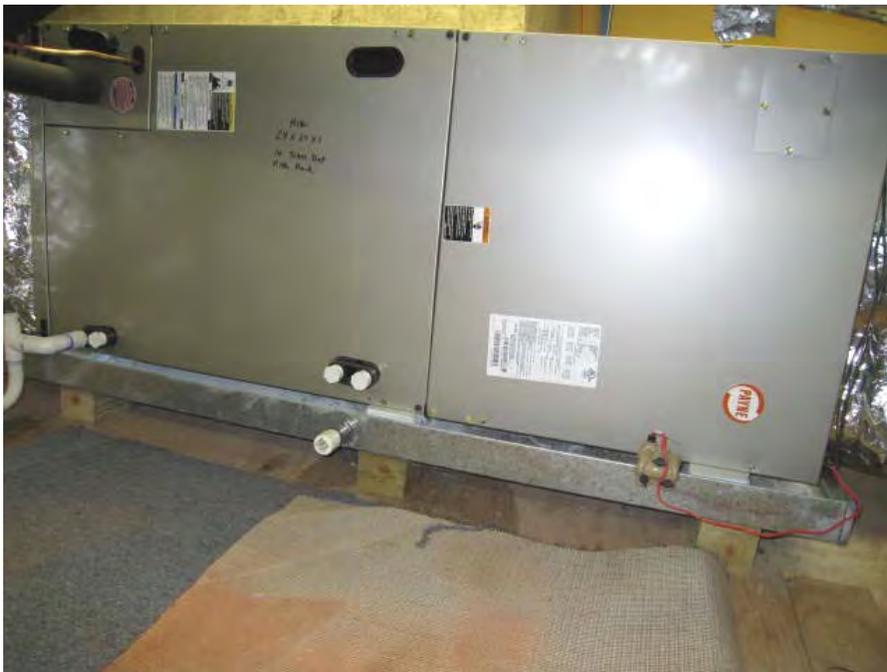
Picture 4

Another pair of AHUs are located in a small mechanical space located above the Planning Department on the 3rd floor (Picture 4). These AHUs distribute heated/cooled air to the upper floor through ducts to supply vents primarily to serve the IT department (Picture 5). The fresh air intake for these AHUs could not be ascertained. An exhaust vent returns air to them.

AHU in attic space above Planning Department

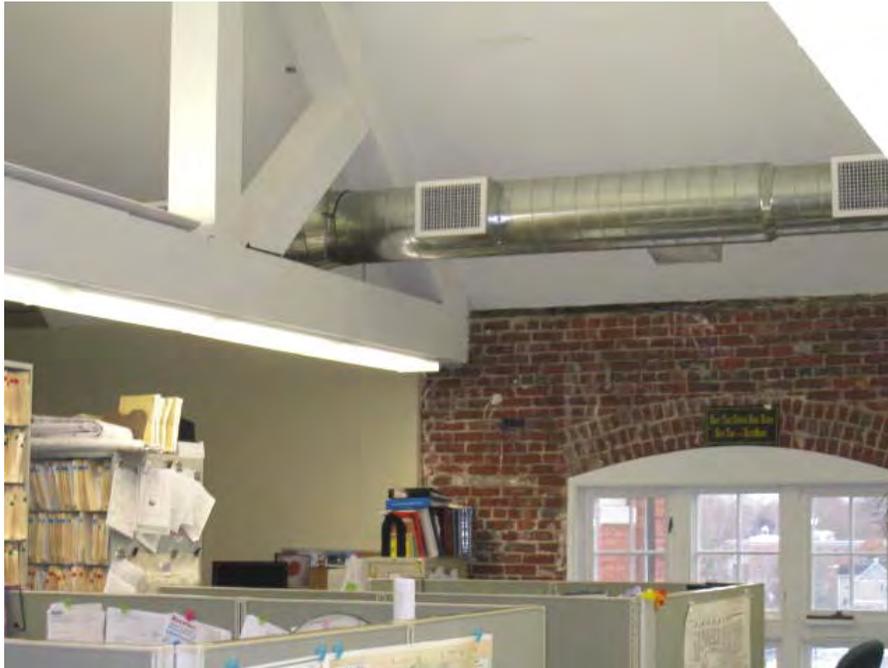
Picture 5

Supply duct with vents on the third floor

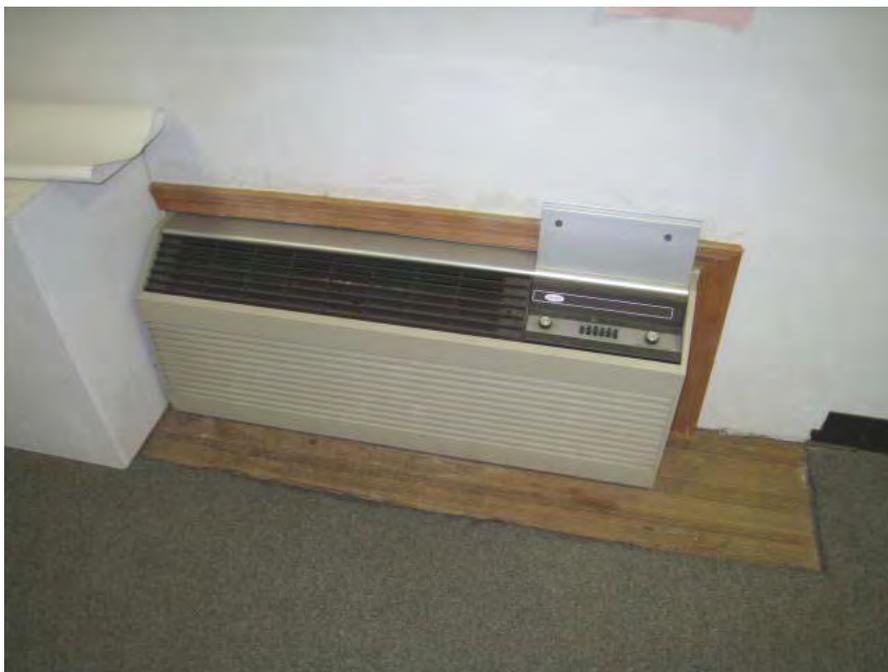
Picture 6

On the second floor, the Selectmen's Meeting Room and the Conference Room are served by unit ventilators (univents, Picture 6). A univent is designed to draw air from outdoors through a fresh air intake located on the exterior wall of the building. Return air is drawn through an air intake located at the base of each unit where fresh and return air are mixed, filtered, heated or cooled and provided through an air diffuser located in the top of the unit ([Figure 1](#)). Univents were found deactivated in both locations (Table 1). In order for univents to

provide fresh air as designed, intakes/returns must remain free of obstructions. Importantly, these units must remain on and be allowed to operate while rooms are occupied. Other areas have no supply for fresh air apart from, in many cases, openable windows (Table 1).

Unit ventilator (univent) in the conference room

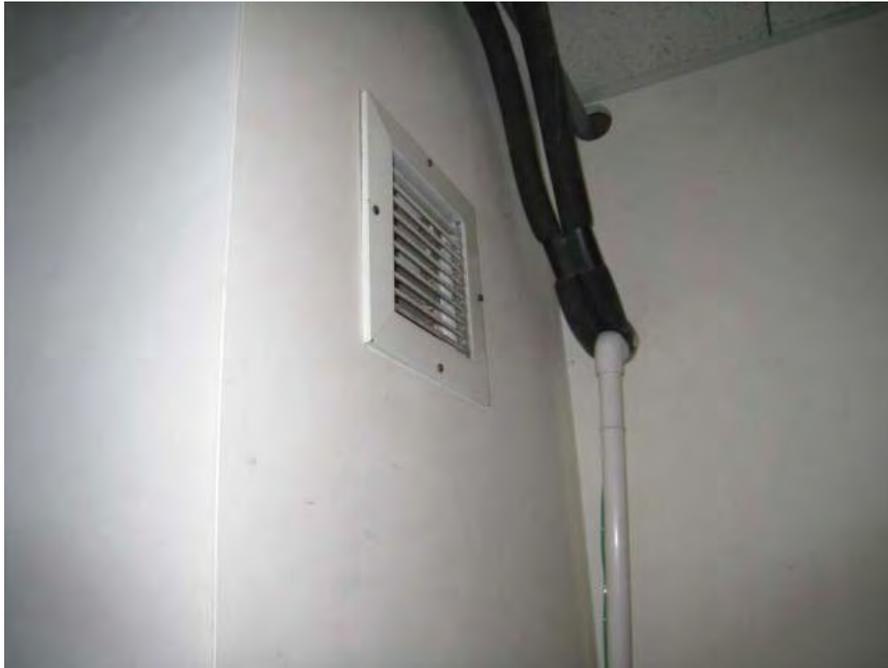
Picture 7

Exhaust vent in janitorial closet

3. Consider reactivating/repairing exhaust vents for janitorial/utility closets.
 4. For buildings in New England, periods of low relative humidity during the winter are often unavoidable. Therefore, scrupulous cleaning practices should be adopted to minimize common indoor air contaminants whose irritant effects can be enhanced when the relative humidity is low. To control for dusts, a high efficiency particulate arrestance (HEPA) filter equipped vacuum cleaner in conjunction with wet wiping of all surfaces is recommended. Avoid the use of feather dusters. Drinking water during the day can help ease some symptoms associated with a dry environment (throat and sinus irritations).

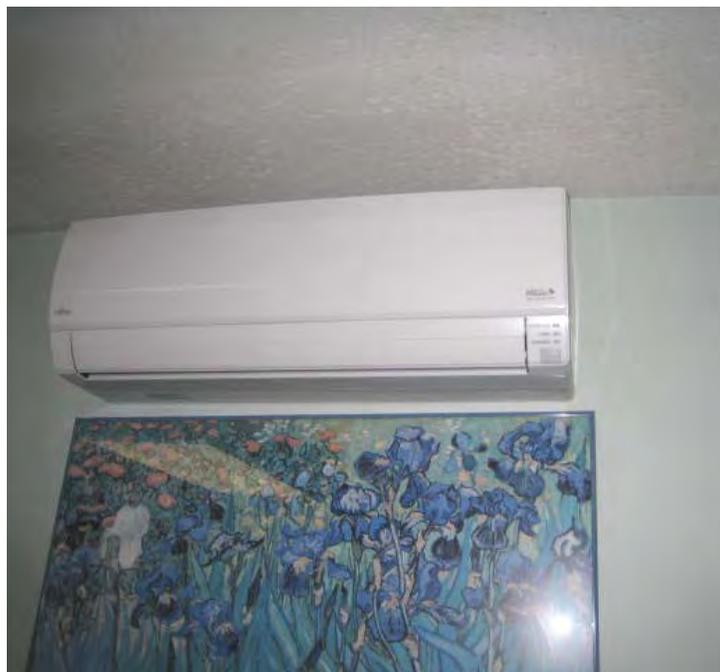
Picture 8

Supplemental heating is provided by forced hot water baseboard heaters in many areas of the building. In several areas not supplied with other HVAC equipment, ductless air conditioning (Picture 8) units and wall-mounted/window-mounted air conditioners (Picture 9) were observed (Table 1). Window/wall air conditioners can function to provide a limited amount of fresh air when operating in “fresh air” mode, even when cooling is not needed. Ductless air conditioners, on the other hand, only cool mixed indoor air and do not provide any source of outside air.

The ductless air conditioners are equipped with condensation collection receptacles and pumps to direct collected water outside. These should be regularly examined/maintained to ensure that they are functioning to remove condensation when the air conditioners are in use.

Ductless air conditioning unit

8. Repair/seal the backplash in the basement kitchen.
 9. Maintain the condensation collection system for ductless air conditioners.
 10. Maintain dehumidifiers and remove collected water regularly.

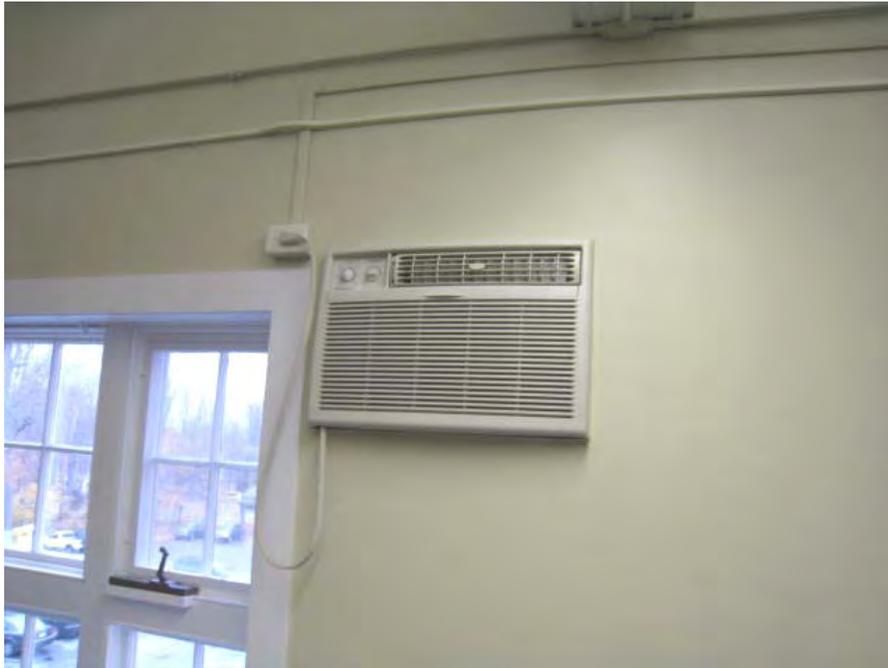
Picture 9

Wall-mounted window-type air conditioning unit

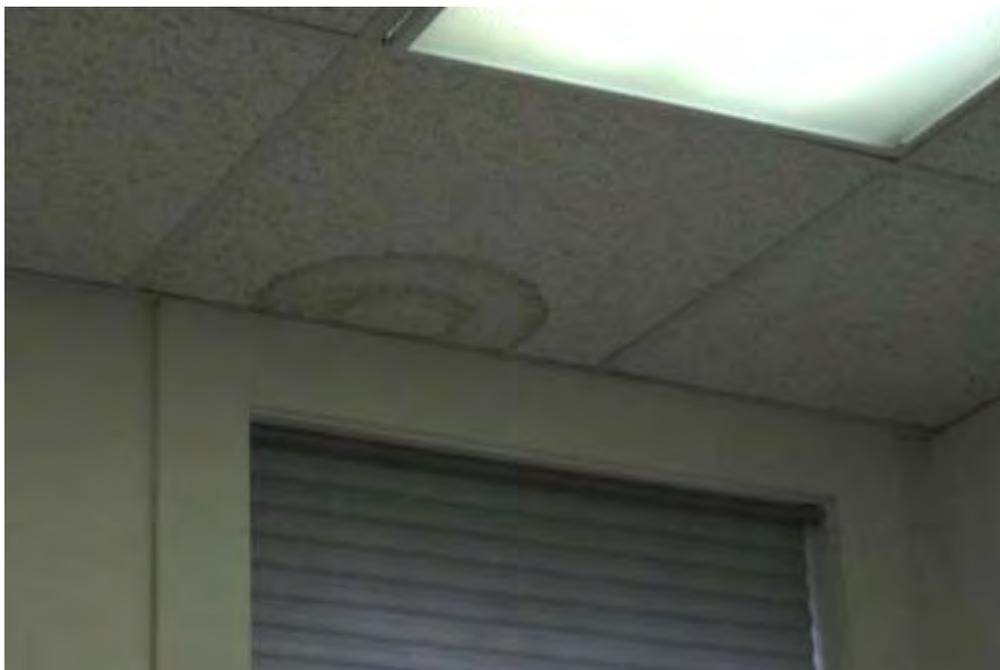
Picture 10

In order for building materials to support mold growth, a source of water exposure is necessary. Water-damaged ceiling tiles were seen in a few areas on the first floor (Picture 10), suggesting leaks from the roof or plumbing. Some windowsills were also found to be water-damaged (Table 1), indicating that windows are not tight in these areas.

Water-damaged ceiling tile

5. Ensure leaks are repaired and remove/replace water-damaged ceiling tiles. Examine the area above and around these areas for mold growth. Disinfect areas of water leaks with an appropriate antimicrobial.

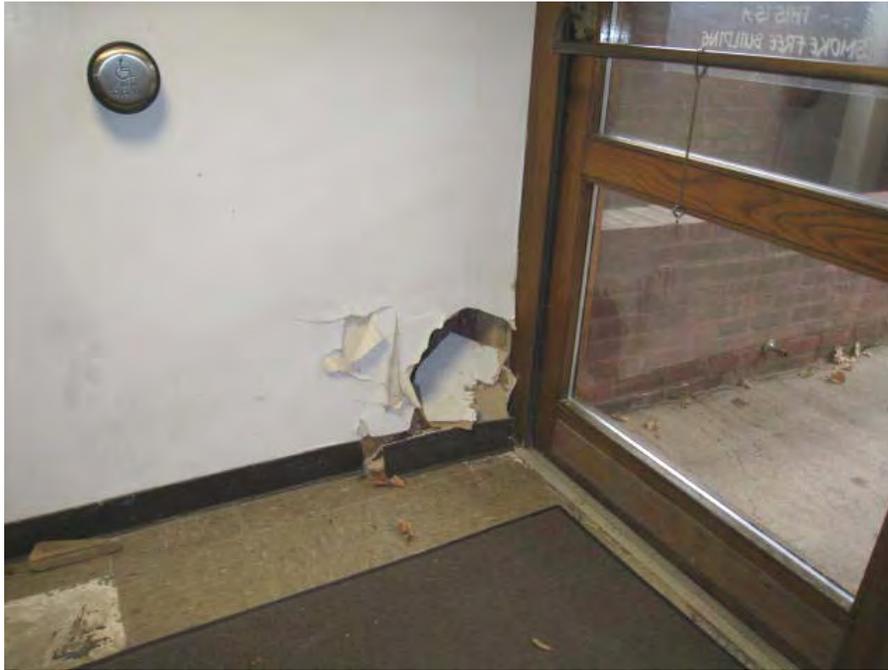
Picture 11

It was reported that the basement had been subject to periodic flooding during wet weather events up until recent repairs of the façade. No damp materials were observed in the basement; however floor tiles showed evidence of previous water damage/infiltration in that mastic/glue could be seen coming up from between tiles. The rear entryway also showed significant signs of water damage (Picture 11), including wall plaster and possible evidence of water flowing through an electrical socket (Picture 12), which can damage the wiring and present a fire hazard. Water infiltration to the rear hallway appears to be related to the construction/design of the handicapped-access ramp which may function to channel storm water into this area of the building.

Water-damaged wall in rear entryway

6. Repair any water-damaged windowsills and ensure that windows are rendered as tight as possible.
 7. Repair the water-damaged material in the basement hallway and check the operability/safety of the potentially-impacted electrical socket.

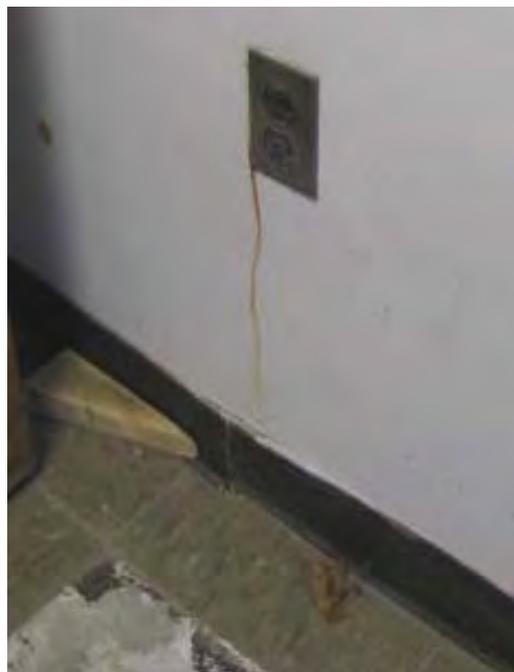
Picture 12

Water stain below electrical socket in rear entryway

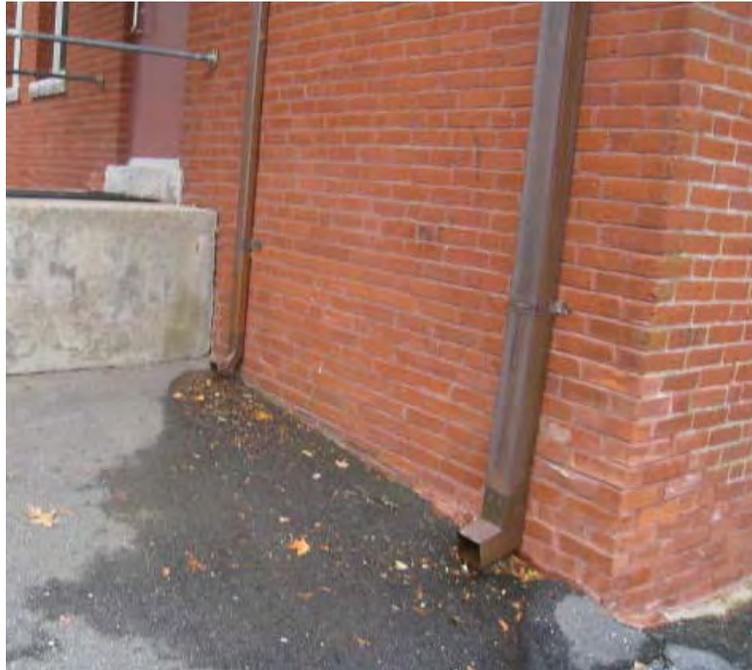
Picture 13

BEH/IAQ staff examined the outside perimeter of the building to identify breaches in the building envelope and/or other conditions that could provide a source of water penetration. Downspouts were observed to drain only a short distance from the building (Picture 13). If downspouts are not configured to drain correctly, water from the roof may accumulate against the walls or foundation. These conditions can undermine the integrity of the building envelope and provide a means of water entry by capillary action into the building through exterior walls, foundation concrete and masonry (Lstiburek & Brennan, 2001).

Drainage spouts emptying directly next to the building

11. Ensure downspouts drain at least five feet away from the outside of the building.

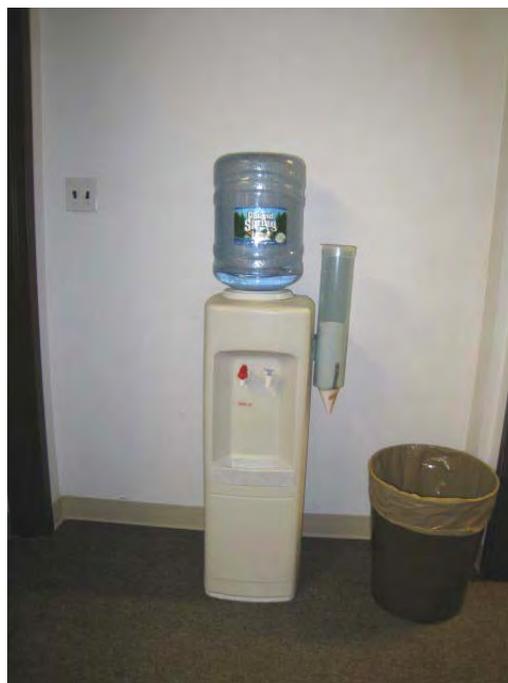
Picture 14

Water dispensers and refrigerators were observed in carpeted areas (Picture 14). Spills or leaks from these appliances can moisten carpeting. Stained carpeting was observed in the vicinity of at least one refrigerator (Picture 15). Water-dispensing and other appliances should be located in an area with non-porous flooring or on a waterproof mat.

Water dispenser on carpet

12. Prevent water damage by using drip pans for plants and cleaning them regularly.
13. Consider outfitting water dispensers and refrigerators with a rubber/plastic mat to prevent damage to carpeting.

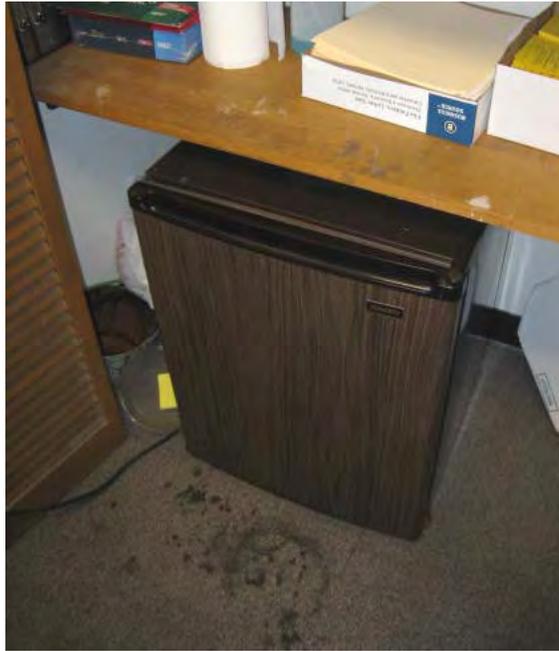
Picture 15

Stained carpeting in front of refrigerator

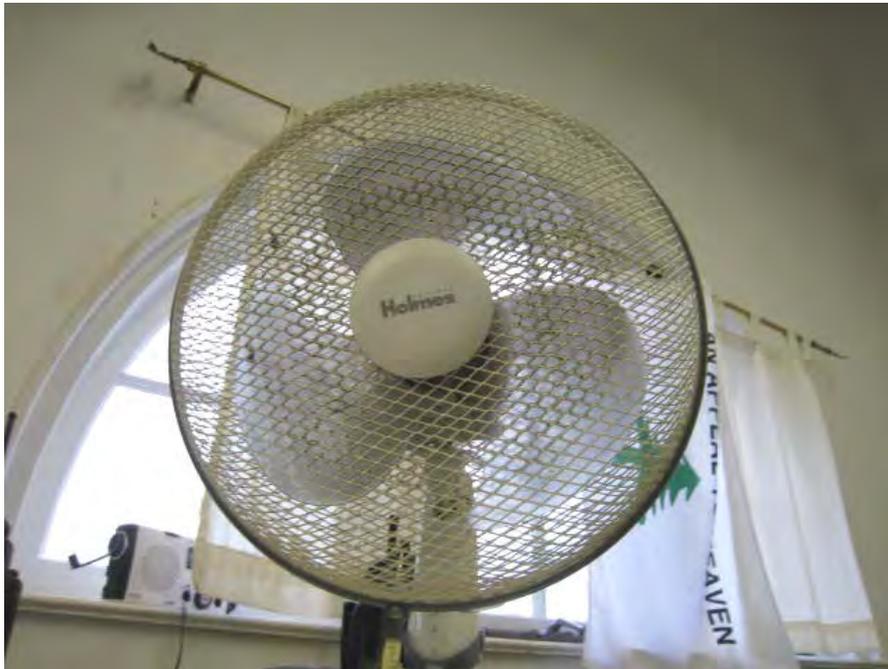
Picture 16

A number of air diffusers, exhaust/return vents and personal fans were found to have accumulated dust/debris (Picture 16; Table 1). If exhaust vents are not functioning, backdrafting can occur, which can re-aerosolize accumulated dust particles. Re-activated supply, exhaust/return vents and fans can also aerosolize dust accumulated on vents/fan blades.

Dusty personal fan

19. Clean ceiling fans, personal fans and vents regularly.
20. Change filters in AHUs, univents and air conditioning units in accordance with manufacturer's recommendations.
