# **INDOOR AIR QUALITY ASSESSMENT**

**Proposed Food Bank  
Cowell Gymnasium  
51 Maple Street  
Shelburne, Massachusetts**

Prepared by:  
Massachusetts Department of Public Health  
Bureau of Environmental Health  
Indoor Air Quality Program  
May 2014

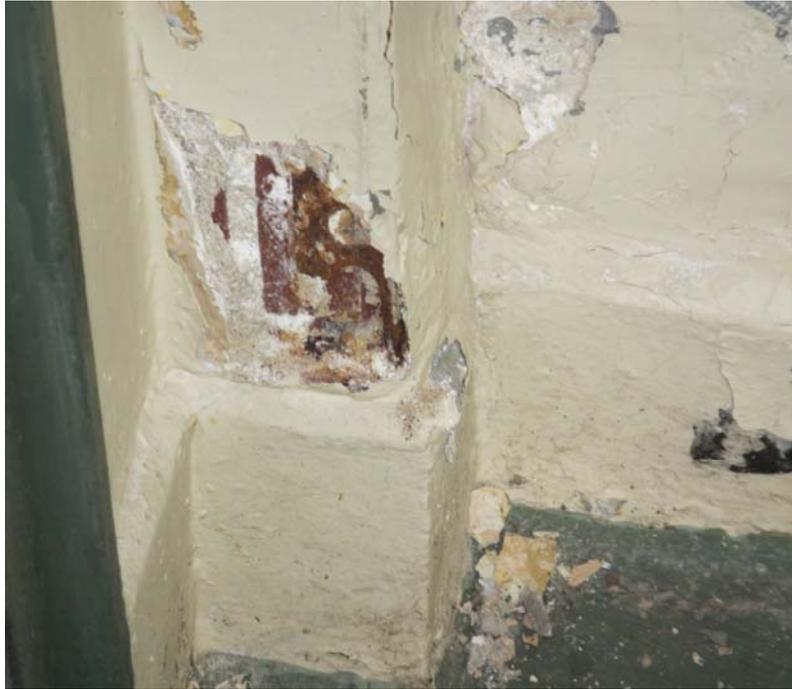
**Picture 1**

Peeling paint and damaged wall plaster was observed on walls, floors and windows (Picture 1). The window frames were found to be deteriorated and screened with an open wire mesh of insufficient tightness to deter many pests (Picture 2). In addition, grass/debris had accumulated between the windows and the wire mesh screen, and a beehive was noted in one

**Peeling paint/damaged wall plaster in food bank room**

1. Continue implementing recommendations from the July 2010 MDPH report; refer to Appendix A.
2. Consult with an HVAC engineering firm to ensure the mechanical room has adequate make-up air for appliances.
3. For buildings in New England, periods of low relative humidity during the winter are often unavoidable. Therefore, scrupulous cleaning practices should be adopted to minimize common indoor air contaminants whose irritant effects can be enhanced when the relative humidity is low. To control dusts, a high efficiency particulate arrestance (HEPA) filter equipped vacuum cleaner in conjunction with wet wiping of all surfaces is recommended. Avoid the use of feather dusters. Drinking water during the day can help ease some symptoms associated with a dry environment (throat and sinus irritations).
4. Use the openable windows for ventilation as needed.
5. Repair damaged wall plaster.

6. Paint the walls with an appropriate paint.
7. Install new windows in food bank rooms that are equipped with tight insect-proof window screens. Discontinue use of wire mesh on all exterior windows.

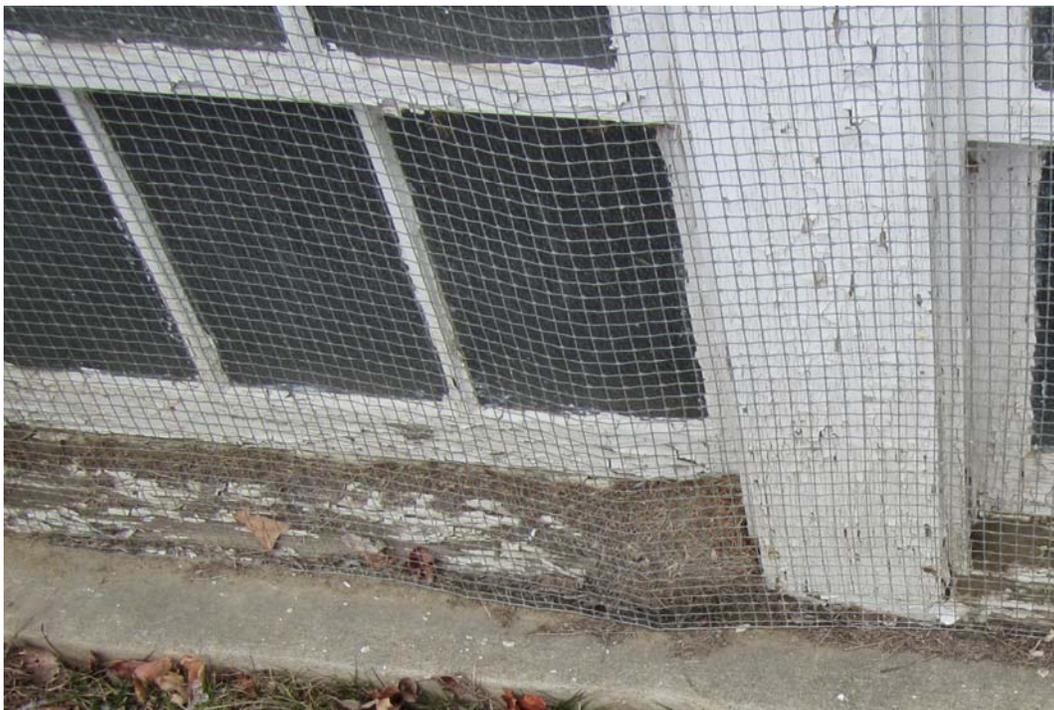
**Picture 2**

**Deteriorated window with wire mesh (note grass/debris)**

window (Picture 3). These windows should be replaced and enclosed with appropriate window screens to prevent insects and other pests from entering the building when the windows are open.

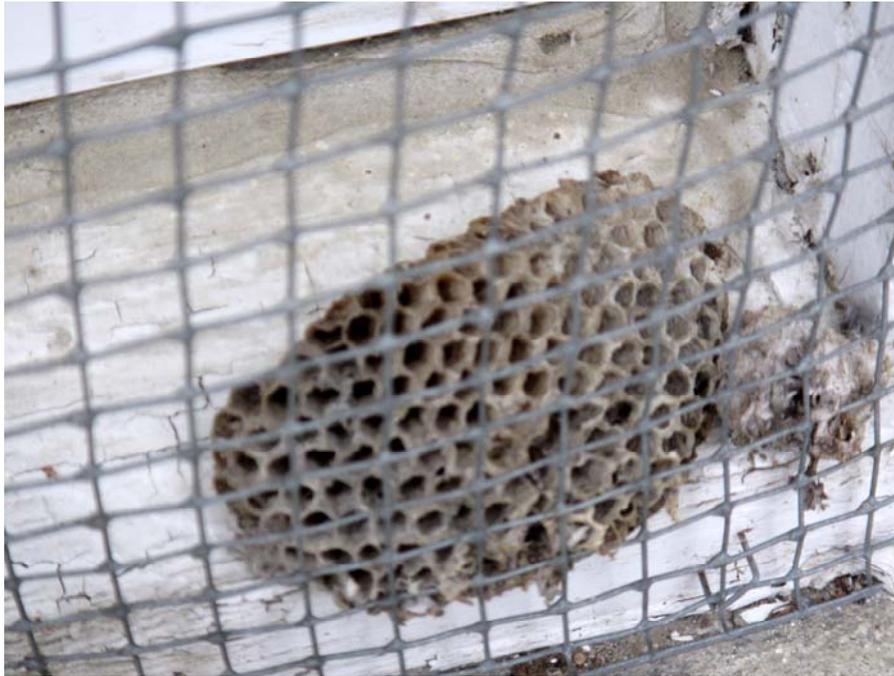
**Picture 3**

**Exterior window showing bee hive behind wire mesh**

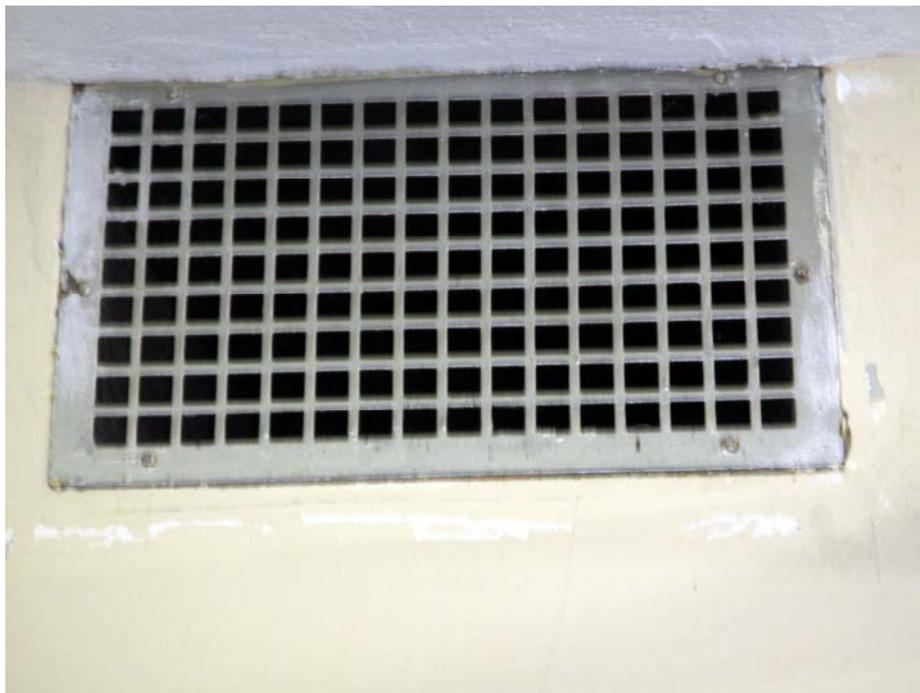
**Picture 4**

BEH/IAQ staff detected an odor of hydraulic fuel in the hallway outside the elevator shaft. Hydraulic fluid has a distinct odor and contains volatile organic compounds (VOCs), which can be irritating to the eyes, nose and throat. Odors can be distributed to surrounding areas if the elevator does not have an operable exhaust fan. Both food bank rooms contain ductwork that formerly served as an exhaust vent system (Picture 4). The ductwork vents should be sealed to prevent hydraulic fuel odors from migrating into the food bank space.

**Former ductwork exhaust vent**

11. Seal former exhaust vents in the food bank rooms to prevent odor migration from the elevator and other locations in the basement.
12. Seal gaps and spaces around plumbing/utility pipes with a fire-rated expandable foam to prevent odor migration from the boiler room into the food bank space.

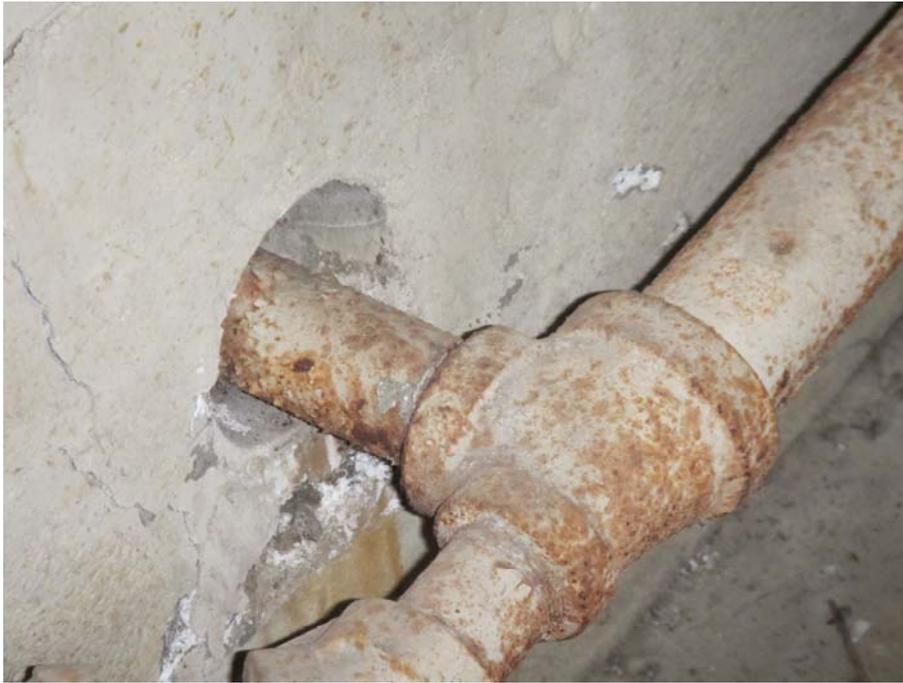
**Picture 5**

Propane/gas-like odors were noted in the food bank space which is adjacent to the boiler room and garage space. BEH/IAQ staff observed holes and gaps surrounding utility pipes that penetrate the common wall of the boiler room and the food bank space (Picture 5). Since these breaches can serve as pathways for air, moisture, odors and particulates to migrate from the boiler room into surrounding spaces, all gaps and holes in this area should be sealed with appropriate fire-resistant materials.

**Utility pipe leading from food bank to boiler room showing large gap around pipe**

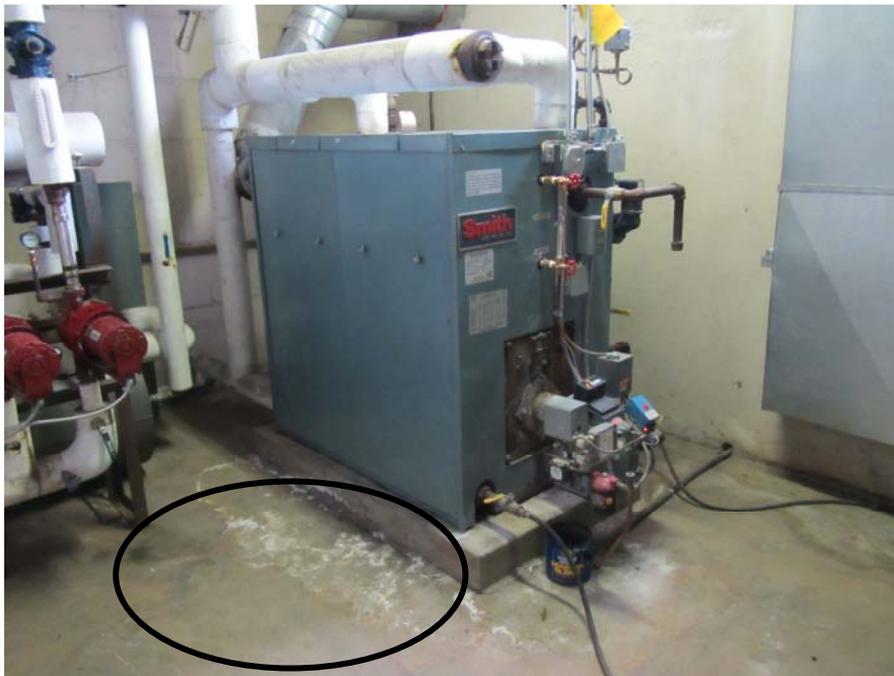
**Picture 6**

The floor surrounding the boiler was noted to have efflorescence<sup>1</sup> (Picture 6). This condition is likely due to a leak from the boiler. In addition, BEH/IAQ staff observed that hoses designed to drain condensation from the boiler into the existing floor drains, terminated on the floor of the boiler room floor (Picture 7) which can result in moisture/water accumulation in the space. During the heating season, if floor drains are not used or filled with water on a regular basis, the drain traps can dry out, which will allow sewer gas/odors and additional moisture to enter other parts of the building. In order to maintain the watertight seal, water should be poured down the drain routinely during the heating season or the drains should be capped to prevent the back up of gas/odors.

**Efflorescence on floor surrounding boiler (circle)**

15. Consult with an HVAC professional to repair or replace boiler as necessary. Ensure drainage hoses terminate over floor drains.
16. Ensure floor drains that are not used regularly are wetted down to prevent dry traps and the infiltration of sewer odors into occupied areas. Regularly pour water into drains to maintain the trap seal, and consider permanently capping/removing those that are no longer needed.

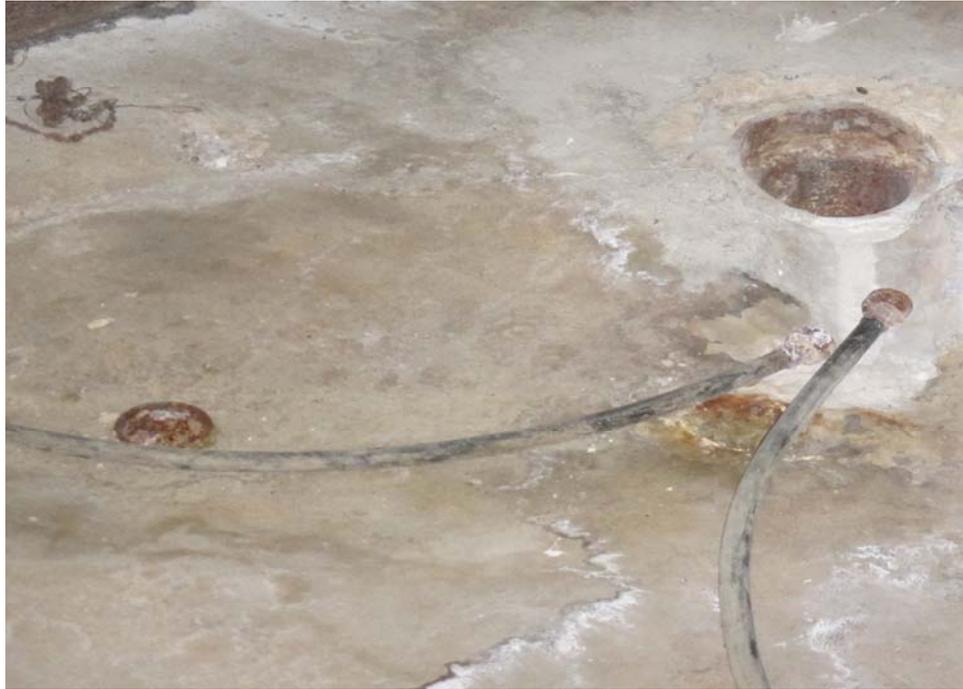
**Picture 7**

**Boiler condensation hoses terminating on floor**

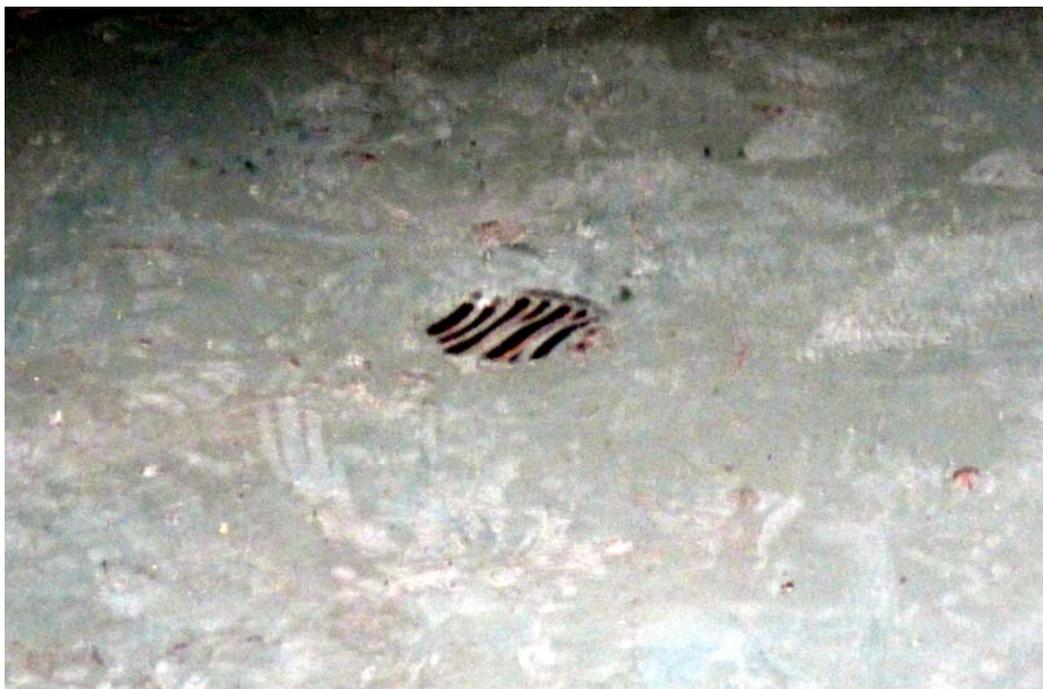
**Picture 8**

Floor drains were also observed in the former shower rooms in the basement (Picture 8). Consideration should be given to permanently capping/sealing these as they are no longer needed.

**Floor drain in former shower room**

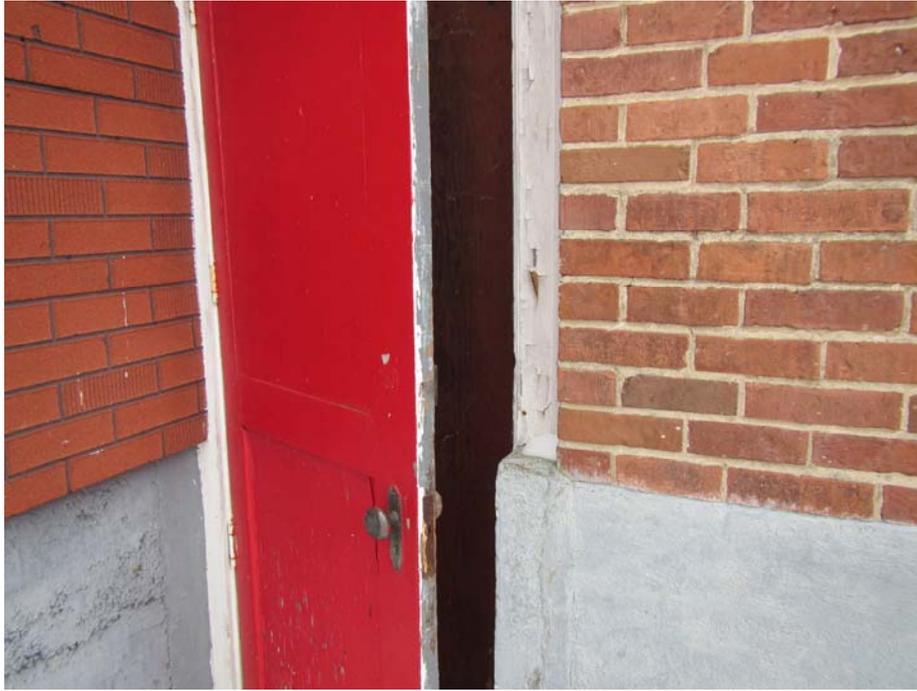
**Picture 9**

Exterior doors had gaps and were ill-fitting; in some cases the weather-stripping had become worn or the door did not seal tightly allowing light to be seen through the gaps. These gaps can allow water, drafts, particulates and pests into the building. All exterior doors should be checked for light penetration, and damaged/missing weather-stripping should be repaired/replaced. In particular, the exterior doors of the garage were found deteriorated and one unable to be closed tightly (Picture 9). These doors are located in the rear of the building and, as mentioned in the 2010 report, exist below the sloped driveway (Picture 10) and are subject to water runoff and penetration. These doors should be replaced with metal/steel doors if they are going to be used as a means of egress from the building or removed and sealed over if they are no longer needed.

**Exterior door to garage unable to close**

17. Replace exterior access doors to the garage. Remove and seal over with wood/siding if not needed as an access door from the building.
18. Refer to resource manuals and other related indoor air quality documents for further building-wide evaluations and advice on maintaining public buildings. These materials are located on the MDPH's website: <http://mass.gov/dph/iaq>.

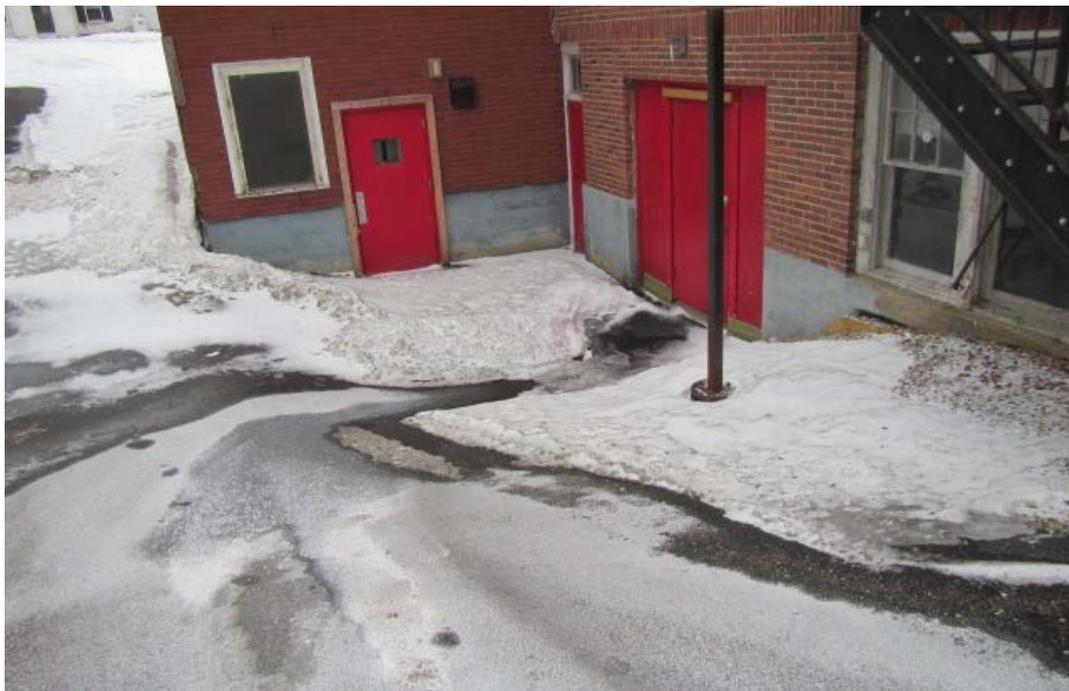
**Picture 10**

**Exterior doors at rear of building (note slope from driveway).**
