INDOOR AIR QUALITY ASSESSMENT

**Mendon Town Hall
20 Main Street
Mendon, Massachusetts**

Prepared by:
Massachusetts Department of Public Health
Bureau of Environmental Health
Indoor Air Quality Program
October 2014

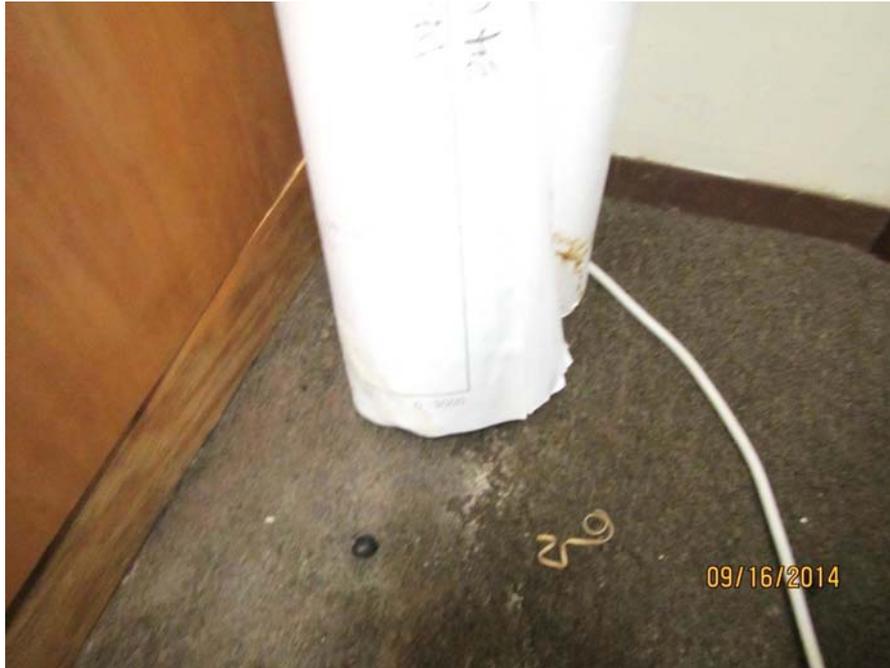
Picture 1

Concerns were expressed by MTH staff relating to the growth of mold in basement areas. At the time of the assessment, BEH/IAQ staff noticed a strong musty odor in the Planning Board Meeting Room as well as the Planning Board Records Room both of which are located in the basement. Upon entering the Planning Board Records Room, BEH/IAQ staff observed water damage and visible mold on carpeting, plans, cardboard boxes, and on porous items located on shelving (Pictures 1 through 3). It was also observed that the painted surface of walls in the Planning Board Records Room had dark staining typical of mold colonization (Picture 4). BEH/IAQ staff observed a dehumidifier operating in this room. The dehumidifier was full to capacity with water and the carpeting beneath was water-damaged apparently from previous overflows of the dehumidifier due to lack of maintenance (Pictures 5 and 6). Improperly maintained dehumidifiers can be a source for water damage and microbial growth. The manufacturer's recommendations should be followed regarding cleaning and proper maintenance procedures.

In order for building materials to support mold growth, a source of water exposure is necessary. Identification and elimination of the source of water moistening building materials is necessary to control mold growth. The MTH appears to have had a replacement roof installed recently. The gutter system and building envelope appear to be intact as well. However, a building contractor should be consulted regarding possible condensation/water intrusion contributing to chronically moist conditions in basement areas.

Water-damaged plans and mold along baseboard and carpet

7. Remove and discard porous items that have visible mold colonization (carpeting, plans, cardboard boxes, papers, etc.). Items of importance such as plans or important legal documents could be scanned or copied prior to discarding.

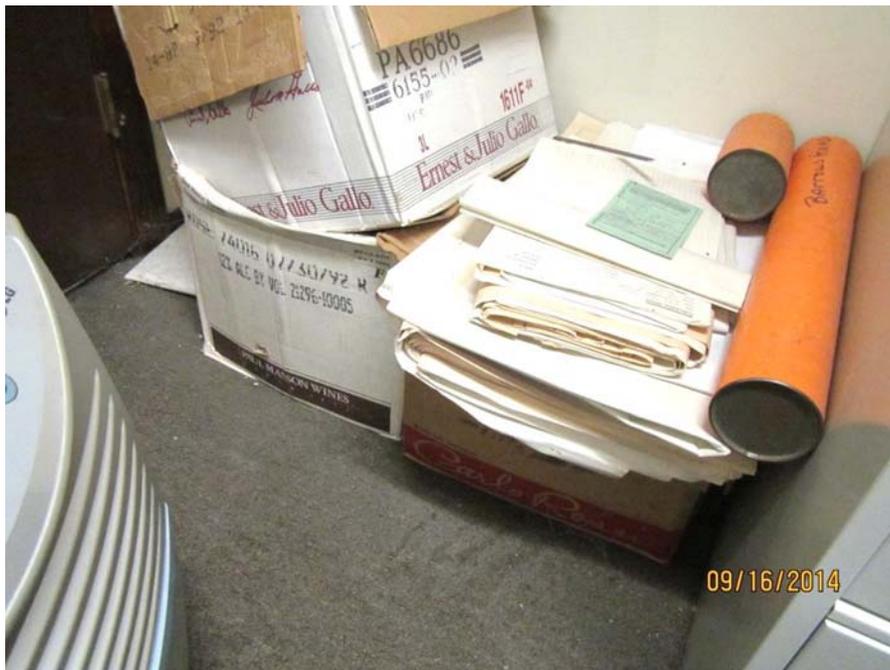
Picture 2

Water-damaged, mold-colonized boxes/papers

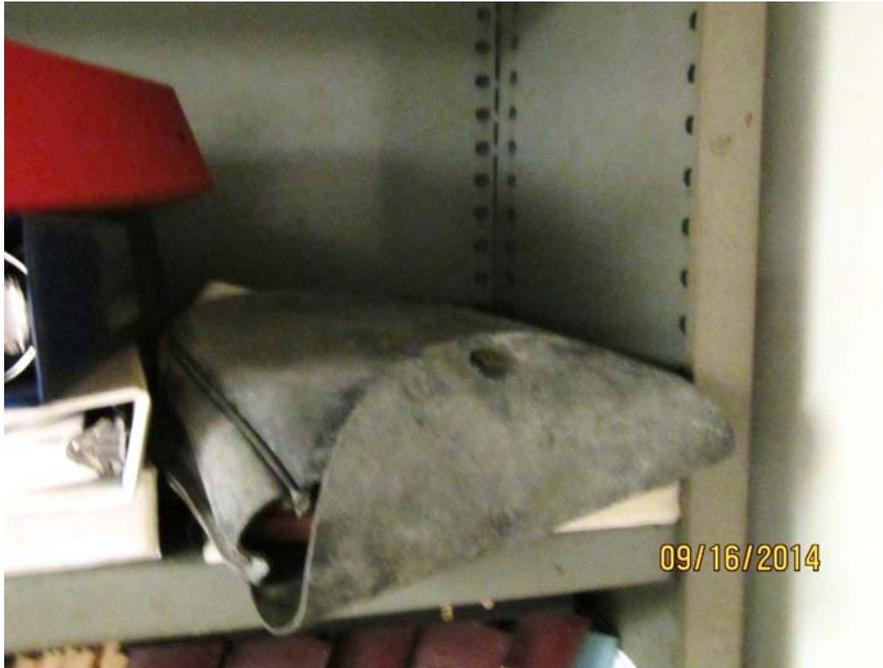
Picture 3

Mold-colonized porous items on shelving

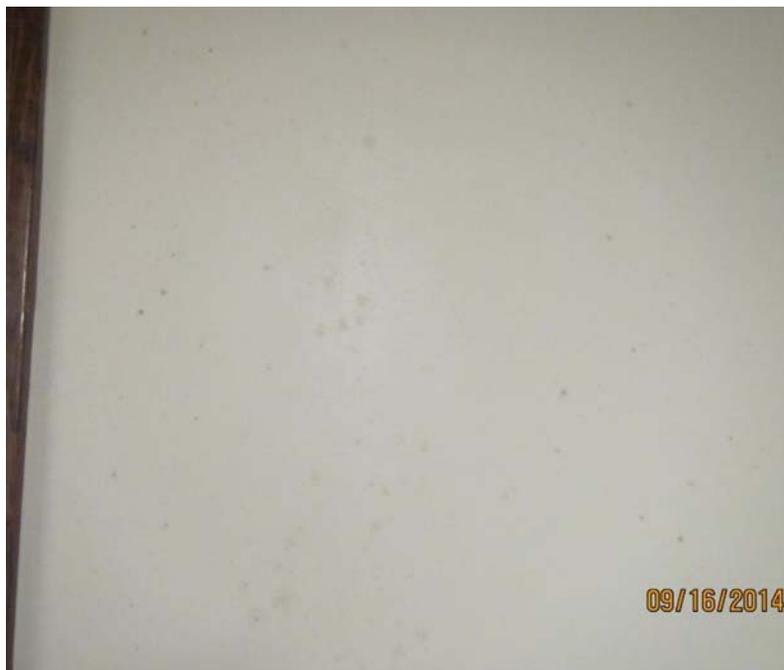
Picture 4

Visible mold on surface of wall in Planning Records Room

8. Clean and disinfect mold-colonized nonporous surfaces with a mild detergent or antimicrobial agent according to EPA guidelines (US EPA, 2001).
9. Consult "Mold Remediation in Schools and Commercial Buildings" published by the US Environmental Protection Agency (US EPA, 2001) for more information on mold. This document can be downloaded from the US EPA website at:
http://www.epa.gov/mold/mold_remediation.html.

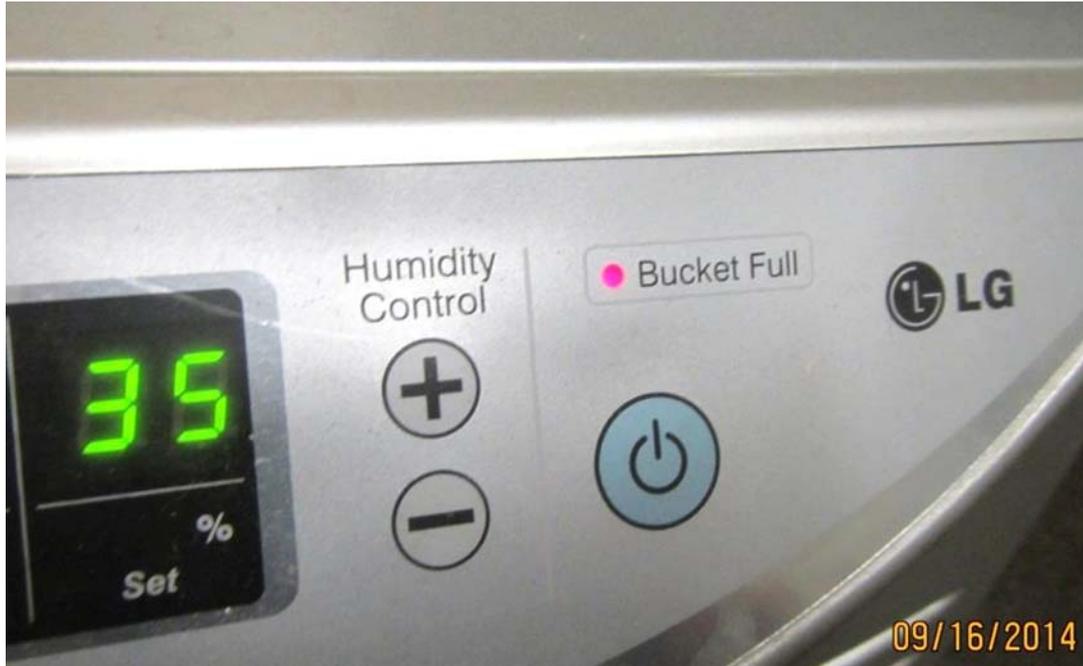
Picture 5

Dehumidifier showing water “bucket full” red light indicator

6. Use dehumidifiers in the Planning Room and Planning Records Room to reduce relative humidity. Manufacturer's recommendations concerning cleaning and regular maintenance should be followed to avoid water damage and microbial growth.

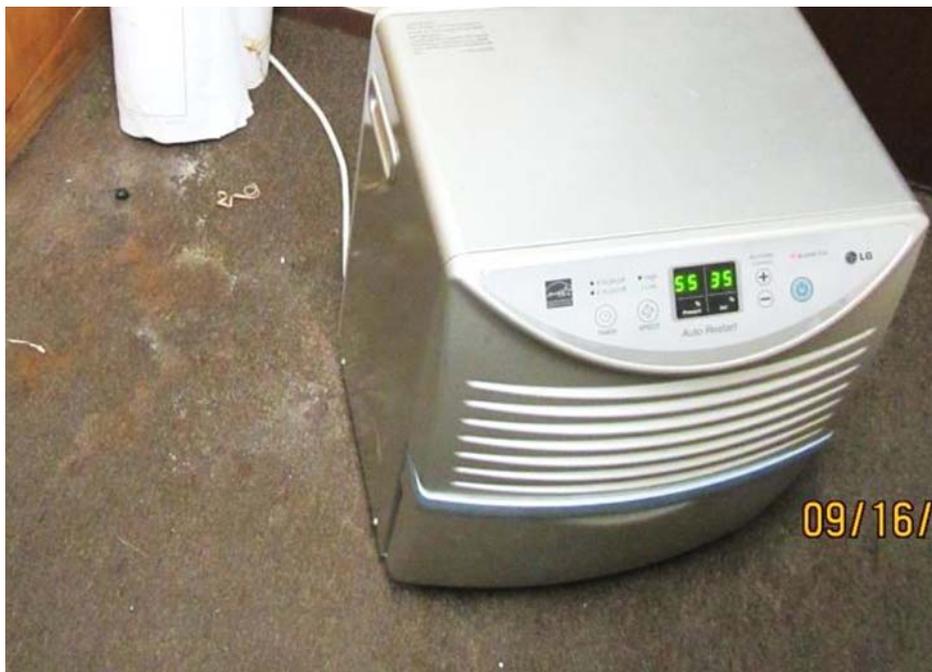
Picture 6

Water-damaged/mold-colonized carpeting under/beside dehumidifier

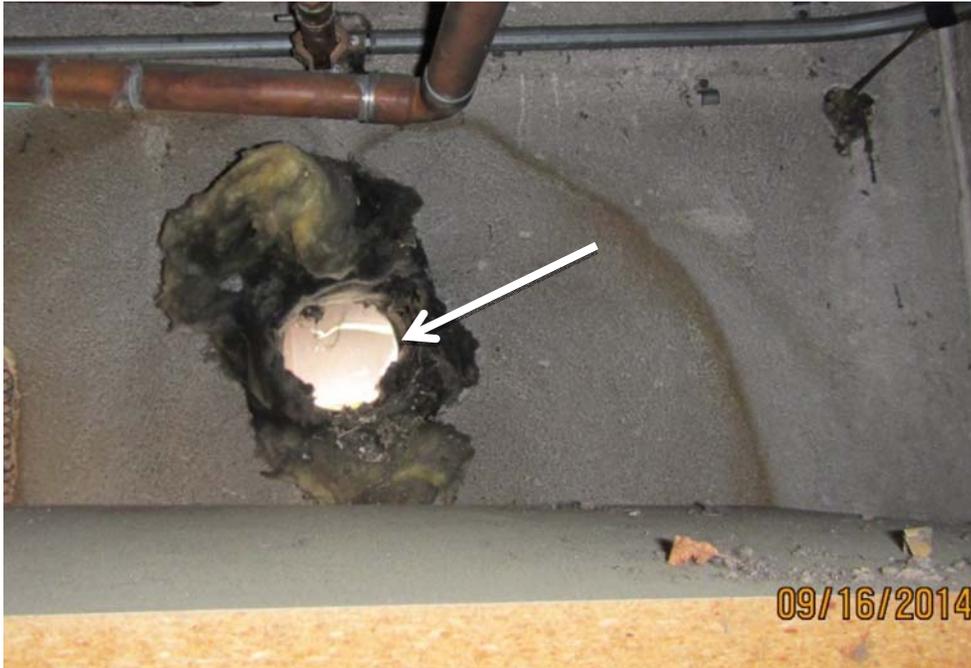
Picture 7

Also of note were two large capacity oil boilers in the mechanical room. These units appear to be fairly new. In this room there is also a three-inch open pipe (Picture 7) which appears to be the combustion air source for the boilers. Based on the combustion rate/capacity of the boilers, this combustion source may be undersized. It is important to have an adequate source of combustion air for combustion of fuel and adequate venting of products of combustion (including CO) from the building. Without adequate combustion air, CO and other products of combustion may enter the mechanical room. This contingency becomes an acute safety issue since the basement is occupied by Mendon town employees.

Combustion air source pipe exiting the mechanical room (arrow)

1. The plumbing department/fire department should be consulted as soon as possible to verify that the diameter of the combustion air source meets applicable codes given the window, ventilation and available air volume limitations in the basement. Mr. Izzo was notified of this concern by IAQ staff via an email on September 22, 2014.
2. Use openable windows (in areas that have them) to bring fresh/outside air into occupied spaces. To facilitate airflow, operate AC's in "fan only" setting. Utilize stand-up fans and open office doors to circulate air.

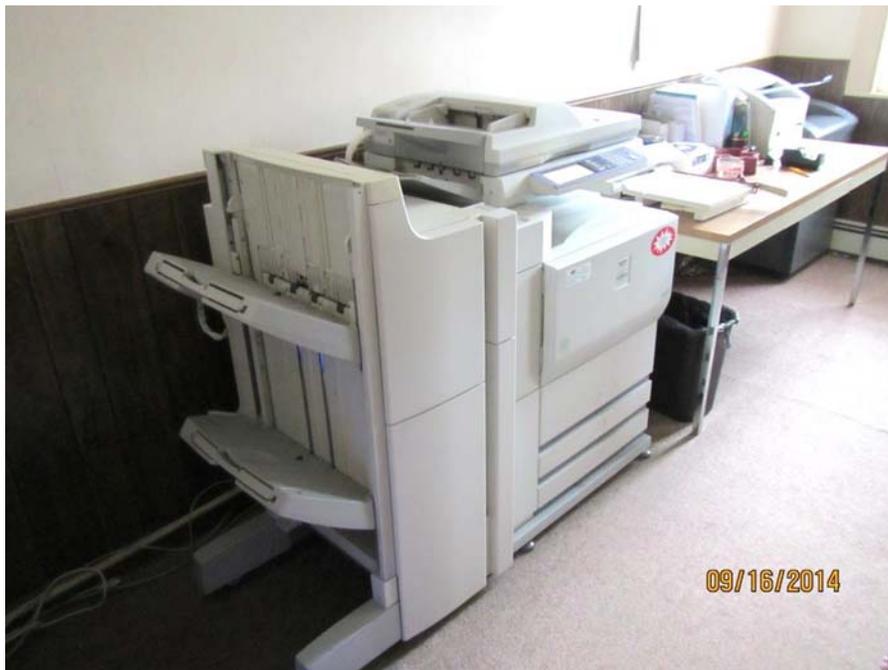
Picture 8

There are several photocopiers located throughout the MTH (Picture 8). Photocopiers can be sources of pollutants such as VOCs, ozone, heat and odors, particularly if the equipment is older and in frequent use. Both VOCs and ozone are respiratory irritants (Schmidt Etkin, 1992). Photocopiers should be kept in well ventilated rooms, and should be located near windows or exhaust vents.

Photocopier lacking local exhaust vent

19. To reduce exposure to VOC's: locate photocopiers in well ventilated rooms and reduce or eliminate the use of dry erase boards, hand sanitizers, air fresheners and cleaners with high VOC content.

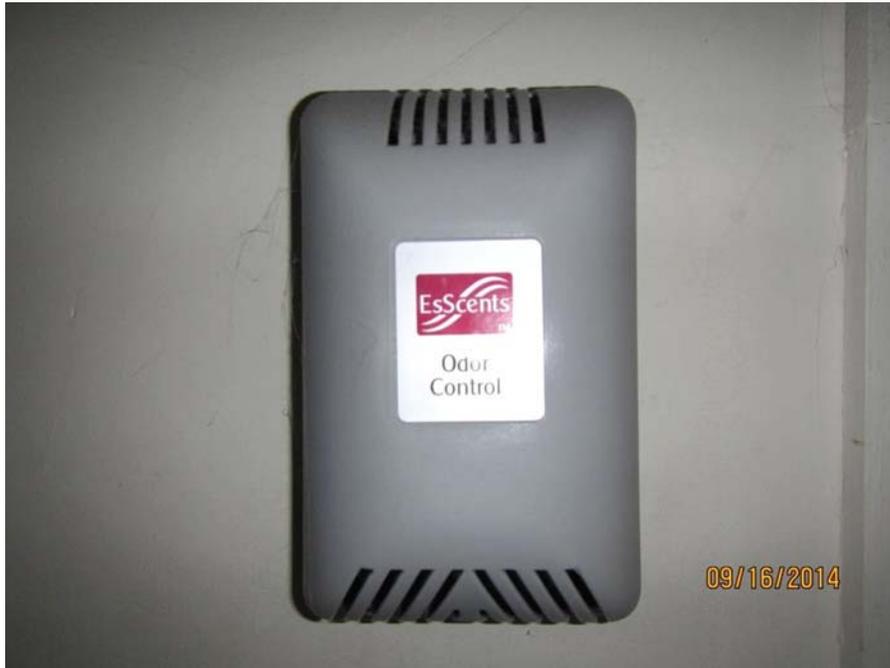
Picture 9

Air fresheners and deodorizing materials were observed in some areas (Picture 9). Air deodorizers contain chemicals that can be irritating to the eyes, nose and throat of sensitive individuals. Many air fresheners contain 1,4-dichlorobenzene, a VOC which may cause reductions in lung function (NIH, 2006). Furthermore, deodorizing agents do not remove materials causing odors, but rather mask odors that may be present in the area.

Air deodorizing unit located in bathroom

23. Consider discontinuing use of air fresheners/deodorizers to prevent exposure to VOCs.

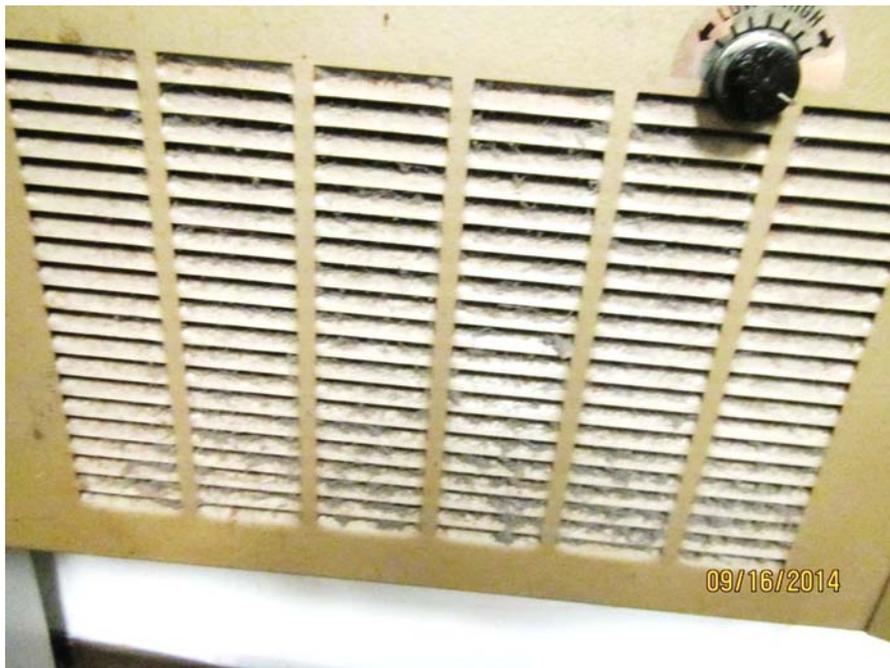
Picture 10

A number of wall heating units in the basement had accumulated dust/debris (Picture 10). One of these units appeared to be abandoned and covered with plastic sheeting (Picture 11). In addition, personal fans and AC filters also had accumulated dust/debris (Picture 12). Dust can be irritating to the eyes, nose and respiratory tract. These items should be cleaned periodically in order to prevent them from serving as a source of aerosolized particulates. Abandoned equipment should be repaired or properly removed/capped.

Wall heating unit occluded with dust/debris

17. Clean dust/debris from personal fans and wall heating units. Abandoned heating units should be repaired or removed and plumbing properly capped.
18. Clean filters in window AC units and clean upholstered furniture regularly.

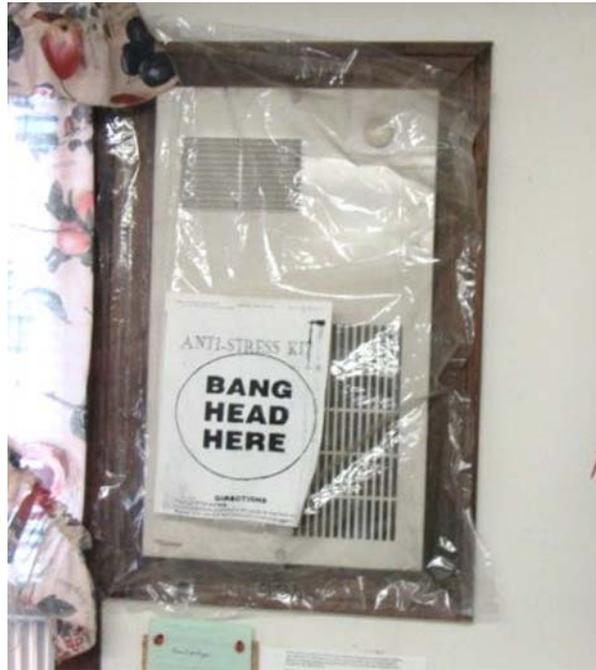
Picture 11

Abandoned wall heating unit covered with plastic sheeting

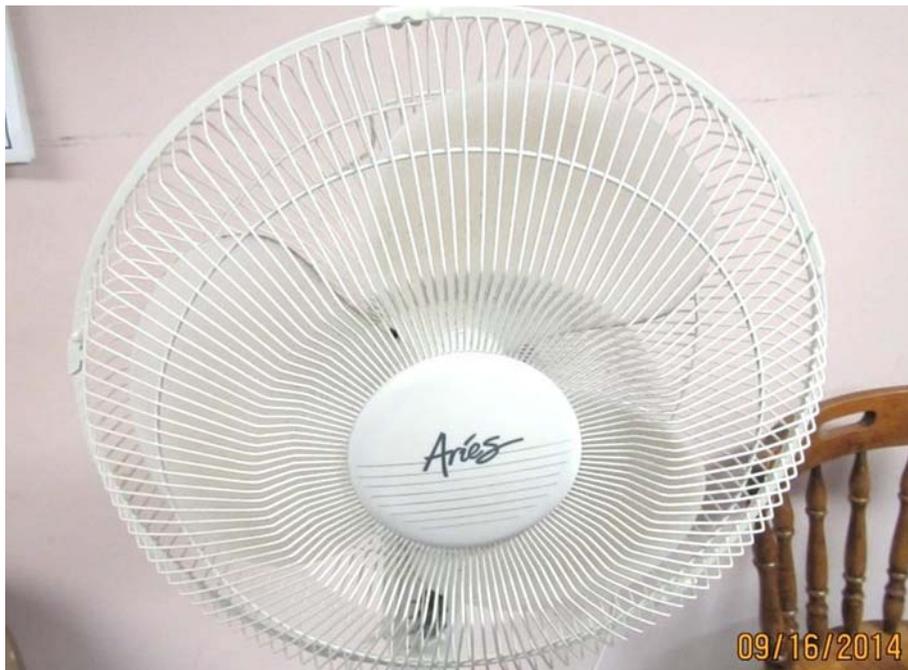
Picture 12

Personal fan with accumulated dust/debris

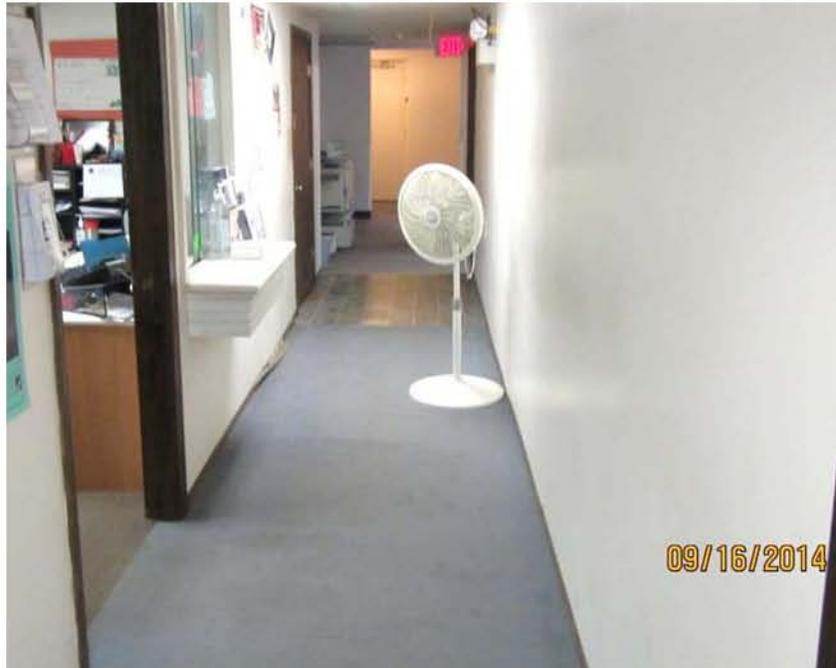
Picture 13

Most occupied areas had wall-to-wall carpeting (Table 1). The Institute of Inspection, Cleaning and Restoration Certification (IICRC), recommends that carpeting be cleaned annually (or semi-annually in soiled high traffic areas) (IICRC, 2012). The carpeting in the basement appears to be heavily soiled, worn and past its useful life (Pictures 6 and 13). Carpeting is generally not recommended in basement areas especially if exposed to chronic moisture. Since the average lifespan of carpeting is approximately eleven years (Bishop, 2002), consideration should be given to planning for the installation of new flooring. However, if asbestos containing tile is located beneath the soiled carpets, care should be taken not to disturb tiles. Where asbestos-containing materials are found damaged, these materials should be removed or remediated in a manner consistent with Massachusetts asbestos remediation laws (MDLI, 1993). Damaged tiles which may contain asbestos were observed in the mechanical room (Picture 14).

Worn carpeting >10 years old

11. Consider replacing carpeting over 10 years old with a non-porous surface (e.g., vinyl floor tiles) for basement areas and carpet squares in above grade levels for easier maintenance/replacement. Please note, due to the possibility of asbestos-containing materials (e.g., floor tiles/mastic) beneath carpeting, carpet removal should be conducted under conditions as to not disturb tiles. If not feasible, contact a licensed asbestos remediation firm as well as the Massachusetts Division of Labor and Industries (MDLI), Asbestos Program for guidance.

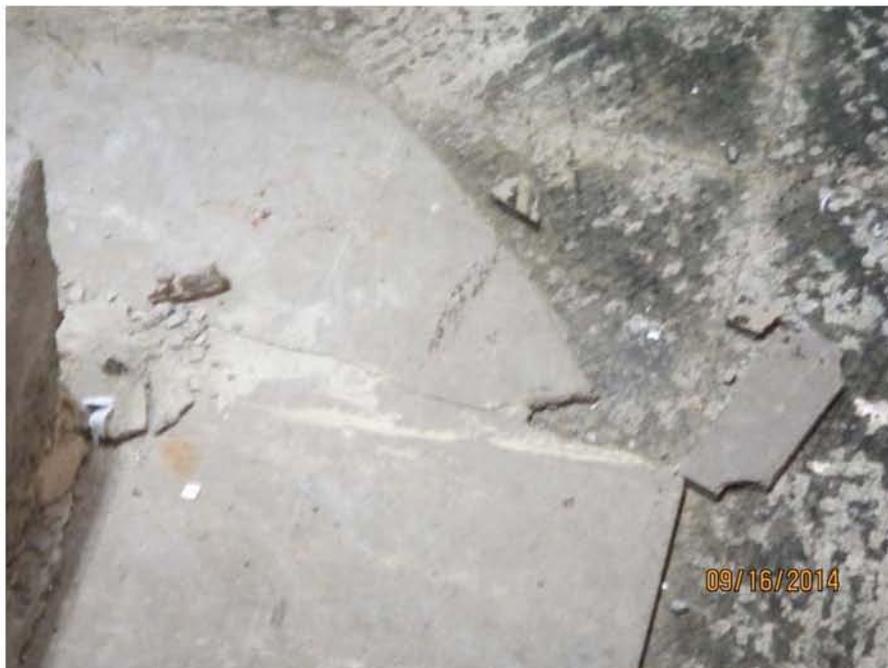
Picture 14

Damaged tile in mechanical room possibly containing asbestos

12. Determine if floor tiles in the mechanical room contain asbestos. Where asbestos-containing materials are found damaged, these materials should be removed or remediated in a manner consistent with Massachusetts asbestos remediation laws (MDLI, 1993).

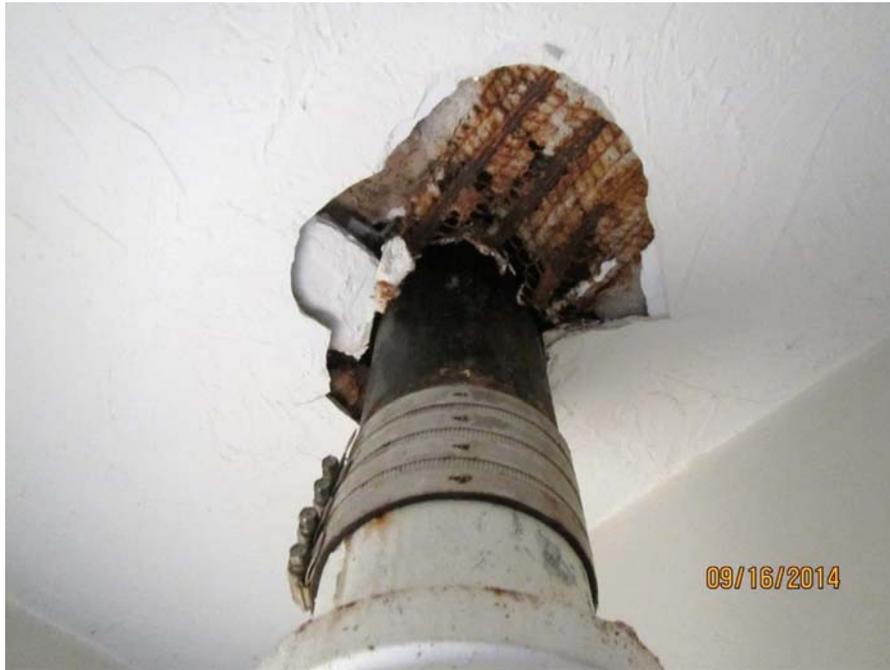
Picture 15

BEH/IAQ staff observed several gaps around utility pipes (Pictures 15 and 16) as well as spaces around windows which could allow moisture, odors and pests to enter the building envelope. These gaps to unconditioned spaces should be properly sealed.

Gaps around sewer pipe in basement bathroom

13. Seal around all utility holes in walls/ceilings with fire proof expanding foam insulation or suitable material to prevent vapors and particulates from passing into occupied areas.

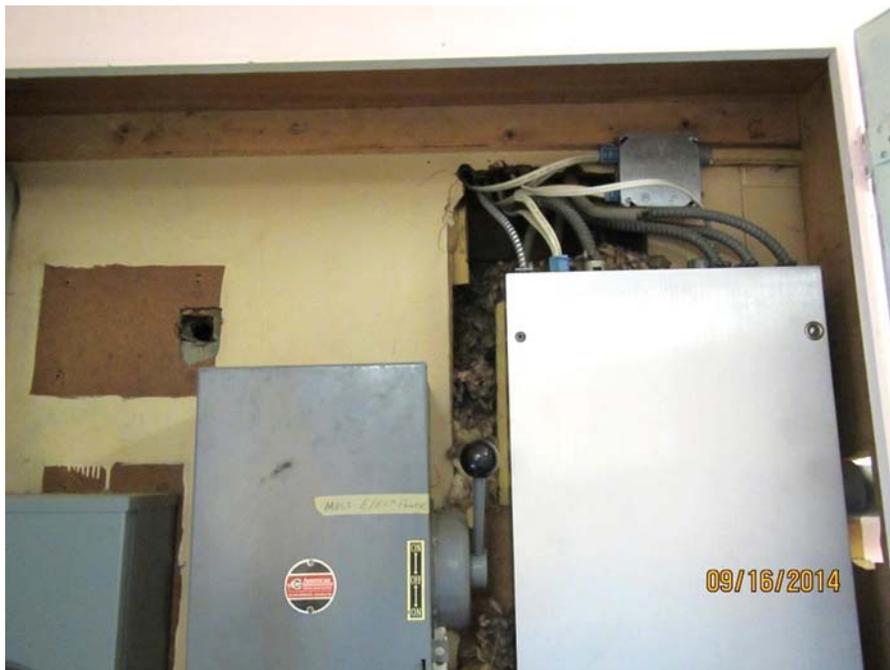
Picture 16

Gaps/breaches in wall in electrical closet leading to ZBA office space

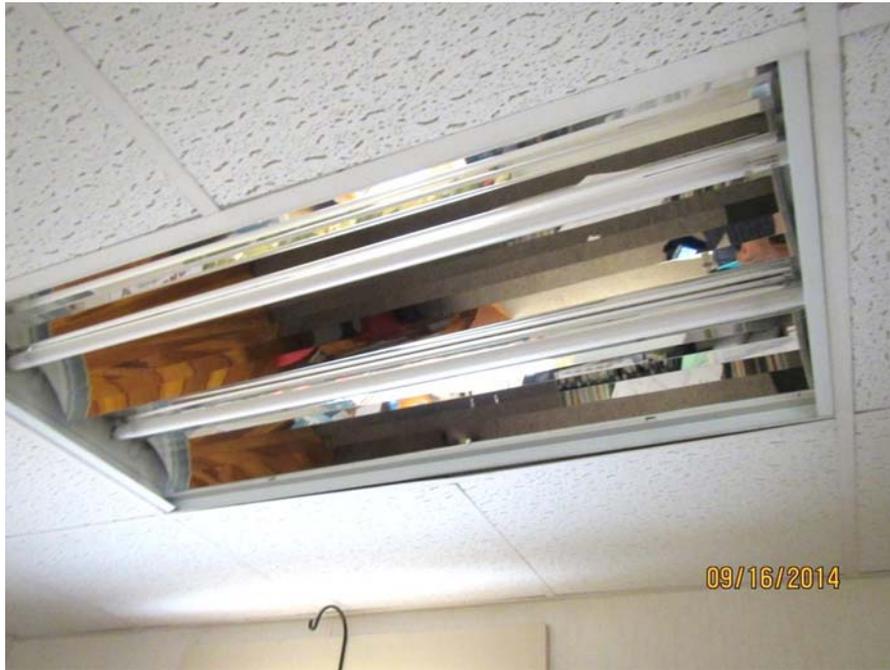
Picture 17

Missing light covers were noted in a number of areas (Picture 17). Fixtures should be equipped with access covers installed with bulbs fully secured in their sockets. Breakage of glass can cause injuries and may release mercury and/or other hazardous compounds.

Light fixture missing cover

15. Light fixtures should be equipped with access covers installed with bulbs fully secured in their sockets. Store fluorescent bulbs in a protective container and locate them in a secure area. Breakage of glass can cause injuries and may release mercury and/or other hazardous compounds.

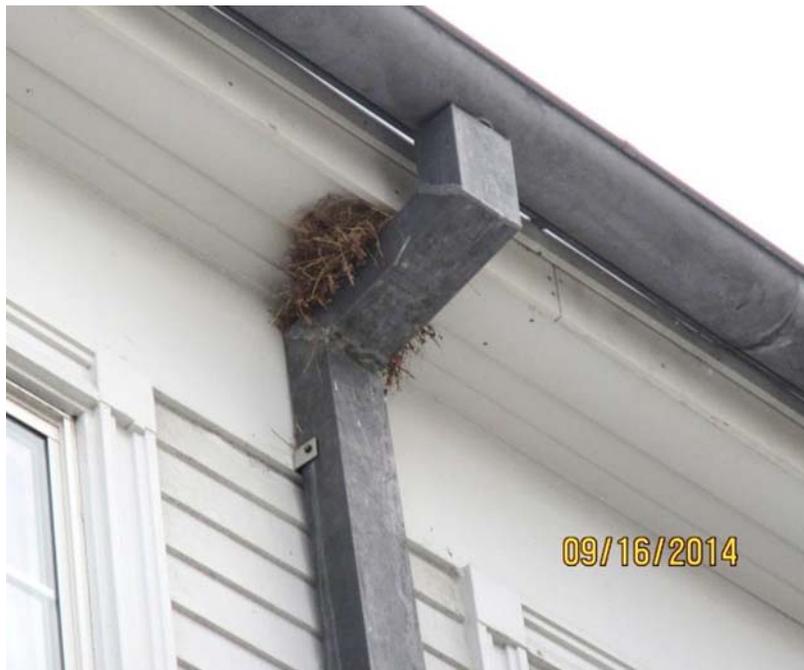
Picture 18

A bird's nest was observed above a downspout in close proximity to a window (Picture 18) on the northwest (Library) side of the building. Birds and bird wastes can be sources of allergens and microbial contamination. The birds/nesting materials should be removed to avoid entrainment of these materials via nearby windows/AC units.

Bird nest above downspout near window

24. Remove birds/nesting materials located above downspout on northwest (Library) side of the building should be removed to avoid entrainment of these materials in the nearby windows or AC units.
25. Large amounts of accumulated items on flat surfaces should be relocated and/or cleaned periodically to avoid excessive dust build up.
26. Refer to resource manuals and other related indoor air quality documents for further building-wide evaluations and advice on maintaining public buildings. Copies of these materials are located on the MDPH's website: <http://mass.gov/dph/iaq>.
