INDOOR AIR QUALITY ASSESSMENT ODOR INVESTIGATION

**E. Ethel Little School
7 Barberry Rd
North Reading, MA 01864**

Prepared by:
Massachusetts Department of Public Health
Bureau for Environmental Health
Indoor Air Quality Program
December 2014

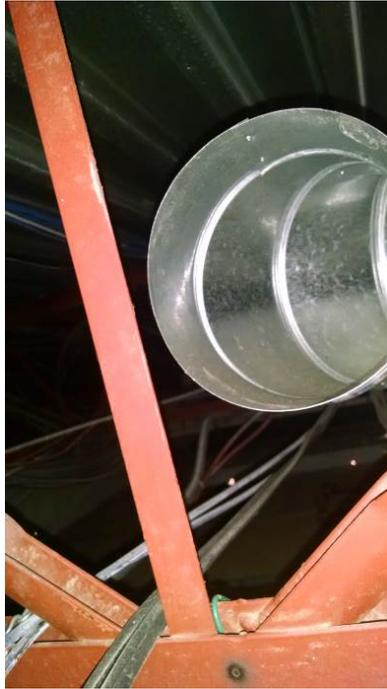
Picture 1

Open exhaust ductwork in hallway ceiling plenum

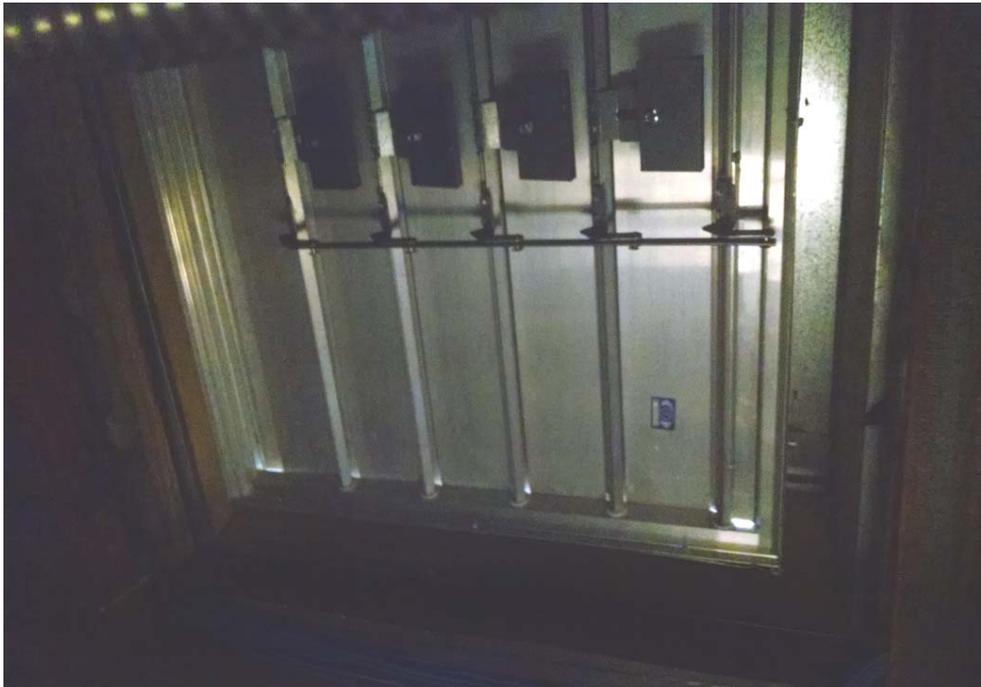
Picture 2

With the assistance of NRPS staff, BEH/IAQ staff examined the ceiling plenum for exhaust equipment and noted a louver for air exhaust; light from the outdoors could be seen penetrating around the louver (Picture 2). BEH/IAQ staff examined the louver from the roof and noted that there was no fan motor on the roof to draw air out from the ceiling plenum (Pictures 3 and 4). Without an exhaust fan to actively remove air, outdoor air can penetrate around the louvers, causing dust and odors in the hallway ceiling plenum to backdraft into the classrooms via the classroom exhaust vents.

Exhaust louver (view from ceiling plenum), note light penetrating at the bottom corners

1. Continue with plans to install a permanent exhaust fan to the rooftop opening.
2. Vacuum visible wastes in the ceiling plenum using a HEPA-filtered vacuum.
3. Clean/disinfect the hallway ceiling-mounted heating unit, as well as flat surfaces nearby.
4. Locate/remove pests that may be in the nesting in the ceiling system. Seal breaches in the wall to prevent future entry.
5. Replace ceiling tiles in the hallway.

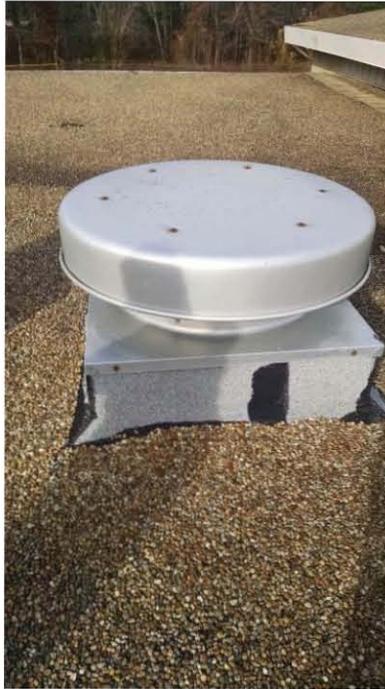
Picture 3

Rooftop return vent ductwork, notice lack of fan motor

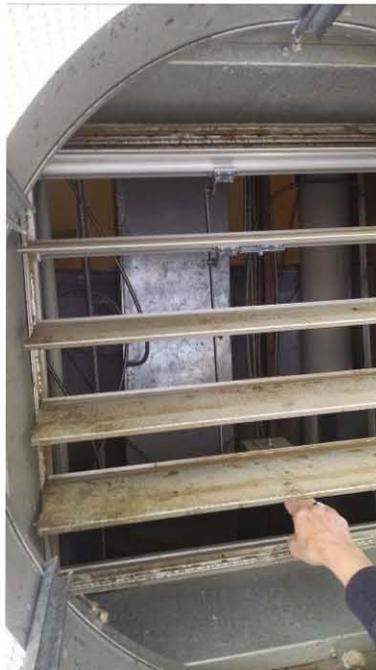
Picture 4

Exhaust louver open, looking out from hallway ceiling plenum, note no fan motor

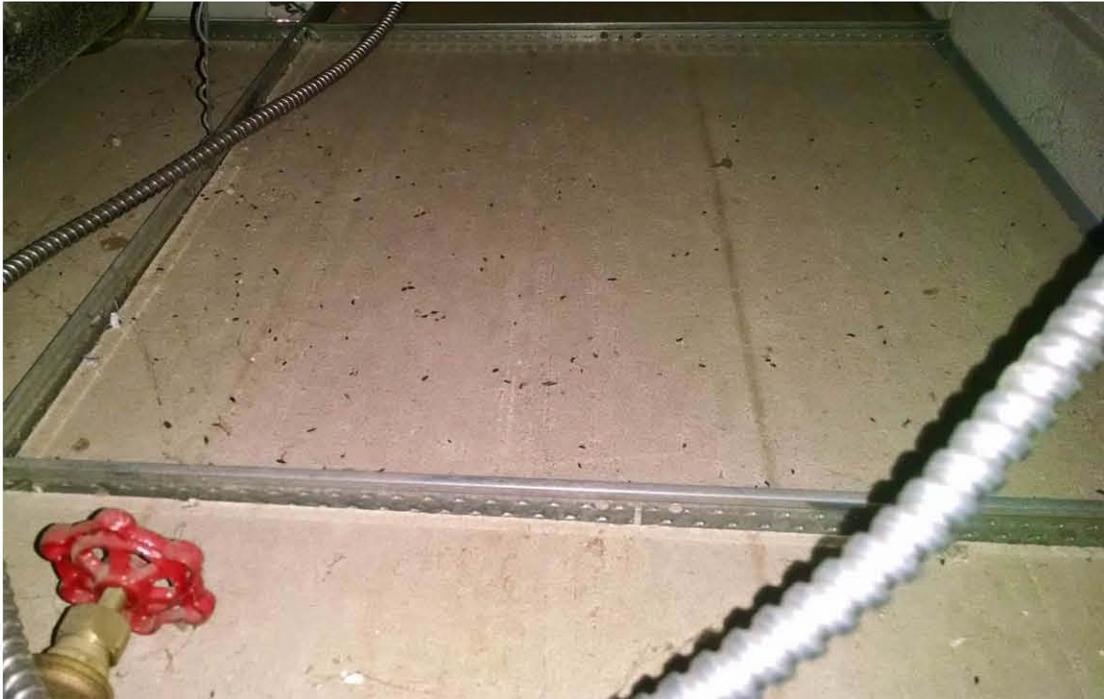
Picture 5

At the time of the assessment, BEH/IAQ staff did not observe any moisture sources that would contribute to water damage and associated odors. However, rodent droppings were noted on ceiling tiles in the hallway plenum (Picture 5). The presence of droppings suggests that rodents are likely nesting in the plenum. The ceiling-mounted heating unit likely serves as a heat source for the pests. Since pests congregate near heat sources for warmth, it is possible that animal waste (e.g. urine) may be collected on the ceiling-mounted heating unit. When the unit is

Rodent droppings on ceiling tiles

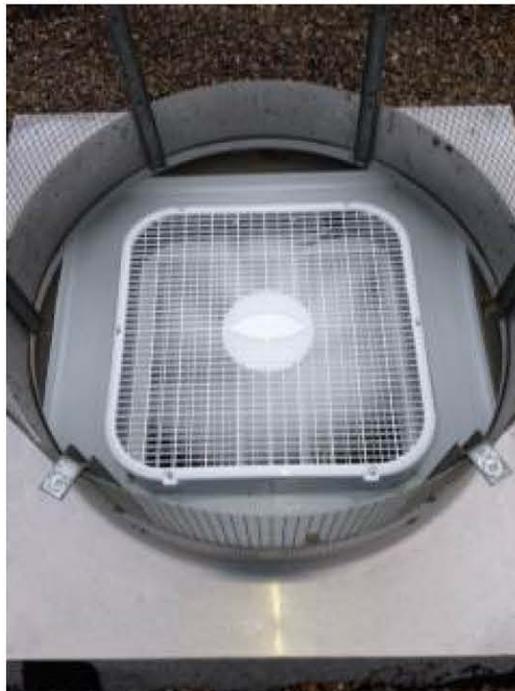
Picture 6

Box fan installed to remove odors (image courtesy of Mike Parow, NRPS)

At the time of the assessment, BEH/IAQ staff recommended interim methods to exhaust air from the hallway ceiling plenum. At the time, the NRPS devised a plan to install a fan to draw air out of the plenum to reduce odors in the building. The NRPS provided confirmation and pictures to show that a temporary exhaust system had been installed (Picture 6). Based on findings at the time of the assessment, the following is recommended:
