WATER DAMAGE FOLLOW-UP INVESTIGATION

**Massachusetts Department of Children and Families
33 East Merrimack Street
Lowell, Massachusetts**

Prepared by:
Massachusetts Department of Public Health
Bureau of Environmental Health
Indoor Air Quality Program
May 2015

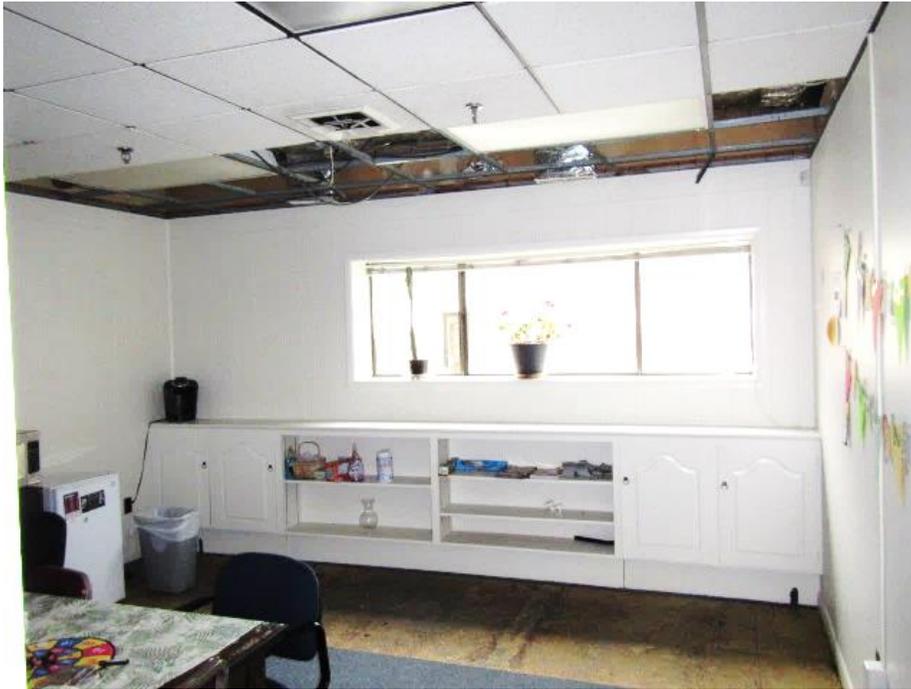
Picture 1

Water-damaged ceiling tiles, insulation and carpeting removed in annex breakroom

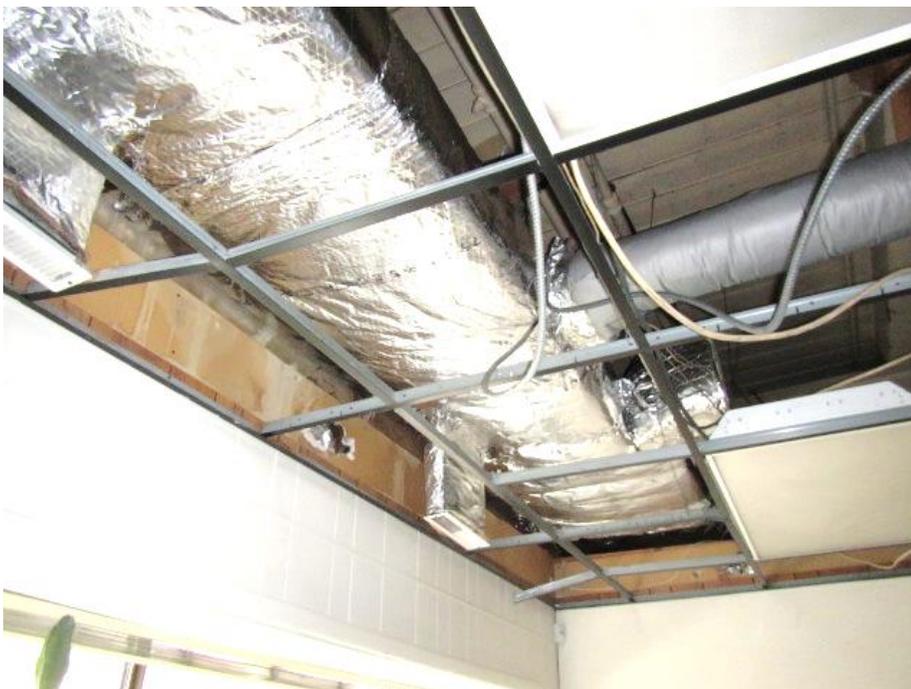
Picture 2

New insulation installed on ductwork in breakroom annex

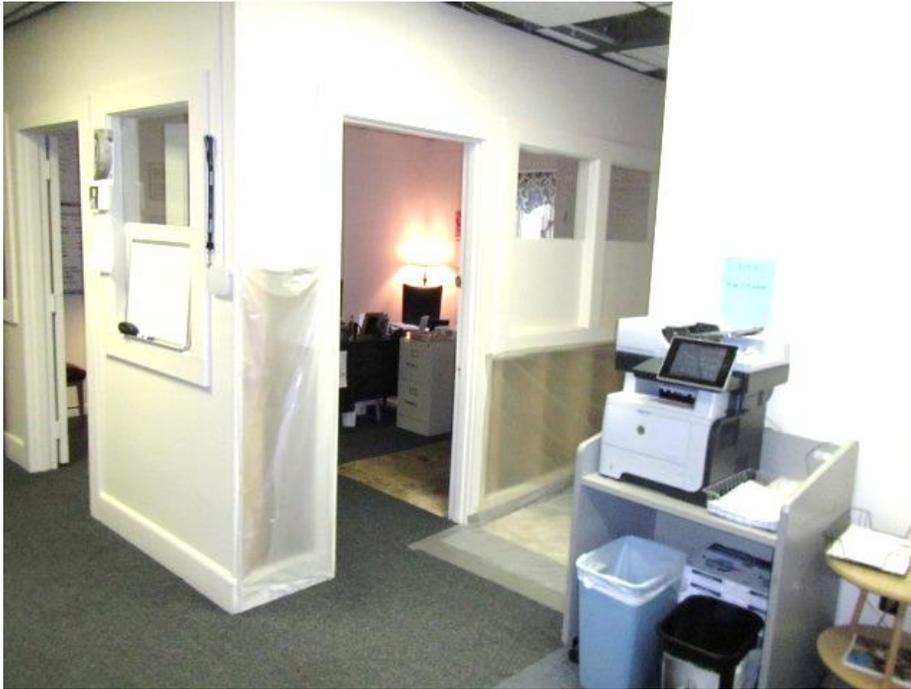
Picture 3

Water-damaged gypsum wallboard and carpeting removed in annex

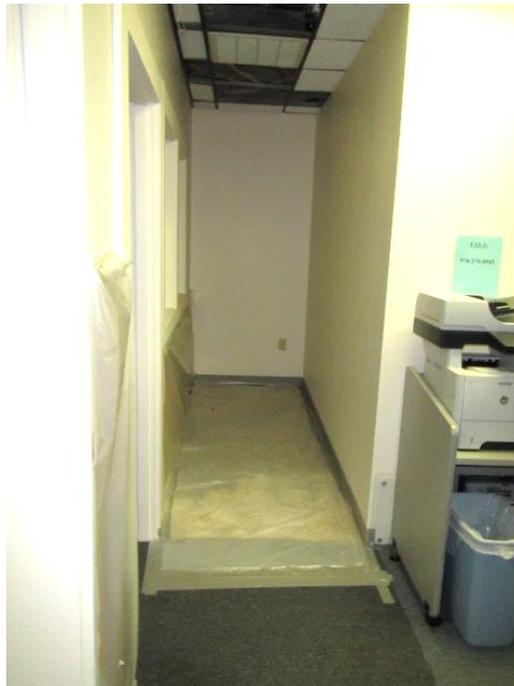
Picture 4

Water-damaged gypsum wallboard, ceiling tiles and carpeting removed in annex

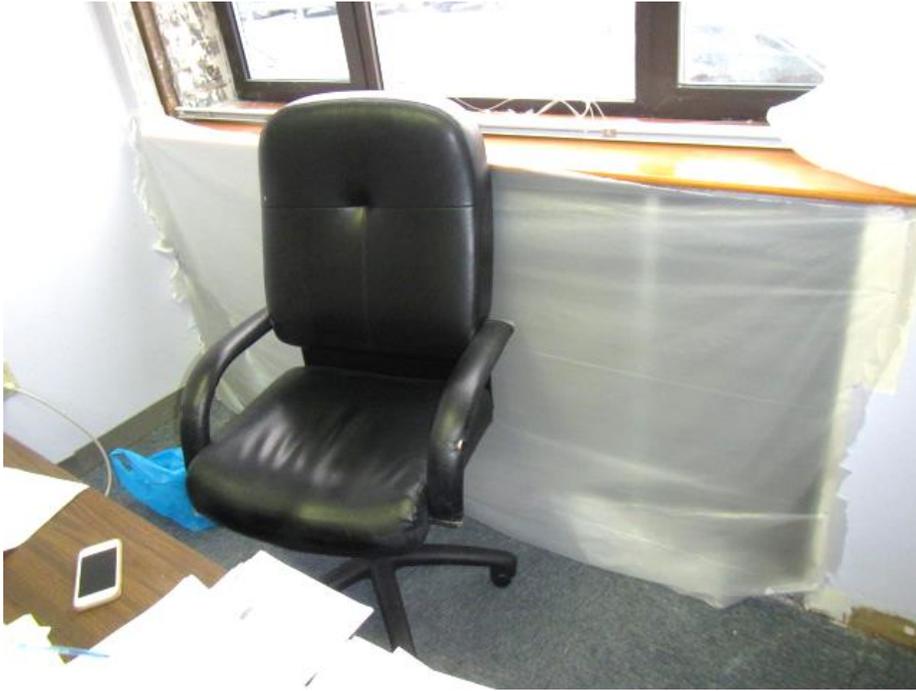
Picture 5

Water-damaged gypsum wallboard removed in Ortiz Office

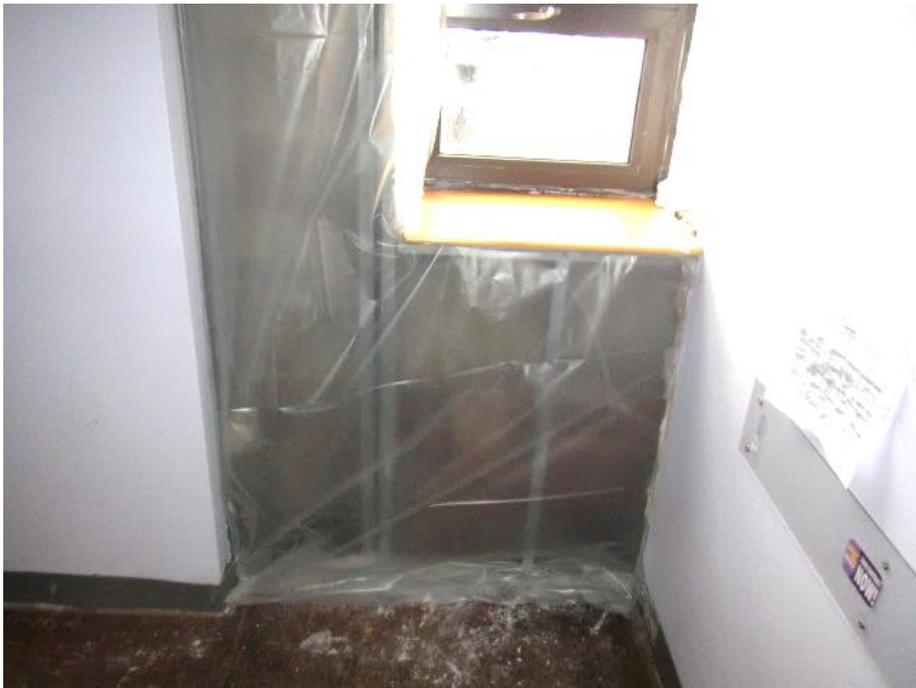
Picture 6

Water-damaged gypsum wallboard and carpeting removed in Lavoie office

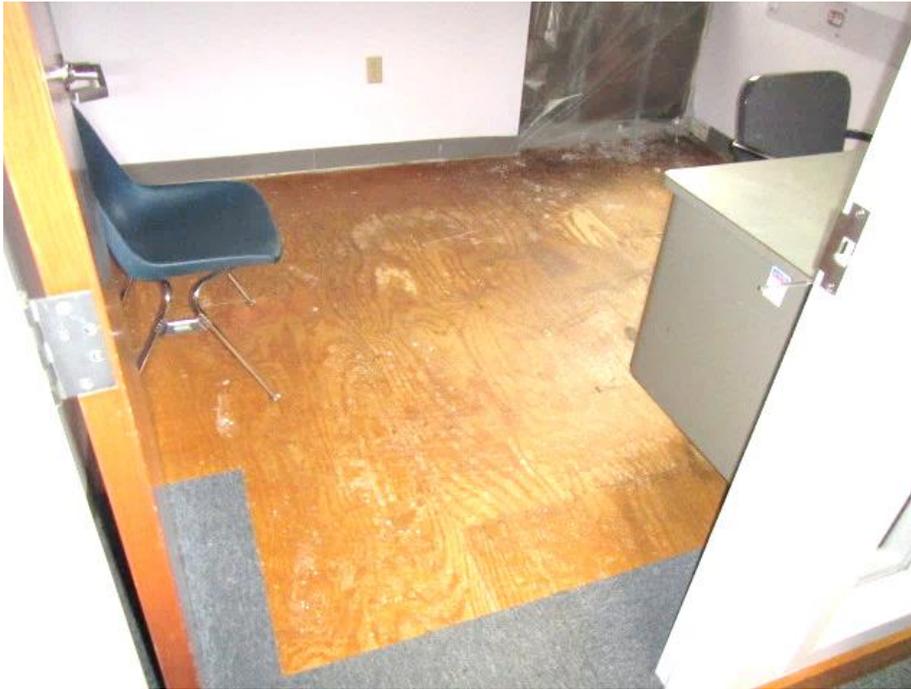
Picture 7

Water-damaged gypsum wallboard and carpeting removed in Lavoie office

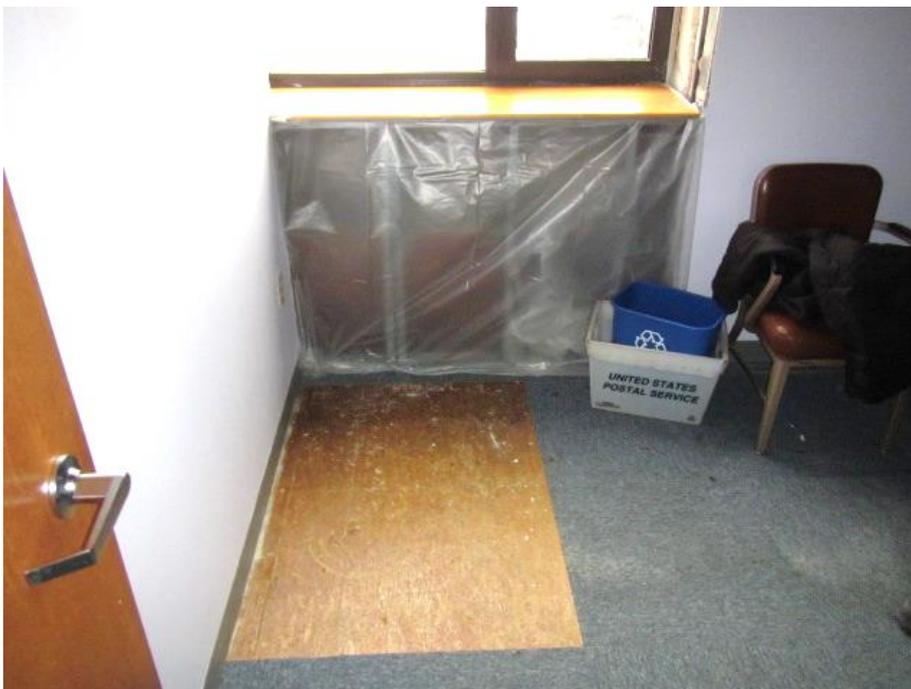
Picture 8

Water-damaged gypsum wallboard and carpeting removed from Barghi office

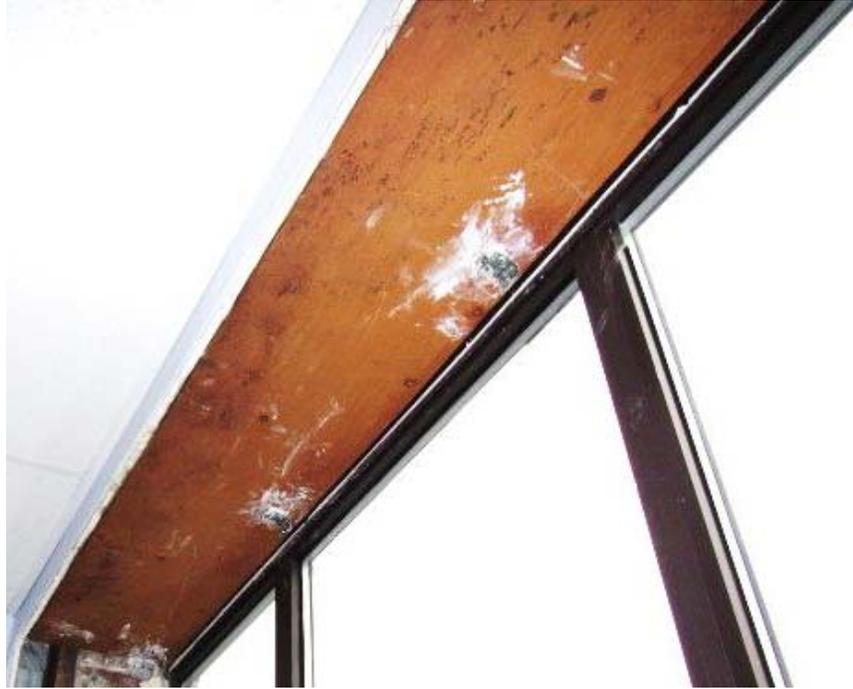
Picture 9

on a piece of wood installed over the window (Picture 9), which may be surface mold.

Stained/discolored wood over window in Ortiz office

BEH/IAQ staff recommended that the surface of the wood be cleaned/sanded and/or the wood be replaced.

4. Ensure leaks are repaired and change ceiling tiles in Investigative Unit B.
5. Clean/sand surface of the wood above Ms. Ortiz office window. If it cannot be adequately cleaned, replace it.

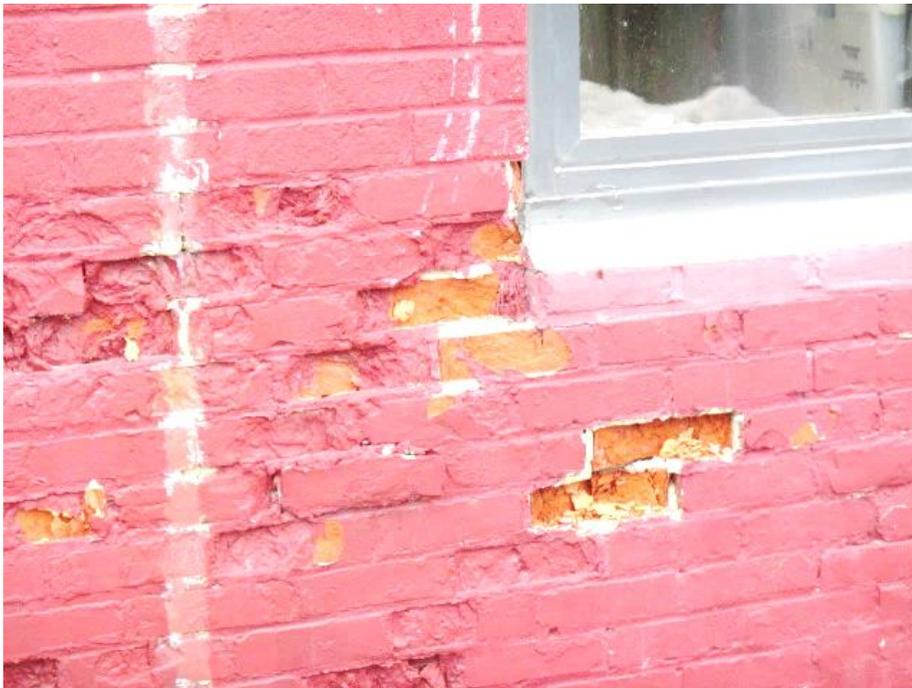
Picture 10

Extensive damage to mortar and brick was observed where ice formations had previously been noted (Pictures 10 through 13). Over time, these breaches in the building envelope can provide a source of water penetration into the building.

Damaged exterior brickwork

6. Contact a masonry firm to make repairs to exterior brickwork to prevent water infiltration and damage to building materials.

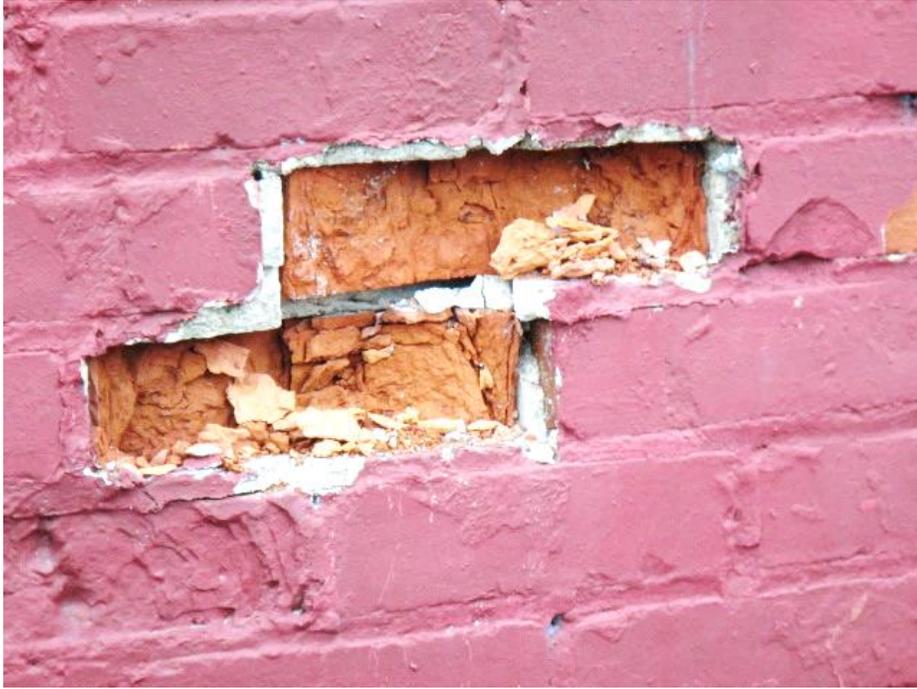
Picture 11

Damaged exterior brickwork

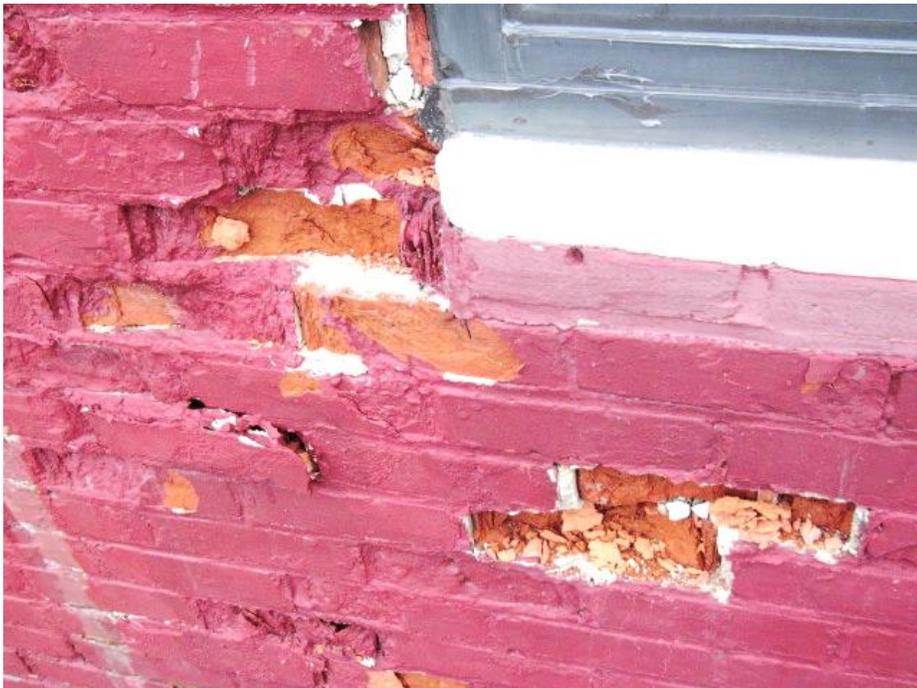
Picture 12

Damaged exterior brickwork

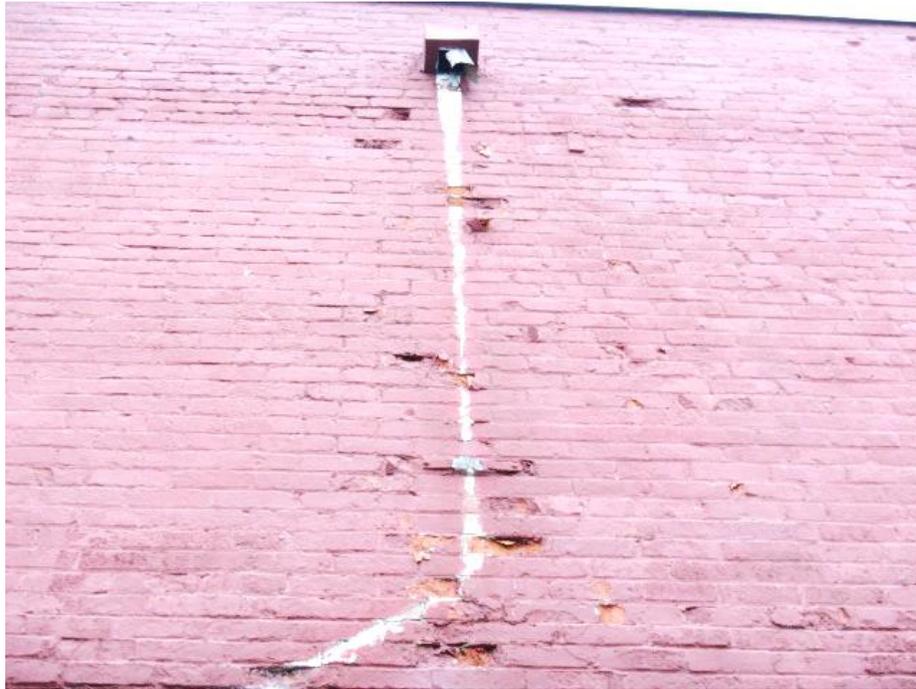
Picture 13

Damaged exterior brickwork
