INDOOR AIR QUALITY ASSESSMENT

**Berkshire Community College
Koussevitzky Arts Center
1350 West Street
Pittsfield, MA**

Prepared by:
Massachusetts Department of Public Health
Bureau of Environmental Health
Indoor Air Quality Program
May 2017

Building:	Koussevitzky Arts Center (KAC)
Address:	1350 West Street, Pittsfield, MA
Assessment Requested by:	David Moran, Director of Facilities, Berkshire Community College (BCC)
Reason for Request:	Concerns regarding respiratory irritation and general indoor air quality (IAQ)
Date of Assessment:	April 27, 2017
Massachusetts Department of Public Health/Bureau of Environmental Health (MDPH/BEH) Staff Conducting Assessment:	Jason Dustin Environmental Analyst/Inspector IAQ Program
Date of Building Construction:	1970's
Building Description:	Two-level concrete building consisting of classrooms, auditorium, art rooms, and office space.
Building Population:	The KAC has approximately 13 employees with members of the student body visiting on a daily basis. The KAC also contains a 500 and 110-seat theatre which are used by BCC and outside groups.
Windows:	Openable

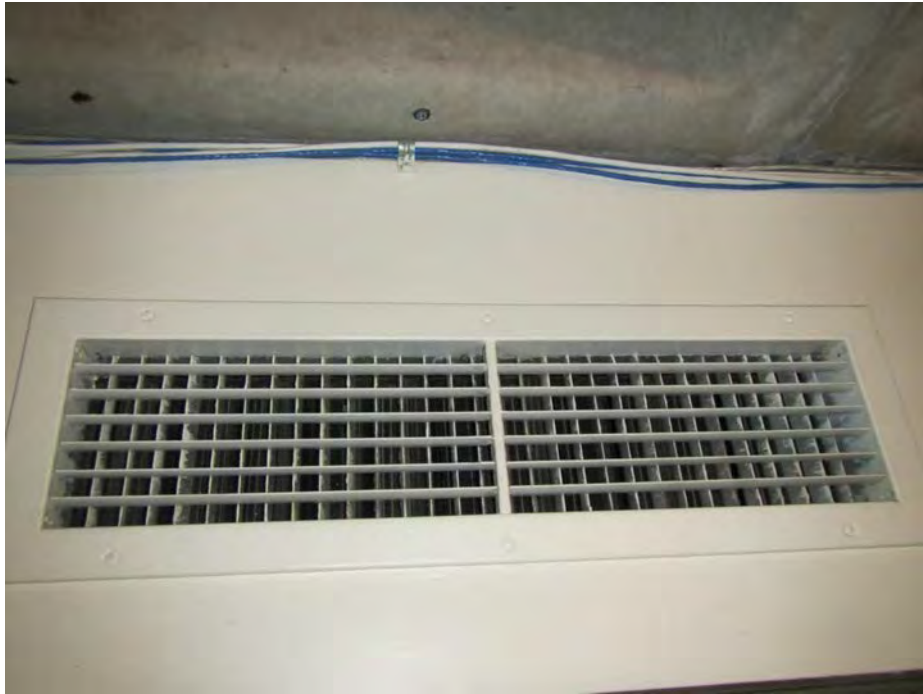
Picture 1

Most areas of the KAC do not have mechanical ventilation and instead rely on natural ventilation through open windows and doors. The testing room (K213) and the adjunct faculty space (F202) were both equipped with supply and exhaust ventilation (Pictures 1 and 2). The testing room supply ventilation appeared to have weak flow. BCC facilities staff noted a hole in the ductwork that supplies this area and reported that they plan to repair it.

Supply air diffuser in Testing Room (K213)

3. Continue with plans to repair the hole in the supply ventilation ductwork leading to the testing room (K213).
4. Consider consulting with an HVAC design engineer to install building-wide mechanical ventilation in the KAC.

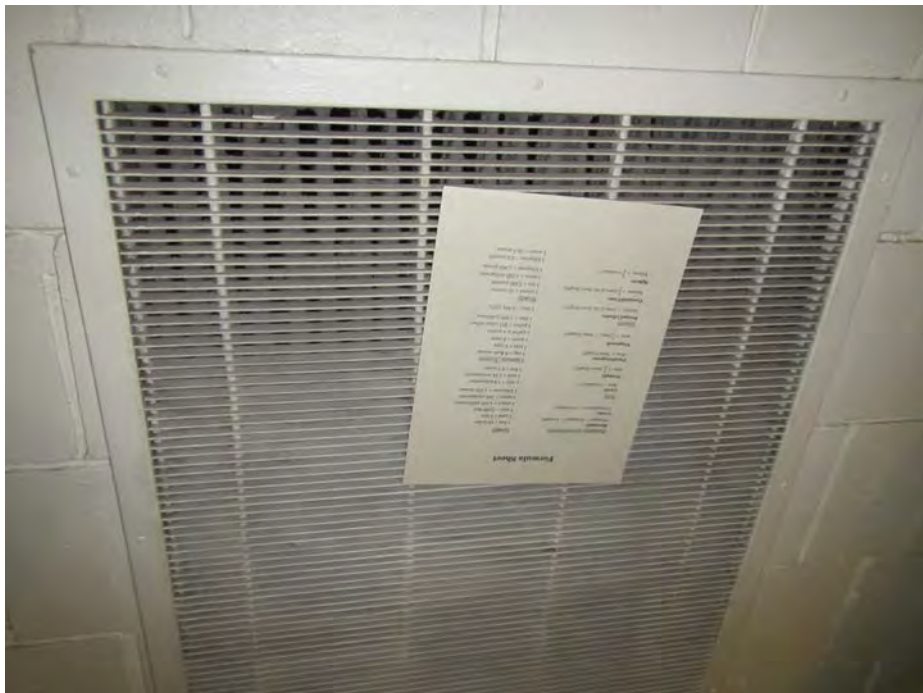
Picture 2

Wall-mounted return vent in (K213)-paper shows it drawing effectively

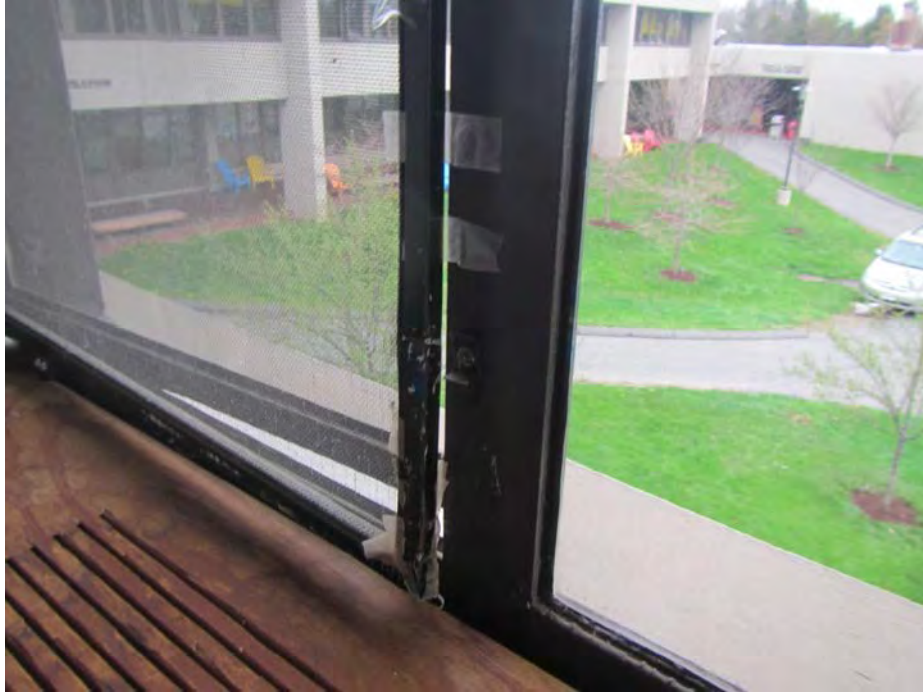
Picture 3

Properly functioning supply and exhaust ventilation are important to dilute and remove indoor air pollutants. Occupants should be encouraged to use open windows and doors for ventilation. Windows and screens were found to need repairs to prevent pest access when windows are open (Picture 3; Table 1).

Screen not attached to window frame

7. Ensure that occupants are aware of procedures to report leaks and other maintenance conditions so that they can be logged and repaired promptly.
8. Make necessary repairs to windows/screens and encourage occupants to open windows to increase ventilation. Ensure windows are closed tightly when rooms are not in use.

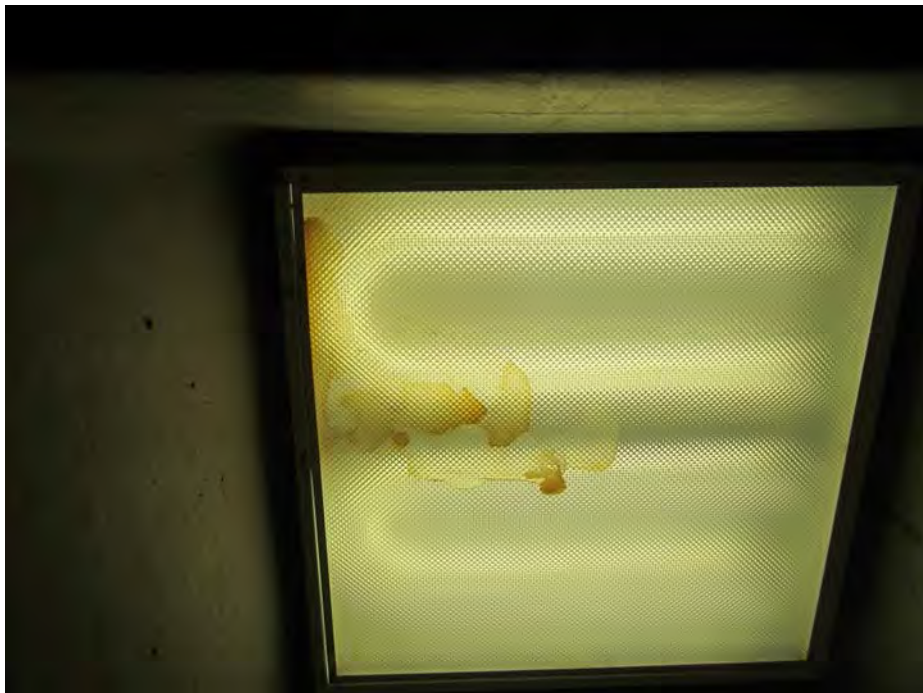
Picture 4

Several active leaks were noted during the visit, specifically in room K213 (main area), the K210 hallway, and the Theatre (Pictures 4 through 6). BCC Facilities reported that a roofing company is in the process of locating and repairing these leaks. BCC Facilities staff use fans to dry occupied areas when leaks occur; however, a slight musty odor was noted in the K210 hallway which may be an indication of chronic water damage. Consideration should be given to replacing this carpet.

Active water leak above light fixture in room K213

1. Continue to ensure all water leaks are fixed promptly and remove any water-damaged porous materials (e.g., ceiling tiles, carpet, gypsum wallboard) that were not dried properly within 24-48 hours.

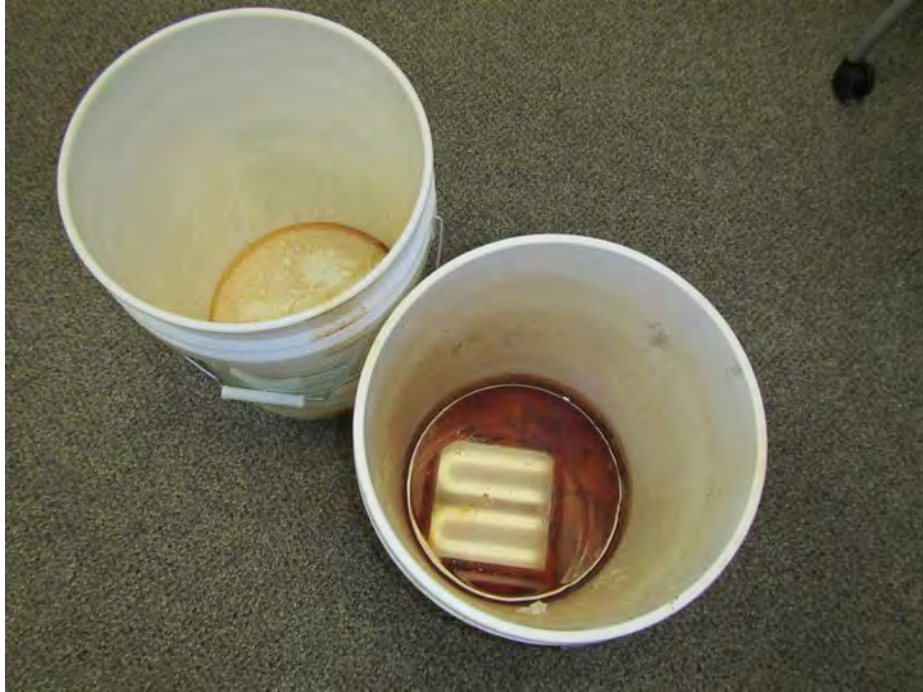
Picture 5

Buckets used in room K213 to catch active water leaks

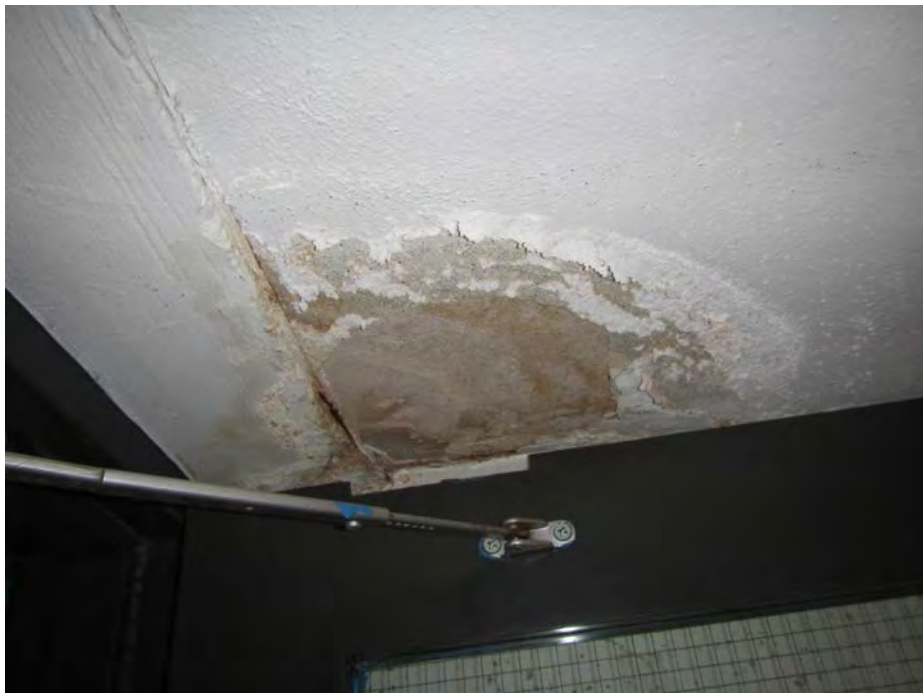
Picture 6

Water-damaged ceiling in K210 hallway

2. Make repairs to the ceiling in K210 hallway after leak has been repaired. Consider replacing the carpeting in this area as it may be water-damaged or mold-colonized.

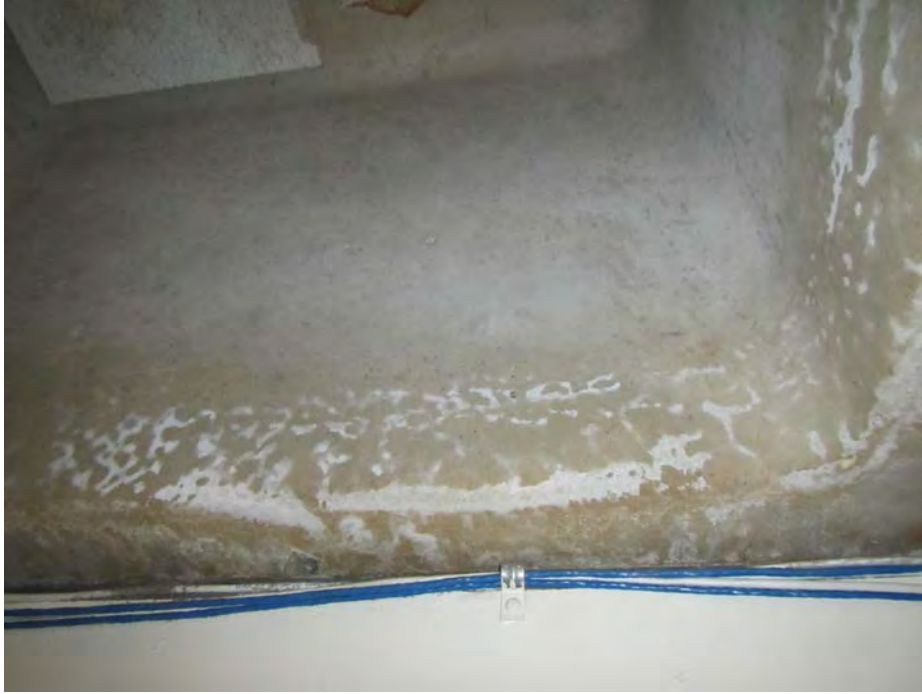
Picture 7

Most of the building components in the KAC are made of concrete which is not conducive to mold growth. BEH/IAQ staff did note accumulations of powdery white material on ceilings in some areas (Picture 7). The white material is called efflorescence; efflorescence is a characteristic sign of water damage to building materials such as brick, mortar, or plaster, but it is not mold growth. As moisture penetrates and works its way through masonry products or concrete, water-soluble compounds dissolve, creating a solution. As the solution moves to the surface of the mortar/concrete, water evaporates, leaving behind white, powdery mineral deposits. This condition indicates that water from the exterior has penetrated into the building. Plaster, concrete, and brick do not typically support mold growth because these materials are not carbon-based; however paint or debris on the wall, or items stored nearby that are moistened, may become mold-colonized. When present, efflorescence can be cleaned.

Efflorescence (white deposits) on concrete ceiling

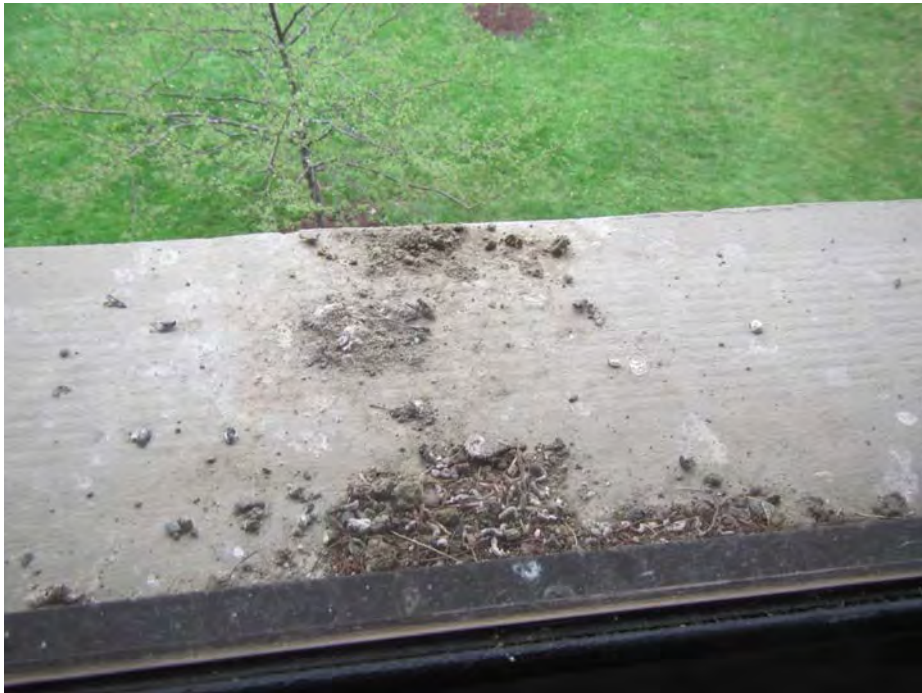
Picture 8

Bird waste and nesting materials were noted on the ledge outside of windows in room K214A (Picture 8). Birds and bird wastes can be sources of allergens and microbial contamination. The bird waste should be removed to avoid entrainment of this material when the windows are opened.

Bird waste and nesting debris outside of window in room K214A

5. Remove any bird waste/nesting materials that are outside of openable windows.
6. Continue to follow MDPH guidelines ([Appendix A](#)) concerning renovations while building is occupied.

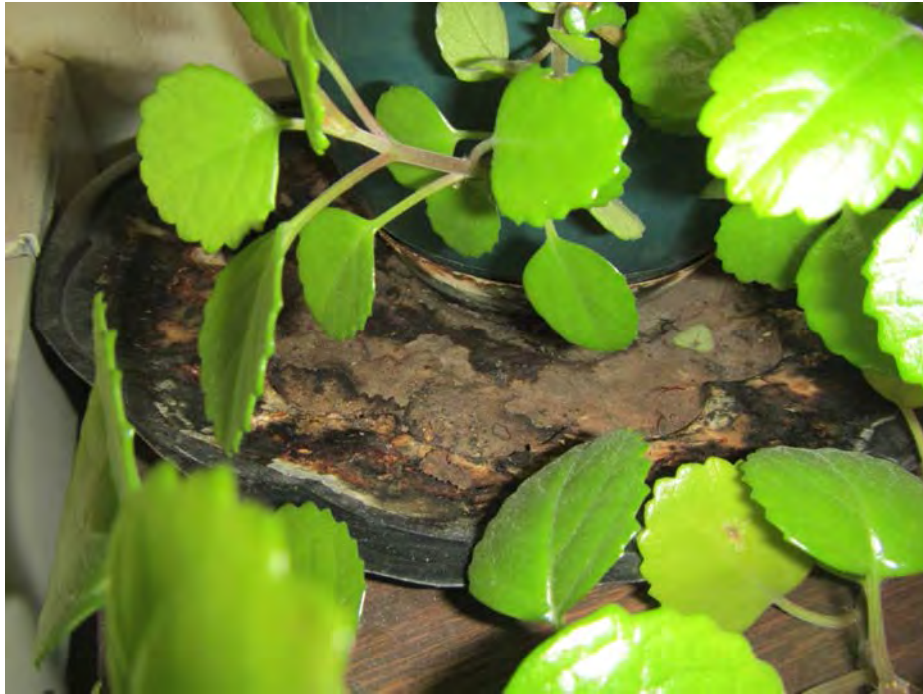
Picture 9

Several areas contained plants, some of which had debris in the drip pans (Picture 9, Table 1). Plants can be a source of pollen and mold, which can be respiratory irritants to some individuals. Plants should be properly maintained and equipped with drip pans to prevent water damage to porous materials. Plants should also be located away from air diffusers to prevent the aerosolization of dirt, pollen, and mold.

Plant showing rotting leaves/debris in drip tray

9. Move plants away from any air streams in classrooms. Avoid over-watering or placing them on porous materials (e.g., cloth, paper) and remove debris from drip pans and clean them periodically.

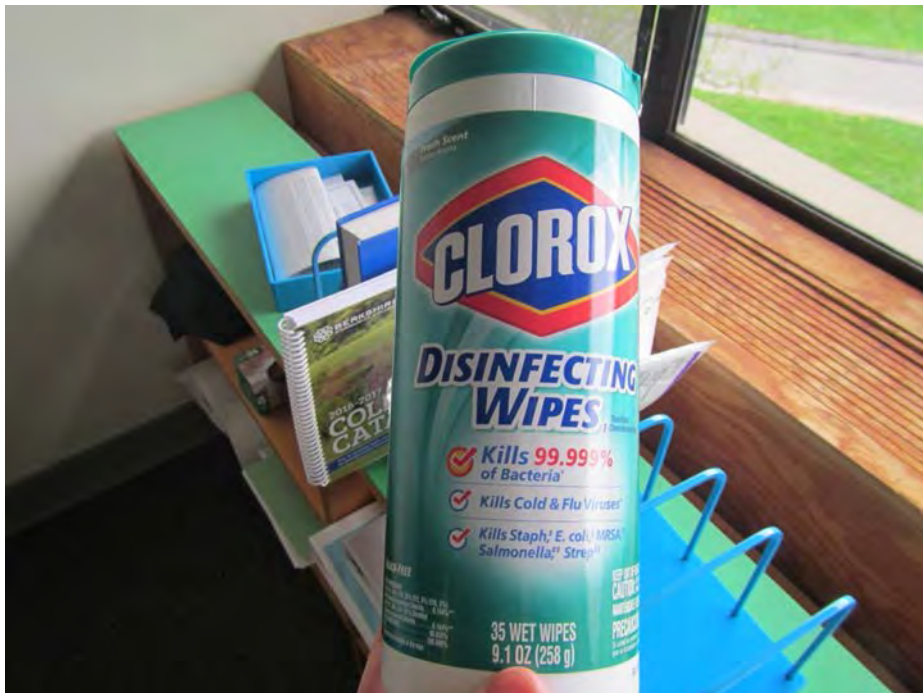
Picture 10

air deodorizers, and dry erase materials in use within the building (Pictures 10 and 11; Table 1). All of these products have the potential to be irritants to the eyes, nose, throat, and respiratory system of sensitive individuals. In particular, dry erase notebooks are used during exams in the Testing Room. Individuals with respiratory sensitivities (e.g., asthma) may experience increased symptoms if a large number of students are using the dry erase markers without adequate ventilation.

VOC-containing cleaning wipes

10. Reduce the use of or eliminate products containing VOC's in classrooms (harsh cleaners/wipes, hand sanitizers, etc.). Ensure adequate ventilation in the testing room during large exam groups which utilize dry erase notebooks.

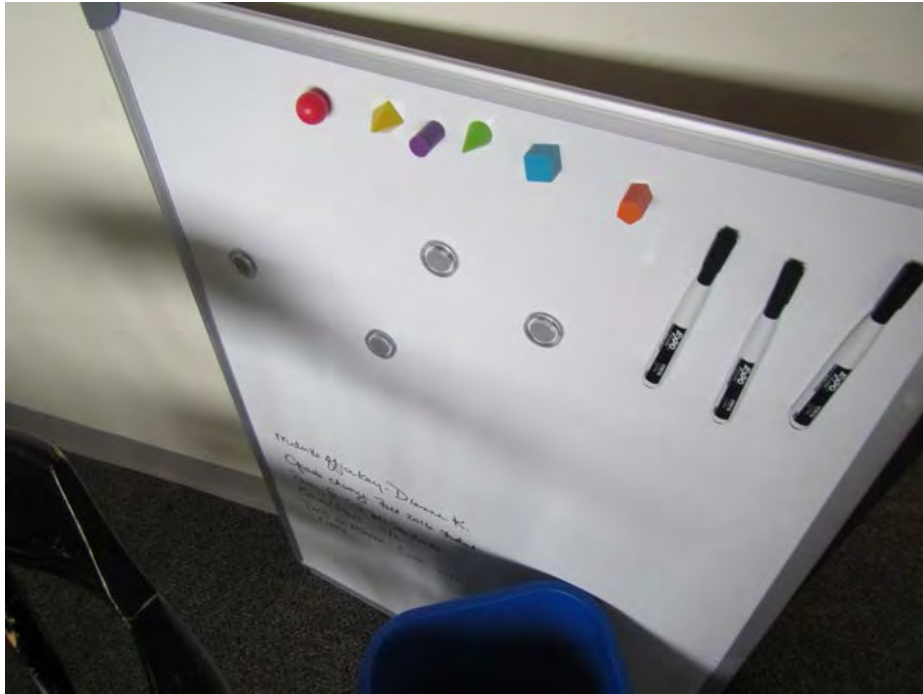
Picture 11

Dry erase materials

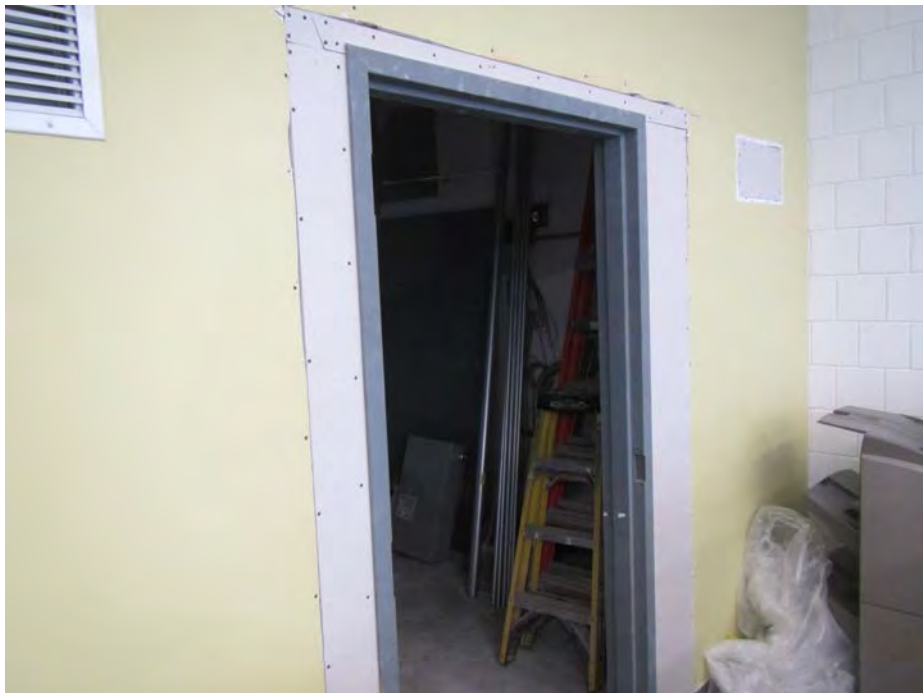
Picture 12

Renovations were being performed in/near the F202 Adjunct Faculty space to build an elevator machine room (Picture 12). Although slight paint odors were noted, no TVOCs were detected, nor were any TVOCs detected when multiple photocopies were made. Because F202 was equipped with mechanical ventilation it had adequate air exchange. The BEH/IAQ program guidance “Methods Used to Reduce/Prevent Exposure to Construction/Renovation Generated Pollutants in Occupied Buildings” is included as [Appendix A](#) for more information on performing these renovations in occupied buildings (MDPH, 2006). At the time of the visit, these guidelines appeared to be being followed.

Elevator machine room renovations near Adjunct Faculty space (F202)
