WATER DAMAGE INVESTIGATION

**Department of Children and Families
1 Washington Street
Mill River Place, Suite 21
Taunton, Massachusetts**

Prepared by:
Massachusetts Department of Public Health
Bureau of Environmental Health
Indoor Air Quality Program
March 2017

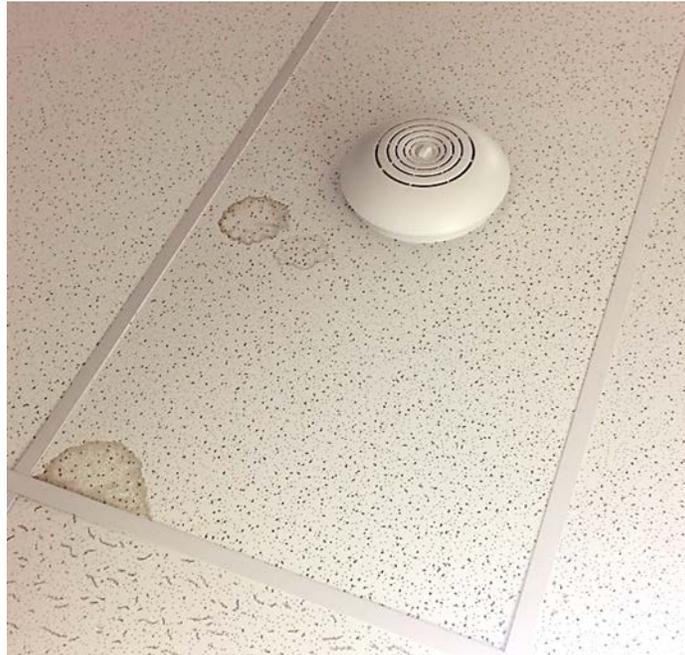
Picture 1

It was reported via EOHHS that DCF staff had concerns regarding possible mold growth/lingering water damage due to roof leaks that occurred during the last week of January 2017. Two areas experienced water-damaged ceiling tiles; the Investigations Unit and Ongoing Unit B. No other wet building materials were reported (e.g., carpet, walls). According to Area Director, Joseph Pacheco and Assistant Facility Manager, Jeanie Ydiarte, a roofing contractor was contacted the first week in February and the contractor examined the roof membrane and found and repaired several breaches (Appendix A). Water-damaged ceiling tiles were replaced, with the exception of one in Ongoing Unit B, which is difficult to change because it surrounds components of the fire suppression system (Picture 1).

Water-damaged ceiling tile surrounding fire equipment in Ongoing Unit B

1. When the opportunity exists (e.g., fire alarm testing), change water-damaged ceiling tile in Ongoing Unit B.
2. Continue to monitor for any additional leaks, if leaks reoccur contact building management for prompt remediation.

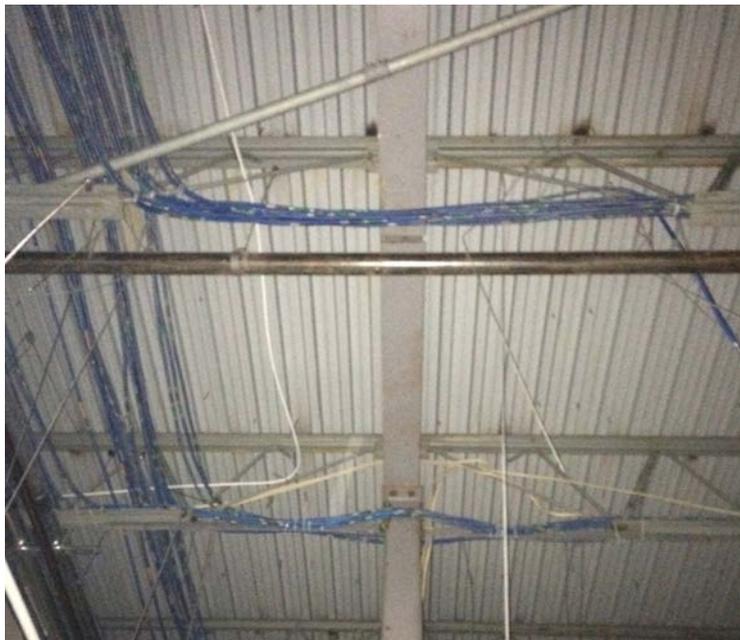
Picture 2

consists of metal and other non-porous building components (corrugated metal ceiling, iron pipes, metal supports, wiring etc.), which are not conducive to mold growth (Pictures 2 and 3). Finally, moisture testing of the stained tile in Ongoing Unit B was conducted and the tile was found to be dry at the time of assessment.

Metal building components above ceiling tile system

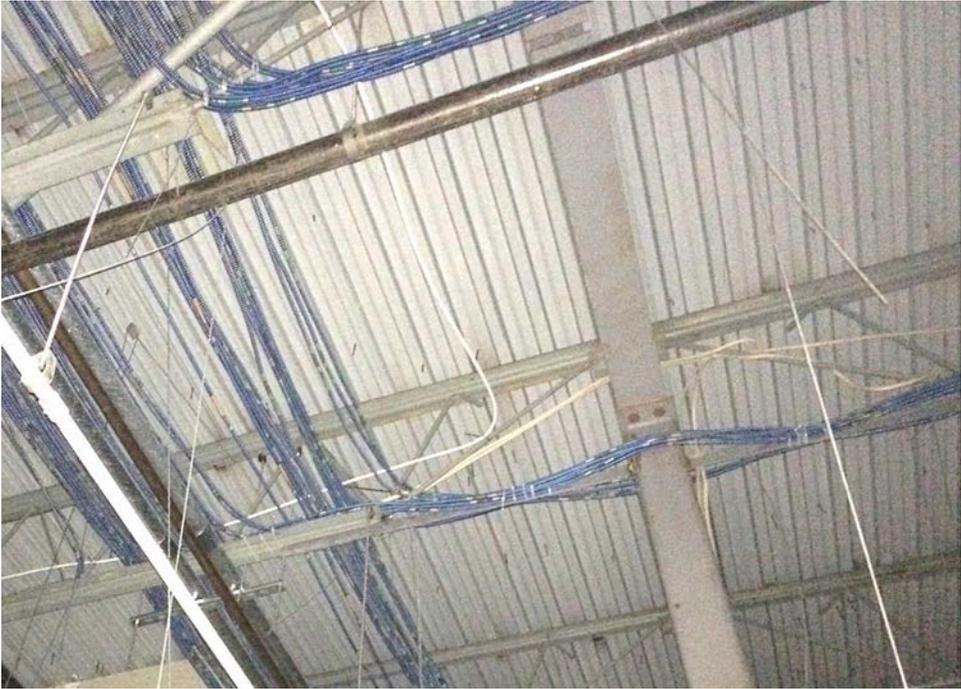
Picture 3

Metal building components above ceiling tile system

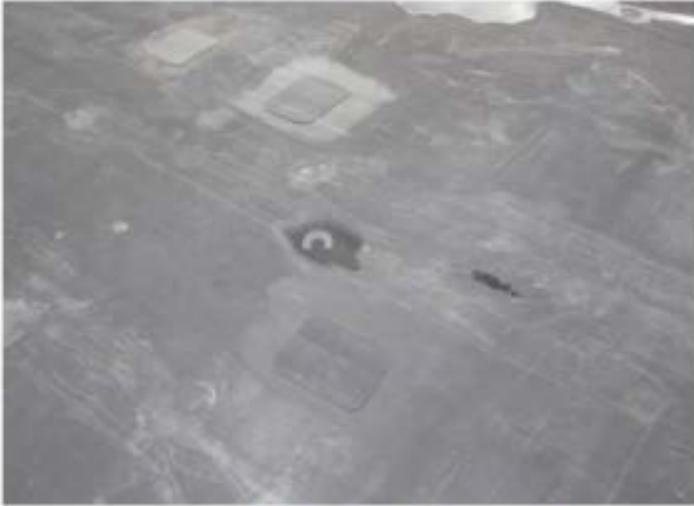
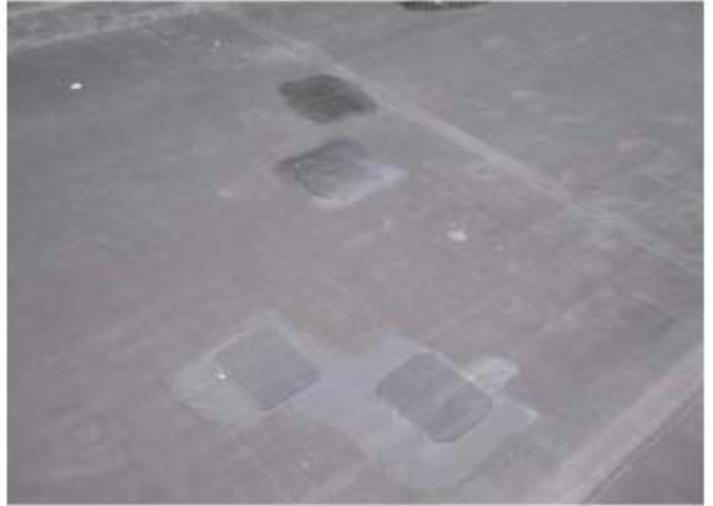
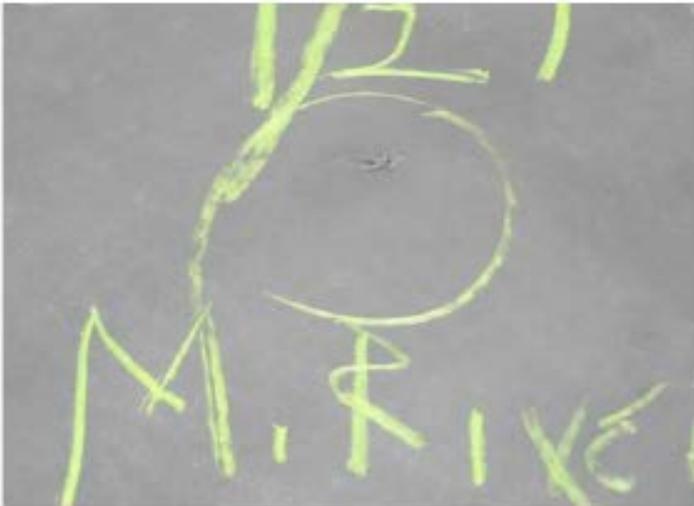
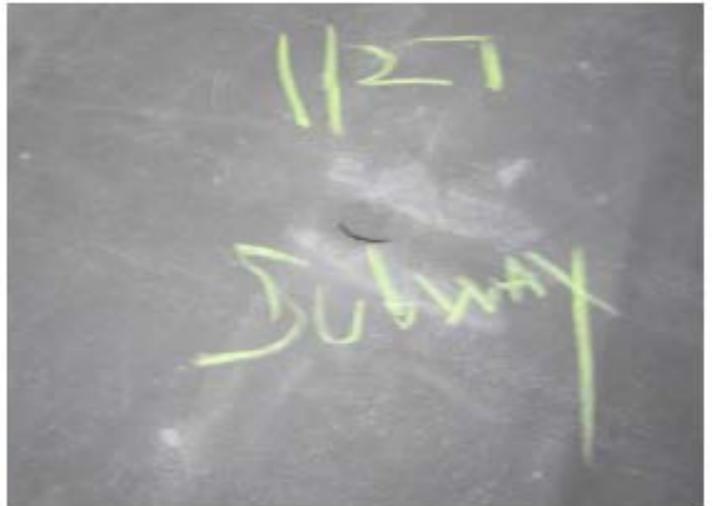
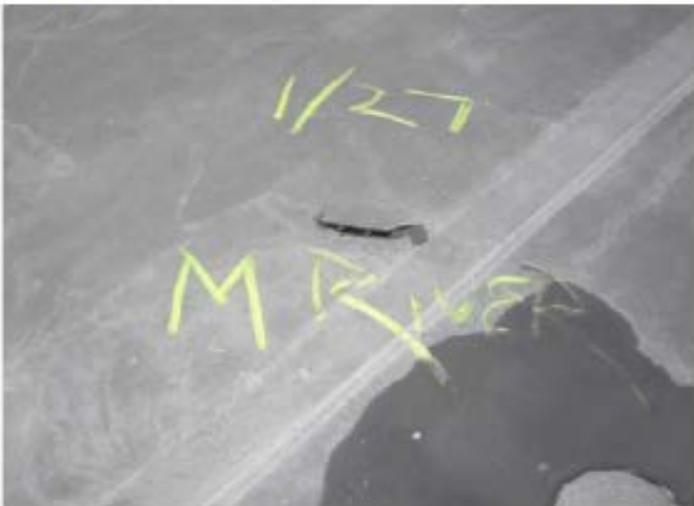
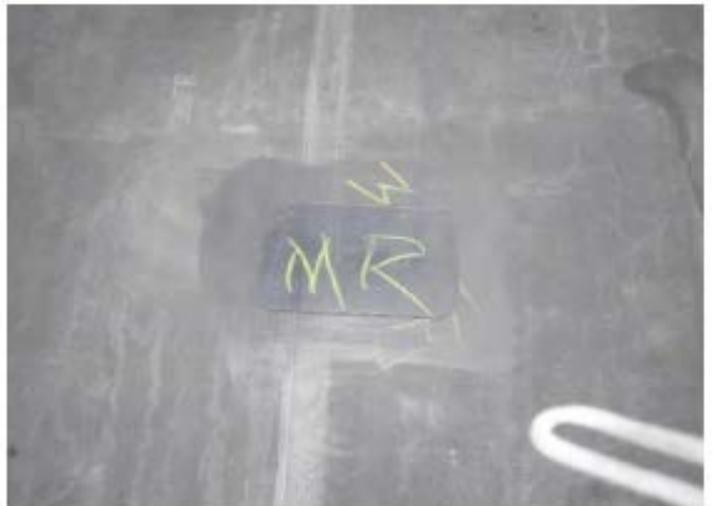
Multiple Leaks
Various Leaks DCF + Counsel
ing units, also Subway
Had leaks found by
DCF + Counseling - 3 Teams
made repairs on - (Tapes)
2- 3" tapes + 1- 1" tape
Subway found several slices
front & towards middle
of store, repairs were
4- 6"x6" cover strip + lap sealant
2- 6"x8" cover strip + lap sealant
