# **INDOOR AIR QUALITY ASSESSMENT**

**John William Decas Elementary School  
760 Main Street  
Wareham, Massachusetts**

Prepared by:  
Massachusetts Department of Public Health  
Bureau of Environmental Health  
Indoor Air Quality Program  
December 2016

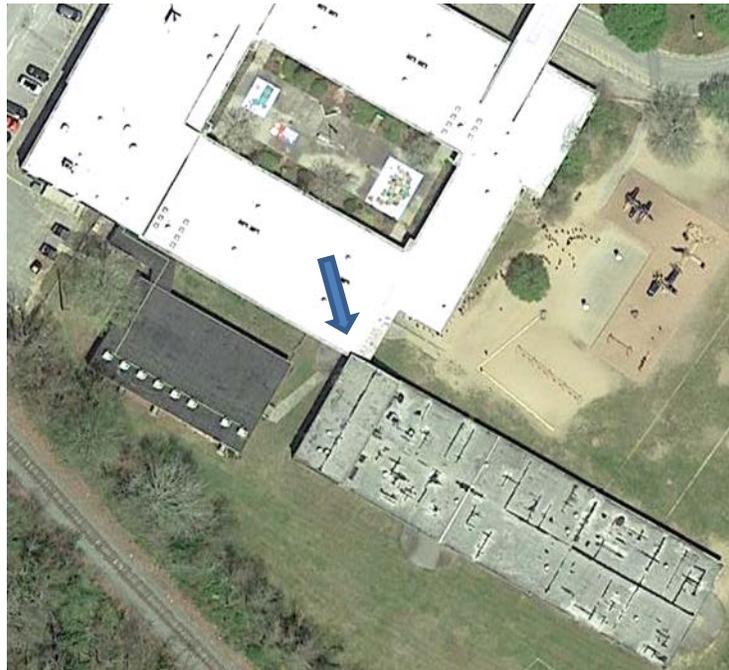
**Picture 1**

Due to the configuration of the 1974 wing to the remainder of the school (Picture 1), exposure should be minimal. More importantly, it is reported that occupants will be temporarily located to other areas of the school (i.e., gym, empty classrooms) during the roofing project, which will greatly reduce, if not eliminate potential exposure. The 1974 wing is connected to the main portion of the school via a corridor with double doors (Pictures 1 and 4), BEH/IAQ staff recommended that these doors be sealed with plastic polyurethane sheeting and duct tape (on *both* sides) to create a physical barrier between occupied areas and the construction zone.

**Aerial view of Decas Elementary School, 1974 wing (lower right), arrow indicates area of containment barrier separating occupied wing from construction zone**

1. Continue with plans to relocate occupants of the 1974 wing during the roof replacement project.

3. Install construction barriers of poly ethylene plastic and duct tape on double doors separating the 1974 wing and the main school building. Seal these barriers on the construction, as well as the occupied side to provide a dual barrier. Inspect daily to ensure tightness/integrity of barriers by monitoring for light penetration and drafts around seams.

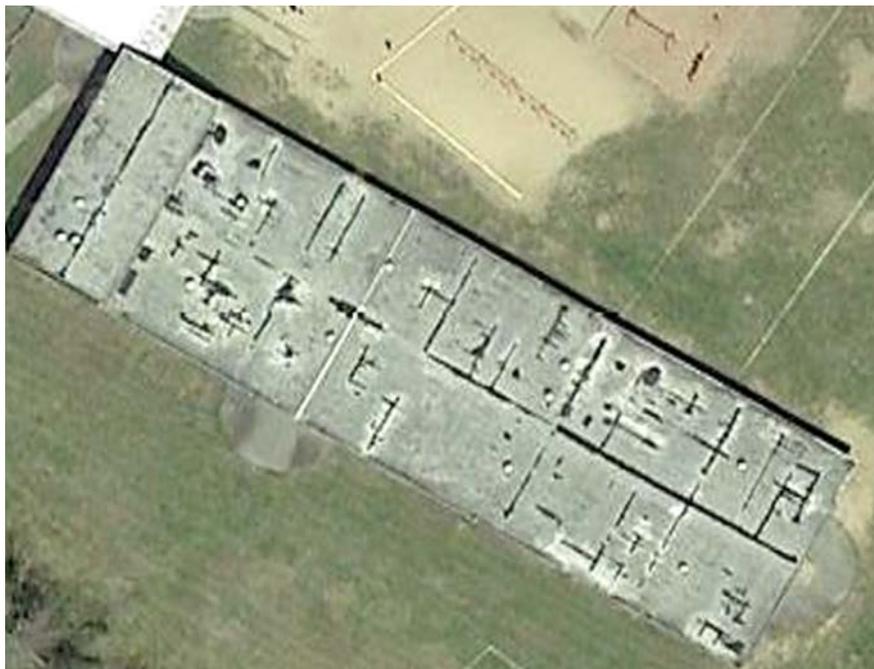
**Picture 2**

No significant renovations have reportedly been done to the school over the years. Currently, the school is involved with two capital improvement projects; boiler replacement and a new roof over the 1974 wing (Picture 1), which will include an asbestos removal project (ceiling tiles). Both projects are much needed, particularly the new roof project as indicated by the condition of the roof surface (Picture 2) and evidenced during the assessment by multiple buckets/containers used to catch leaks (Picture 3).

**Close-up of weathered roof surface 1974 wing**

As mentioned, the roof is being replaced due to chronic/excessive leakage. During the project it is recommended that any water-damaged porous building materials (e.g., insulation material) be replaced and any non-porous materials be cleaned with an appropriate antimicrobial.

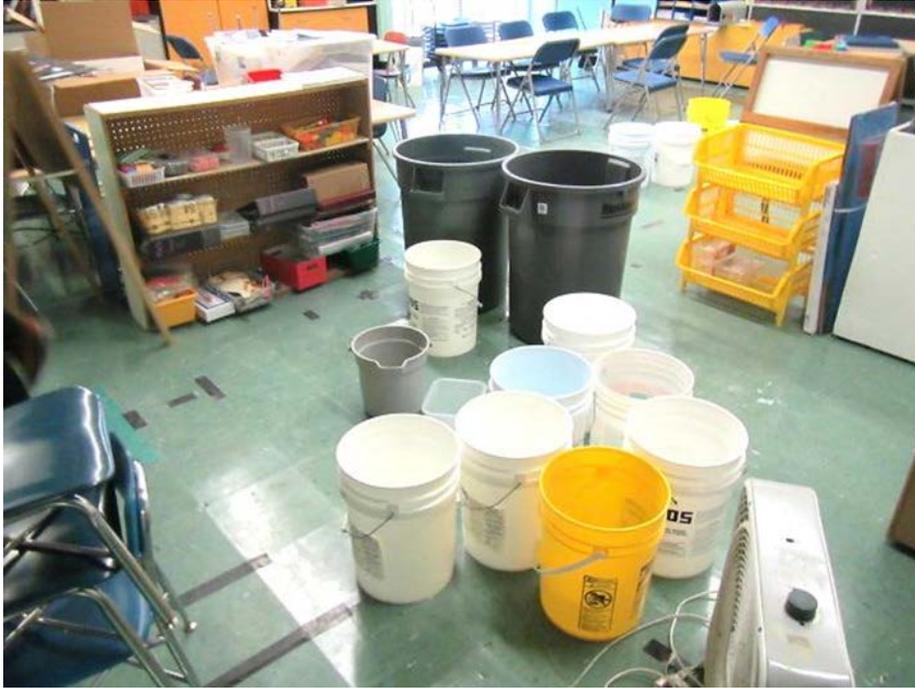
**Picture 3**

**Buckets/containers used to catch active leaks in 1974 wing**

9. During the project it is recommended that any water-damaged porous building materials (e.g., insulation material) be replaced and any non-porous materials be cleaned with an appropriate antimicrobial.

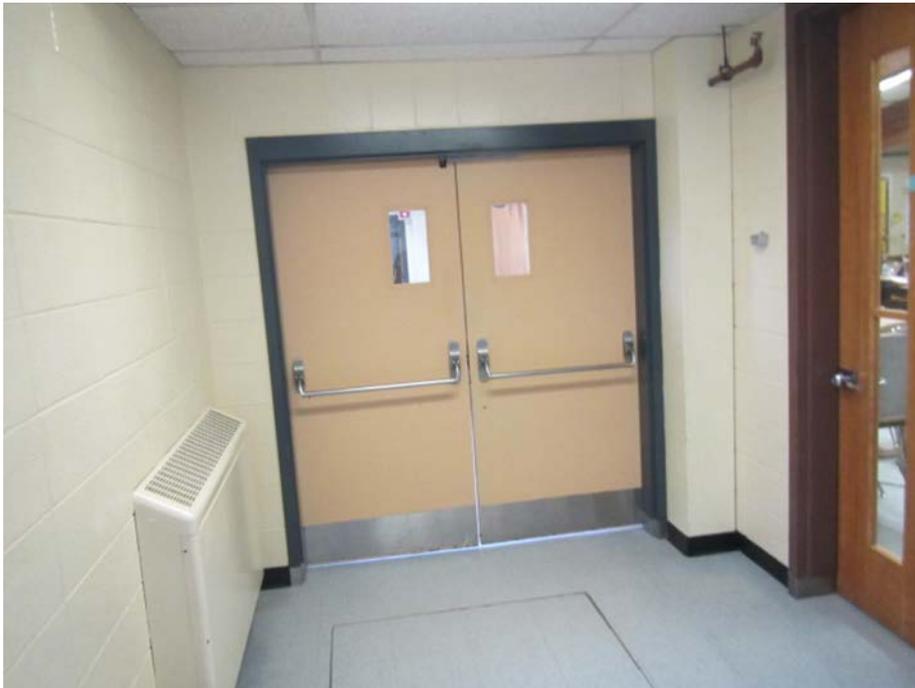
**Picture 4**

**Double doors to the 1974 wing**

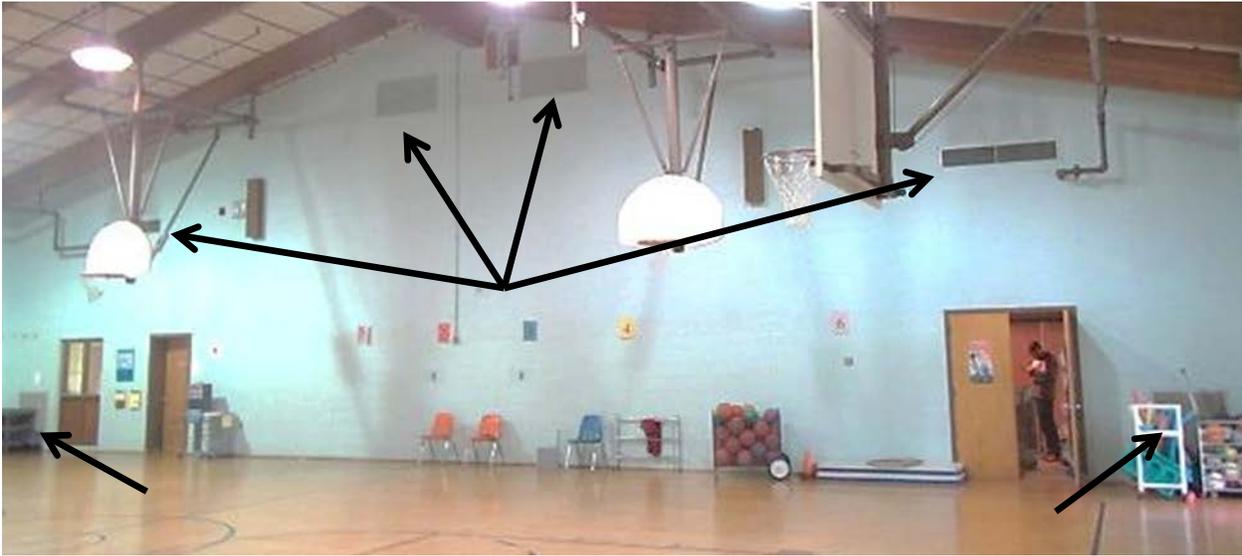
**Picture 5**

Mechanical ventilation for the gym is provided by air-handling units (AHUs) located behind the stage. Heated/supply air is provided by wall-mounted diffusers and drawn back to the units via return vents (Pictures 5 through 7). The AHUs were deactivated during the visit, however school maintenance personal were able to reactivate one of the units via a wall panel. Mechanical ventilation for the modular classroom wing is provided by rooftop AHUs (Picture 8). Air is distributed/returned via ceiling-mounted vents. The BEH recommends that AHUs are operating in the fan “on” mode to provide continuous circulation/filtration during occupied hours.

**Supply (top) and return (bottom) vents for gymnasium (arrows)**

4. Operate supply and exhaust ventilation *continuously* in all occupied areas during school hours. Ensure that all mechanical ventilation units are in proper working order (i.e., gym, classrooms); make repairs as necessary.

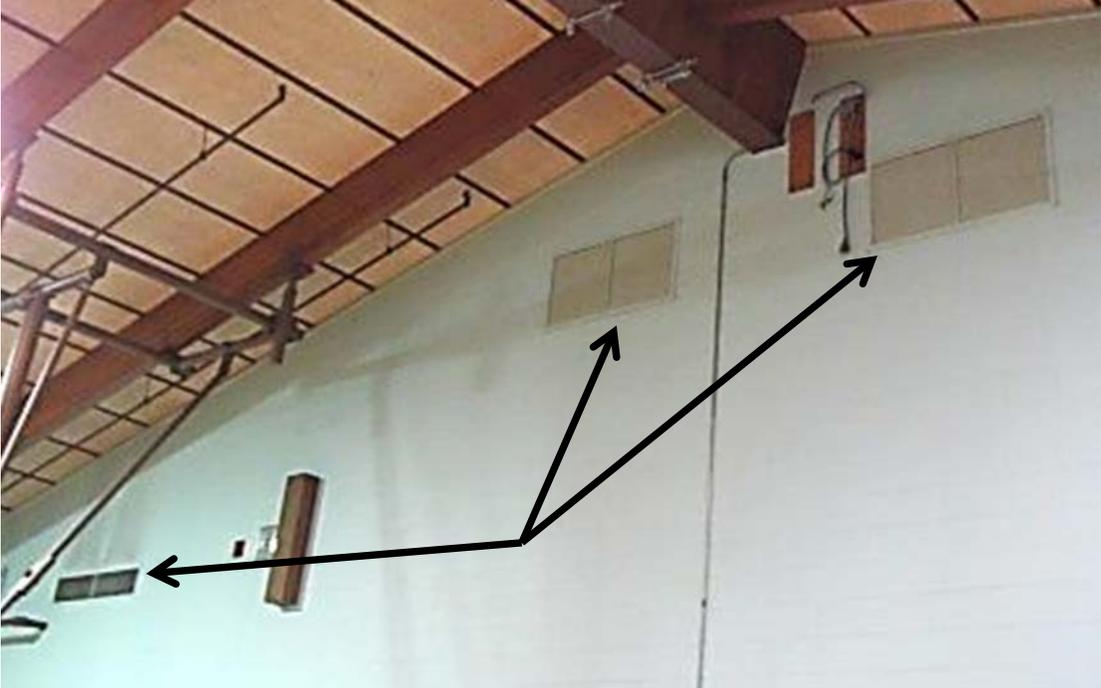
**Picture 6**

**Supply vents (arrows) for gymnasium (3 of 4)**

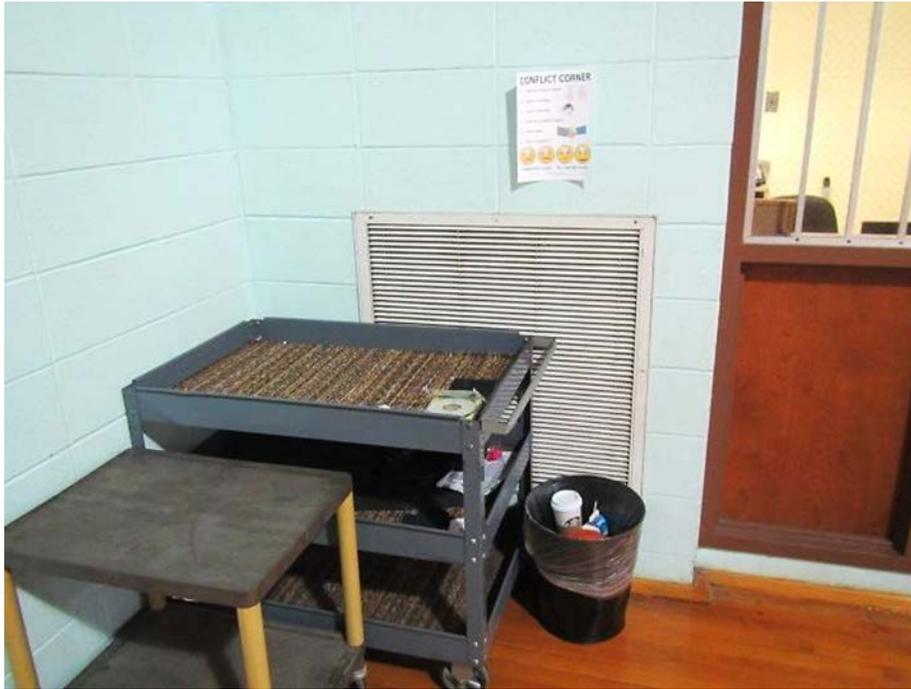
**Picture 7**

**Return/exhaust vent for gymnasium**

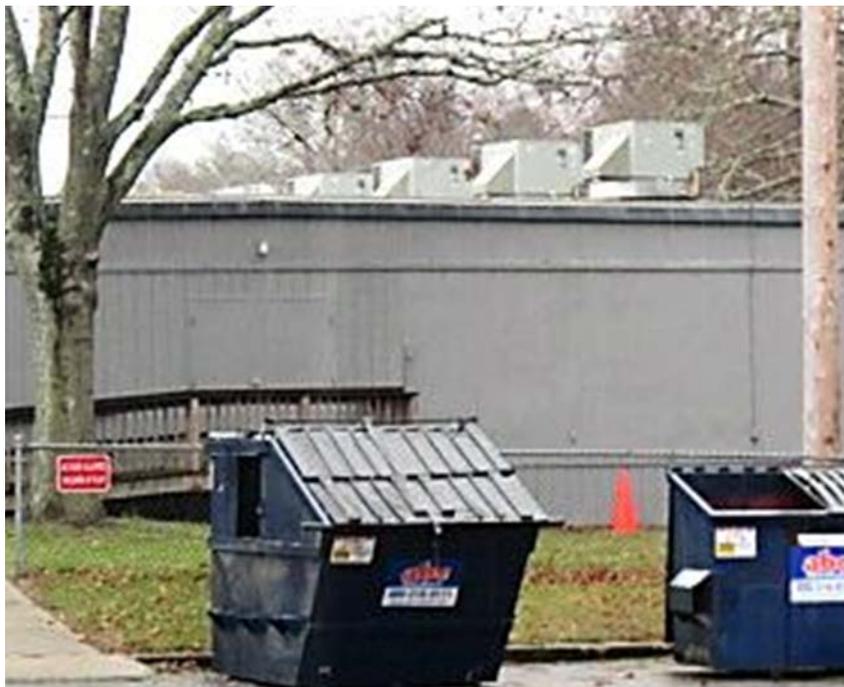
**Picture 8**

**Rooftop air handling units for the modular classroom wing**
