INDOOR AIR QUALITY ASSESSMENT

**Wilbraham Public Library
25 Crane Park Drive
Wilbraham, Massachusetts**

Prepared by:
Massachusetts Department of Public Health
Bureau of Environmental Health
Indoor Air Quality Program
February 2017

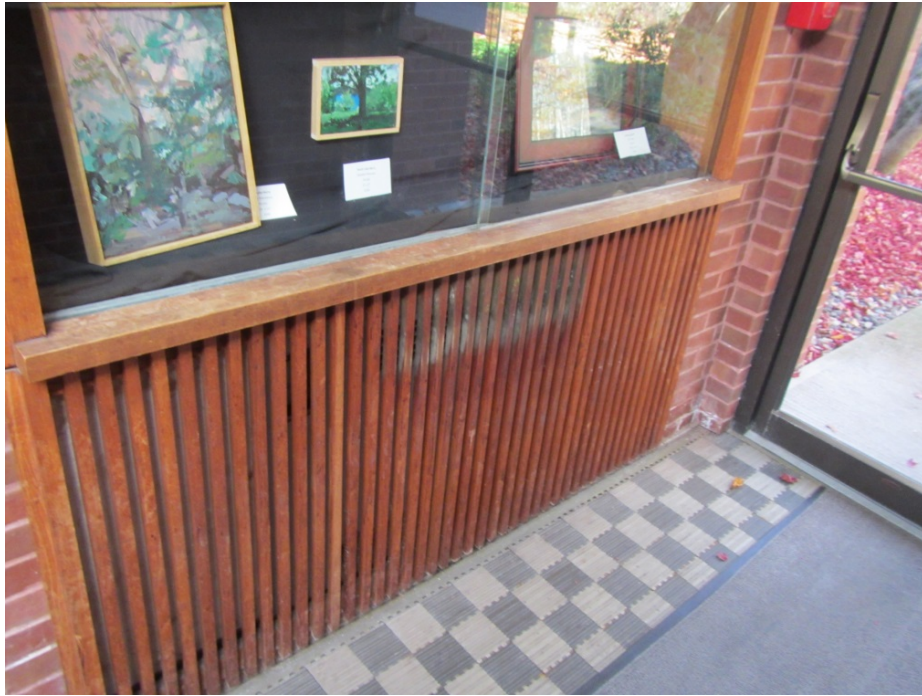
Picture 1

A musty odor was detected in the foyer which was traced to the two FCUs located there. Each FCU is installed behind a decorative wooden cover. The wooden covers had extensive mold growth/staining corresponding to the flow of air from the units (Picture 1). It is likely the wood covering was repeatedly moistened by condensation that resulted from the entrainment of hot, humid air during summer months. The excess humidity may originate from outside through the exterior doors and an open chimney flue in the meeting room, and/or may result from restroom-related moisture due to the inactive exhaust fans. The condition of these covers suggested that the mold growth has been ongoing for several years.

Mold-colonized wood on FCU cover in foyer

1. Remove mold-colonized wood from foyer FCUs.

5. Close the fireplace flue. If not intended for use, seal the flue on both ends to prevent cold air and rainwater from entering the chimney.
6. Due to the age and condition of the units, consideration should be given to replacing the FCUs in the foyer.

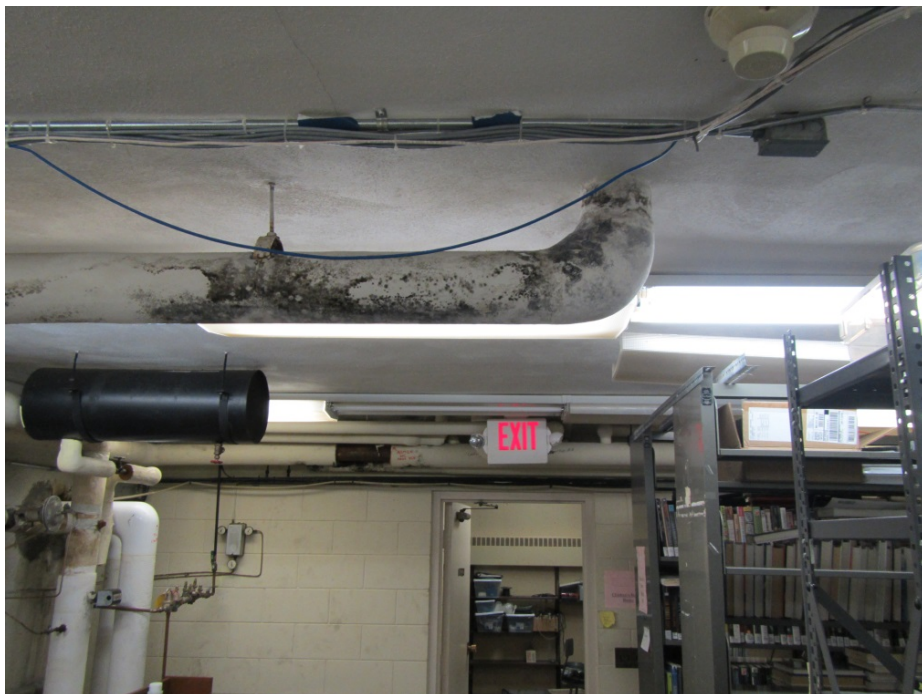
Picture 2

Mold colonization was also found on pipe insulation in the basement (Picture 2). This very likely occurred because the insulation was insufficient for the temperature of the water from the chiller, leading to condensation on the insulation surface, which then can chronically moisten the pipe wrapping and result in mold growth. In addition, once wet, the ability of insulation to prevent temperature transfer becomes reduced which may accelerate condensation. Mold-colonized materials should be removed and a sufficiently-insulating material used to replace it. A possible source of moisture in the basement is an open conduit located in the basement wall (Picture 3). All open pipes found in buildings should be rendered airtight to prevent odors and water vapor movement from outdoors to the indoor environment.

Mold-colonized pipe insulation in basement area

2. Remove water-damaged insulation from pipes in basement area and replace with insulation having a sufficient R Value to prevent condensation when operating in chilling mode.

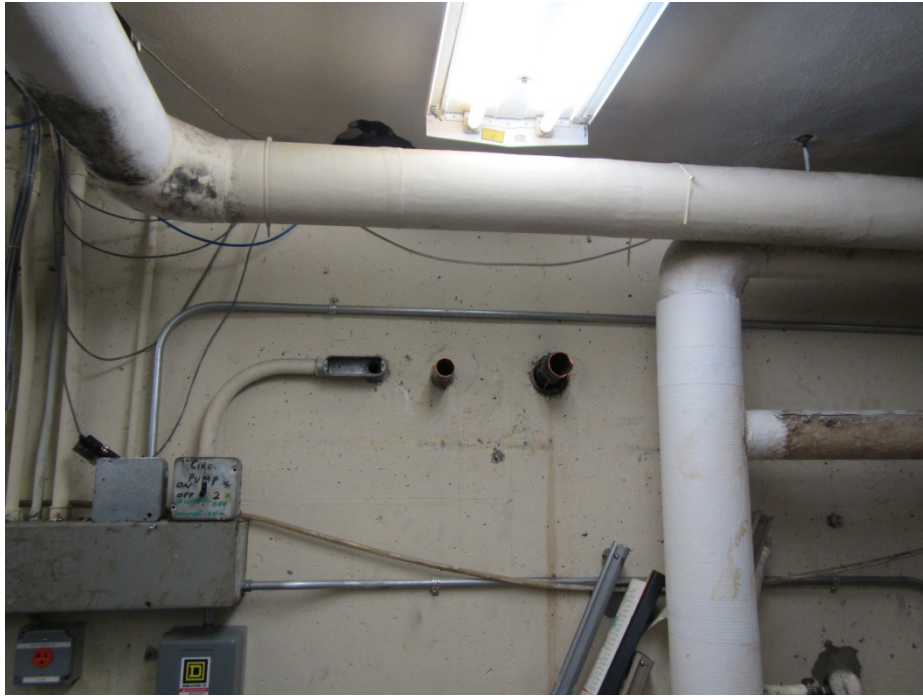
Picture 3

Open abandoned pipe/conduit in the basement area

3. Seal ends of all abandoned pipes and conduit in the basement area.
4. Repair the exhaust vents for the restrooms in the foyer and ensure they operate when the building is occupied.
