MA FACE

Occupational Fatality Report

Electrician Electrocuted while Troubleshooting Envelope Manufacturing Machine - Massachusetts

Release Date: October 30, 2013
Investigation: # 12-MA-007-01

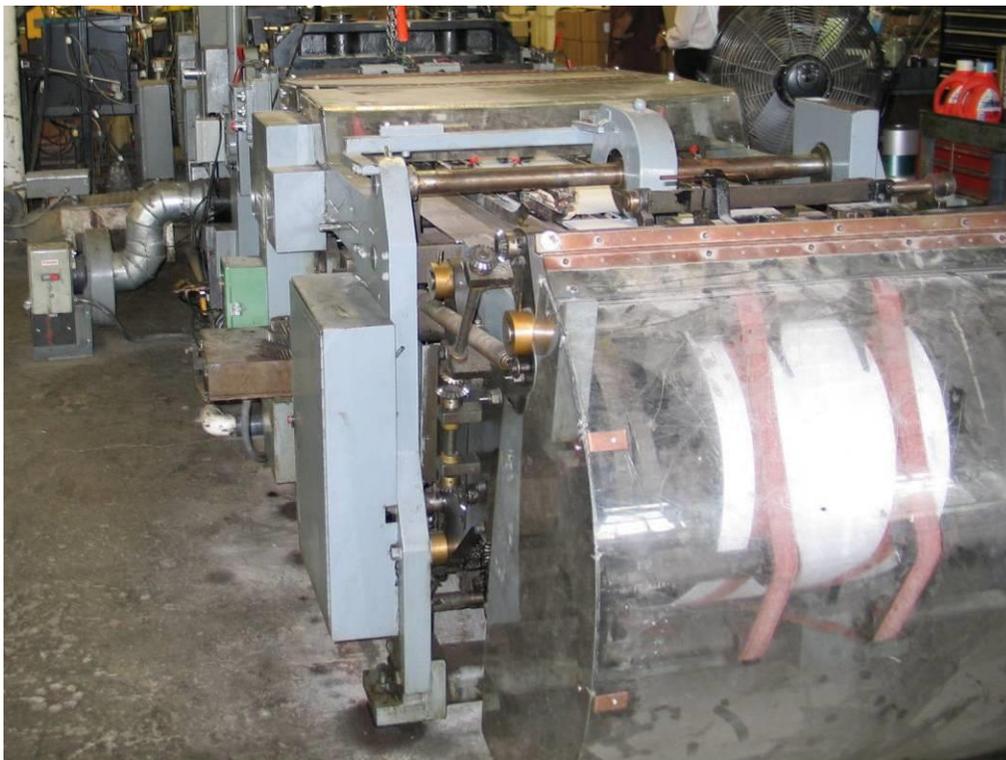
**Figure 1 – Medium open-end envelope machine
View from the front end**

The machine involved in the incident was a medium open-end envelope machine (Figure 1) that the company had owned for about 14 years. It was estimated that the machine was manufactured over 30 years ago and perhaps as early as the 1960's. The machine was configured to punch and install an address window on pre-sized sheets of paper, fold and glue the envelope into shape, and put on a strip of self-sealing glue with removable strip to seal the envelope.

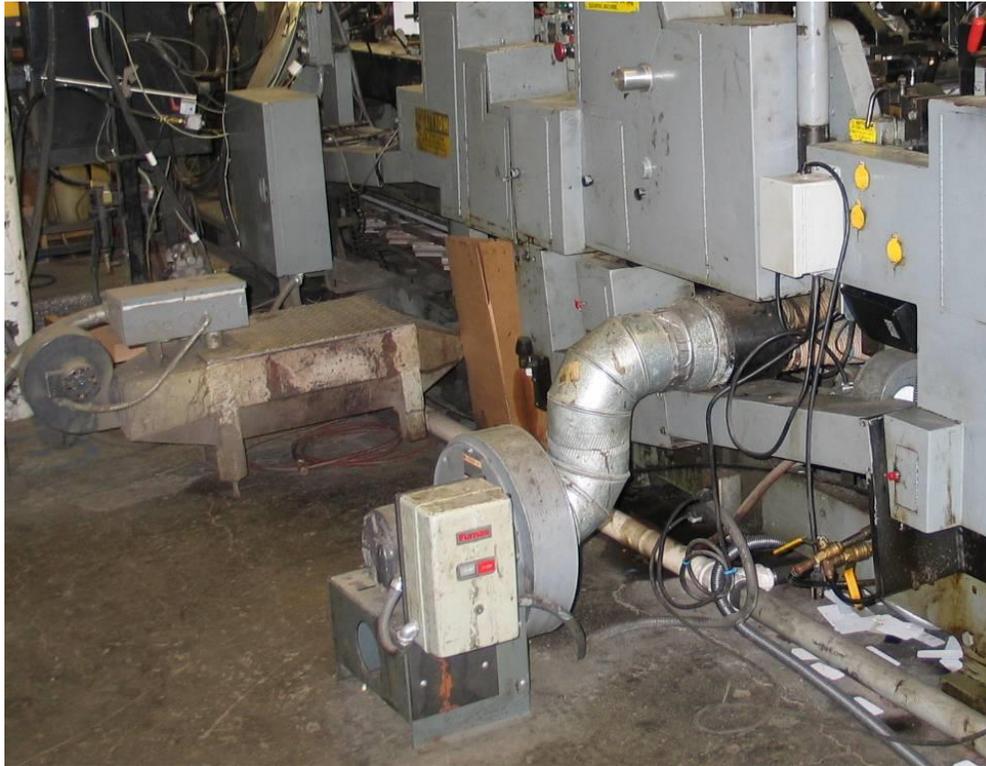
Figure 2 – Envelope machine's blower motor

The machine was equipped with a blower motor (Figure 2) that provided air flow to different sections of the machine through a series of hoses. The main function of the blower was to create negative air pressure on the underside of the transfer belts to keep the paper flat and in position as it passed from one process to the next. The blower motor was powered by 480 volts through a three-phase format, (three powered lines and a neutral line), which ran through conduit and a number of junction boxes from the main fuse panel (see Figure 3).

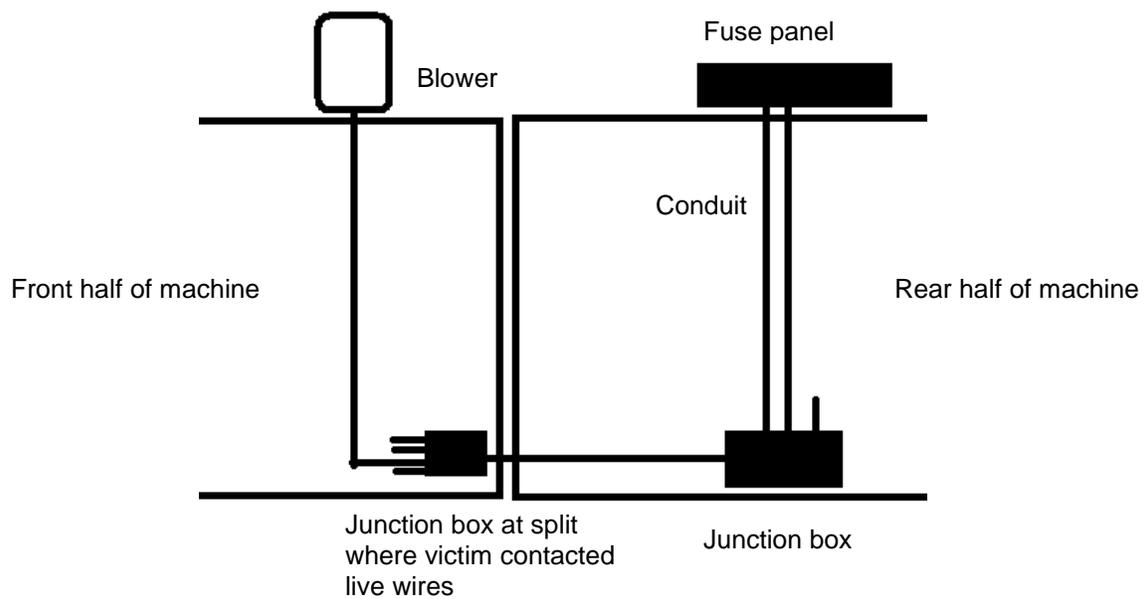
Figure 3 – Envelope machine's blower motor power supply
Approximate pathway of conduit, drawing shows view from above

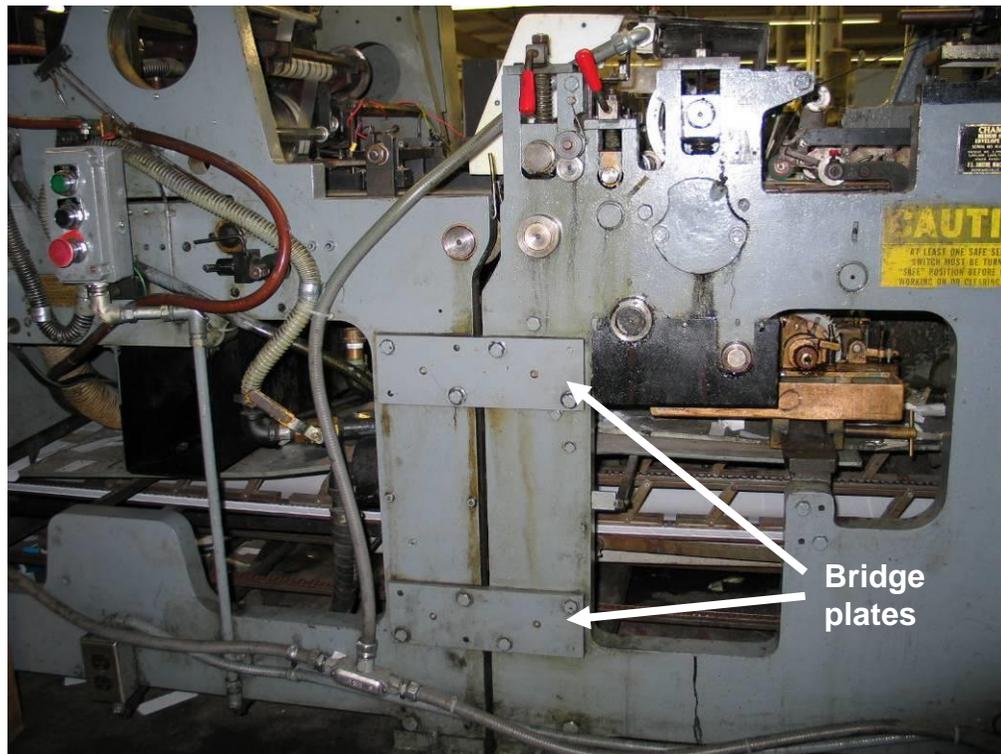
The medium open-end envelope machine involved in the incident was one of the machines that had been split into two pieces for the move. Splitting this particular machine required removing plates which bridged the machine frame at approximately the mid point of the length of the machine, and disconnecting all wiring/conduit and other components which crossed this mid point (Figure 4). The machine had been moved, reassembled, and had been tested and running the evening prior to the incident.

Figure 4 – Bridge plates at envelope machine split point

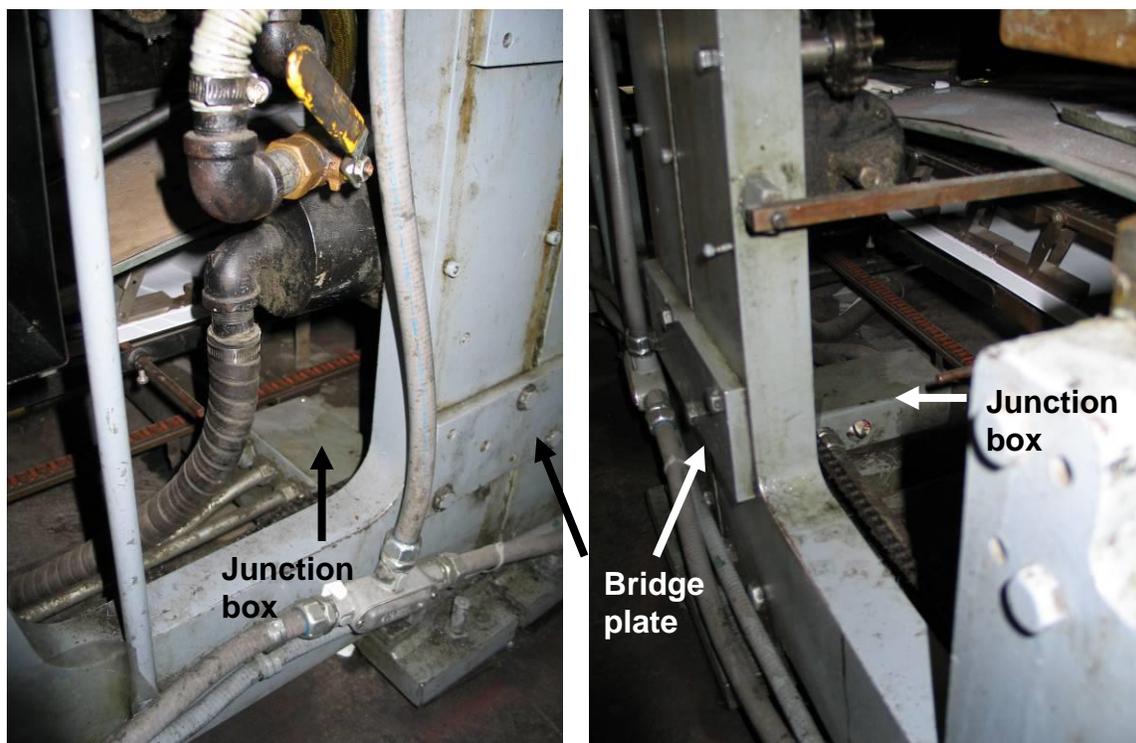
At the time of the incident, the victim was accessing a junction box located near the break in the machine at the floor level (Figure 5). It was unclear if the victim was voltage testing to ensure that the junction box was de-energized or if he was continuing to troubleshoot. It was while he was accessing this junction box that he came in contact with an energized component and was electrocuted. It is suspected the current traveled from one hand, through his torso, and out his other hand or perhaps another part of his body touching the machine. The machine operator noticed the victim looked like he

The envelope machine involved in this incident was at least 30 years old, but this incident can still serve as an example for incorporating PtD. In this case, the junction box being accessed by the victim was both physically and visually inaccessible (Figure 5). The PtD process could have resulted in the junction box being placed in a location that was more accessible, which might have prevented this incident.

**Figure 5 – Envelope machine's junction box where worker contacted live wire
View from left and right of bridge plate**

Recommendation #5: Machine manufacturers should implement the concept of Prevention through Design (PtD) to ensure the safety and health of machine users, including machine operators and maintenance workers.
