# **INDOOR AIR QUALITY ASSESSMENT**

**State Transportation Building  
Suites 4470 and 5510  
10 Park Plaza  
Boston, MA**

Prepared by:  
Massachusetts Department of Public Health  
Bureau of Environmental Health  
Indoor Air Quality Program  
October 2018

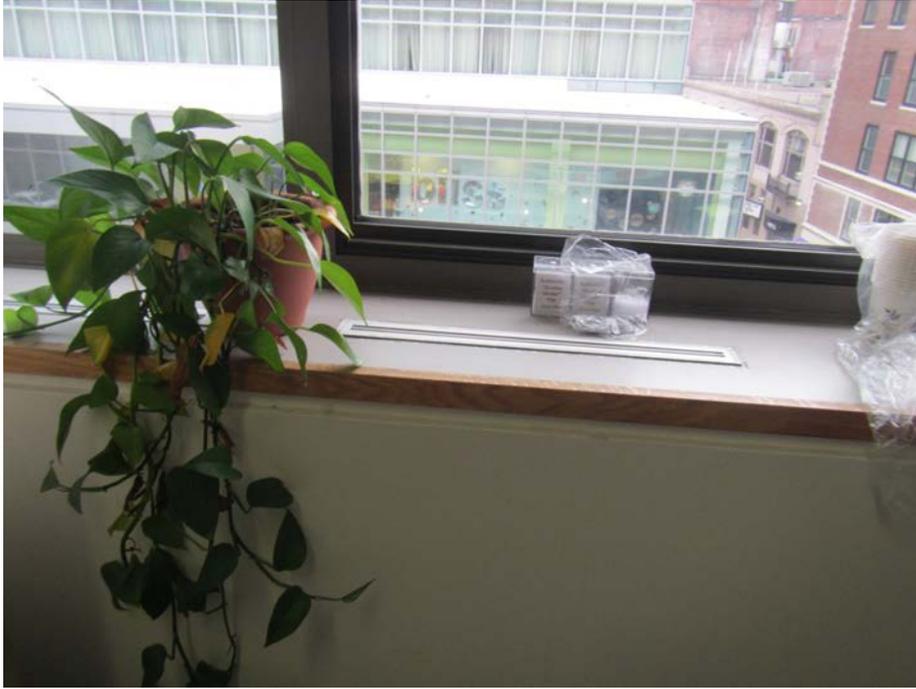
**Picture 1**

Fresh air is supplied by vents located in the ceiling and from units near windows (Picture 1). Return air is drawn through vents around light fixtures using ducted returns (Picture 2). It is also possible that fresh air is supplied around some lights as well. In some areas, items were on the vent cabinets, including plants (Pictures 1 and 3). This can block the supply of fresh air as well as aerosolize odors and particulates such as dust, mold spores, and pollen. Vents should be kept clear of items.

**Air vent unit near window, note plants and other items on top**

3. Regularly clean supply and return vents and vent cabinets on a regular basis.
4. Remove items from the top and front of vent cabinets to allow for air flow.

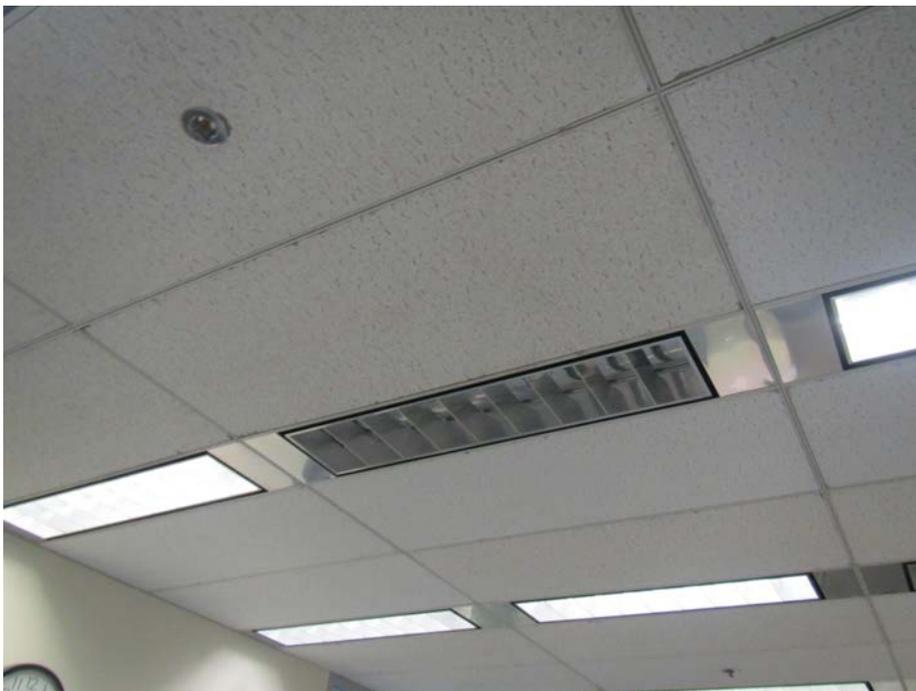
**Picture 2**

**Return vent around light**

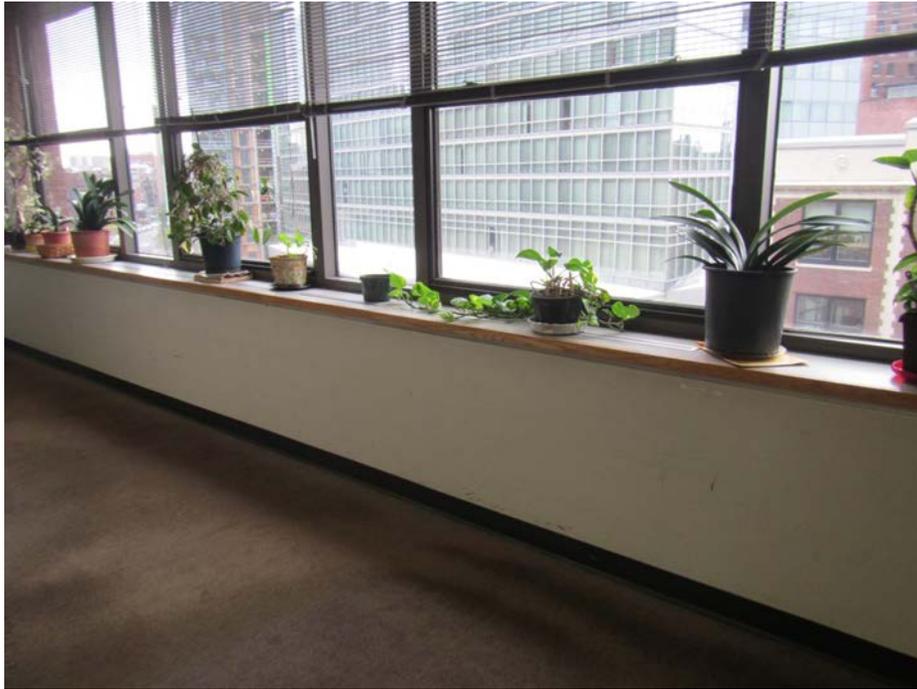
**Picture 3**

As shown in Pictures 1 and 3, plants were noted in many areas, particularly in suite 5510 (Table 1). Some were in poor condition or on porous materials. Plants/flowers can be a source of pollen and mold, which can be respiratory irritants to some individuals. Plants should be properly maintained and equipped with drip pans and should be located away from airflow to prevent the aerosolization of dirt, pollen, and mold.

**Plants on vents next to window**

5. Replace water-damaged ceiling tiles. Repair any source of leaks as they are discovered.
6. Keep plants and flowers in good condition, avoid overwatering, and remove from the airstream of heating and ventilation equipment.

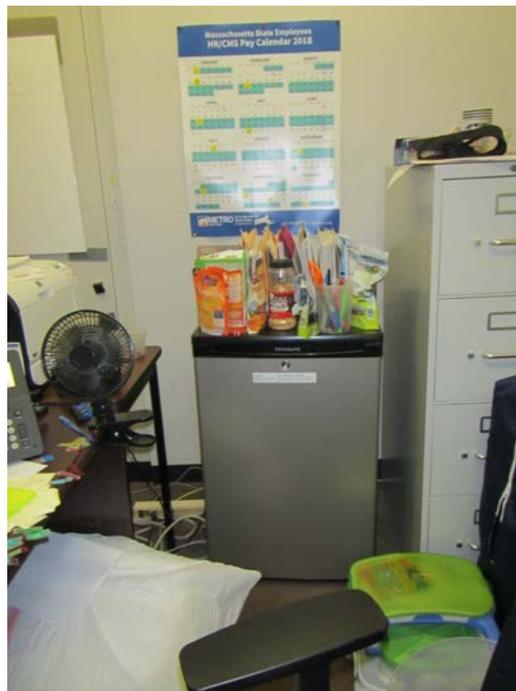
**Picture 4**

Refrigerators and water dispensers were located on carpet (Picture 4). Refrigerators and water dispensing equipment should be located in a non-carpeted area or on a waterproof mat to prevent damage to carpet and subsequent odors.

**Refrigerator in carpeted area, also note food, personal fan and other items**

7. Consider the use of waterproof mats underneath refrigerators and water dispensers to protect carpet from leaks and spills.
8. For buildings in New England, periods of low relative humidity during the winter are often unavoidable. Therefore, scrupulous cleaning practices should be adopted to minimize common indoor air contaminants whose irritant effects can be enhanced when the relative humidity is low. To control for dusts, a high efficiency particulate arrestance (HEPA) filter equipped vacuum cleaner in conjunction with wet wiping of all surfaces is recommended. Avoid the use of feather dusters. Drinking water during the day can help ease some symptoms associated with a dry environment (throat and sinus irritations).

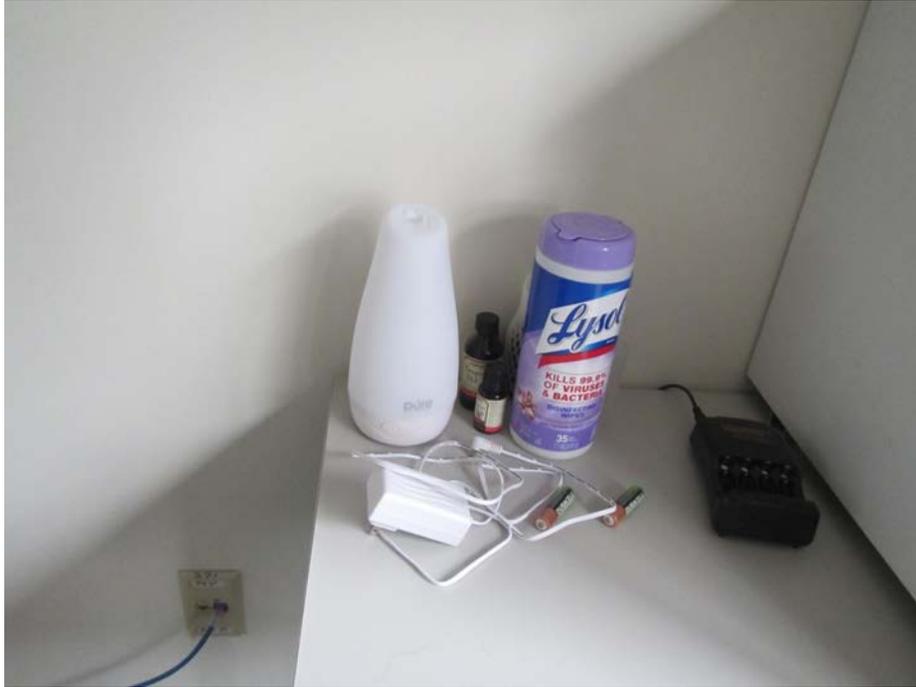
**Picture 5**

Exposure to low levels of total volatile organic compounds (TVOCs) may produce eye, nose, throat, and/or respiratory irritation in some sensitive individuals. BEH/IAQ staff examined spaces for products containing VOCs. BEH/IAQ staff noted air fresheners, hand sanitizers, cleaning products, dry erase materials and a scent diffuser in the office space (Picture 5; Table 1). All of these products have the potential to be irritants to the eyes, nose, throat, and respiratory system of sensitive individuals.

**Cleaning wipes and scented oil diffuser**

9. Reduce the use of cleaning products, sanitizers, and other items that contain VOCs.
10. Keep food preparation equipment clean and clean out the refrigerators, including the gaskets, regularly.

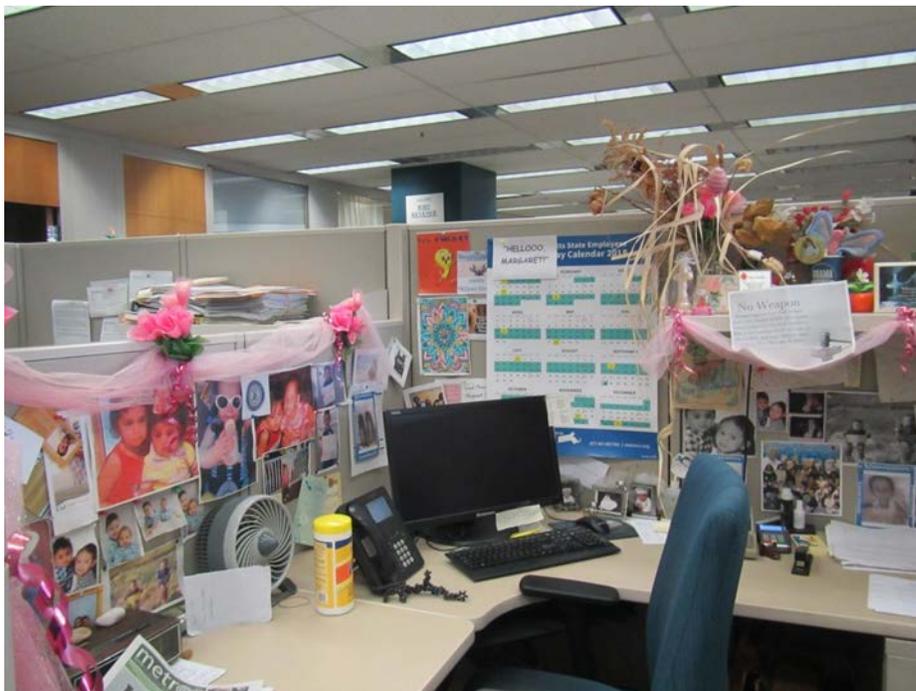
**Picture 6**

Items were observed on flat surfaces, such as windowsills, tabletops, counters, bookcases, and desks (Pictures 4 and 6). Items, including boxes, were also stored on the floor (Picture 7). Items stored in offices provide a source for dusts to accumulate. These items also make it difficult for custodial staff to clean. Items should be relocated and/or be cleaned periodically to avoid excessive dust build up.

**Decorative items in a cubicle**

11. Reduce the amount of items stored on flat surfaces to allow regular cleaning.
12. Clean supply vents, personal fans and other equipment to prevent aerosolizing dust.

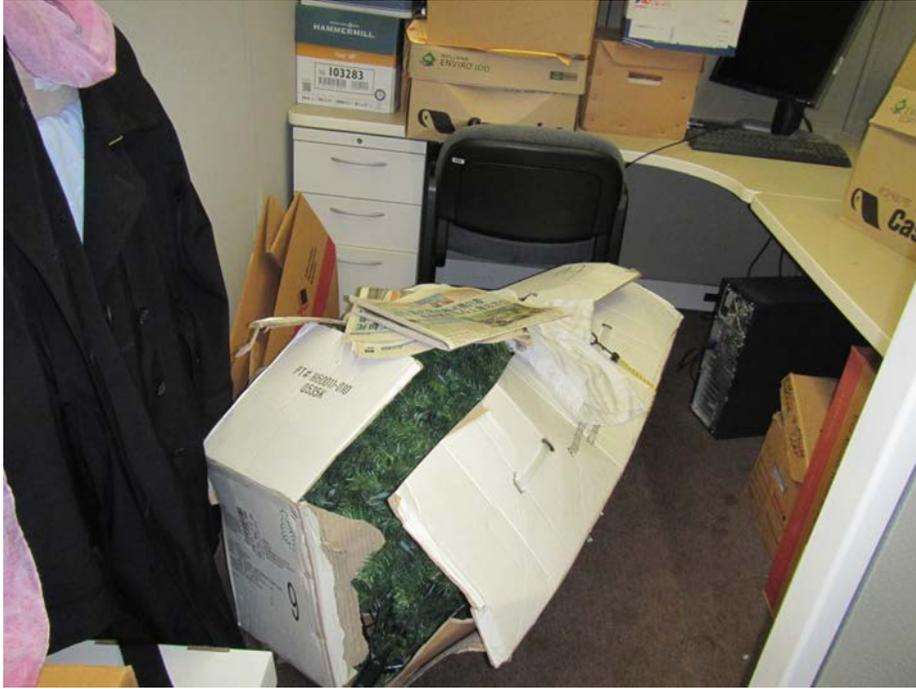
**Picture 7**

**Stored items on the floor**

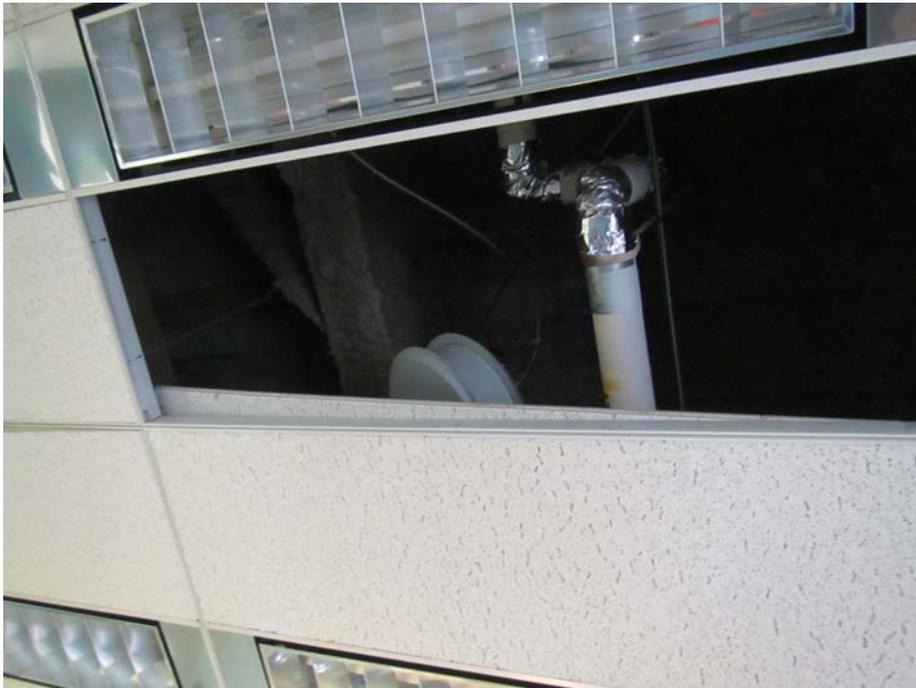
**Picture 8**

In a few areas, ceiling tiles were missing (Picture 8) or ajar/damaged (Table 1), which can allow dust and debris from above the ceiling tiles into occupied spaces. Ceiling tiles should be flush in the ceiling tile grid.

**Missing/displaced ceiling tile**

13. Ensure all ceiling tiles are in place in the ceiling tile grid.
14. Clean carpeting in accordance with IICRC recommendations (IICRC, 2012). Consider the use of plastic chair mats under desks to protect carpeting.

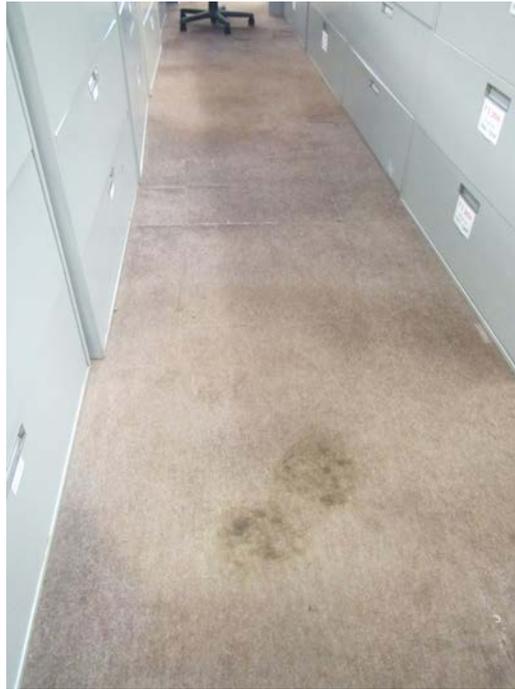
**Picture 9**

The offices were mostly carpeted. The carpeting in suite 5510 is reportedly original to the building and thus over 30 years old. This carpeting appeared worn, stained and in some places torn (Pictures 9 and 10; Table 1). Some carpeting in suite 4470 is also old and worn. The usable life of carpeting is approximately 10-11 years (IICRC, 2002). Carpeting of this age and condition cannot be adequately cleaned and may become a source of particulates and odors. Replacement of old carpeting should be considered. Carpets should be cleaned annually (or semi-annually in soiled/high traffic areas) in accordance with Institute of Inspection, Cleaning and Restoration Certification (IICRC) recommendations, (IICRC, 2012).

**Stained, worn carpeting in suite 5510**

15. Consider a plan to replace worn out carpeting in the building. When carpeting is replaced, carpet squares should be used to allow for easier replacement of small sections if they get damaged.
16. Refer to resource manual and other related IAQ documents located on the MDPH's website for further building-wide evaluations and advice on maintaining public buildings. These documents are available at: <http://mass.gov/dph/iaq>.

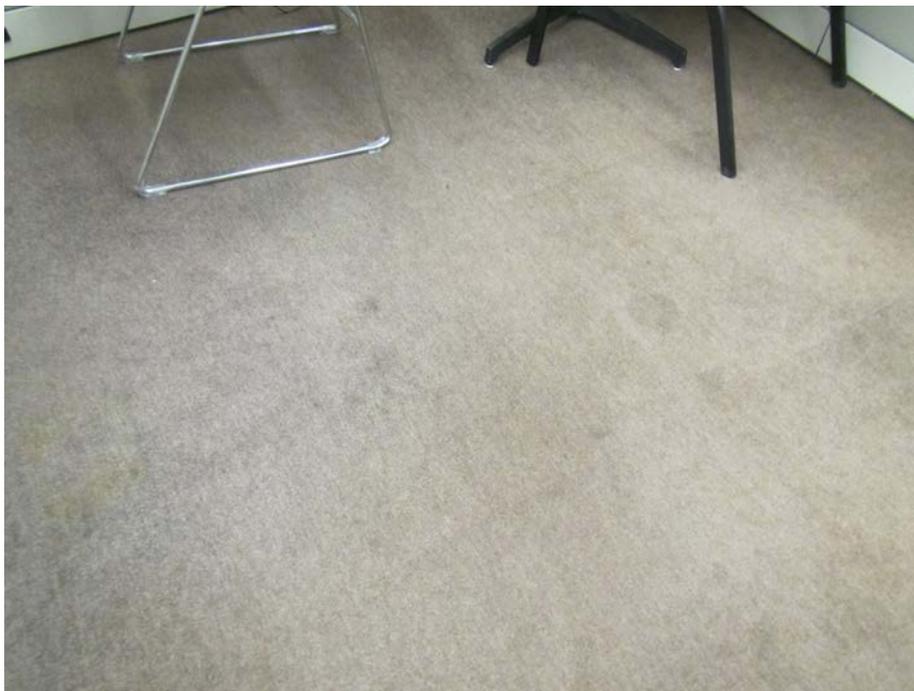
**Picture 10**

**Worn, stained carpeting in suite 5510**
