# **WATER DAMAGE/MOLD INVESTIGATION**

**MassHealth Enrollment Center  
88 Industry Avenue  
Springfield, Massachusetts**

Prepared by:  
Massachusetts Department of Public Health  
Bureau of Environmental Health  
Indoor Air Quality Program  
November 2018

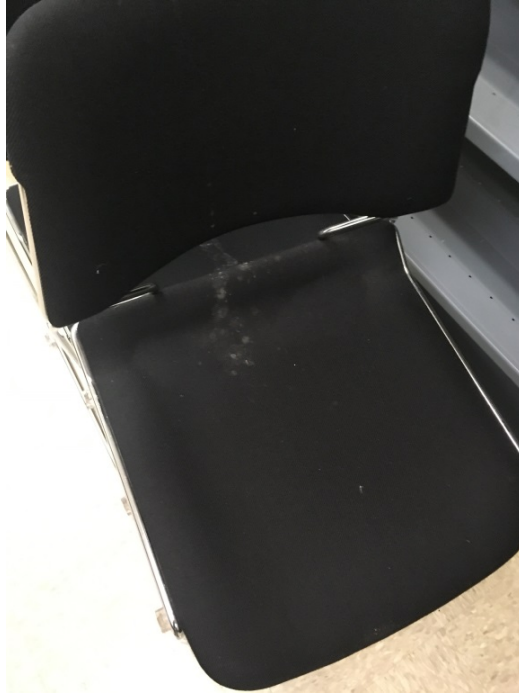
**Picture 1**

IAQ staff examined the conference room and carpeting throughout the office space. Of note were conference room chairs that appeared mold-colonized (Picture 1). Wall-to-wall carpeting in a number of locations were found rippled (Picture 2), which indicated water exposure. IAQ staff used a moisture meter (Picture 3) to check whether carpeting had dried after the HVAC system breakdown. All flooring sampled had measureable moisture including vinyl tile, carpet tile, and wall-to-wall carpeting (Table 1).

**Mold-colonized chairs**

1. Discard water-damaged chairs.
2. Discard wall-to-wall carpeting that was water-damaged. Consider replacing with flooring that can serve as a vapor barrier and not be prone to mold growth, e.g., hard floor tile or carpet tile.
3. Replace water-damaged GW in utility closet.
4. Insulate water service pipes in the utility closet to prevent condensation.
5. For more information on mold refer to the US EPA's "Mold Remediation in Schools and Commercial Buildings", available at: <http://www.epa.gov/mold/mold-remediation-schools-and-commercial-buildings-guide>.
6. Refer to resource manuals and other related IAQ documents for further building-wide evaluations and advice on maintaining public buildings. Copies of these materials are located on the MDPH's website: <http://mass.gov/dph/iaq>.

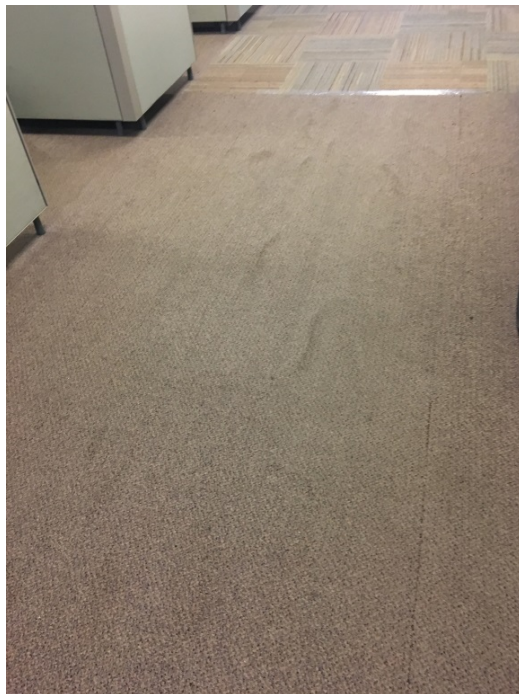
**Picture 2**

**Rippled carpet, indicating water exposure**

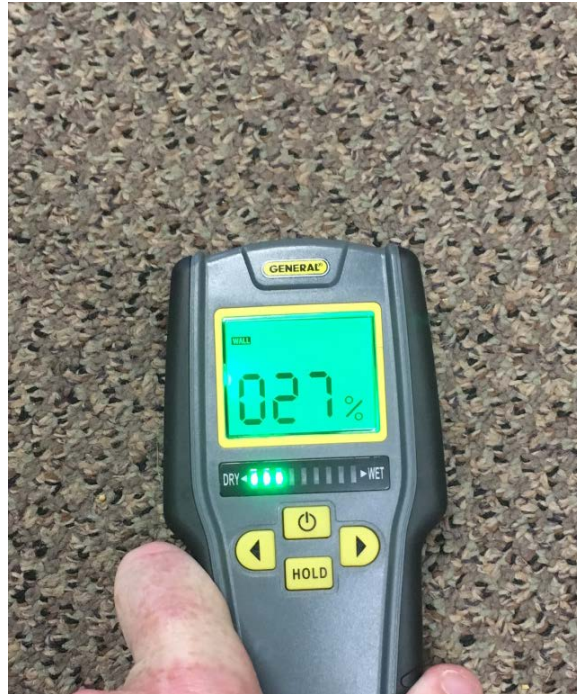
**Picture 3**

**Moisture meter indicating moisture in carpet.**

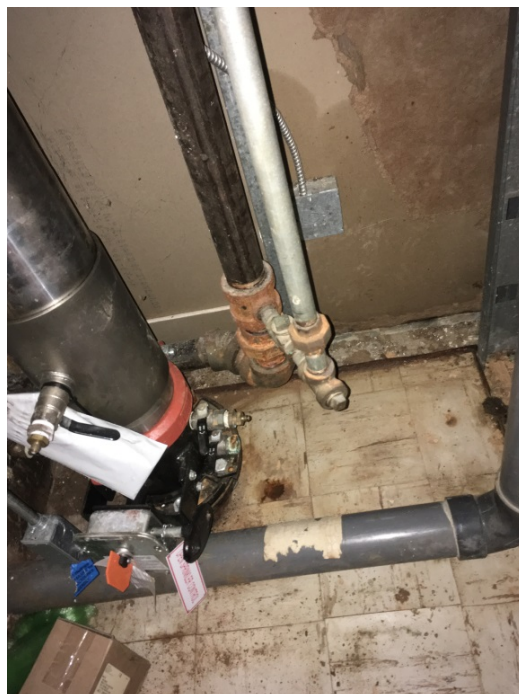
**Picture 4**

Of note was a utility closet which appeared to have a moistened floor and moisture in adjacent wall-to-wall carpeting and gypsum wallboard (GW) (Pictures 4 and 5). The source of this moisture appears to be condensation from water service pipes.

**Floor of water-damaged utility closet**

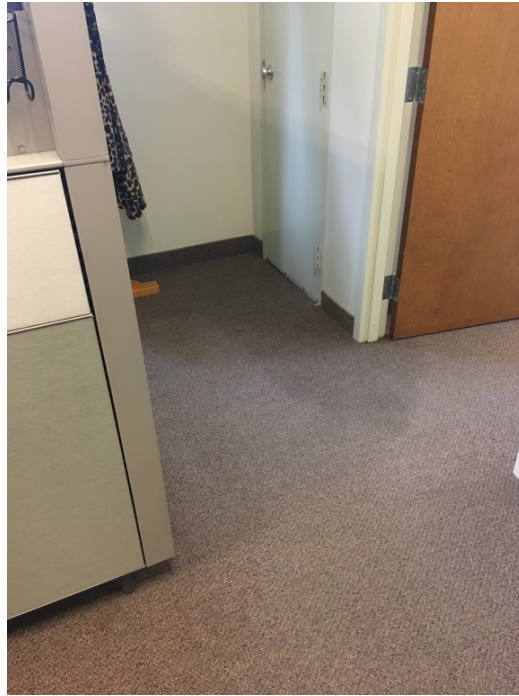
**Picture 5**

**Moistened carpet outside utility closet**
