WATER DAMAGE INVESTIGATION

**Page Elementary School
694 Main Street
West Newbury, Massachusetts**

Prepared by:
Massachusetts Department of Public Health
Bureau of Environmental Health
Indoor Air Quality Program
February 2018

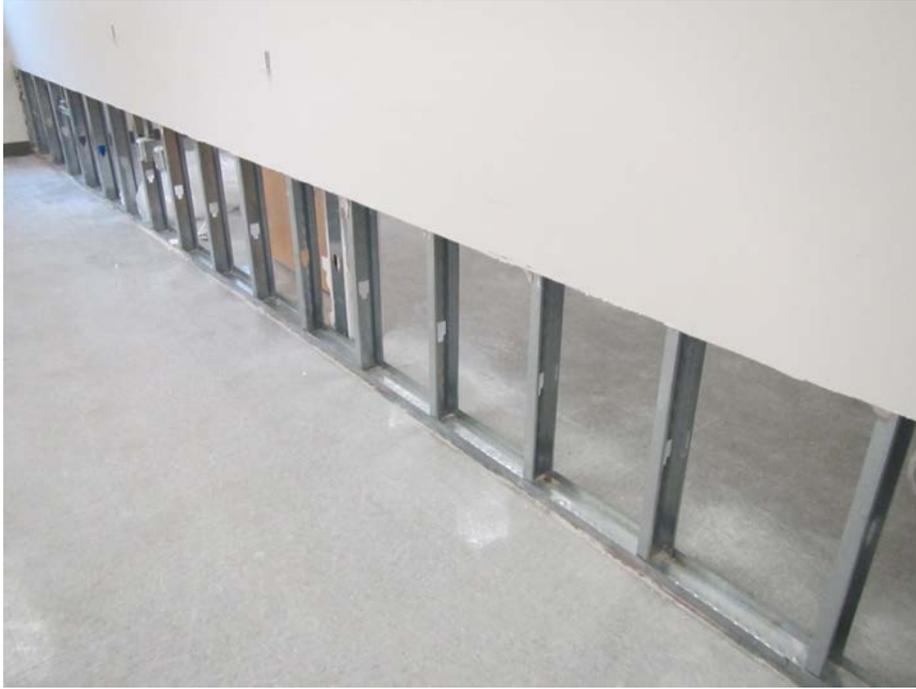
Picture 1

included: water extraction, mechanical drying with fans/dehumidifiers, removal of sections of gypsum wallboard (GW) (Pictures 1 and 2) and the removal of area rugs and personal items from affected areas. Water-damaged ceiling tiles were also removed in several areas below the area of the broken sprinkler pipe which has since been repaired (Picture 3).

Water-damaged gypsum wallboard (GW) removed

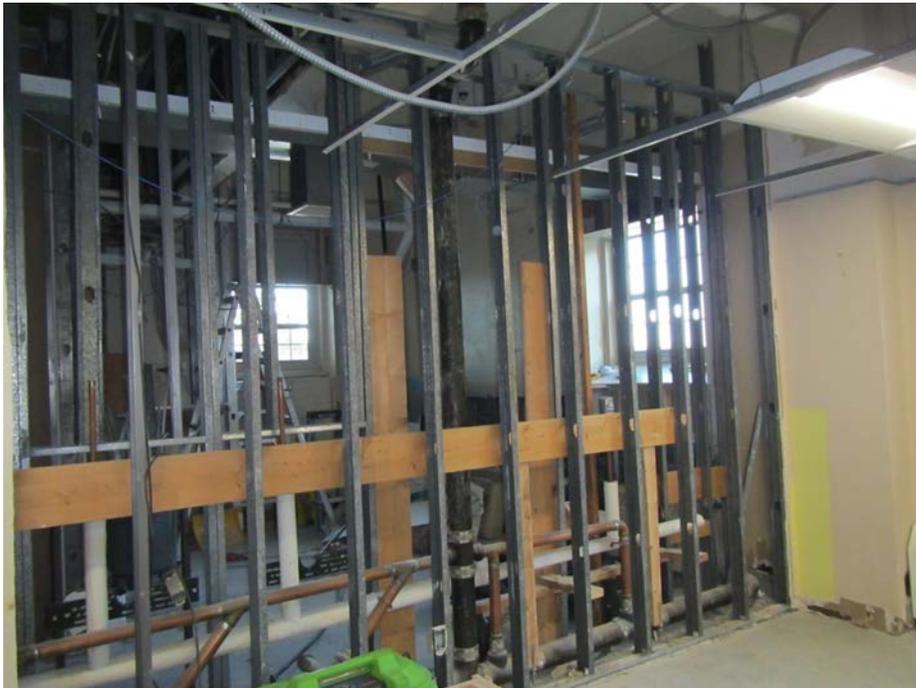
Picture 2

Ceiling tiles and GW removed in classroom adjacent to area of pipe burst

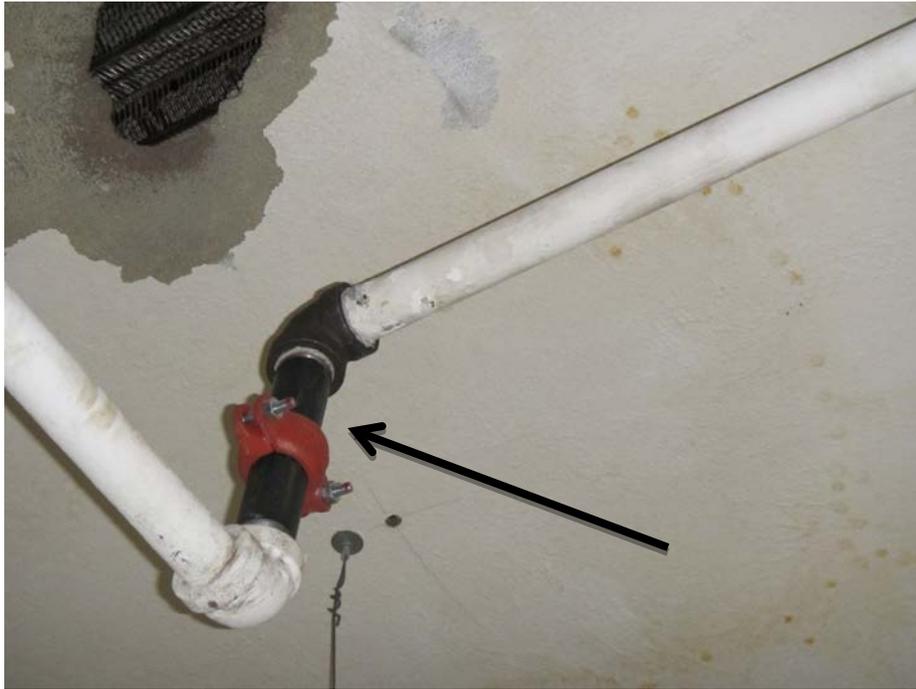
Picture 3

Newly repaired sprinkler pipe section where pipe had burst (above ceiling tile grid)

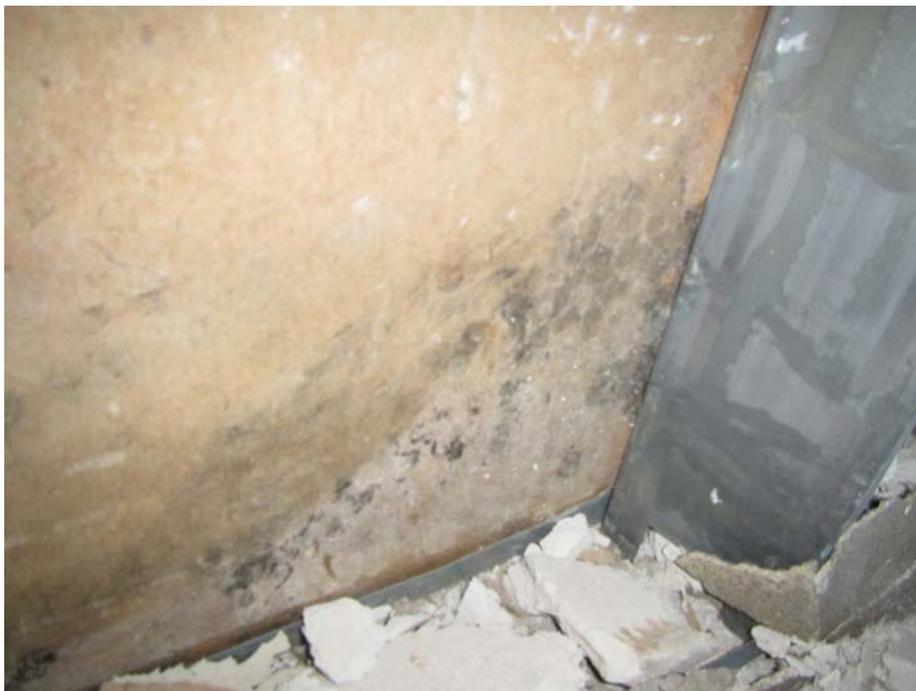
Picture 4

No visible mold was reported in any offices or classrooms impacted by the flooding event according to West Newbury town officials. IAQ staff could not identify any mold growth in remaining GW in classrooms or offices during the January 16, 2018 visit. A small area of visible mold was observed on a wall cavity in the boys' bathroom (Picture 4). This microbial growth appeared to be historic in nature and was likely caused by previous penetration of moisture into the wall cavity unrelated to the most recent pipe break incident. This wall is comprised of gypsum wallboard (GW) which is faced with paper and which may become moldy if exposed to moisture in a high water use area (e.g., mopping). For this reason, it is recommended that a material without paper (cement board) be used to repair this wall.

Small area of microbial growth in wall cavity of boys' bathroom

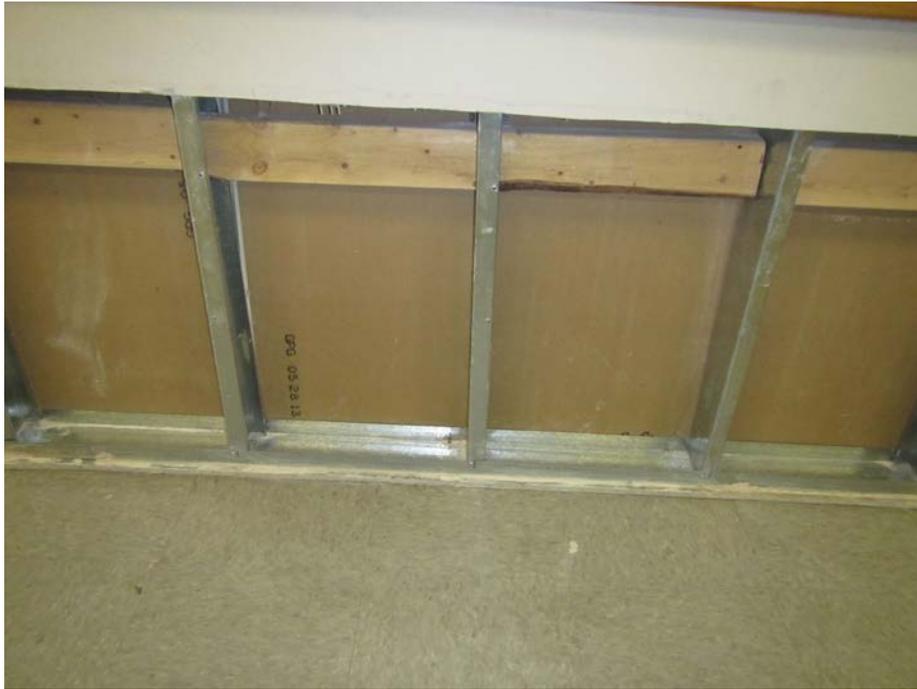
Picture 5

Some areas of GW that remained were dried by opening wall cavity on one side

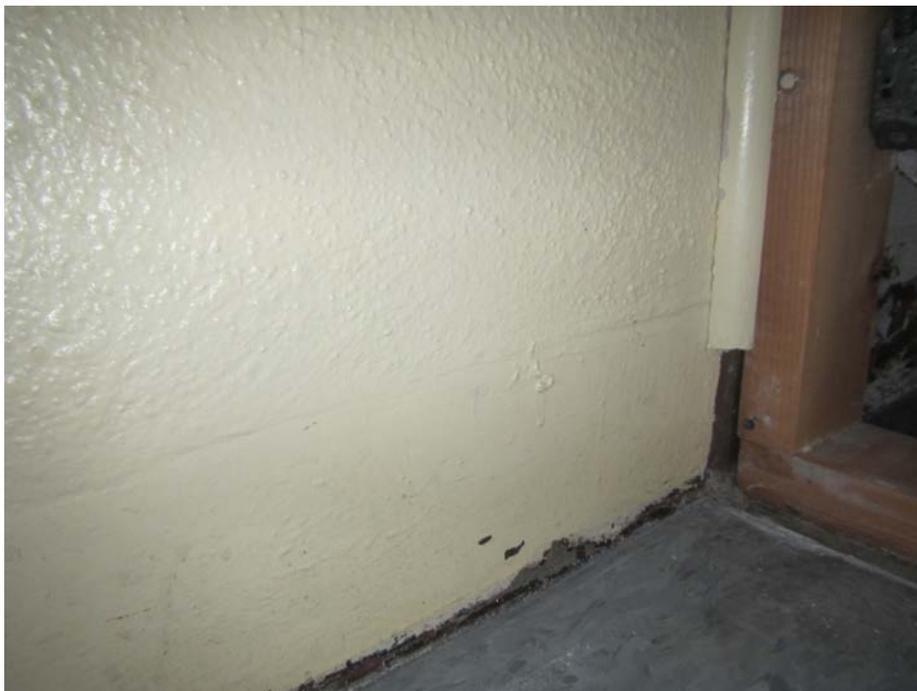
Picture 6

It is important to note that relative humidity levels were maintained in a low range (between 17 to 26% in areas tested) by mechanical means. The low humidity combined with the use of fans, heating, and dehumidifiers during the remediation effort aids drying. IAQ staff checked room wall surfaces with a moisture meter and verified that no walls showed any remaining signs of elevated moisture. ServPro representatives also reported that moisture sampling was performed throughout the drying process and that any porous materials not thoroughly dried within 24 to 48 hours were removed per US EPA recommendations. The remaining gypsum wallboard was dried by removing one side of the wallboard to thoroughly dry the wall cavity (Picture 5). Other walls were composed of plaster, which is a masonry product much less susceptible to mold growth (Picture 6).

Other remaining walls were plaster (above) and not susceptible to mold growth

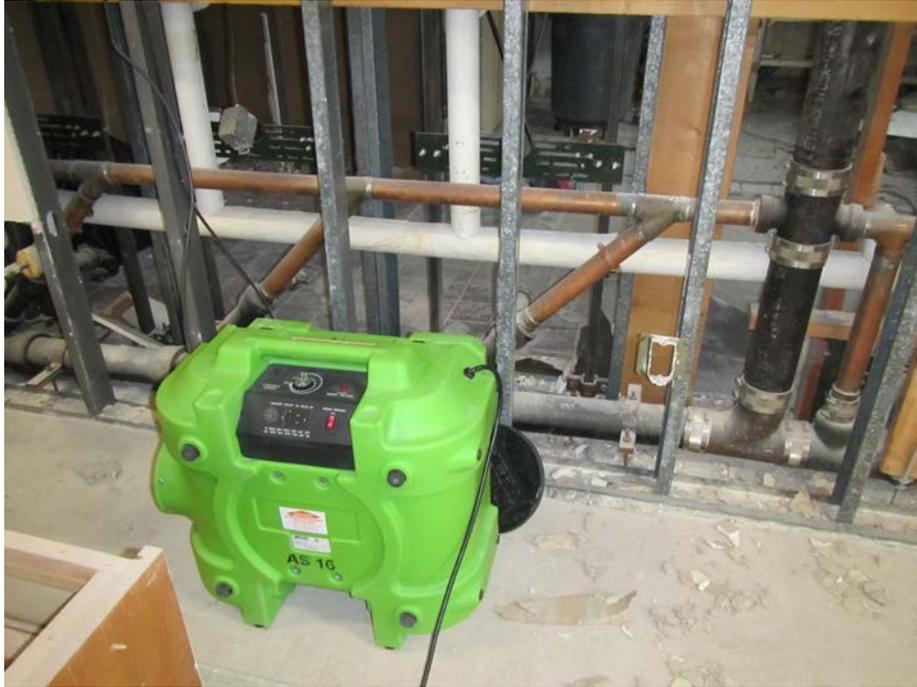
Picture 7

High efficiency particulate arrestance (HEPA) filter units were observed operating throughout the affected space (Picture 7). In addition, IAQ staff observed containment barriers in

HEPA filters/scrubbers used in the remediation effort

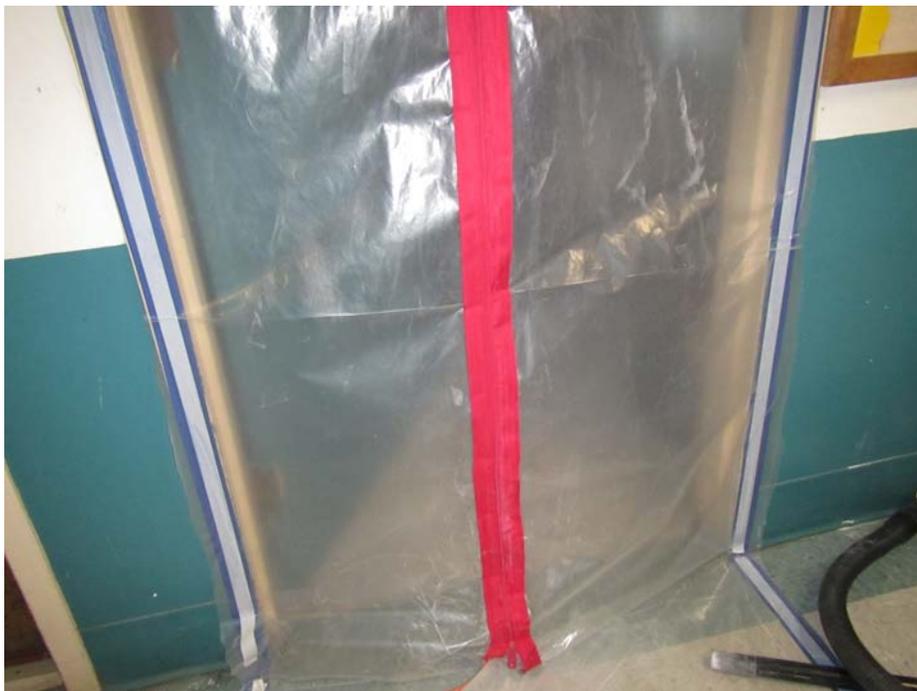
Picture 8

place at the time of this assessment (Picture 8) which prevents dust, debris and odors from the area undergoing remediation being spread to other areas.

Containment barriers used during remediation

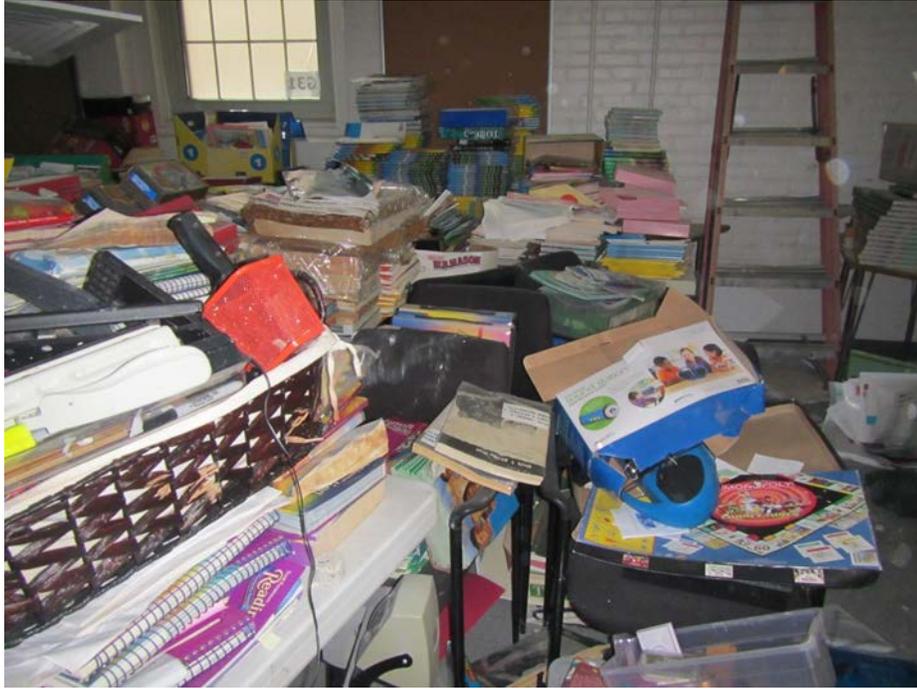
Picture 9

Water-damaged materials (books, school supplies and furniture) were removed from damaged areas (Picture 9). Most of these items (e.g. books, fabric bean bags, and other paper/cardboard materials) are porous and if water damaged, can readily support mold growth. These items cannot be properly cleaned of mold and should be discarded. It is recommended that the water-damaged items be discarded.

Stored water-damaged items that are to be itemized and then discarded

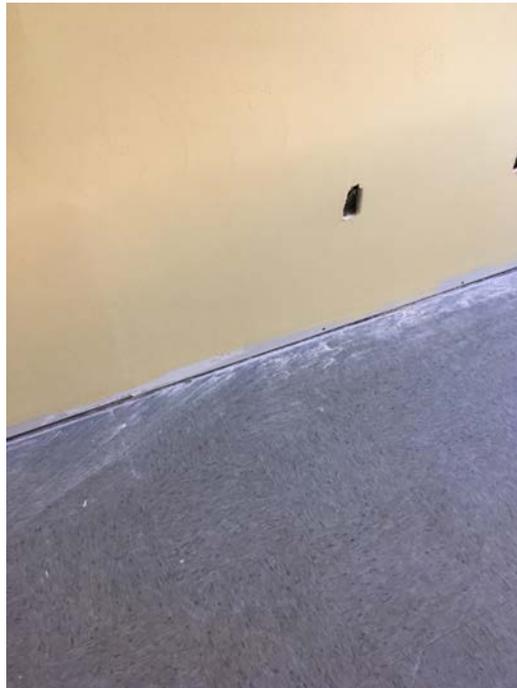
Picture 10

IAQ staff returned to the school on February 6, 2018 to conduct a follow-up assessment with regard to the water damage remediation efforts. Water-damaged gypsum wallboard was removed and replaced (Pictures 10 and 11).

Repaired GW

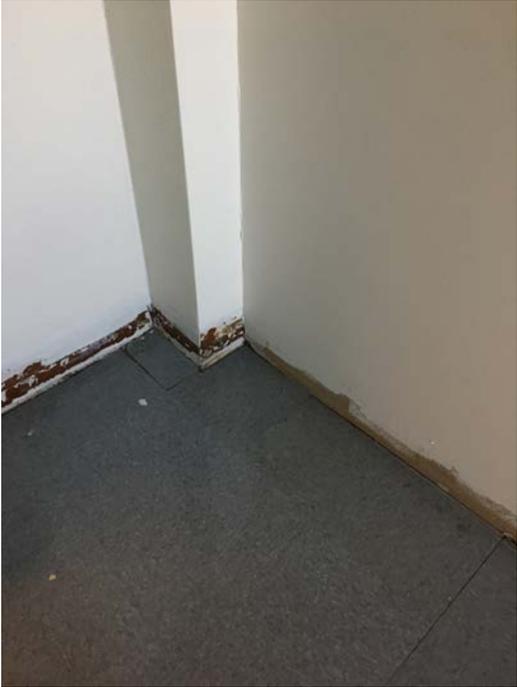
Picture 11

Repaired GW
