INDOOR AIR QUALITY ASSESSMENT

**Brockton Public Library West Branch
540 Forest Avenue
Brockton, Massachusetts**

Prepared by:
Massachusetts Department of Public Health
Center for Environmental Health
Bureau of Environmental Health Assessment
May 2005

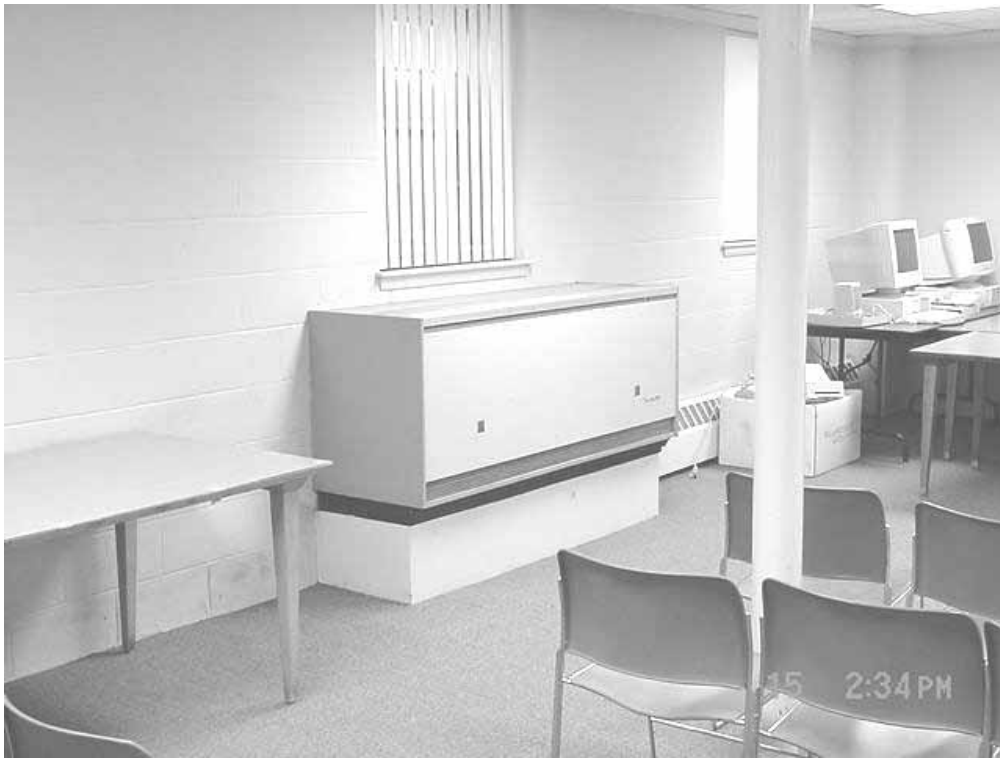
Picture 1

Fresh air is mechanically provided to the building through unit ventilator (univent) systems (Pictures 1 and 2). A univent draws air from outdoors through a fresh air intake located on the exterior wall of the building (Picture 3). Fresh air intakes for basement level univents are located in concrete-lined subterranean pits (Picture 4). Return air is drawn in through an air intake located at the base of each unit ([Figure 1](#)). Fresh and return air are mixed, filtered, cooled/heated and provided to occupied areas through an air diffuser located in the top of the unit. Univents have manual fan control settings of low, medium and high for

fan speed adjustments. Several univents were found deactivated or inoperable (Table 1). Univents are reportedly original equipment, approximately 30-35 years old. Univents of this age can be difficult to maintain because replacement parts are often unavailable. In order for univents to provide fresh air as designed, they must be activated and allowed to operate while rooms are occupied.

One of Two Basement Unit Ventilators

1. Operate all ventilation systems throughout the building continuously during periods of occupancy. To increase airflow during full occupancy, set univent controls to "high".

2. Contact an HVAC engineer to evaluate the ventilation control system and survey univents for function. Consider having univent fresh air control dampers calibrated building-wide.

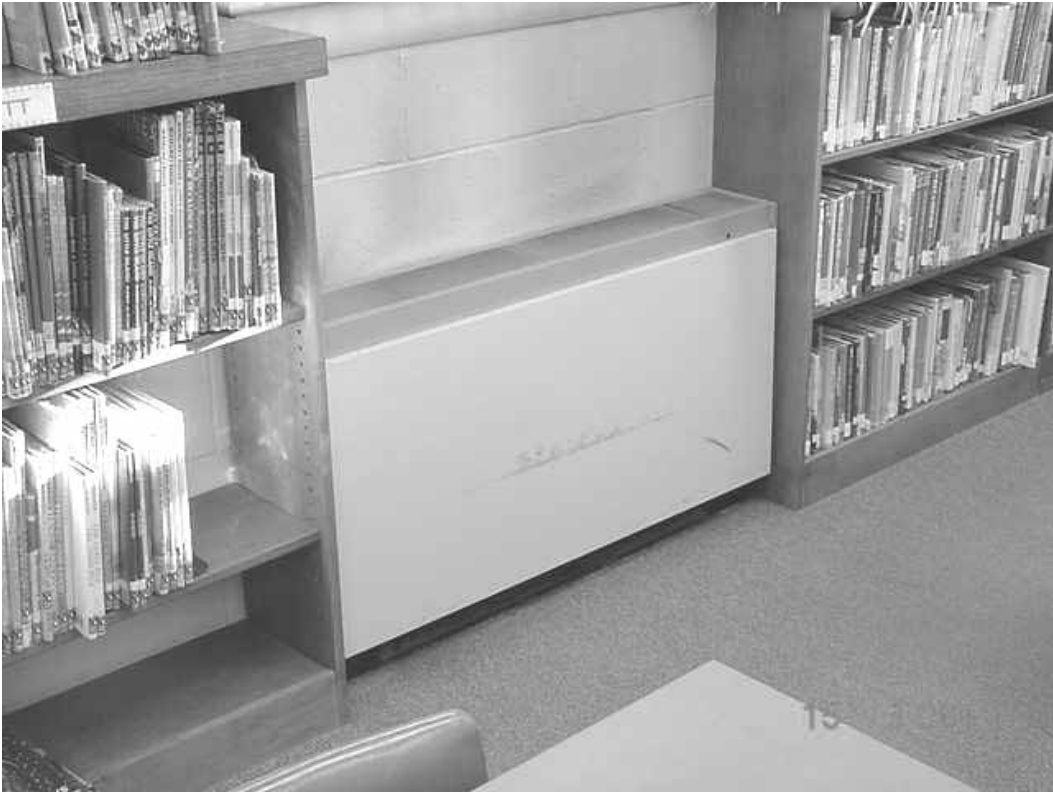
Picture 2

Example of Unit Ventilator on Main Floor

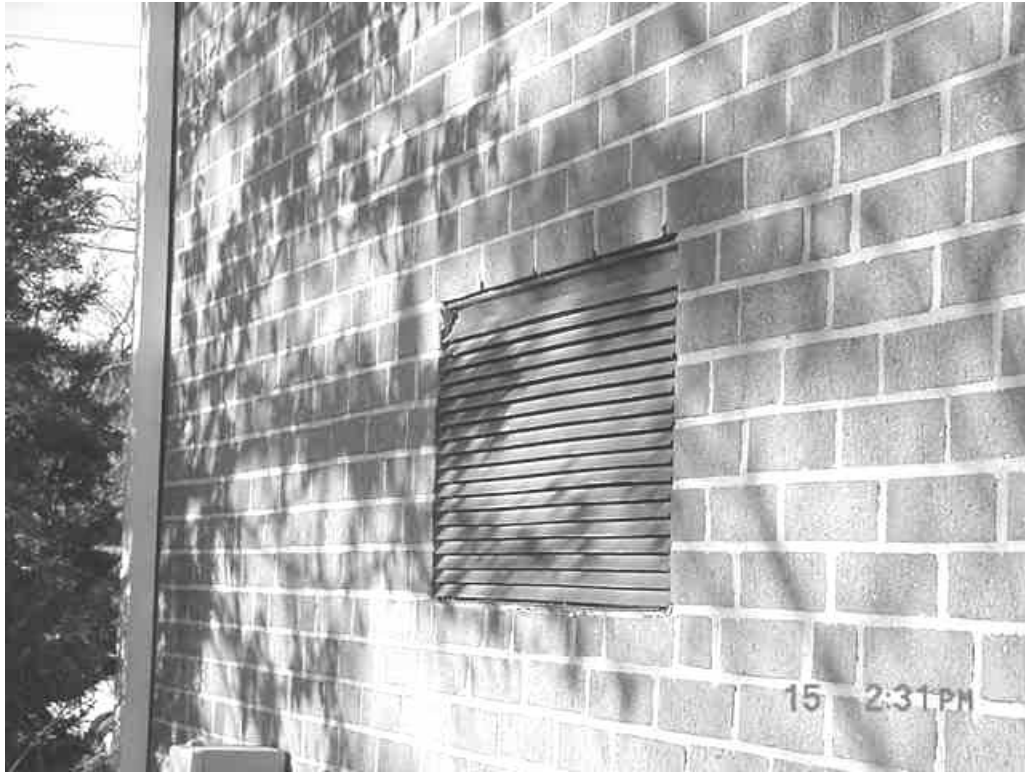
Picture 3

Univent Fresh Air Intake

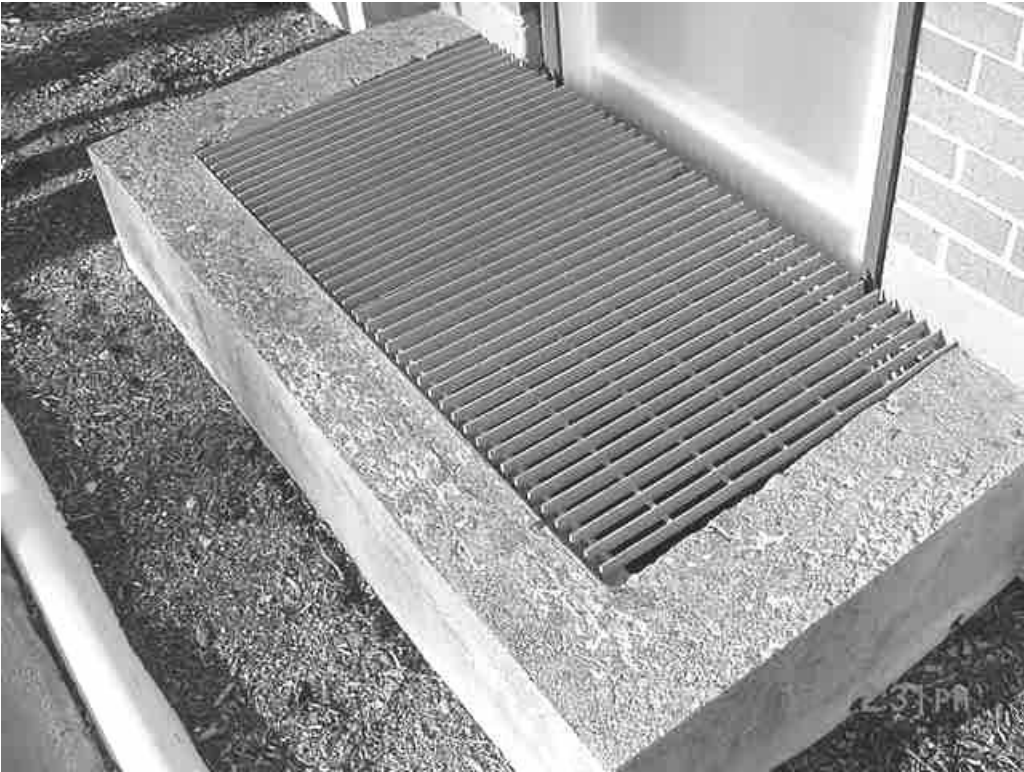
Picture 4

As discussed, several subterranean pits are located along the perimeter of the building (Picture 4). These pits allow air to flow into below grade air intakes for the mechanical

ventilation system. Leaves, papers and other debris were observed on the bottom of the pits. Such materials can provide a source of mold growth. Mold odors and growth can subsequently be entrained into the ventilation system and distributed to occupied areas.

Subterranean Concrete-Lined Pit for Basement Univent Air Intake

11. Remove leaves and debris from subterranean pits seasonally.
12. Ensure plants have drip pans. Examine drip pans periodically for mold growth and disinfect with an appropriate antimicrobial where necessary.

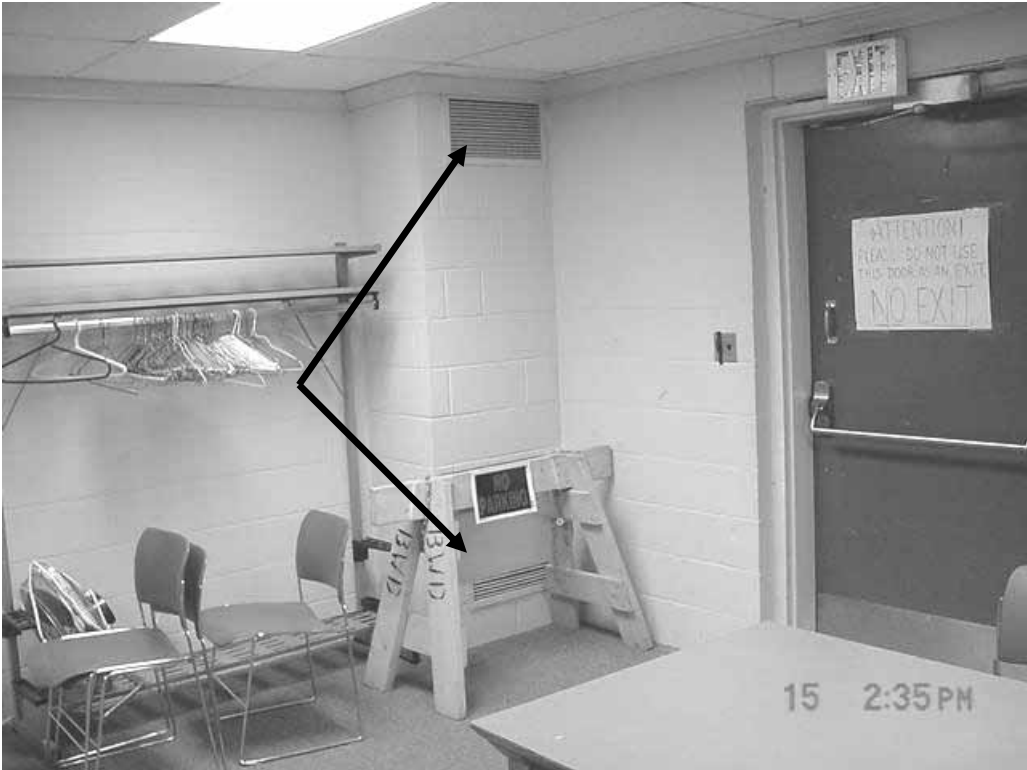
Picture 5

The mechanical exhaust ventilation system consists of ceiling and/or wall-mounted vents (Pictures 5 to 7) ducted to motors located above the ceiling tile system or in the attic. At the time of the assessment, a number of exhaust vents were not operating (Table 1), which can indicate that they were deactivated or not operable. Without dilution by the introduction of fresh air via univents and removal by the exhaust ventilation system, normally occurring environmental pollutants can build up and lead to indoor air/comfort complaints.

Wall-Mounted Exhaust Vents in Basement Auditorium

3. Restore the general exhaust ventilation system. Inspect exhaust motors and belts for proper function, repair and replace as necessary.
4. Use openable windows and operate air conditioners in the “Fan Only” setting to introduce outside air as measures to supplement air flow.

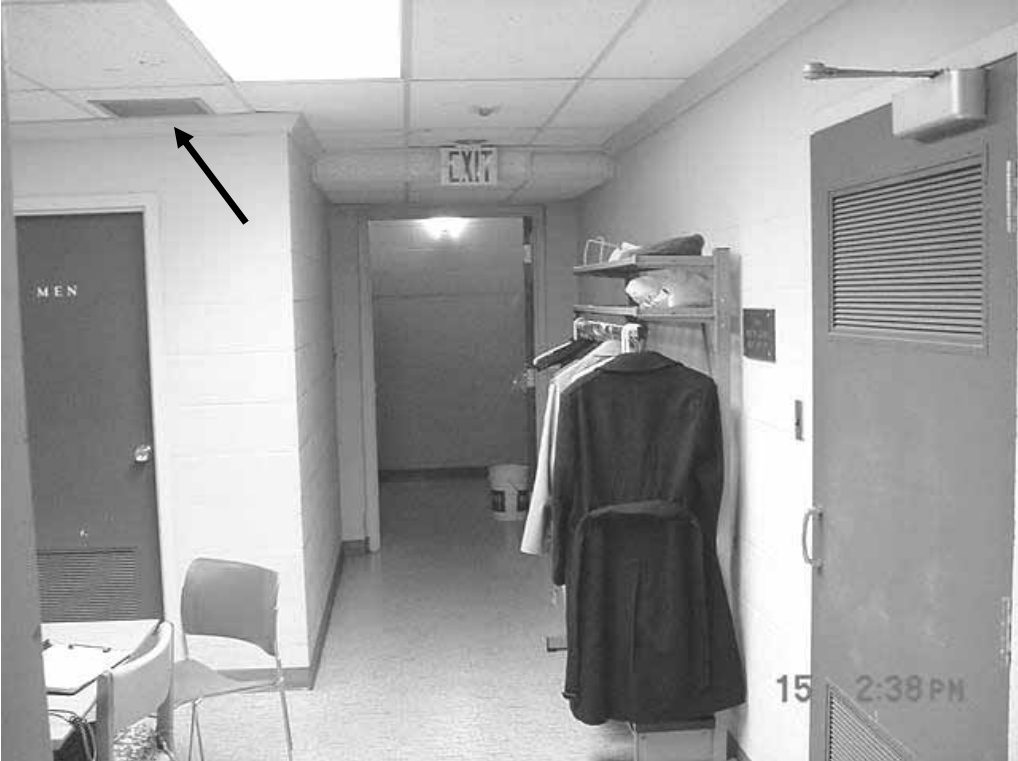
Picture 6

Ceiling-Mounted Exhaust Vent in Basement Breakroom

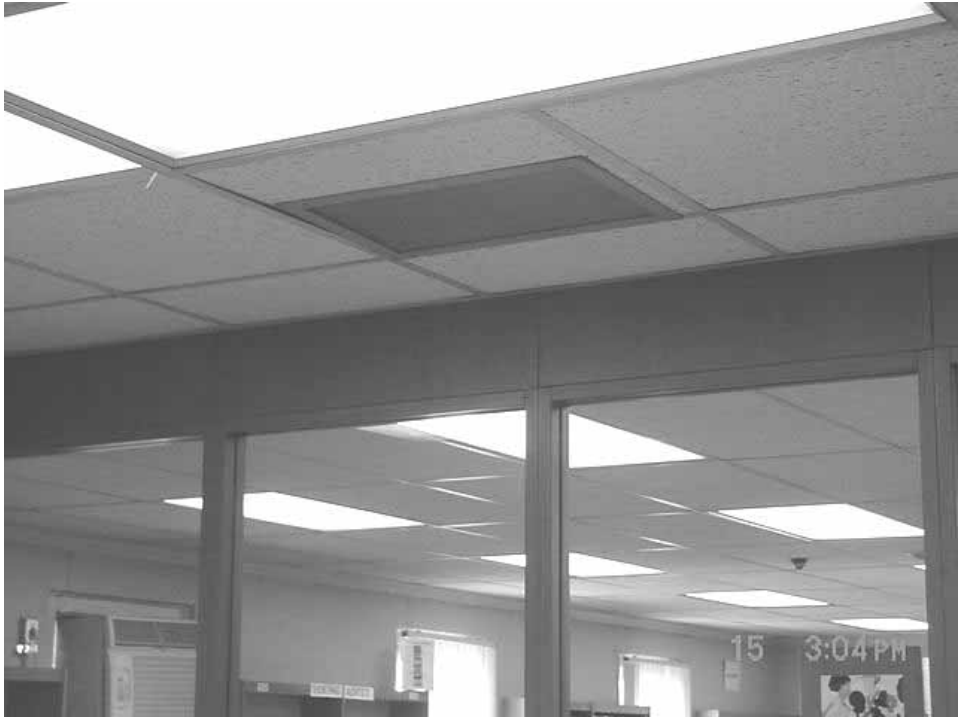
Picture 7

Ceiling-Mounted Exhaust Vent in Main Office

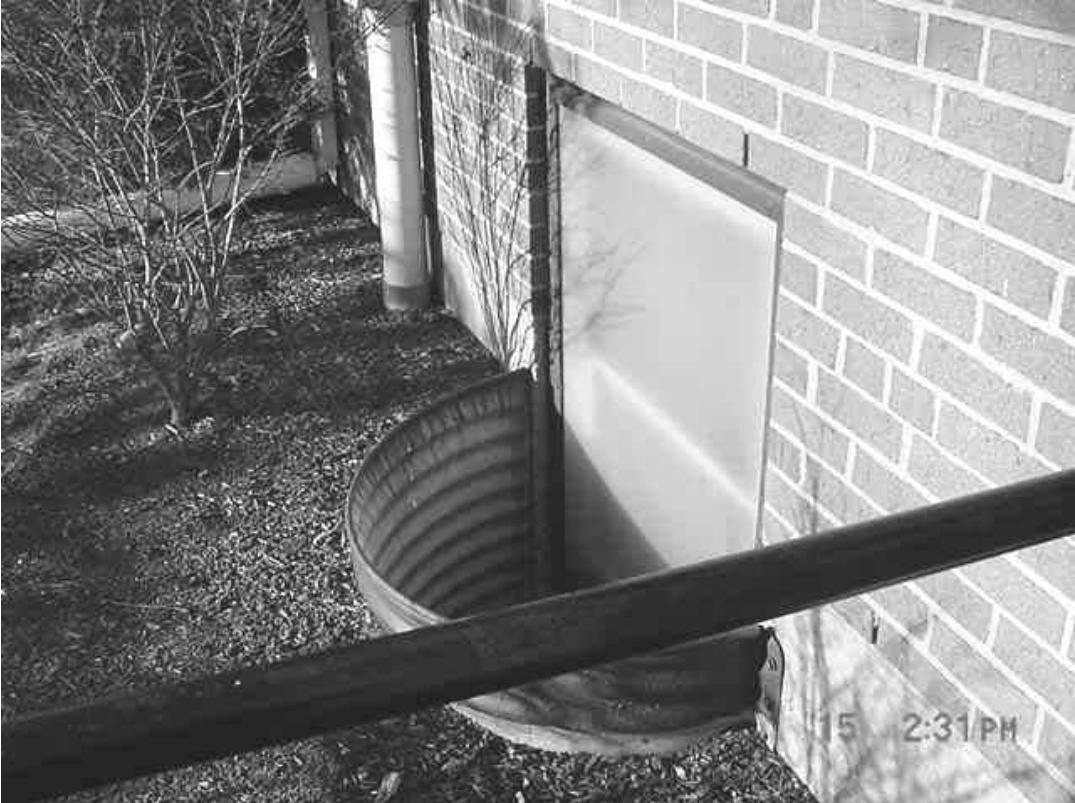
Picture 8

Openable windows are additional sources for fresh air to the library. Occupants reported that windows in several areas are in disrepair or have been temporarily sealed for security reasons (Picture 8). In a number of cases, openable windows have been eliminated with the permanent installation of window-mounted air conditioners. The air conditioners are equipped with a “fan only” or “exhaust open” settings (Picture 9). In this mode of operation, air conditioning units can provide air circulation by delivering outside air without cooling (i.e., air provided by unit equals that of outside temperature).

Basement Window Sealed With Plexi-Glass

5. Work with staff to determine which windows are unopenable/difficult to operate and make repairs. Consider removing plexiglass from auditorium windows.

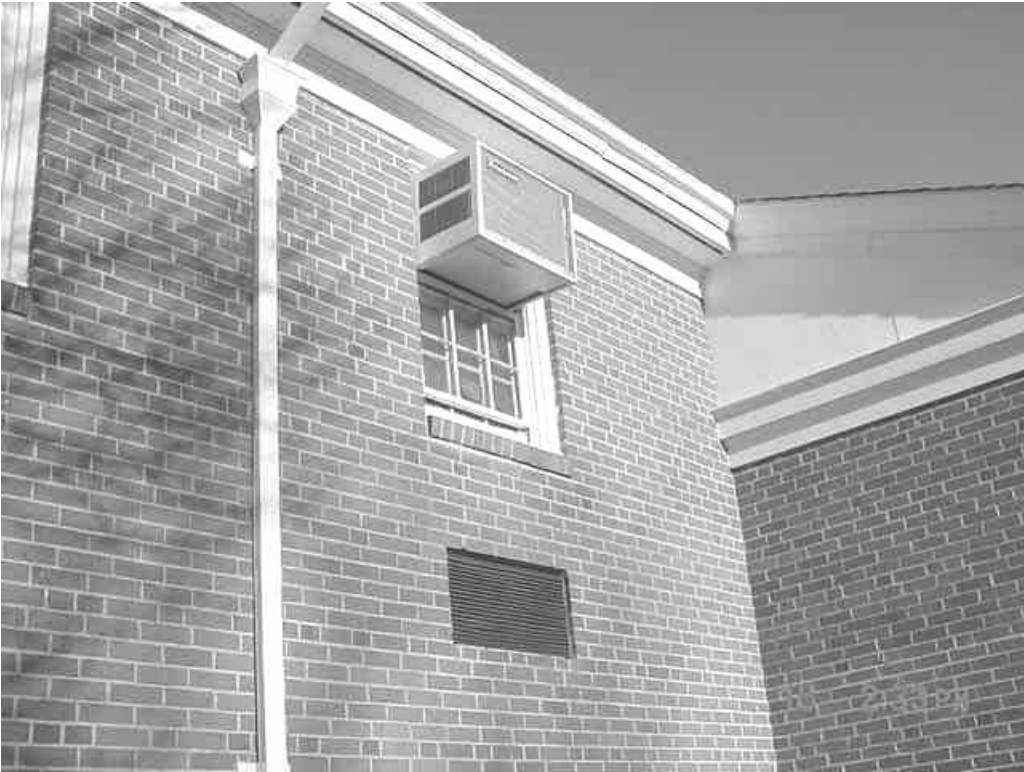
Picture 9

Finally, as discussed several areas contained window-mounted air conditioners. These units are equipped with filters, which should be cleaned or changed as per the manufacturer's instructions to avoid the build up and re-aerosolization of dirt, dust and particulate matter.

Portable Air Conditioning Unit Installed in Window

7. Work with city officials to develop a preventative maintenance program for all HVAC equipment system wide.
8. Change filters for window-mounted air conditioners and air-handling equipment as per the manufacturer’s instructions or more frequently if needed. Vacuum interior of units prior to activation to prevent the aerosolization of dirt, dust and particulates. Ensure filters fit flush in their racks with no spaces in between allowing bypass of unfiltered air into the unit.

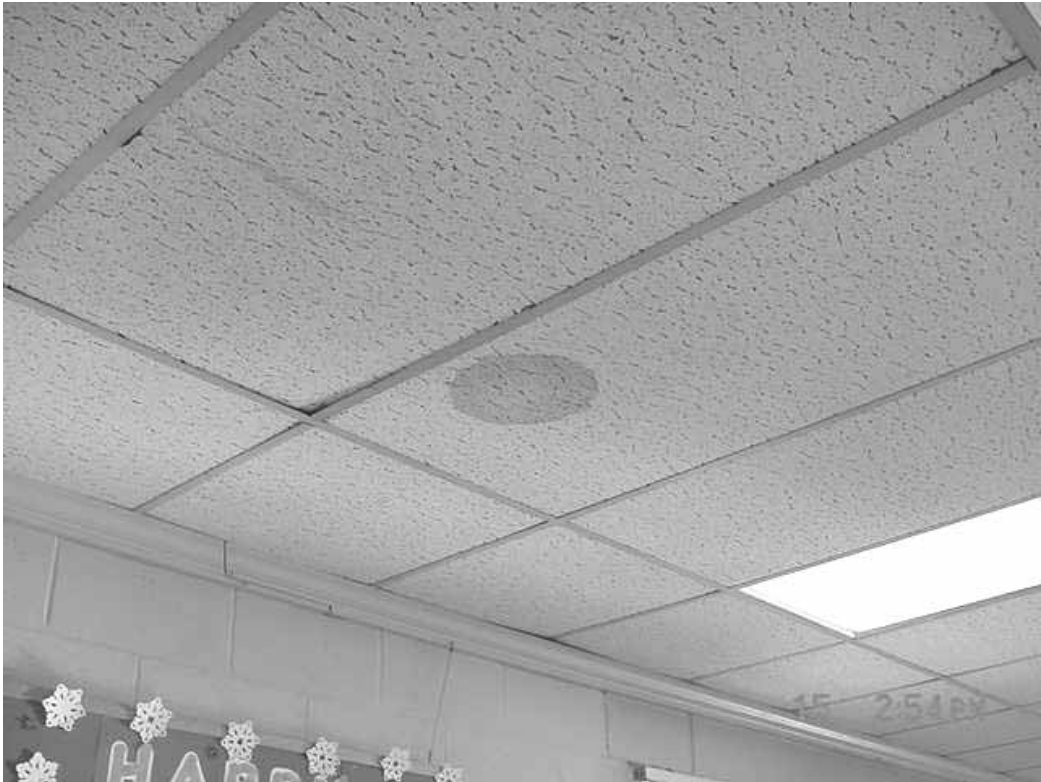
Picture 10

Water-damaged ceiling tiles were observed in the children's section on the main floor. Such damage can indicate leaks from the roof or plumbing system (Picture 10). Water-damaged ceiling tiles can provide a source of mold and should be replaced after a water leak is discovered and repaired.

Water Damaged Ceiling Tile

10. Ensure roof/plumbing leaks are repaired and replace any remaining water-damaged ceiling tiles and fiberglass insulation. Examine the area above and around these areas for mold growth. Disinfect areas of water leaks with an appropriate antimicrobial as necessary. Conduct work above ceiling tiles during *unoccupied* periods or periods of low occupancy. Once work is completed wet wipe and/or vacuum area with a HEPA filtered vacuum cleaner to clean up all residual dirt, dust and particulates.

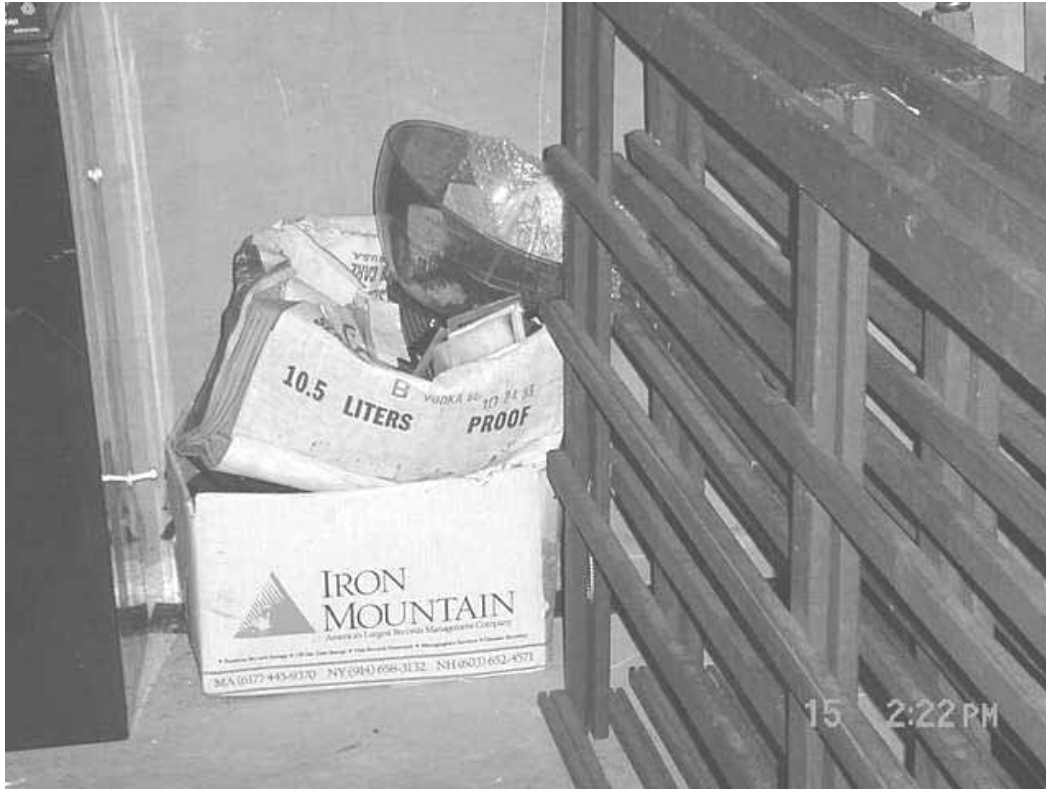
Picture 11

The basement contains a storeroom with a cement floor. BEHA staff observed a large number of cardboard boxes and other porous items stored on the floor (Picture 11). These items should be elevated off the floor (e.g., on pallets, tables) to prevent water damage and potential mold growth.

Cardboard Boxes on Cement Floor in Basement Storeroom

13. Refrain from storing porous materials directly on cement floor in basement storage room. Inspect and discard any water damaged cardboard boxes. Disinfect any areas of microbial growth with a one in ten bleach in water solution; wipe clean surfaces with soap and water after disinfection.

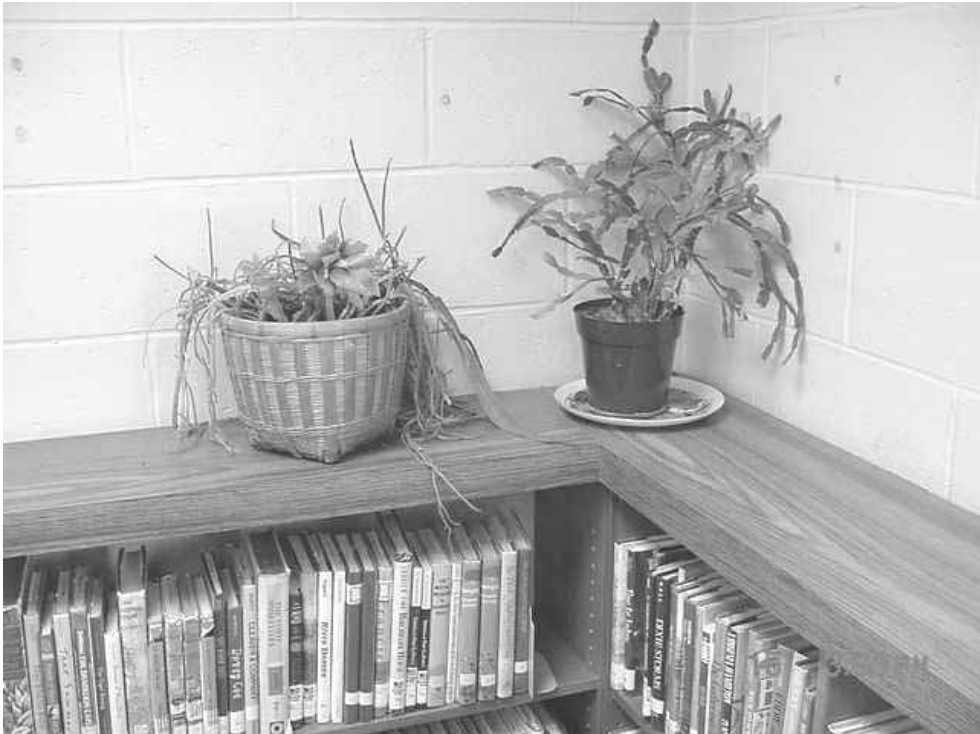
Picture 12

Plants were noted in several areas (Picture 12). Plants can be a source of pollen and mold, which can be respiratory irritants for some individuals. Plants should be properly maintained and equipped with drip pans. Plants should also be located away from univents to prevent the aerosolization of dirt, pollen or mold.

Plants on Bookshelves

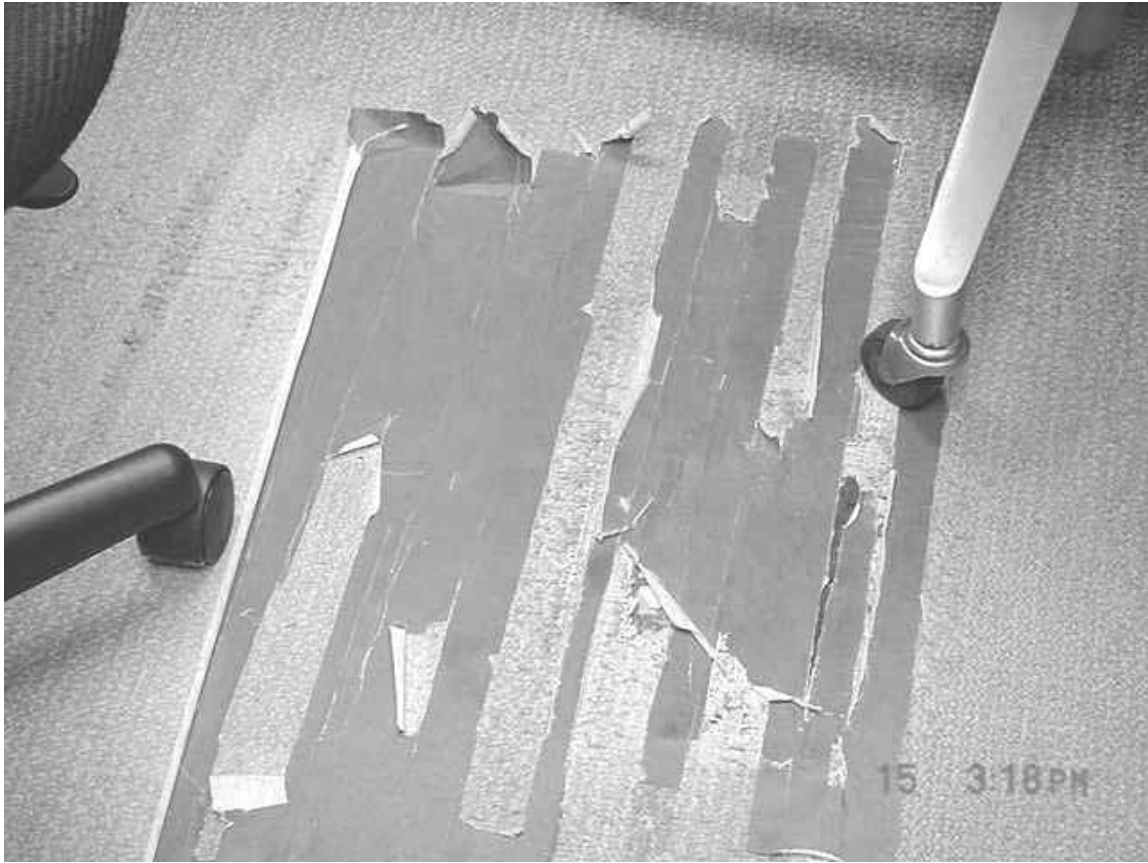
Picture 13

Carpeting in several areas was extremely worn and damaged (Picture 12). The carpet was reportedly installed during the original construction of the building, which would make it

over thirty years old. Disintegrating textiles can be a source of particulates, which can be irritating to the eyes, nose and throat. Carpet fibers/particulate matter can also be entrained and suspended in air by the mechanical ventilation system.

Damaged Carpeting in Circulation Area

1. Consider contacting an HVAC engineering firm to fully evaluate the ventilation systems. Based on the age, physical deterioration and availability of parts for ventilation components, BEHA strongly recommends this measure.
2. Consider replacing damaged/worn carpeting throughout the library to prevent the aerosolization of carpet fibers.
3. Repair/replace loose/broken windowpanes and missing or damaged window caulking building-wide to prevent water penetration through window frames.
4. Repair and/or replace thermostats and controls as necessary to maintain control of thermal comfort. Consider contacting an HVAC engineer concerning the repair and calibration of thermostats and ventilation controls building-wide.
