INDOOR AIR QUALITY ASSESSMENT

**Farmington River Regional Elementary School
555 North Main Street
Otis, Massachusetts**

Prepared by:
Massachusetts Department of Public Health
Center for Environmental Health
Emergency Response/Indoor Air Quality Program
October 2005

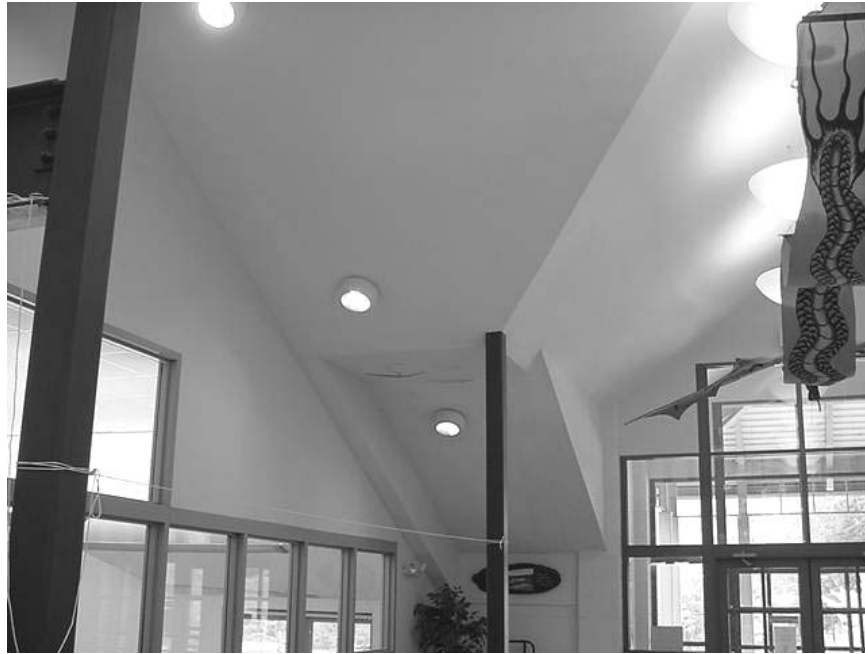
Picture 1

The central section of the building contains a large atrium. The atrium ceiling is installed along the contours of the roof, forming a large, vaulted ceiling (Picture 1). One section of the ceiling is parallel to the floor (Picture 2). Ms. Leep reported that this general area of the ceiling had significant repair work, which removed water damaged insulation and gypsum wallboard. The water damaged area roughly corresponds to a section where the roof joins in a seam that covers the main entrance lobby (Picture 3). The eave of the lobby roof appears to penetrate through the plane of the cafeteria atrium roof. At the time of this assessment the section of the ceiling was under repair. There was no evidence of mold growth or water damaged materials in any other area during this evaluation.

Large, Vaulted Ceiling

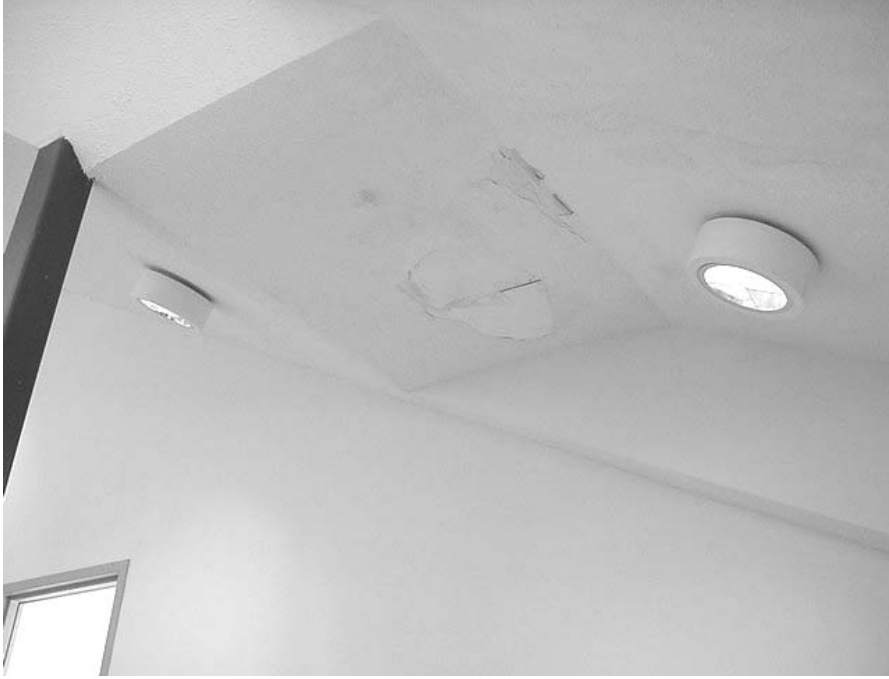
Picture 2

The main lobby ceiling appears to be damaged from chronic roof leaks detailed in this assessment. The materials moistened appear to be limited to a small section of the ceiling, which was under repair. Until rainwater drainage of the roof is addressed as described in the following recommendations, the water damage noted in the main lobby is likely to be a recurring problem. In view of the findings at the time of the assessment, the following recommendations are made:

Section of Ceiling That is Chronically Water Damaged

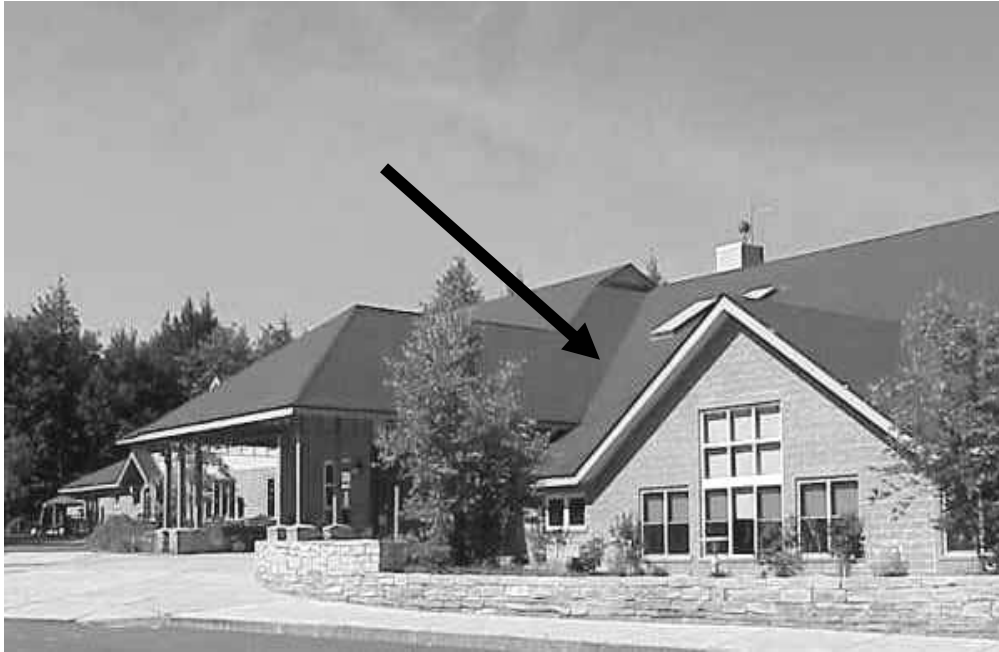
Picture 3

chimneys, etc.); 3) the seam where two separate roof planes are joined; or 4) sections of the roof that abut the exterior wall. In this case, two of these conditions exist above the water damaged ceiling in the atrium. Where two separate roof planes are joined, a trough is created where rainwater will likely concentrate (Picture 4). This situation is addressed through a number of different methods. Older, slate shingled roofs usually have metal sheeting (e.g., copper/lead/aluminum) installed over the seam and under shingles, to create a trough. With modern construction, it is customary to place asphalt shingles over seams, to create a cascade effect of water transferring from one shingle on to another. This type of installation was actually done on several other roof seams (Picture 5). Above the problem area, the shingles are *not* overlapping the seam, allowing for rainwater to concentrate and likely penetrate beneath shingles.

Section of Roof That Corresponds to Water Damage in Atrium (Arrow)

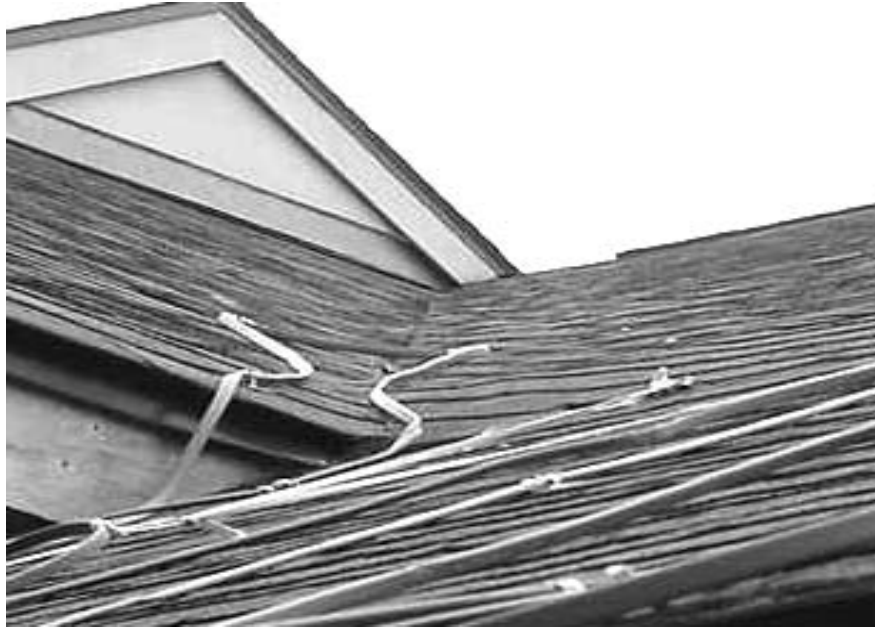
Picture 4

Trough Created by Roof Seam, Note Distinct Seam Created by Shingles Joining at Trough

- a) Examining the flashing and installing in a manner to prevent water penetration.
 - b) Considering reinstalling shingles along roof trough to overlap the seam between the roof joint in a manner similar to other sections of the roof.

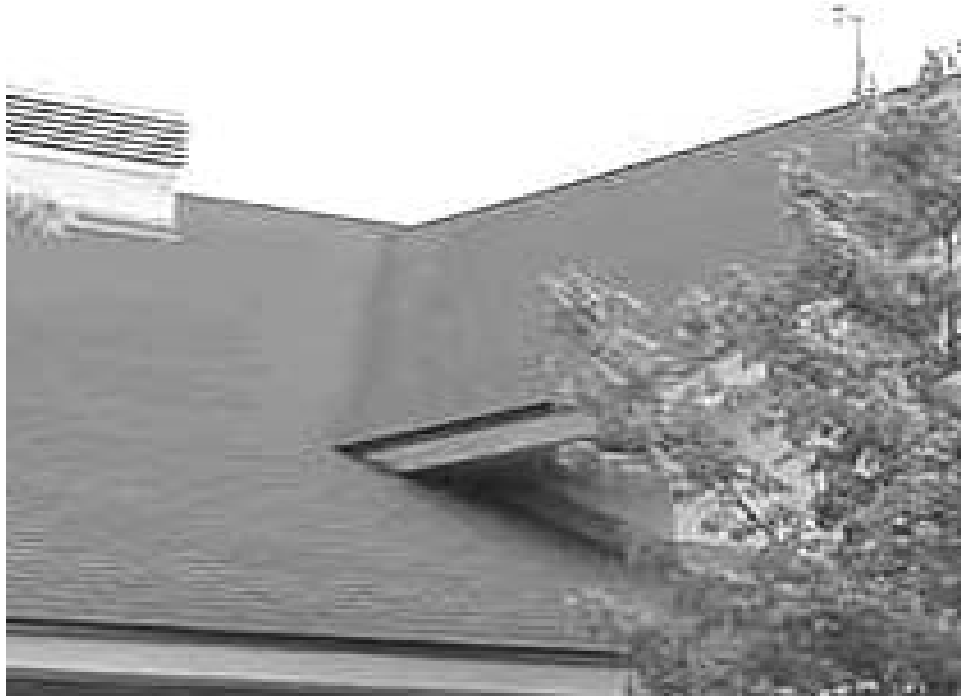
Picture 5

Asphalt Shingled Over Seams, to Create A Cascade Effect of Water Transferring From One Shingle on to Another, Note Lack of Distinct Seam at Roof Tough

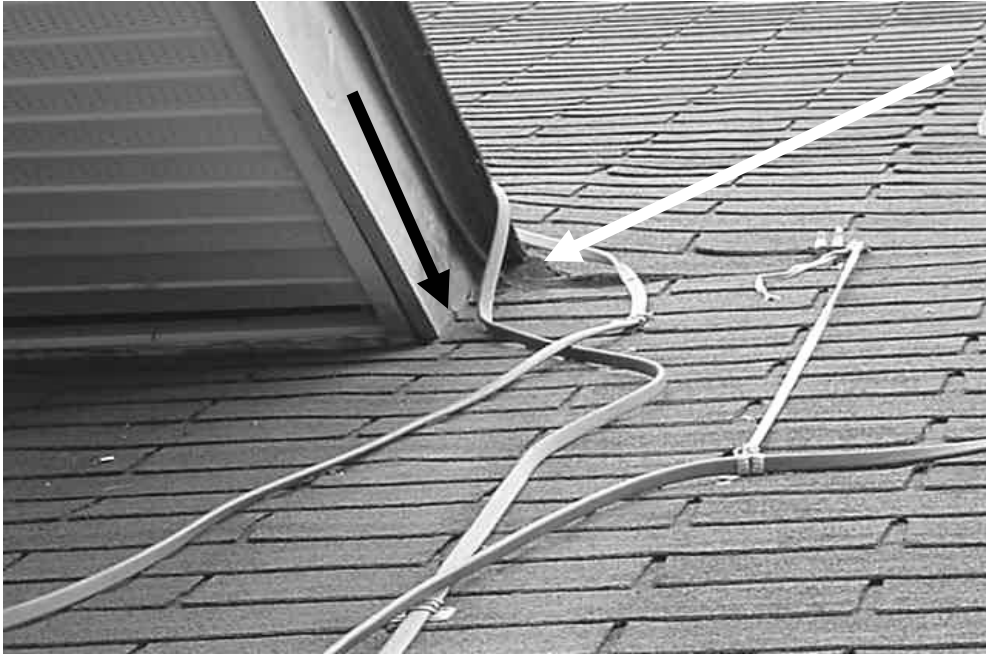
Picture 6

Another possible source for moisture penetration is missing flashing. It appears that part of the roof eaves penetrate the plane of the roof without the installation of flashing (Picture 6). In general where two dissimilar materials meet on the exterior of a building, the seam between these materials is likely to be a point source for water penetration. The installation of flashing allows for water to transition from one surface to the next. Without flashing, water can penetrate through the seam resulting in water damage and potential mold growth.

Joint Missing Flashing

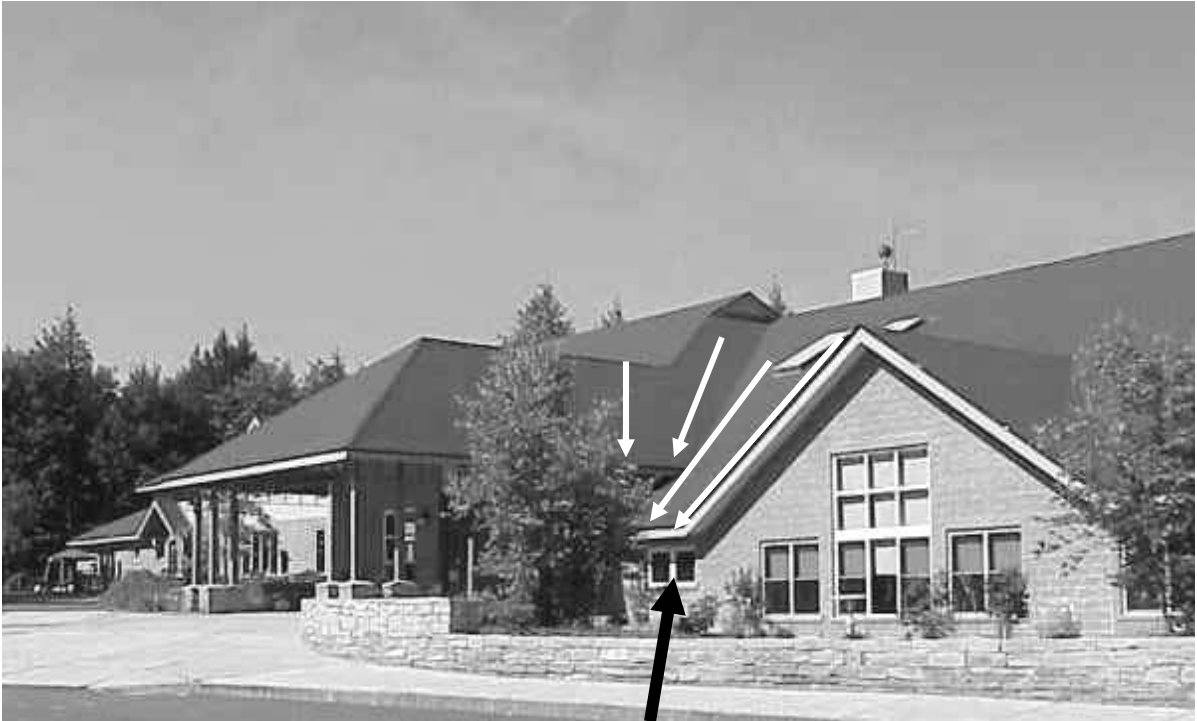
Picture 7

Lastly, the design of the roof directs a large amount of rainwater on this small section of roof (Picture 7). Not only does the lower section drain the largest portion of the roof, water from a large section of the roof over the lobby entrance is directed onto this roof as well. This design concentrates rainwater onto the lower roof, more so than any other section of the building, which can lead to water accumulation along the base of the building. Since the cafeteria is below the level of the soil, water can accumulate against the exterior wall and may eventually penetrate into the cafeteria.

Cafeteria windows with brick cracks

White Arrows Indicate Likely Water Flow from Three Roof Sections onto the Roof Section above the Cafeteria Window

- c) Exploring the feasibility of installing a gutter/downspout system along the roof edge of the front lobby and the roof shown in Picture 7. Please note that the gutter must be designed and configured with the appropriate capacity to drain water from this roof while preventing overspill onto the ground outside the cafeteria.

- d) Improving drainage outside the cafeteria window wall. Repair of any cracks and crevices in the exterior wall and foundation in this area is advised.
