INDOOR AIR QUALITY ASSESSMENT

**Bristol County Superior Court
9 Court Street
Taunton, Massachusetts**

Prepared by:
Massachusetts Department of Public Health
Center for Environmental Health
Bureau of Environmental Health Assessment
Emergency Response/Indoor Air Quality Program
November 2004

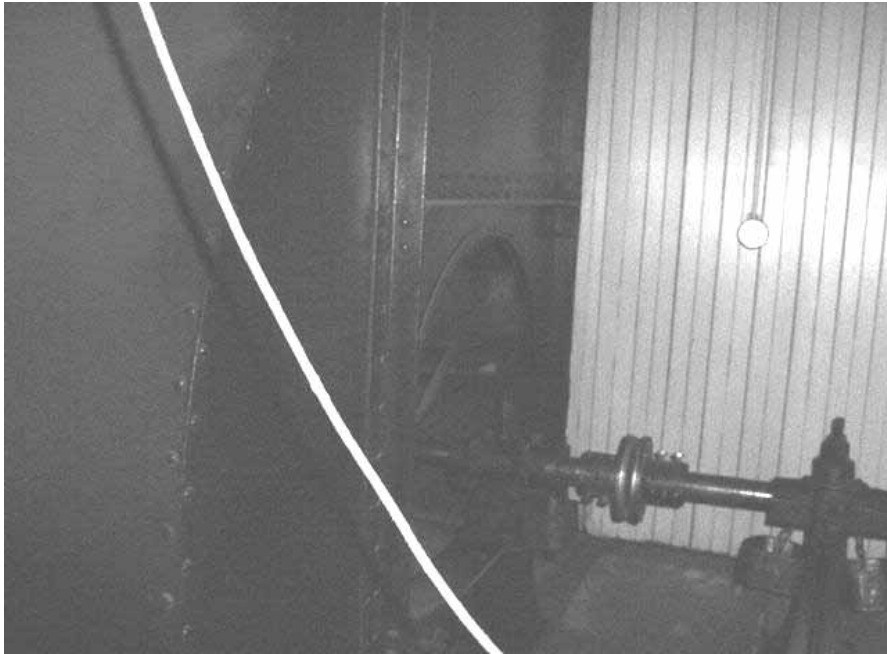
Picture 1

Fresh air is provided by an air handling unit (AHU) located in a large room on the ground floor. The AHU has a large fan powered by a motor, which operates the large fan belt (Picture 1). Fresh air drawn into the AHU room is controlled by a door/window (Picture 2). Fresh air is mixed in this room prior to being drawn into the heating elements via the air handler. Ductwork connects the AHU to air diffusers throughout the building.

Fresh Air Supply Fan in Basement

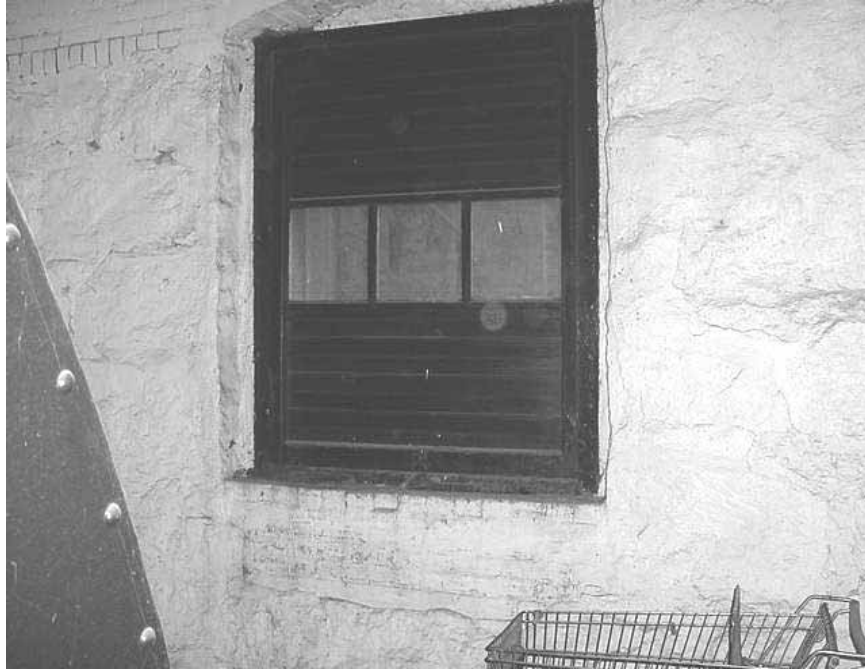
Picture 2

Source of Fresh Air Supply to Basement Fan

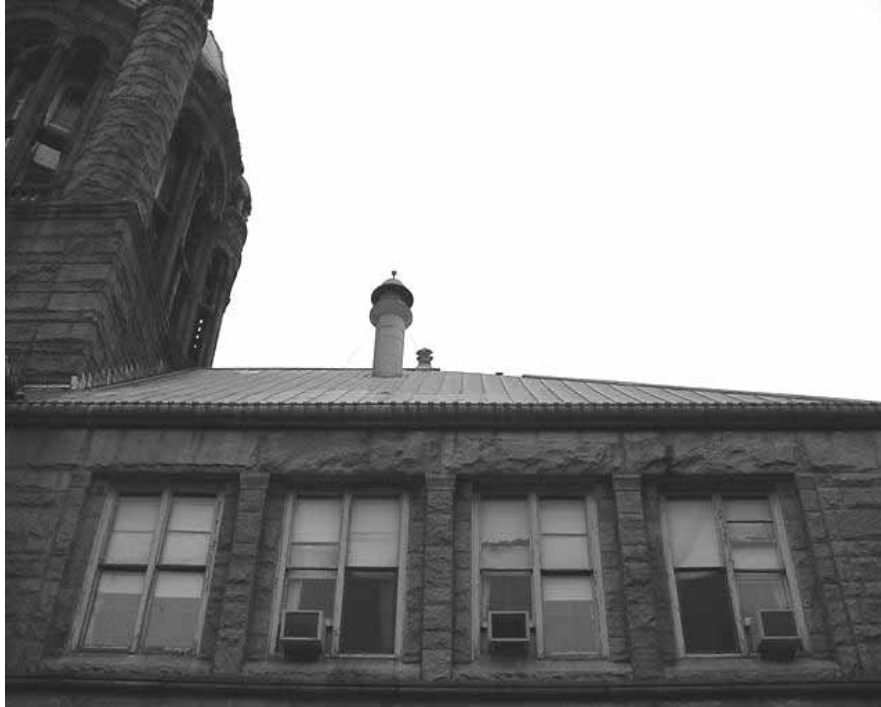
Picture 3

The BCSC has a gravity exhaust system, which consists of airshafts connecting to roof vents (Picture 3). The operation of the exhaust system appears to depend on air

Rooftop Exhaust Vent

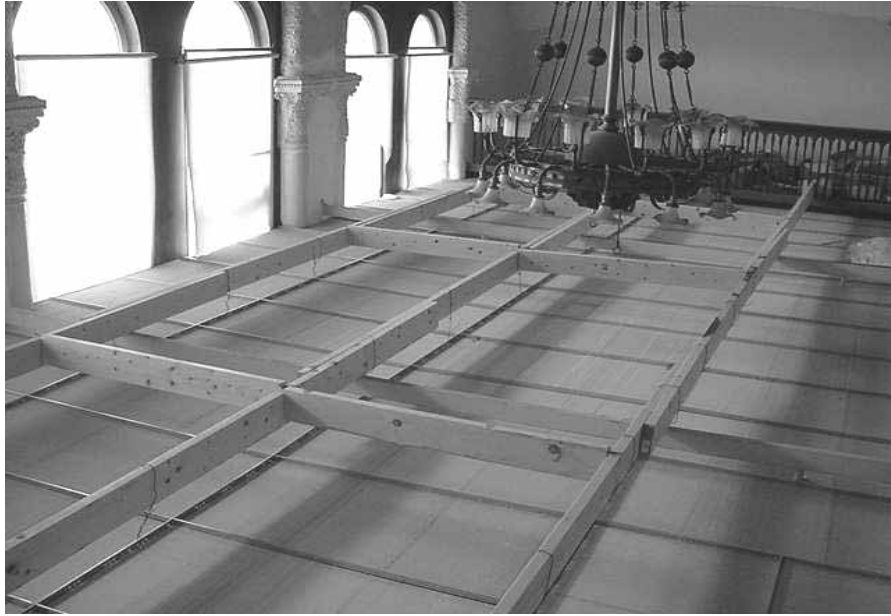
Picture 4

Three conditions likely contributed to increased relative humidity in this storeroom. First, the installation of the suspended ceiling separated the storeroom from the conditioned space. The suspended ceiling has rendered the storeroom as an unconditioned space, subject to little environmental control by heating from AHUs or cooling via window-mounted air conditioners. Second, it appears that polyethylene plastic was installed over the entranceway to the storeroom, further isolating this area from environmental control. Lastly, the storeroom did not have either a dehumidifier or window-mounted air conditioning system, both of which would have helped to decrease the relative humidity in this area. The most likely source of mold growth appears to be the book collection in the storeroom, rather than the discoloration noted on the exterior wall.

Suspended Ceiling Installed In Clerk of Courts Office Which Separates the Balcony from the Office below the Ceiling

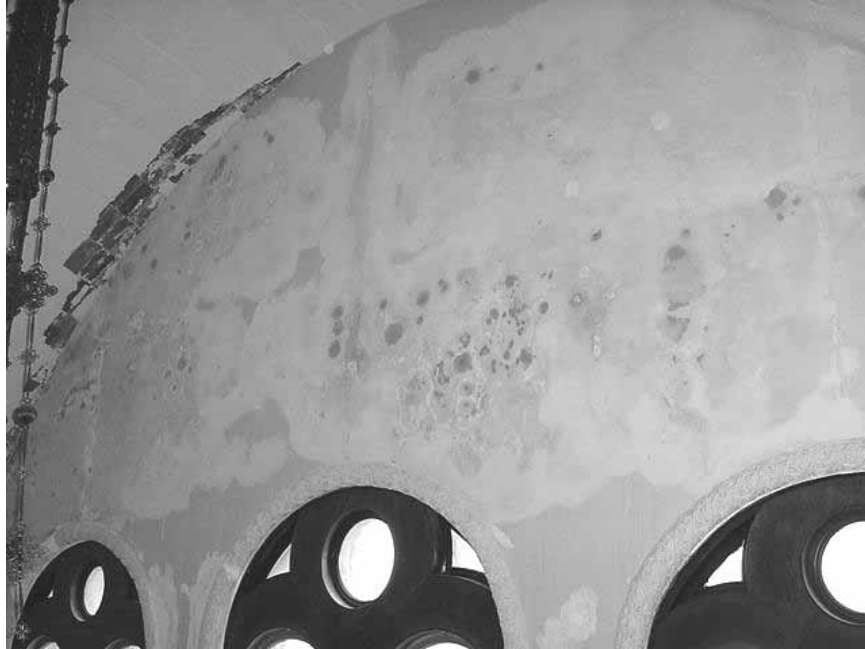
Picture 5a

Discoloration of Wall Material above Clerk's Office Suspended Ceiling

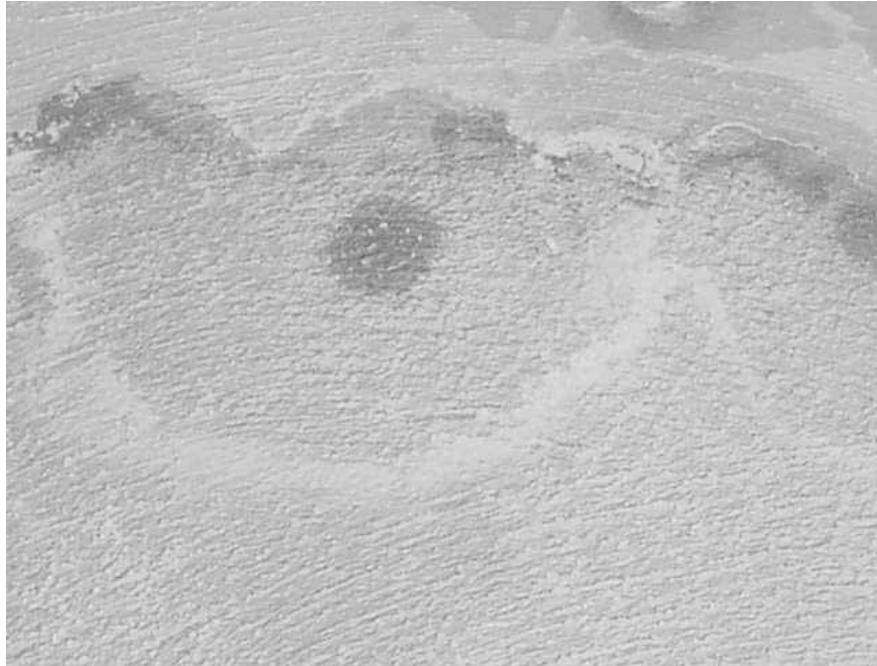
Picture 5b

Close-Up of Discoloration of Wall Material above Clerk's Office Suspended Ceiling

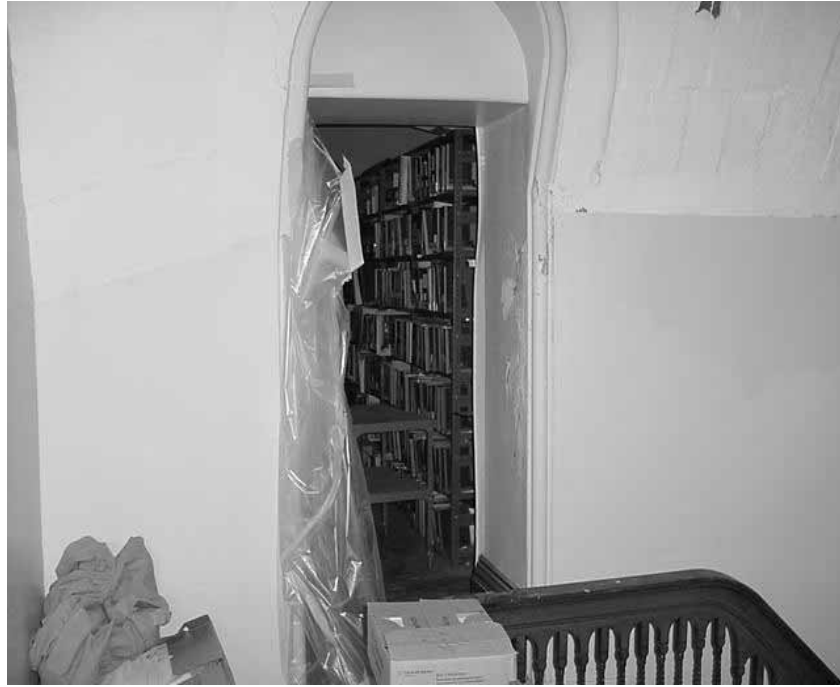
Picture 7

A musty odor was detected in the upper, unconditioned space. The odor was traced to a storage room, adjacent to the upper, unconditioned space and accessible only by the balcony. The storage room is used by the law library to store rarely-used law books (Picture 7). The musty odor appeared to emanate from book volumes, which was confirmed by opening several volumes.

Book Storeroom off the Balcony above Clerk's Office Suspended Ceiling

2. Remove the GW around the window of room 62 in a manner consistent with the US EPA mold remediation guidelines.
3. Install a window-mounted air conditioner above the suspended ceiling in the book storage area to control temperature and humidity in this area.

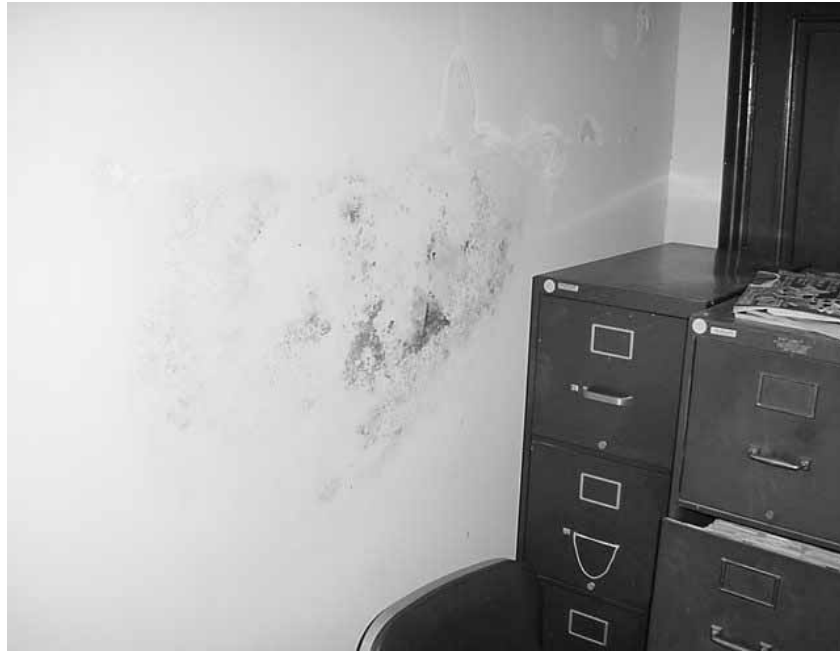
Picture 8

Other conditions related to water damage were also observed at the BCSC. Visible mold growth was noted on a wall in the balcony rotunda, behind a file cabinet (Picture 8). This water damage corresponds to an area on the roof where it appears that a downspout from an upper roof gutter is missing (Picture 9). Without this downspout, water pours on to the lower roof, wetting adjacent exterior stone, resulting in water penetration.

Mold Colonization of Wall behind File Cabinets in Rotunda Balcony

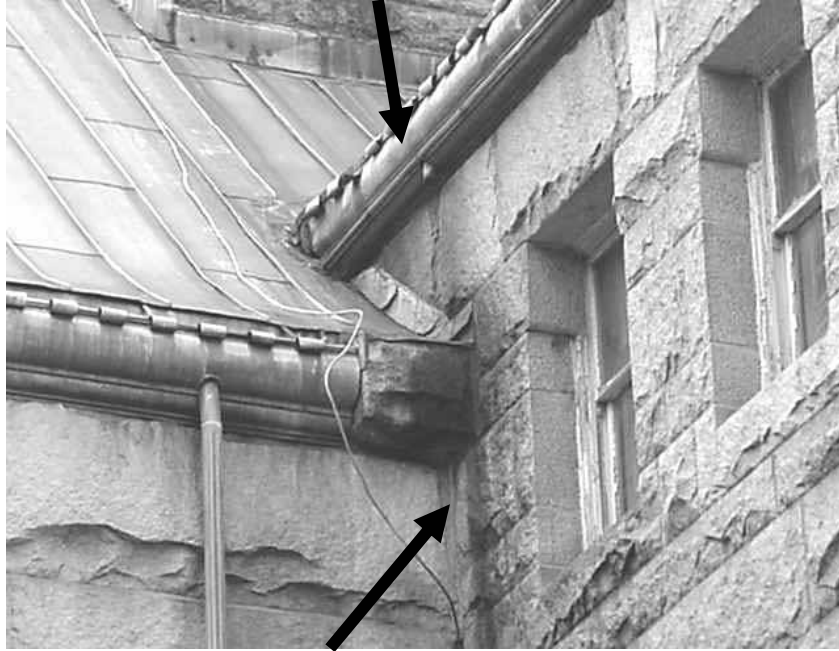
Picture 9

Missing Downspout

Stain Indicating Chronic Water Exposure

Missing Downspout of Roof Drainage System opposite Interior Wall Damage Depicted In Picture 8, Note Black Staining Of Stone below Missing Drainpipe

4. Move the air conditioner in room 62 from the west-facing window and install in the north facing window in a manner to prevent water penetration.
5. Repair the gutter/downspout system shown in Picture 9.

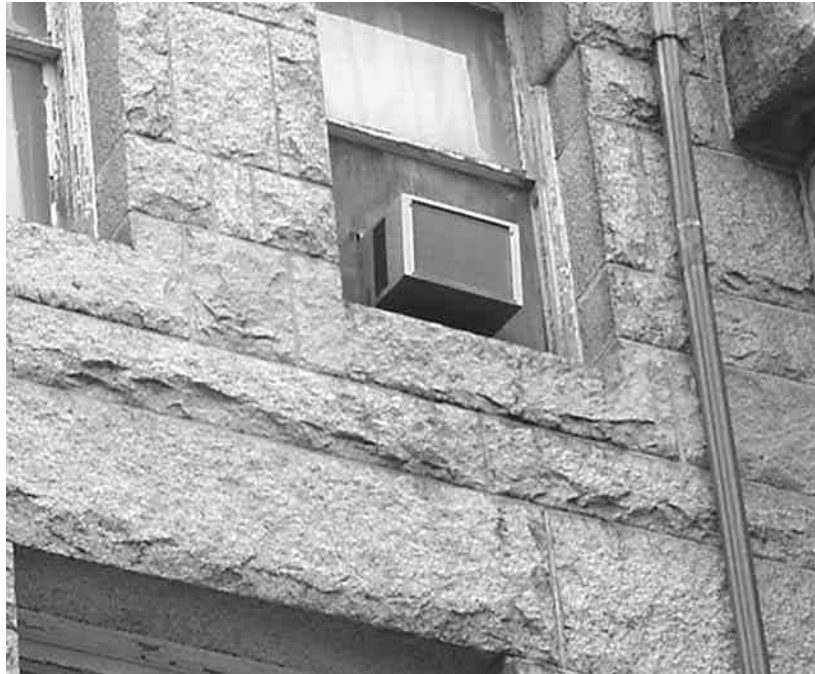
Picture 10

Office room 62, which is located at the rear of the northwest corner of the third floor, has an air conditioner installed in a west-facing window (Picture 10). The flat-topped surface of the air-conditioning cabinet can accumulate water, subsequently wetting the wood frame used to support the air-conditioner. As reported by building occupants, this particular room has experienced water penetration, as evidenced by water damaged to the original plaster walls. In an effort to refinish the walls, a gypsum wallboard (GW) material was installed over the water-damaged materials (Picture 11). It is unclear whether the water leaks damaging the wall plaster were remediated. GW can be susceptible to mold growth if moistened repeatedly and/or not dried within 24 to 48 hours.

Exterior View of Air-Conditioner Installed In West Facing Wall of Room 62, Note Weathering Of Wood Used To Install the Air Conditioners

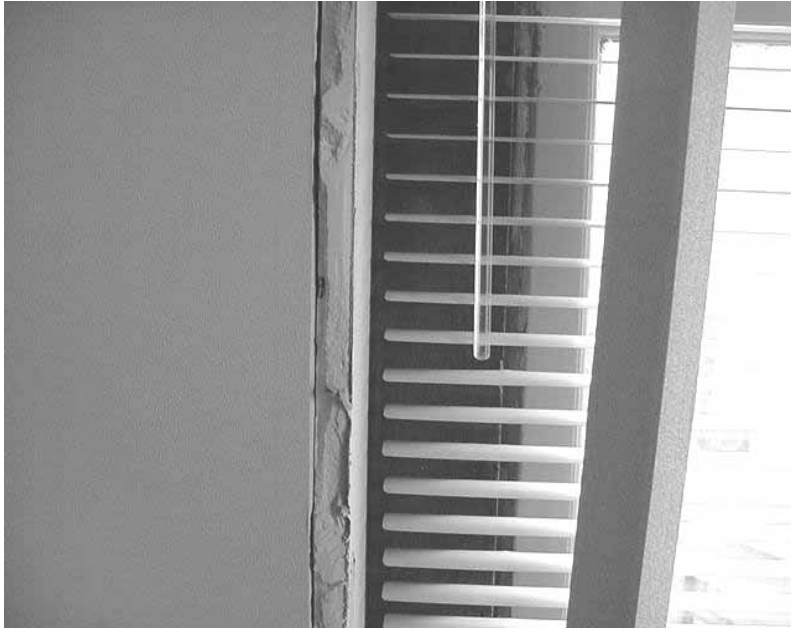
Picture 11

Gypsum Wallboard (GW) Material Was Installed Over the Water Damaged Materials

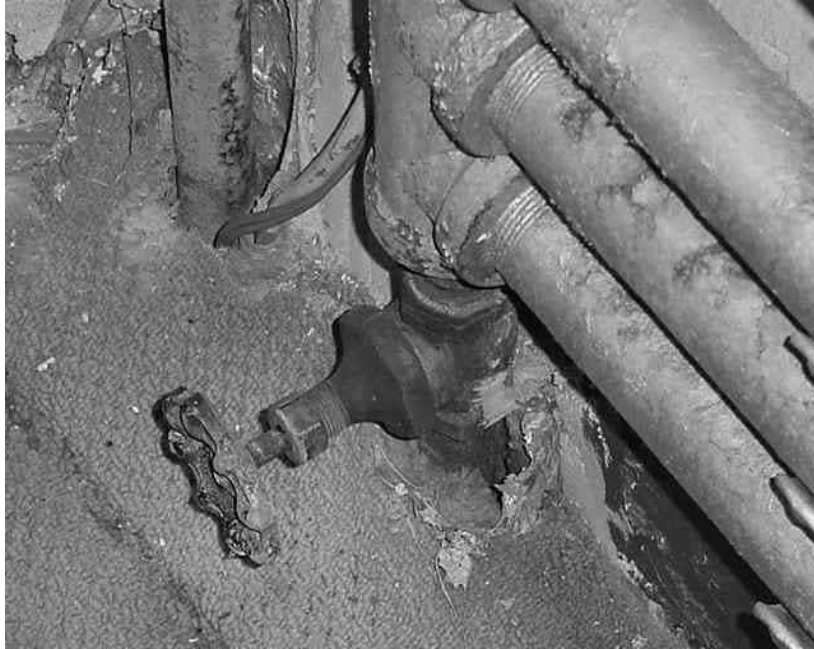
Picture 12

A musty odor was noted in an office located at the rear of the northeast corner of the third floor; however, no apparent water damage was observed. A musty odor was also noted on the second floor. The odor was traced to office room 17, which had experienced a radiator leak that flooded the second floor office and soaked the carpet. The radiator leak was repaired, but the water-damaged carpet was left in place. Upon entering the office, a distinct musty odor was detected from the carpet beneath the radiator (Picture 12). It appears that the musty odor from the second floor office was migrating into the third floor office through holes around the radiator pipes. As with other porous materials, the American Conference of Governmental Industrial Hygienists (ACGIH) and the U.S. Environmental Protection Agency (US EPA) recommends that carpeting be dried with fans and heating within 24 to 48 hours of becoming wet (ACGIH, 1989; US EPA, 2001). If carpets are not dried within this time frame, mold growth may occur. Water-damaged carpeting cannot be adequately cleaned to remove mold growth.

Room 17 Water Damaged Carpet, Likely From Heating System Steam Leak

1. Remove water-damaged carpeting from offices in a manner consistent with recommendations found in Mold Remediation in Schools and Commercial Buildings published by the US Environmental Protection Agency (US EPA, 2001). Copies of this document can be downloaded from the US EPA website at: http://www.epa.gov/iaq/molds/mold_remediation.html. If moldy, disinfect areas of floor underneath water-damaged carpeting with an appropriate antimicrobial.

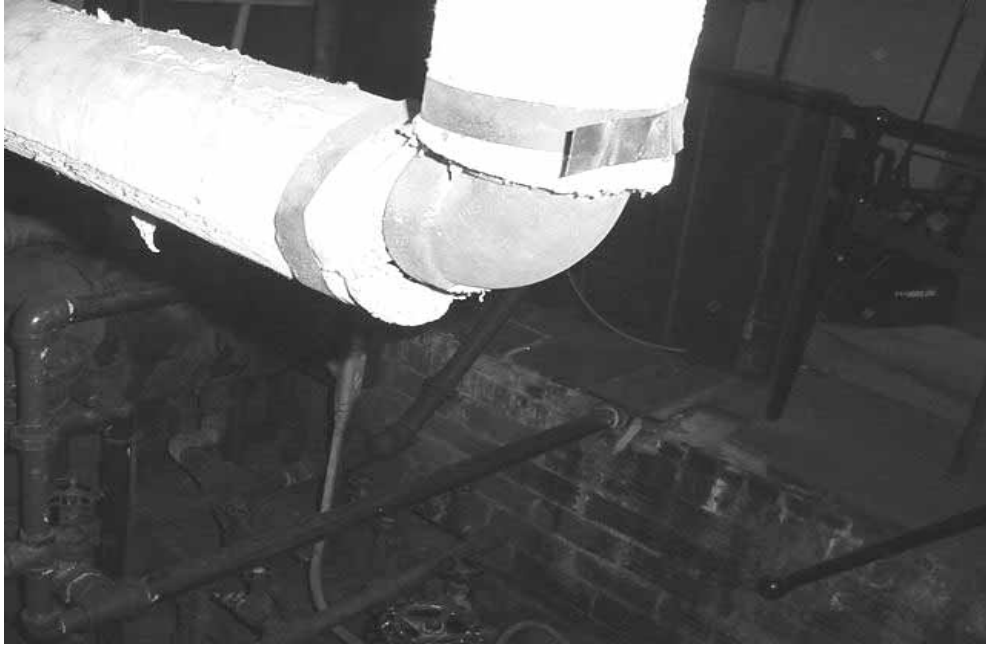
Picture 13

A pipe joint with exposed insulation that consists of a white, powdered material was found in the basement (Picture 13). The material may contain asbestos and, if so, should be remediated in conformance with all applicable Massachusetts asbestos abatement and hazardous materials disposal laws.

A Pipe Joint with Insulation That Consists Of a White, Powdered Material Was Found In the Basement
