# **INDOOR AIR QUALITY REASSESSMENT**

**James Leo McGuinness Administration Building  
Lynn Public Schools  
14 Central Street  
Lynn, Massachusetts**

Prepared by:  
Massachusetts Department of Public Health  
Bureau of Environmental Health Assessment  
July, 2002

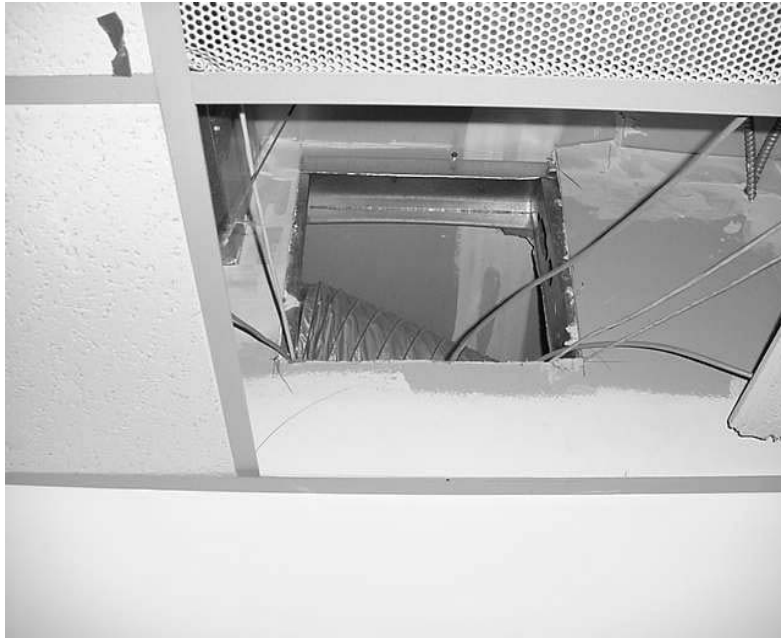
**Picture 2**

Of note was the condition of the return vent in the east office of the south corner of the first floor. Carbon dioxide levels in this room were approximately 100 ppm higher than adjacent rooms (see Tables). Each office has a hole cut into the gypsum wallboard (GW) above the doorway, which serves as the means for air to return from the office to the ceiling plenum via a plastic ceiling grate (see Picture 1). Almost half of the “return hole” for the east office is blocked by a flexible duct used as supply vent for the west office in the south corner of the building (see Pictures 2 and 2A). This blockage can serve to reduce air supply and pollutant removal from the east office on the first floor.

**Return Hole For The East Office - 50 Percent Blocked By A Flexible Duct**

1. To prevent uncontrolled water vapor penetration into the building, it is not recommended that windows be opened during hot, humid weather.
2. Expand the size of the hole in GW for the east office in the south corner of the first floor.

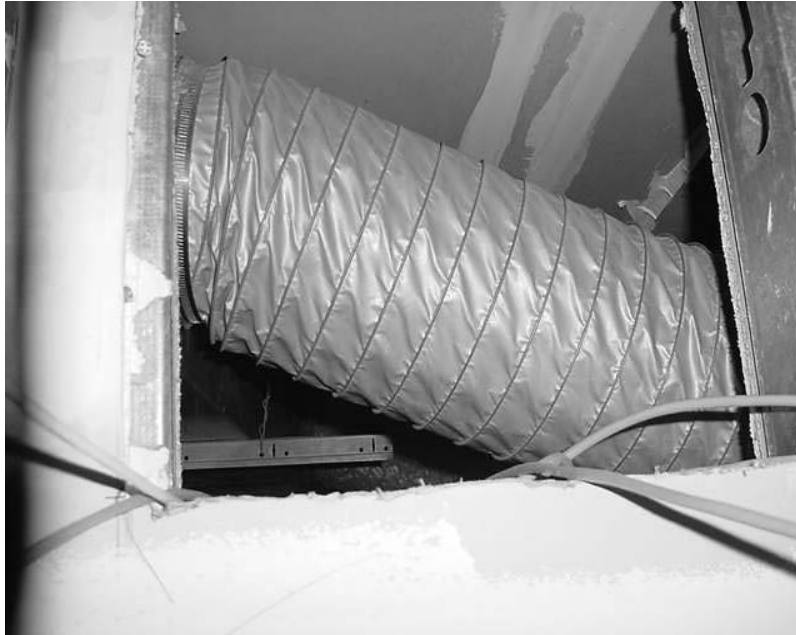
**Picture 2A**

**Return Hole For The East Office - 50 Percent Blocked By A Flexible Duct  
(view at same level as return hole)**

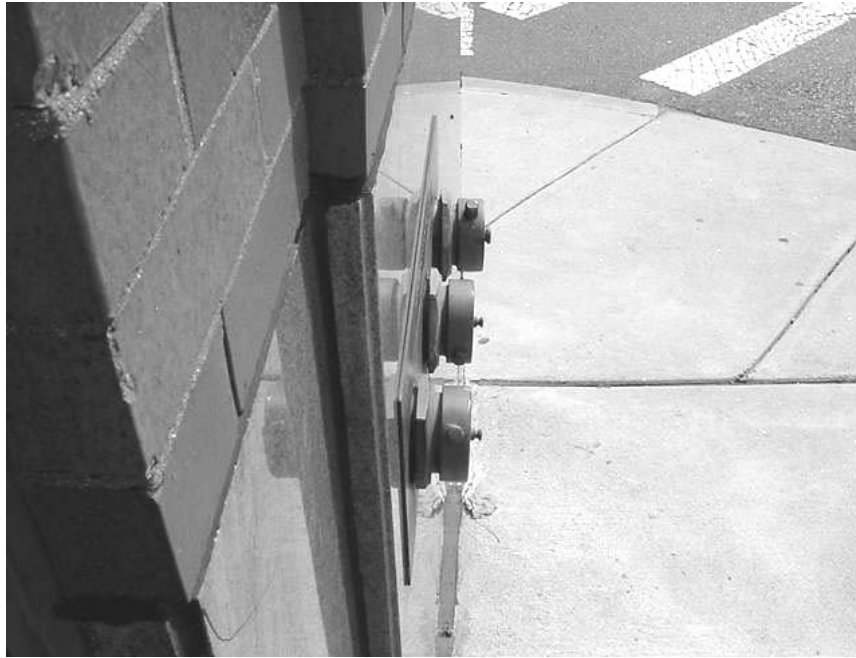
**Picture 3**

The east office in the south corner of the first floor of the building contains fire standpipes that traverse the exterior wall (see Picture 3). The standpipes are housed within a cabinet constructed of GW (see Picture 4). The seam between the stand pipe

fixture and stone slab of the exterior wall does not have any sealing compound to prevent water penetration behind the plate. This condition may allow moisture to migrate to the interior of the cabinet along the pipes. The condition of the cabinet along the exterior wall/pipe junction could not be examined due to the configuration of the cabinet. Since materials that can support microbial growth (e.g., GW) exist in this cabinet, it is suggested that the interior of the cabinet be opened for examination.

**Fire House Standpipe on Exterior Wall**

4. Apply an appropriate sealing compound to the fire standpipe plate/exterior wall junction to prevent water penetration.
5. Do not relocate materials stored in the basement into occupied areas. In areas where this occurred, use a high efficiency particulate arrestance (HEPA) filtered vacuum cleaner to remove residues that may have contaminated surfaces.

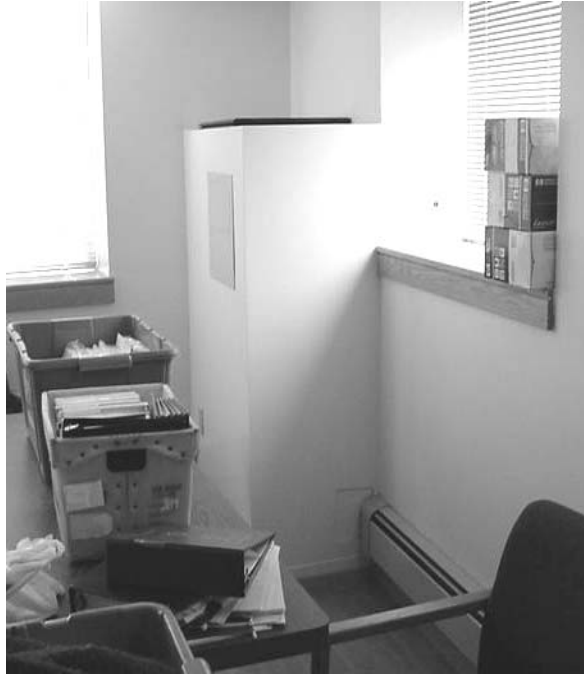
**Picture 4**

**Cabinet Concealing Fire House Standpipe**

3. Open the interior of the fire standpipe cabinet in the east office in the south corner of the first floor and examine for water damage. If water damaged materials exist, replace. Consider installing a cabinet sized, removable grate in the side of the cabinet to allow for inspections and access to pipes.

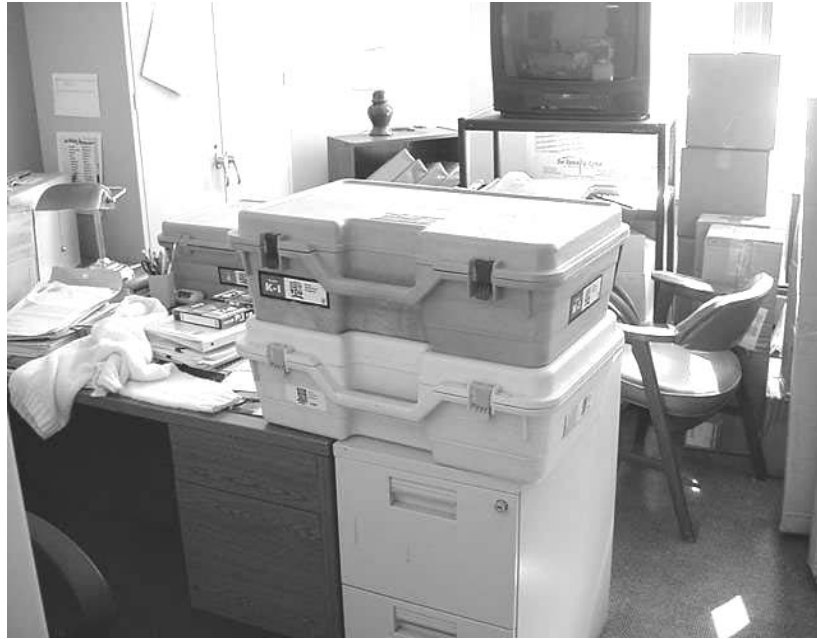
**Picture 5**

One of the primary concerns which prompted BEHA involvement was related to mold concerns. During the course of the assessment on March 5, 2002, LPS personnel reported that materials that were previously housed in the basement were moved to a fourth floor office for examination. Since materials previously stored in the basement could carry residue of mold growth, it is not recommended that any more materials be removed from the basement to occupied areas in upper floors to prevent cross contamination. Please refer to Recommendations section of this report for advice concerning handling of possible mold-contaminated materials.

**Plastic Container with Stored Materials**

6. For material sealed in non-porous containers (plastic cases), wipe the outside of these boxes with a soap and water solution prior to transport from the basement.

7. Open plastic containers in an area that is well ventilated.
8. Do not store large amounts of cardboard boxes in occupied offices.
9. Examine the feasibility of creating a photocopying room with dedicated local exhaust ventilation to remove particles, waste heat, ozone and TVOCs. Do not use the Risograph<sup>®</sup> unless it can be used in a well-ventilated area. Store Risograph<sup>®</sup>-printed materials in an area that has adequate ventilation to remove/dilute evaporating TVOCs.

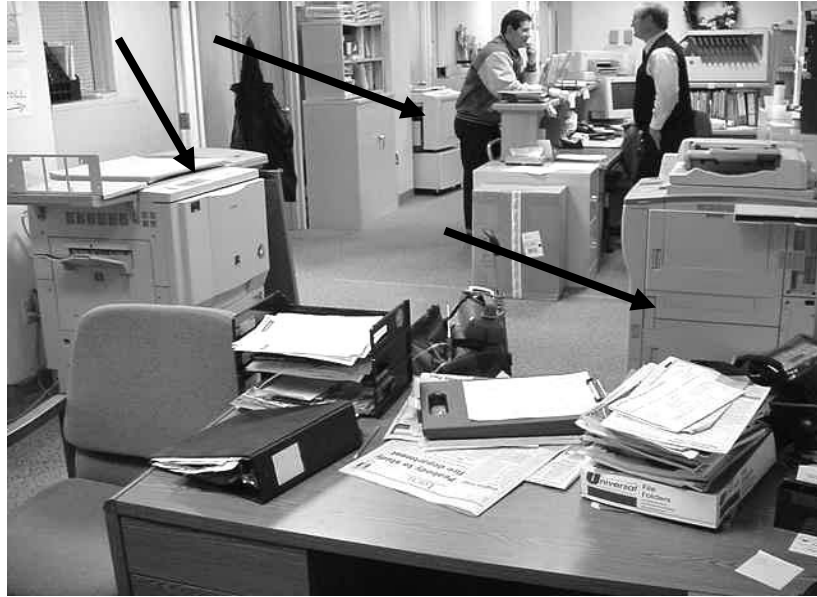
**Picture 6**

Located in and around the work area adjacent to the 4<sup>th</sup> floor elevator foyer are a number of photocopying machines (see Picture 6). No local exhaust ventilation for the photocopiers exists. A single plastic grill in the ceiling serves as the return vent for this area. Of note is that at least one printer (Risograph<sup>®</sup>) uses a liquid toner. This product contains petroleum distillate, which is a VOC (see Pictures 7 and 8). TVOC measurements taken from paper printed from this machine produced measurable levels in

a range of 0.8 ppm to 1.3 ppm, but again, these results did not exceed levels of health concerns. Photocopiers can also produce VOCs and ozone, particularly if the equipment is older and in frequent use. VOCs and ozone are respiratory irritants (Schmidt Etkin, D., 1992). It is recommended that local separate exhaust systems that do not recirculate into the general ventilation system be used (US DOE, unknown).

**Cluster Of Photocopiers In The 4<sup>th</sup> Floor Elevator Foyer Area**

10. If a photocopier room is not feasible, consider dispersing or reducing the number of photocopiers around the 4<sup>th</sup> floor elevator foyer.
11. Examine the feasibility of increasing fresh air provision to the 4<sup>th</sup> floor elevator foyer.

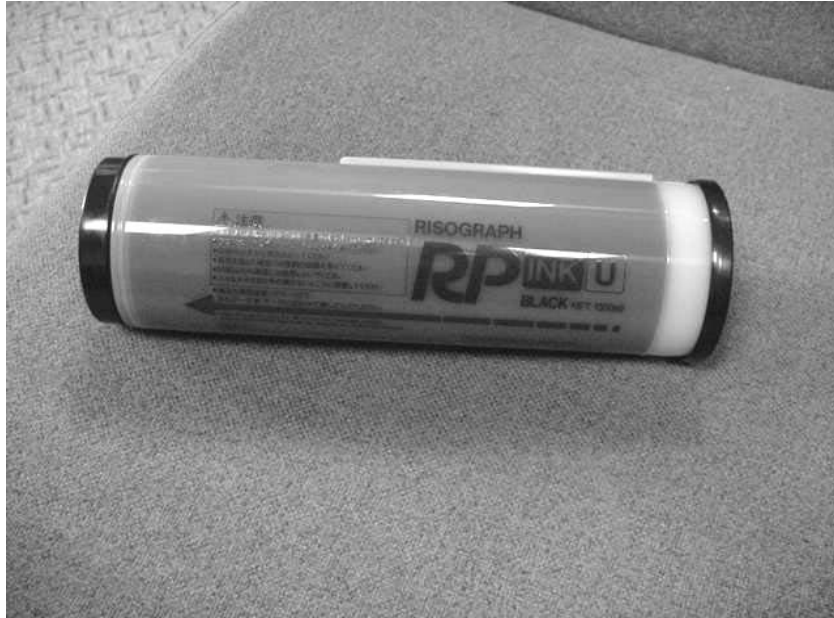
**Picture 7**

**Container of Risograph® Toner**

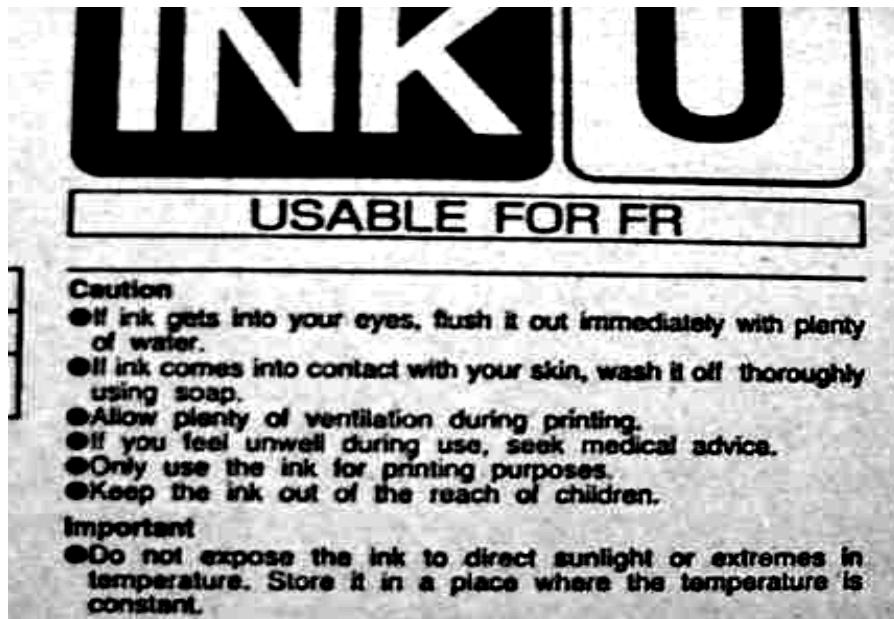
Picture 8

Instructions on Risograph<sup>®</sup> Toner, Note Third Instruction from Top of List
