INDOOR AIR QUALITY ASSESSMENT

**Beachmont School
15 Everard Street
Revere Massachusetts**

Prepared by:
Massachusetts Department of Public Health
Bureau of Environmental Health Assessment
Emergency Response/Indoor Air Quality Program
March 2003

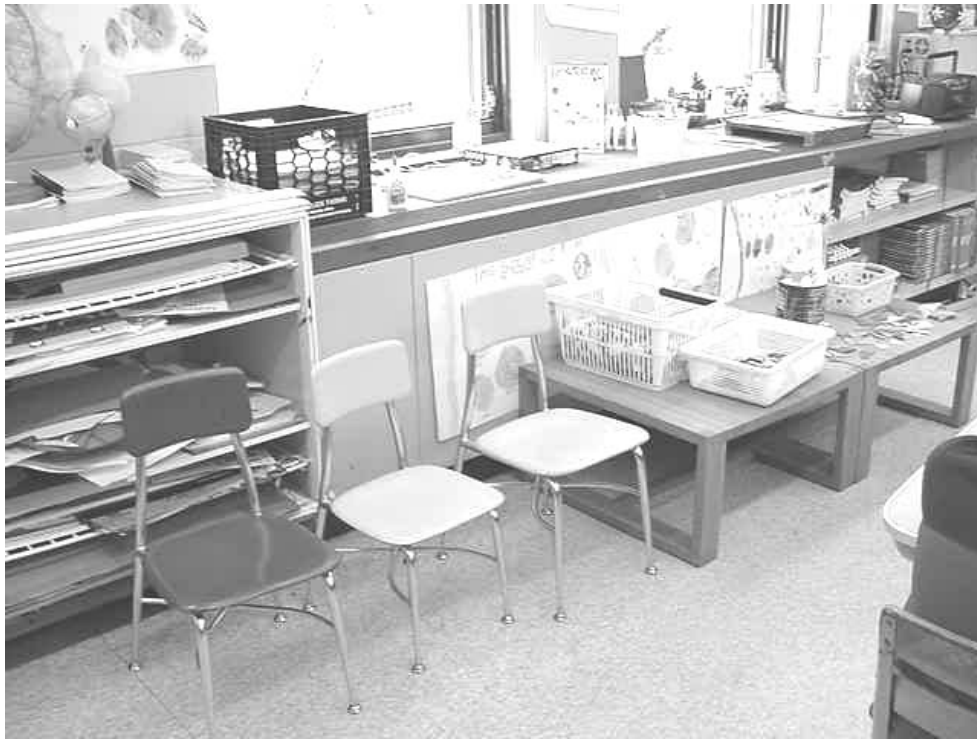
Picture 1

ventilator (univent) system (see Picture 1). Univents draw air from outdoors through a fresh air intake located on the exterior walls of the building and return air through an air intake located at the base of each unit (see [Figure 1](#)). Fresh and return air are mixed, filtered, heated and provided to classrooms through a fresh air diffuser located in the top of the unit. Univents have three controls: low, high and off. Obstructions to airflow, such as papers and books stored on univents and bookcases, carts and desks in front of univent returns were seen in a number of classrooms (see Picture 2). In order for univents to provide fresh air as designed, intakes must remain free of obstructions.

Classroom Univent

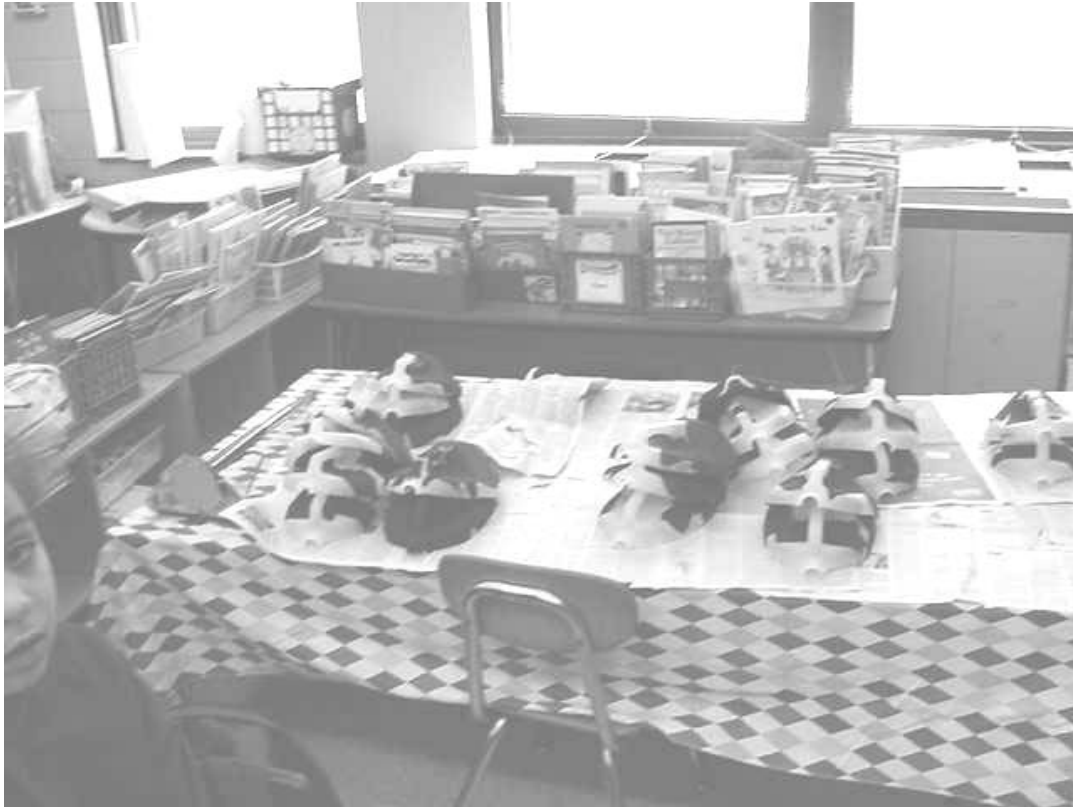
Picture 2

Classroom Univent Obstructed by Various Items

8. Inspect exhaust motors and belts for proper function, repair and replace as necessary.
9. Remove all blockages from univents and exhaust vents.

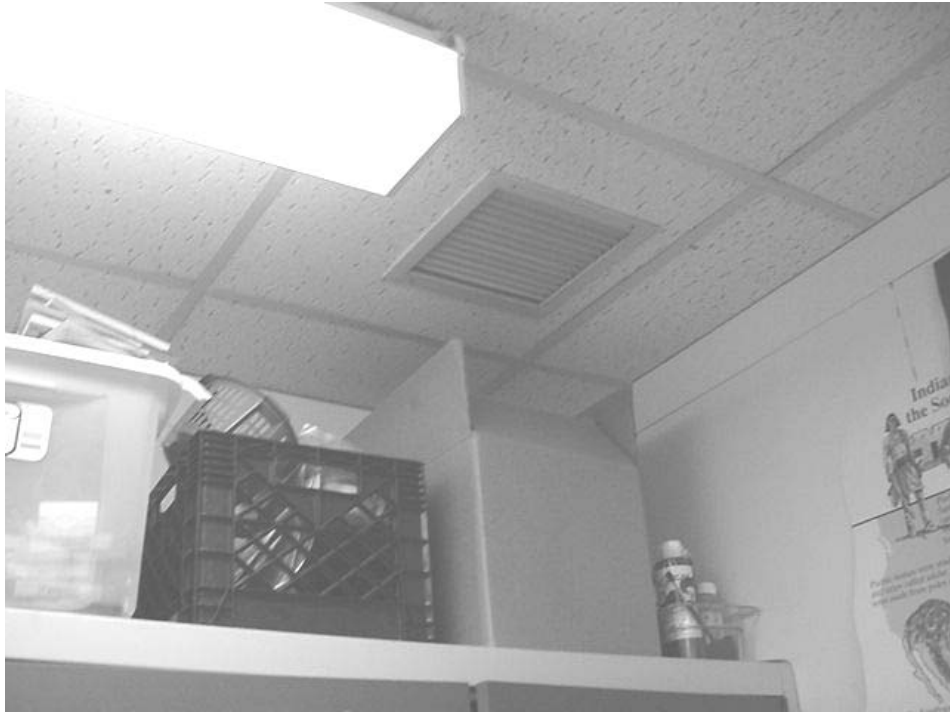
Picture 3

Exhaust ventilation in classrooms is provided by a mechanical system. The exhaust system in each classroom consists of grated ceiling vents (see Picture 3) connected via ductwork to rooftop motors. No draw of air was detected in several of the classroom vents, which indicates that they were either deactivated or that rooftop motors were inoperable. Without exhaust ventilation functioning properly, environmental pollutants can build up and lead to indoor air quality/comfort complaints. Mr. Ciarlone stated that work to repair the rooftop exhaust motors was to begin within the next several weeks. [Note: Subsequent to the BEHA staff visit, Honeywell, an HVAC firm reportedly visited the building and determined that at least 10 of the rooftop exhaust motors were not operating]. Univents were also reportedly cleaned out; filters changed and outside air intake was increased.

Classroom Exhaust Vent

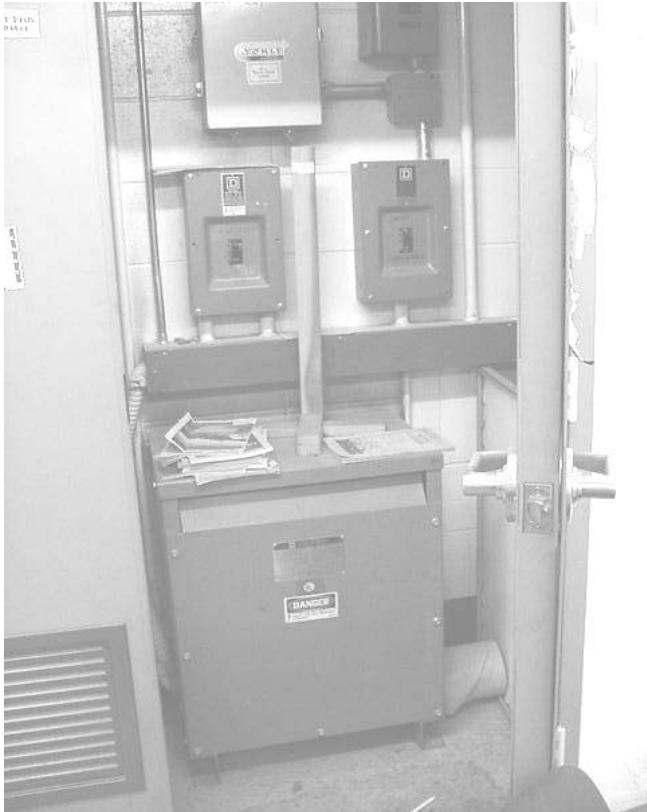
Picture 4

Specific heat complaints were expressed in room 120, which is an interior room that has no windows to supplement mechanical ventilation. Room 120 also contains a mechanical closet with louvered doors containing heat-generating machinery with no local exhaust vent (see Picture 4). Without exhaust ventilation, heat from this equipment can raise the temperature within room 120 independent of the HVAC system. This type of equipment was not found in other classrooms.

Heat Generating Electrical Equipment in Mechanical Closet in Classroom 120

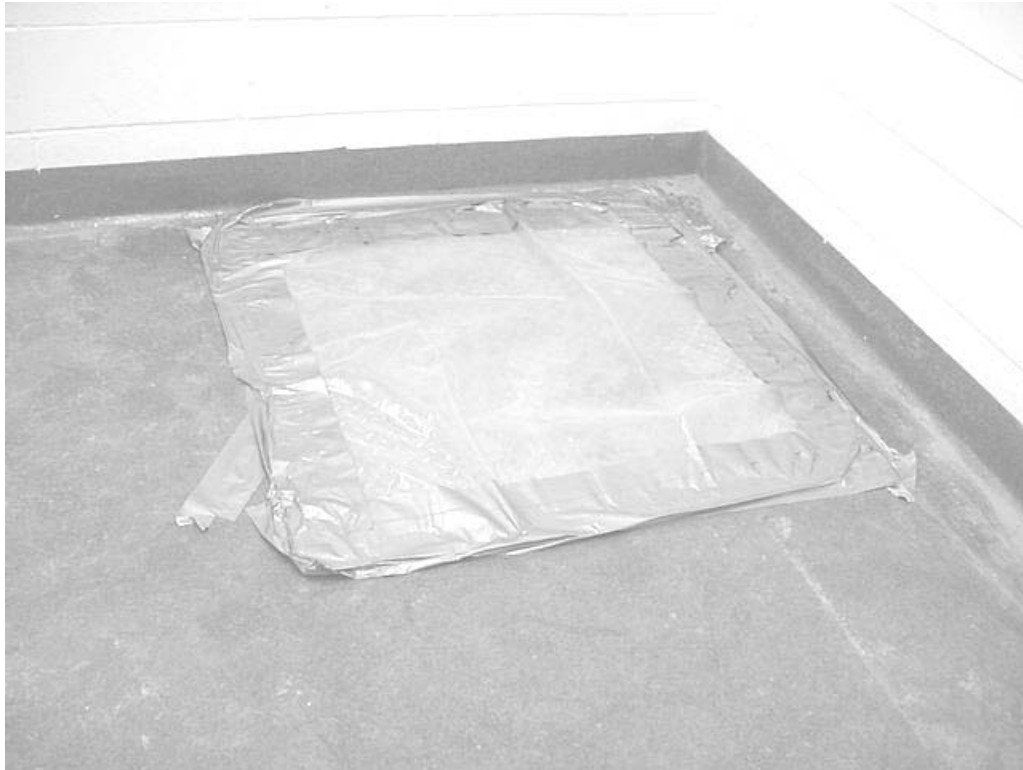
Picture 5

Crawlspace Access Hatch (Room 123) Sealed with Plastic and Duct Tape, Note Crawlspace is Sealed inside as well

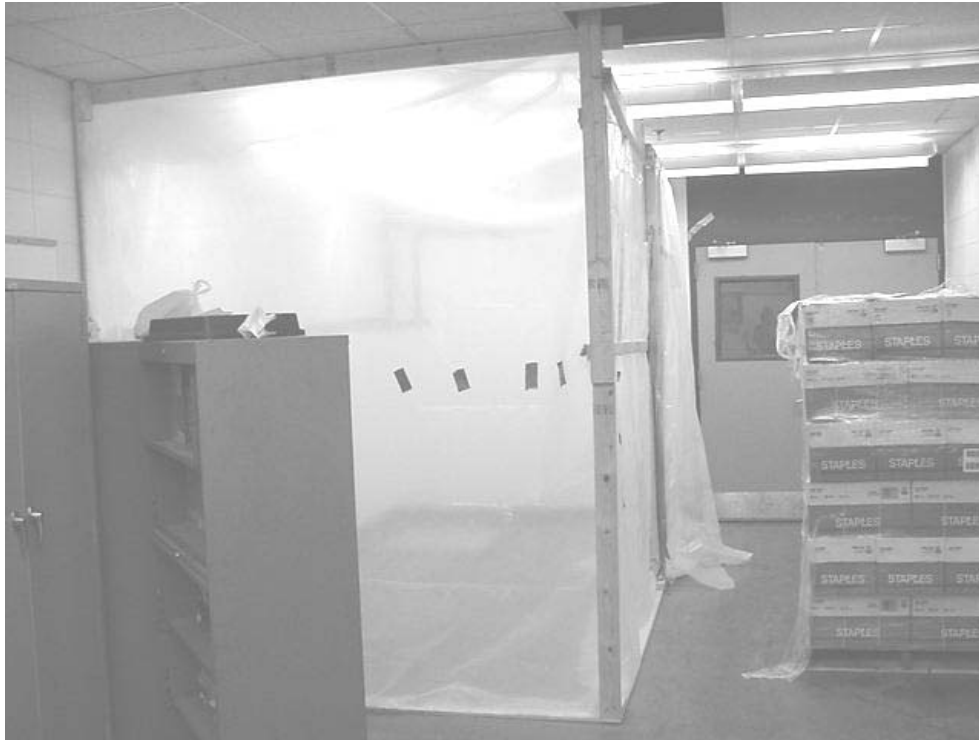
Picture 6

Containment Walls Constructed around Crawlspace Hatch in Room 123

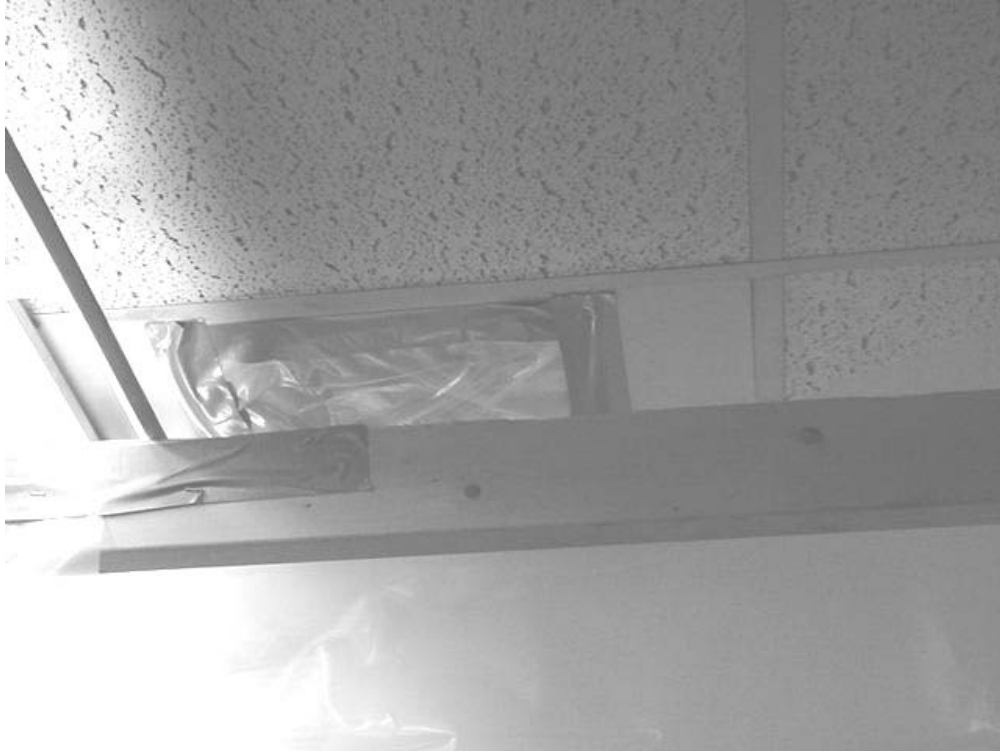
Picture 7

Ceiling Vent Sealed with Plastic and Duct Tape in Classroom 123

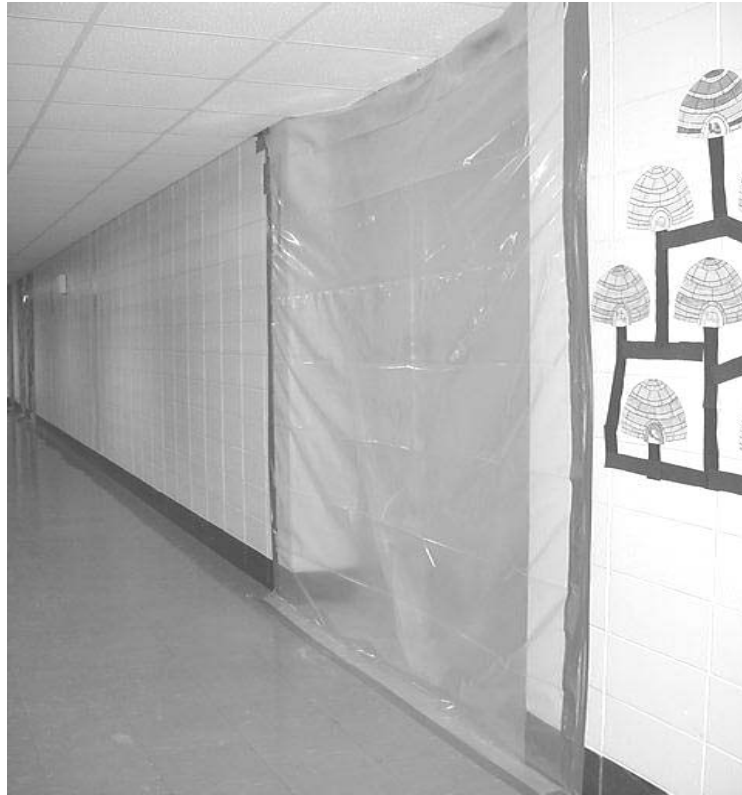
Picture 8

Plastic Poly Containment Wall, Note also Sealed on Interior Side

4. Continue with current methods of isolating areas of heavy odor detection with polyethylene plastic barriers. Consider creating dual barriers by installing polyethylene on both sides of the barrier. Inspect these areas regularly for integrity as remediation efforts progress.

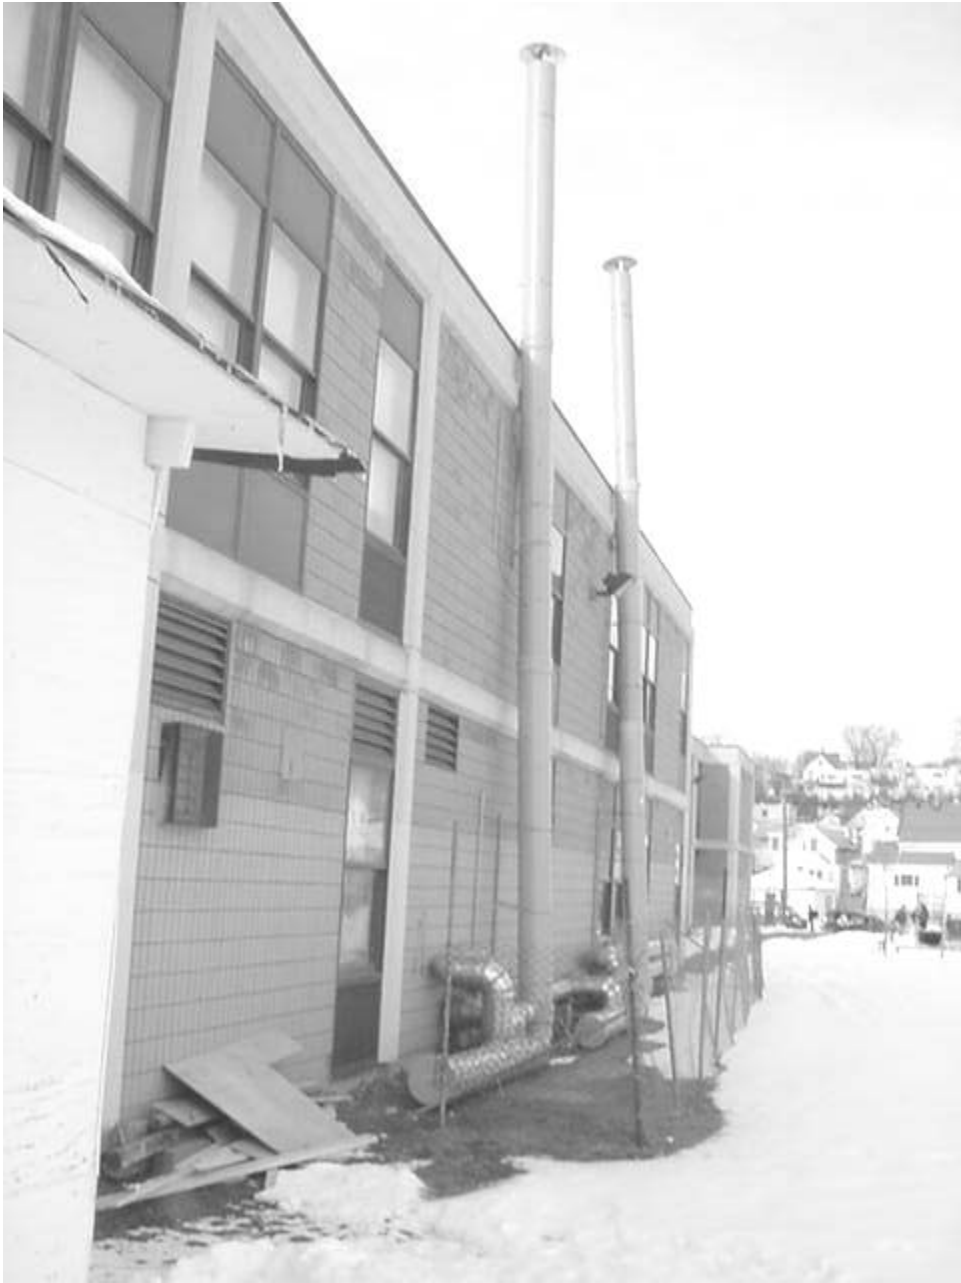
Picture 9

As discussed, this assessment was initiated due to concerns of symptoms believed to be related to petroleum odors in the building. To prevent the fuel odor migration, barriers of polyethylene plastic were used to seal the crawlspace as well as any areas impacted by the fuel release that had a strong oil odor, including the gymnasium and locker rooms (see Pictures 5-8). To draw odors away from occupied areas, local mechanical ventilation was installed in the crawlspace and hard ducted up the side of the building to a height of approximately 12 feet above the top of the roof (see Picture 9).

Crawlspace Ventilation System

1. Continue working with MADEP, ECS Marin and Commonwealth Tank to evaluate, optimize and upgrade sub-slab mechanical ventilation system.
