Appendix I

Actions on Previous BEHA Recommendations

The following is a status report of action(s) taken on previous BEHA recommendations (**in bold**) based on reports from building staff, documents, photographs and BEHA staff observations.

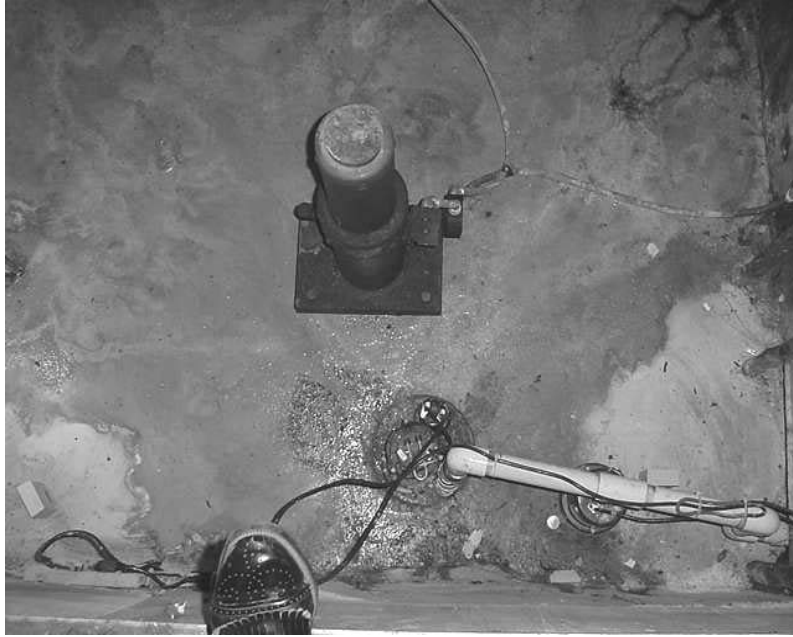
Picture 1

2. **Continue with plans to remediate the elevator shaft water accumulation. Prior to the release of this report, RMR (Reit Management & Research) reported that a mason was contacted to repair the masonry in the base of the elevator shaft. RMR also reported that a drain in the elevator floor was located and cleared of clogs.**

Floor Of Elevator Shaft Was Free Of Pooling Water

Action Taken: Floor of elevator shaft was free of pooling water (see Picture 1). Some water penetration continues to exist, but is removed from the floor by the drain.

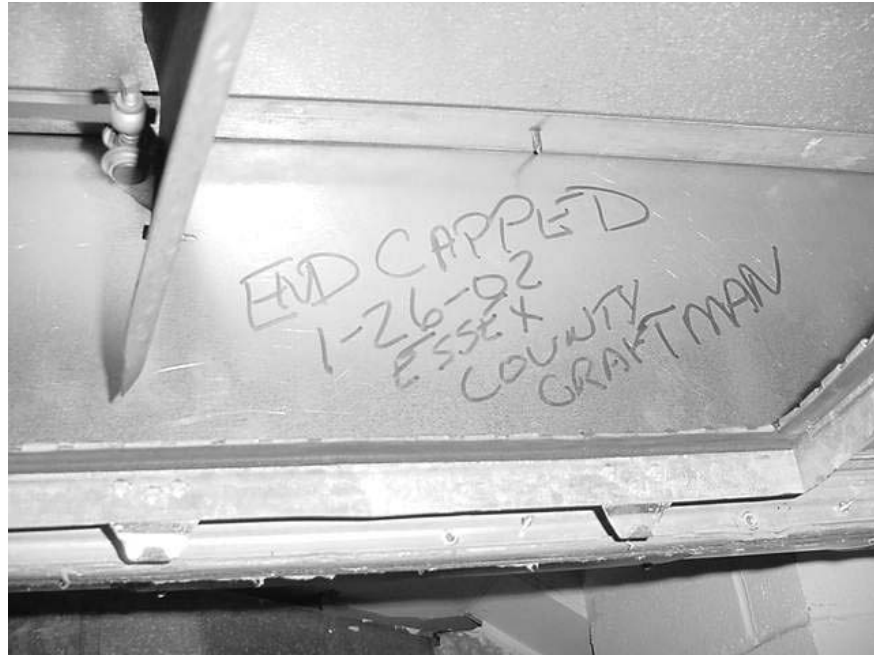
Picture 2

- 4. Continue with efforts to separate the building's HVAC system from the basement record storage area.**

Sheet Metal Installed In Duct to Prevent Basement Draw

Action Taken: Vents connecting the basement to the buildings HVAC system were sealed (see Pictures 2 and 3).

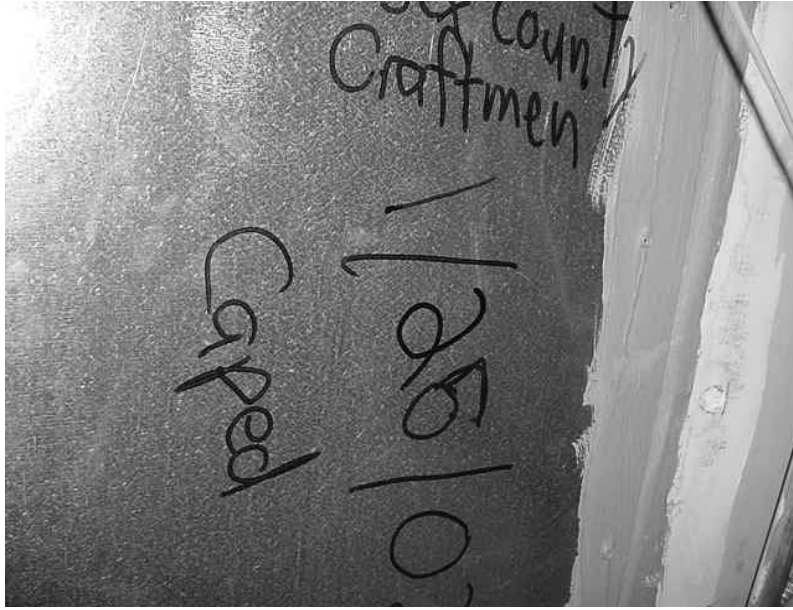
Picture 3

Sheet Metal Installed In Another Duct to Prevent Basement Draw

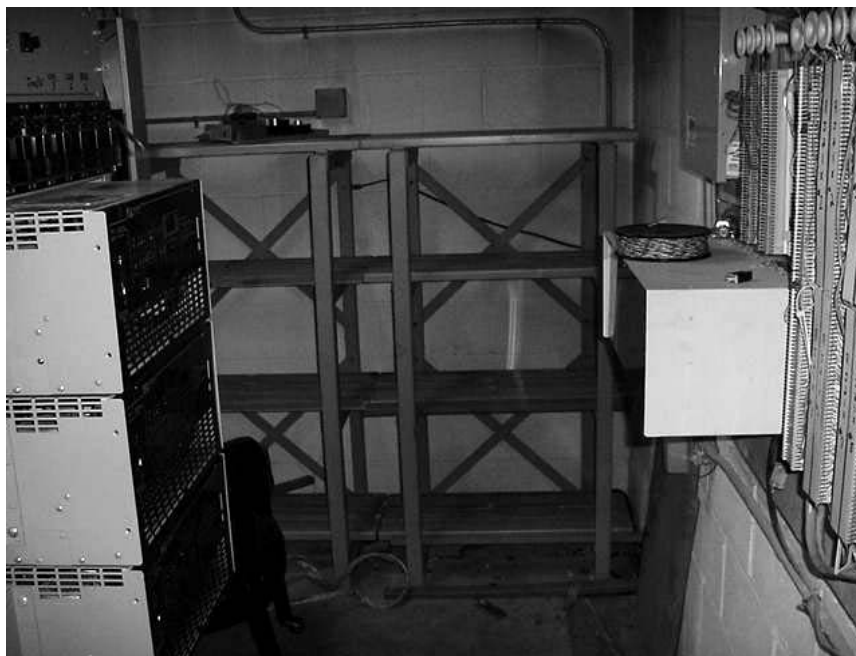
Picture 4

- 5. Remove leaking batteries from the basement.**

Batteries Were Removed From Basement

Action Taken: Batteries were removed from basement (see Picture 4).

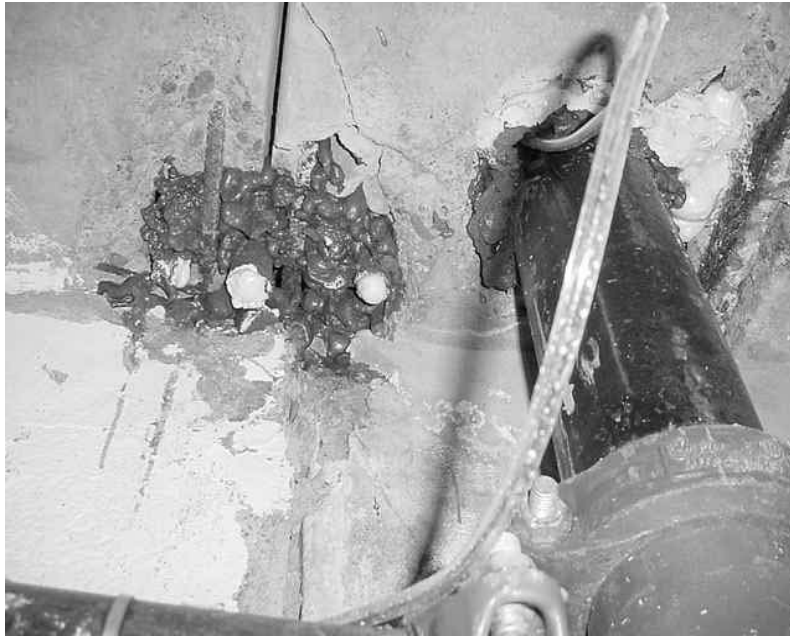
Picture 5

- 8. Seal all abandoned pipes entering into the basement from the outdoors. Seal all pipe, conduit and other penetrations through the basement ceiling that penetrate into the 1st floor office space.**

Pipes and Other Holes in the Basement Ceiling Were Sealed With Expanding Foam

Action Taken: Pipes and other holes in the basement ceiling were sealed with expanding foam (see Pictures 5 and 6 for examples).

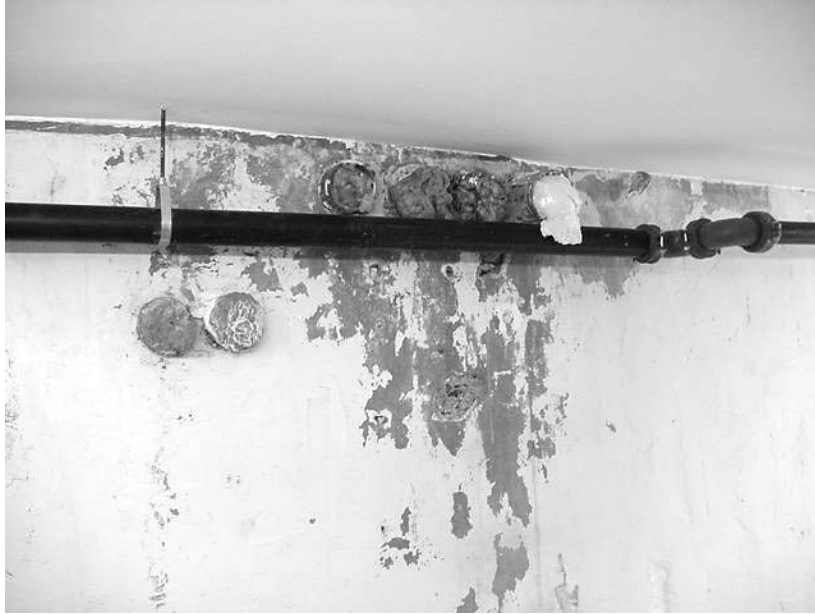
Picture 6

Pipes and Other Holes in the Basement Ceiling Were Sealed With Expanding Foam

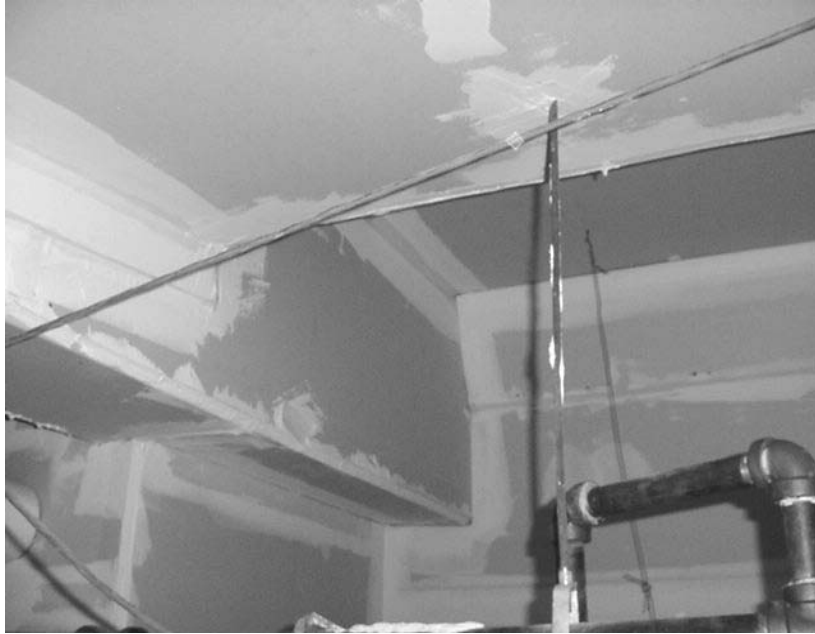
Picture 7

- 12. Removal of the water damaged GW above the 6th floor foyer should be considered. Consult a building engineer as to what materials may be used other than GW to provide fire resistance.**

Replaced Gypsum Wallboard above 6th Floor Elevator Lobby

Action Taken: GW was removed and replaced (see Picture 7).

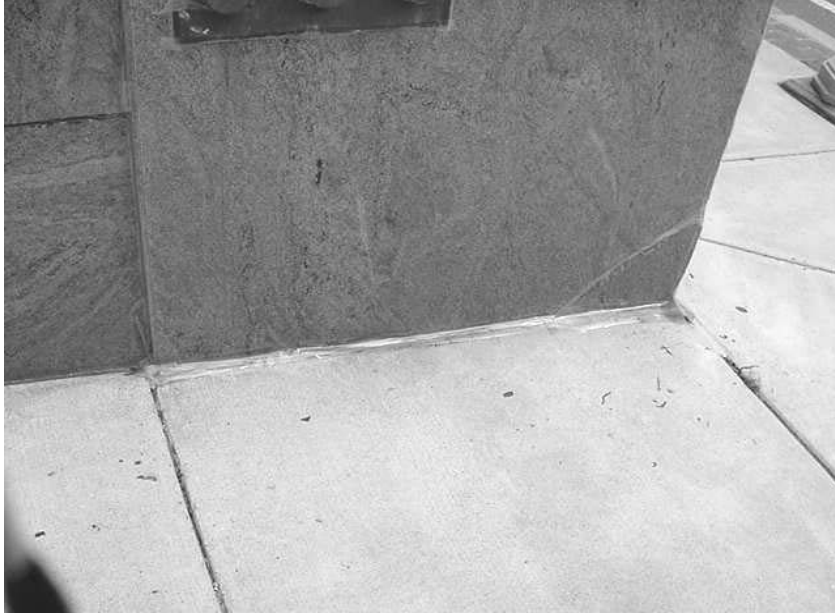
Picture 8

- 13. Consult a building engineer to examine options for repairing the seal in the granite exterior wall system. Repairs may include replacement of damaged slabs.**

Sidewalk/Exterior Wall Seam Under Repair

Action Taken: Seams in the granite exterior wall system were replaced. Repairs were made on holes. Reit Management planned further repair work on holes in granite slabs (see Picture 8).

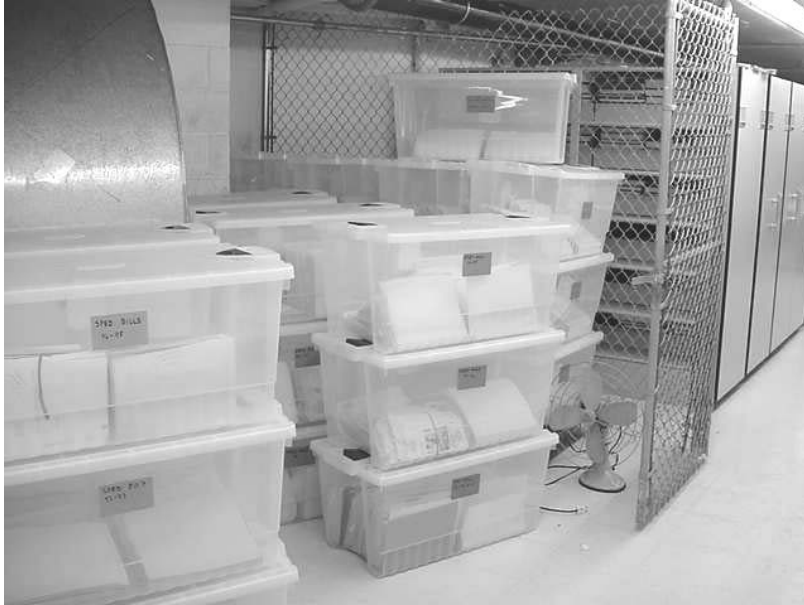
Picture 9

- 14. Consult a building engineer as to the best method for preventing or minimizing water penetration through the foundation.**

Records Sealed Within Airtight Plastic Boxes to Prevent Moisture Exposure

Action Taken: Repair of the granite exterior wall system and removal of peeling paint were the remediation methods used. In addition, porous materials (e.g., paper records) were sealed within airtight plastic boxes to prevent moisture exposure (see Picture 9). Other porous materials were removed from the basement.
