# **INDOOR AIR QUALITY REASSESSMENT**

**Norfolk Probate Court  
649 High Street  
Dedham, Massachusetts**

Prepared by:  
Massachusetts Department of Public Health  
Bureau of Environmental Health Assessment  
April, 2002

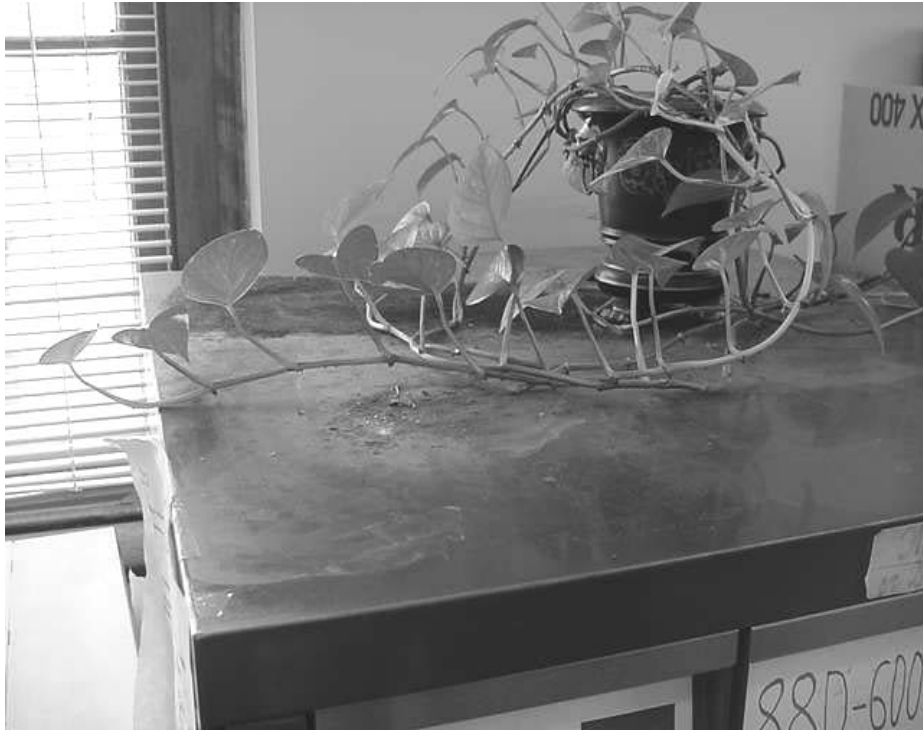
**Picture 1**

**Plants Were Found In Offices**

**Action Taken:** Plants were still observed in offices (see Picture 1).

3. Reduce excessive numbers of plants in offices.
4. Seal ceiling plenum in the Family Court office on the second floor of the south wing addition.
5. Repair and activate the univents in the 3rd session courtroom.
6. Continue to prohibit vehicles from idling in the courtyards.
7. If products containing hazardous materials must be used in the courthouse in the microfilm department, please consider following these recommendations to ensure the safe handling and application of these products:
  - (a) Make sure that the directions that are listed on the product label are followed explicitly. Failure to follow directions may result in misuse, which can lead to exposures.
  - (b) Ensure that all personnel in the building who use these products are properly trained. Training in handling these materials is mandated by the Massachusetts Right-To-Know Law, M.G.L. c. 111F (M.G.L., 1983).

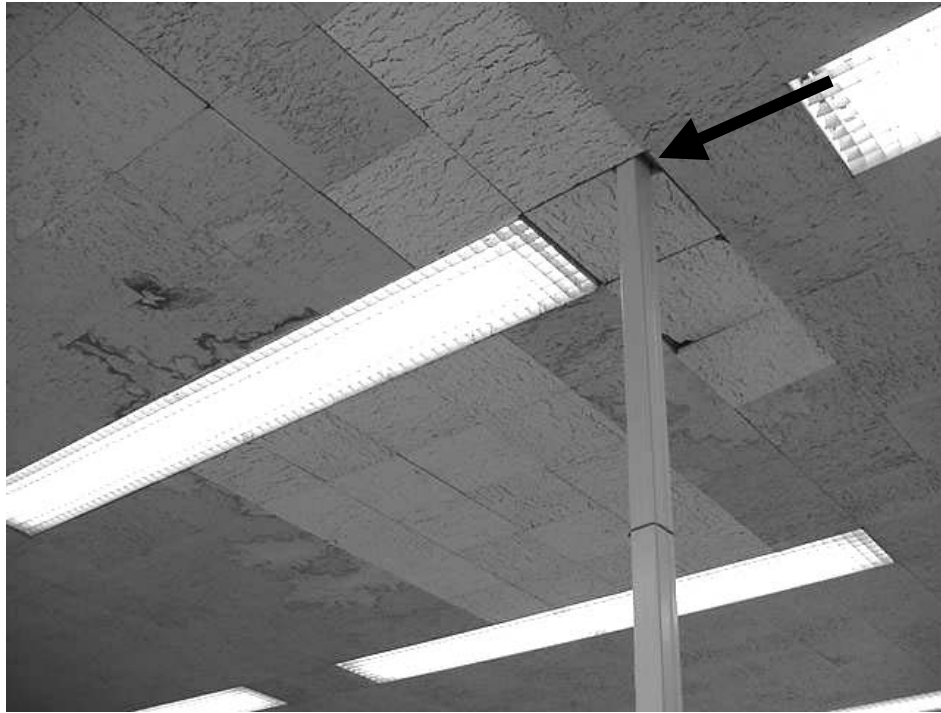
**Picture 2**

**Spaces Continue to Exist in This Ceiling – Family Court Office, 2<sup>nd</sup> Floor**

**Action Taken:** Spaces continue to exist in this ceiling (see Picture 2). Of note is the condition of the ceiling tile system in this office and water damage (for further discussion, refer to the **Moisture/Microbial Concerns** of this report).

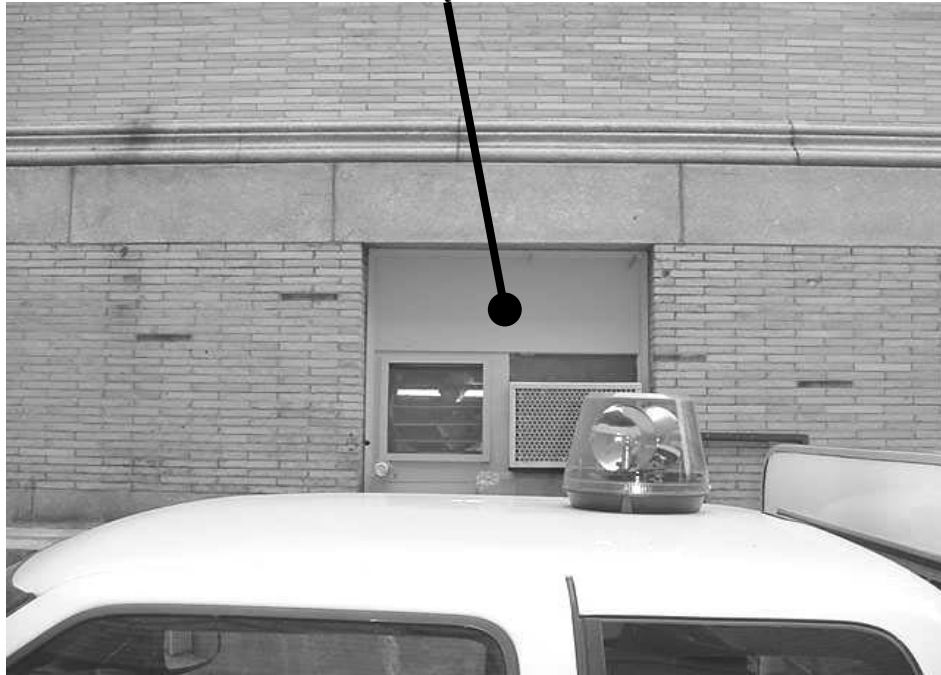
**Picture 3**

**Formerly Cardboard**

**Cardboard Replaced With Plywood**

**Action Taken:** Cardboard was removed and replaced (see Picture 3).

**6. Replace cardboard and other inappropriate materials sealing fresh air intakes with a water impermeable material.**

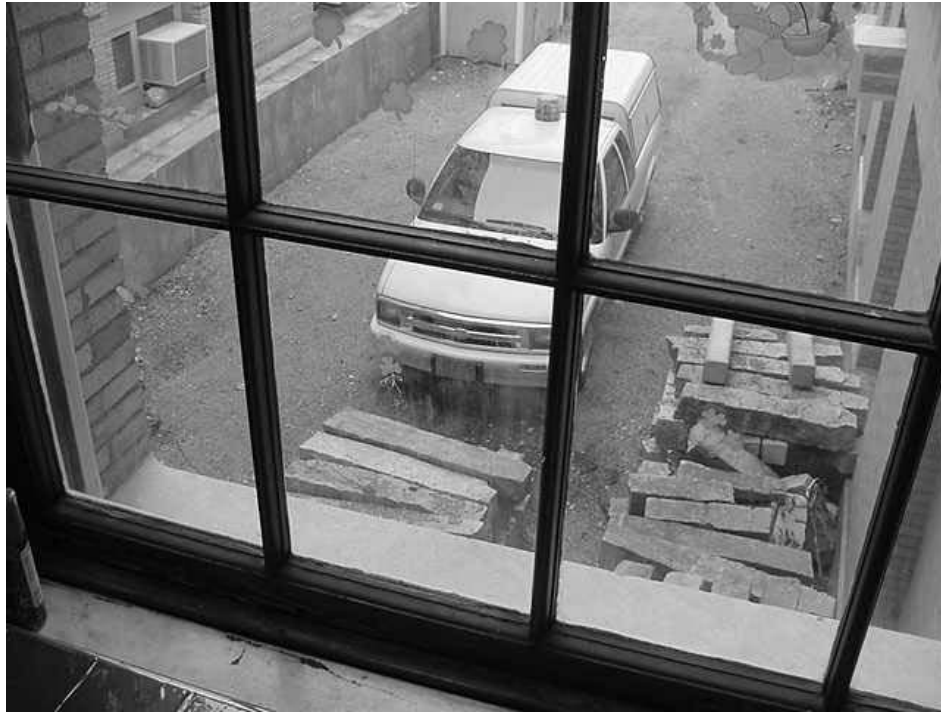
**Picture 4**

**Courtyard Used For Parking**

**Action Taken:** No idling vehicles were found in the courtyards. These areas are used for parking (see Picture 4).

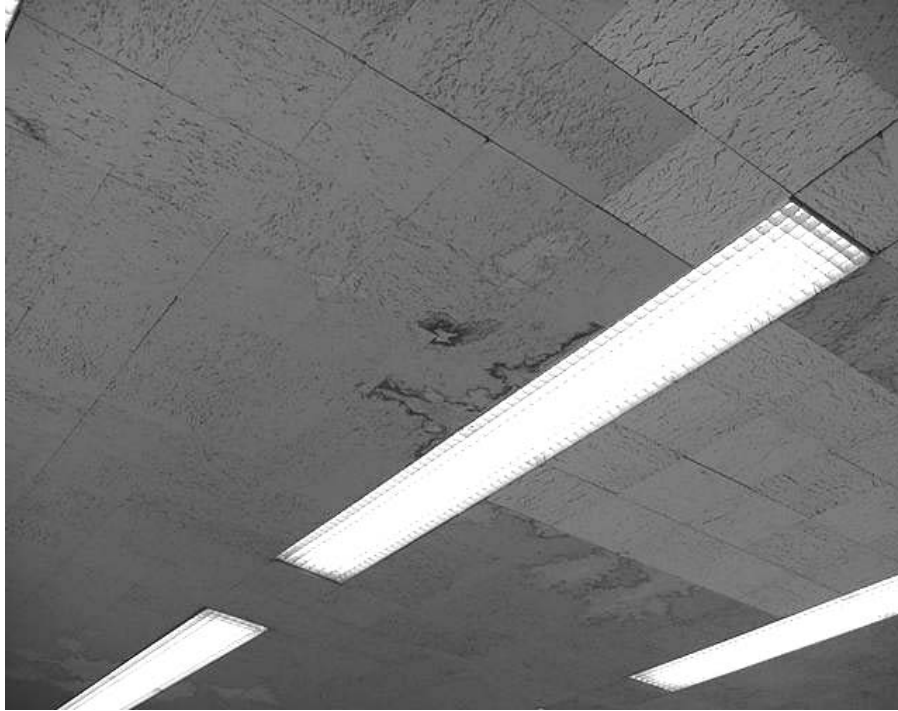
**Picture 5**

The Family Court office on the second floor of the south wing addition has a significant number of water-damaged ceiling tiles, which are evidence of historical roof leaks. Ceiling tiles were replaced in this area, but other water-damaged ceiling tiles remain. Water-damaged ceiling tiles can provide a source of microbial growth and should be replaced after a water leak is discovered. In addition, several ceiling tiles of this interlocking system were removed, opening the ceiling plenum to occupied areas. Under certain conditions airflow can move from the ceiling plenum into the room below, which can result in materials, including mold spores, to penetrate into the occupied areas.

**Water-Damaged Ceiling Tiles in the Interlocking System in the Family Court Second Floor South Wing.**

**Action Taken:** Some water-damaged tiles were removed (see Picture 5). Other water-damaged ceiling tiles remain in place. Employees report that a mold odor occurs in this area, particularly in spring months after rainstorms.

- 21. Replace water-damaged ceiling tiles in the interlocking system in the Family Court second floor south wing.**

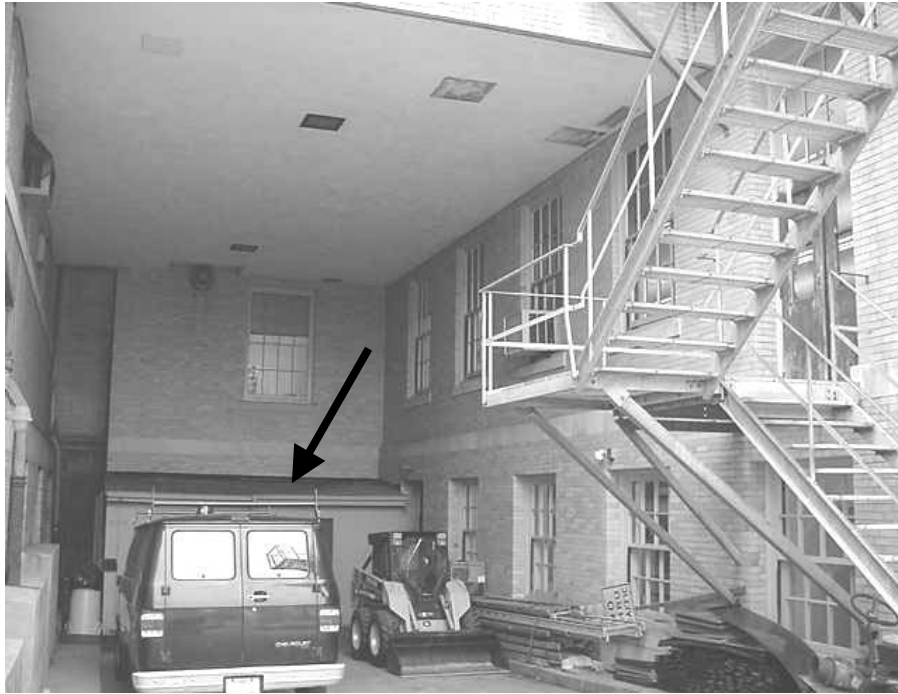
**Picture 6**

This ventilation system appears to be either renovated out of existence, adapted to other uses or abandoned. The fresh air intake for the north mixing room was blocked by the addition of storage sheds during the 1958 renovations (see Picture 6). The south mixing room appears to be abandoned. At this time, the only source in the original building for fresh air appears to be openable windows or doors.

**The Fresh Air Intake for the North Mixing Room Was Blocked by the Addition of Storage Sheds During the 1958 Renovations**

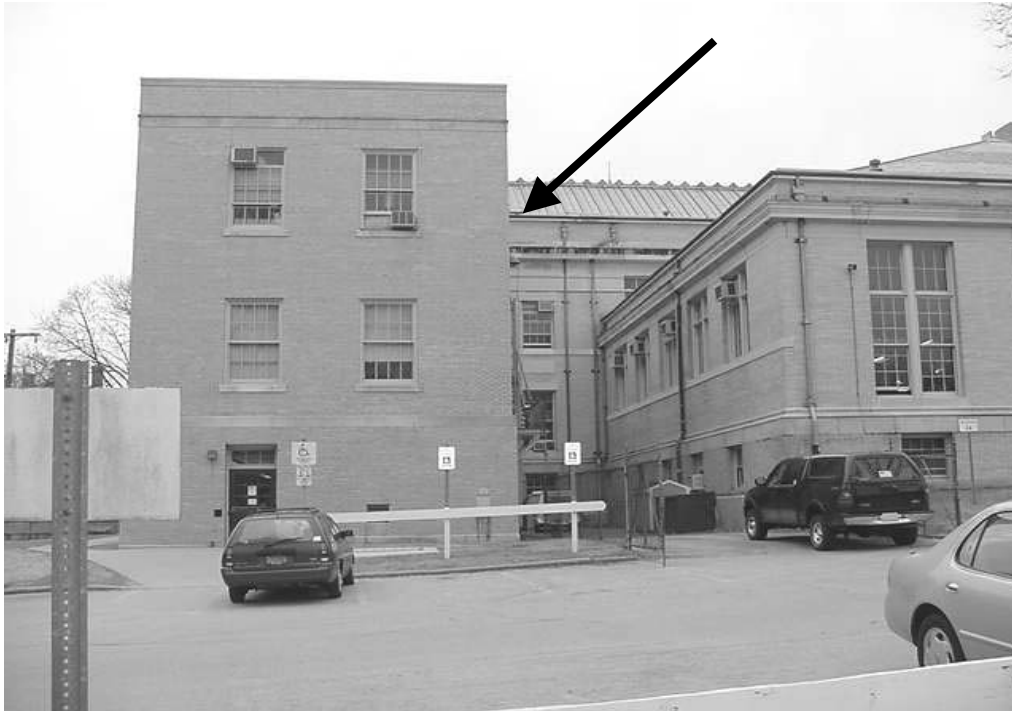
**Picture 7**

**Installation of the New Roof In 1990 Resulted in the Sealing of Original Ventilation Shaft;  
Arrow Denotes Approximate Location of this Shaft**

- 15. If the ductwork is determined to be useable with repairs, the following activities should be done: Examine the feasibility of reopening the south airshaft through the roof. In order to restore the function of this system, restoration of the chimney top of this shaft may be necessary. Consult a structural engineer as to whether this is feasible. If this is an option, the contractor who installed the roof should be contacted in order to ascertain the appropriate procedure to render the roof watertight around this extension.**

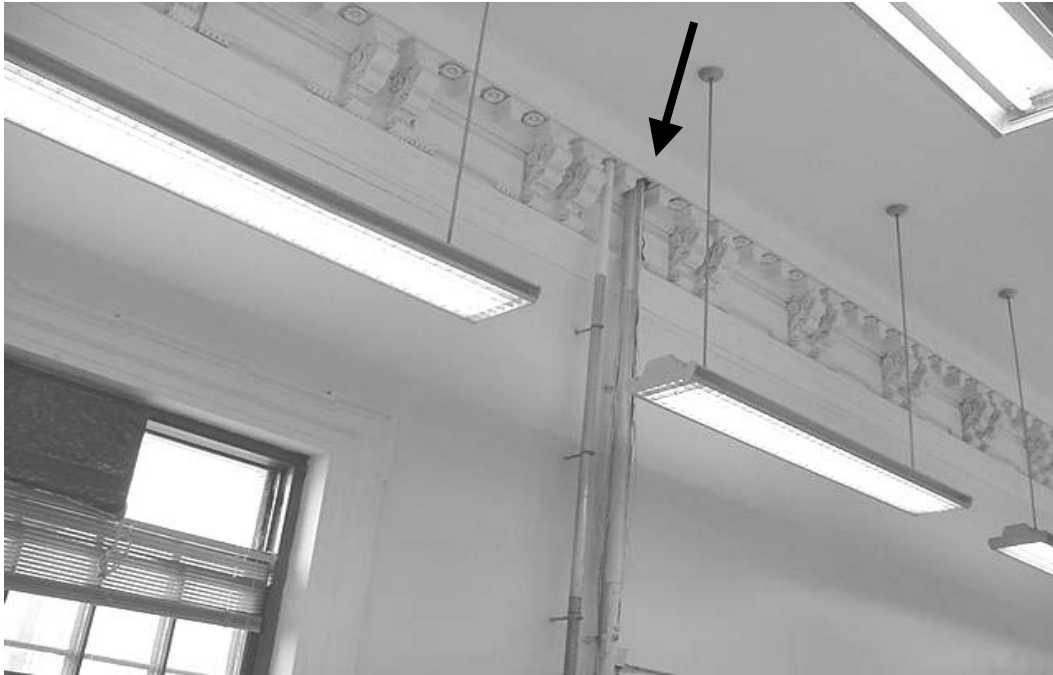
**Picture 8**

building. Holes for pipes connected to the heating system exist between floors. In addition, the installation of computer network cables warranted drilling numerous holes in interior walls and floors. The drilling of these holes has created plaster dust as well as a means for pollutants from one room to penetrate into an adjacent room. Further, materials within the wall cavities now have a pathway to penetrate occupied space. Extensive efforts to provide containment and ventilation need be made prior to commencement of any renovation to occur in the NPC.

**Possible Pollutants Migration Path through Pipe and Utility Holes**
