# **INDOOR AIR QUALITY ASSESSMENT**

**Natick Fire Department  
22 East Central Street  
Natick, Massachusetts**

Prepared by:  
Massachusetts Department of Public Health  
Bureau of Environmental Health Assessment  
April 2003

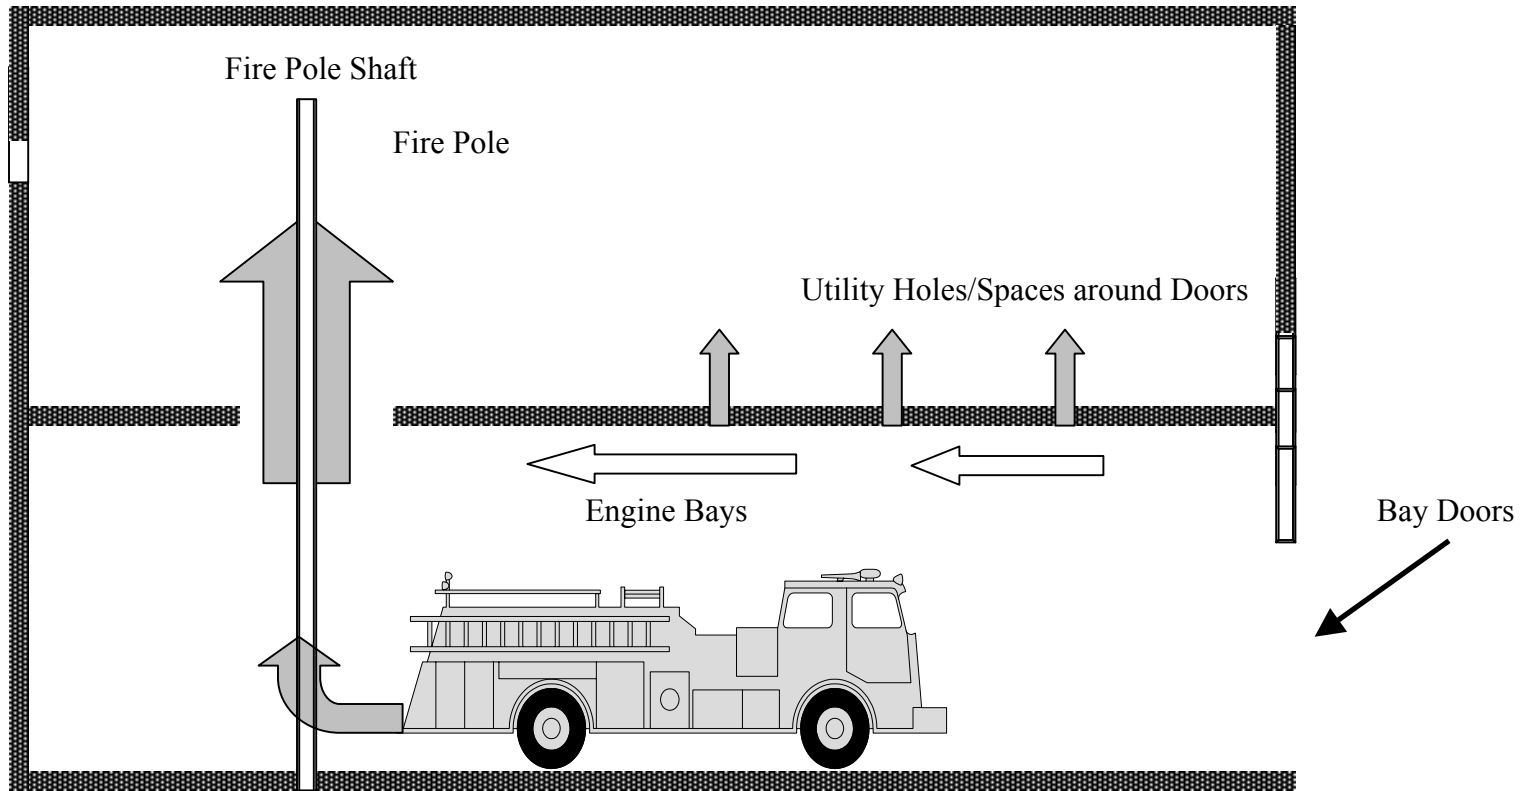
Figure 1

As demonstrated by the particle counts shown in Table 3, a number of pathways for vehicle exhaust and other pollutants to move from the engine bay into occupied areas on both the first and second floors were identified by BEHA staff (see Figure 1). The watch desk office directly off the engine bay had a large gap beneath the engine bay door (see Picture 4). A similar space in which light could be seen penetrating was observed beneath the door to the stairwell (also off the engine bay) leading to the upstairs (see Picture 5). During engine operation an ultrafine particulate reading of 50,000 particles/cc of air was taken at the bottom of the door inside the watch desk office as compared to a measurement of 6,600 particles/cc prior to vehicle operation. Similar readings were recorded in the stairwell and above spaces in second floor fire pole dampers (see Tables/Picture 6). These results demonstrate that breaches are serving as pathways for diesel exhaust and particulates to move from the engine bay into other areas of the station.

Potential Pathways of Air and Pollutant Movement from Engine Bays through Holes in Ceilings and Spaces around Door Frames

1. Ensure doors around engine bay fit completely flush with threshold. Seal doors on all sides with foam tape and/or weather-stripping. Consider installing weather-stripping/door sweeps on both sides of doors with access to the engine bay to provide a dual barrier. Ensure tightness of doors by monitoring for light penetration and drafts around doorframes.

3. Ensure all utility holes are properly sealed in both the engine bay and their terminus to eliminate pollutant paths of migration.
4. Continue to work with Natick Town Officials to develop a preventative maintenance program for all HVAC equipment including local exhaust system for the engine bay.

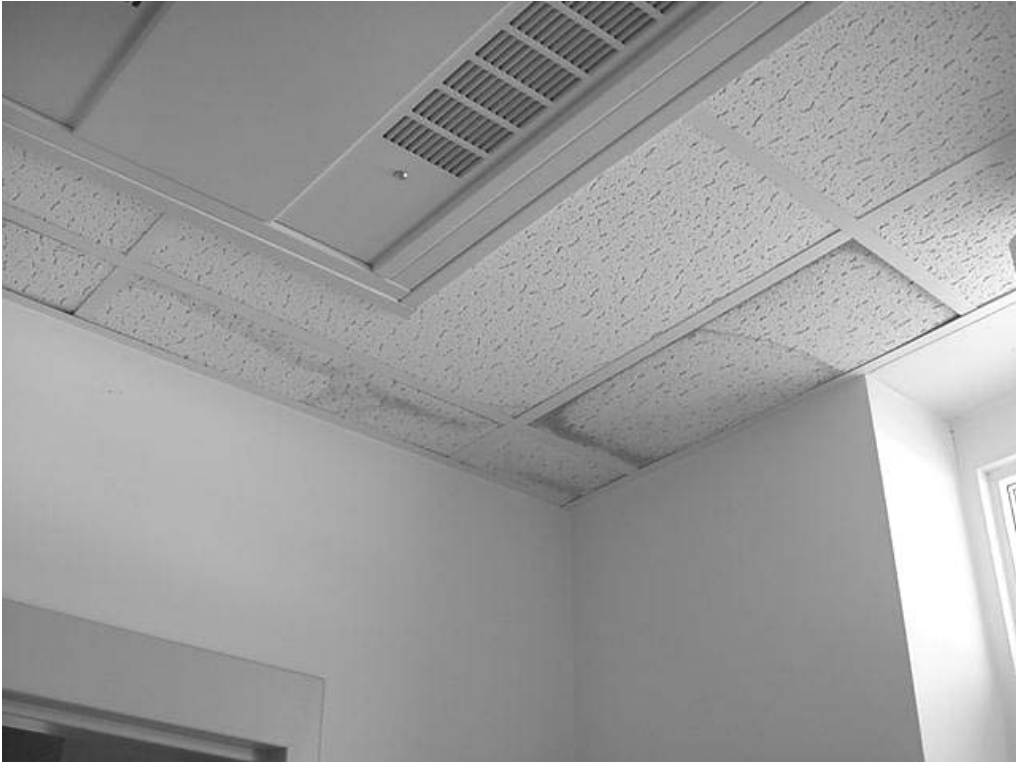
**Picture 1**

The building has experienced problems with water penetration, most notably the second floor ceiling (see Tables/Picture 1). Water-damaged ceiling tiles can provide a source of mold growth and should be replaced after a water leak is discovered. BEHA staff observed conditions in the ceiling plenum above ceiling tiles in a number of areas where water damage was noted. No visible microbial growth and/or associated mold-like odors were detected nor were any obvious sources of interior moisture problems identified.

**Water Damaged Ceiling Tiles**

9. Continue working with Natick Town Officials to identify and address building leaks. Once repaired, replace any remaining water-stained ceiling tiles. Examine the area above and behind these areas for microbial growth. Disinfect areas of water leaks with an appropriate antimicrobial.

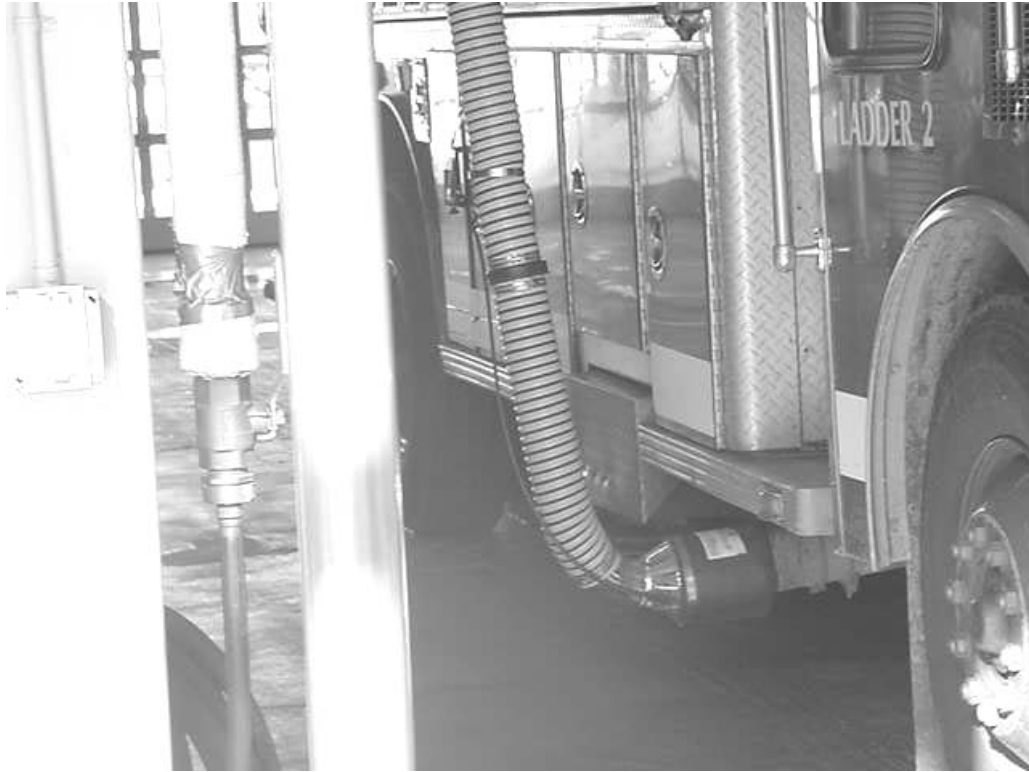
**Picture 2**

As mentioned previously, the station is equipped with a mechanical exhaust system to remove exhaust from the engine bays during vehicle idling. The system is designed with a pressurized cuff attached to flexible hose that fits directly over the exhaust pipe of fire apparatus

**Pressurized Cuff/Flexible Hose for Local Exhaust System in Engine Bay**

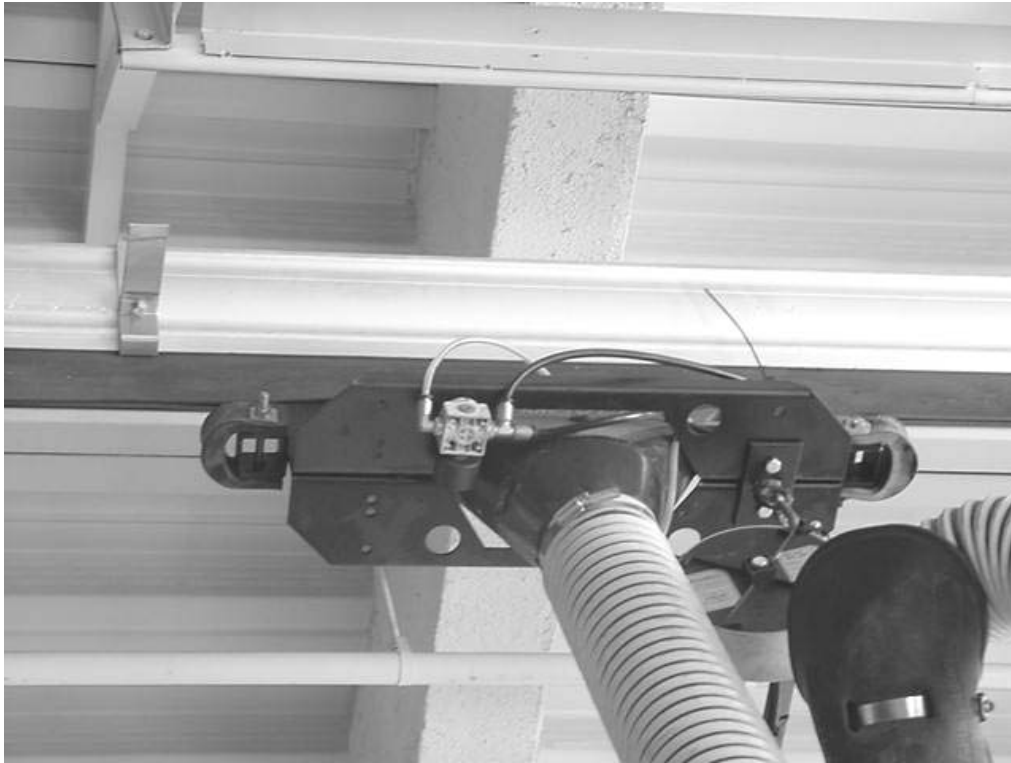
**Picture 3**

(see Picture 2). As vehicles exit the engine bay the hose slides down a runner tripping a switch that depressurizes and releases the cuff (see Picture 3). When vehicles return to the firehouse, the flexible hoses are manually reattached.

**Runner Attached to Flexible Hose for Local Exhaust System in Engine Bay**

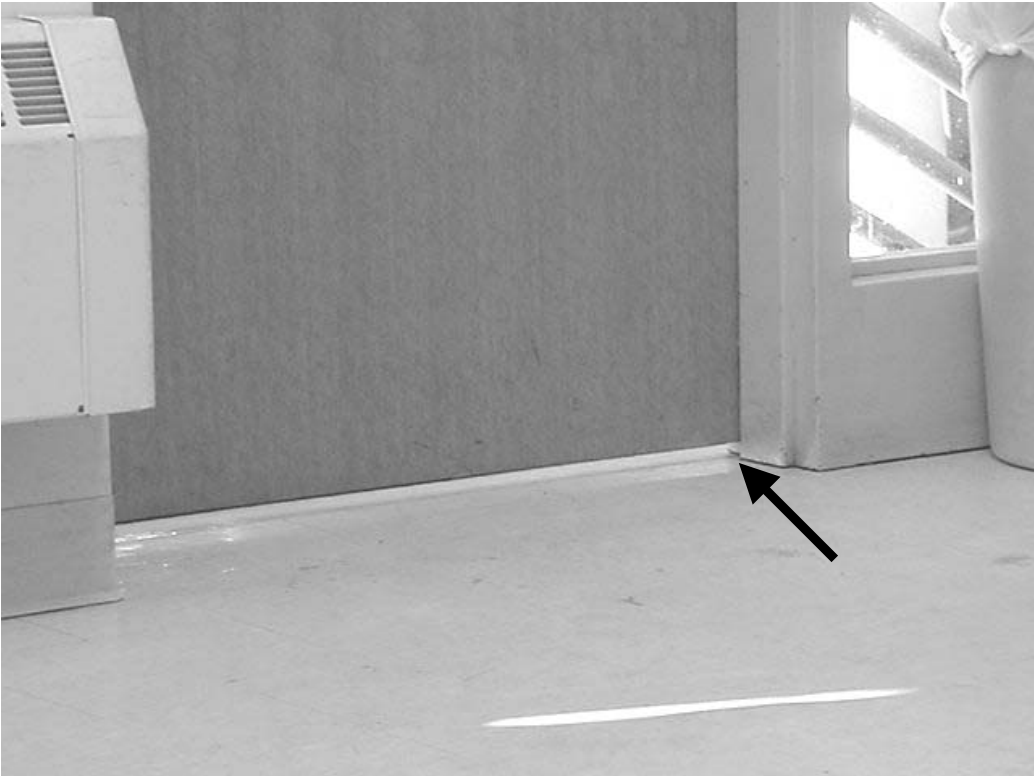
**Picture 4**

**Approximate one-inch Gap beneath Watch Desk Door to Engine Bay**

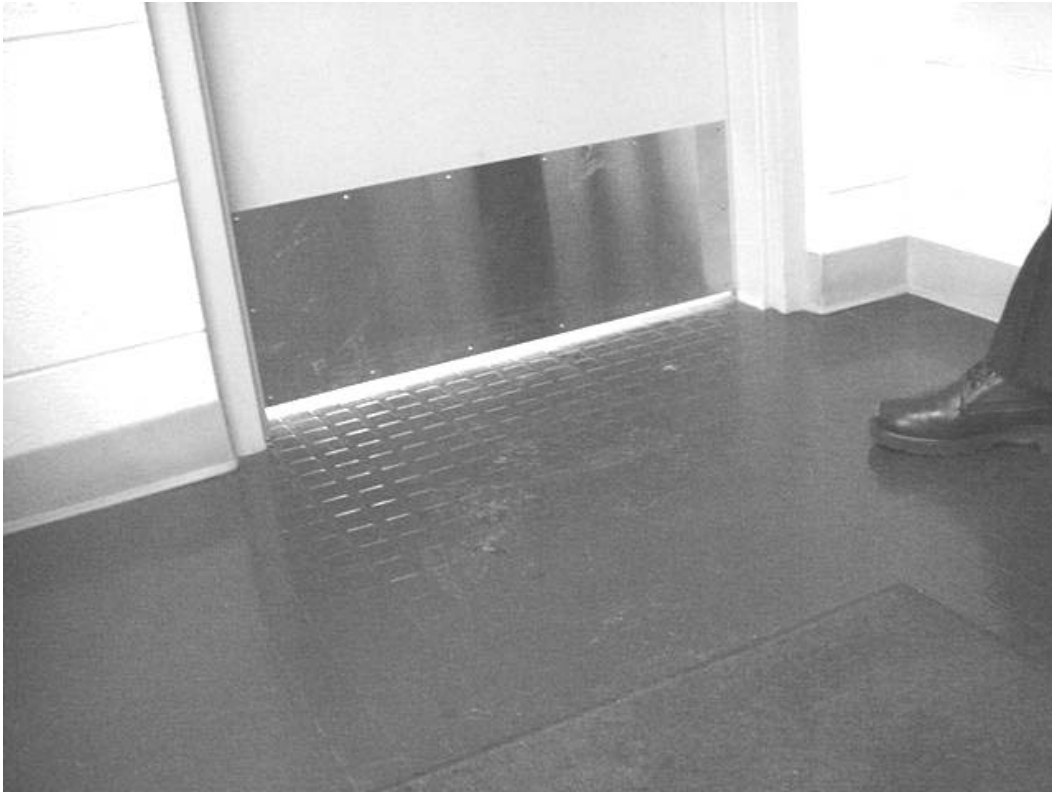
**Picture 5**

**Space Beneath Stairway Door to Engine Bay**

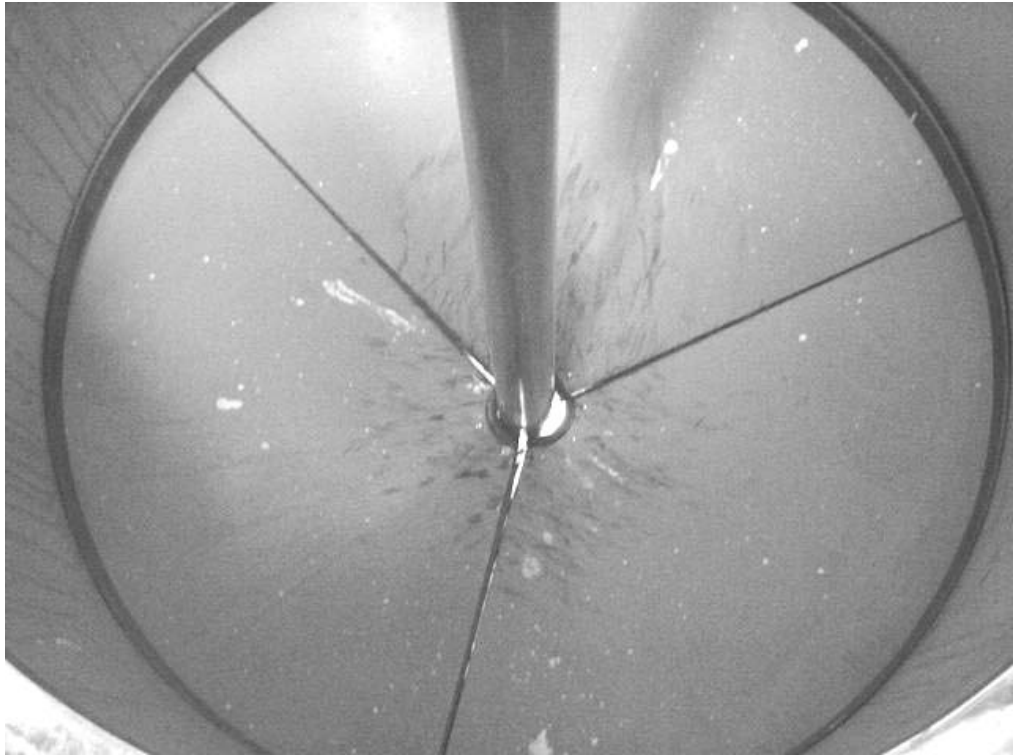
**Picture 6**

**Spaces around Fire Pole Dampers Taken from Second Floor**

2. Examine ways to prevent leakage around fire pole dampers or consider installing local exhaust ventilation directly over fire poles to remove lingering exhaust fumes.

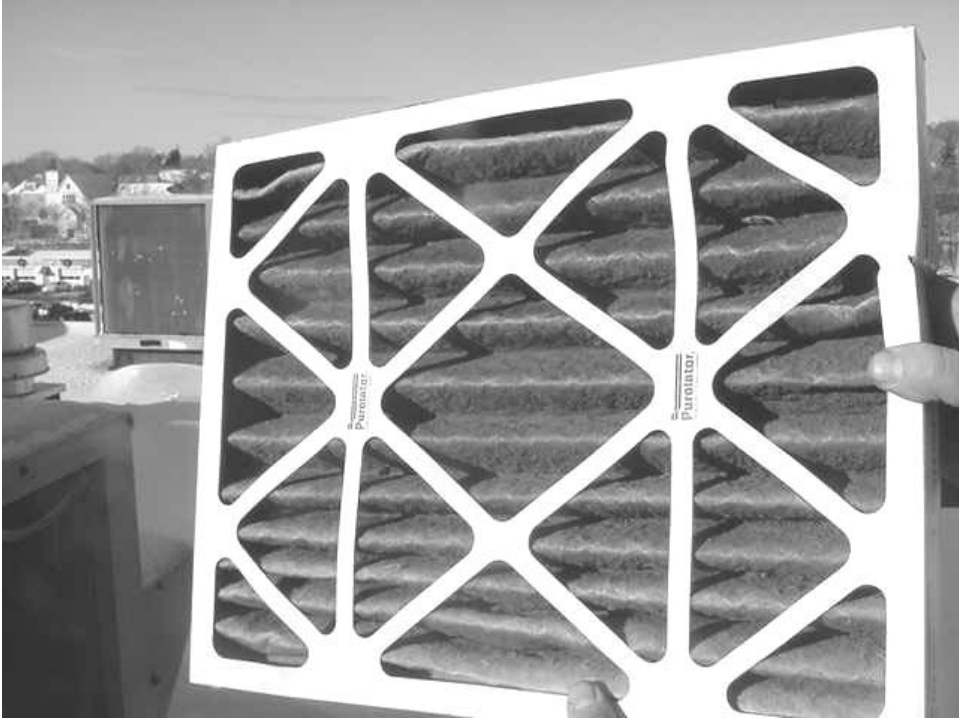
Picture 7

NFD staff could not identify the date of the last HVAC filter change or if a preventative maintenance program for HVAC equipment was in place. BEHA staff removed the access plates from several of the rooftop AHUs to examine filters. AHUs were equipped with high efficiency pleated filters. Several filters were saturated with dirt and debris (see Pictures 7 & 8). A clogged filter can obstruct airflow through the filters, and may serve as a reservoir of particulates that can be re-aerosolized and distributed to occupied areas via the ventilation system.

5. Change filters for AHU equipment as per the manufacturer's instructions or more frequently if needed.
6. To maximize air exchange, the BEHA recommends that both supply and exhaust ventilation operate continuously during periods of building occupancy independent of thermostat control (excluding engine bay exhaust system).

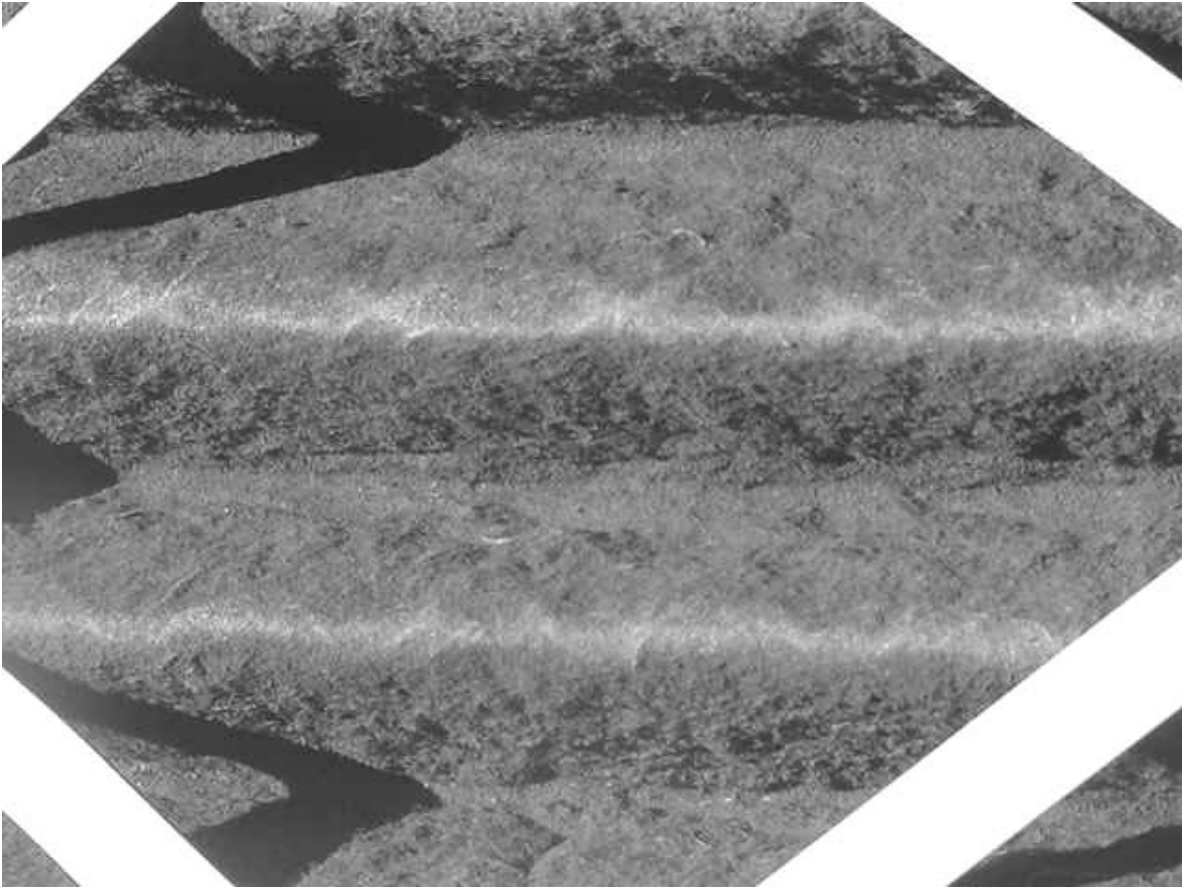
**Picture 8**

**Close-up of Filter in Preceding Picture**

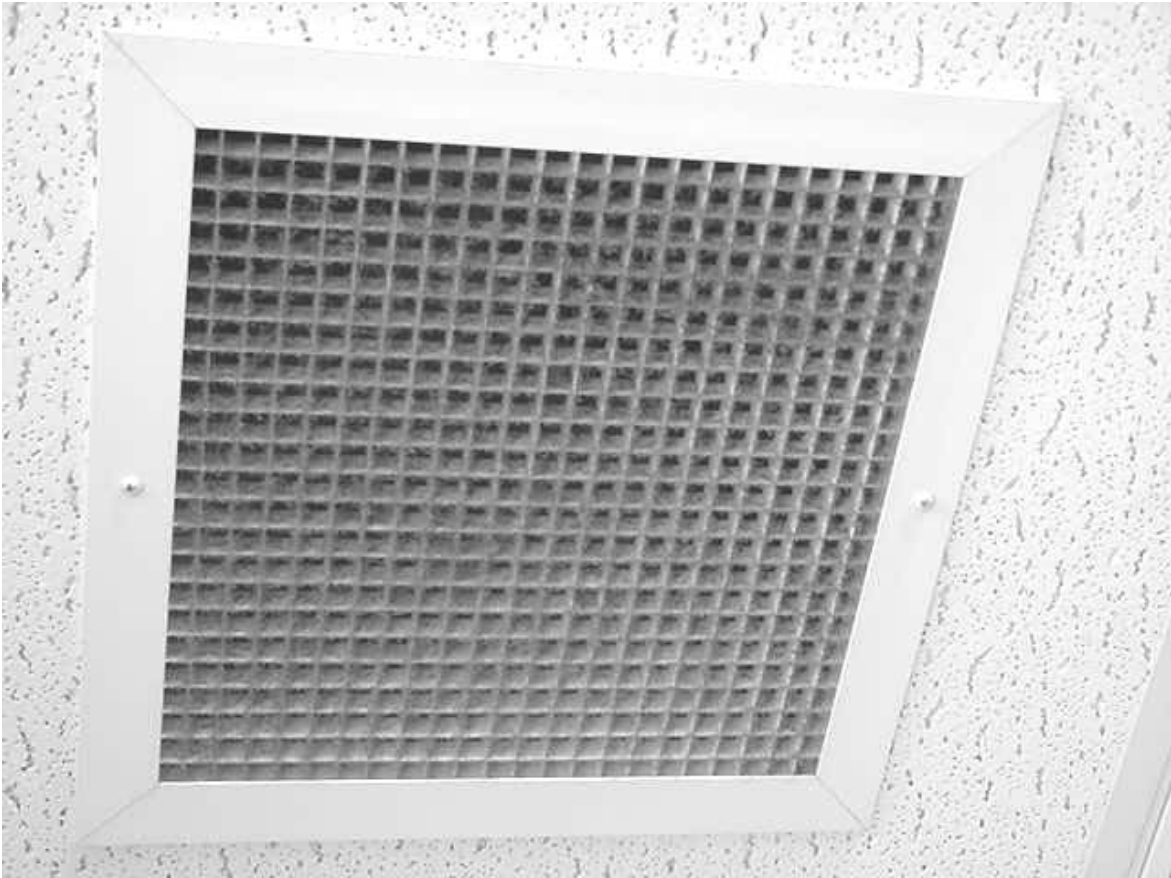
Picture 9

return vents were coated with dirt/dust (see Picture 9). The activation of the HVAC system or the movement of ceiling tiles can introduce dirt, dust and particulate matter into occupied areas. These materials can be irritating to certain individuals.

Dirt/Dust Build-up on Return Vent

10. Clean air diffusers and return vents periodically of accumulated dirt/dust build-up.
11. For further building-wide evaluations and advice on maintaining public buildings, see the resource manual and other related indoor air quality documents located on the MDPH's website at <http://www.state.ma.us/dph/beha/iaq/iaqhome.htm>.
