# INDOOR AIR QUALITY ASSESSMENT

**Springfield School Department  
195 State Street  
Springfield, Massachusetts**

Prepared by:  
Massachusetts Department of Public Health  
Bureau of Environmental Health  
Indoor Air Quality Program  
January 2010

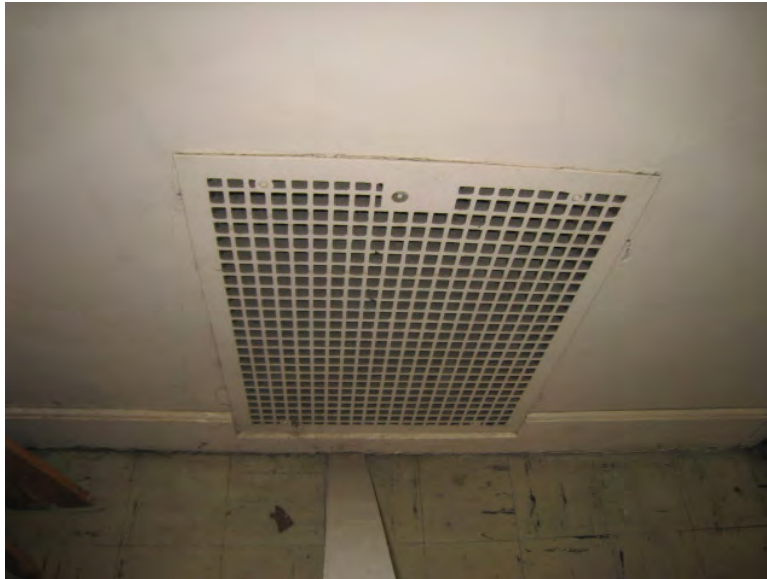
**Picture 1**

This building does not have a functional mechanical ventilation system. Fresh air supply and exhaust (Picture 1) vents were identified, but were found not operating. Exhaust ventilation non-motorized vent termini exist on the roof (Picture 2). Of note is the ductwork connected to these rooftop vents. It appeared that sections of ductwork had been disconnected in a crawlspace that exists between the roof and second floor ceiling (Picture 3). This open ductwork would allow unconditioned cold air from the ceiling crawlspace as well as dust, dirt and other attic crawlspace pollutants to migrate into the occupied space during cold weather. Dust and dirt can be respiratory irritants.

**Exhaust Vent**

1. Seal both fresh air supply and exhaust vents with plywood to prevent attic crawlspace and basement air entering occupied space.
2. Supplement airflow in rooms by using openable windows to control for comfort. Care should be taken to ensure windows are properly closed at night and on weekends to avoid the freezing of pipes and potential flooding.

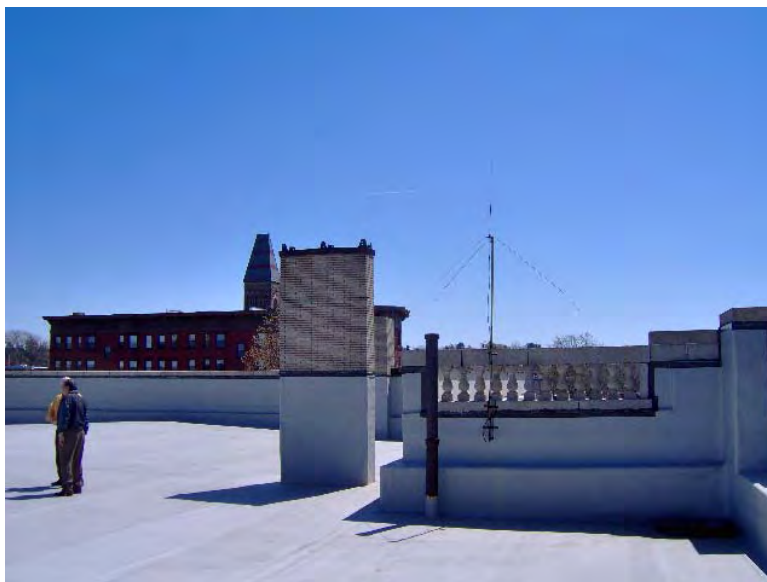
**Picture 2**

**Likely Non-Motorized Exhaust Vent On Roof**

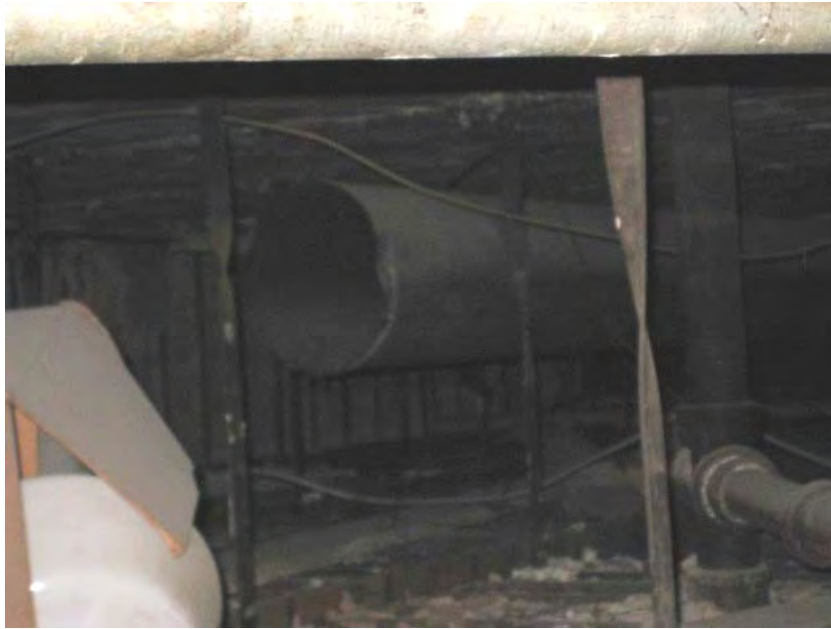
**Picture 3**

**Disconnected Ductwork in Attic**

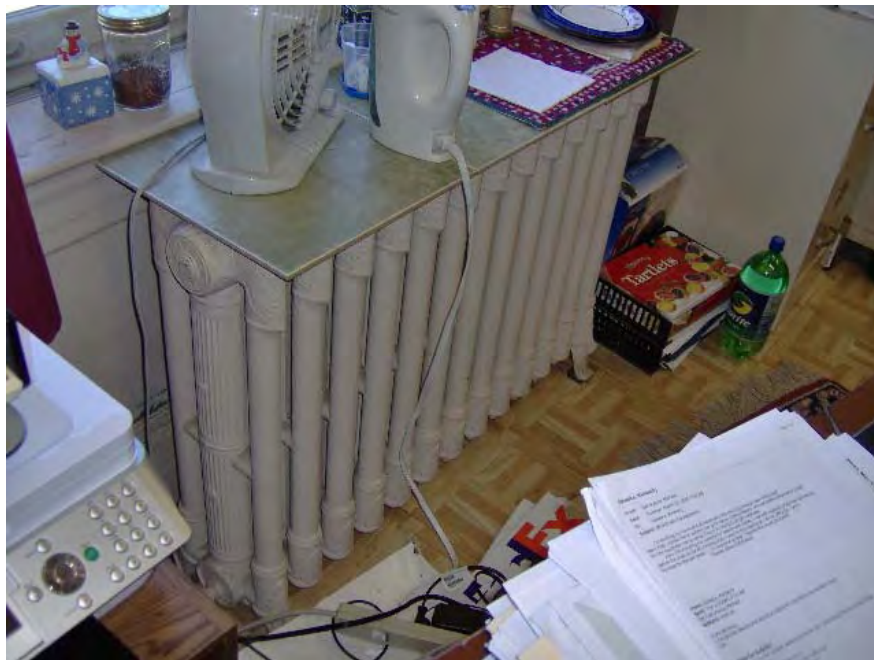
**Picture 4**

The only means for creating airflow in this building is the use of openable windows. Rooms are heated using wall-mounted radiators (Picture 4). During summer months, ventilation in the SSD/HQ was controlled by the use of openable exterior windows in rooms. The building was configured in a manner to use cross-ventilation to provide comfort for building occupants. It is equipped with windows on opposing exterior walls. Another set of openable sash windows bisect the floor space on both the first and second floors (Picture 5). In addition, the building has hinged windows located above the office doors (Picture 6).

**Example of Building Radiator**

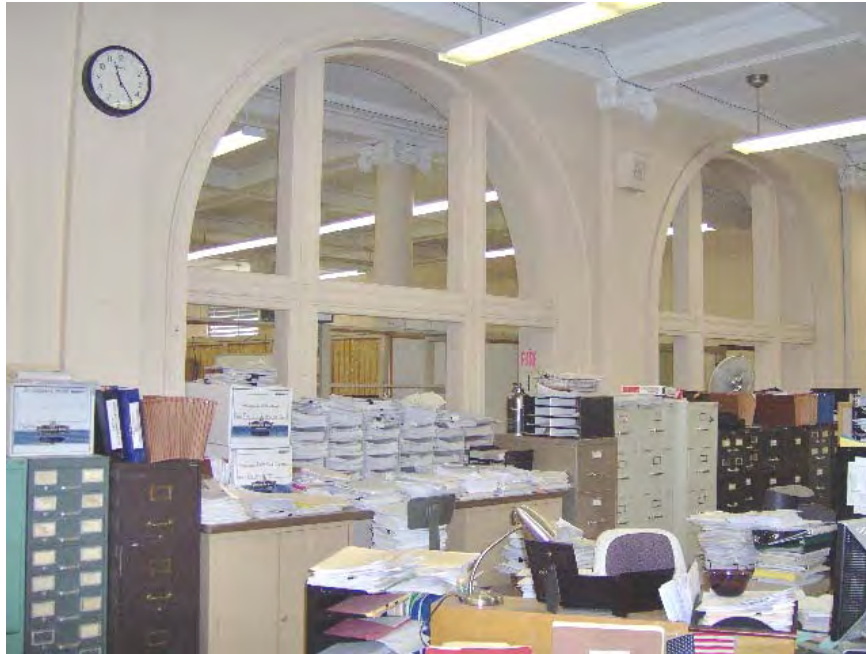
**Picture 5**

**Openable Sash Windows on the First Floor**

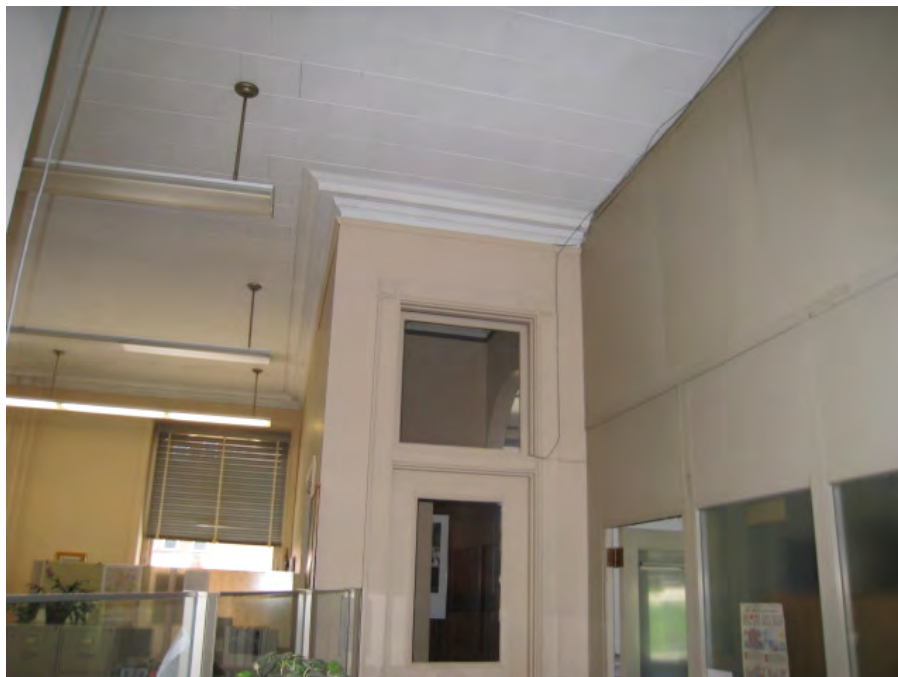
**Picture 6**

The hinged windows (called transoms) enable room occupants to close the hallway door while maintaining a pathway for airflow. This design allows airflow to enter an open window, pass through a room and subsequently pass through the open transom. Airflow then enters the hallway, passing through the opposing open room transom and into the room, finally exiting the building on the leeward side (opposite the windward side) ([see Figure 1](#)). With all windows and transoms open, airflow can be maintained in a building regardless of the direction of the wind. The system fails if the windows or transoms were closed ([see Figure 2](#)). Rooms that are not opposite other rooms would have increased difficulty in creating cross-ventilation and some means to increase air movement is warranted (e.g., floor fan in an open window). Transoms were closed in most locations. In order to create airflow, hallway doors need to be open. Open windows may also allow rainwater to penetrate through windows. Pests, such as birds, bats and insects, also have access to the interior if windows left open overnight.

**Transom**

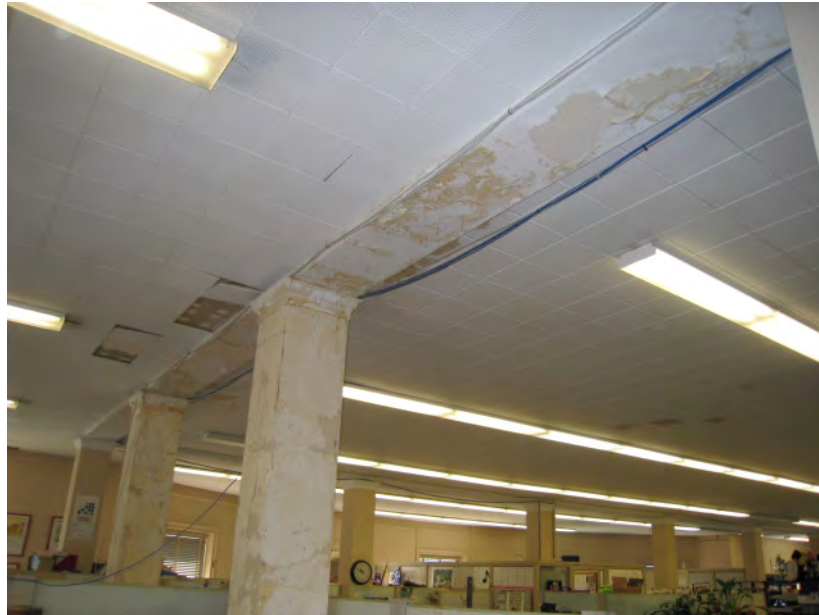
**Picture 7**

Several potential sources of water damage/water infiltration were observed in the building. The second floor ceiling showed signs of water damage to plaster (Pictures 7 and 8), ceiling tiles and peeling paint, which can indicate roof leaks. A substantial number of

**Water Damaged Plaster, 3<sup>rd</sup> Floor**

5. Insulate all pipes carrying either coolant or chilled water to and from the mainframe air conditioning unit.
6. Ensure leaks are isolated and repaired. Repair/replace any wall/ceiling plaster and/or other damaged building materials. Examine above and around these areas for mold growth. Disinfect areas of water leaks with an appropriate antimicrobial.

7. Repair water damaged plaster. Remove peeling paint.
8. For buildings in New England, periods of low relative humidity during the winter are often unavoidable. Therefore, scrupulous cleaning practices should be adopted to minimize common indoor air contaminants whose irritant effects can be enhanced when the relative humidity is low. To control for dusts, a high efficiency particulate arrestance (HEPA) filter equipped vacuum cleaner in conjunction with wet wiping of all surfaces is recommended. Avoid the use of feather dusters. Drinking water during the day can help ease some symptoms associated with a dry environment (throat and sinus irritations).

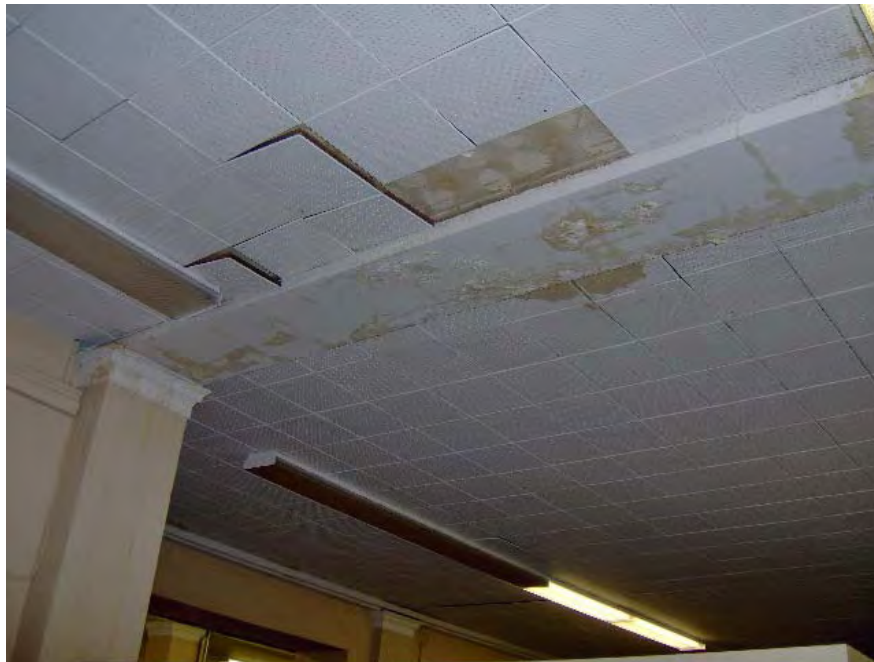
**Picture 8**

**Water Damaged Plaster, 3<sup>rd</sup> Floor**

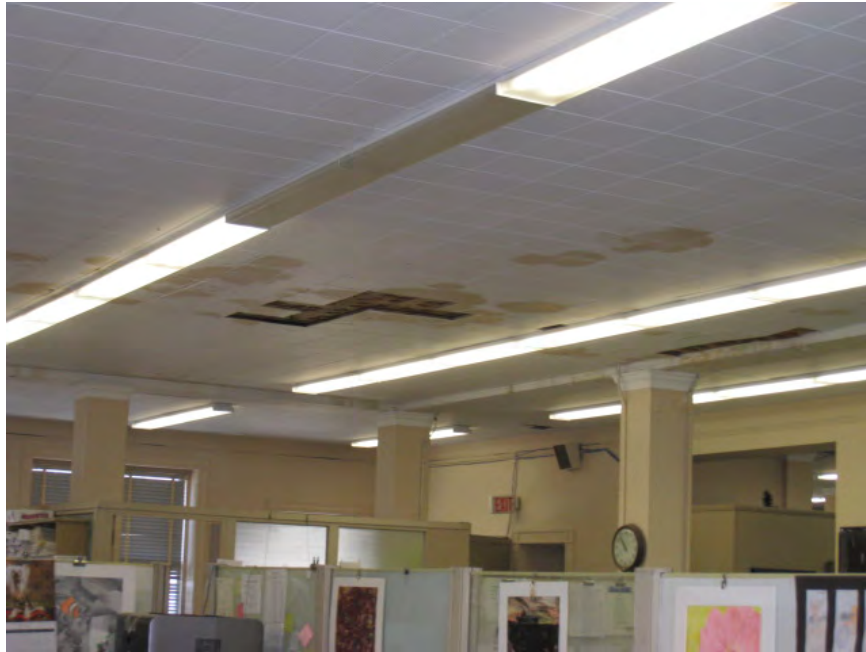
**Picture 9**

interlocking ceiling tiles are missing (Picture 9). Water-damaged ceiling tiles can provide a source of mold and should be replaced after a water leak is discovered and repaired.

**Missing Interlocking Ceiling Tiles**

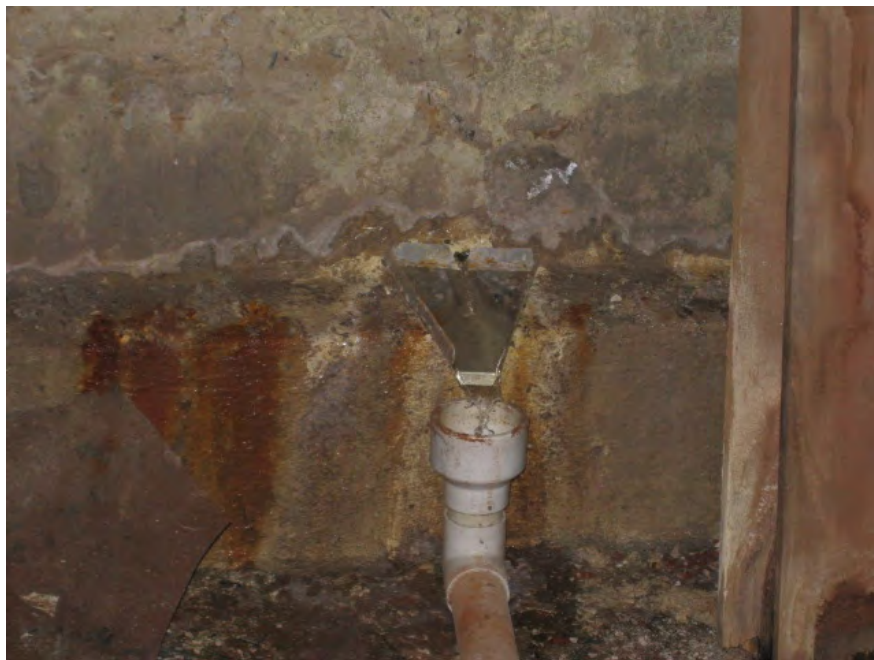
**Picture 10**

The basement contains a storage area that has water running through the foundation into a drain system (Pictures 10 through 12) that terminates into a sump pump. The basement walls show signs of flooding. A large number of materials that can support mold growth are stored in this area, including upholstered furniture (Picture 13) and rolled-up carpeting (Picture 14). All porous materials stored in this location have the potential for mold colonization and should be discarded.

**Hole In Foundation Wall Leaking Water, Note Jury Rigged Water Collector**

4. Remove all porous materials from the sump pump basement area. Do not use this area for storage. Examine options for providing proper drainage for water entering the foundation.

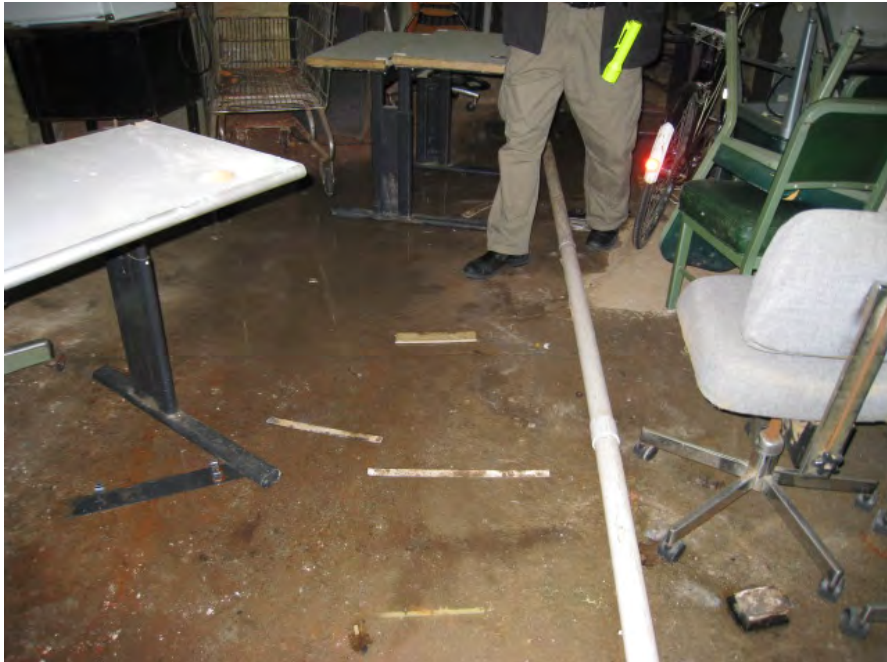
**Picture 11**

**Pipe Connected To Water Collector in Picture 10**

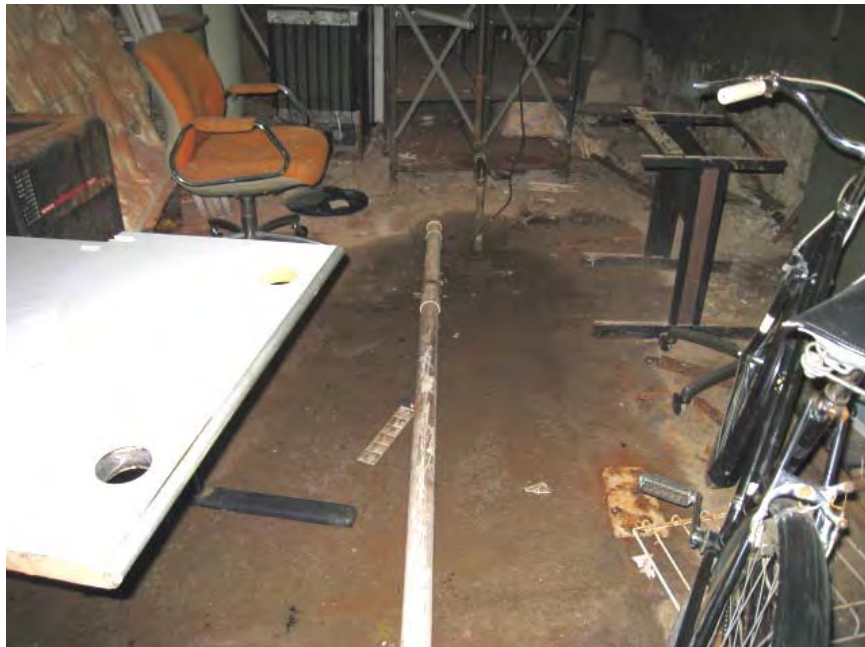
**Picture 12**

**Pipe Terminus over Drain**

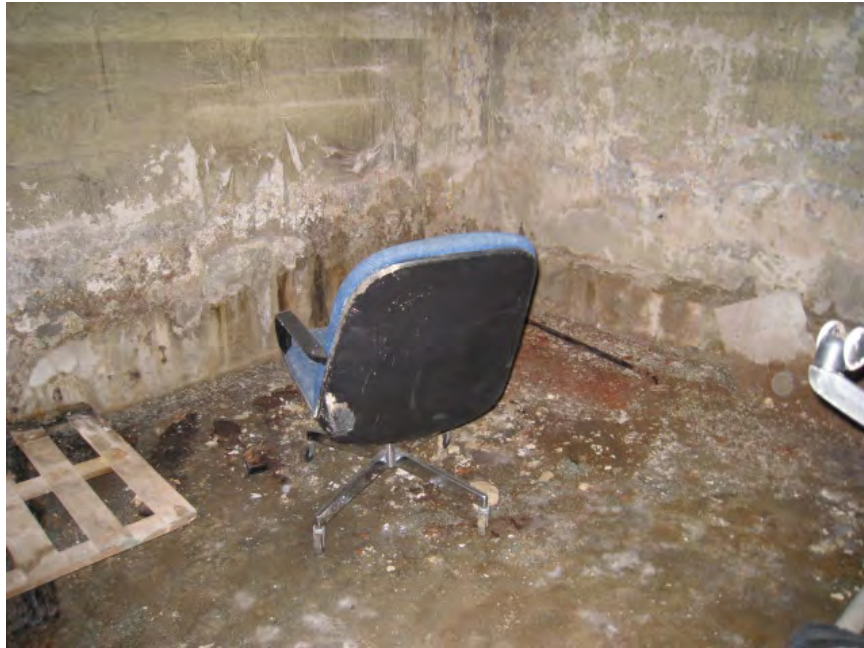
**Picture 13**

**Upholstered Furniture in Basement**

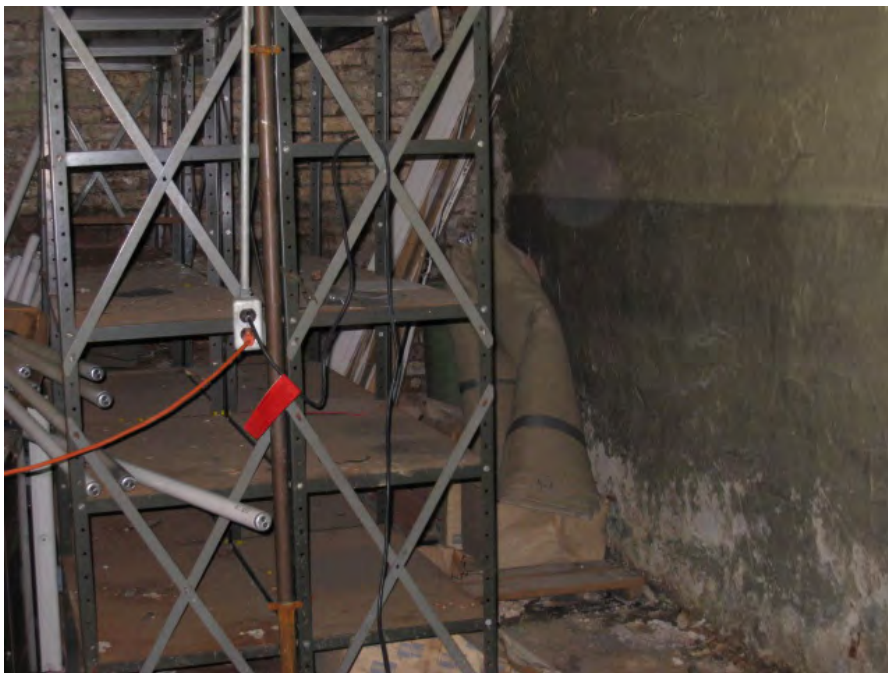
**Picture 14**

**Rolled Up Carpet in Basement**

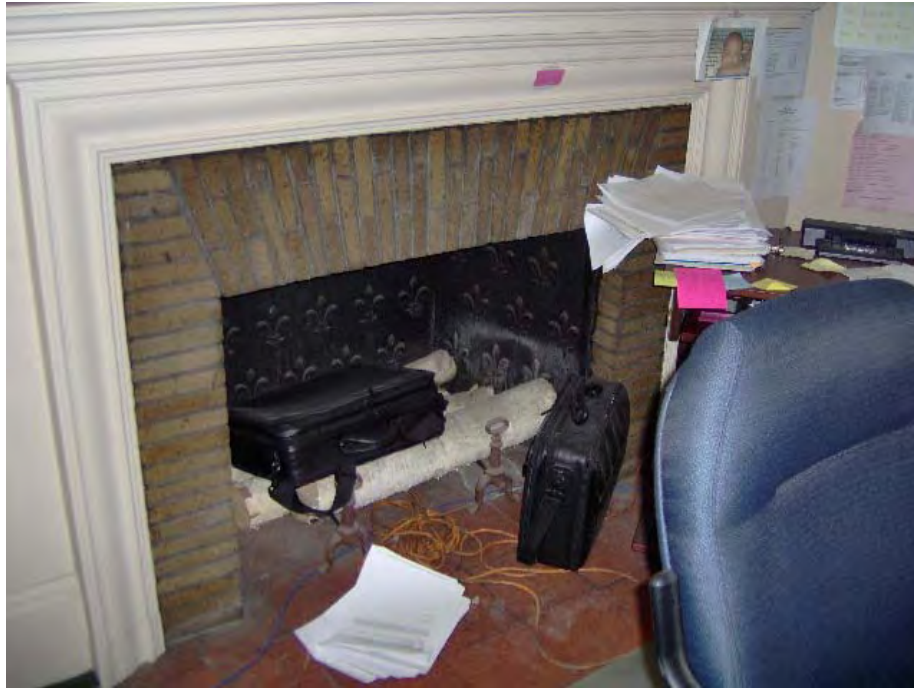
**Picture 15**

Offices in the northwest corner of the building have fireplaces. These fireplaces are connected to chimneys located on the northwest corner of the roof (Pictures 15). The chimneys' flues appeared to be ajar and show signs of water intrusion (Picture 16) and efflorescence<sup>1</sup>. Water intrusion is likely the result from the lack of chimney caps (Picture 17) over the flue openings. Since the fireplaces are not used, sealing the chimney openings would prevent further water intrusion.

**Fireplace in Office**

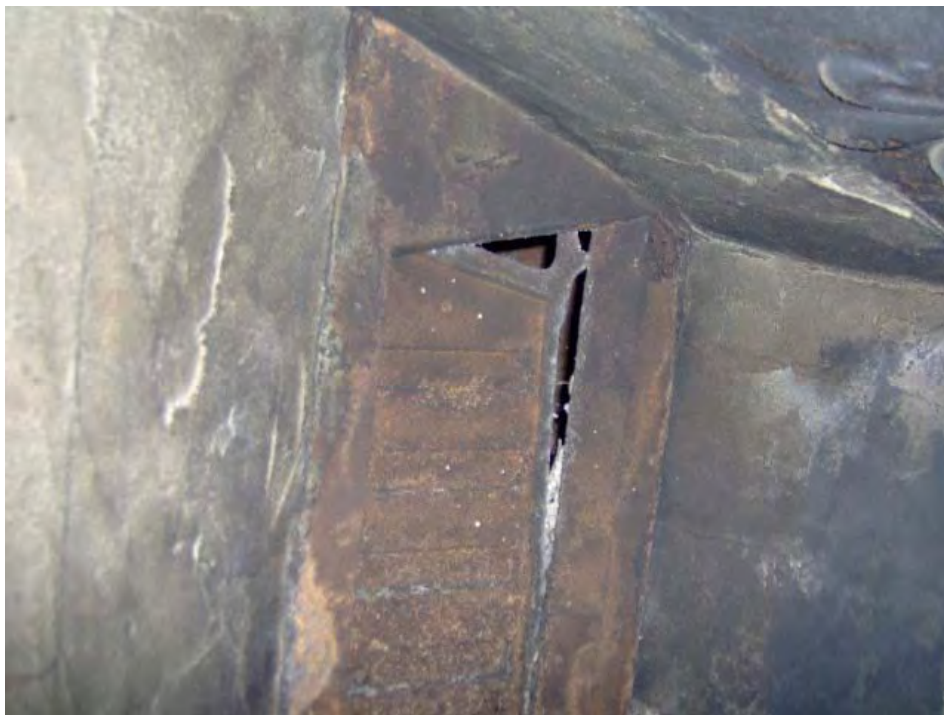
**Picture 16**

**Ajar Flue in Chimney**

16. Consider sealing chimney openings to prevent further water intrusion.
17. Refer to resource manual and other related indoor air quality documents located on the MDPH's website for further building-wide evaluations and advice on maintaining public buildings. These documents are available at: [http://mass.gov/dph/indoor\\_air](http://mass.gov/dph/indoor_air).

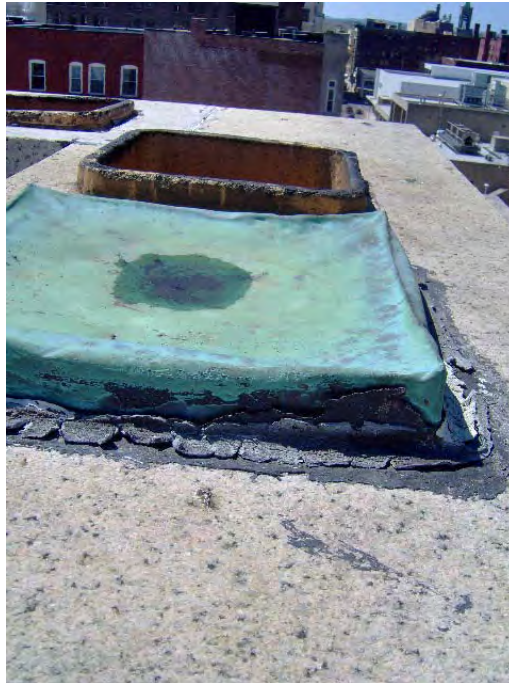
**Picture 17**

**Chimney Openings on Roof, Note Lack Of Chimney Cap**

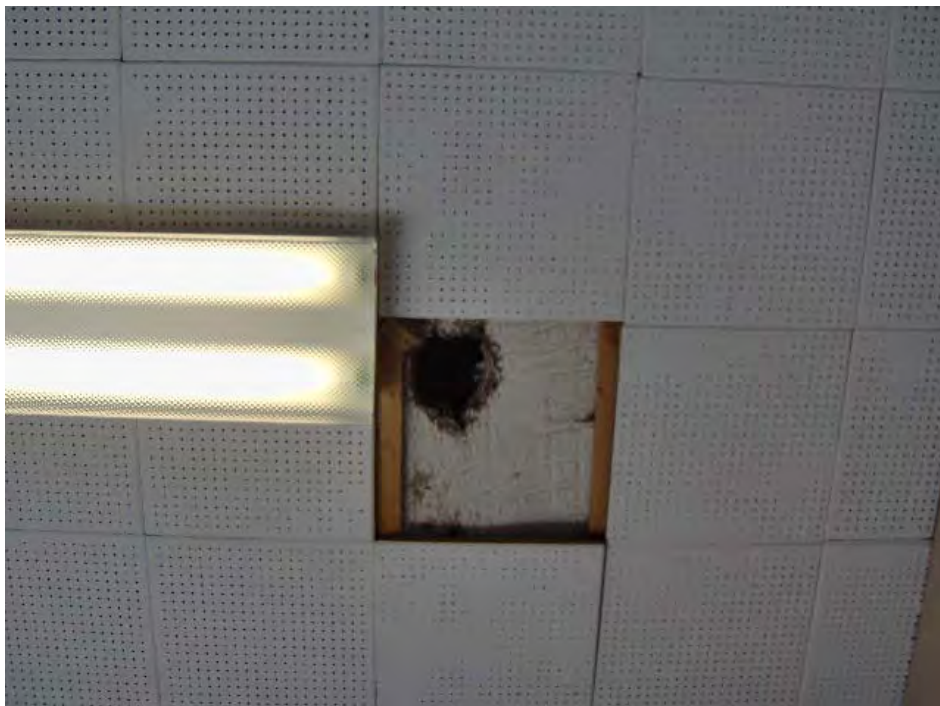
**Picture 18**

Open utility holes and penetrations of pipes and conduits through floors, walls and ceilings were not properly sealed (Picture 18), which can provide pathways for drafts, dust and particulates to migrate into occupied areas.

**Hole through Ceiling**

11. Repair/replace damaged exterior doors and woodwork.
12. Clean dry erase trays to prevent accumulation of materials.
13. Seal penetrations of pipes through walls, floors and ceilings throughout the building.
