INDOOR AIR QUALITY ASSESSMENT

**Edward B. Newton Elementary School
45 Pauline Street
Winthrop, Massachusetts**

Prepared by:
Massachusetts Department of Public Health
Bureau of Environmental Health Assessment
April, 2000

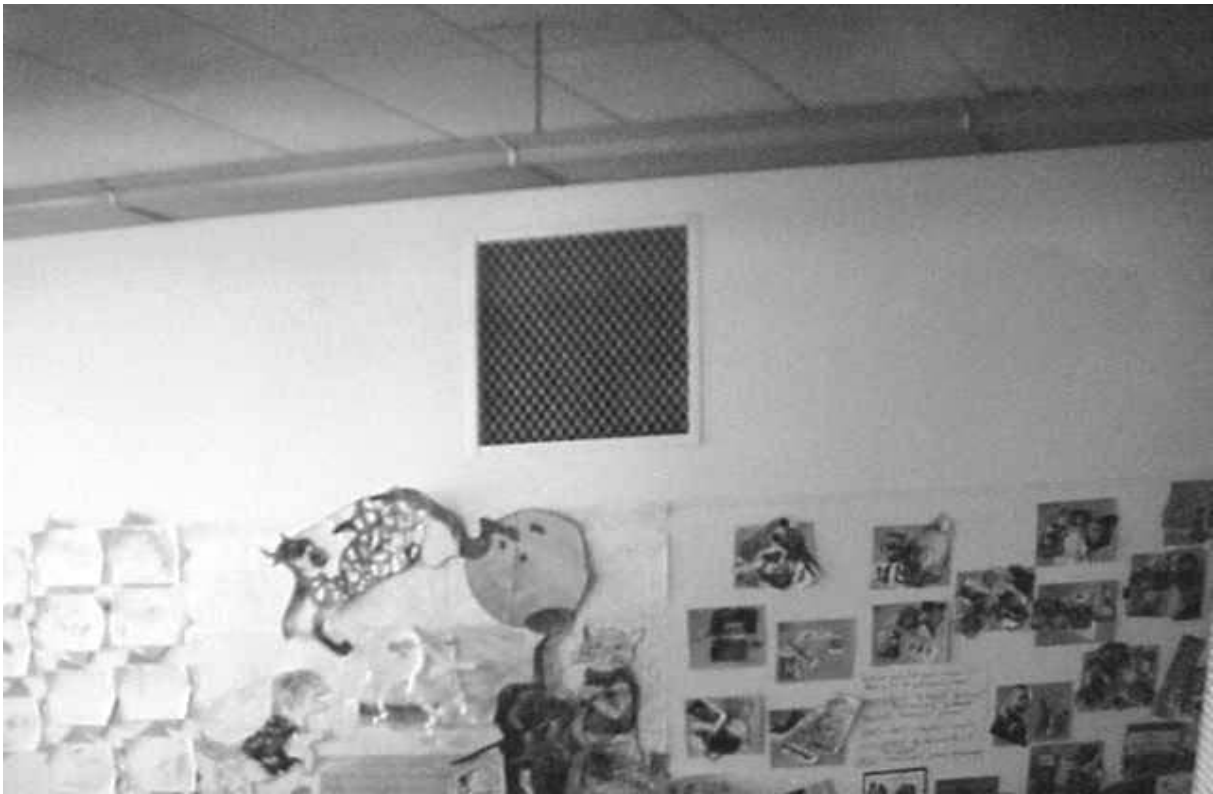
Picture 1

Ventilation is provided by a series of louvered vents. Each classroom has an approximately 3' x 3' grated air vent in the center of an interior wall near the ceiling (see Picture 1), which is connected by ductwork to a "hearth"-like opening in the basement (see Picture 2). A corresponding 3' x 3' vent exists in each room near the classroom doorway that is connected to an exhaust ventilation shaft that runs through the roof to the basement.

Natural/Gravity Feed Supply Vent in Classroom

1. Consider consulting a ventilation engineer concerning the feasibility of restoring the original gravity feed ventilation system with a ventilation engineer. This may entail repair or replacement of heating elements located in ventilation shafts; repair of broken or missing warm air and cool air pulley chain/louver door systems to provide ventilation in this building as designed; repair of the hinged-pulley system or installation of openable windows in basement area to provide fresh air to classrooms. If these systems are not to be restored, ensure exhaust vents are sealed on the roof and in classrooms to prevent the egress of dirt, dust and drafts into occupied areas. Regulate airflow in classrooms with the use openable windows to control for comfort. Care should be taken to ensure windows are properly closed at night and weekends to avoid the freezing of pipes and potential flooding.

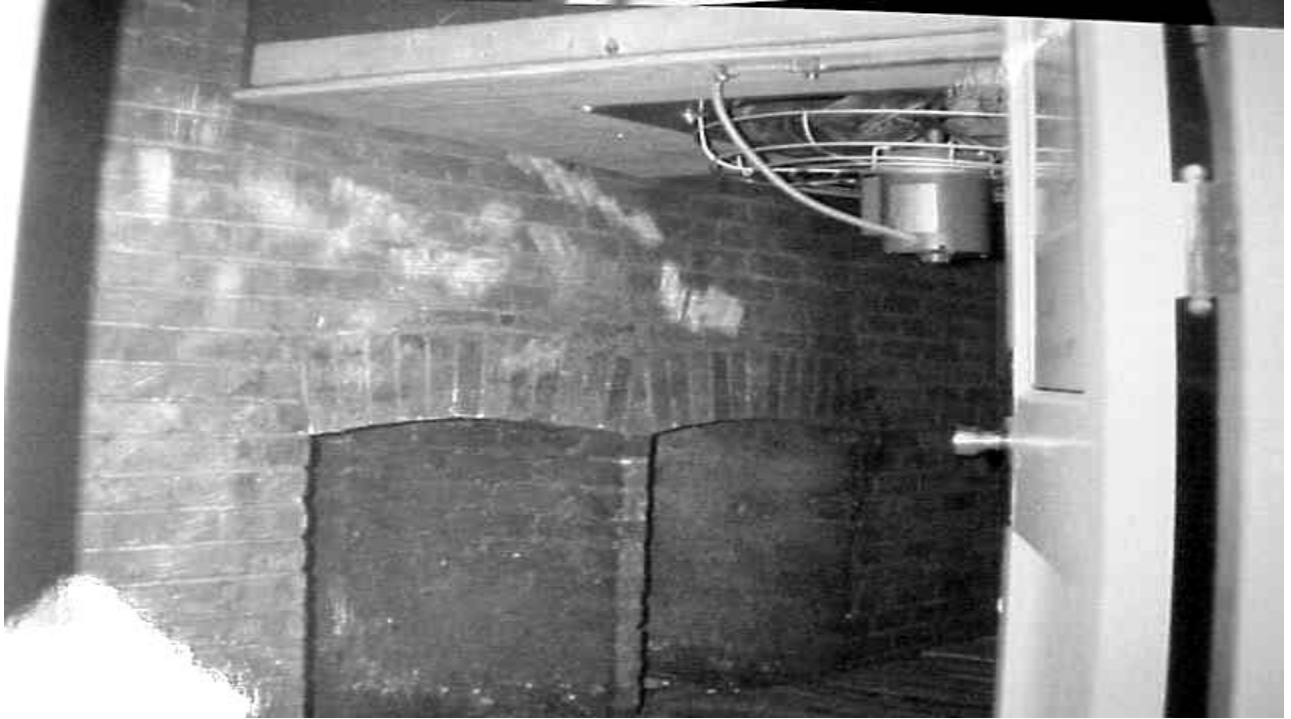
Picture 2

Air movement is provided by the stack effect. The heating elements warm the air, which rises up the hot air ventilation shafts. As the heated air rises, negative pressure is created, which draws cold air from the basement area into the heating elements. This system was designed to draw air from two sources in the basement: fresh air from a hinged window-pulley system on the exterior wall of the building and return air from the exhaust ventilation shafts. These sources of air are mixed in the basement prior to being drawn into the heating elements. The percentage of fresh air to return air was controlled by the hinged window-pulley system. The chains of the pulley system were designed to be set to lock the hinged window at a desired angle to limit fresh air intake. Non-openable windows have replaced the hinged window-pulley system; therefore no fresh, cool air can be introduced into the system. However according to Mr. Cali, heating elements are still activated to supplement radiators in providing heat to classrooms throughout the building. A mechanical fan installed in the base of one of the airshafts (see Picture 2) to enhance airflow by mechanical means.

**Hearth-like opening for Airshafts in Basement
Note Mechanical Fan Installed in Ventilation Shaft**

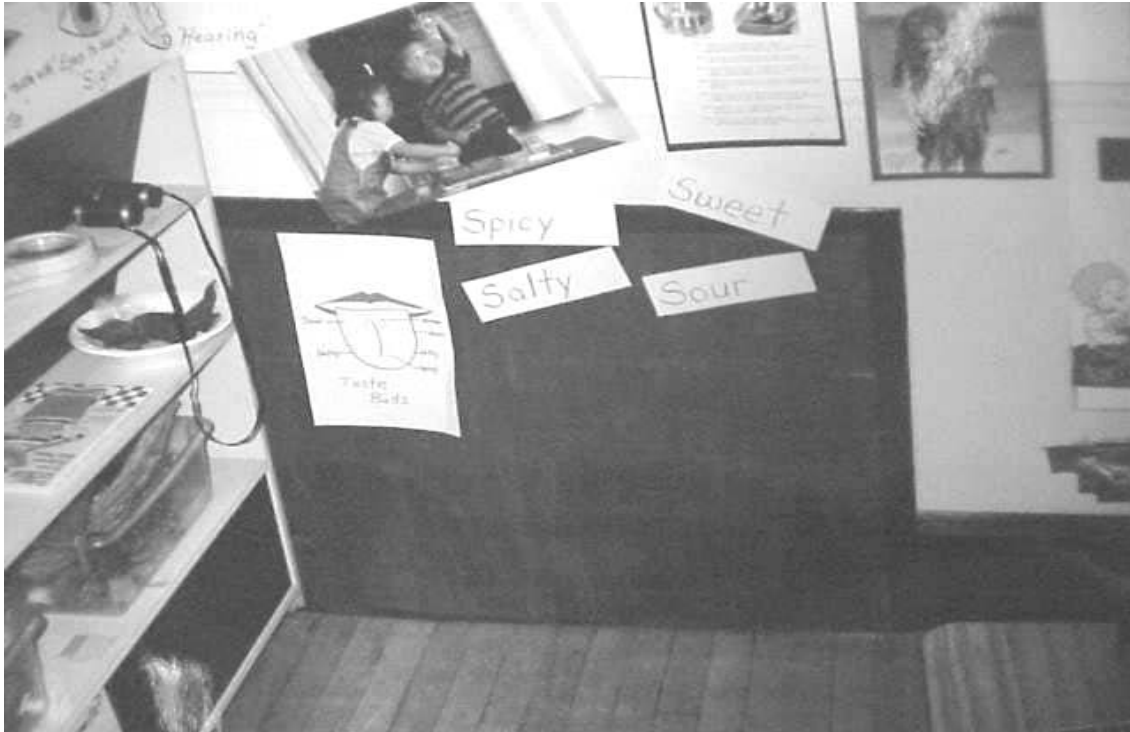
Picture 3

These vents are sealed with plywood (see Picture 3). Classrooms were constructed around these shafts to provide exhaust ventilation.

The negative pressure created by the fresh air supply system also provided classroom exhaust ventilation. Each classroom is connected by ductwork to the basement beneath the heating elements in a hearth-like structure. As the heating elements draw air into the hot air ducts, return air is drawn from the “hearths” at the bottom of the exhaust ventilation shafts. Negative pressure is created in these shafts, which in turn draw air into the exhaust vents of each classroom. The draw of air into these cool air vents is controlled by a draw chain pulley system. As mentioned previously, exhaust vents were sealed with plywood in classrooms, therefore no means of exhaust ventilation exists. In addition, many of the control mechanisms for the natural ventilation system are not operable or missing

Sealed Natural/Gravity Feed Exhaust Vent Noted in Classroom

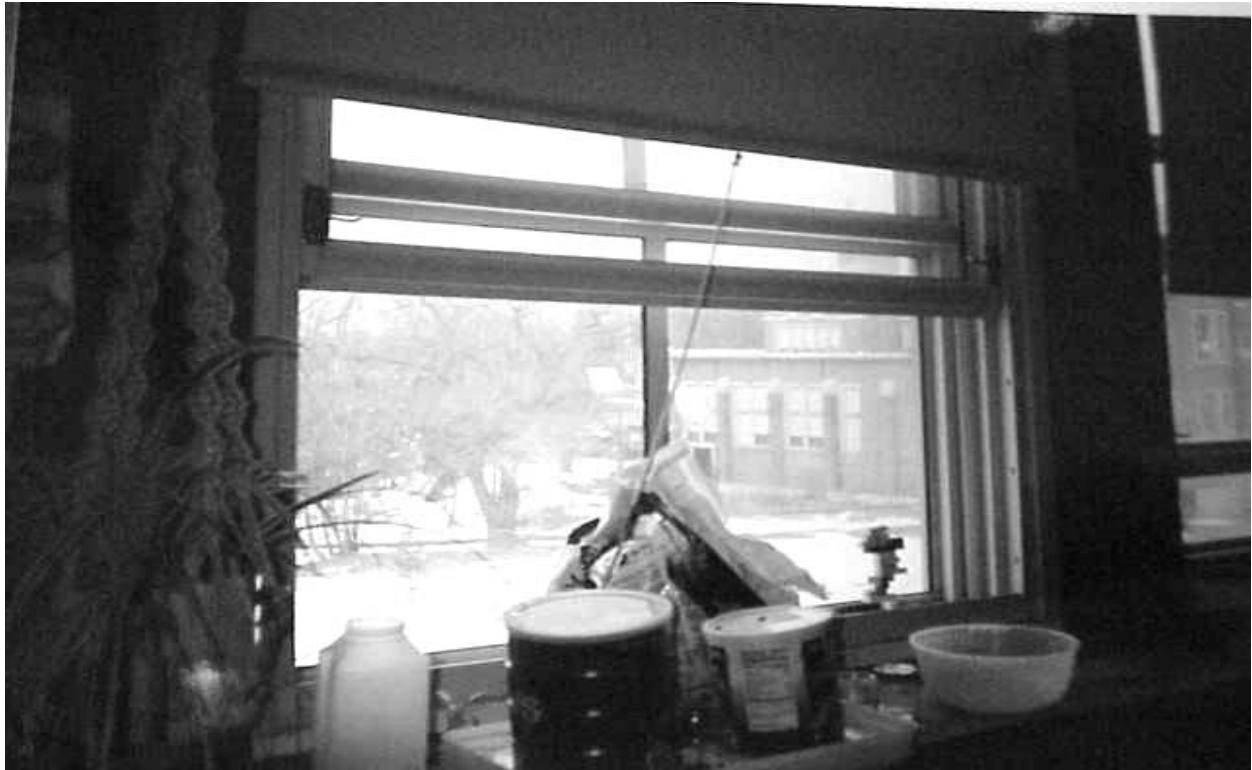
Picture 4

Unless the original ventilation system is restored to its original design by restoring control systems, openable basement windows and unsealing of exhaust vents, the sole source of ventilation in the building is openable windows. Each classroom window has a double sash. In many areas of the school, building occupants open windows to provide fresh air to classrooms. The inner sash is raised with the outer sash closed (see Picture 4). Spaces in the window frames allow for fresh outdoor air to infiltrate into classrooms. This method allows some fresh air infiltration while limiting penetration of moisture and direct air drafts into classrooms.

**Double-paned Windows Note Inner Window is Opened
to Allow for Air Infiltration**

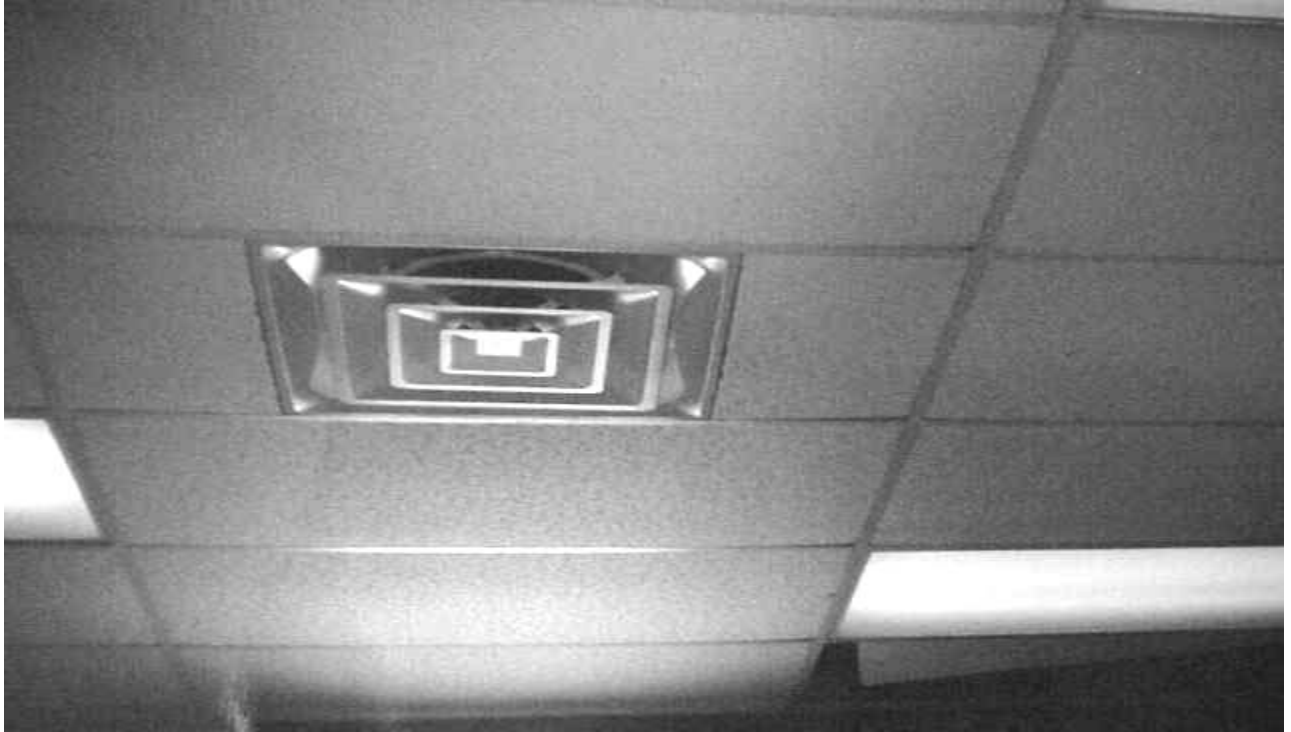
Picture 5

Heat complaints were reported to BEHA staff in a number of areas. Temperature control is difficult in an old building without a functioning ventilation system. A heating system was installed on the third floor. Heat is provided by an air-handling unit (AHU) in the attic. Heated air is distributed to rooms on the third floor by ceiling-mounted air diffusers and ducted return vents (see Pictures 5 & 6). As reported by Mr. Cali, this is a closed loop system, therefore no cool outside air is supplied, which can lead to increased temperatures.

Ceiling-Mounted Air Diffuser Noted on Third Floor

3. Consider contacting a ventilation-engineering firm to examine the possibility of providing fresh, outside air to the third floor heating system.
 4. Repair and/or replace thermostats as necessary to maintain control of comfort.

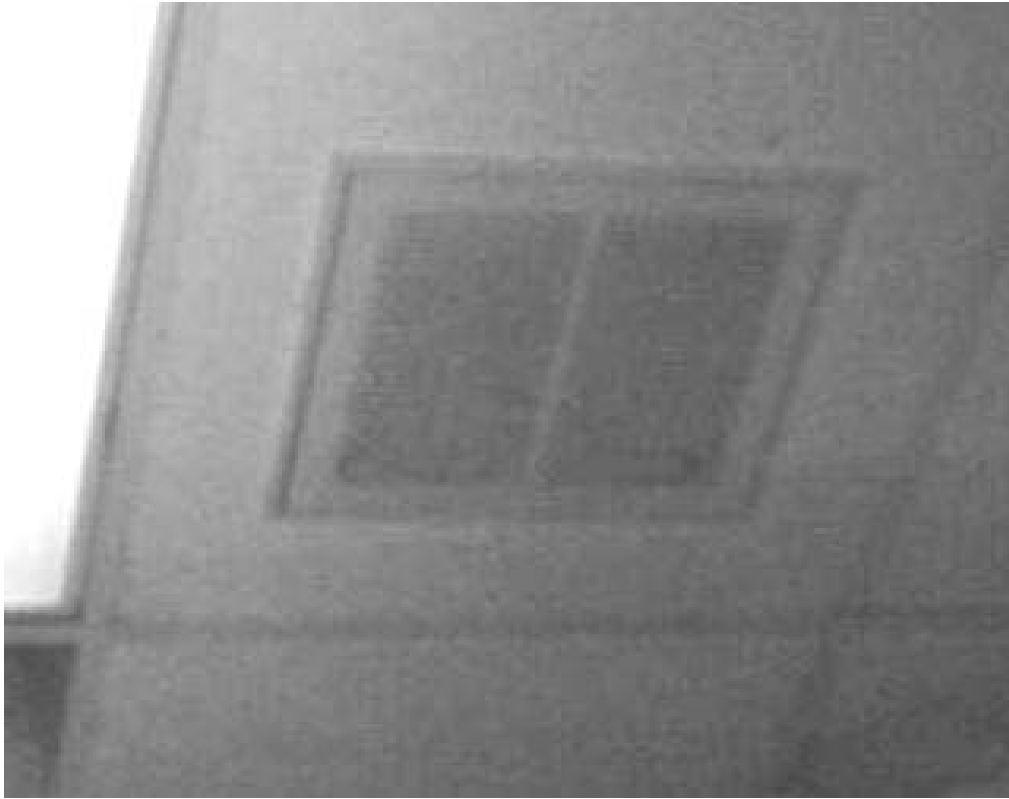
Picture 6

Ceiling-mounted Return Vent Noted on Third Floor

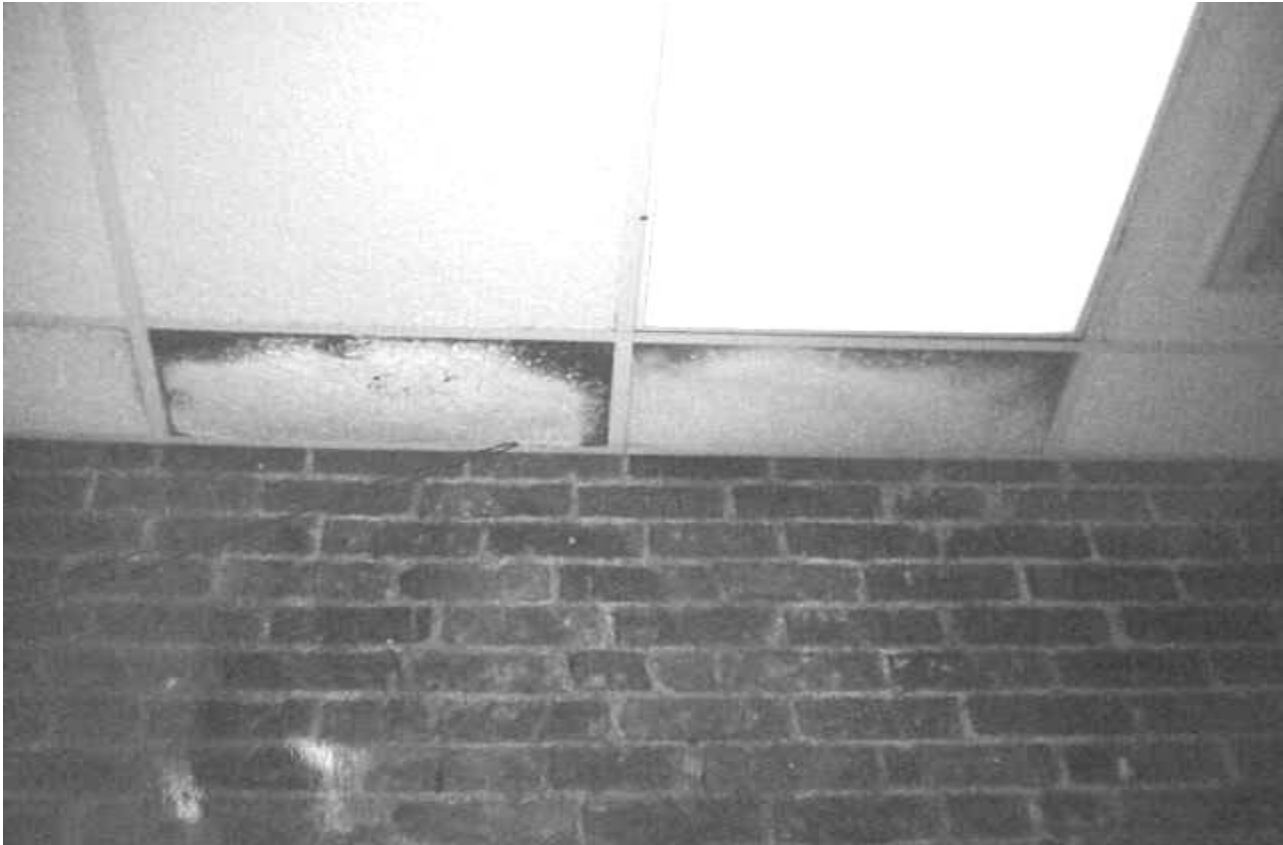
Picture 7

A number of rooms had water-stained ceiling tiles, which are evidence of roof and/or plumbing leaks (see Picture 7). Water-damaged ceiling tiles can provide a source of mold and mildew growth, especially if they are moistened repeatedly. These tiles should be replaced after a water leak is discovered and repaired.

Water-Stained Ceiling Tiles Noted on Third Floor

6. Repair any existing water leaks and replace any remaining water-stained ceiling tiles. Examine the areas above these tiles for mold growth. Disinfect areas of water leaks with an appropriate antimicrobial as needed.

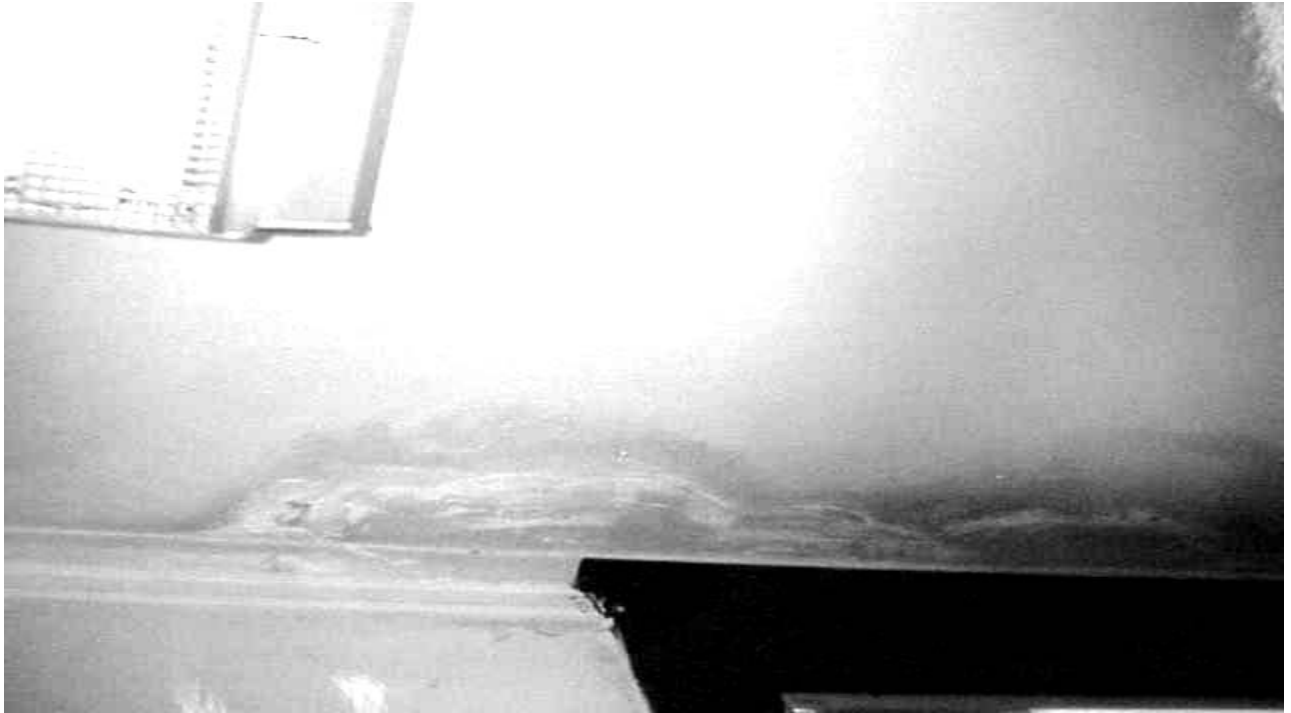
Picture 8

Water-damaged wall plaster was noted around the window in the business office, which may be evidence of a current or historic leak (see Picture 8). Water intrusion was evident by the presence of efflorescence (e.g., mineral deposits) and water-damaged plaster. Efflorescence is a characteristic sign of water damage to brick and mortar, but it is not mold growth. As moisture penetrates and works its way through mortar around brick, water-soluble compounds in bricks and mortar dissolve, creating a solution. As this solution moves to the surface of the brick or mortar, the water evaporates, leaving behind white, powdery mineral deposits. Water-damaged wall plaster, if wetted repeatedly, can be a medium for mold growth.

Water-Damaged Ceiling Plaster Noted in Business Office

5. Consider having exterior brick repointed and waterproofed to prevent further water intrusion. Repair water damaged ceilings, walls and wall-plaster as necessary.

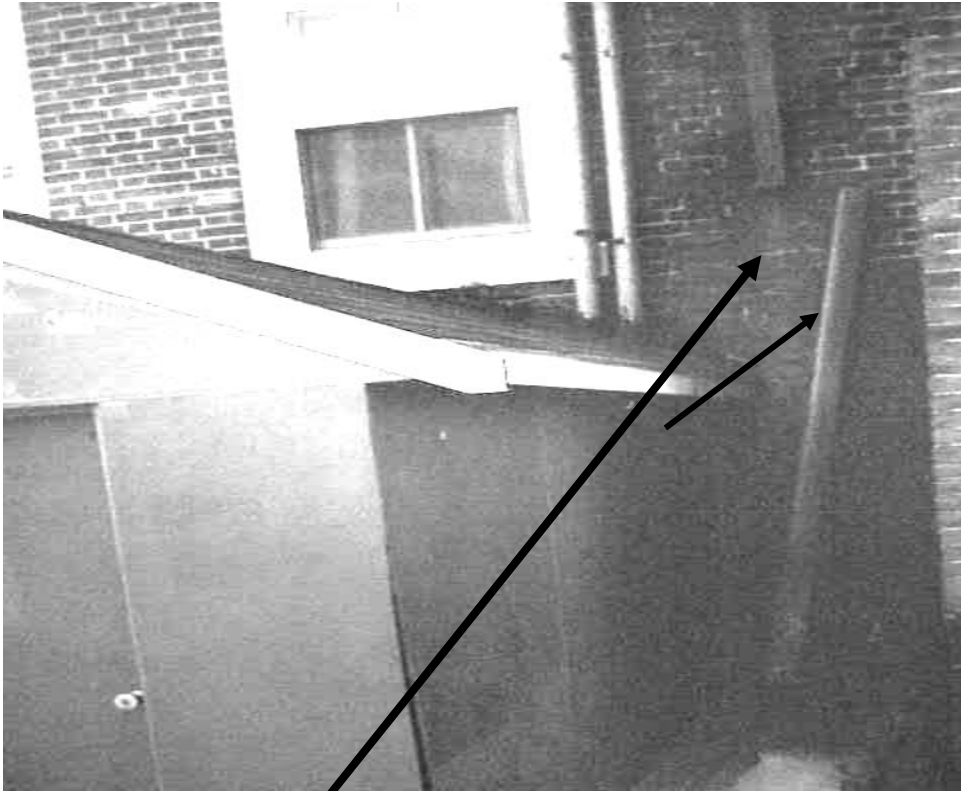
Picture 9

An inspection of the exterior of the school was conducted to identify possible sources of water entry. The building's roof drainage system collects water and directs it into a series of downspouts. Several downspouts had missing or dislodged elbow extensions at their bases (see Picture 9), which allows rainwater to pool on the ground against the building. The freezing and thawing action of water during the winter months can create cracks and fissures in the foundation. Over time, this process can undermine the integrity of the building envelope and provide a means of water entry into the building.

Dislocated Downspout Noted on Exterior of Building

7. Repair/replace downspouts to divert water away from the foundation of the building.
 8. Ensure plants are equipped with drip pans. Avoid over-watering and examine drip pans periodically for mold growth. Disinfect areas of water leaks with an appropriate antimicrobial where necessary.

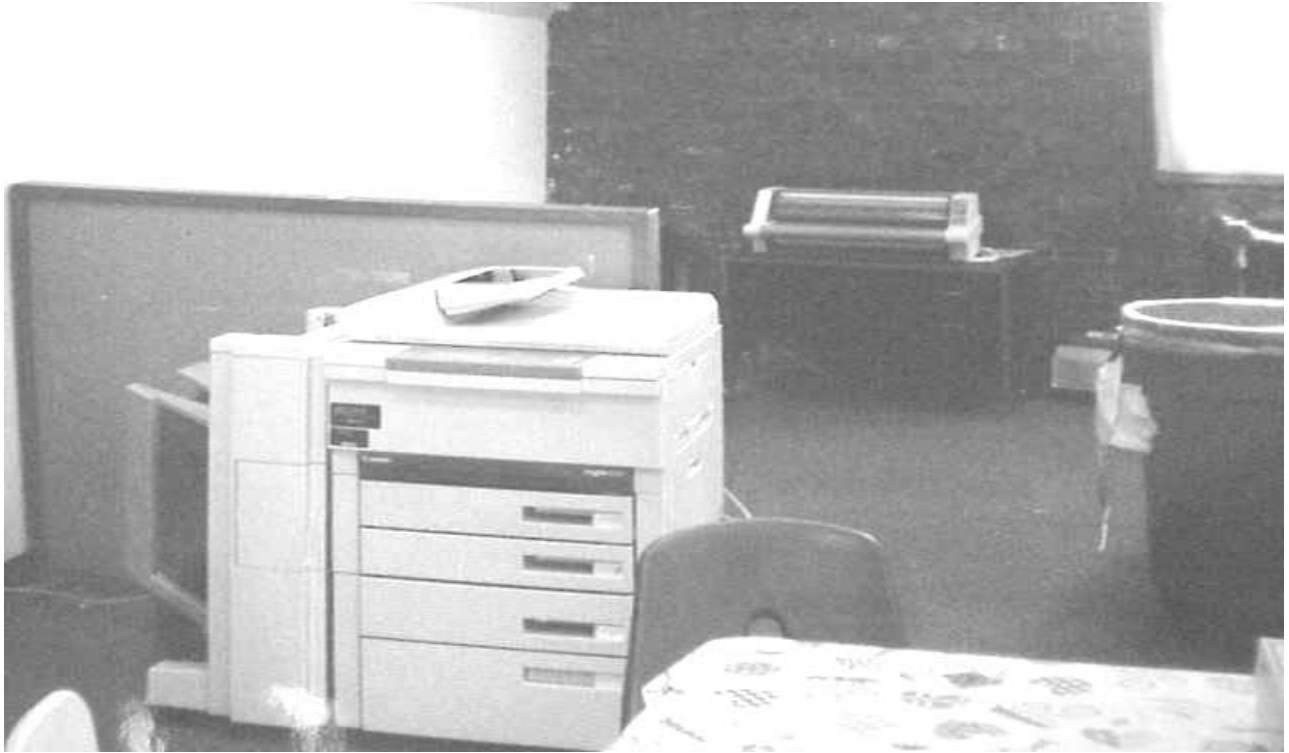
Picture 10

The teacher's lounge contained a photocopier and a lamination machine. (see Picture 10). Lamination machines can give off heat and odors. Volatile organic compounds (VOCs) and ozone can be produced by photocopiers, particularly if the equipment is older and in frequent use. Ozone is a respiratory irritant (Schmidt Etkin, D., 1992). No mechanical exhaust ventilation is provided for this room. Without mechanical exhaust ventilation, pollutants produced by office equipment can build up. Mechanical exhaust ventilation should be installed in this area to help reduce odors, pollutants and excess heat.

**Photocopier and Lamination Machine Noted in Teacher's Lounge Note
No Mechanical Exhaust Ventilation is Provided in This Area**

14. Consider installing local exhaust ventilation in the teacher's lounge to help reduce heat and odors.
15. Consider removing snow blowers from inside the building or relocating to a well-ventilated area.

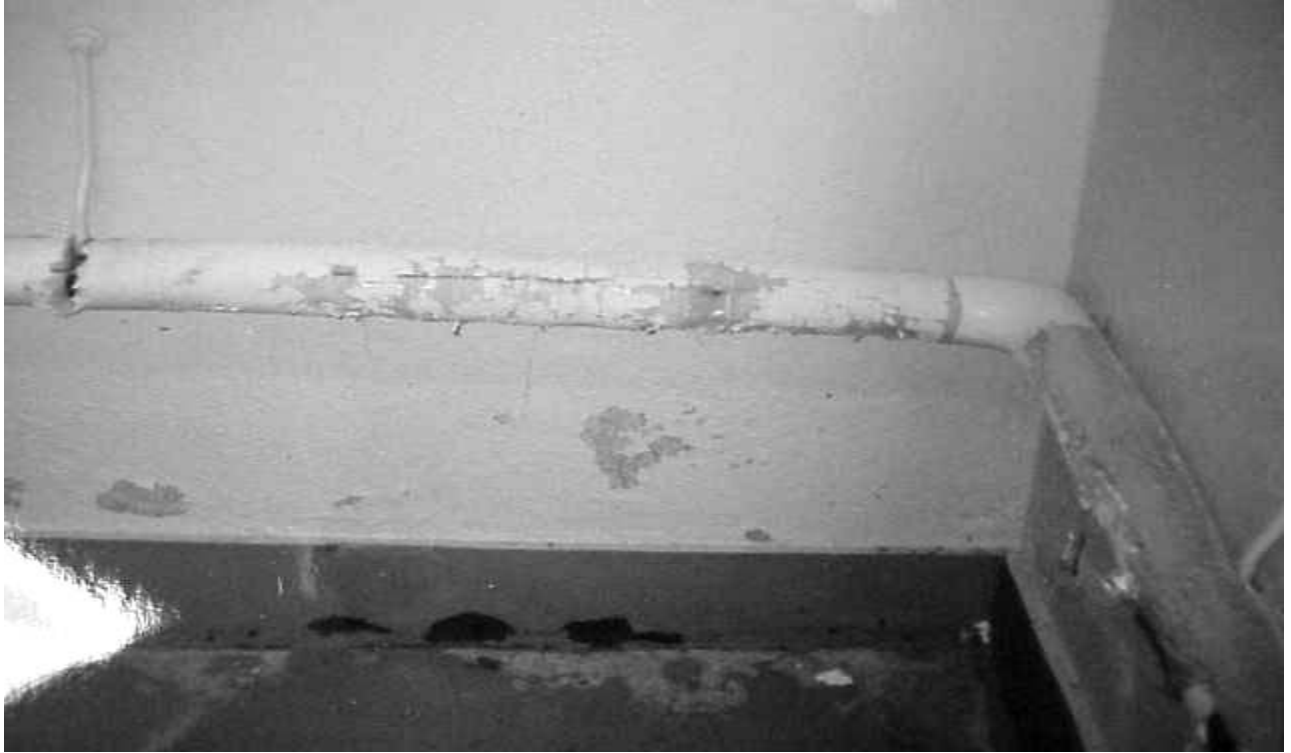
Picture 11

The teacher's lounge contained a damaged ceiling tile with exposed fiberglass insulation. In addition, the girl's restroom in the basement contained a damaged pipe exposing a fiberglass insulation material (see Picture 11). Fiberglass can serve as a skin, eye and respiratory irritant to sensitive individuals. Mr. Cali reported that the school was planning to encapsulate the damaged pipe insulation in the girl's restroom with a metal barrier.

Damaged Fiberglass Pipe Insulation Noted in Girl's Basement Restroom

11. Store cleaning products and other chemicals properly and out of reach of students.
 12. Seal utility holes and replace missing/damaged-ceiling tiles to avoid the aerosolization of dirt, dust and particulates in occupied areas. Continue with plans to encapsulate damaged pipe insulation in the girl's basement restroom to avoid the aerosolization of fiberglass fibers.

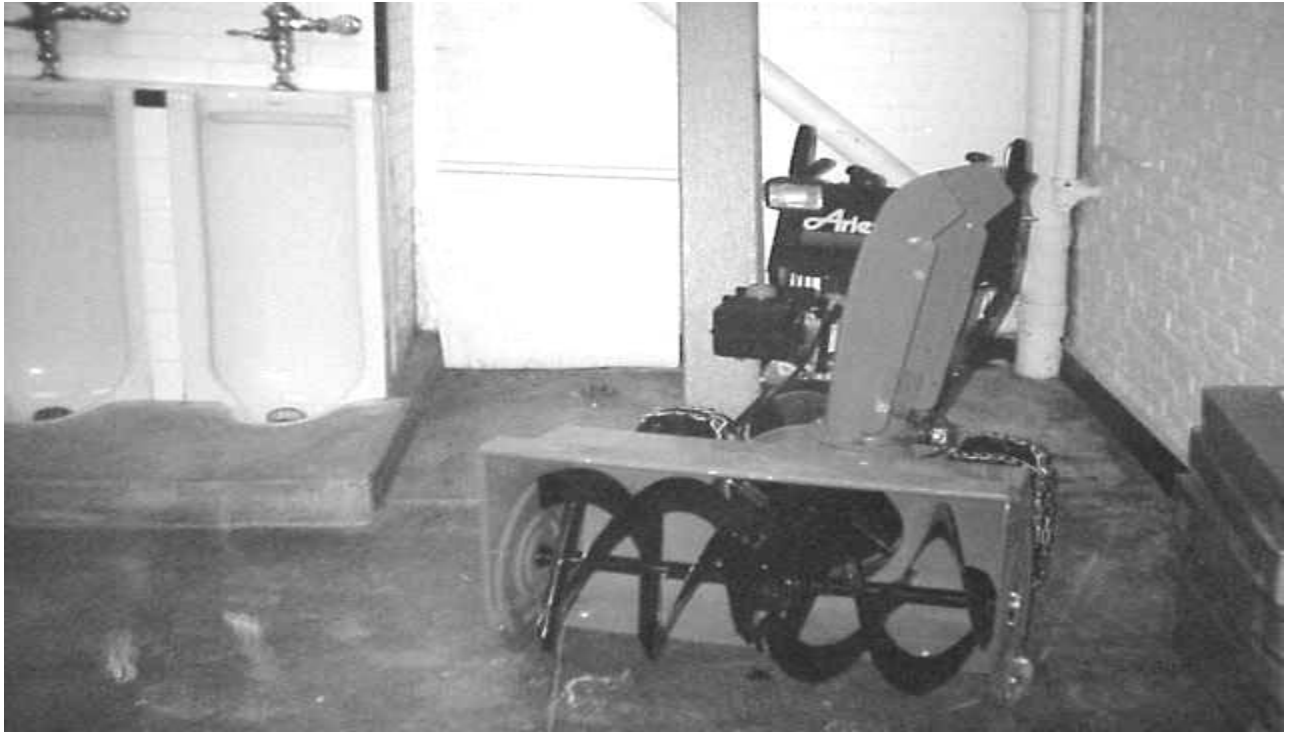
Picture 12

The basement restroom was being used to store a gas-powered snow blower (see Picture 12). It was reported to BEHA staff that the fuel tank was emptied prior to storage. However, this still may provide a source of possible odors and off gassing of volatile organic compounds (VOCs) found in gasoline, which can have an adverse effect on indoor air quality.

Snow Blower Noted in Basement Restroom
