INDOOR AIR QUALITY ASSESSMENT

**Massachusetts Rehabilitation Commission
100 Medway Road
Milford, Massachusetts**

Prepared by:
Massachusetts Department of Public Health
Bureau of Environmental Health
Indoor Air Quality Program
May 2017

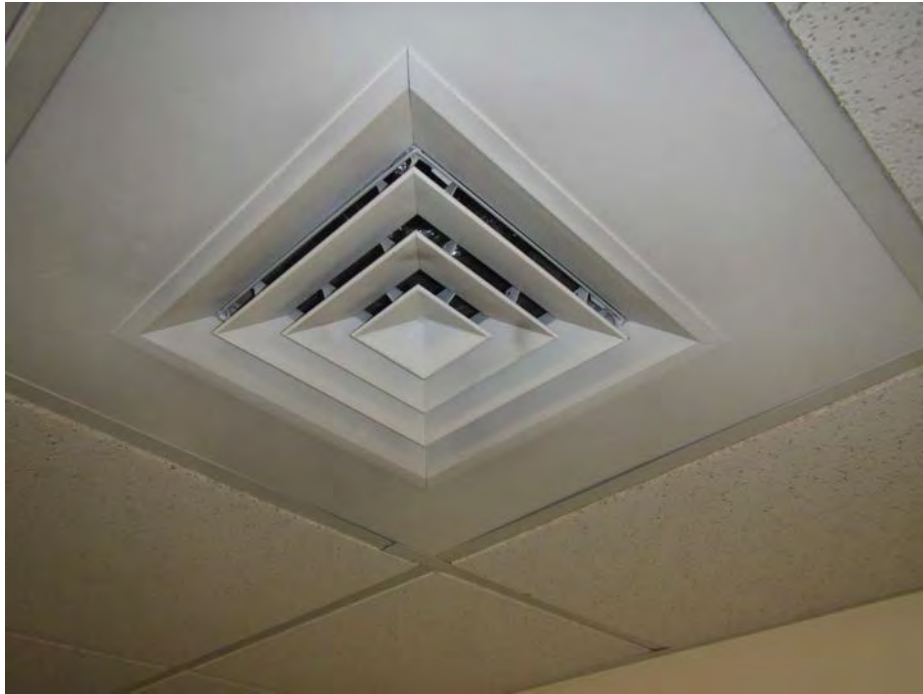
Picture 1

Supply air diffuser

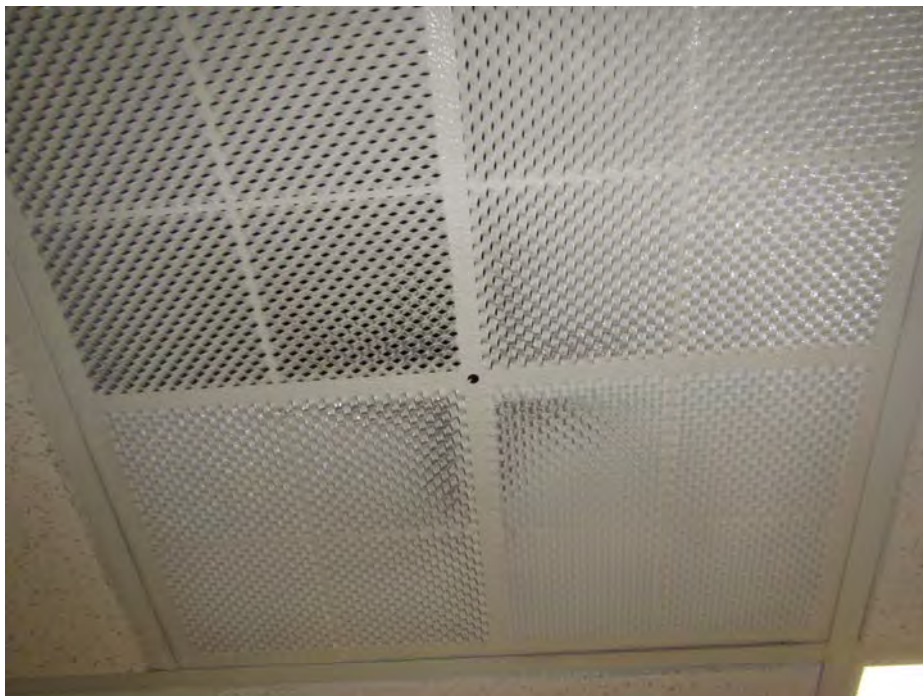
Picture 2

Ceiling-mounted return vent

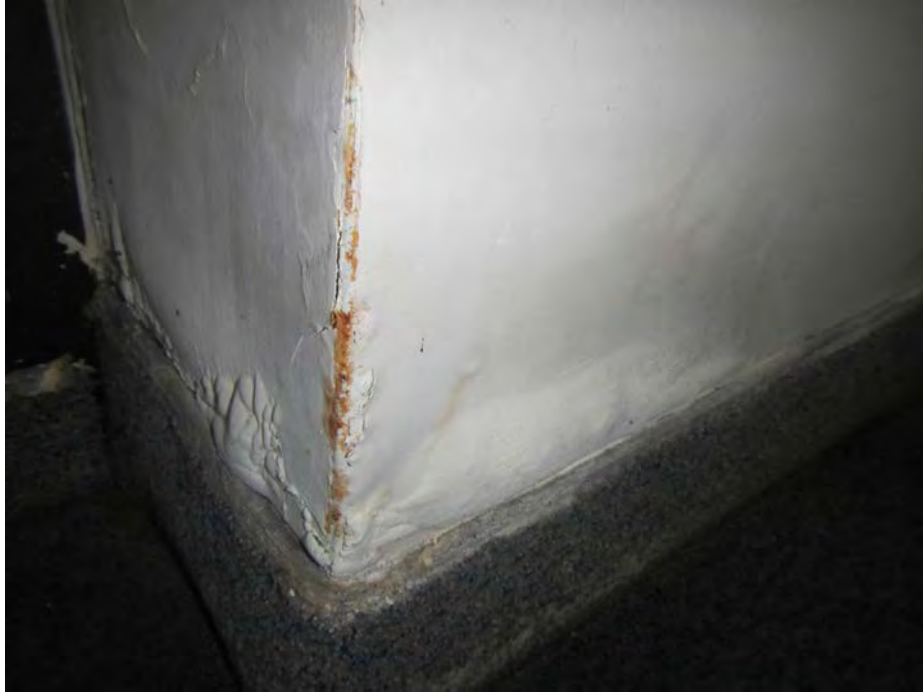
Picture 3

BEH/IAQ staff examined several exterior (perimeter) offices which had visible chronic water damage to gypsum wallboard, window sills, and carpeting (Pictures 3 to 6). This water damage likely resulted from a number of contributing factors. Firstly, it was noted that the weep holes for the brick exterior appear to drain below grade in several areas (Picture 7). Weep holes allow any water that passes through the brick façade to drain down the interior drainage plane and exit through these holes between the brick and mortar (Figure 1). Next, the bark mulch around the building not only holds moisture against the building exterior but also is above the level of the window frames in several areas (Picture 8). The drainage and grading around the building should be assessed to avoid pooling water against the building. Also, the window frames/gaskets appeared to have pathways (e.g., gaps, cracks) for water infiltration. Window flashing should be inspected to prevent further water infiltration as well. Lastly, condensation may be a contributing factor. When surfaces are cooled below the dew point temperature, water droplets form and may damage porous building materials. Cooler surface temperatures such as window frames and concrete slab were measured and are shown in Table 3. Condensation is typically more of a problem when warmer humid air comes in contact with these cooler surfaces.

Water-damaged gypsum wallboard and carpeting

1. Work with a water intrusion contractor to address water infiltration and possible condensation issues in offices where chronic water damage was observed. Inspection of the

weep holes, window gaps/flashing, perimeter drainage, insulation, and mulch level should be included in the assessment.

2. Remove water-damaged gypsum wallboard and carpeting in a manner consistent with US EPA “Mold Remediation in Schools and Commercial Buildings” (US EPA, 2008). This work should be performed when the building is unoccupied.

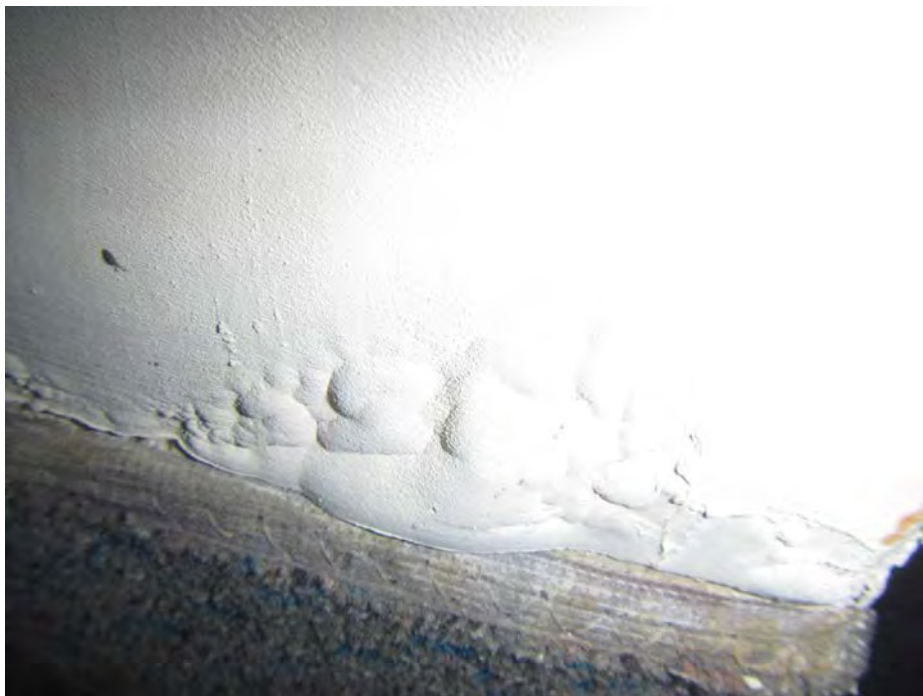
Picture 4

Water-damaged wall and carpeting

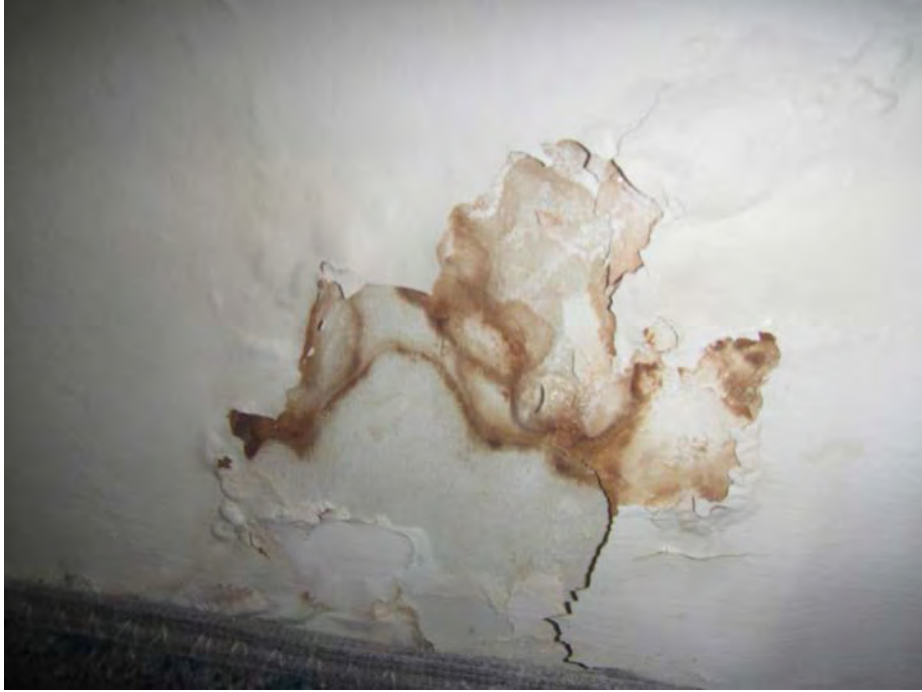
Picture 5

Water-damaged wall and carpeting

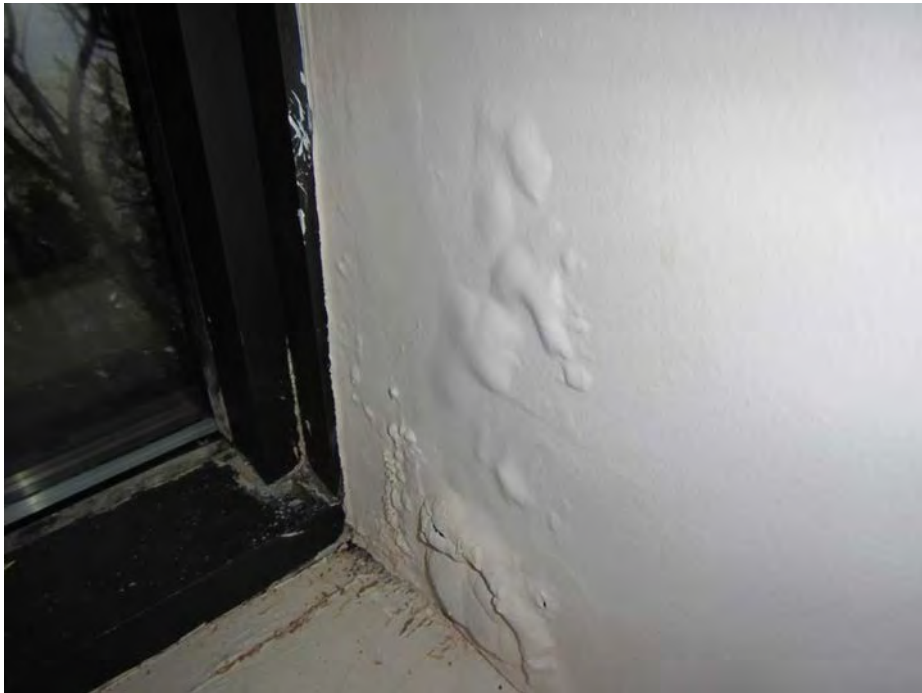
Picture 6

Water-damaged wall and window sill

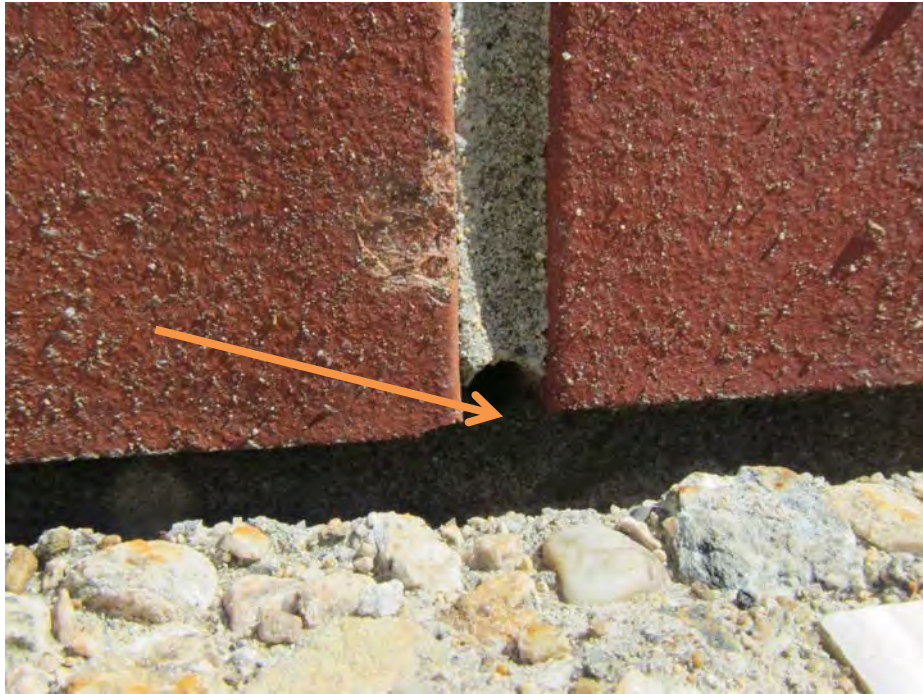
Picture 7

Weep hole drains against building below raised walkway

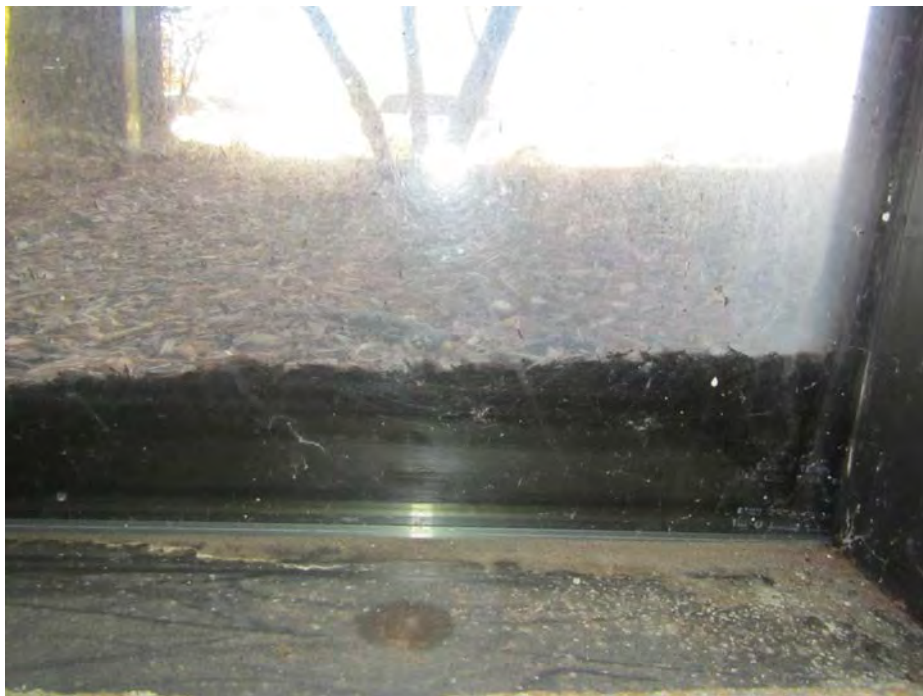
Picture 8

Bark mulch piled high above the level of window/frame

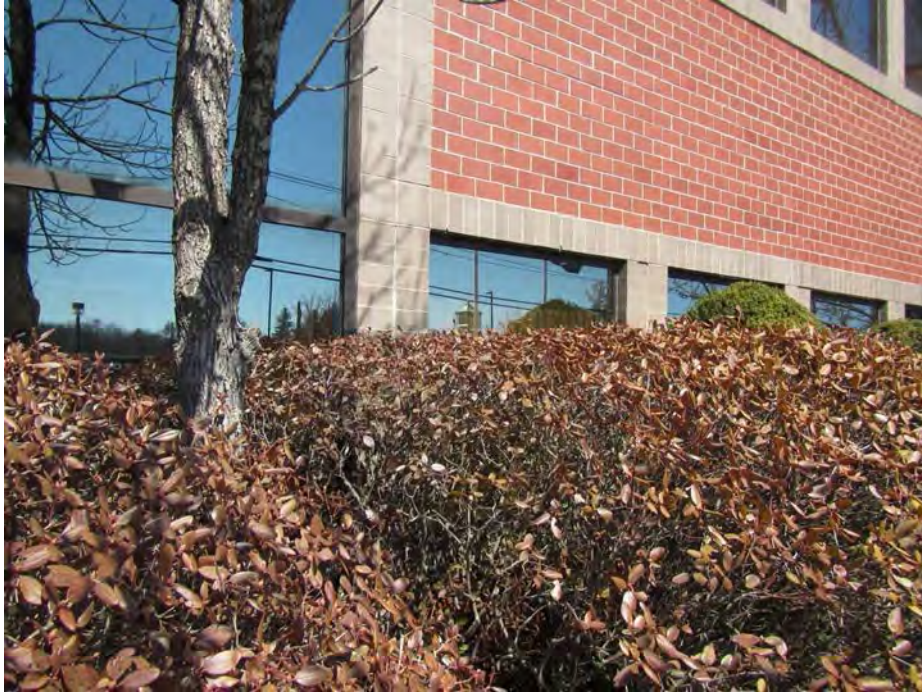
Picture 9

BEH/IAQ staff observed trees and other plantings growing against the building exterior (Picture 9). Vegetation will hold moisture against the masonry surface and may lead to damage and water infiltration.

Trees and vegetation growing against building exterior

10. Keep plants in good condition, avoid overwatering, and remove from the airstream of heating and ventilation equipment.
11. Remove any trees/vegetation within 5’ of the building exterior to avoid damage to the brickwork and water infiltration.

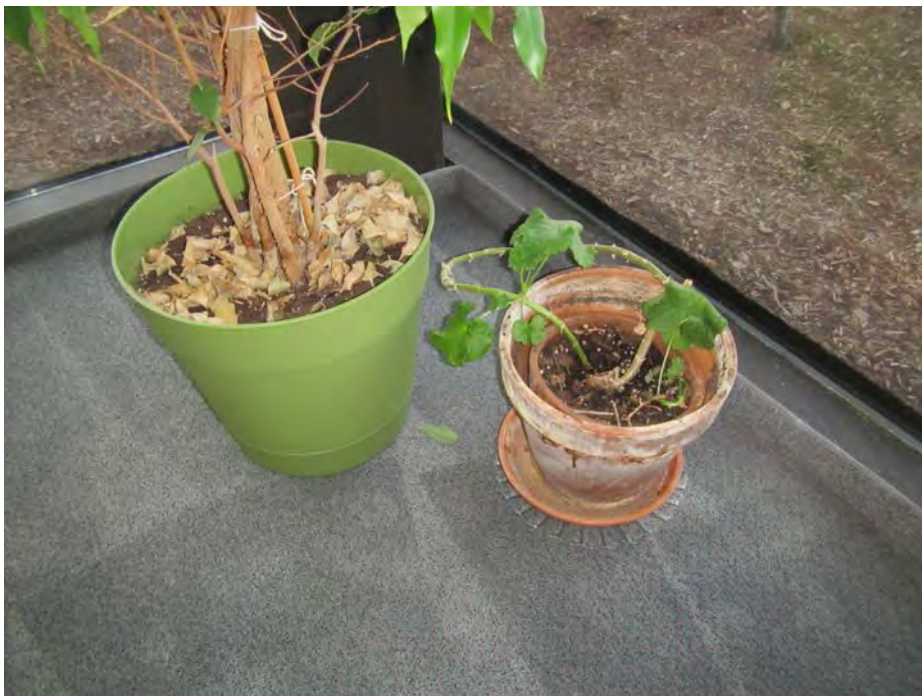
Picture 10

Plants were observed in a few areas (Picture 10, Table 1). Plants can be a source of pollen and mold, which can be respiratory irritants to some individuals. Plants should be properly

maintained and equipped with drip pans and should be located away from air diffusers to prevent the aerosolization of dirt, pollen, and mold.

Plants on office carpeting

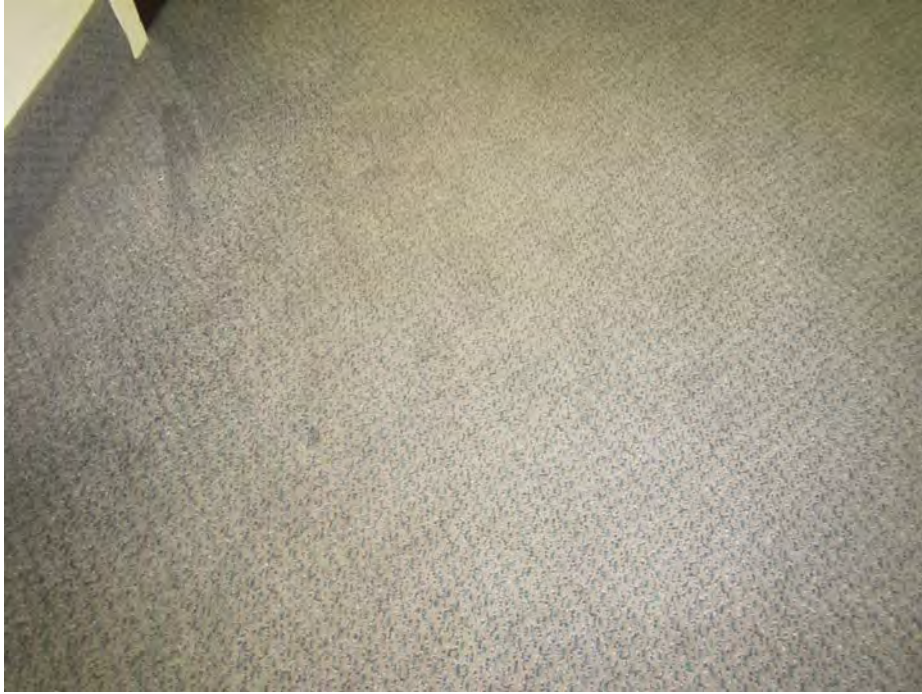
Picture 11

Many areas contained worn and water-damaged carpeting that appeared to be past its useful life (Table1; Picture 11). The Institute of Inspection, Cleaning, and Restoration Certification (IICRC), recommends that carpeting be cleaned annually, or semi-annually in high-traffic areas (IICRC, 2012). MRC staff reported that the carpeting was cleaned prior to this assessment. Since the average lifespan of carpeting is approximately eleven years (Bishop, 2002), consideration should be given to planning the installation of new flooring (e.g., carpet tiles).

Worn carpeting

14. Replace water-damaged/worn carpeting throughout the building. Consider replacing with carpet squares which provide more flexibility in terms of replacing tiles in small areas if damaged in the future.
15. Consider increasing fresh air supply and/or adding or increasing local exhaust to the break room area to improve air exchange and more effectively remove food odors and particulate matter.
16. Clean carpeting annually (or semi-annually in soiled high traffic areas) as per the recommendations of the Institute of Inspection, Cleaning and Restoration Certification (IICRC).
17. Refer to resource manual and other related IAQ documents located on the MDPH's website for further building-wide evaluations and advice on maintaining public buildings. These documents are available at <http://mass.gov/dph/iaq>
