INDOOR AIR QUALITY ASSESSMENT

**Reading Fire Department
757 Main Street Firehouse
Reading, Massachusetts**

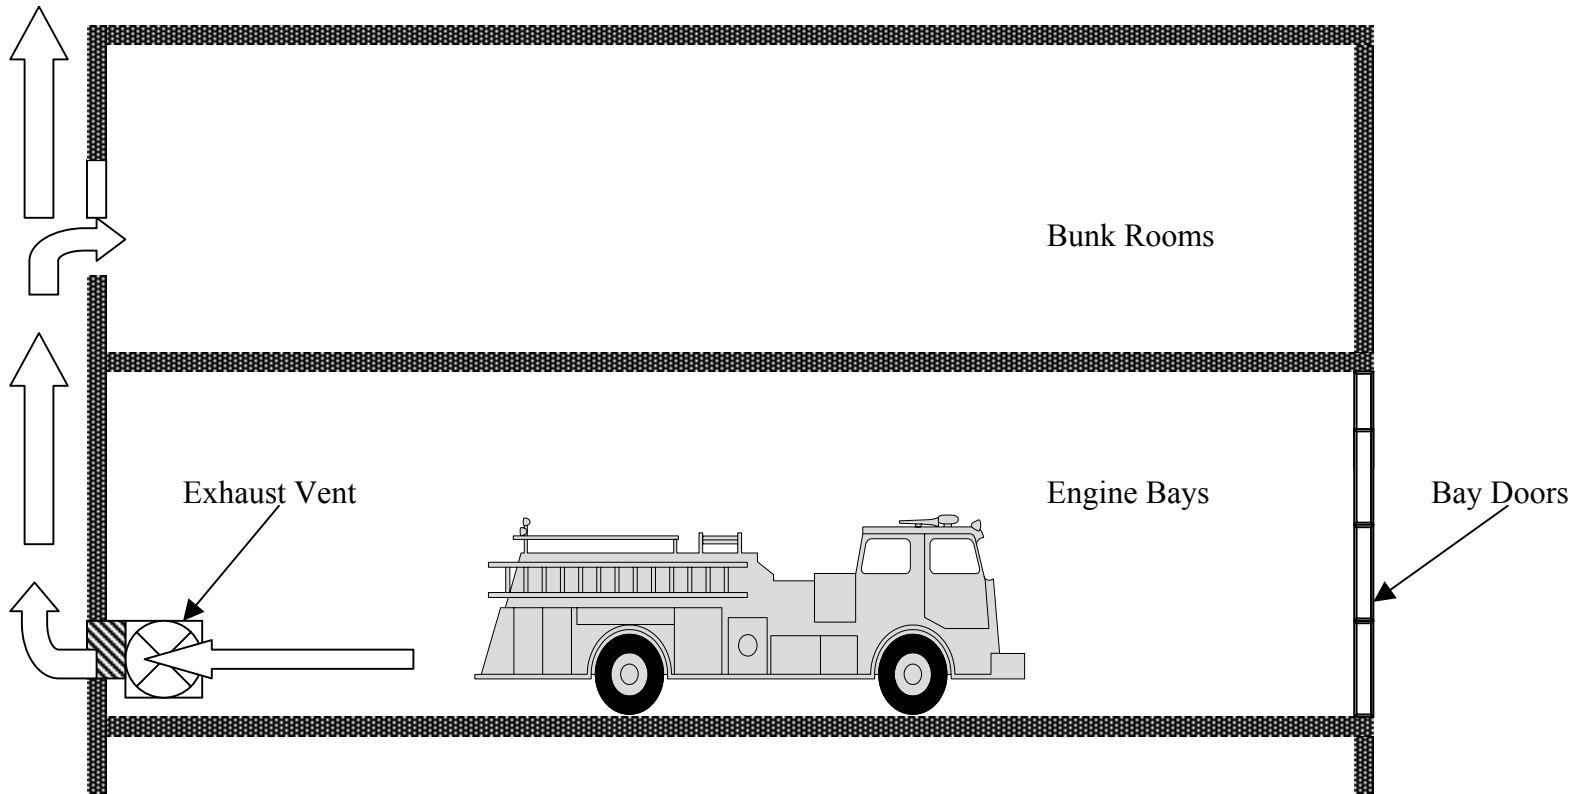
Original Design Expels Engine Exhaust out Rear Wall, Which Then Infiltrates into Bunk House Rooms through Open Windows
